Handbook of Materials Failure Analysis

With Case Studies from the Aerospace
and Automotive Industries

Abdel Salam Hamdy Makhoul

Mahmood Aliofkhazraei

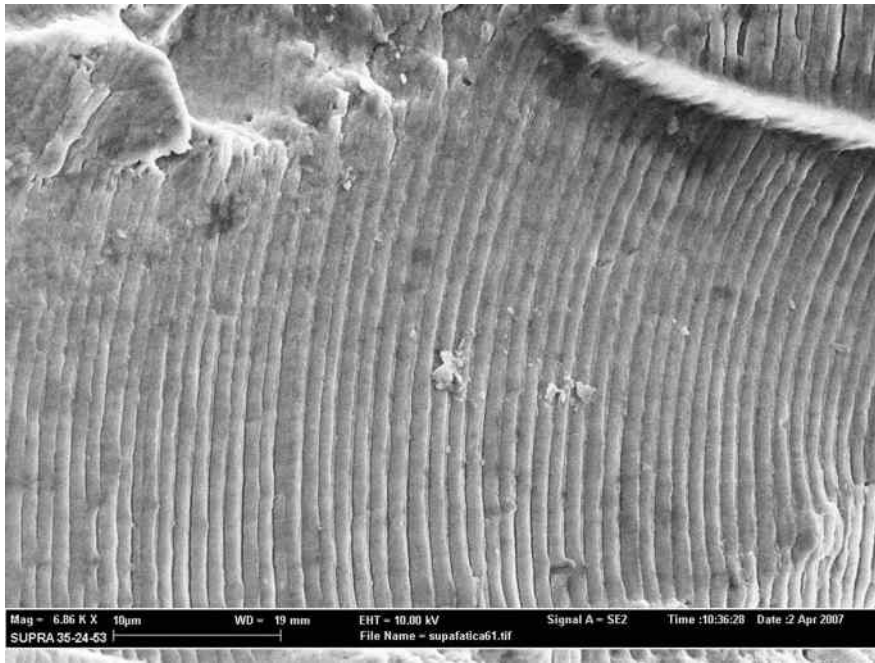
FIGURE 5.7

SEM micrograph of the fracture surface of the crack in the stable propagation. Zone C.

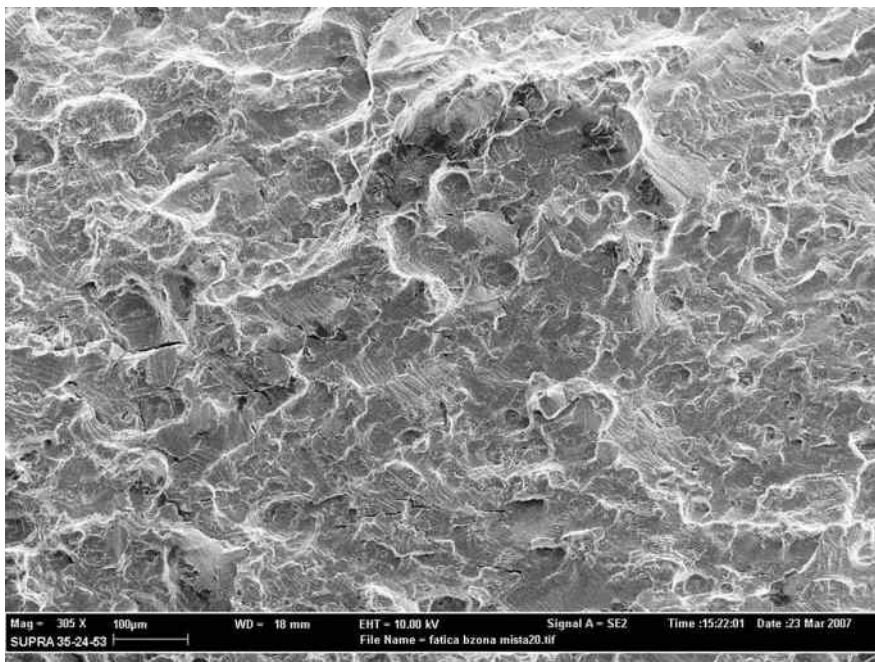
FIGURE 5.8

SEM micrograph of the fracture surface of the crack in the unstable propagation. Zone C.

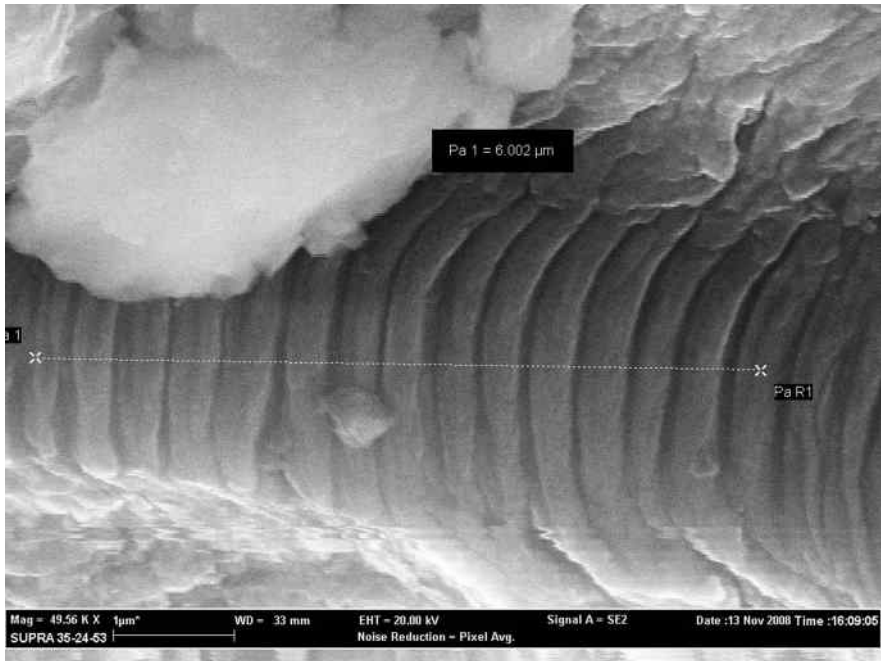
FIGURE 5.17

Striation spacing near the starting point at crack length less than 12 mm.

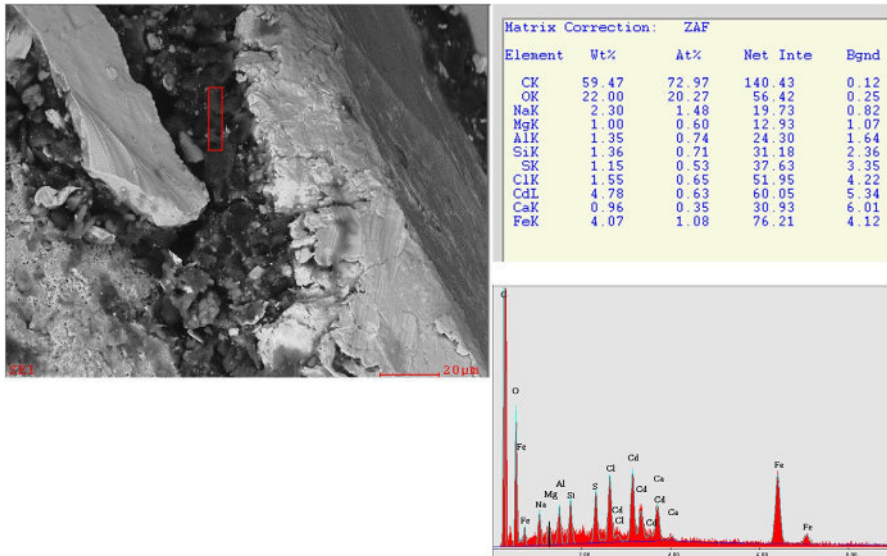
FIGURE 11.6

Surface analysis using EDS of the deposits formed over the pitting zones.

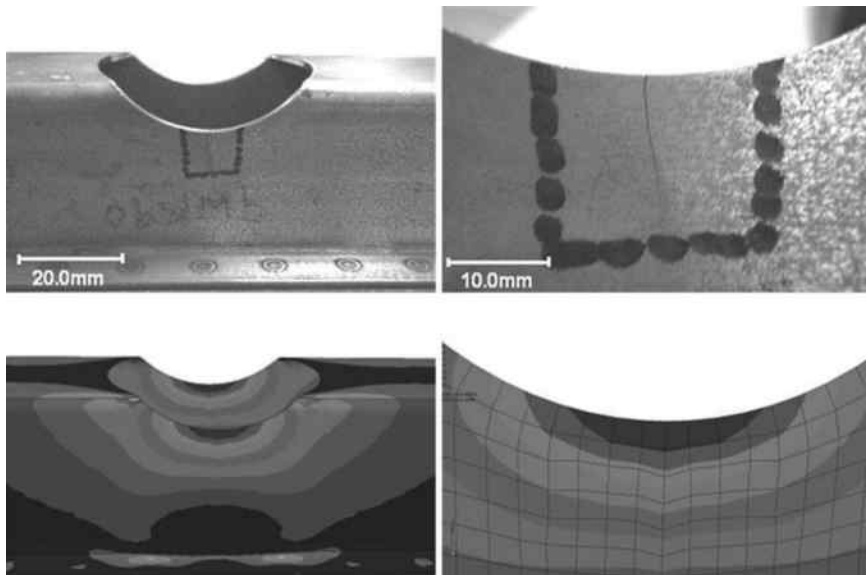
FIGURE 16.22

The critical region on the structure showing the location of maximum stress from where a crack initiates.
