# FAILURES IN CONCRETE STRUCTURES

Case Studies in Reinforced  
*and* Prestressed Concrete

Robin Whittle

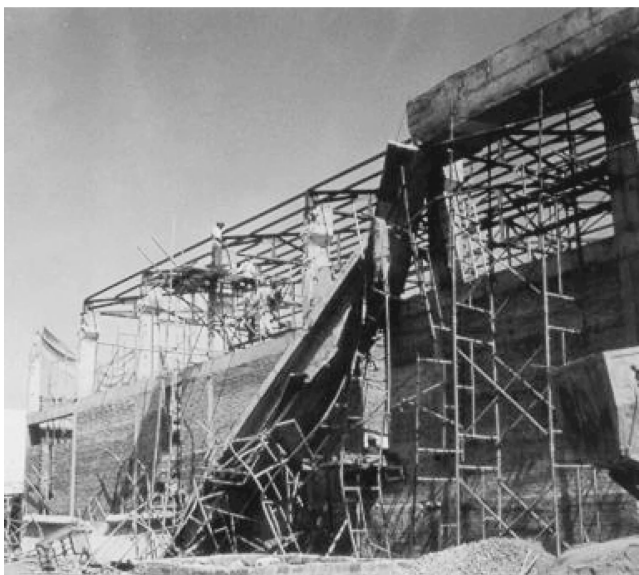
*Figure 1.1* Collapse of concrete gutter.

The contractor had been using the gutter to pile bricks and sand. This load exceeded the design load and failure occurred.

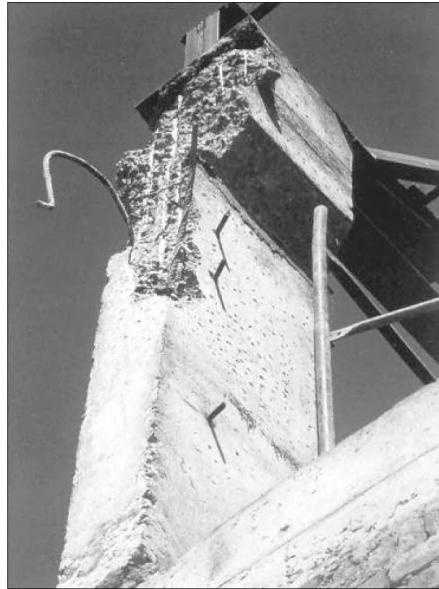
**Figure 1.3** Column where edge beam has broken off.

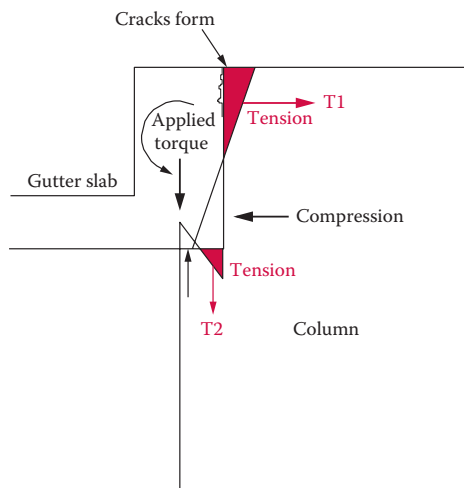
**Analysis** — Figure 1.4 shows a failure model based on the tension strength of the concrete. Even if the links that had been detailed to pass through the joint had been constructed this way, they would have been inadequate to support the loading.

**Figure 1.4** Failure model relying on tension strength of concrete.

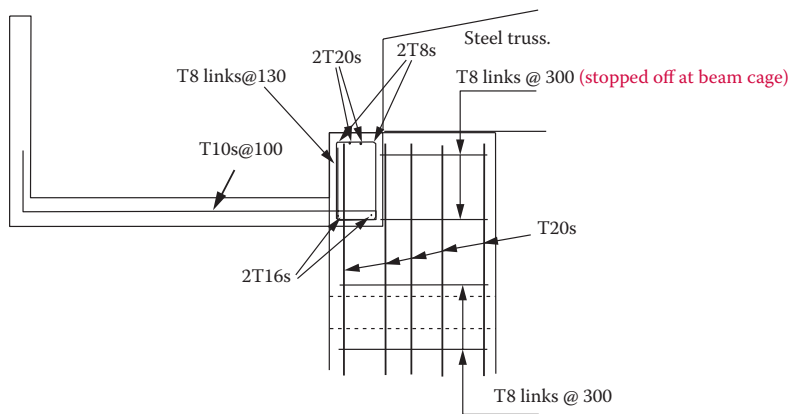
**Detailing** — The reinforcement for the edge beam–column joint was built as shown in Figure 1.5. The top two links were detailed to enclose

**Figure 1.5** Reinforcement detailing for edge beam and column joint.

all the column main bars. Even if the links that had been detailed to pass through the joint had been constructed this way, they would have been inadequate to support the loading. If the detail had been drawn to a large scale it would have become apparent that the column links would have been difficult to fit through the beam cage, and this should have triggered concern about the connection.

**Comment** — Although the edge beam had been designed and detailed to resist the full load from the gutter (moment, shear, and torsion), this had not been carried through to the joint. The joint relied on the tension strength of the concrete which was not sufficient. This was a serious design error, but it is unlikely that the failure would have occurred if the gutter had been subject to just the load from rain. If the detailing and construction had been carried out thoroughly and correctly it is unlikely that the collapse would have occurred.

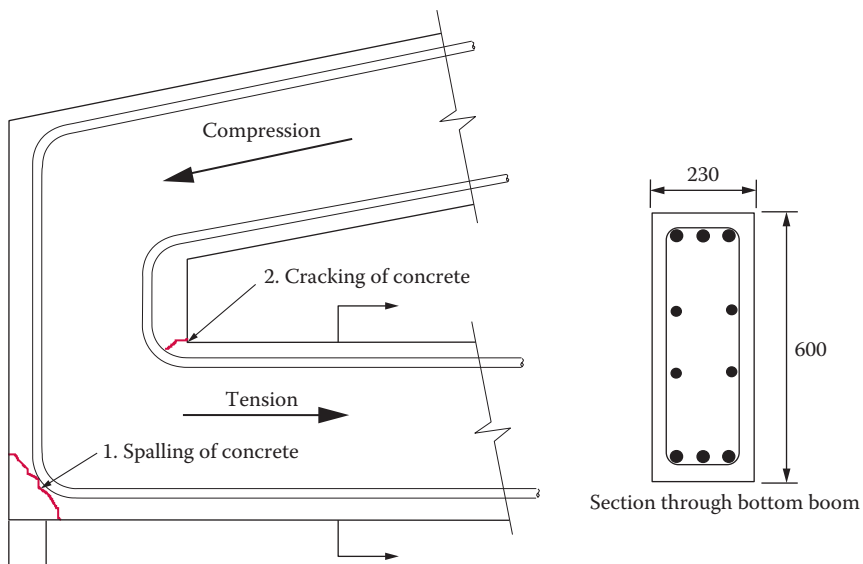
**Failure of concrete at support (1 in Figure 1.8)** — The support width was only 150 mm and the drawing did not show any reinforcement in the connection to the truss. If reinforcement was intended in the joint, then it would be difficult to fit this between the reinforcement of the truss. If not, the effect of the cover and the radius of bend of the T32 bars at the corner of the truss would lead to spalling of the concrete and the support would fail.

**Failure of concrete at inner corner (2 in Figure 1.8)** — Since the bottom boom was a tension member, the top reinforcement in it would be in tension. The way that it was detailed meant that a crack in the concrete would develop on the inside of the bend where it joined the vertical post at the end of the truss.

Figure 1.8 Concrete failure points.

**Comment** — These problems were noticed whilst checking something quite different. For the design strength of concrete, the shear reinforcement was insufficient and the concrete strut strength inadequate. If the cube strength had been increased from 25 to 35 MPa, the section would have been strong enough.

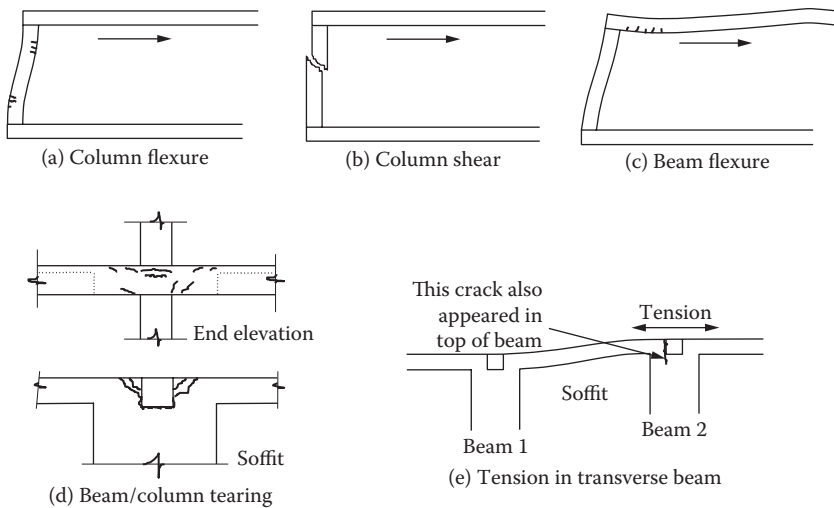
Figure 1.14 Different types of cracking.

widespread in both the columns and beams and exceeded 0.7 mm in places. Figure 1.14 shows the different types of cracking that occurred.

It took a long time to understand what caused the cracking. Whilst the problem was debated, in order to proceed with construction with minimum delay, the prestressing was altered to a two-stage process—only 50% applied at transfer and the remaining prestress applied after 2 weeks. After much discussion, it was concluded that when early thermal effects were included with the other shortening effects, the total shortening was sufficient to cause the cracking. At that time (early 1990s) it was not common to include early thermal effects in the designs of concrete frames (for reinforced or prestressed concrete). The calculated value of early thermal movement at the outer ends of a six-span beam was over 8 mm which, when added to the elastic shortening from prestress of 7 mm, provided sufficient movement to cause the cracking that occurred.

From a layman's view, as the concrete started to set, the temperature rose. During this period, the concrete remained somewhat plastic. The stiff columns prevented any expansion of the beams (they just bulged a bit). When the temperature started to fall, the concrete had hardened and the beam shortened, causing the cracks.

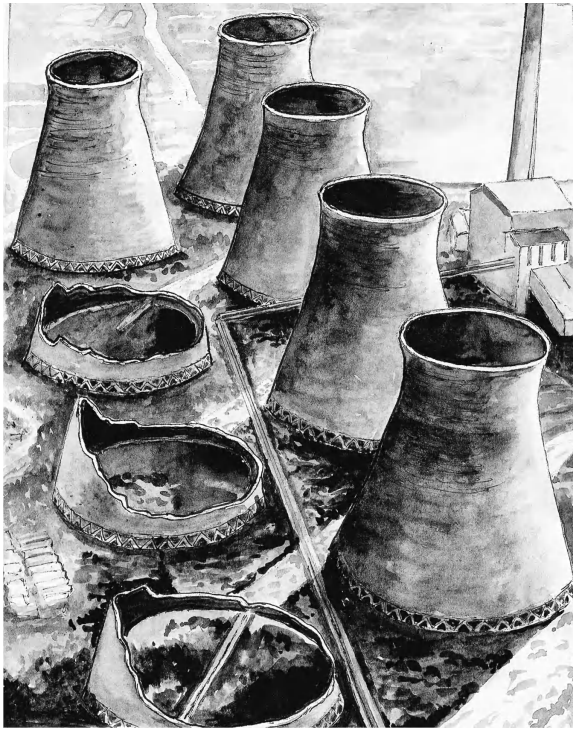
- British Standard wind speeds had not been used in the design; as a result, design wind pressures at the tops of the towers were 19% lower than they should have been.
- Basic wind speed was interpreted and used as the average over a 1-minute period, whereas, in reality the structures were susceptible to much shorter gusts.
- The wind loading was based on experiments using a single isolated tower. The grouping of the towers created turbulence on the leeward towers—the ones that did actually collapse.
- Safety margins did not cover uncertainties in the wind loadings.

**Figure 3.1** View of collapsed cooling towers. (Courtesy of Gillian Whittle.)

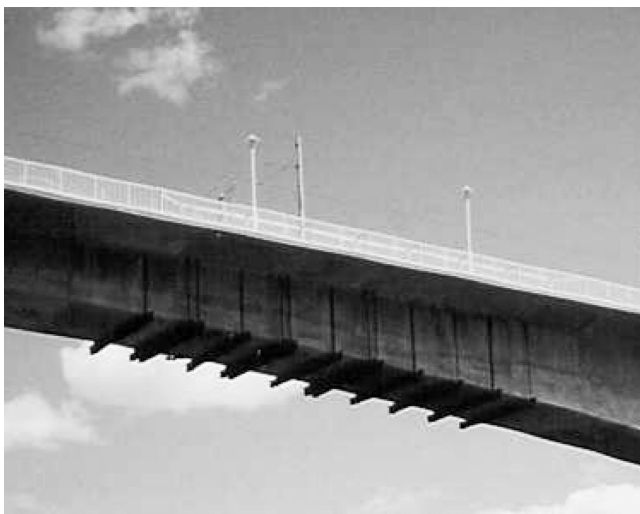
The design of a prestressed bridge section followed a code of practice that some considered to overestimate the shear capacities of prestressed beams. Soon after construction, cracks appeared. There was a long debate about the cause of cracking and, until remedial work was carried out, temporary additional external shear reinforcement was put in place (see Figure 3.5).

**Figure 3.5** Temporary repair work on bridge.

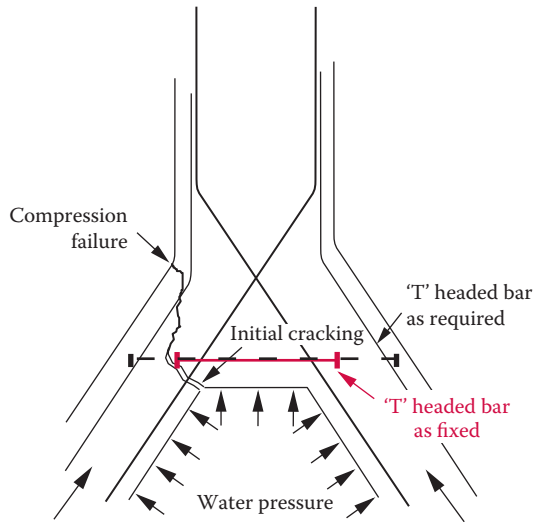
Figure 6.4 Section through tri-cell where failure occurred.

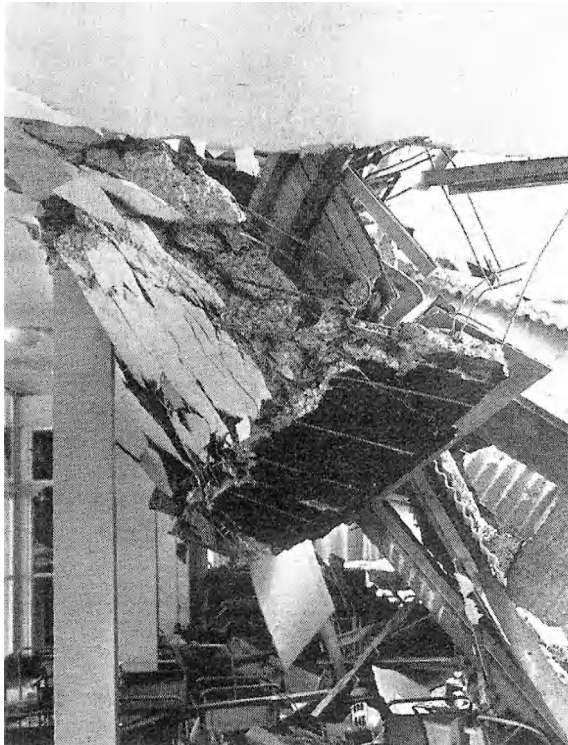
**Comment** — This was an example of inadequate design and poor detailing of the end bearing nibs built into the supporting beam for the precast beams. The reduction in strength caused by HAC left no margin for temperature effects. The combination was likely to have triggered the collapse.

**Figure 6.6** Part of roof that collapsed on chairs below. (From Scott, G.A., *Building Disasters and Failures*, Construction Press Ltd., Lancaster, 1976. With permission.)

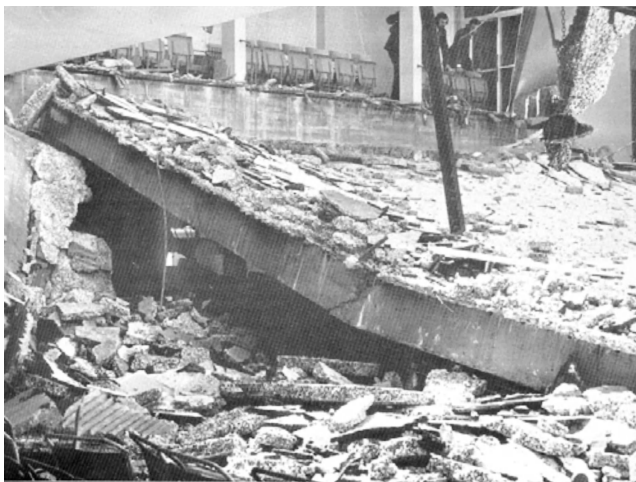
**Figure 6.7** Collapsed roof lying on floor below. (From Scott, G.A., *Building Disasters and Failures*, Construction Press Ltd., Lancaster, 1976. With permission.)

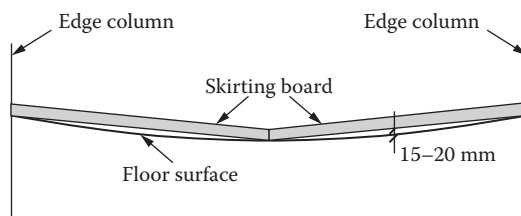
The conclusion was that much of the deflection occurred during construction, some of which was due to the sagging of the formwork and some due to early removal of the formwork.

Figure 8.2 Skirting board deflection.

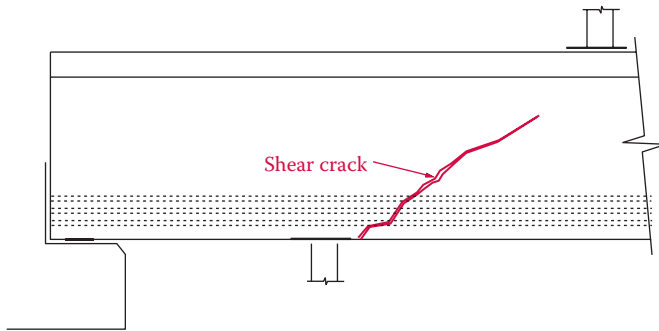
Figure 8.3 Cracked T unit.

The subcontractor proposed to repair the damaged T unit by drilling angled holes down the centre of the web and grouting in straight deformed reinforcing bars. He was sufficiently confident to agree to then test load

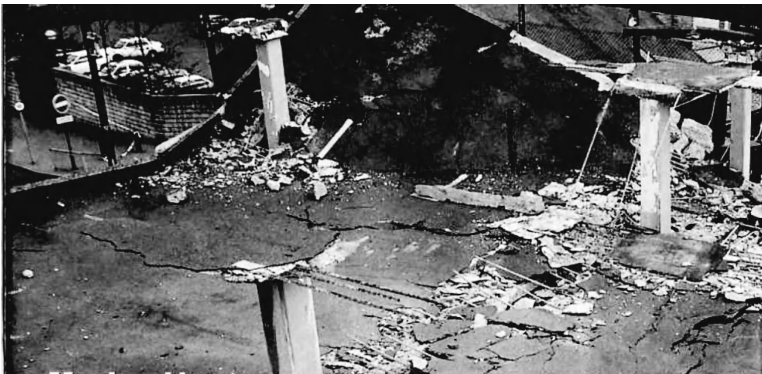
**Figure 8.8** Collapse of roof of car park. (From Jonathan Wood, <http://www.hse.gov.uk/research/misc/pipersrowptl.pdf>.)

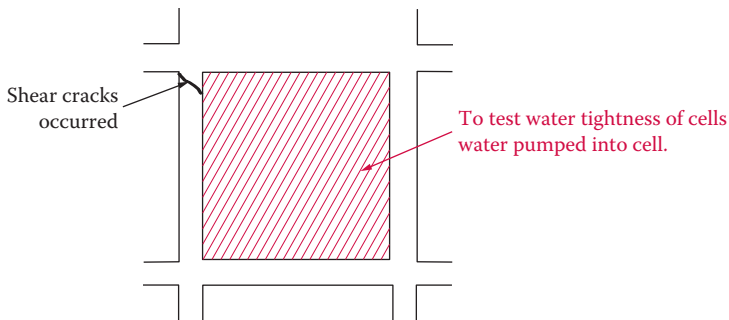
Figure 8.13 Shear crack in wall.

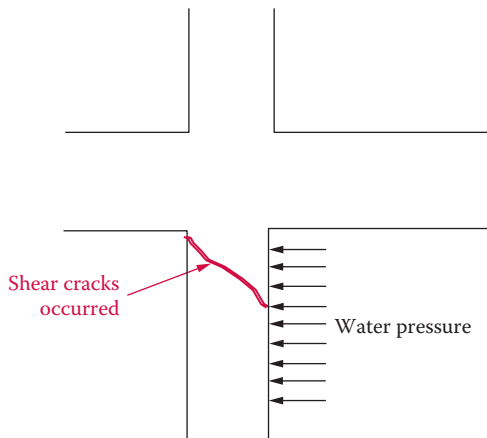
Figure 8.14 Enlarged view of shear crack.

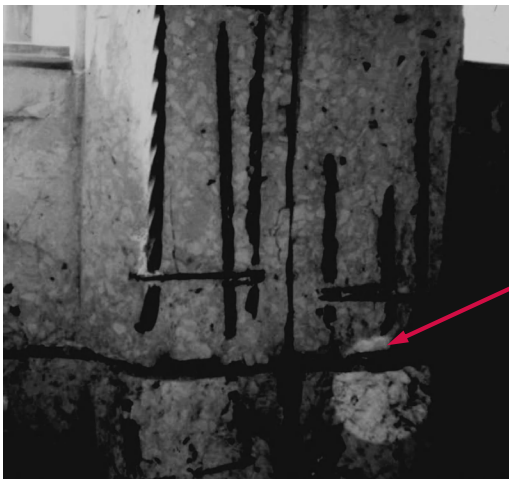
*Figure 8.17* Spalling of mullions. (Courtesy of Poul Beckmann.)

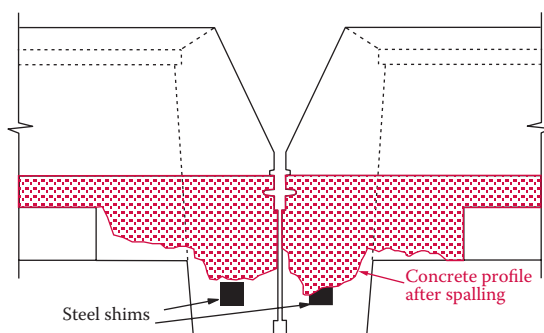
*Figure 8.18* Plan section through mullion after spalling.

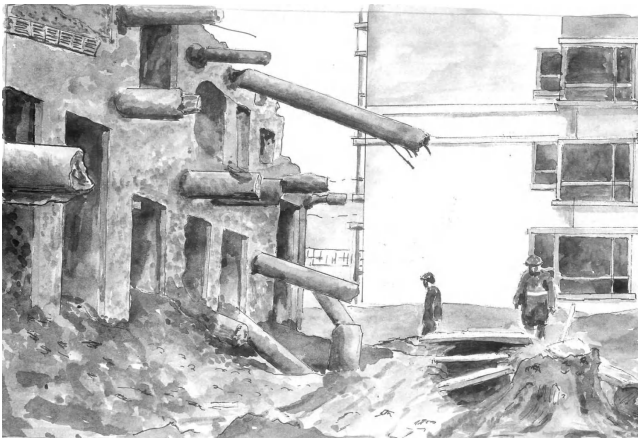
**Figure 10.9** Unreinforced piles with short reinforced length at tops. (Courtesy of Gillian Whittle; redrawn from Reuters, <http://www.telegraph.co.uk/news/world-news/asia/china/5685963/Nine-held-over-Shanghai-building-collapse.html>.)

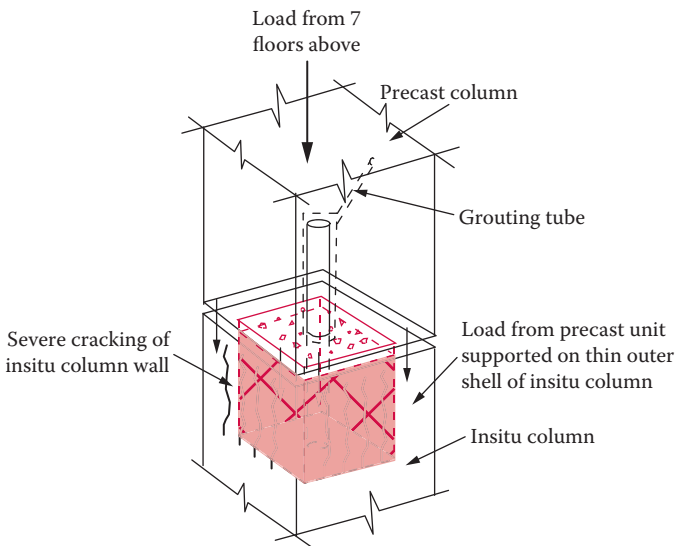
Figure 11.5 Cracking of outer rim of in situ column.
