Understanding Bridge Collapses

Björn Åkesson

Consulting Engineer, Fagersta, Sweden

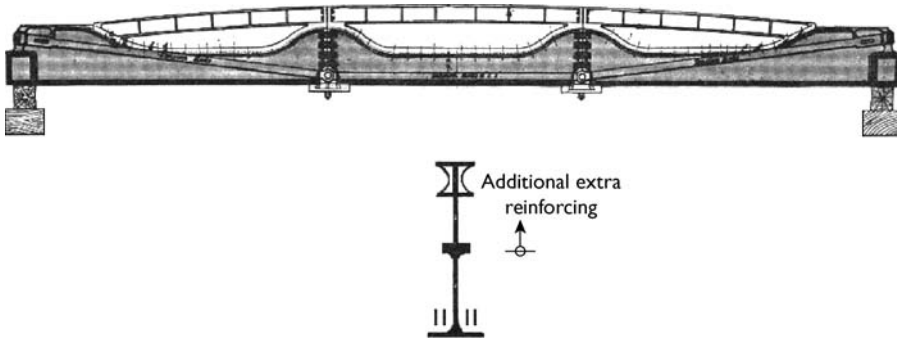
Fig. 1.21 As a consequence of the Dee Bridge collapse many existing cast-iron bridges had to be strengthened. (Berridge: The girder bridge after Brunel and others)

The collapse of the Dee Bridge had some large repercussions. An investigation did result in both that the choice of material, and the tension bar reinforced girder system as such, was blamed for the collapse and more or less doomed this bridge type for further use. Most of the already existing cast-iron girder bridges were either replaced or strengthened. An example of the latter was the 18 metre long and also tension bar stiffened girder bridge over Trent Valley, which was strengthened by the adding of extra plates and profiles in order to increase the girder depth (Fig. 1.21).

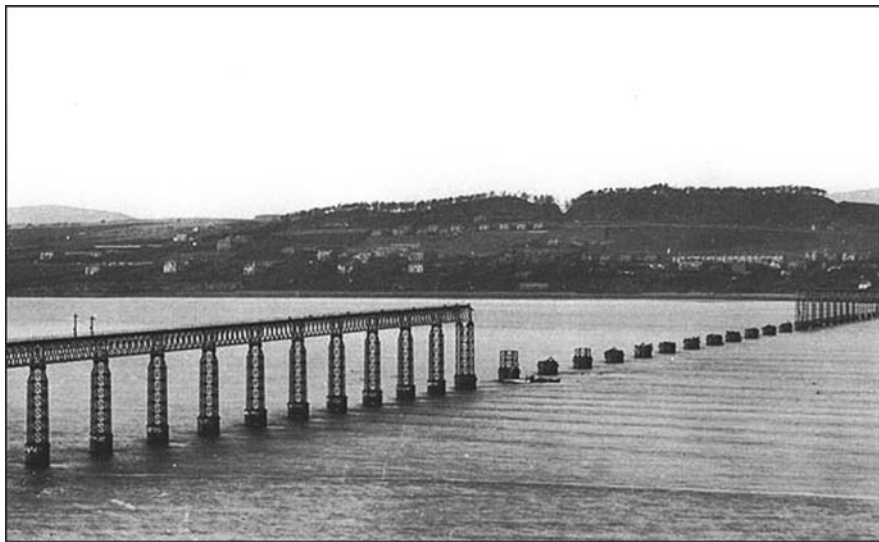
Fig. 3.7 All thirteen high girders of the Tay Bridge had collapsed into the river. (Wolcott: The breaks of progress. Mechanical Engineering)

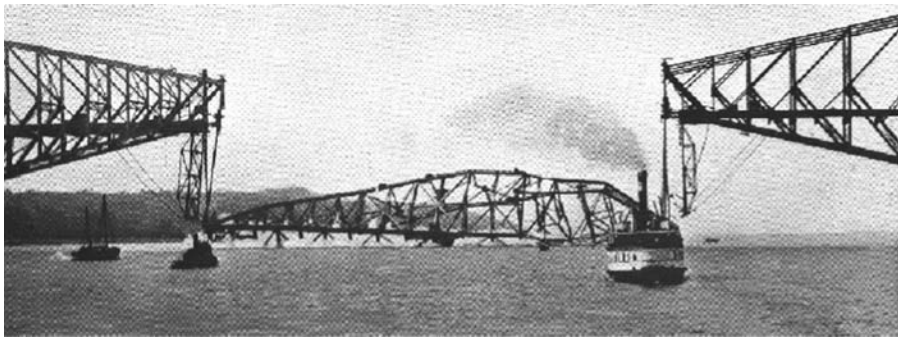
Fig. 4.26 The second failure in September 1916 in the construction of the Quebec Bridge (quite a remarkable picture taken by a very alert photographer). (www.civeng.carleton.ca/Exhibits/Quebec_Bridge/intro.html)

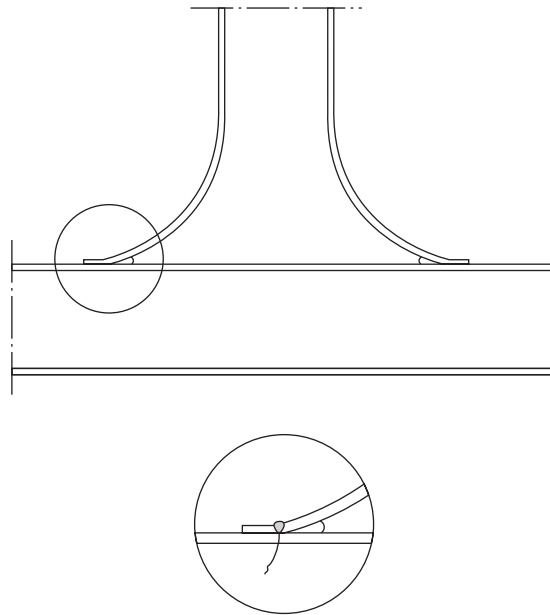
Fig. 5.3 The initiating point where the crack started that ruptured the lower tension chord.

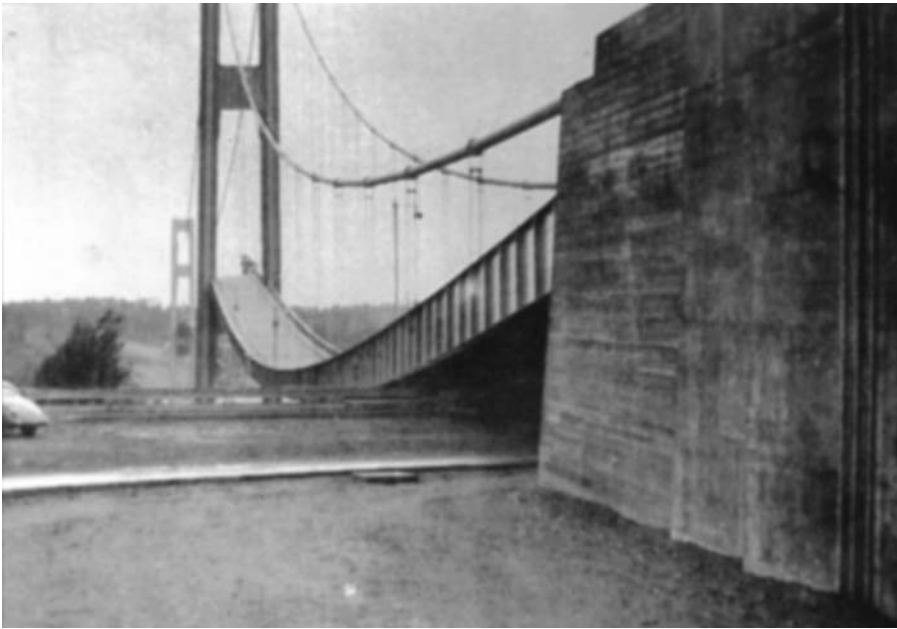
Fig. 7.7 The deflected side span on the east side, at the time of the collapse of the main span. (University of Washington Libraries, Special Collections, UW 27459z)

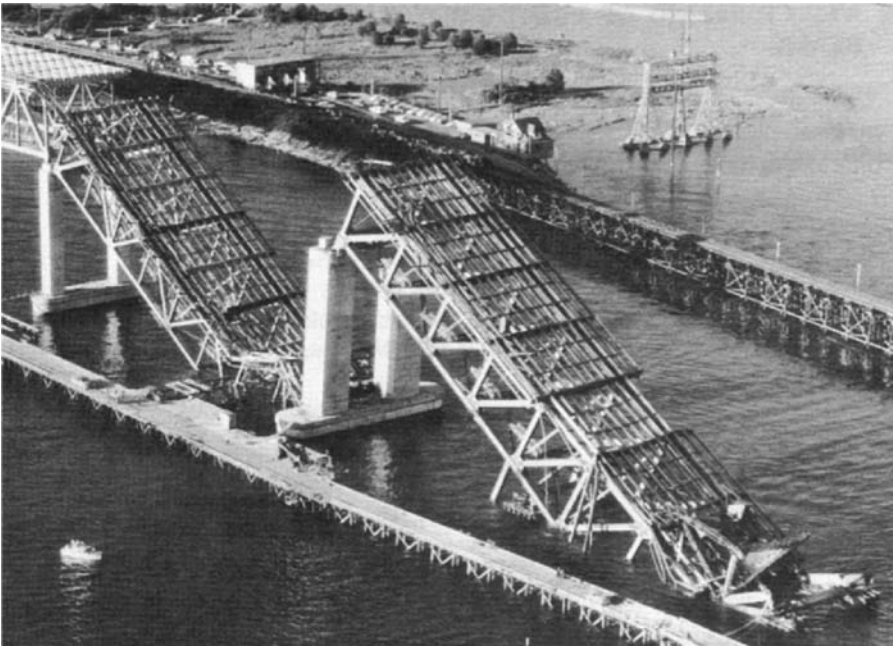
Fig. 9.4 The collapse of the Second Narrows Bridge. (McGuire: Steel Structures. With kind permission of Pearson Education Publications).

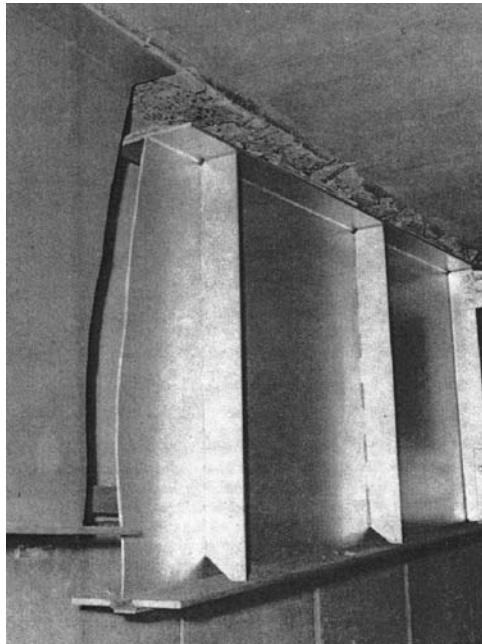
Fig. 10.7 Complete fracture of I-girder No. 1 on the western carriageway. The photo is taken inside the bridge looking north, in between girder No. 1 and 2. (Hopkins: A span of bridges – an illustrated history).

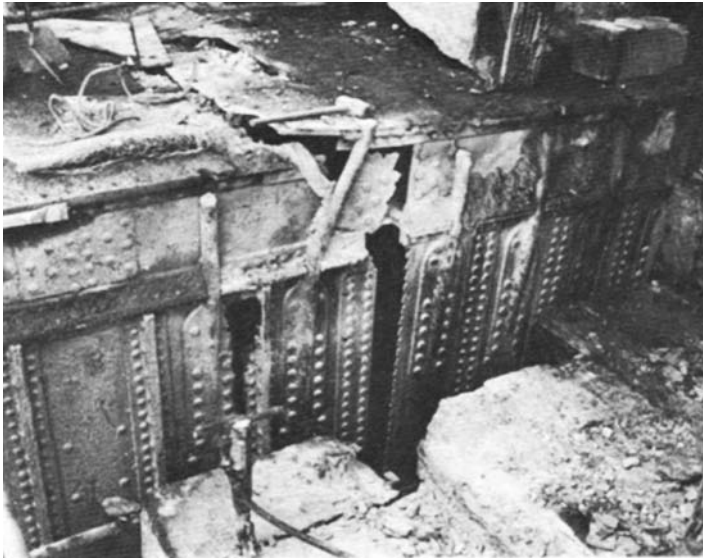
Fig. 13.14 The tubes split open over each intermediate support (i.e. at the towers).

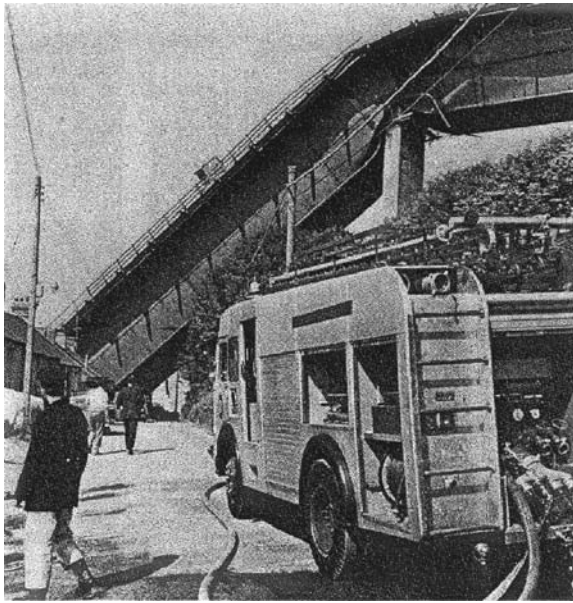
Fig. 14.5 The cantilever arm of the second span on the south end of the bridge buckled over the inner support and fell to the ground. (Aurell/Englöv: Olyckor vid montering av stora lådbroar. Väg- och Vattenbyggaren)

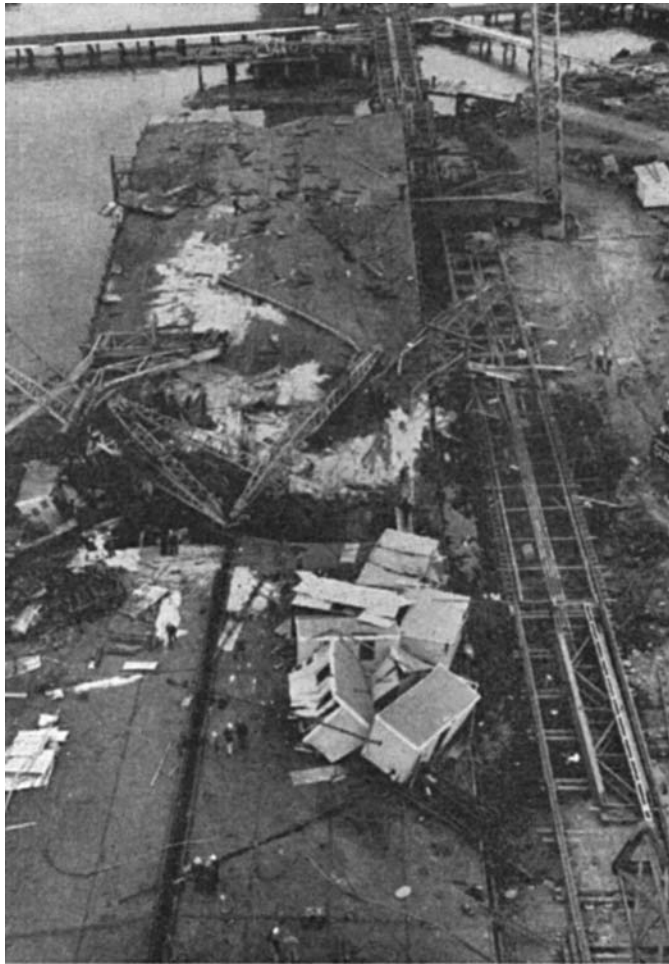
Fig. 15.18 The collapsed girder span on the ground. (Report of Royal Commission into the Failure of West Gate Bridge. Copyright State Government of Victoria, Australia)

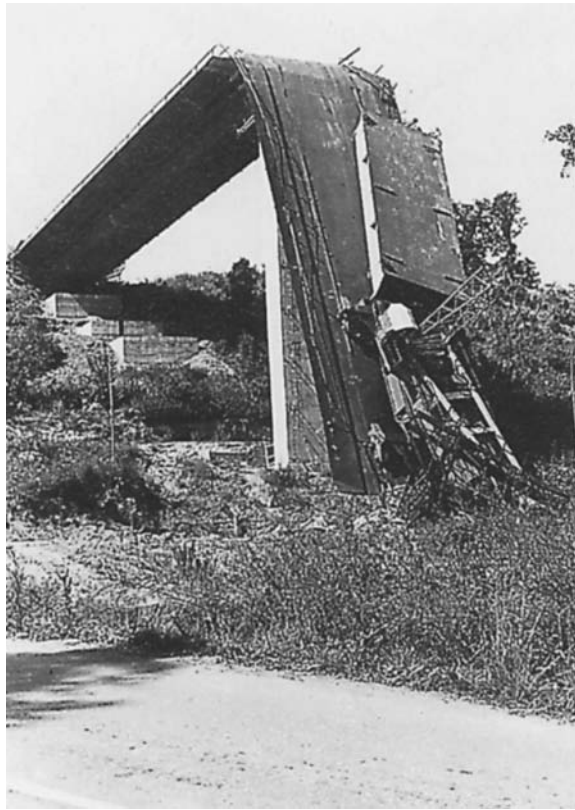
Fig. 17.5 The unexpected and sudden collapse of the Zeulenroda Bridge. (Ekardt: Die Stauseebrücke Zeulenroda. Ein Schadensfall und seine Lehren für die Idee der Ingenieurverantwortung. Stahlbau. With kind permission of Karl-Eugen Kurrer)

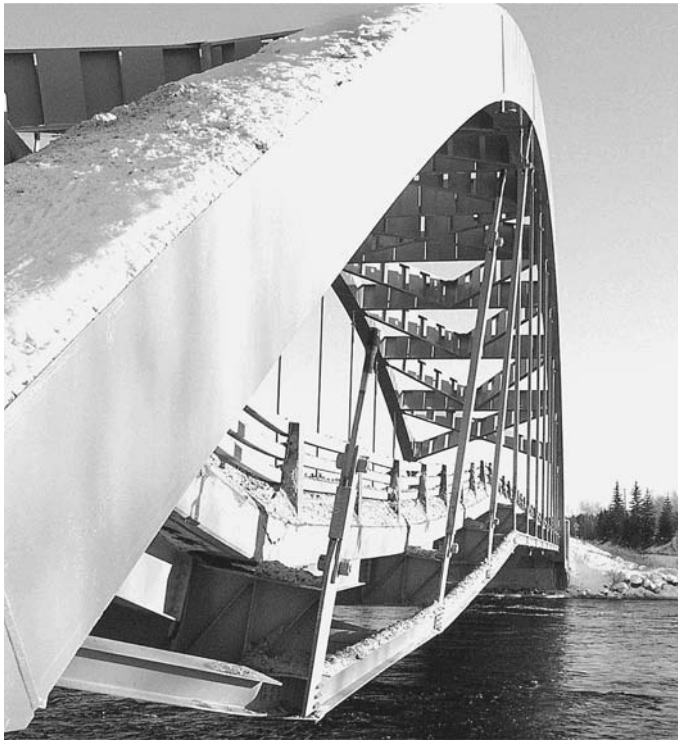
Fig. 20.15 The (partial) collapse of the Sgt. Aubrey Cosens VC Memorial Bridge. (<http://speaker.northernontario.ca/content/Feature%20Story/C%20Front%2011:01:06.pdf>)
