Historic Bridges

Evaluation, Preservation,
and Management

Edited by Hojjat Adeli

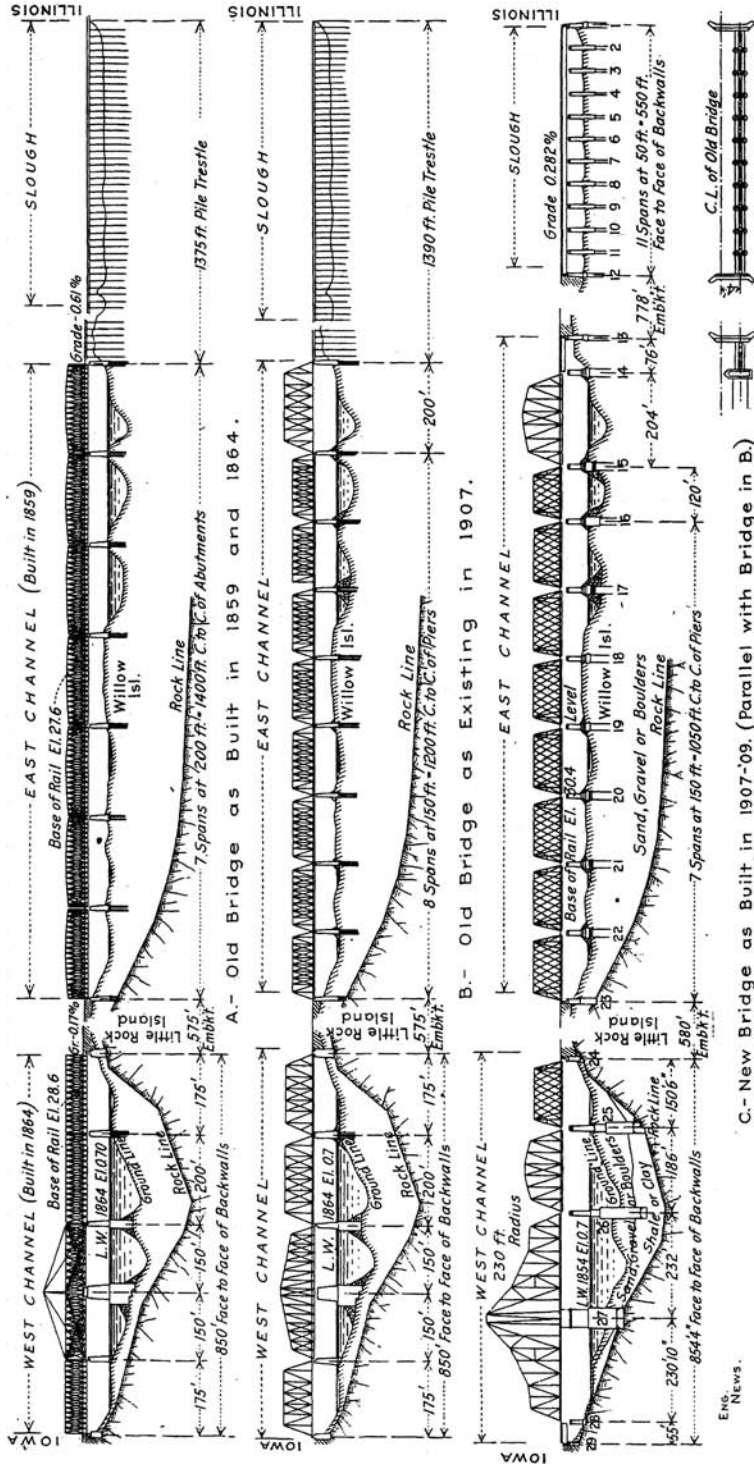
FIGURE 2.3 Profiles of the three C&NW bridges over the Mississippi River. (From Bainbridge.)

Commencing on the left or Illinois shore, there is 1,300 feet of wooden trestling in the approach to the bank of the river; then there were at first 7 spans of wooden truss, each 200 feet long; then a causeway 583 feet long across Little Rock Island to the Iowa Channel ... The span next to the Illinois shore ... at the time of our survey, in 1866, this bridge was in very bad condition, the piers, built with a core of concrete, were cracked in several places, and to support the spans temporarily various devices had been resorted to. The trusses, which were of the pattern known as McCallum's, were decayed in many parts, and a large number of the diagonals were broomed where they abutted against the angle blocks. [See Figure 2.3.]

Repairs not chronicled in Warren²⁴ included replacement, in 1874, of the timber Howe trusses over the west channel by wrought-iron Whipple trusses that were erected by the American Bridge Company.²² The Whipple trusses appear in Figure 2.3(A), flanking the Bollman swing span. The first span over the east channel (200 feet) was replaced by a Whipple truss span in 1880. In 1885, Pratt trusses replaced the remaining eight 150-foot truss spans over the east channel. This litany of truss span replacements should not be considered too unusual because it occurred during a period when the weight of rolling stock increased dramatically. Railroads also procured major bridges on a design-build basis. In this process, the contractor usually offered a fixed price for a turn-key completion of the project to the owner. The problem was that competing contractors did not design to the same criteria. Most railroads did not have engineering staffs able to specify structural bridge design requirements and were even less able to monitor and enforce them. They generally left the structural design of the superstructure to the contractor, and, as the lowest bidder usually received the purchase order, the railroad got what it paid for at best.

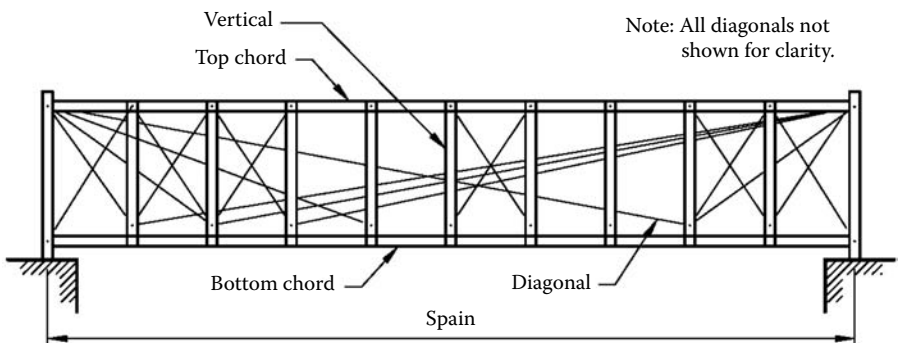
FIGURE 2.6 Bollman patent suspension truss bridge.

Wendell Bollman patented the first all-metal American railroad truss.³ It had cast iron compression members and wrought-iron tension members and was designed so that local members could be replaced without shoring the whole span. Figure 2.6 is

a simplified diagram of his invention. The Baltimore and Ohio Railroad replaced wooden truss bridges that required extensive repair with Bollman trusses. The first railroad bridges had wooden chords and web members that deteriorated with time, especially under increasing locomotive weights. As was standard practice at the time, many contractors used locally sawn timber when it was green, and this led to decay and shrinkage after the members were built into the bridge, resulting in deformations that loosened truss joints and increased dead load deflections. This was compensated for, to a degree in combination bridges, by periodically retightening rod diagonals. The engineers' reports included in the G&CU annual reports frequently mention replacing chords of timber trusses and whole bridges. In 1862 a new bridge was brought into use across the Fox River near Elgin, IL, consisting of three spans of 125 feet each. "The bridge is of iron, of the style known as the patent of Wendell Bollman, of Baltimore." Thus, the G&CU had experience with the Bollman trusses before they were selected for the swing span of the bridge at Clinton.

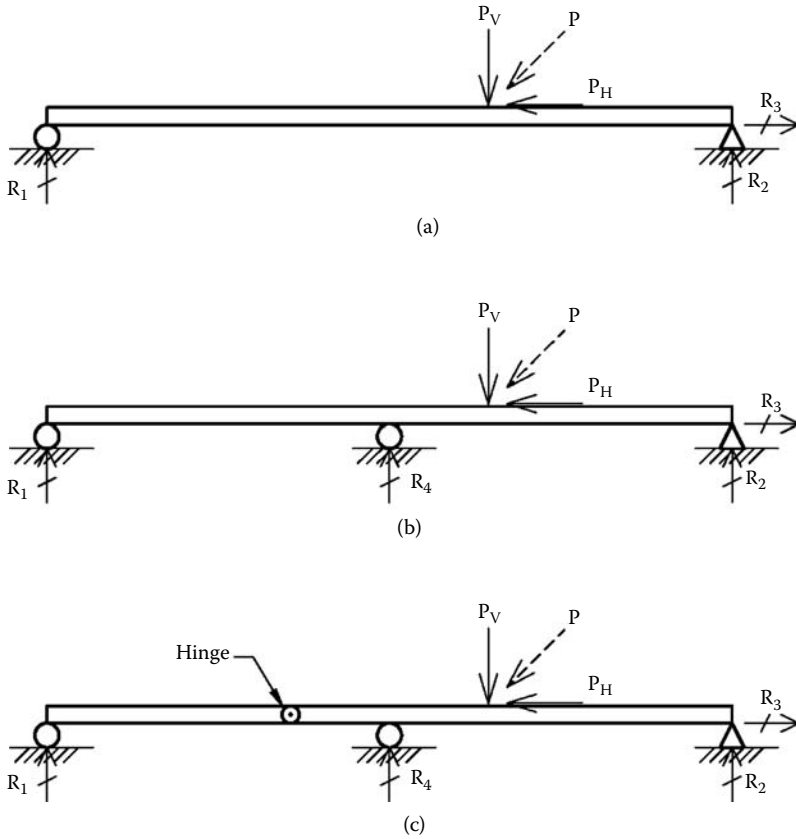
FIGURE 2.9 Beam diagrams.

Now suppose the beam is supported by an additional reaction R_4 as in Figure 2.9(b). There are four reaction components but we have only three equations of statics available, insufficient for computing the four reactions. The system is said to be externally indeterminate to the first degree because we have one more unknown

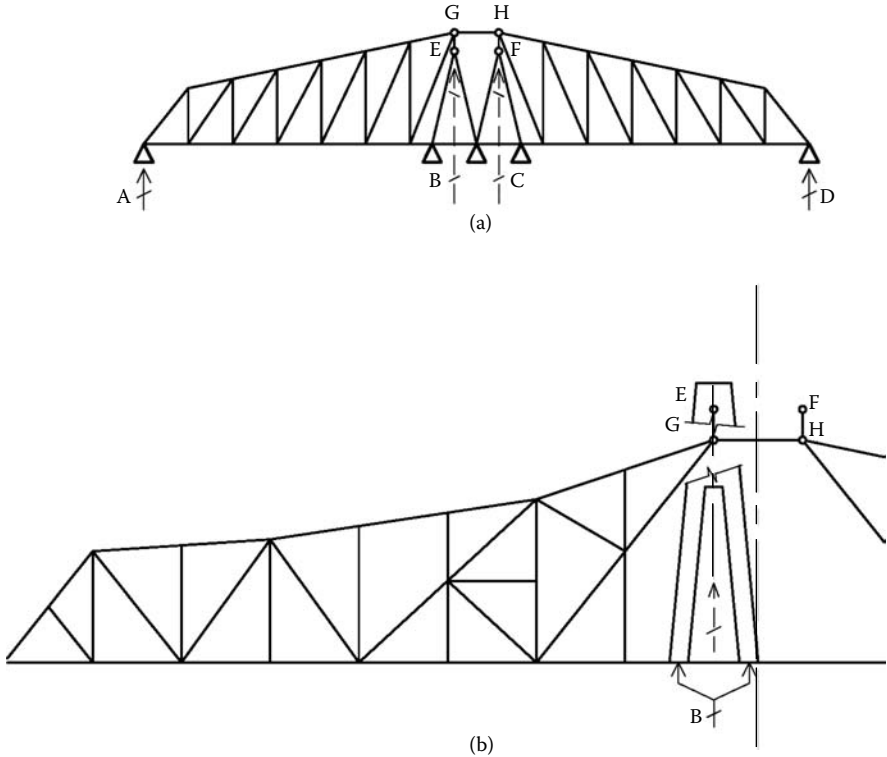
FIGURE 2.11 Swing span trusses supported by A-frames.

Figure 2.11(a). Pratt truss. Effectively same as Figure 2.10(d). Quadrangular rigid frame of 10(d) replaced by two A-frames. Indeterminate to first degree. No live load shear transfer across BC because lack of diagonals EH and FG.

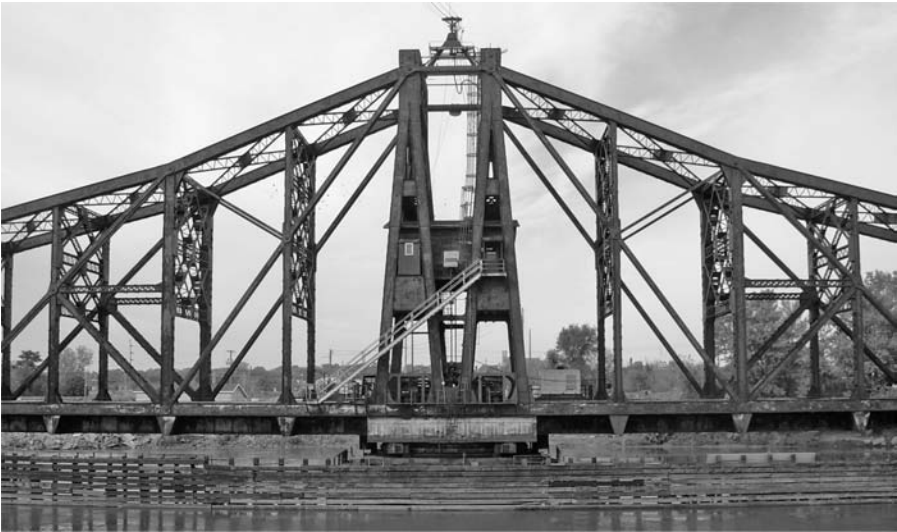
FIGURE 2.14 Third swing span in fully-open position.

Congress authorized reconstruction of the bridge, and the secretary of war approved plans in May of 1907. The contract for the entire substructure was placed with the Foundation Company (New York) less than two weeks later. Structural steel for the west channel spans was let to the Pennsylvania Steel Co. of Steelton, PA, and for the structure east of Little Rock Island, to the Wisconsin Bridge and Iron Co. of Milwaukee, WI. Figure 2.3(C) shows the profile of the new bridge and its relation to the second bridge. A larger scale profile of the structure over the west channel is shown in Figure 2.12. A photograph of the closed bridge, taken in October 2007 from the southwest, appears as Figure 2.13. Every component visible in the photograph is thought to be original—at least 98 years old. A view of the fully open draw, taken from the end of the east flanking span (looking west), is in Figure 2.14.

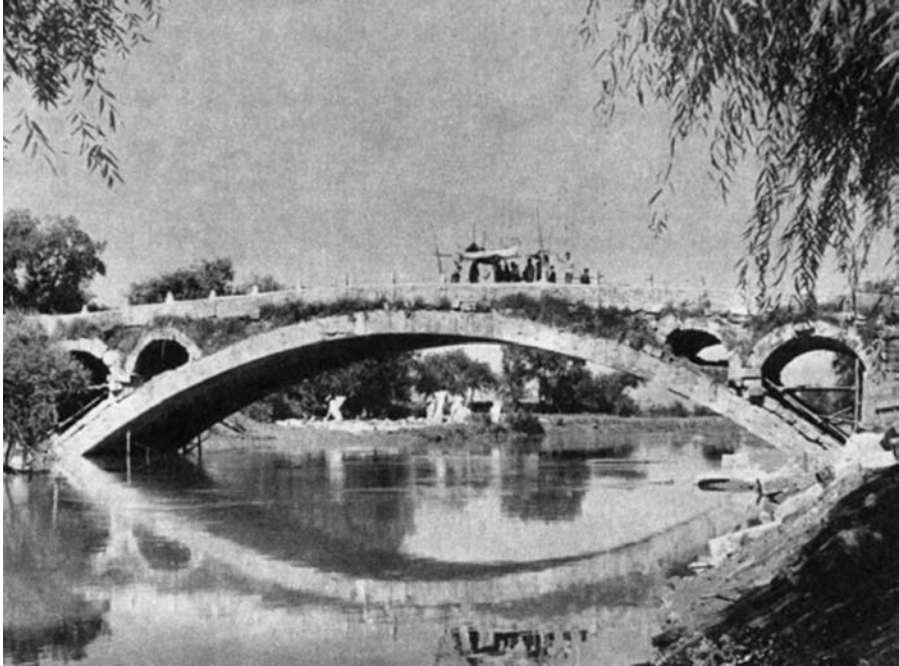
FIGURE 3.6 Elevation view of the An Ji Bridge immediately prior to its 1956 restoration.

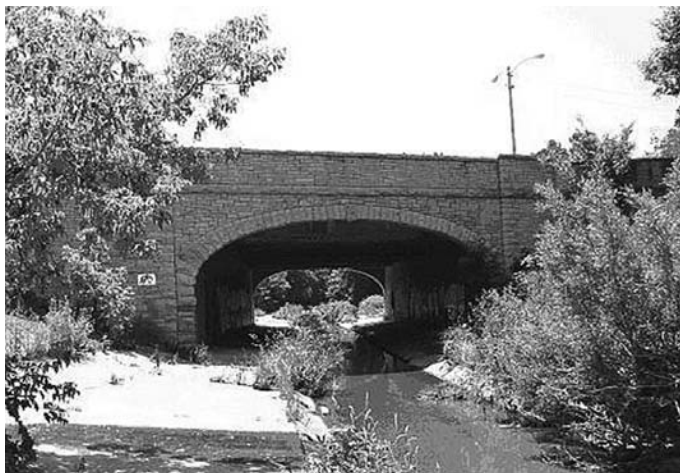
FIGURE 4.5 The West Forest Home Avenue Bridge (B40-979) is a 1931 concrete T-beam bridge with a stone-faced headwall that features a segmental arch opening. Its handcrafted, rock-faced, limestone parapet walls feature a random ashlar pattern. (Photo by author.)

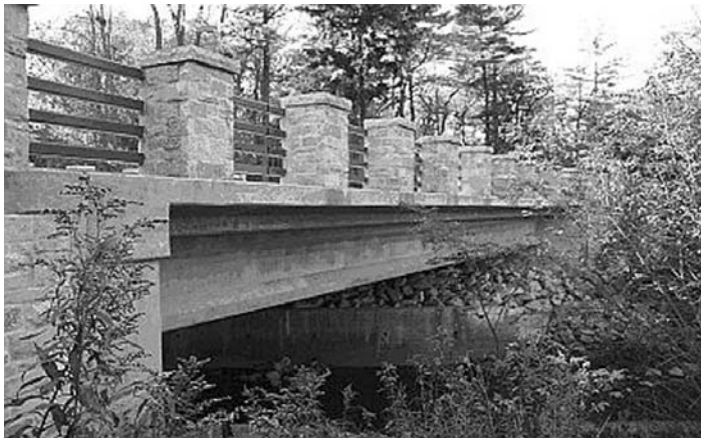
FIGURE 4.6 In an effort to match the original design and materials, the new Oak Creek Bridge (P40-559) featured steel railings embedded in veneered posts and stone-veneered abutments. However, the modern styling of the multiple railings and posts contrasts with the simplicity of its historic, rustic design. (Photo by author.)

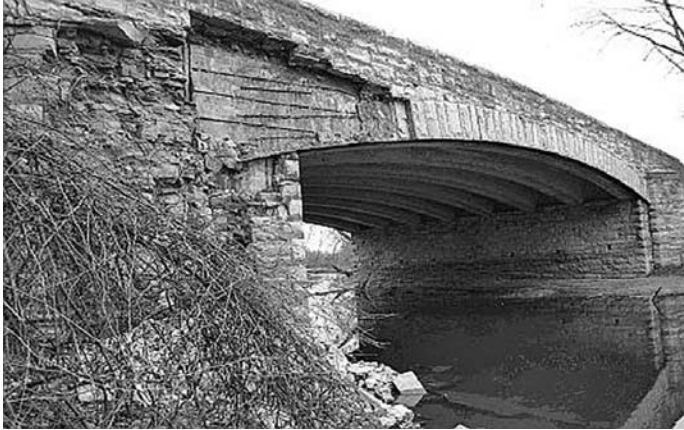
FIGURE 4.8 The Milwaukee River Bridge (B40-647) displays deteriorated abutment walls and spalling stonework. With a sufficiency rating of 34.7, it is scheduled for replacement in 2008. (Photo by author.)

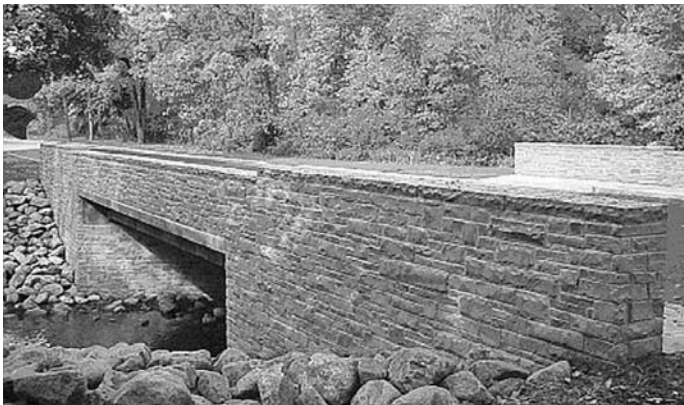
FIGURE 4.9 The new parapet wall for this Honey Creek Parkway Bridge was substantially taller than the original to comply with current standards but replicates the historic stone veneer. Photographs of the original stonework were used as the reference for matching the new stone masonry. (Photo by author.)

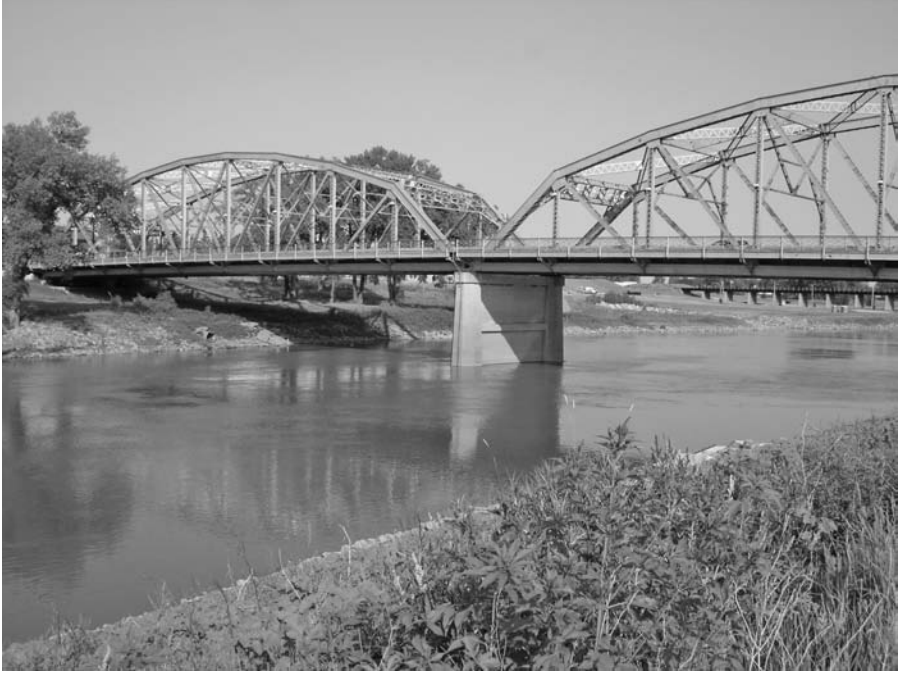
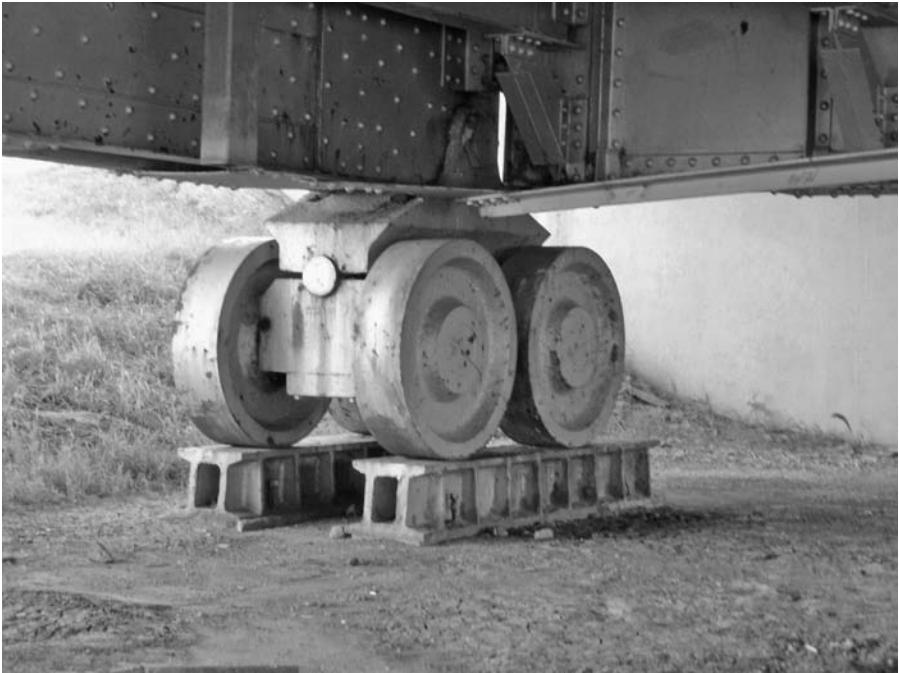
FIGURES 5.2 AND 5.3 Bridge 4700. *Top:* Elevation view. *Bottom:* Truss-support trucks, a character-defining feature.

Bridge 4700 (Sorlie Memorial Bridge, built 1929, Figure 5.2 and Figure 5.3) is an example of a bridge requiring minimal rehabilitation.²¹ This two-span Parker truss bridge carries U.S. 2 over the Red River of the North, connecting the communities of East Grand Forks, Minnesota, with Grand Forks, North Dakota. The structural condition codes for the bridge varied from fair to good with the need for repainting the bridge topping the list of work items. No work was recommended that would affect the character-defining features (original truss design, ornamental railing, and truss-support trucks), or other historic fabric. Compliance with SOIS was not difficult.

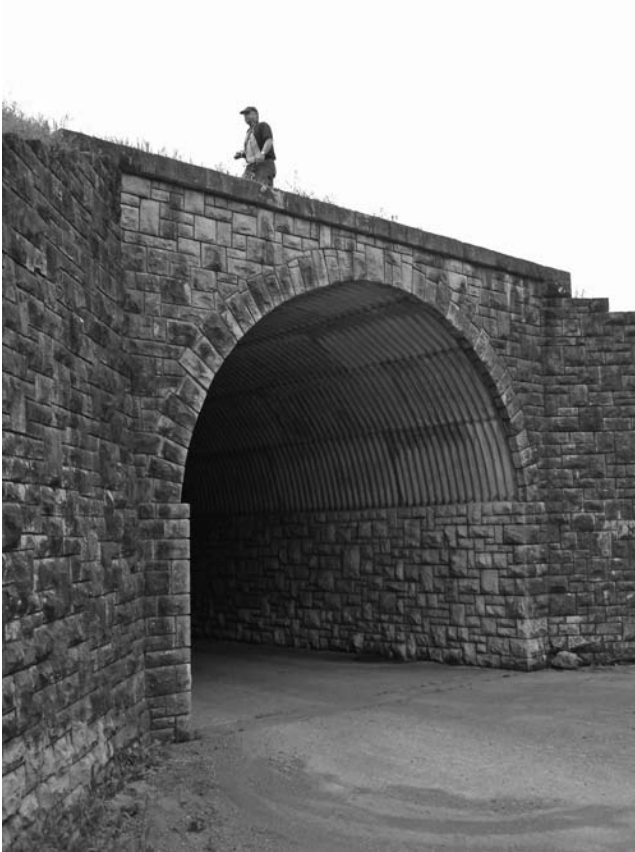
FIGURE 5.4 Bridge 5827, a large Multi Plate arch bridge with WPA stone-masonry head-and wing-walls.

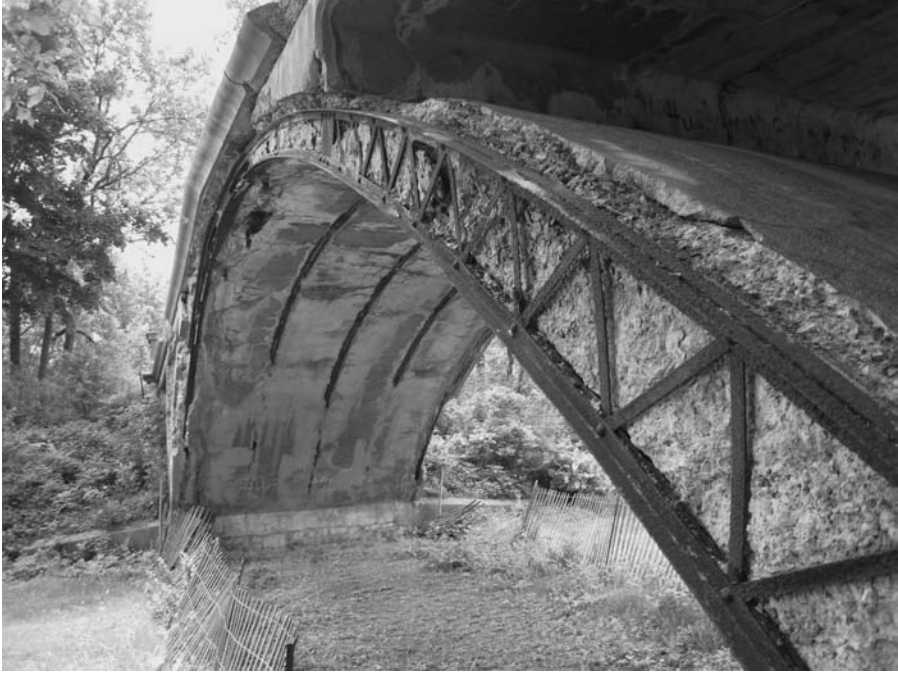
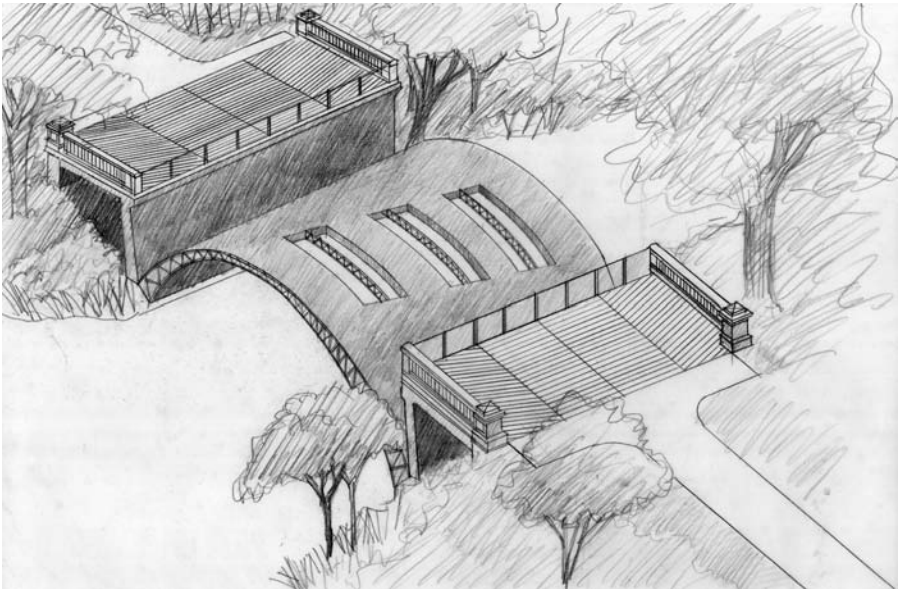
FIGURES 5.10 AND 5.11 Bridge L-5853, Como Park. *Top:* View from below. *Bottom:* Preservation concept.

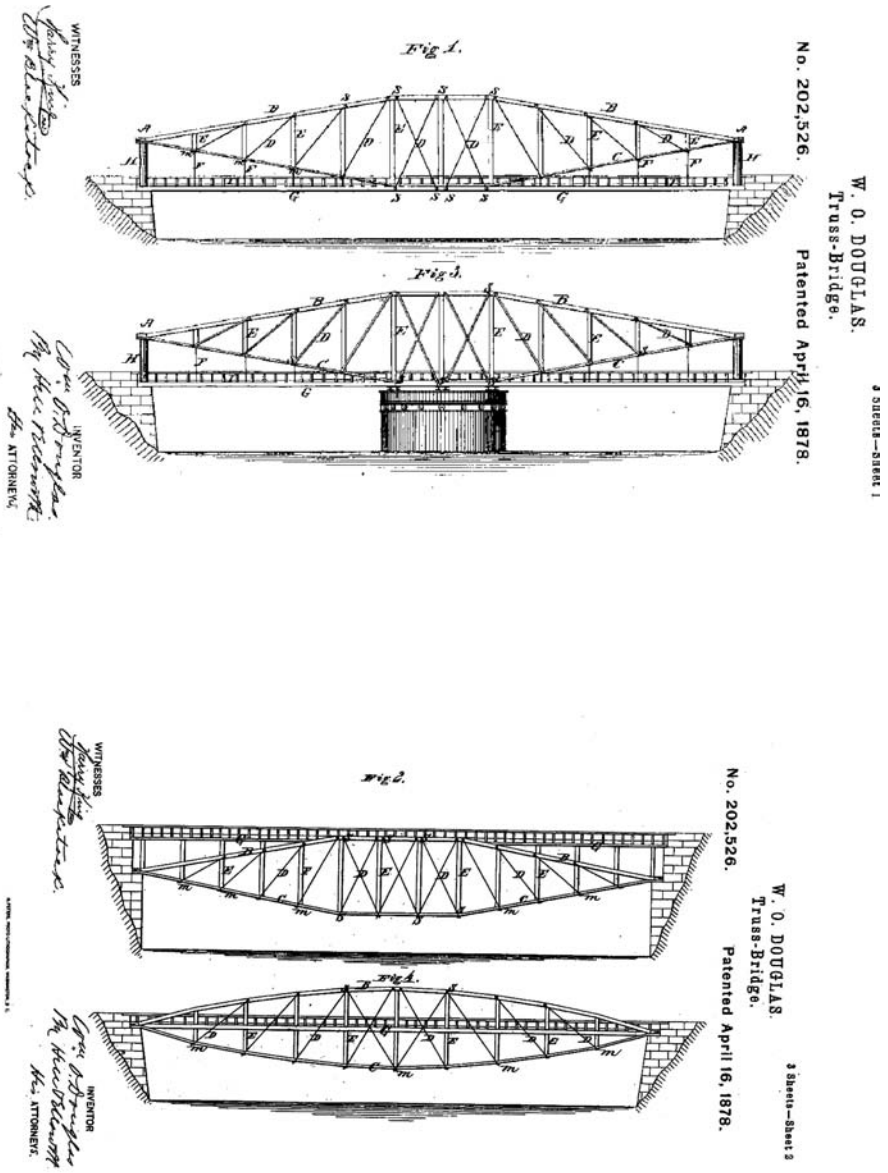
FIGURE 7.2 Drawings from William O. Douglas’s 1878 patent.

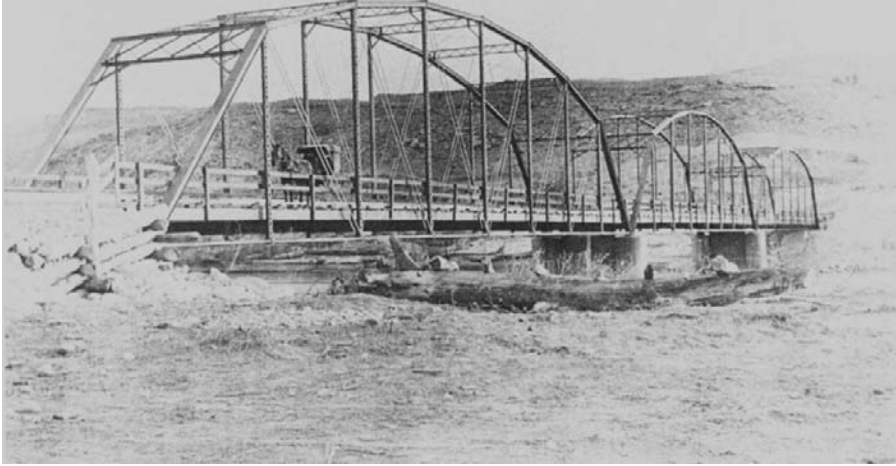
FIGURE 8.1 Undated photograph of Fruita Bridge over the Colorado River, near Fruita, Colorado. This three-span steel Parker truss was built in 1907. It has steel floor beams and timber stringers covered by a timber deck. The deck timbers in place over the timber stringers and the wood rail can be seen. The University of Colorado Denver instrumented the span in the foreground in 2004. (Photo courtesy of Museum of Western Colorado.)

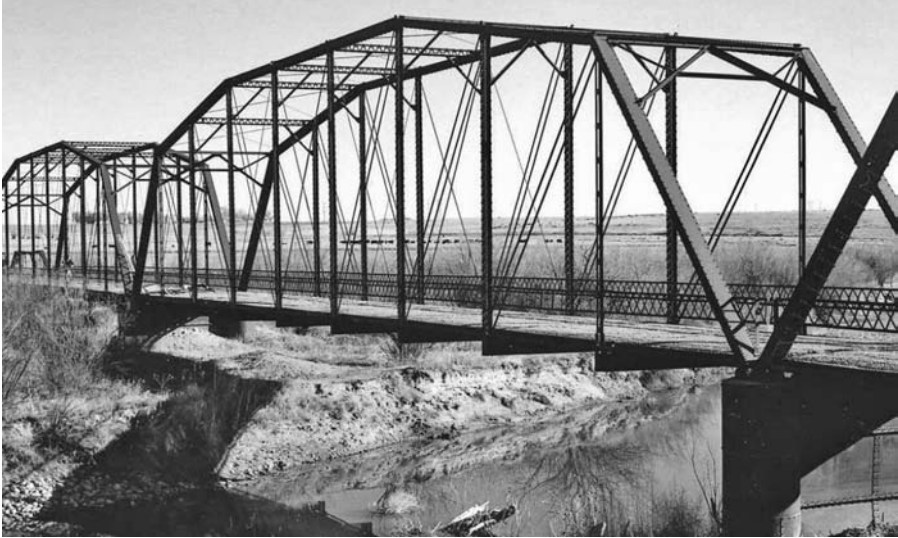
FIGURE 8.5 Prowers Bridge over the Arkansas River, near Lamar, Colorado. The Camelback Pratt through truss span, seen in this photo, was instrumented because it received the greatest wind exposure. It survived a major flood of the Arkansas River in 1921 and served as a highway bridge until its abandonment in 1994 when a nearby replacement bridge was constructed. (With permission from ASCE.)

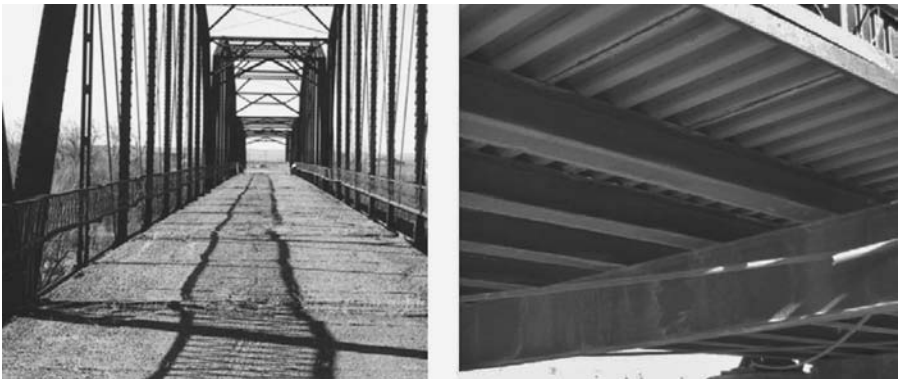
FIGURE 8.6 Prowers Bridge deck. The steel stringers are riveted to the floor beams, suggesting that the stringers are original. However, the corrugated bridge deck is clearly a replacement. Asphalt pavement, now significantly weathered, was installed over the corrugated deck. (With permission from ASCE.)

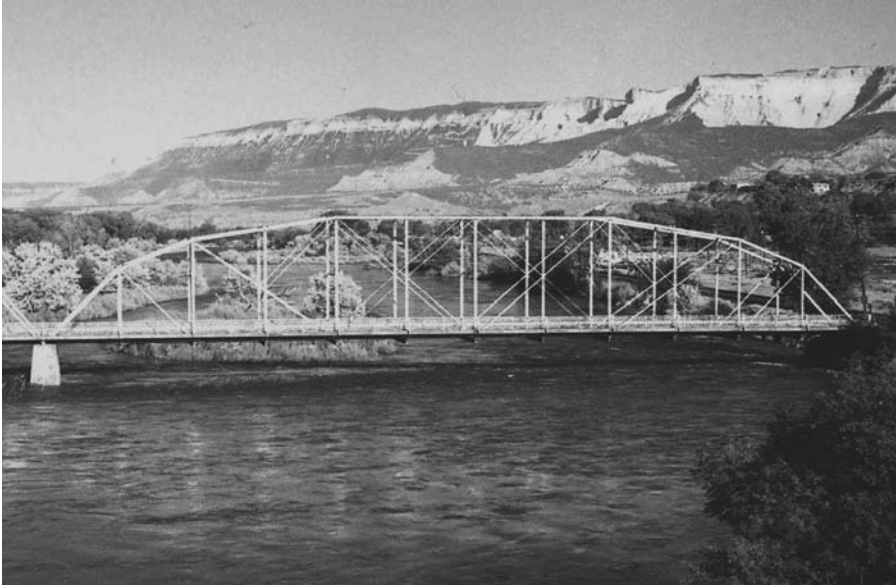
FIGURE 8.7 Rifle Bridge over the Colorado River at Rifle, Colorado. This Pennsylvania truss has steel floor beams with steel stringers, covered by a corrugated metal deck with asphalt pavement. It has been abandoned since the late 1960's, when a replacement bridge was constructed. (With permission from ASCE.)

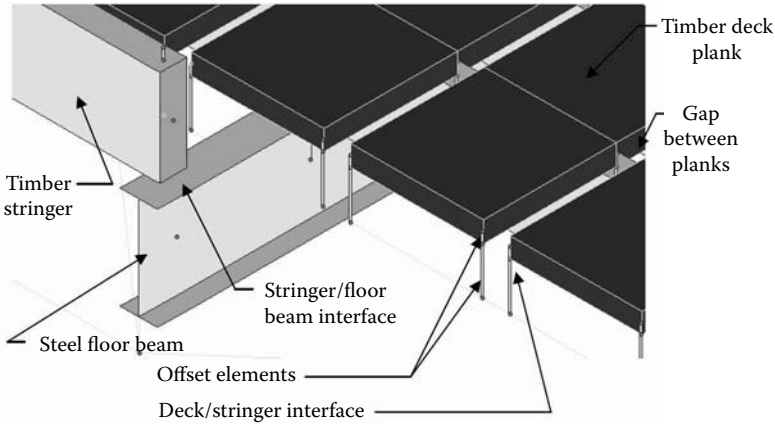
FIGURE 8.15 Detail of deck and stringer modeling. This computer-generated rendering of the timber deck planks on timber stringers on steel floor beams is for the Fruita Bridge deck, so gaps are present between the rows of plate elements. Continuous deck for other bridges had the corner nodes of deck elements connected. (With permission from ASCE.)

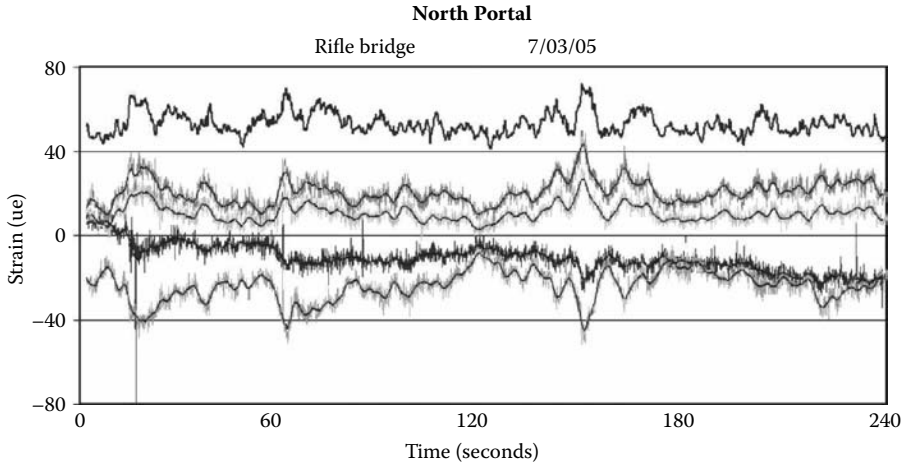
FIGURE 8.19 Example of strain measurements. The upper trace is the wind speed, averaged from seven anemometer measurements, and presented at an arbitrary scale for presentation purposes. The four lower traces are strain measurements from different members. This example is from the north portal of Rifle Bridge. Note that changes in strain correspond to changes in wind velocity. From such measurements, forces in members were determined for comparison with forces determined from the verification models. (With permission from ASCE.)

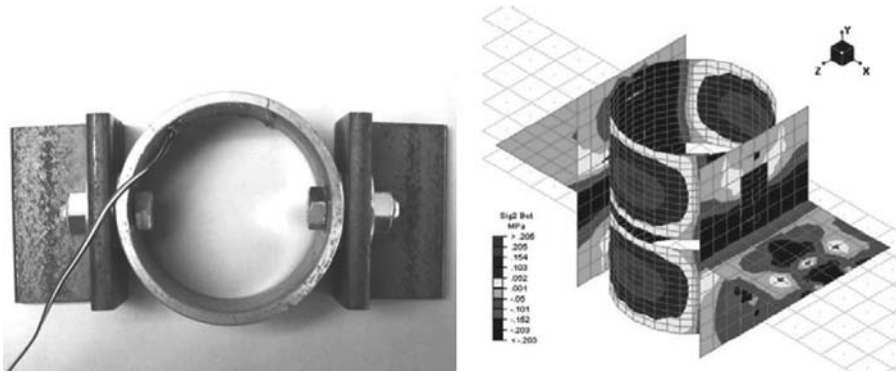
FIGURE 8.22 Strain transducer and its finite element stress analysis results. The transducer consists of a 3" diameter steel ring, bolted to steel angles. The strain gage is on the inside ring surface, 90 degrees from the axis of the bolts. The transducer senses axial strain and mechanically amplifies it via flexure of the ring. (With permission from ASCE.)

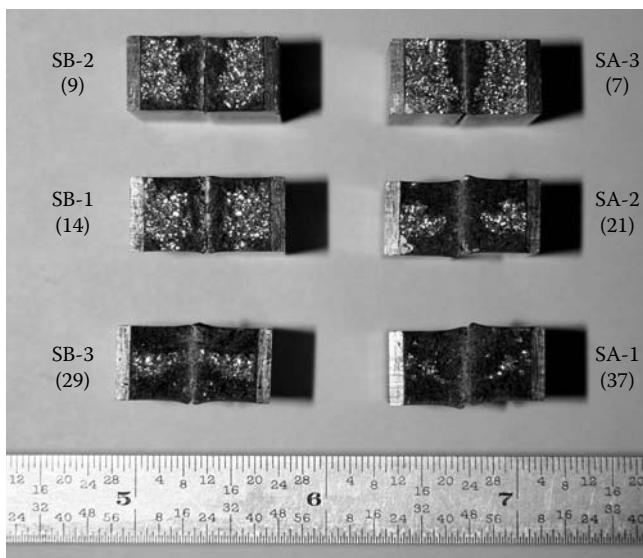
FIGURE 9.12 Impact fracture surfaces (value in parentheses is impact strength in ft-lbs).

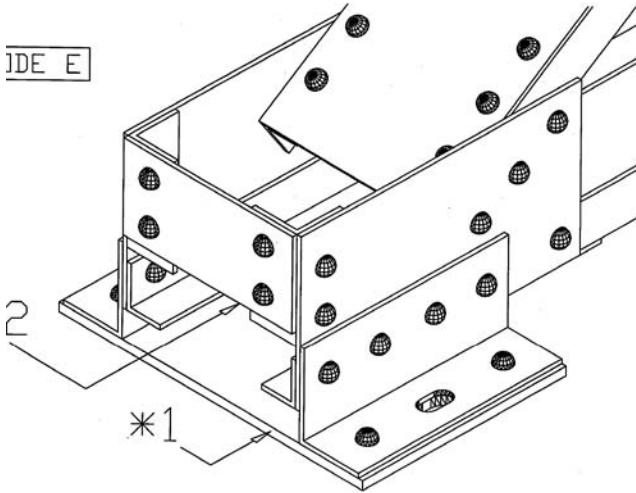
FIGURE 11.10 Typical AutoCad drawing of end connection and bearing plate.

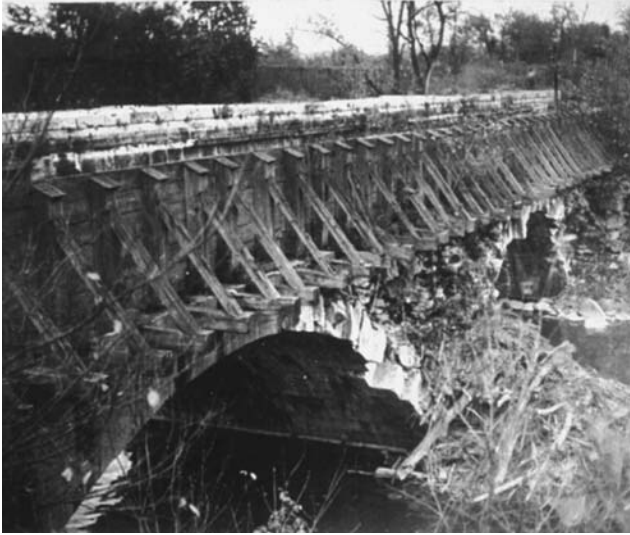
FIGURE 12.7 Wooden Wall Repairs at the Conococheague Aqueduct.

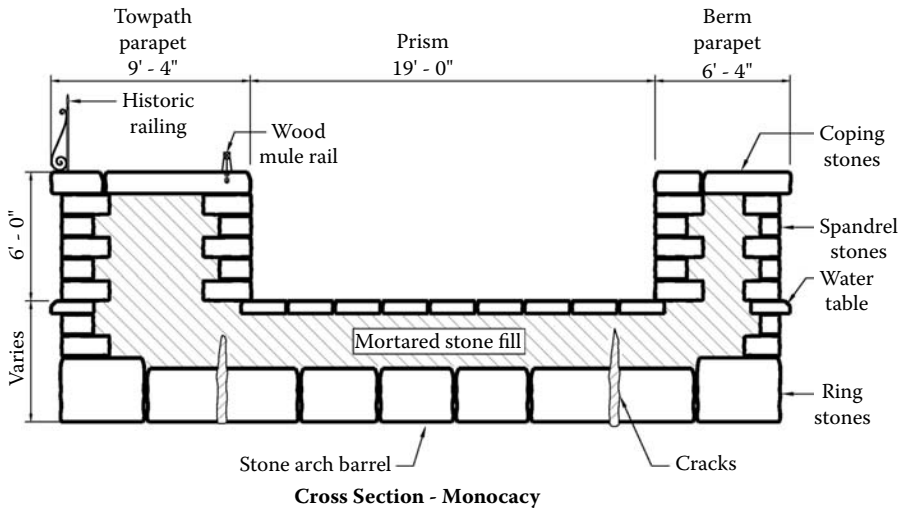
FIGURE 12.13 Cross section of the Monocacy Aqueduct.

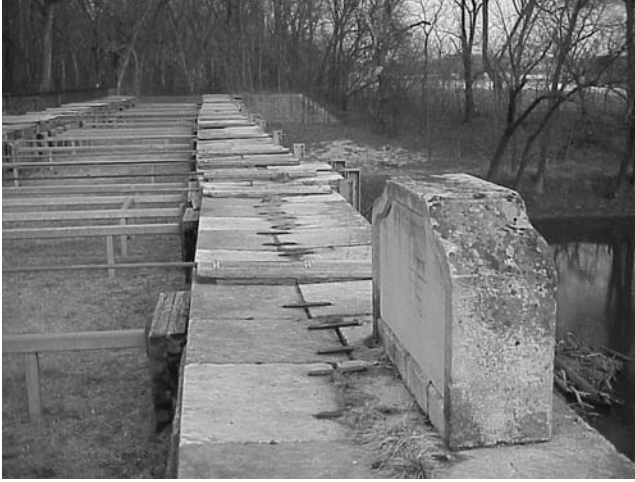
FIGURE 12.14 Iron cramps between coping stones at the Monocacy Aqueduct.

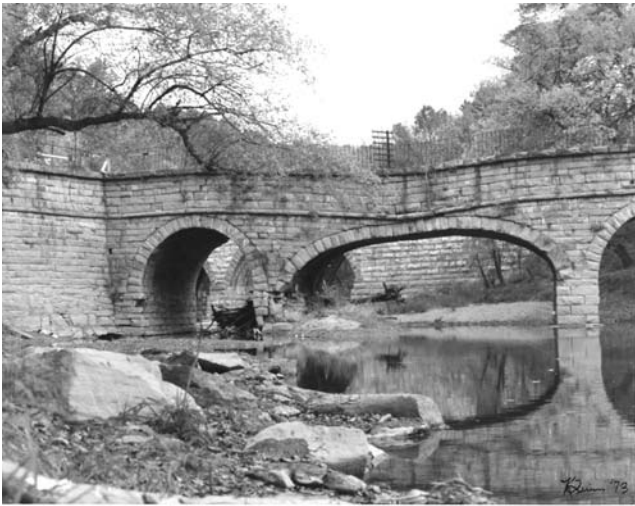
FIGURE 12.15 Hinge formations at the Catoctin Aqueduct.

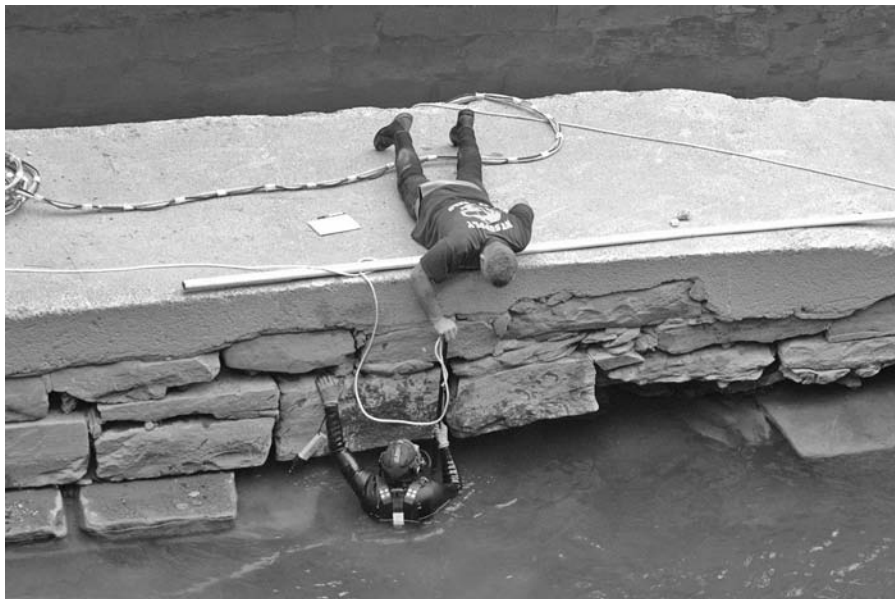
FIGURE 12.16 Underwater inspection of the remains of the west pier at the Catoctin Aqueduct.

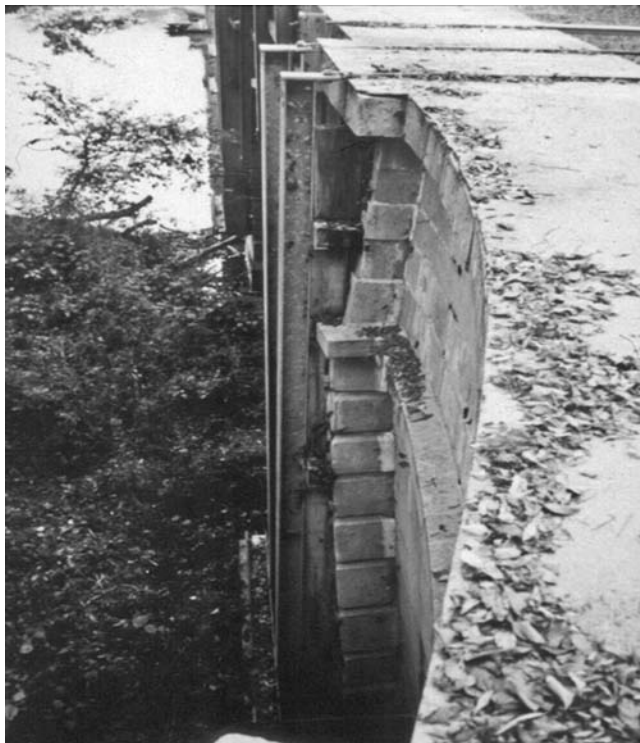
FIGURE 12.17 Bulge at the Monocacy Aqueduct West Abutment.

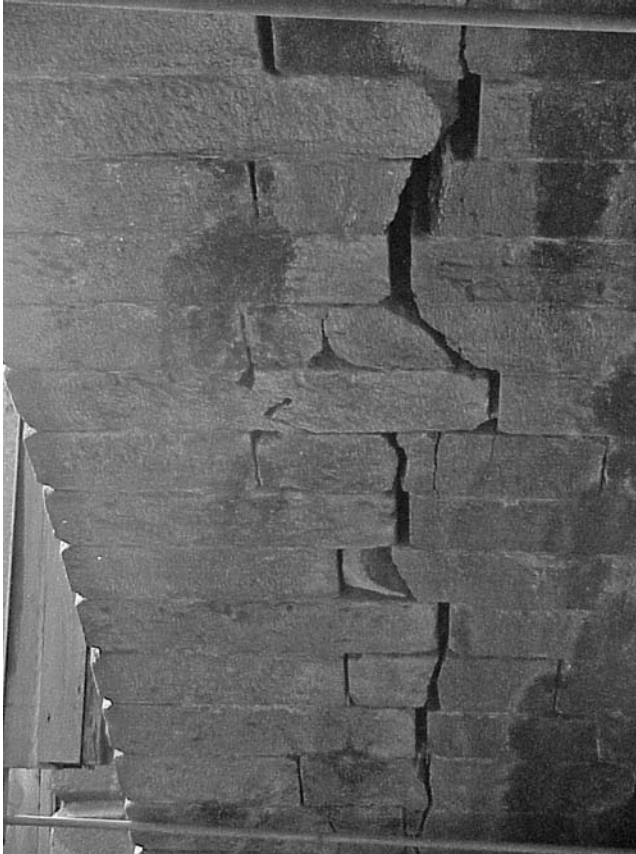
FIGURE 12.19 Longitudinal cracks in one of the Monocacy Aqueduct's arch barrels.

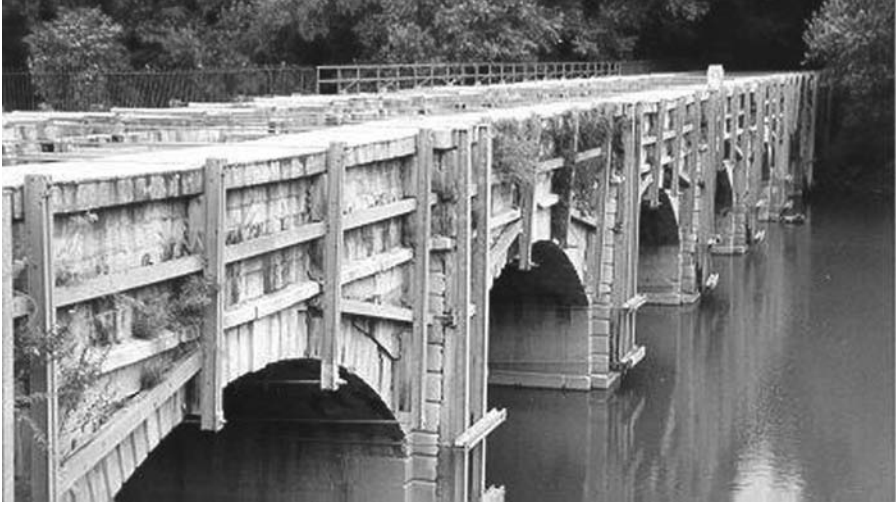
FIGURE 12.20 Steel banding installed in the 1970's at the Monocacy Aqueduct.

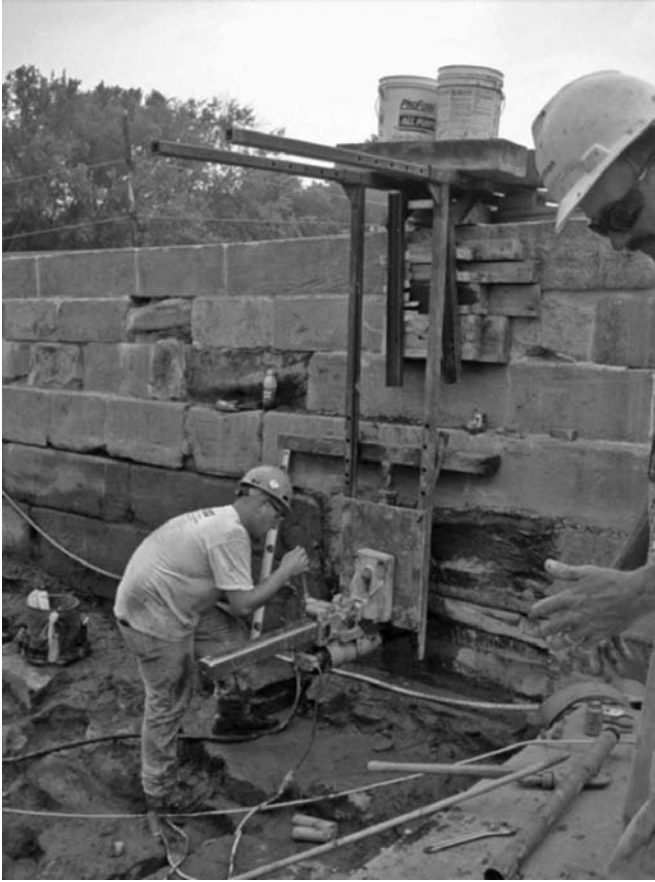
FIGURE 12.21 Drilling hole for reinforcing bars into the parapet at the Monocacy Aqueduct.

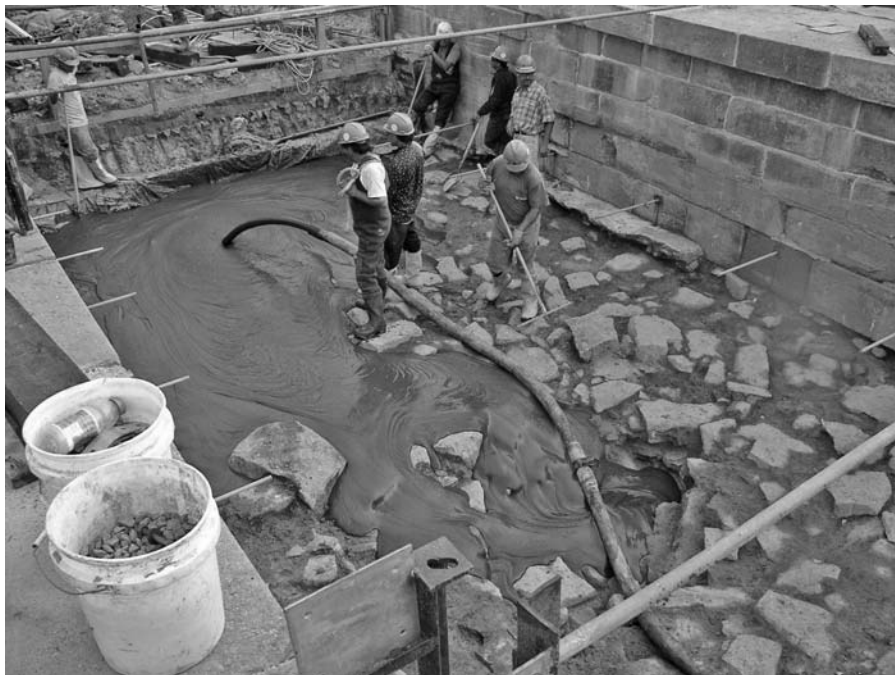
FIGURE 12.22 Flow grouting the prism floor at the Monocacy Aqueduct.

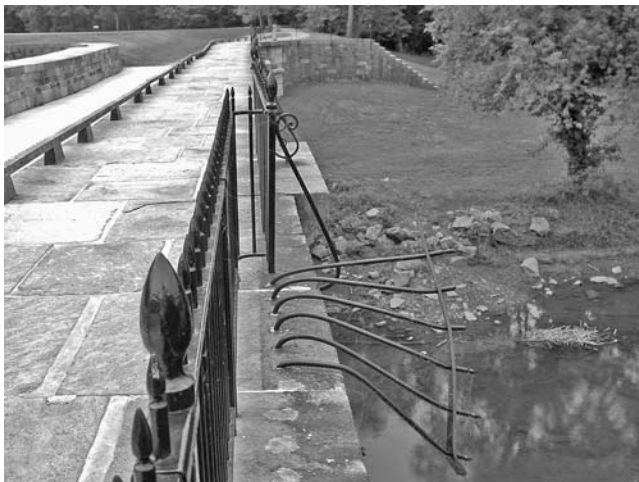
FIGURE 12.23 New and existing railing at the Monocacy Aqueduct.

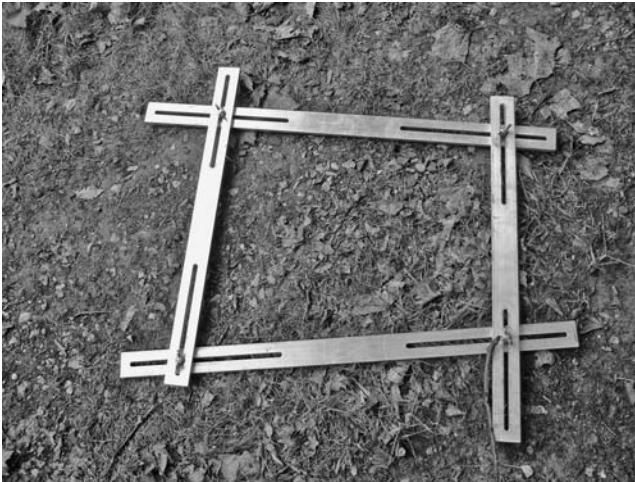
FIGURE 12.25 The device to measure arch stones at the Catoctin Aqueduct.

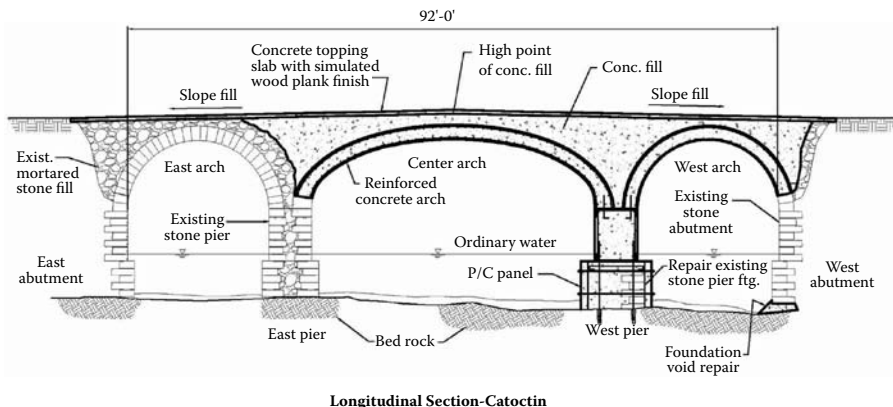
FIGURE 12.26 Longitudinal section of the Catoctin Aqueduct.

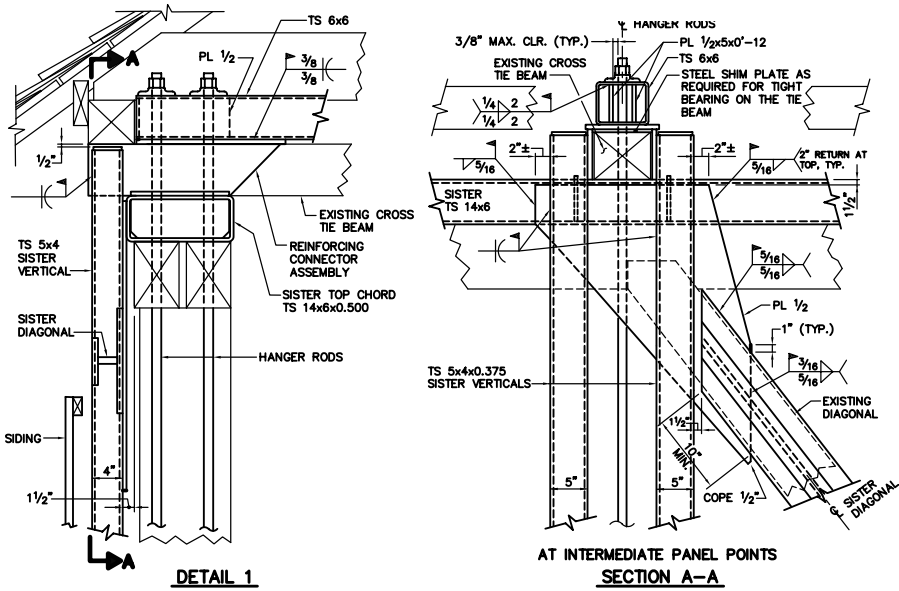
FIGURE 13.3 Details of steel supplemental frame at top chord panel point.

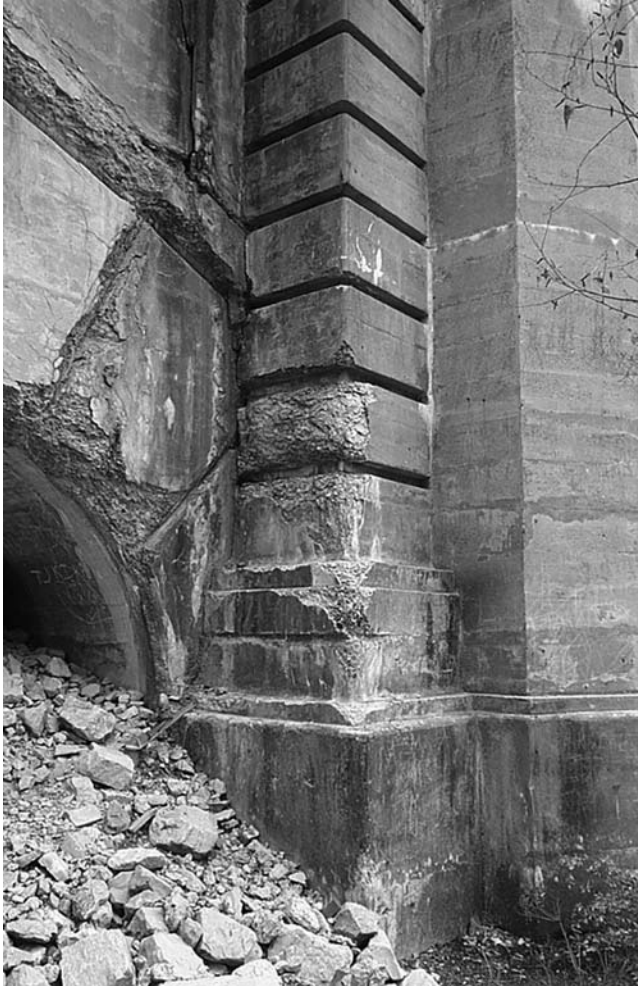
FIGURE 14.5 Deterioration at Abutment 1, 2000. (Source: Ian Engstrom, Parsons Transportation Group Inc.)

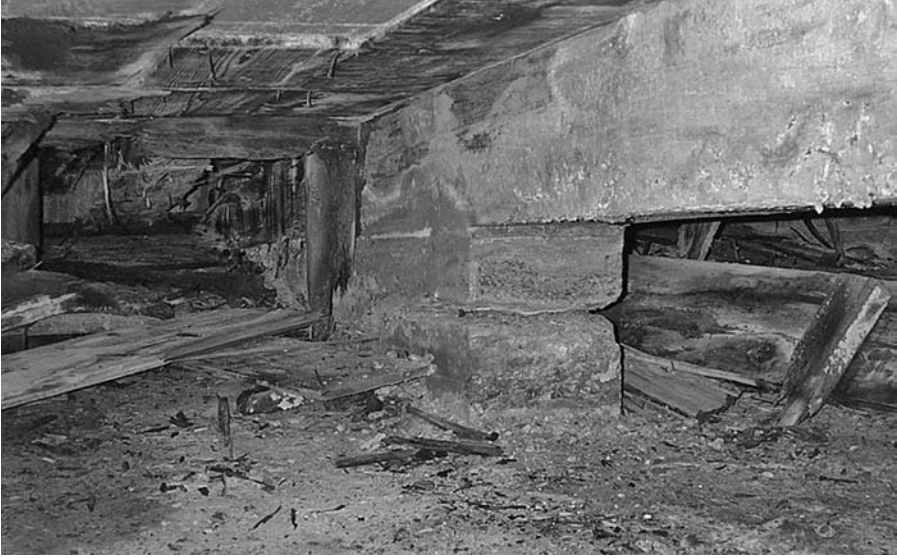
FIGURE 14.6 Deterioration of Arch Superstructure Frame, 2000. (Source: Ian Engstrom, Parsons Transportation Group Inc.)
