Historic Bridges

Evaluation, Preservation,
and Management

Edited by Hojjat Adeli

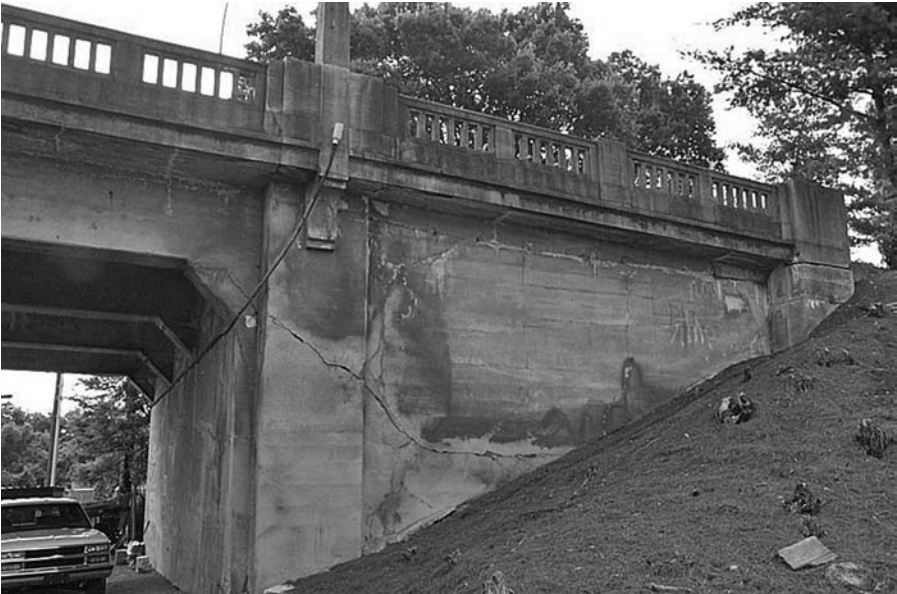
FIGURE 14.7 Deterioration at Abutment 2, 2000. (Source: Ian Engstrom, Parsons Transportation Group Inc.)

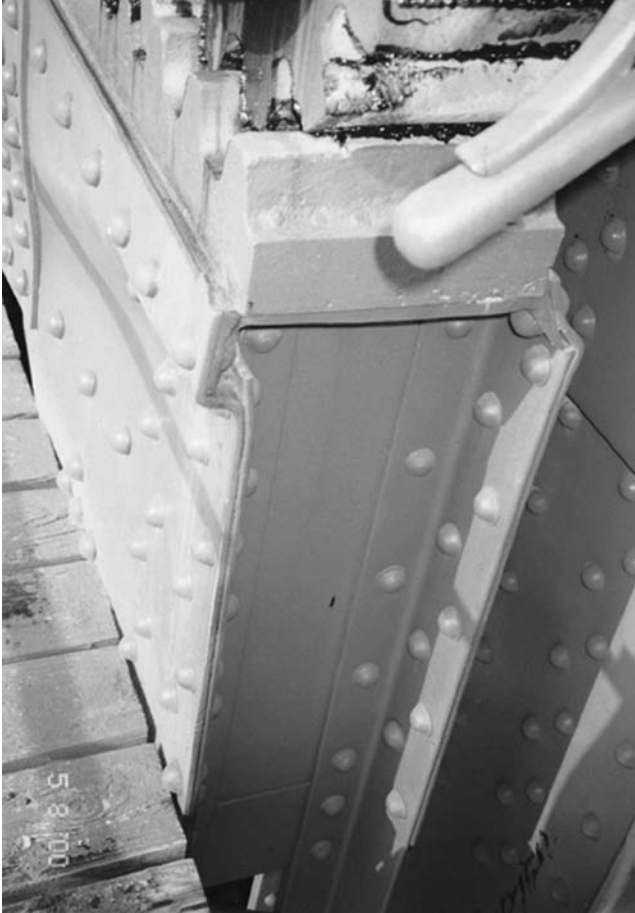
FIGURE 14.9 Fixed Rack, Buckled Track Girder. (Source: Ian Engstrom, Parsons Transportation Group Inc.)
