WHY BUILDINGS FALL DOWN

How Structures Fail

MATTHYS LEVY
and
MARIO SALVADORI

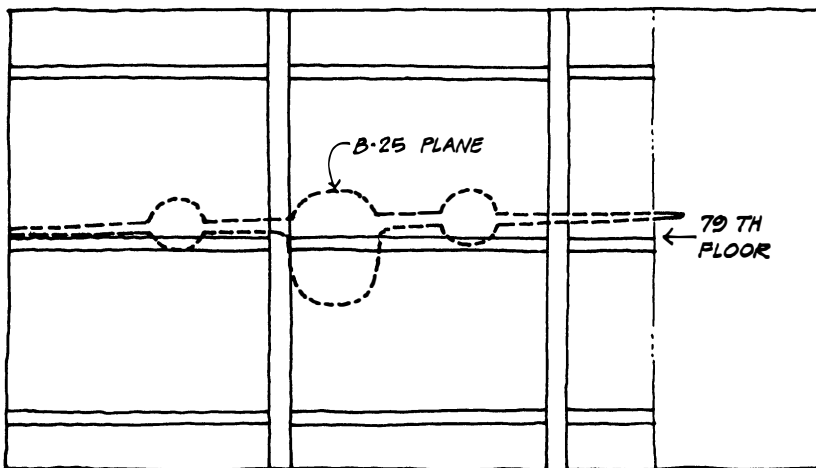
The center of impact aligned almost exactly with a column on the face of the tower. The right motor passed on one side of the column and the left motor on the opposite side (Fig. 2.4). The column itself was barely damaged, although a steel beam supporting

2.4 B-25 Straddling Column

the masonry wall struck by the right motor was torn out, and a second beam supporting the floor slab was bent back 18 in. (450 mm). The plane apparently struck the seventy-ninth floor dead-on, which explains the lack of damage to the column. Had the plane been just a bit higher or lower, it might have struck and bent the column, and then . . .

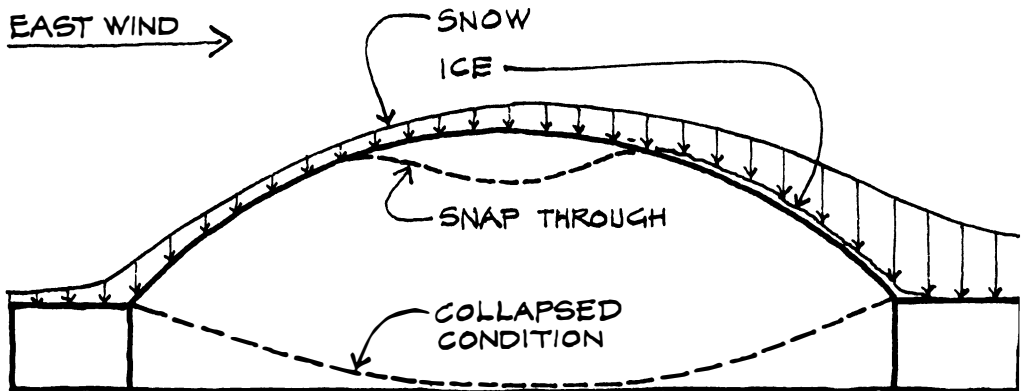
3.12 Stages of Collapse of C. W. Post Dome

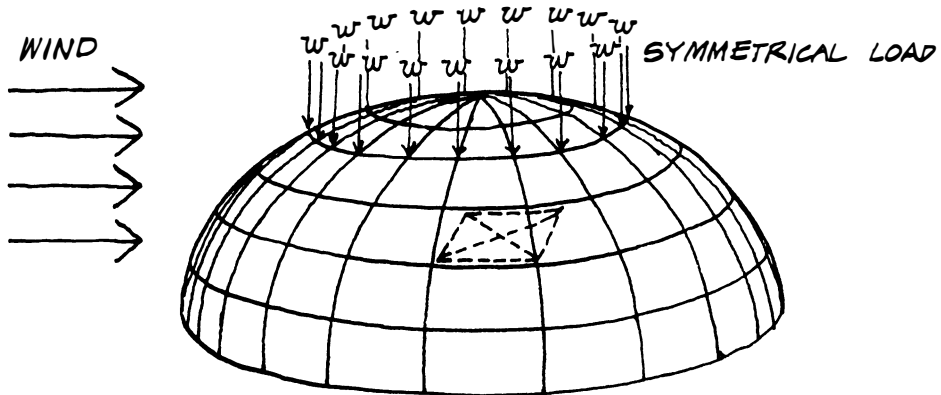
3.14 Skewing of Radial Ribs Caused by Wind

But perhaps the most dangerous consequence of using membrane theory in the design of shallow reticulated domes is that under symmetrical gravity loads its meshes *shrink* (slightly) on all four sides, *remaining square*, while under wind loads they become skewed (Fig. 3.14) and require diagonals to be stable. Finally, since most of the bars of the mesh are compressed, reticulated domes must be checked against the dangerous phenomenon of *instability in buckling as a whole*, which causes the dome to invert or *snap through*. (You may easily check instability in buckling by pushing down on a thin metal or plastic ruler that will bend out at right angles to its thin surface and lose all capacity to resist compression higher than a small push [p. 289, Fig. D4].) Rather unwisely the

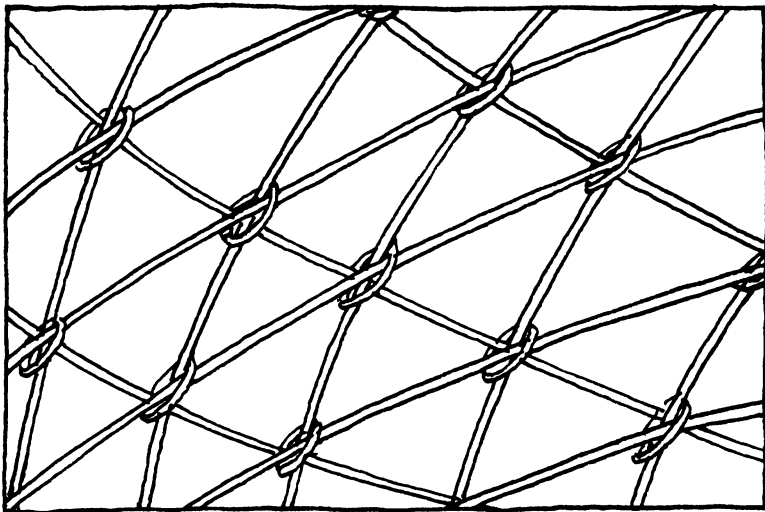
3.16a Bar Arrangement in Bucharest Dome

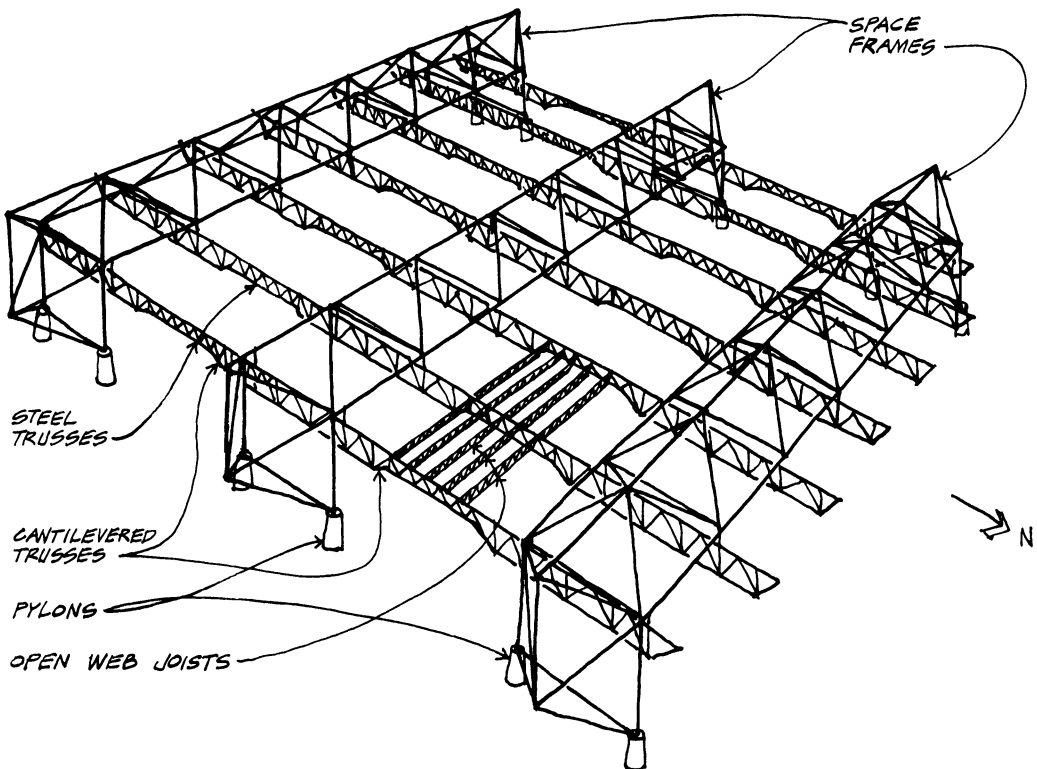
The basic structural elements supporting the loads of the roof itself and those acting on it, as well as the weight of the upper part of the walls of the arena, were three external space frames spaced at 153 ft. (46 m) in the north-south direction in the shape of rectangular portals, 360 ft. (108m) long in the east-west direction, and 81 ft. (24 m) high (Fig. 4.4). The horizontal element, or beam, of the portals consisted of a *space frame* of steel tubes with an equilateral

4.4 Diagrammatic Layout of Structure of the Kemper Arena

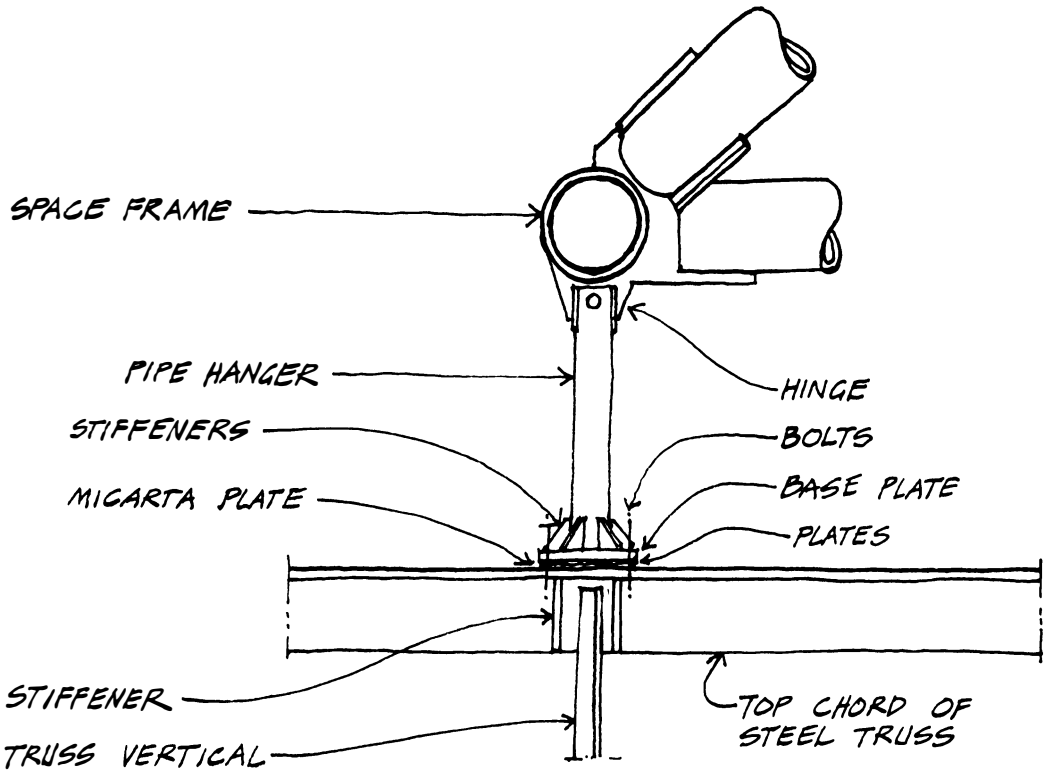
The hanger assembly, because of its two essential functions, does not consist of a simple rod as the word “hanger” may have implied to the reader (Fig. 4.6). Since the weight of the roof itself is 26 psf (1.3 kN/m²), or about 1,500 tons, and since the roof was designed to carry 25 psf (1.25 kN/m²) of additional load caused by rain, the load of the mechanical systems, and other hanging loads (or about

4.6 Components of the Hanger Assembly

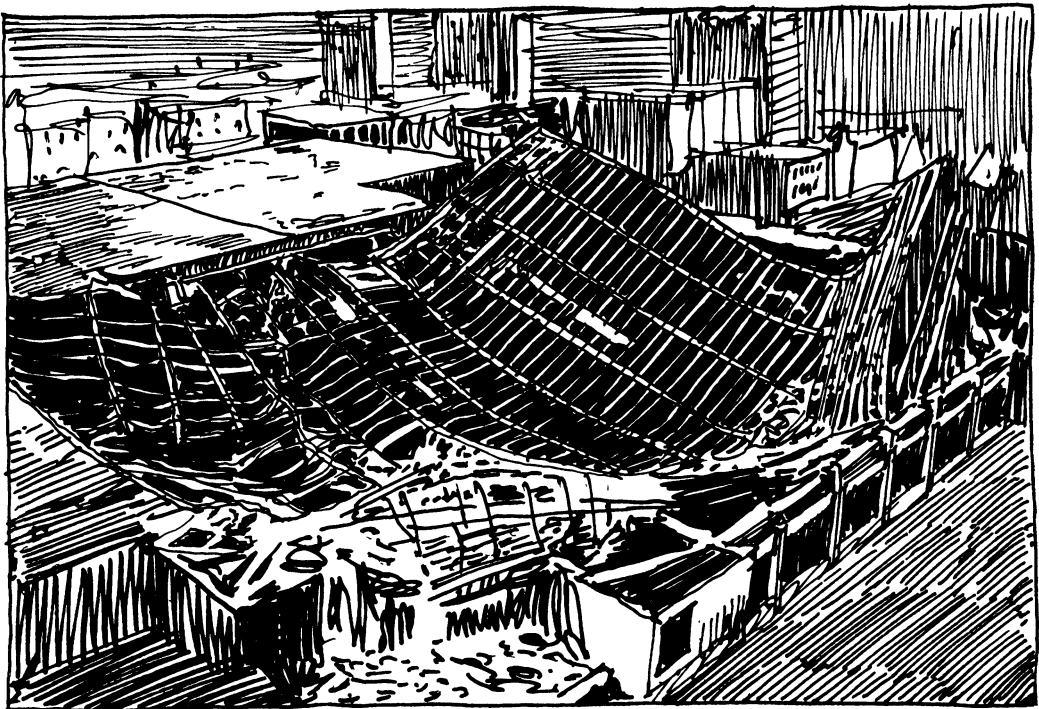
4.10 Hartford Center Roof: after the Collapse

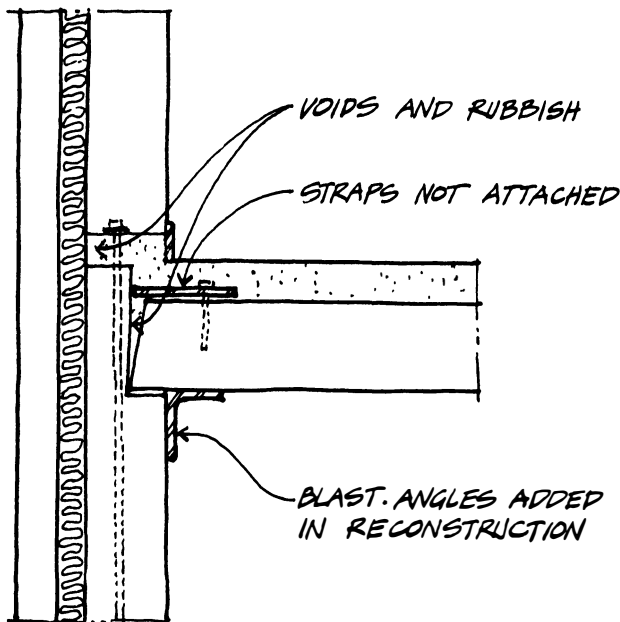
5.4 Joint between Floor Slab and Outside Wall—Reinforced after the Blast

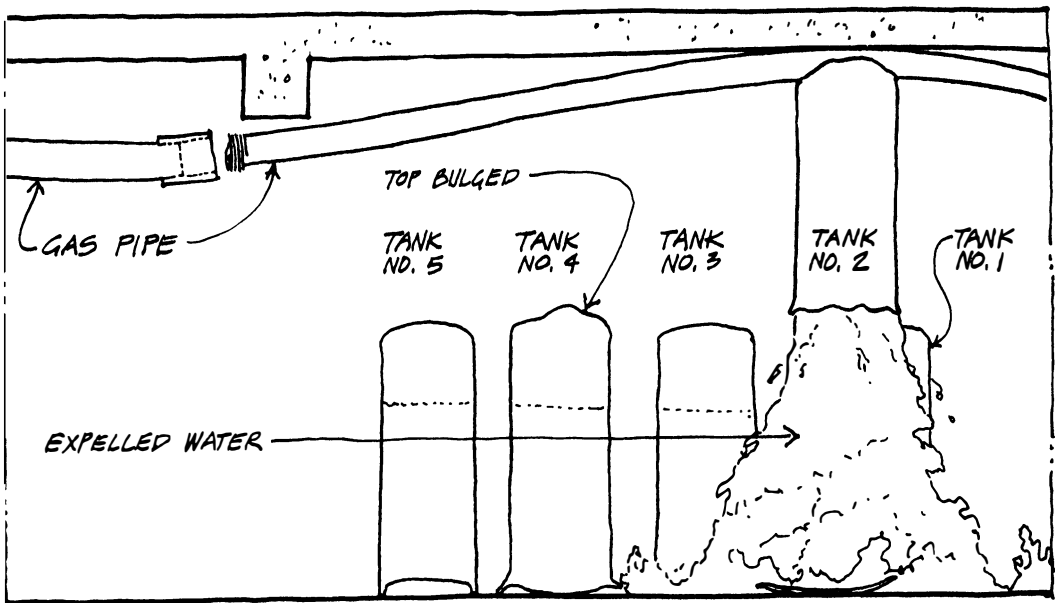
5.6 Ruptured Tank Striking the Gas Pipe

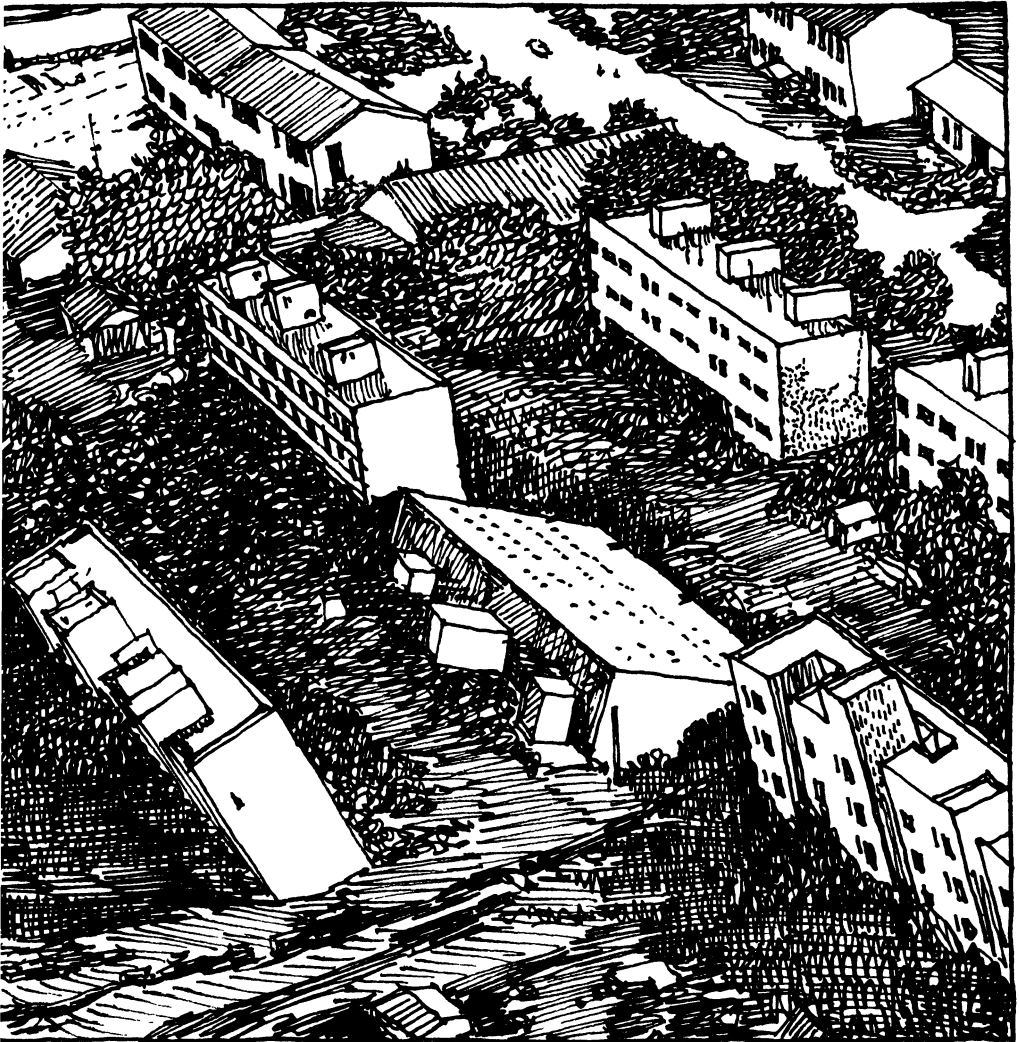
urated with water that suddenly become liquid when subjected to shaking from the quake. To demonstrate this action, place a weight on a pot full of sand to which water has been added almost to the top. Shaking the pot will cause the sand-water mixture to liquefy and the weight to sink and/or tilt. This is precisely what happened in Niigata, Japan, in 1964, when an apartment building tilted through an angle of 80° from the vertical without breaking up, so that after the movements stopped, the occupants were able to walk to safety down the face of the building (Fig. 6.6).

6.6 Niigata Apartment Buildings: After the Earthquake

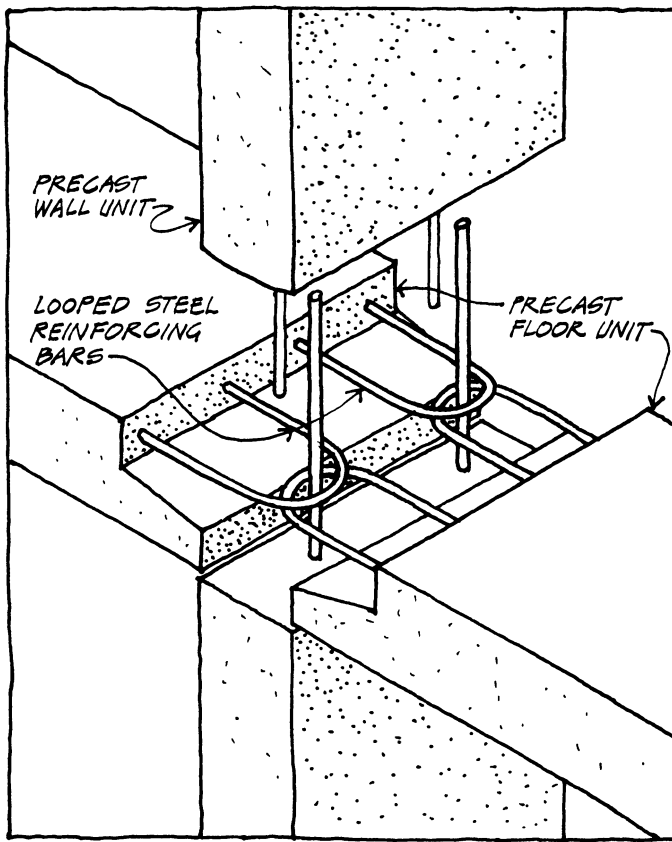
6.9 Detail of Joint between Precast Concrete Wall and Floor Panels

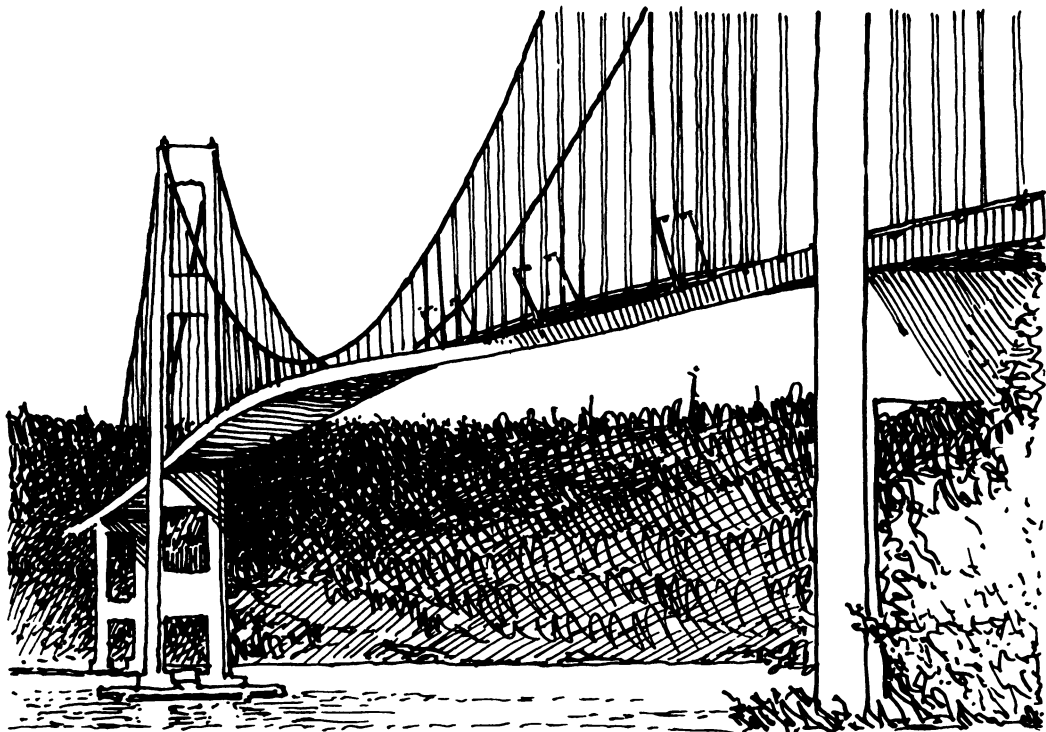
circular arc. Shortly before 10:00 A.M. Arkin again checked the wind velocity and saw that it had increased to 42 mph (67 km/h) and that the movement of the bridge deck had heightened dramatically; by his count, the deck rose and fell at the center of the bridge 38 times per minute with a 3 ft. (0.9 m) amplitude. Greatly concerned, Arkin halted all traffic, and Professor Farquharson, who happened to be at the site that day, observed that the up-and-down motion of the center span consisted of at least nine vertical undulations while the bridge was also deflecting laterally by as much as 2 ft. (60 cm). Suddenly the bridge started twisting violently, and the nine-wave motion changed to a two-wave motion while the bridge deck near the Tacoma side appeared to twist to an almost 45° angle (Fig. 7.3).

7.3 Twisting Motion of Tacoma Narrows Bridge

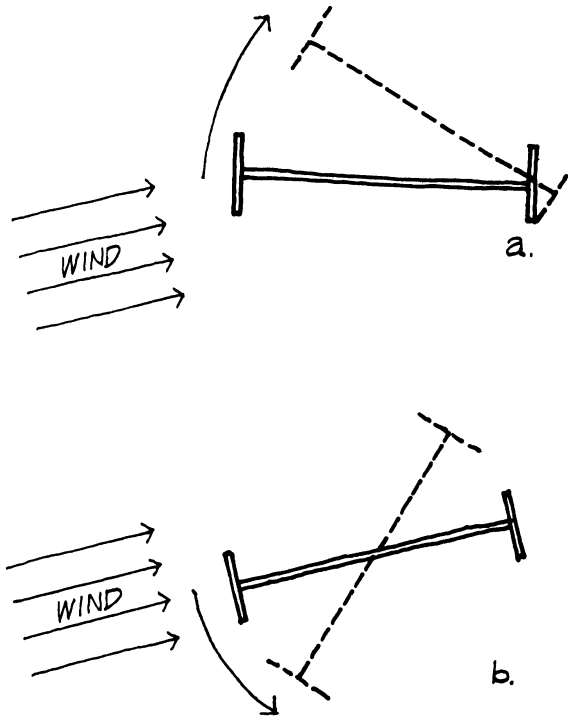
7.6 Wind-Induced Twist

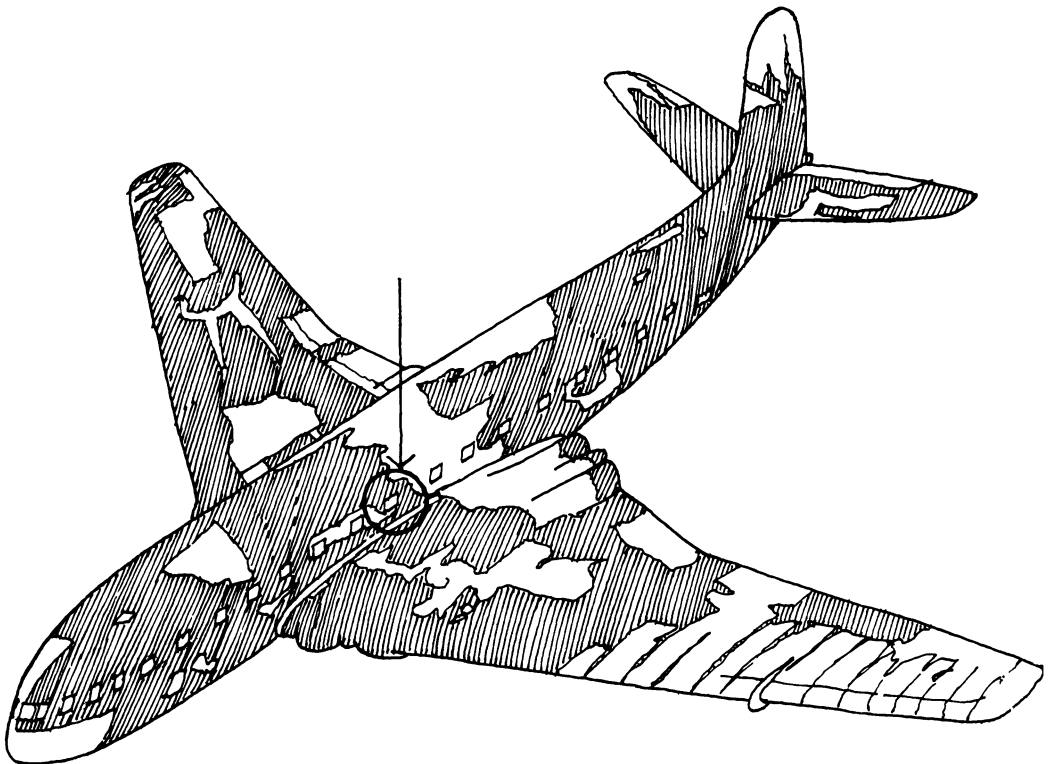
8.1a Comet Airliner with Recovered Sections Shown Shaded

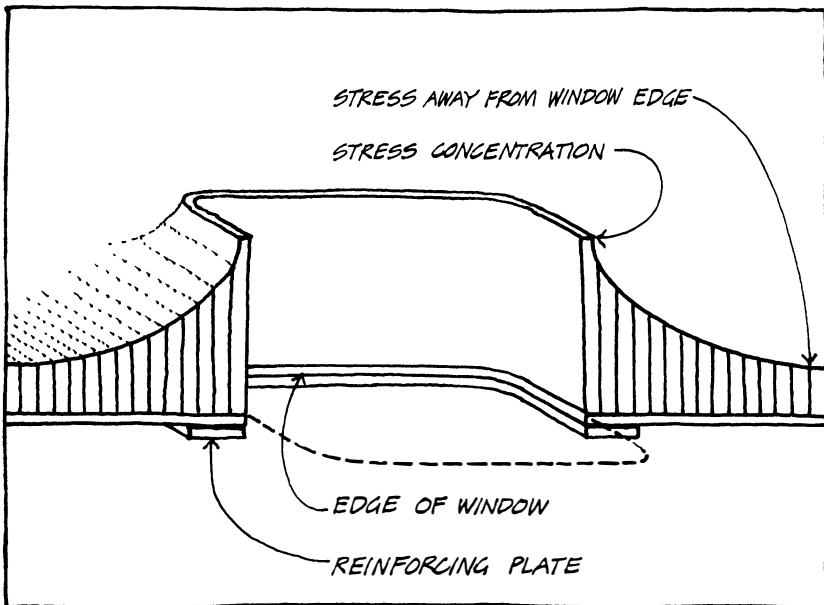
8.2 Stress Concentration at Window's Edge

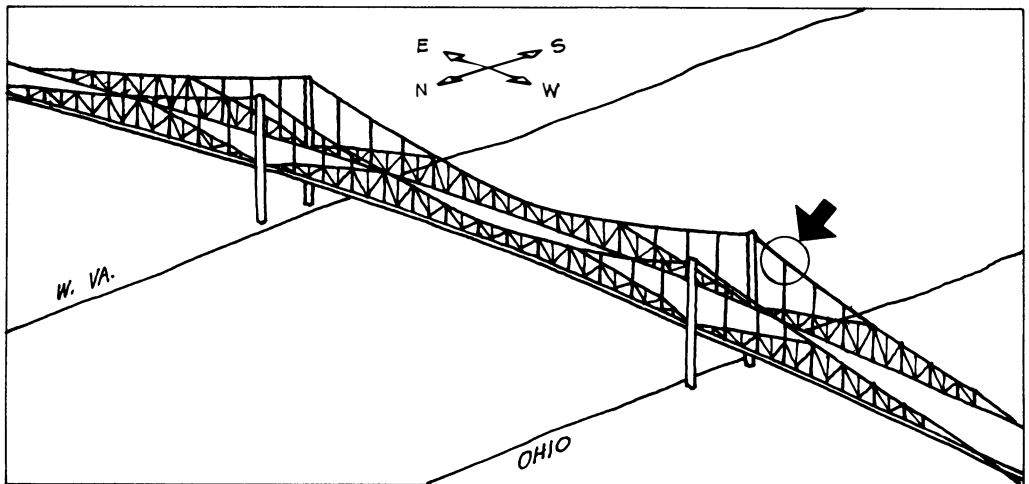
8.3 Point Pleasant Bridge

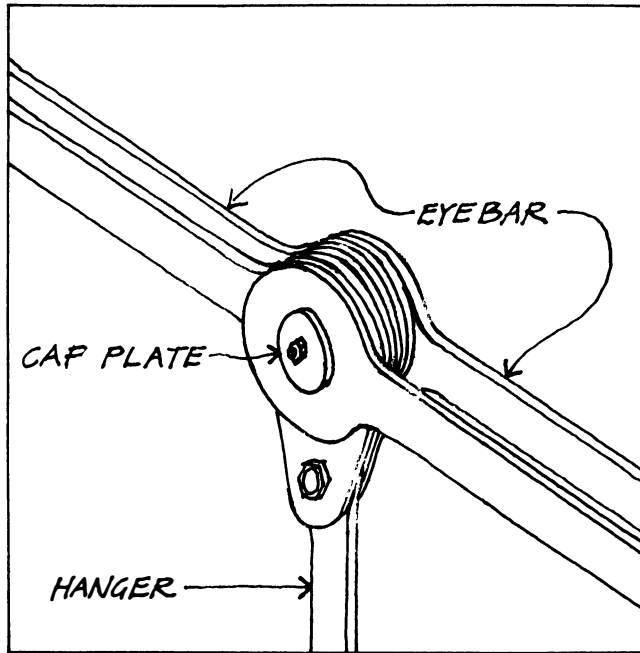
8.4 Typical Eybar Joint

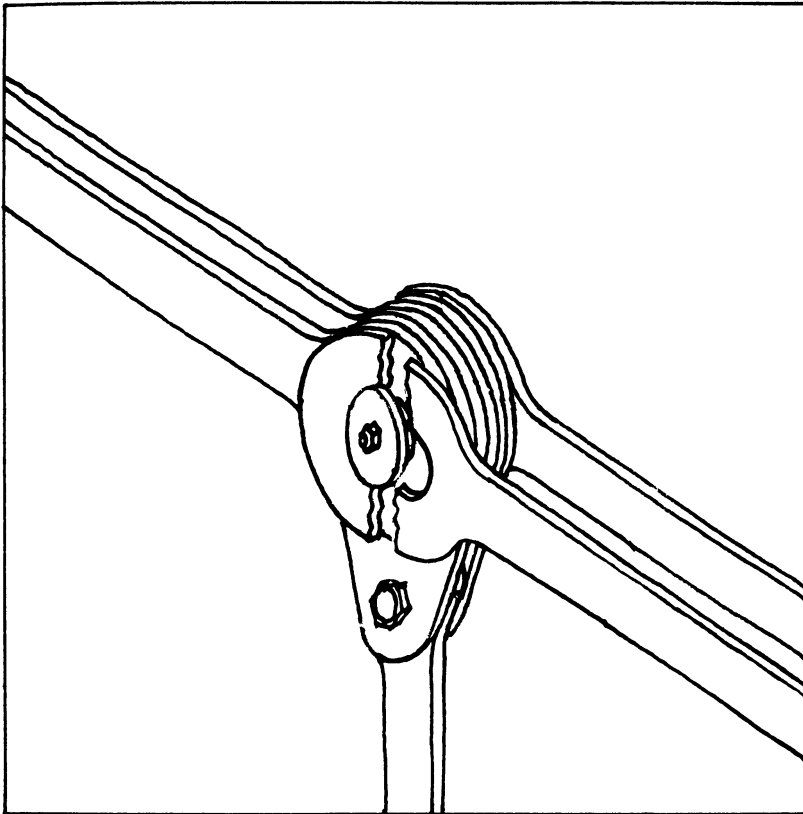
8.7 Cracked Eyebar

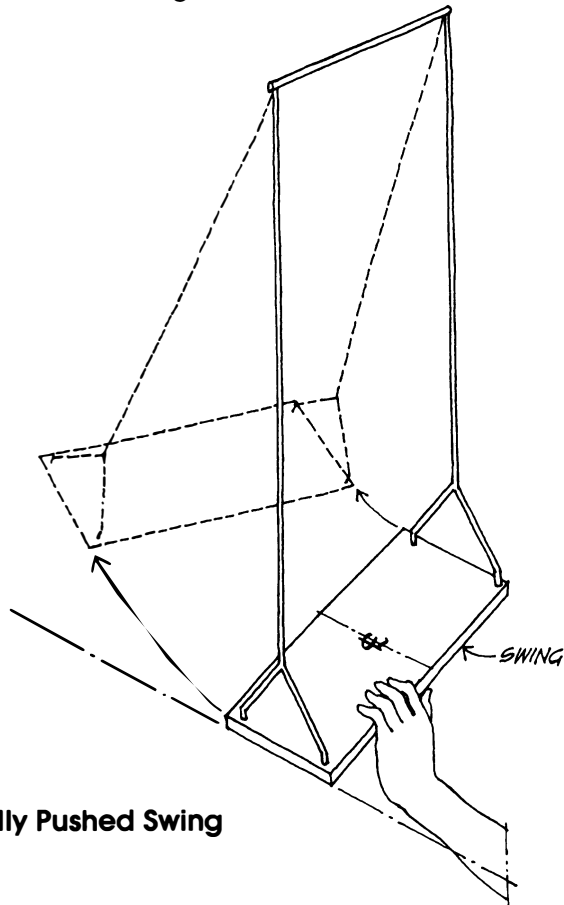
9.5 Eccentrically Pushed Swing

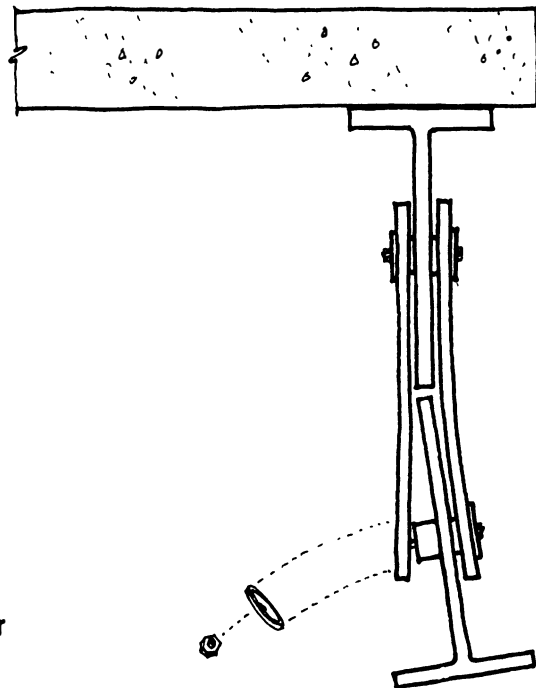
We can now reconstruct the events leading to the collapse of the Mianus Bridge. Over the bridge's twenty-five years, corrosion builds up between the hanger plates and the pins because of the constant wetting action of rain, brought on by the paving over of the floor drains. Each time a car or truck passes over the bridge, the skew effect imposes a lateral force on the hanger plates, contributing to the tendency of the hanger plates to be pushed off the pin. At the southeast corner of the suspended span, the force of corrosion, aggravated by the skew effect, is so large that it causes the restraining pin cap to dish out and possibly pop off. Sometime before the collapse, hours or days earlier, the bottom of the inside hanger plate slips off the pin (Fig. 9.6), causing a transfer of the

9.6 Failure of Hanger

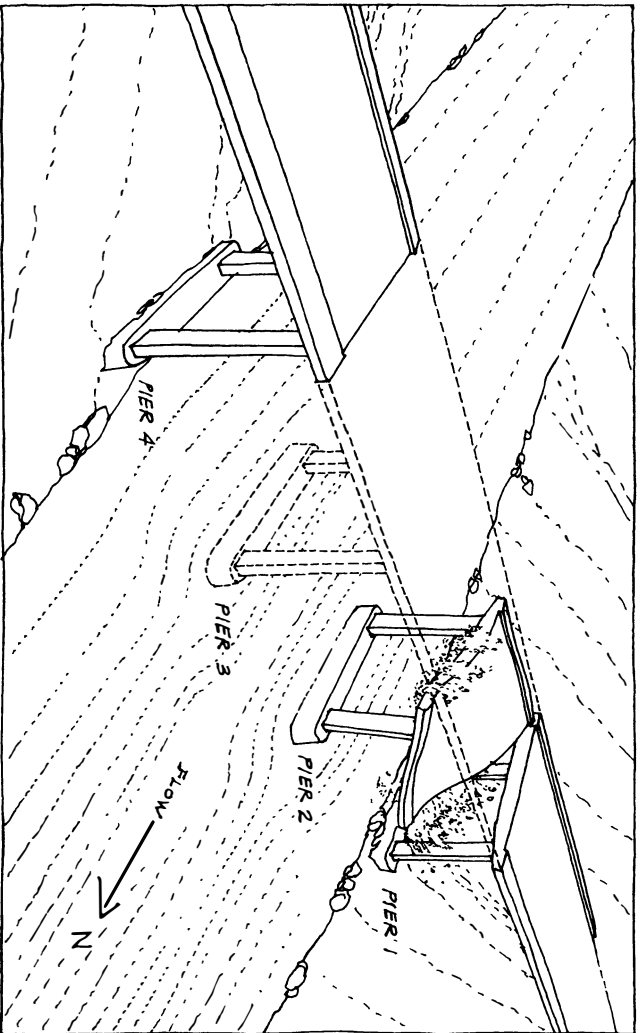
9.9 Collapsed Schoharie Bridge

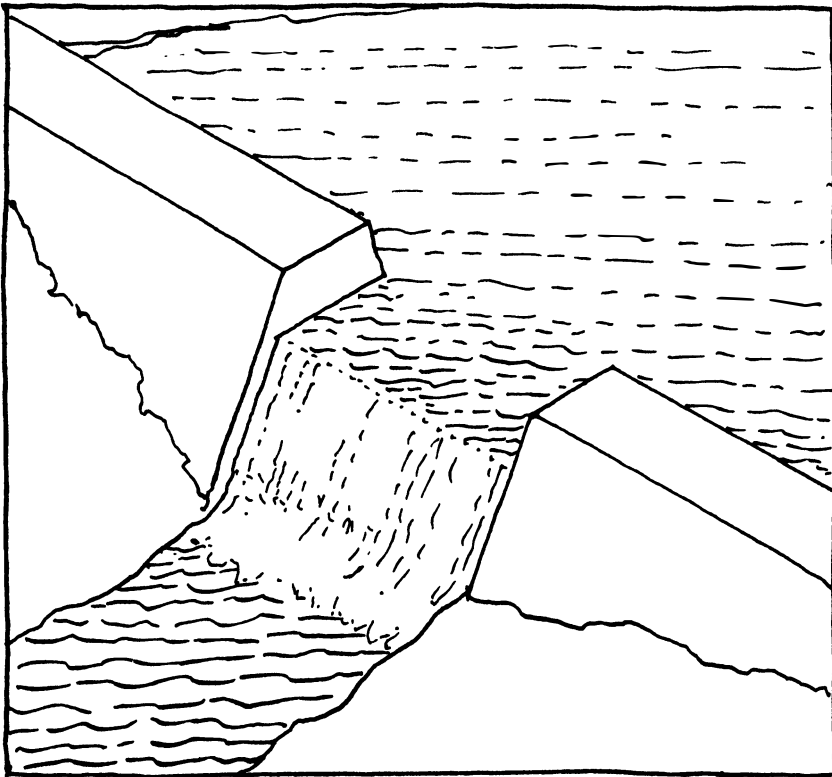
11.1 South Fork Dam: Original Construction

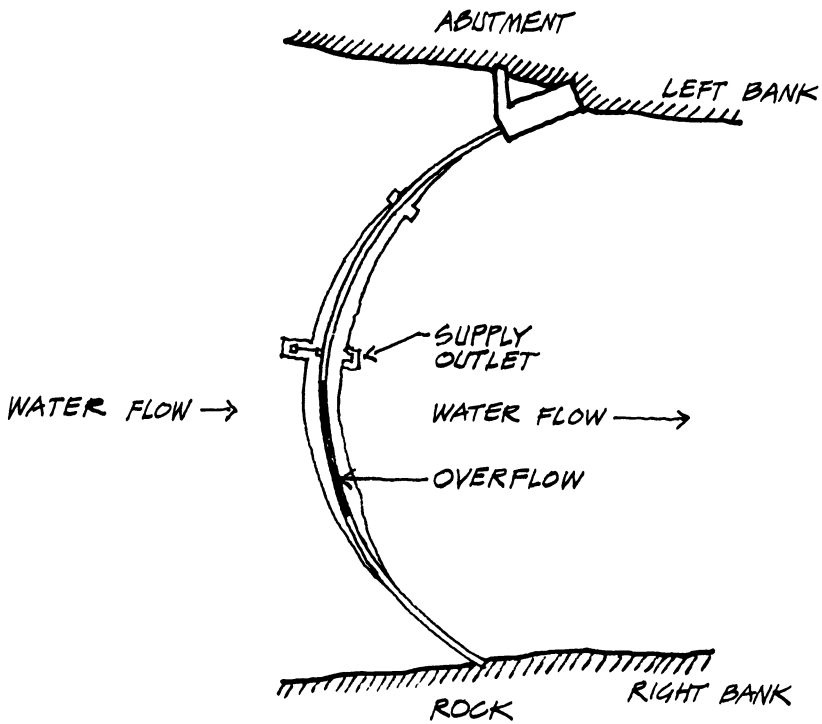
11.4 Plan of Malpasset Dam

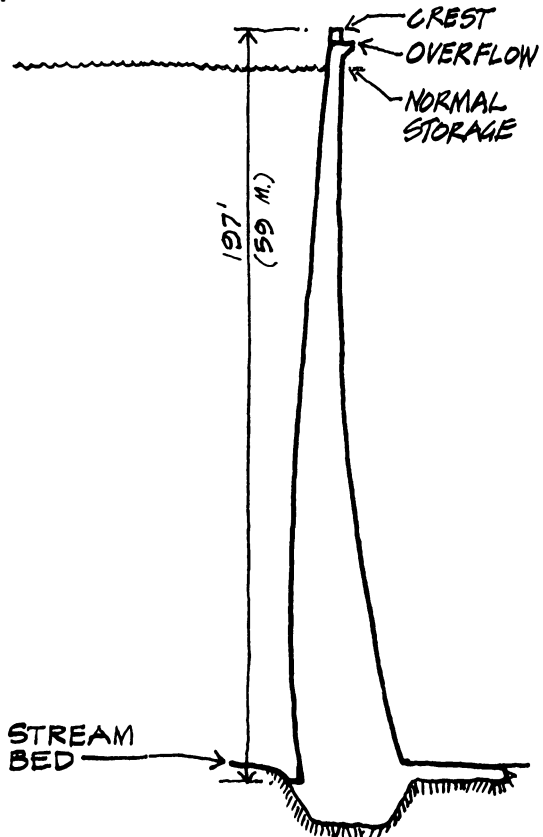
somewhat complicating its construction (Fig. 11.5). It was the thinnest arch dam ever built: 22.6 ft. (7 m) thick at the base and 5 ft. (1.5 m) at the crest, a direct descendant of a dam built in 1926 at Stevenson Creek in California to test the arch dam theory. While Malpasset was still under construction, Coyne designed Le Gage Dam, a double-scale reproduction of the one at Stevenson Creek and a dam with calculated stresses more than twice those predicted for Malpasset, showing that Malpasset was safely within the limits of technological feasibility.

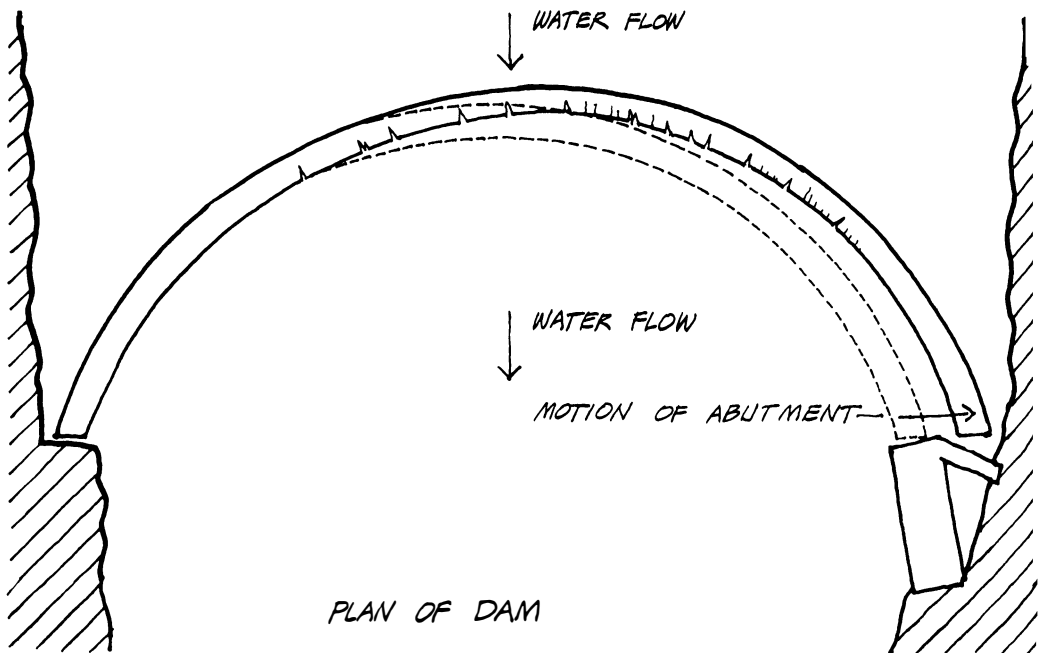
11.6 Failure of Arch Owing to Displacement of Abutment

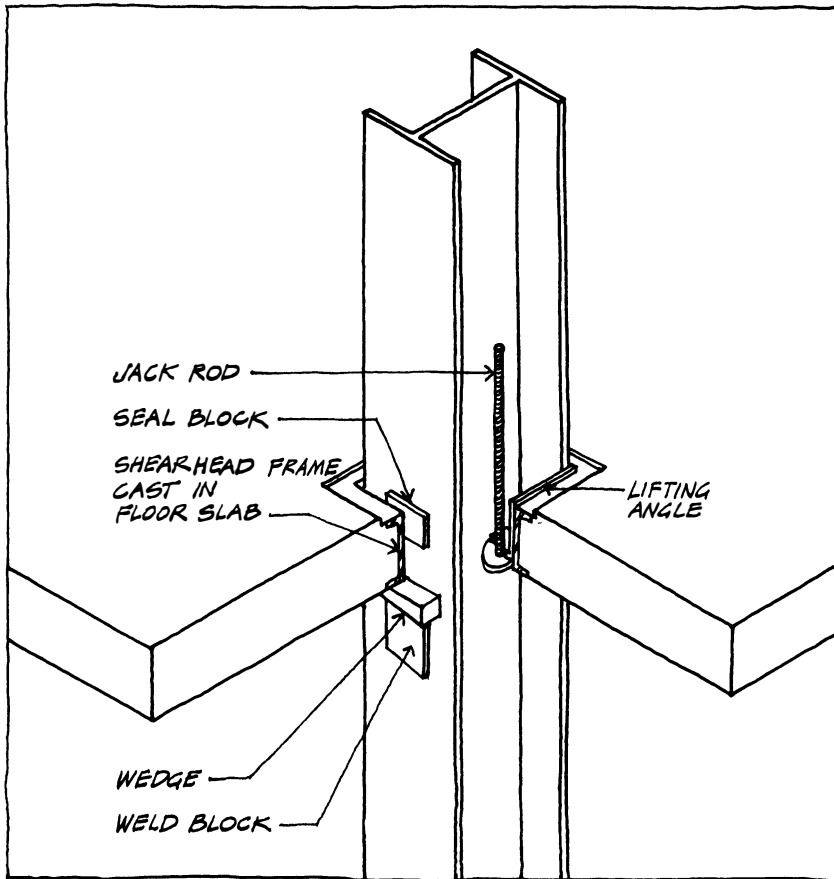
12.4 Typical Shearhead Arrangement

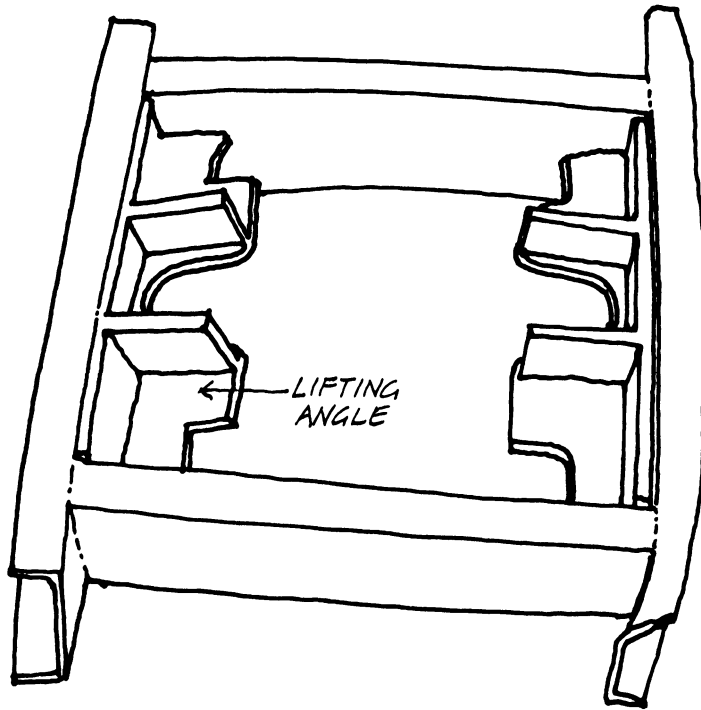
12.6 Failed Shearhead Showing Rotation of Lifting Angles

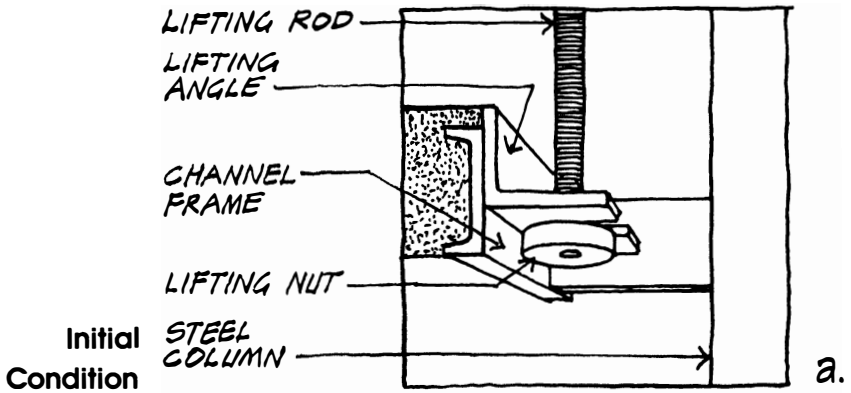
12.7 Failure Sequence

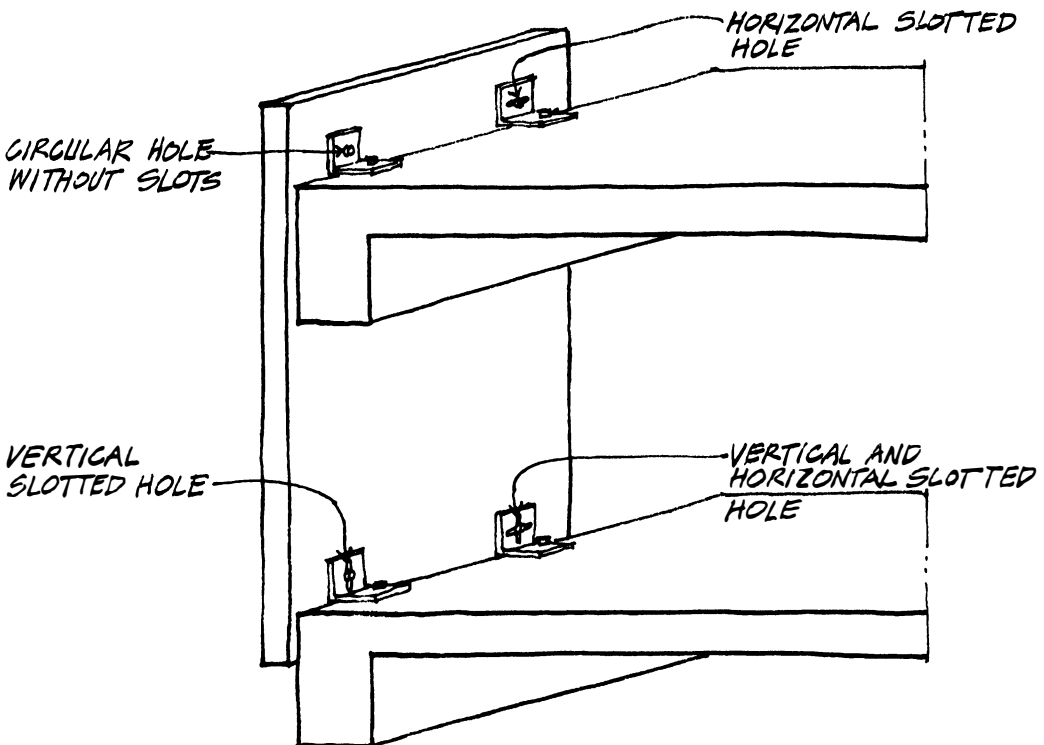
13.1 Attachment of Precast Panel

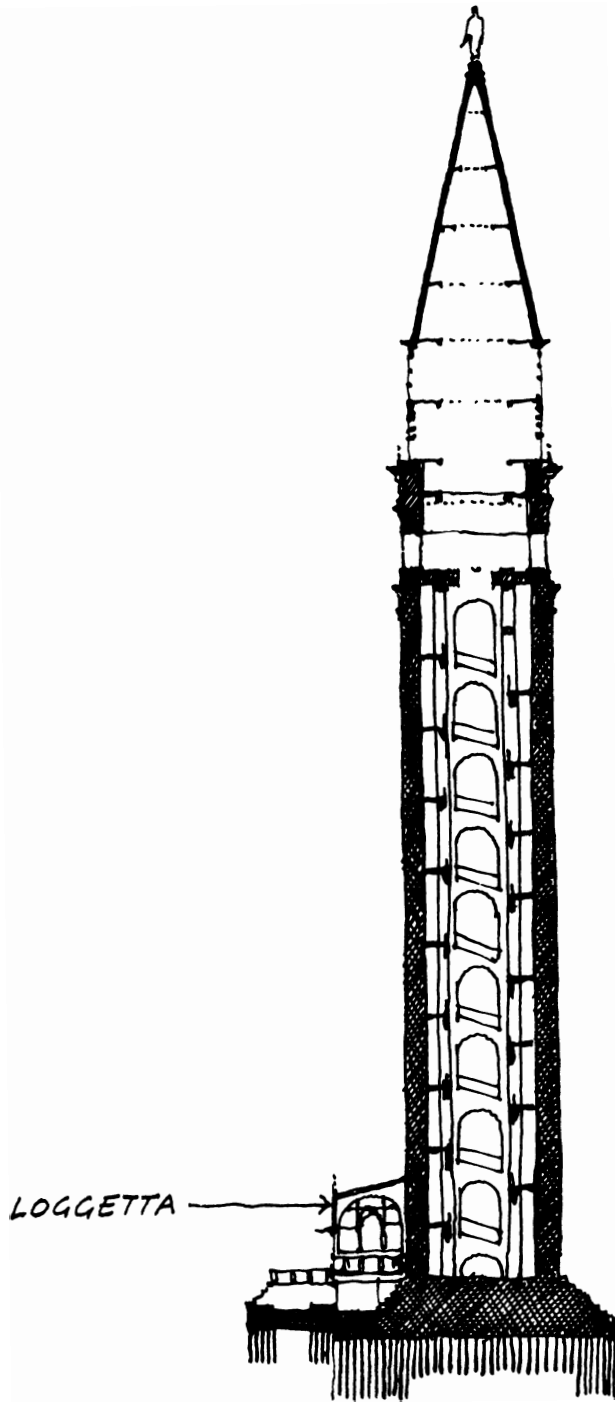
14.2 Section through Campanile of San Marco

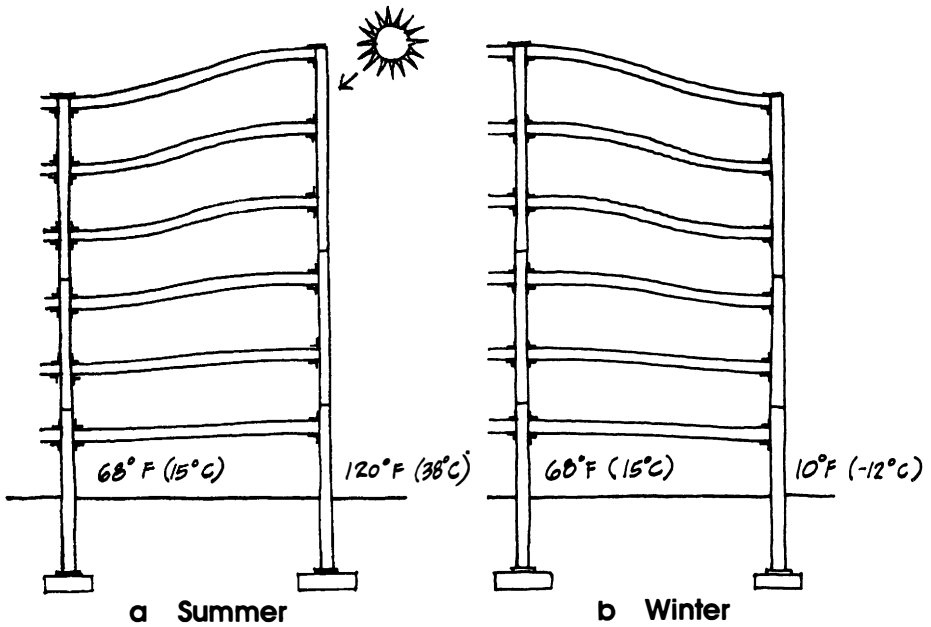
A3 Thermal Bending of Frame Beams in:

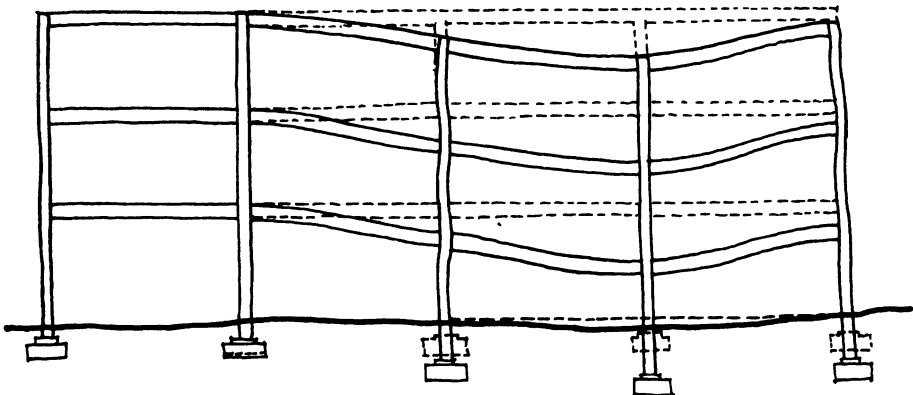
A4 Uneven Settlement of Building Foundation, Causing Bending of Beams

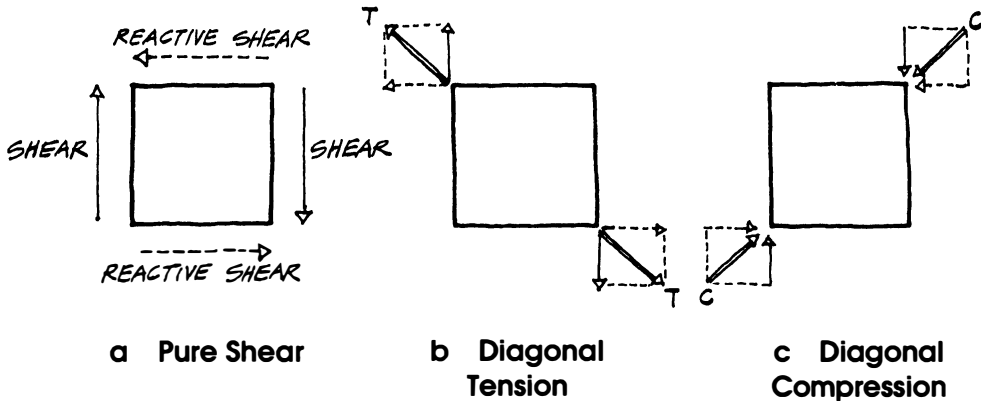
D12 Shear Equivalent to Tension and Compression

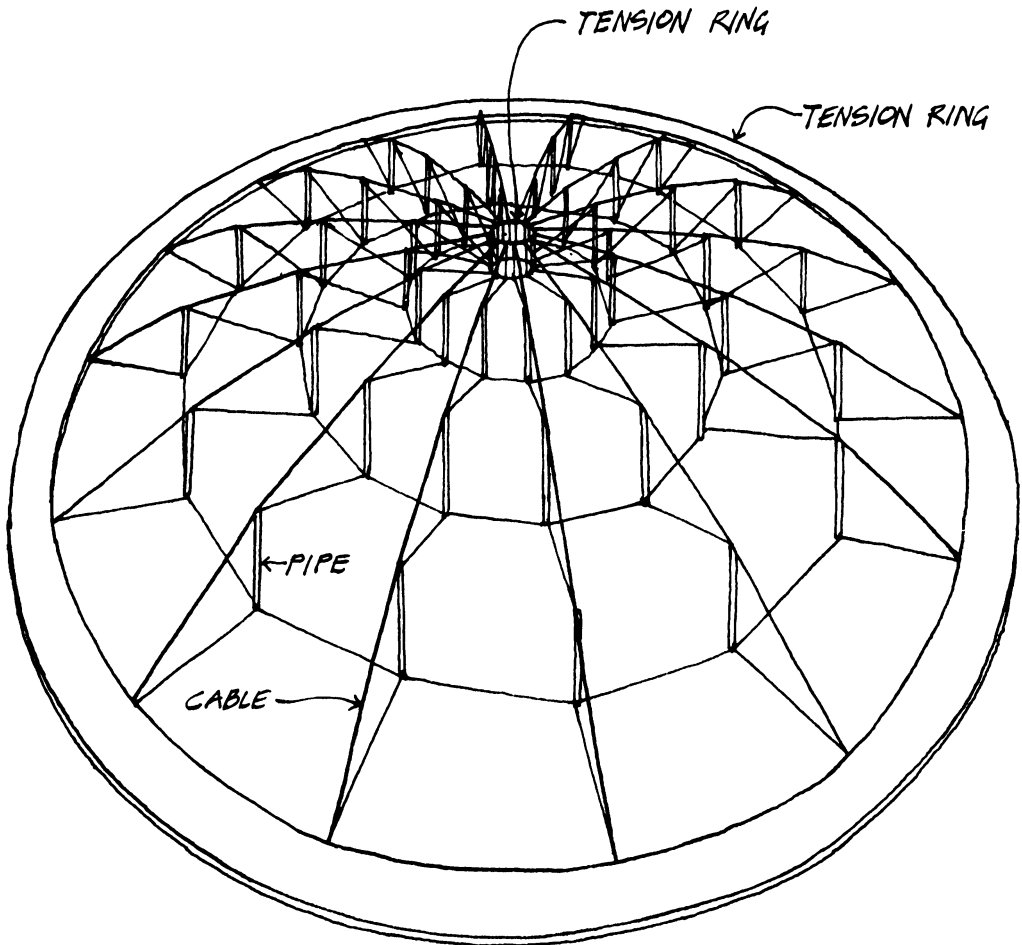
D34 Tensegrity Roof of Suncoast Dome, St. Petersburg, Florida
