Staircases

HISTORY, REPAIR AND CONSERVATION

Editors: James W. P. Campbell and Michael Tutton
Managing Editor: Jill Pearce

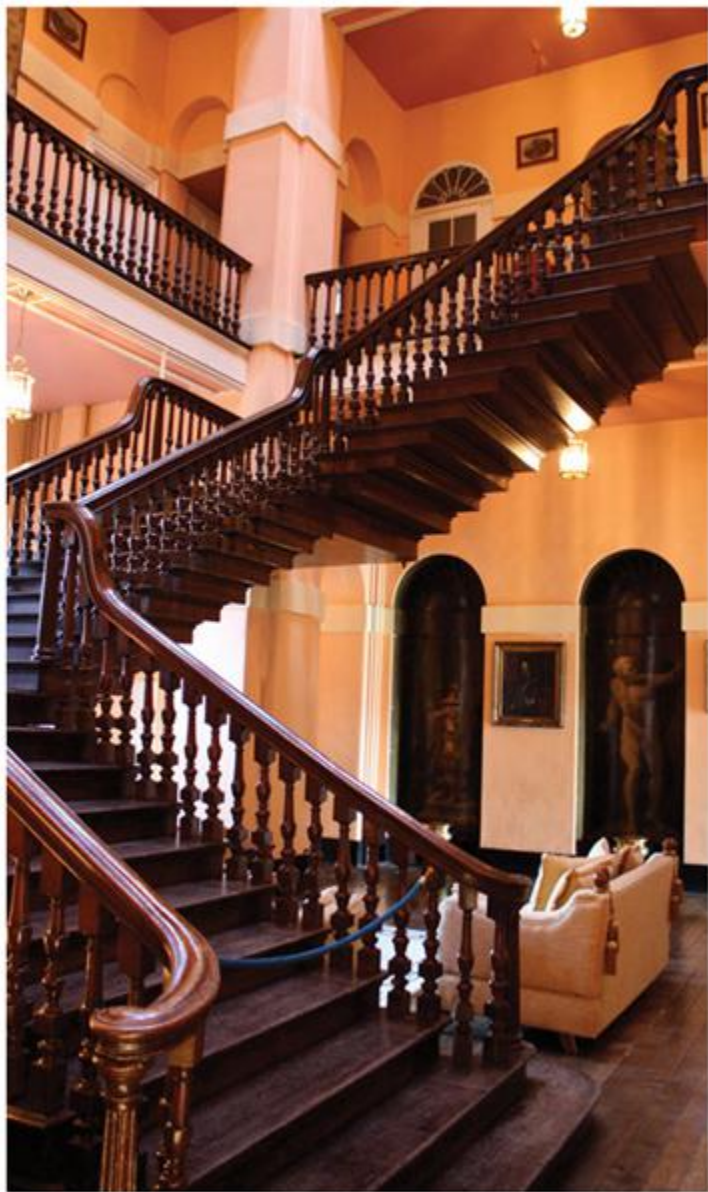
I.1 Kings Weston, Bristol. The extraordinary timber hanging or flying staircase. The house by Vanbrugh, begun c.1719, has been substantially altered over time and this staircase in its present form cannot be original. It is, however, a work of brilliant virtuosity. (Michael Tutton)

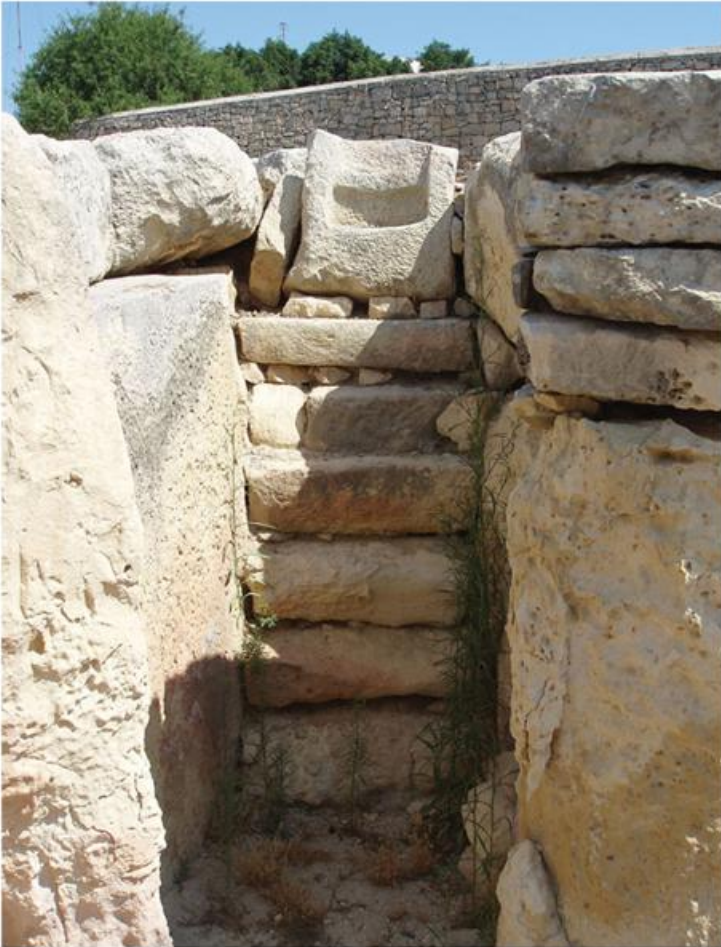
1.1 Early stone steps within the Tarxien temple and Saflieni Hypogeum complex, on the island of Malta, within a date range of 3800–2400 BC. The steps within the walls are mostly single blocks. There has undoubtedly been some restoration and reconstruction and the upper two steps, carved from a single block, are somehow unconvincing being much narrower – they

may have been placed here from elsewhere. (David Davidson)

From very early times mankind has hewn blocks of stone to form stairs, mostly within religious sites. The humble and even higher status house would have made do with wooden ladders where they were needed to access areas such as lofts and sleeping platforms. Within the prehistoric Tarxien Temple and Safflieni Hypogeum site in Malta, dating to 3600–2500 BC, which lay claim to being probably the earliest free-standing megalithic monuments in the world,² an ancient civilisation has left extensive remains which include a short staircase. Simple rectangular blocks have been laid between solid megalithic block walls to form a staircase of some nine steps to connect two temples ([Figure 1.1](#)).

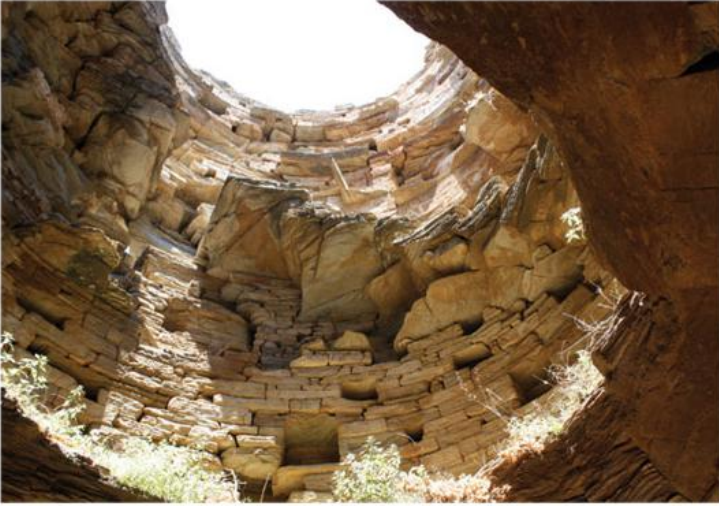
1.4 Remains of the cantilevered staircase in the tower of Agios Petros on the island of Andros. Taken from the ground-floor vaulted room through the collapsed crown of the vault. (Michael Tutton)

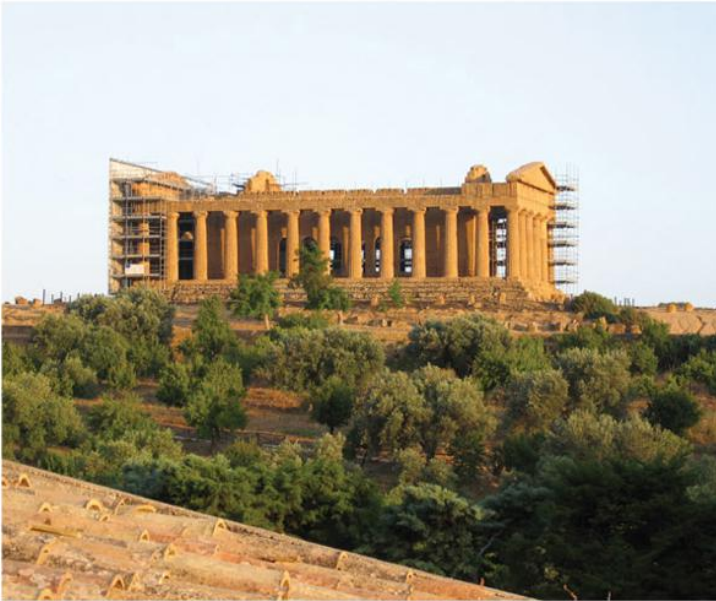
1.6 Temple of Concord, Agrigento, Sicily. The pair of staircases are housed within the superstructure to the left within the colonnade; their landing at attic level is just below the inner pedimented section. (Michael Tutton)

examples survive, internal Greek stairs are less common. The western Greek temples, principally those in southern Italy and on the island of Sicily, are unusual in having pairs of interior staircases which lead to the attic. They are generally sited within the cella, the sacred chamber, either side of the doorway from the pronaos or outer vestibule. It is thought that their function was to gain access to the upper space in the roof for ritual purposes rather than the utilitarian functions of storage or maintenance of the roof structure.¹⁰ Many of these staircases are helical, usually built partly within the thickness of the internal walls. They are always in pairs opposite each other, one being clockwise and the other anticlockwise, typically with treads no more than approximately 650 mm wide. The most remarkable survival of these staircases is in the temple of Concord at Agrigento, c.430 BC, on the south coast of Sicily (Figure 1.6), where both staircases survive to attic level and are still usable today.¹¹

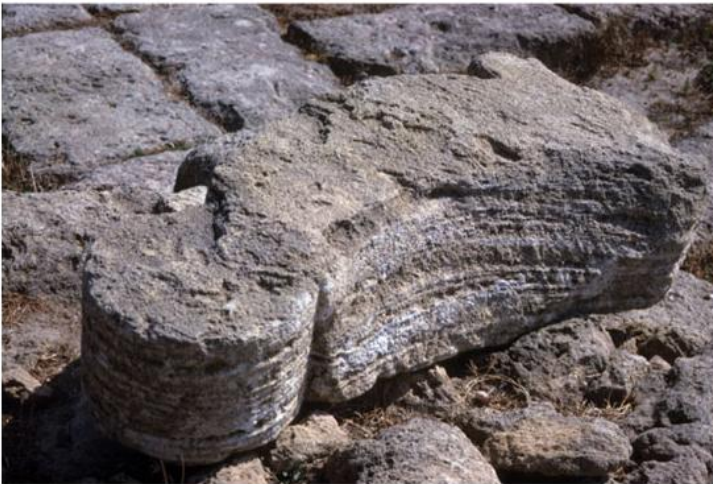
1.8 Temple A at Selinunte, Sicily. Stair tread *c.*450 BC. Here is clearly seen the precursor of the newel stair seen in virtually every house, fortress and church of the Romanesque and Medieval periods. (Margaret M. Miles)

Further up the coast to the west at the complex of temples at Selinunte, sufficient evidence of temple A, c.450 BC, remains for the reconstruction shown in [Figure 1.7](#). The base of the shaft of the northern staircase and many treads and fragments survive to indicate a newel spiral staircase with a chamfered soffit ([Figure 1.8](#)).¹² Other examples of these staircases on mainland Italy were constructed in straight and dog-leg flights, particularly those at the temple of Hera at Foce del Sele, south of Salerno ([Figure 1.9](#)) and the second temple of Hera at Paestum ([Figure 1.10](#)).¹³ These staircases in their

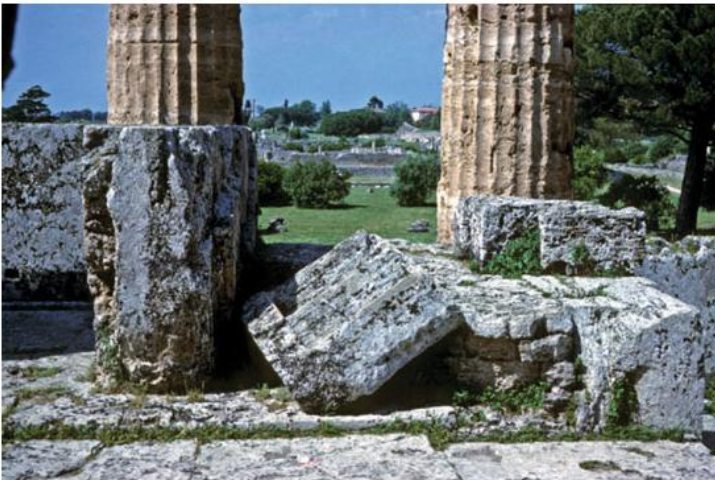
1.10 Paestum, Temple of Hera II. Block of three stair treads, resting at an angle, in the middle foreground. (Margaret M. Miles)

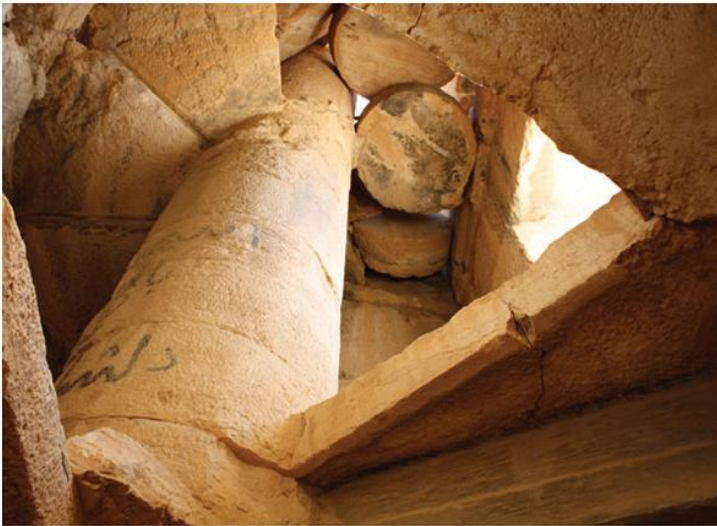
1.13 The western stair within the inner chamber or adyton of the Temple of Bel, Palmyra, Syria. This is a newel stair where the newel and tread are one piece of stone and each section is separate rather than several treads being cut from a single block. This is the standard mode of construction adopted in Europe in the Medieval period, particularly in England from the end of the

twelfth century onwards. Several treads have sheared off and have fallen through to the base and sections of displaced newel block the upper part of the stair; possibly damage associated with earthquakes. (Michael Tutton)

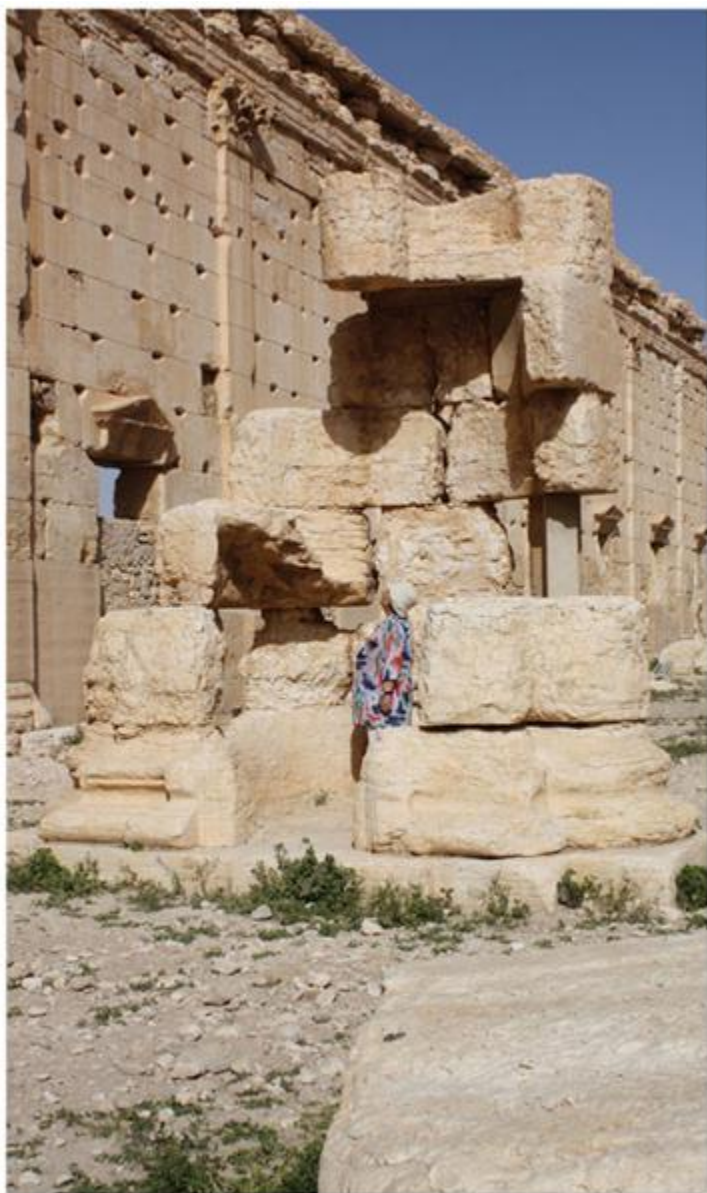
1.14 Temple of Bel, Palmyra, Syria. Northwestern corner of the outer enclosure, restored part of a spiral staircase which would have led to the roof of the colonnade. This is a newel staircase but made of large blocks of stone incorporating two or three treads. There would have been four such staircases, one at each corner. (Michael Tutton)

The Romans made few advances in staircase design and construction. They carried on the Greek tradition of pairs of tight newel stairs in temples, particularly in Asia Minor. The sanctuary of Bel, AD 32, at Palmyra, Syria, contains a pair at the southern end on each side of the adytoni.¹⁸ They are unusual in that the eastern one is in a square shaft and consists of a dog-leg stair, while the other on the western side is a spiral newel stair (Figure 1.13); the significance of this is not known. Within the outer enclosure or Temenos, at the northwestern corner are the remains of a spiral stair that would have led to the roof of the colonnade (Figure 1.14); there was probably

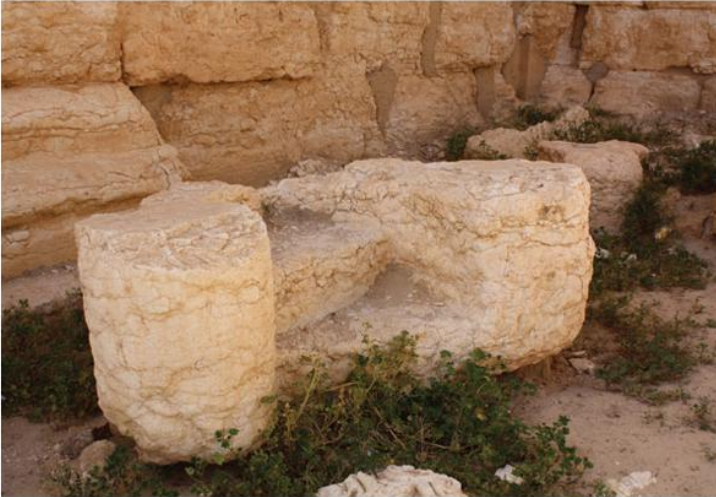
1.15 Temple of Bel, Palmyra, Syria. Newel and three treads all cut from a single monolithic block, part of the staircase shown in [Figure 1.14](#). (Michael Tutton)

one at each corner.¹⁹ Although the actual stairs are narrow, they are built of monolithic blocks, comprising several treads, and is set within a group of pilasters forming the corner of the inner colonnade. Lying on the ground nearby are other blocks forming treads (Figure 1.15). Within the propylaea, or main gate, mid-way along the western wall of the sanctuary are a similar pair of staircases to those in the temple, either side of the entrance portals. Both of these are dog-leg stairs, again cut from monolithic blocks.²⁰

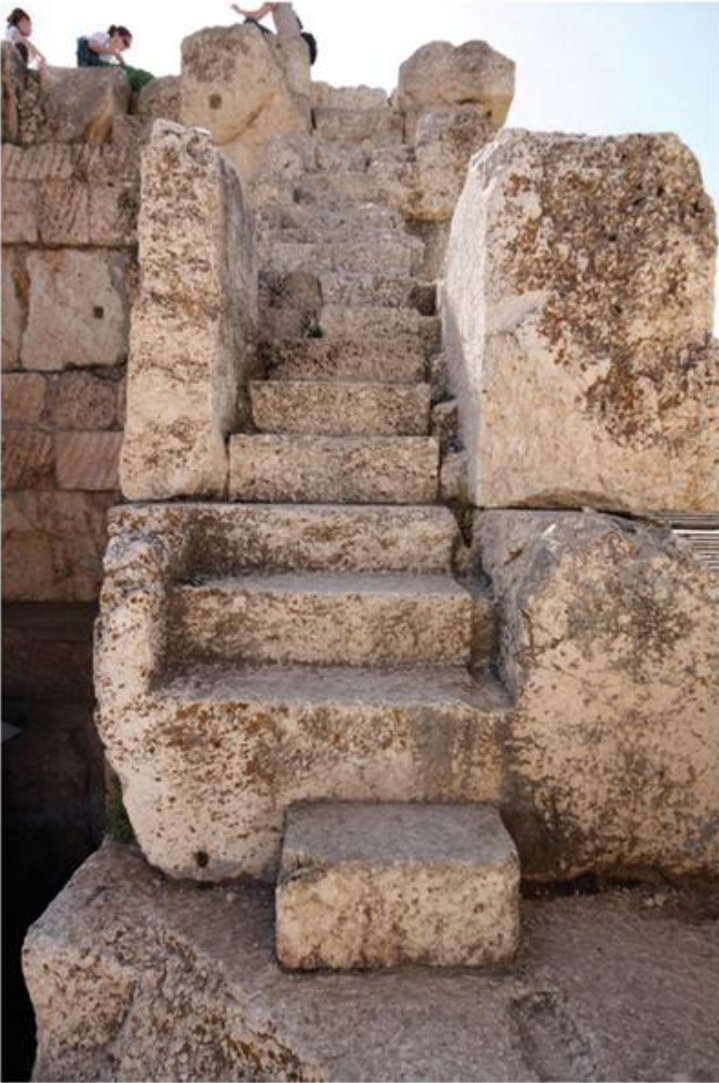
1.16 Baalbek, Lebanon, Temple of Jupiter, ceremonial staircase forming part of the monumental altar, one of a pair either side of the altar. Huge blocks of stone are

employed, a significant feature of Baalbeck; in the foreground are three treads and side walls all hewn from the same piece of stone. (Michael Tutton)

Also at Baalbek are the remains of ceremonial staircases within the monumental altar in front of the Temple of Jupiter. These are in straight flights and again have several treads cut from single large blocks ([Figure 1.16](#)).

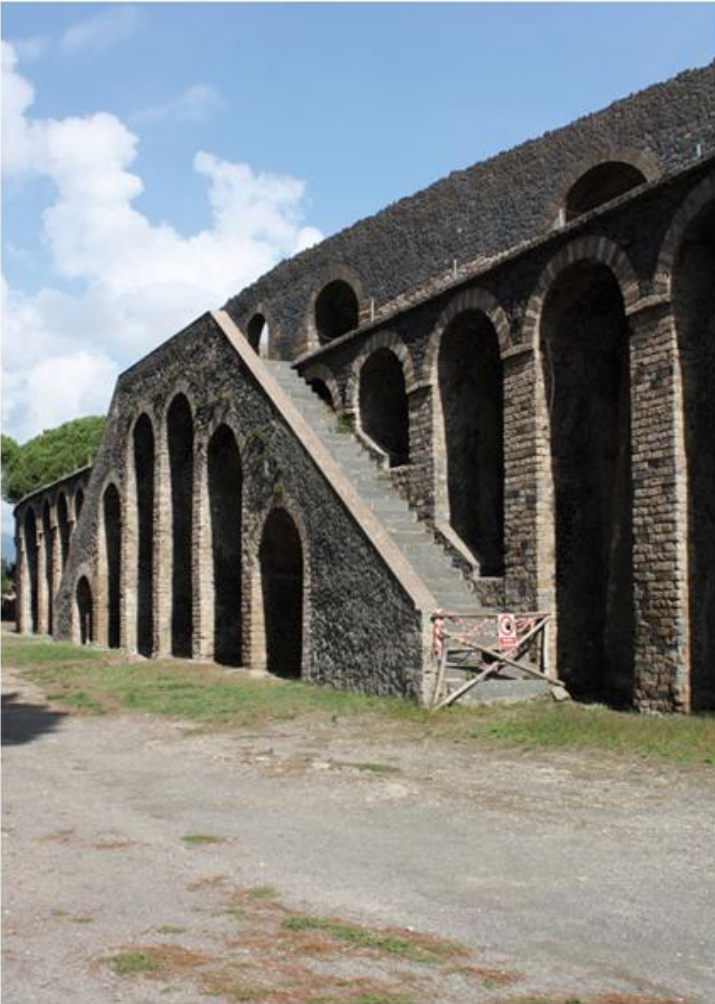
1.18 Pompeii, Italy, the amphitheatre. Double-flight staircases carried on mirrored diminishing arches. There are two such pairs of flights and this is the northern one. At the extreme north and south ends are single flight

stair which climb up the bank where the building abuts higher ground. (Michael Tutton)

The sheer scale of Roman buildings meant they needed complex systems of stairs. For example, the amphitheatre at Pompeii, *c.*70 BC, has external double-flight staircases carried on an arched structure which transported spectators to the upper levels (Figure 1.18). There are two such double flights at the northwest and southwest, together with single flights at the north and south where the building abuts higher ground. Similar but smaller staircases exist at the theatre at Paestum, *c.*100 BC–AD 100, built in brick and supported on brick arches (Figure 1.19).

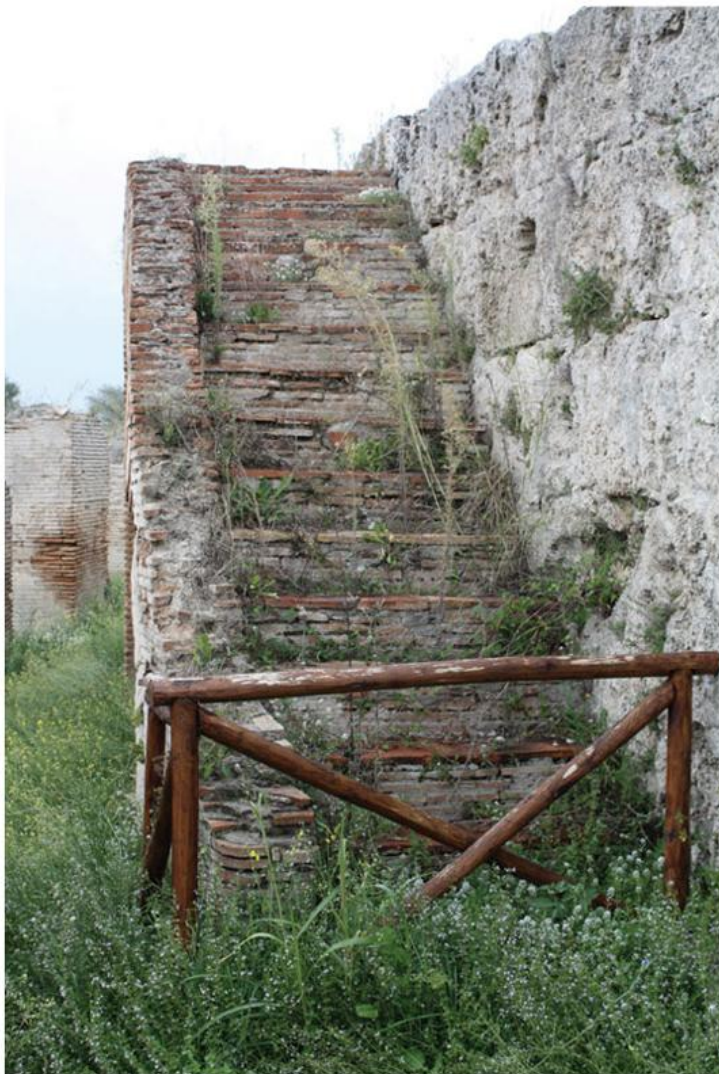
1.19 Paestum, the Roman theatre, started in the first century BC. The entire staircase structure is of brick. These stairs may have originally been external as at the Pompeii Amphitheatre. The theatre was altered and added to in the first century AD, with the outer colonnade adding both height and width. The stairs may date from this time as the brick exterior contrasts with the stone interior. (Michael Tutton)

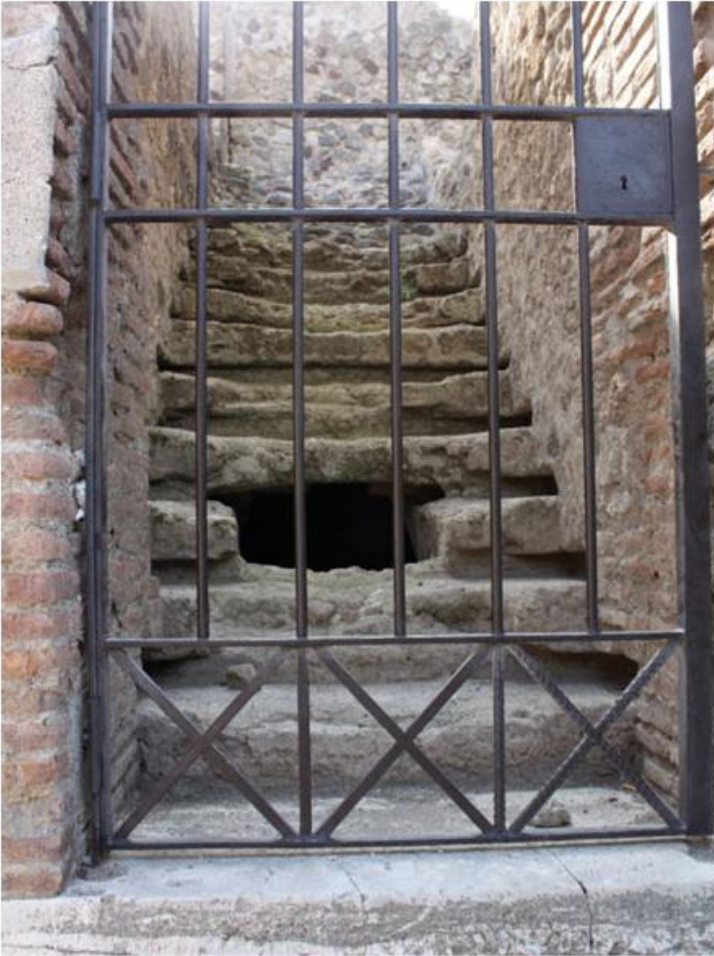
1.21 Staircase in the Vicolo della Terme, Pompeii. There is a chute into, or ventilation for, the cellar below and a staircase down to that cellar immediately to the right. The treads were originally overlaid with a different material, the insets for which can be clearly seen. This has either perished or has been removed or stolen. It may

have been a thick tile or brick, timber or marble. The staircase leads directly off of the street. (Michael Tutton)

There is much evidence for domestic stairs in residential and commercial properties, examples of which have survived at Ostia Antica, Pompeii, Herculaneum and Paestum. Straight flights of brick stairs to upper storeys can be seen at Ostia Antica. Very few timber examples survive intact. Those that do consist of simple straight flights of stairs of solid treads supported on strings or carriage pieces, such as those at Herculaneum. Most such stairs would have started with a small section of masonry steps to be continued in timber. The base of such a staircase can be seen within the remains of Roman housing at Paestum (Figure 1.20). Pompeii and Herculaneum abound in masonry staircases leading direct from the street to upper apartments over shops and other commercial premises. Most are straight flights carried on solid masonry or arches (Figures 1.21–1.22).

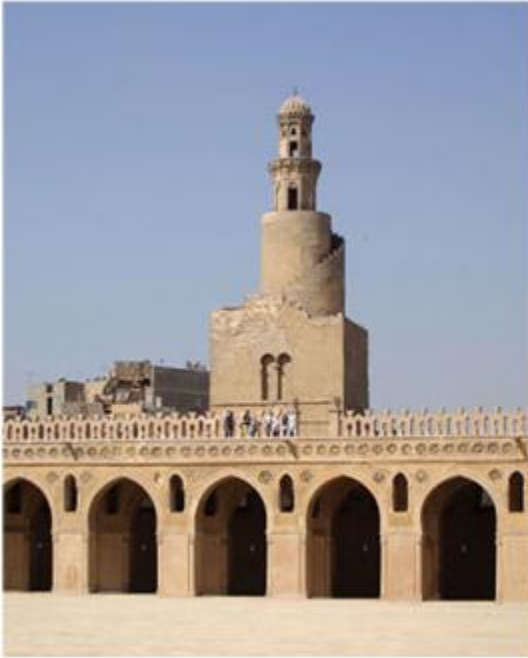
1.23 Minaret, Ahmad Ibn Tulun Mosque, Cairo. The circular drum with external spiral stairs is coeval with the mosque built between CE 876 and 879. The square base and lantern are later additions. (Berthold Werner, http://commons.wikimedia.org/wiki/File:Kairo_Ibn_Tulun_Moschee_BW_11.jpg)

55 m high. The spiral ramp-like steps wind anticlockwise around the minaret five times and end in a circular chamber. The Mosque of Abu Dulaf, built CE 859–861, has a similar but smaller minaret with stairs that revolve four times. Both minarets are built of brick and clay and have been restored in recent times.²⁴ Another minaret of this type with an external spiral stair is in Cairo at the Ibn Tulun Mosque, completed CE 879 (Figure 1.23).

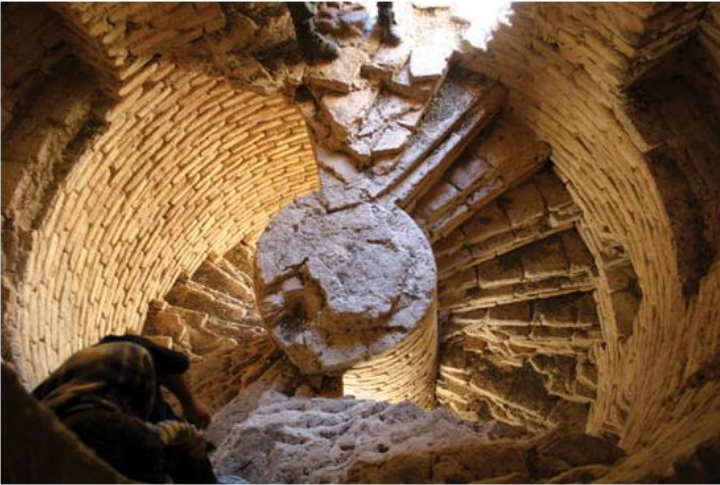
1.24 Jam minaret, western Afghanistan, the two spiral flights clearly visible with a figure (the boots only visible) standing atop one flight while another in the left foreground nears the top of the other flight. Each tread has a rebate at the leading edge where there was once a timber element or nosing. (David Thomas, MJAP 2005)

three circular sections are divided by the remains of two balconies and the minaret is topped by a six-sided lantern composed of open arches. Inside the lower sections up to a height of 38 m to the level of the second balcony is a double spiral staircase (Figure 1.24) The steps are keyed into the minaret's central pillar and its exterior wall and are composed of, as is the whole structure, large flat bricks, almost very large tiles similar to Roman bricks. These bricks forming the treads are laid flat, without any attempt at vaulting, which is normal and almost universal in later brick staircases, and act as flat brick arches (Figure 1.25). Further up in the narrower upper shaft is a series of six vaulted brick platforms which complete the rest of the minaret's internal structure. There is much evidence of timber elements in this upper section, possibly structural reinforcement, much of which has rotted away. The vaults are accessed by a series of six steep, staggered steps, five or six courses high, whose rough construction and narrowness are in marked contrast to the staircase below.²⁶

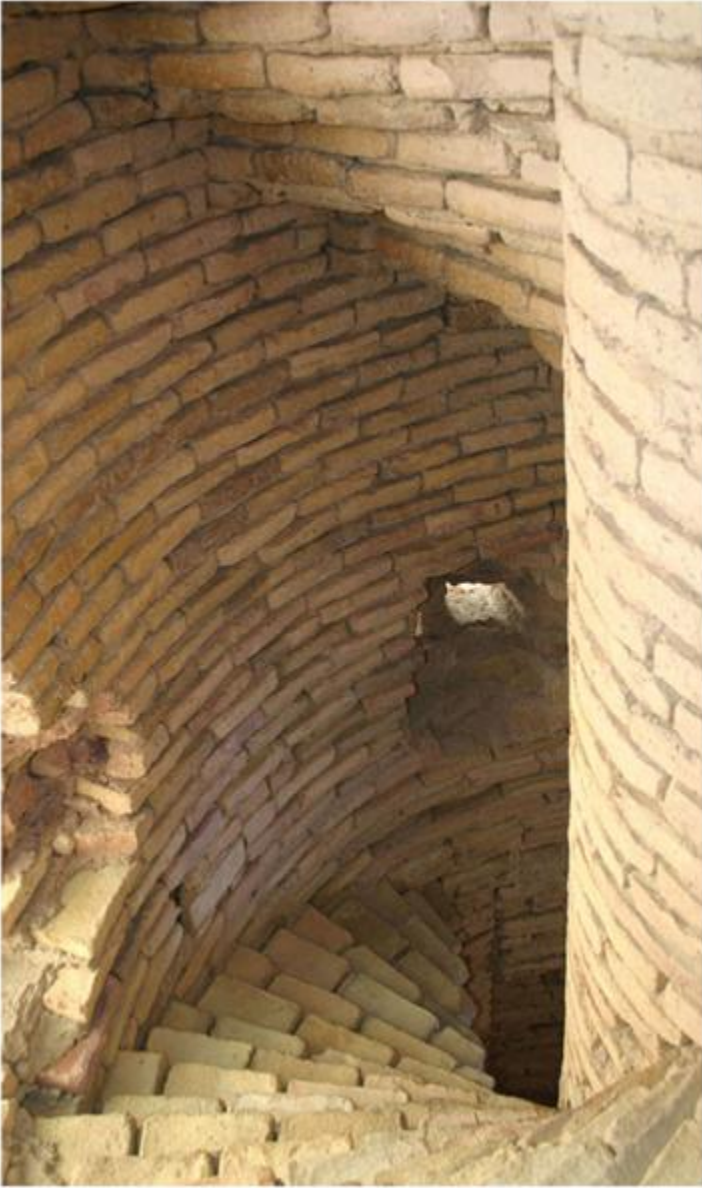
1.25 Jam minaret, western Afghanistan. The flat brick soffit is shown at the top of the photograph. The staircase is 1.4 m wide near its base and tapers gradually to 1.0 m wide at its summit. Each step is *c.*0.4 m deep at the exterior wall and consists of four courses of four or five baked bricks, laid horizontally. The steps range in height from 0.21 m to 0.33 m. (David Thomas MJAP 2005)

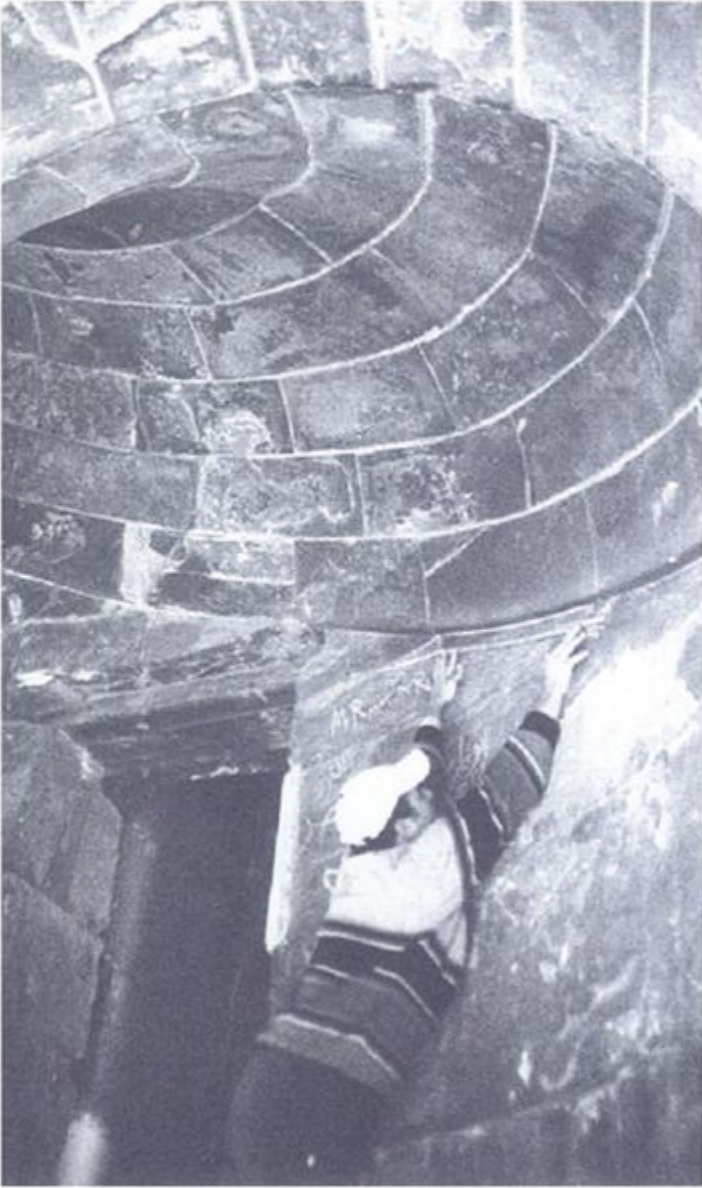
1.26 Vault of the staircase in the Bab el Nasr, Cairo, Egypt. (L. Tamborero, 2002, see note 30).

Medieval period had its antecedents in the first century AD Romano-Egyptian staircase at Kom-el-shoqafa, Alexandria. One of its direct descendants, although at some distance in time but not geographically, is the staircase within the wall of the Bab el Nasr gate in Cairo, which was built between 1087 and 1092 by Armenian masons from Urfa (Edesse in modern southeastern Turkey), who brought with them their particular skills possibly derived from Mesopotamian or Hellenistic origins, as well as those from Alexandria.³⁰ The staircase is constructed as a vault using large stones of 60–80 cm in length and employing complex geometry and stone-cutting skills (Figure 1.26).

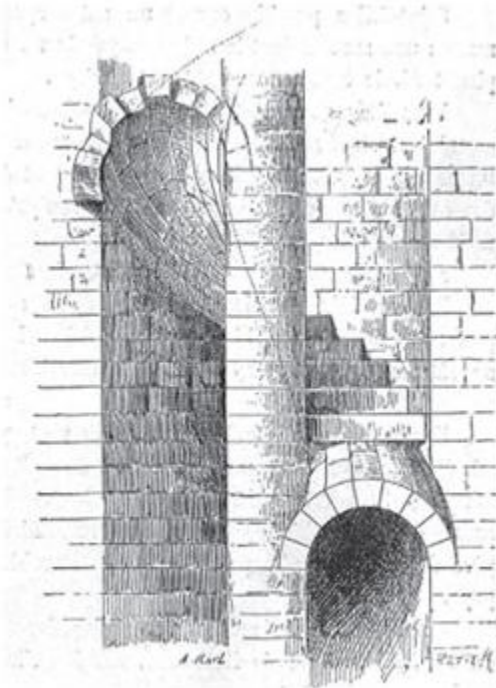
1.27 Sectional drawing by Viollet-le-Duc of Vis de Saint-Gilles, illustrating the principle of cut stone vault construction for spiral staircases.

The Bab el Nasr staircase is the precursor of the famous Vis de Saint Gilles at St Gilles du Guard in southern France (Figures 1.27 and 1.28). Built c.1150,³¹ it became a site of pilgrimage, not for religious purposes, but for stone masons and apprentices to study its exacting stereometry. Thus the seeds were sown for the spiral vaulted staircase throughout France and further afield.³²

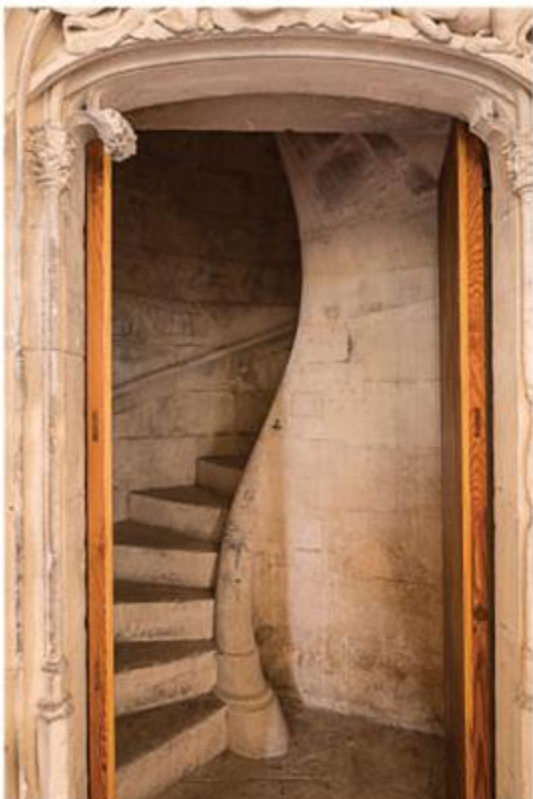
1.30 Palma de Mallorca, Llotja, spiral vault staircase designed by Guillem Sagrera, built 1426–1446. (Jose Calvo-Lopez and Alberto Sanjurjo-Alvarez)

One of the first developments was to bend or coil the newel itself into a spiral; the Spanish architect and sculptor Guillem Sagrera³⁴ designed and built such a staircase into one of the interior corner turrets of the Llotja (commodities exchange) in Palma de Mallorca,

built 1426–1446 (Figure 1.30), the model of which came to be known as ‘Caracol de Mallorca’.³⁵ This type of staircase became popular throughout Spain, with examples in the Valencia Llotja (Figure 1.31), commenced 1483, Salamanca and Murcia. Valencia is particularly rich in these staircases, with further examples at the Torres de Quart (Figure 1.32) and in the Royal Chapel of the convent of Santo Domingo. Much later Gaudi would use a similar design for the tower stairs of the Sagrada Familia in Barcelona, commenced 1882. Some of these staircases where the central aperture is small are essentially newel staircases, and we can assume that the newel acts in a similar way to a vertical one. The departure from this comes with Segrera’s next commission in Naples³⁶ Here he produced a truly remarkable staircase in the Castel Nuovo. In a much larger shaft he opened out the aperture to produce an open well, the structurally enigmatic spiral vault, also known as a *caragol ull ubert* or ‘open-eyed’ staircase³⁷ (Figure 1.33).

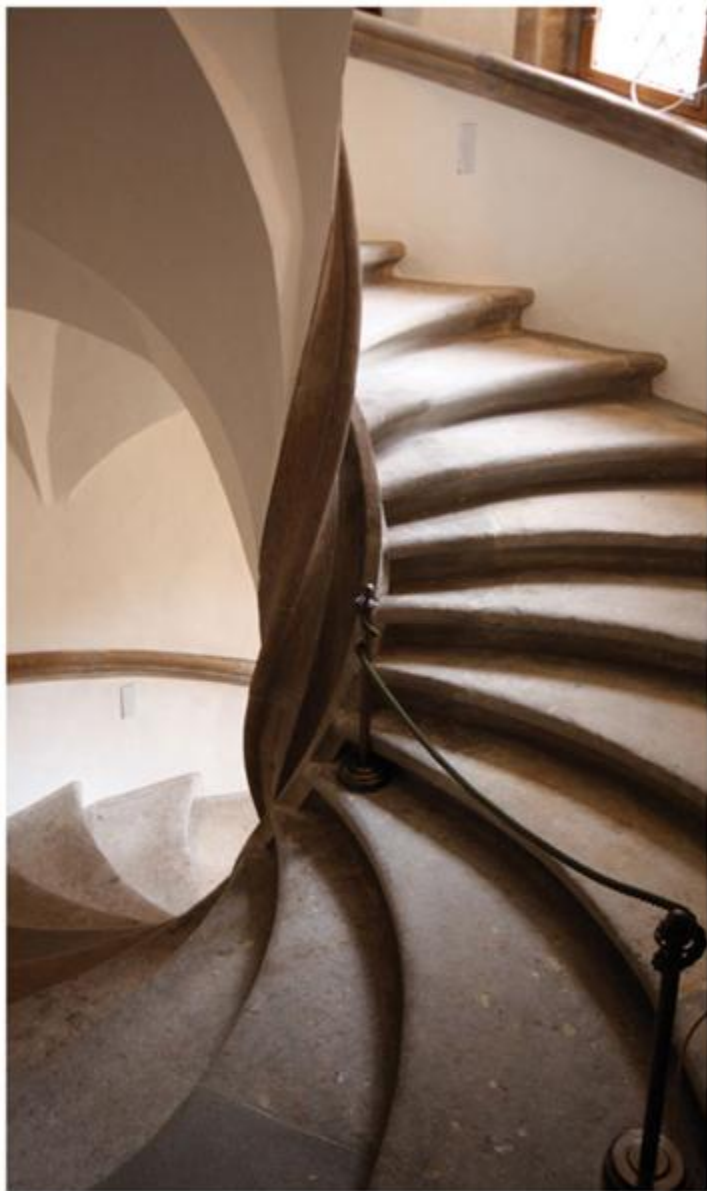
1.34 Meissen, Germany, Aubrechtsburg, by Arnold of Westphalia. (Michael Tutton)

The brothers Ernst and Albrecht von Wettin in 1470 commissioned the architect Arnold of Westphalia to design a palace in Meissen adjoining the cathedral. The palace contains two spiral staircases. The lesser of the two is a derivation of the 'Caracol de Mallorca', without the open aperture, with a twisting ribbed newel. From this springs an intricate crystalline vaulted soffit without ribs, just curving arrises.³⁸ The stone treads with bold nosing are concave (Figure 1.34).

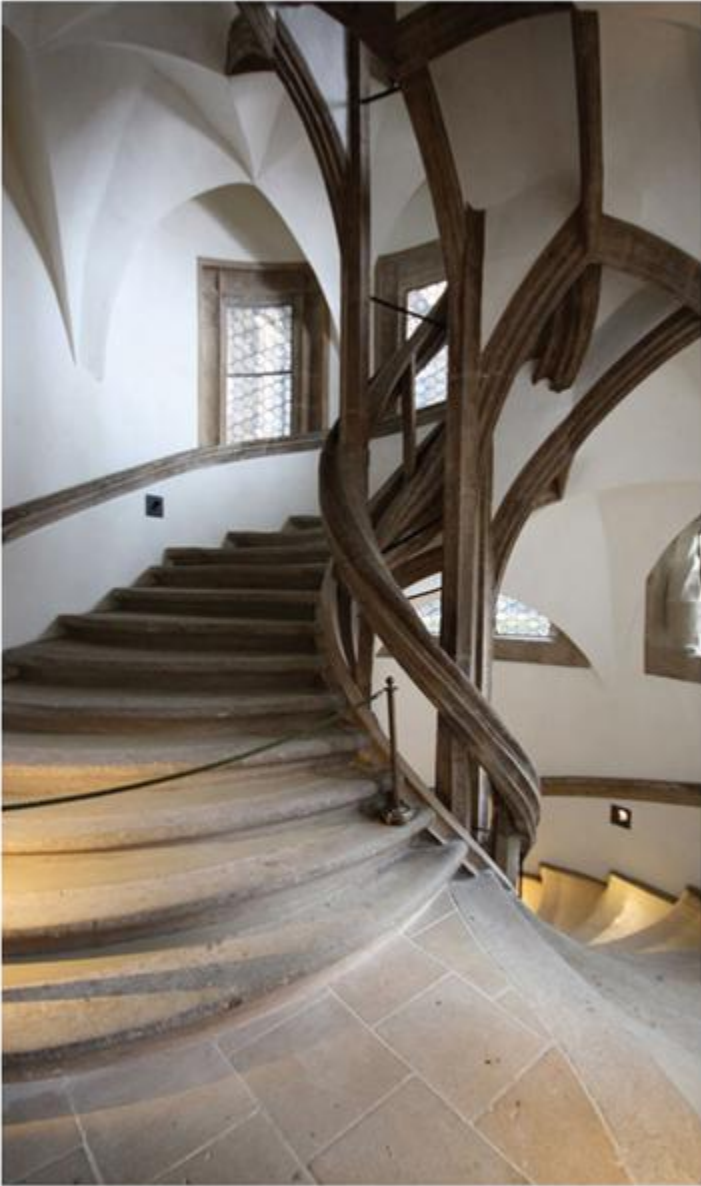
1.35 Meissen, Germany, Aubrechtsburg, by Arnold of Westphalia. The main staircase ‘has a dynamism all its own, one that elicits the torsion of its architectural components’.³⁹ (Michael Tutton)

The principal staircase ([Figure 1.35](#)) is unusual in having alternating convex and concave treads between landings. It has an open well with three slim vertical supporting columns ([Figure 1.36](#)). Through these run a ribbed and moulded string and handrail. Springing from the columns is a complex vaulted soffit starting with moulded ribs which meld into simple curved arrises. The columns, string, banister and ribs are all of one rust-red stone and the soffit plaster. The whole composition is one of exquisite complexity.

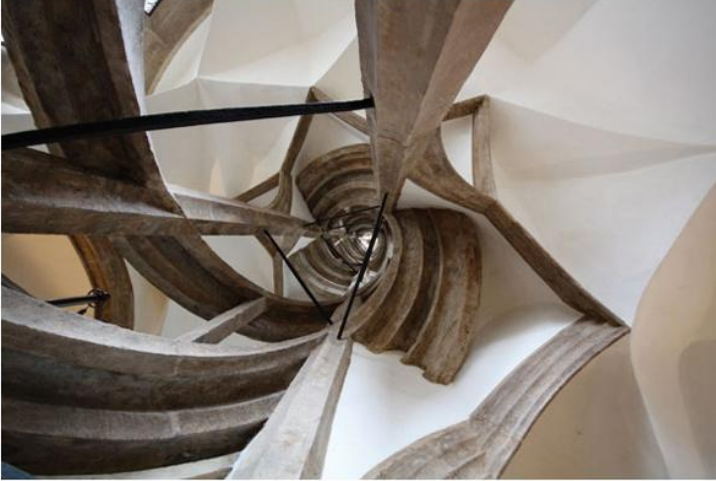
1.36 Meissen, Germany, Aubrechtsburg, by Arnold of Westphalia. The main staircase looking up through the centre. (Michael Tutton)

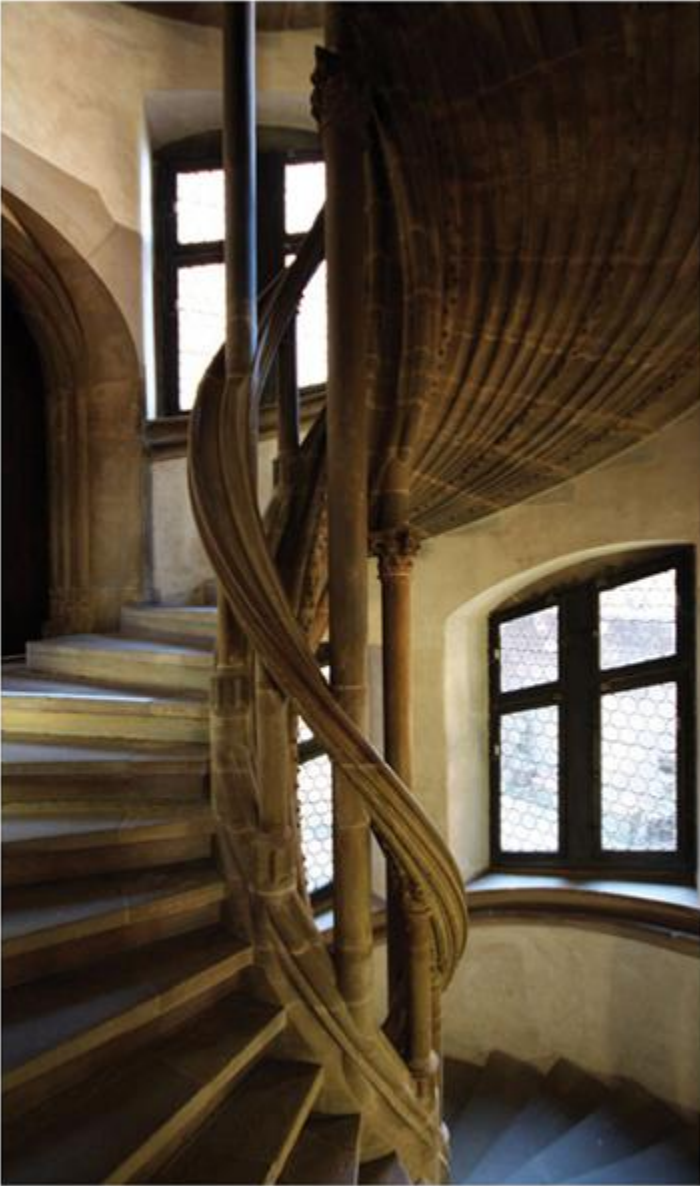
1.37 Strasbourg, France, staircase, built 1570–1574 in the Œuvre Notre-Dame building by Hans Thoman Uhlberger. The soffit, composed of parallel spiralling ribs in continuous lines, runs from the base to just above the first floor, where it ends abruptly and continues unadorned. The ribs are plain except for two outer and one central in the form of a tree or vine trunk. The supporting columns rise through the handrail and newel, just below the intersection with the newel are classical composite capitals. (Michael Tutton)

A similar staircase by the architect Hans Thoman Uhlberger is in the Œuvre Notre-Dame building in Strasbourg. An adjoining linked building known as the Frauenhaus served as the lodging for masons working on the cathedral,⁴⁰ which may explain the intricate design of the staircase which serves both buildings, built 1570–1574. This is a stair with a spiralling newel with the added support of three circular columns. The treads are straight, with bold squared nosings and a deep overhang. The staircase ends at the top in a riotous

assembly of tightening spirals and columns which rise to the vaulted ceiling (Figures 1.37 and 1.38).

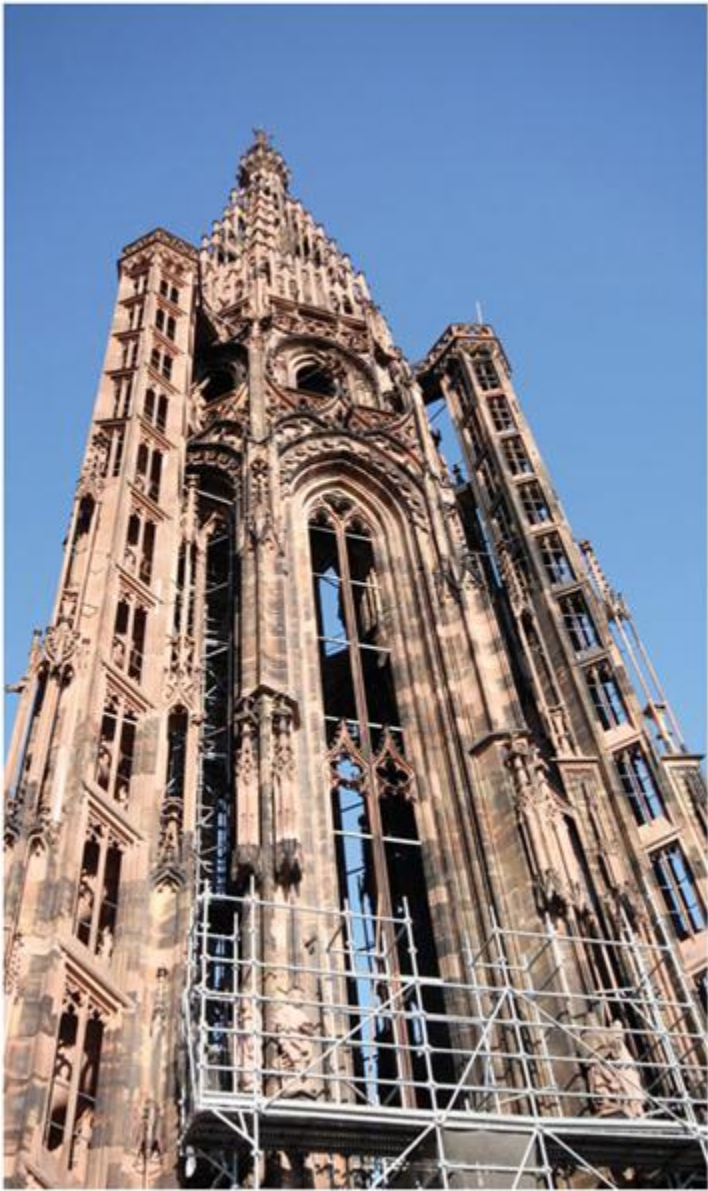
1.39 Strasbourg, France, north tower of the cathedral with detached staircases at each corner. (Michael Tutton)

Some of the most dramatic skeletal or lattice spiral stairs were designed by Ulrich von Ensingen (d. 1419), such as at Ulm Cathedral where, as well as corner stairs, a central dazzling open staircase rises through the centre of the spire, taller than Strasbourg but only completed in the nineteenth century. He also designed the octagonal open-work north tower of Strasbourg cathedral⁴¹ which has at its four corners quite audacious detached open lattice-work spiral staircases, built 1402–1419 by those same masons who lodged at the Frauenhaus. As the octagon rises and steps in, the vertical polygonal ‘tubes’ become more detached; apart from metal strengthening bars they are attached only by short bridges at the top, to the base of the spire (Figure 1.39).⁴² Within the open lattice-work spire a whole series of staircases from each corner step inwards as they rise and the spire diminishes in girth.

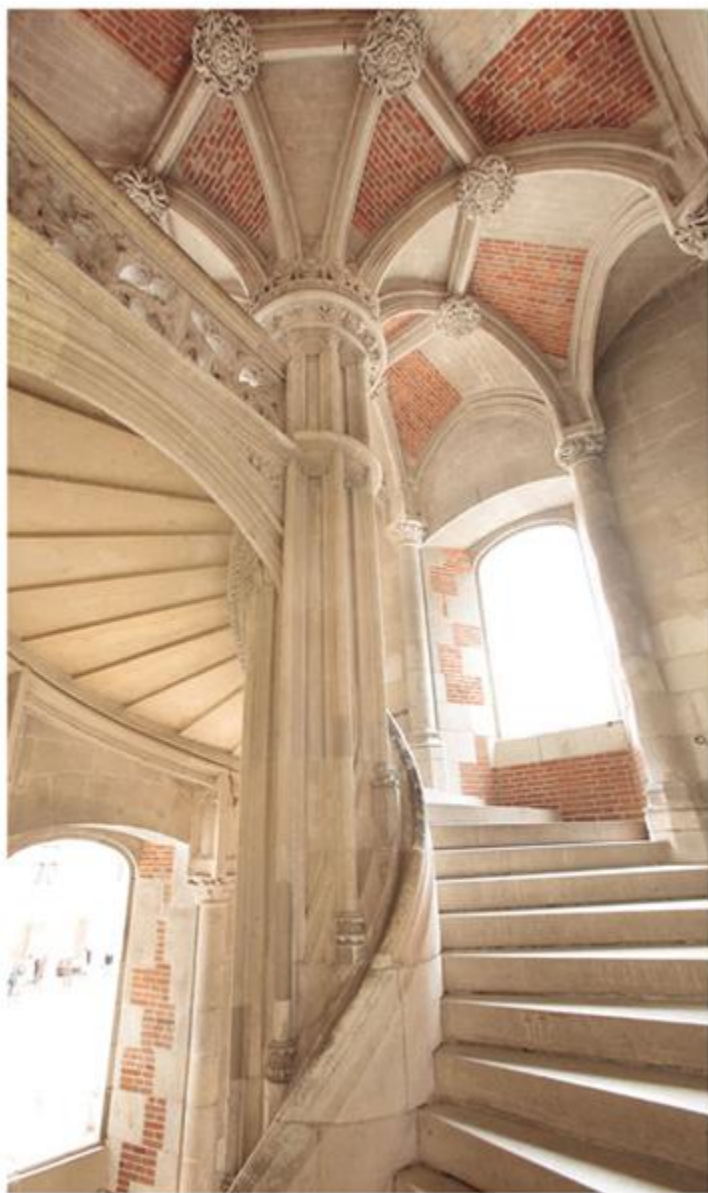
1.40 Blois, France, northern staircase of the Louis XII wing. The staircase turns around a central columned newel with wide treads consisting of single blocks of stone, the soffit is simply the underside of the treads without any decoration except for inner and outer mouldings. (Peter Stone)

Some 50 km further south, at Blois, both Louis XII and Francis I commissioned two magnificent staircases. The first, finished *c.*1501, is markedly Gothic in the vaulting at the head of the staircase ([Figure 1.40](#)).

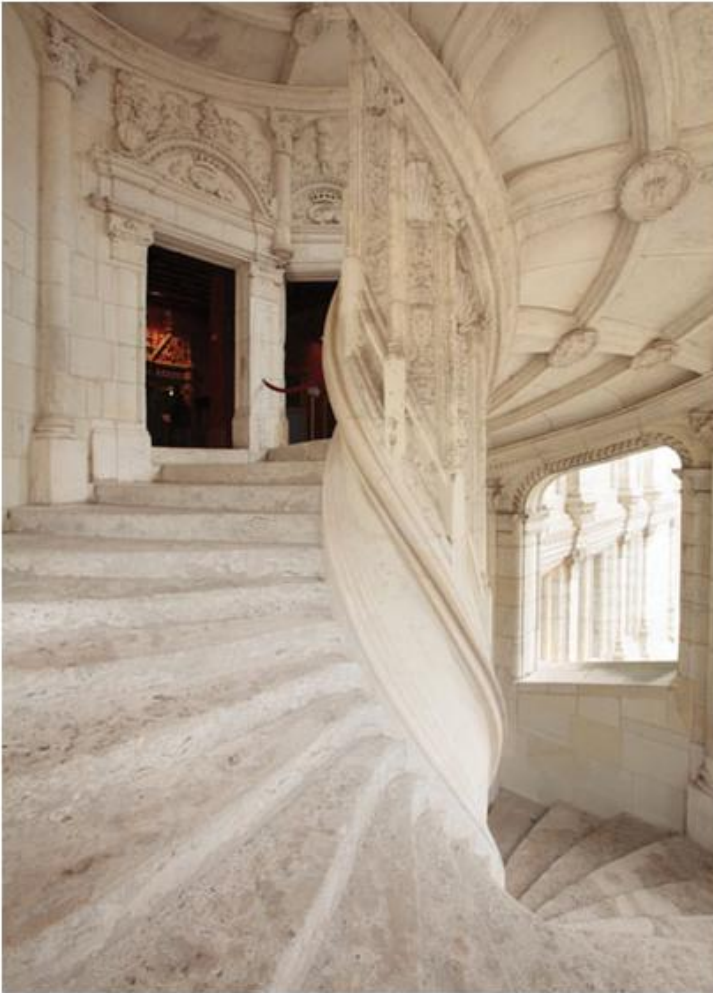
1.41 Blois, France, the main staircase of the Francois I wing. (Peter Stone)

The great central staircase at Blois, on the other hand, is pure Renaissance. Built *c.*1515–1520, the external elevation is a polygonal turret with open ramped balconies. The treads of the staircase within are subtly convexly curved with a sudden turn outwards at the newel so that the whole on plan has a double curve or cyma. The soffit is slightly curved with a rectilinear lattice pattern of ribs with medallions at the intersections. The bays of the outer curved wall are divided by responds in the composite order with pedestal bases. On the courtyard face these frame open arches onto the balconies with open, unglazed windows. On the inner face they are blind arches or frame the richly carved doorcases into the principle rooms and apartments. The newel column is carved with Italianate detail (Figures 1.41–1.42).

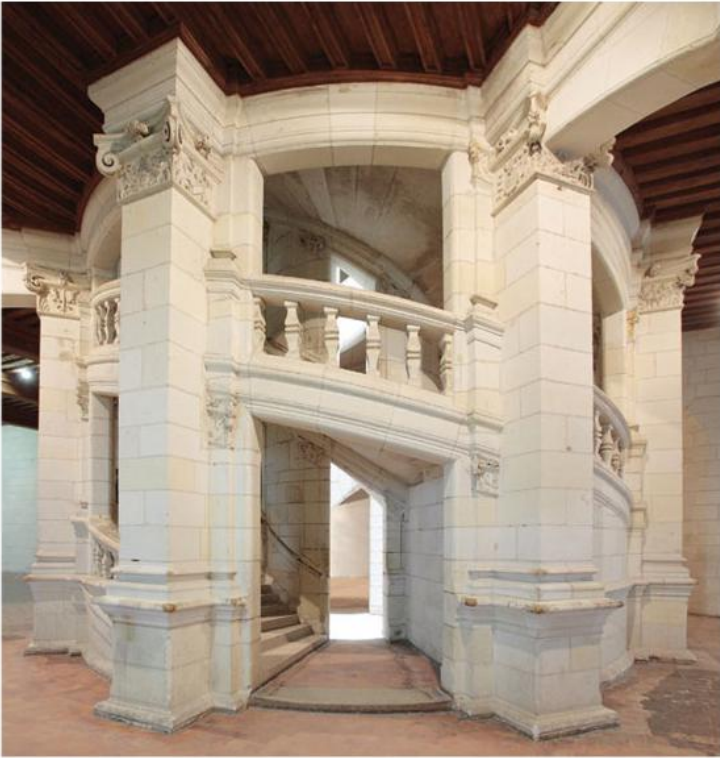
1.43 Chambord, France, the majestic central staircase, here rising from the ground to the first floor. Access to the opposite spiral can be gained by passing through the central shaft rather than walking around the staircase, a necessity on the upper floors. (Peter Stone)

Soon after Francis I had remodelled Blois,⁴³ he turned his attention to Chambord, begun 1519, some 12 km or so to the west, where he built a vast chateau which boasts some 77 staircases. Within the central cruciform keep is one of the grandest spiral staircases ever built (Figure 1.43). The central staircase at Chambord is a double helix which gently rises to each of the three principle floors of the keep. At the centre is an open well with windows looking into the central shaft (Figure 1.44). Reginald Blomfield described this staircase, along with those at Blois and the northeast one at Chateaudun, as the apotheosis of the newel staircase of the Middle Ages.⁴⁴

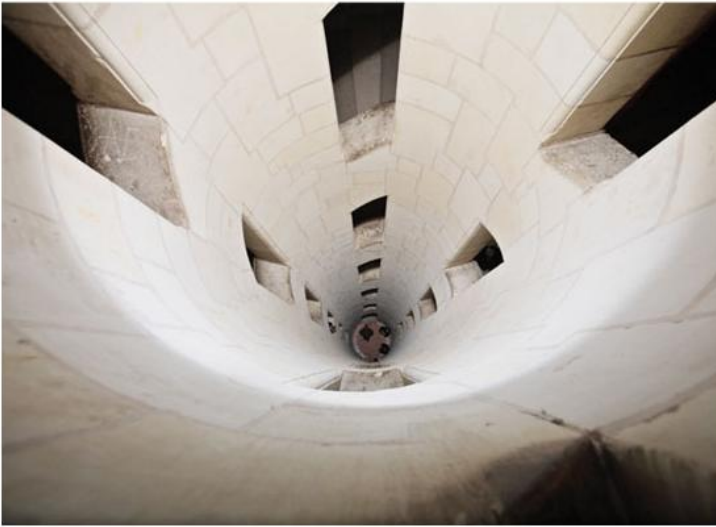
1.44 Chambord, France, the central shaft and internal windows. The shaft is reminiscent of the well of San Patrizio at Orvieto, built by Antonio da Sangallo in 1532, around which a ramp runs and the much earlier shaft at Kom el-Shuqafa in Alexandria, Egypt which forms the core of a spiral staircase down to the catacombs and dating to the first century ad. (Peter Stone)
