Staircases

HISTORY, REPAIR AND CONSERVATION

Editors: James W. P. Campbell and Michael Tutton
Managing Editor: Jill Pearce

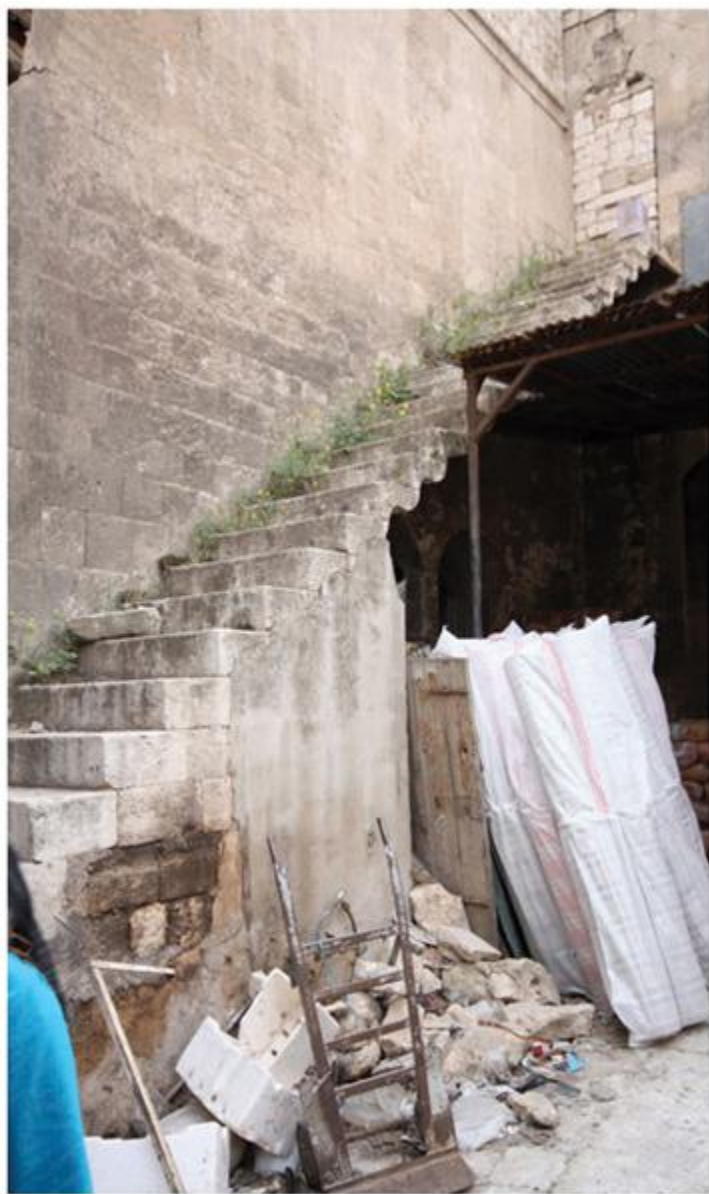
1.47 Aleppo, Syria, cantilevered staircase in a khan in the suq adjacent to the Great Umayyad Mosque. (Michael Tutton)

of the gateway a beautifully detailed straight flight cantilevered stair of possibly late fifteenth-century date. It survives virtually untouched without any handrail (nor was any ever intended). The cantilevered treads are composed of cyma-reversa sectioned blocks thus forming a continuous repeat moulding to the outer face of the stairs ([Figure 1.47](#)).

The stairs rise to a now blocked doorway. The lower four cantilevered treads have been underbuilt, possibly to form some sort of enclosed storage space rather than for structural reasons. The lowermost eight or so treads are composed of solid masonry and the first four or five are missing.⁴⁹ A few metres from this first staircase within the same suq is another equally refined staircase, late fifteenth to late sixteenth century. This starts within a vault between a pillar and the corner of a building, but continues as a cantilever in its upper part around a slightly curved wall to the floor above (Figure 1.48). Here, a decorative, if crudely fixed, balustrade has been inserted as the staircase is still in regular use.

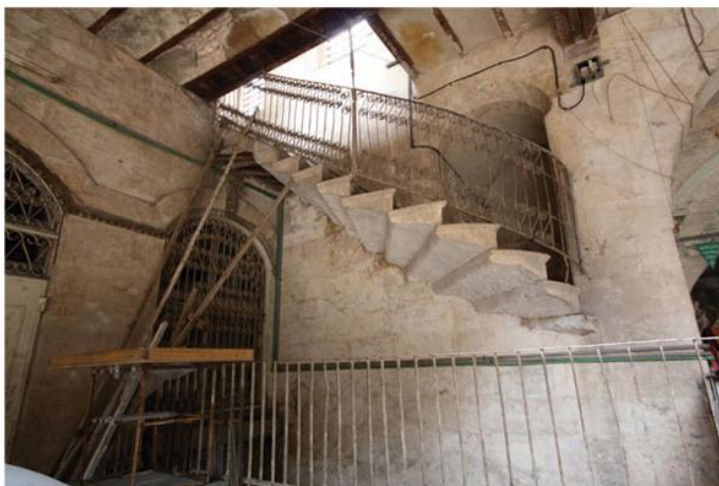
1.48 Aleppo, Syria, cantilevered staircase in the suq adjacent to the Great Umayyad Mosque. (Michael Tutton)

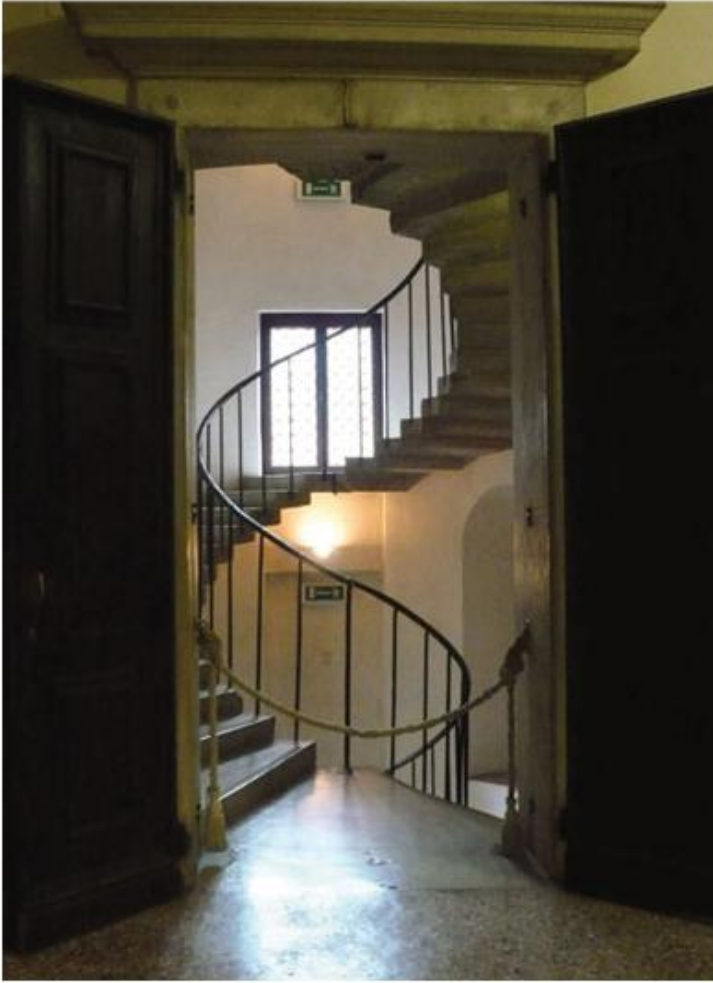
1.49 Cantilevered staircase, *c.*1561, in the Convento della Carita in Venice, by Andrea Palladio. (Helen Rogers, www.stonestairs.net)

Palladio's first use of the cantilevered stair is not until *c.*1561, in the Convento della Carita in Venice ([Figure 1.49](#)): 'I have made a stair-case void in the middle, in the monastery de la Carita in Venice, which succeeds admirably.'⁵⁰ The convent was partially destroyed by a fire in 1630. Fortunately, the staircase survives, incorporated into the present buildings, the Gallerie dell'Accademia. The staircase is oval in plan and conforms to type 'F', the oval staircase without a column shown in Plate 32 of the *Four Books* ([Figure 1.50](#)). Its construction is robust and basic, without the Syrian finesse, being rectangular stone slabs set into the wall with a simple overlap of approximately 50 mm tread to tread, there are no mouldings or rebate. The balustrade is equally simple, each baluster is an oval wrought iron bar beaten flat where it is set into the ends of each tread, probably with a pin. Every fifth or sixth (they vary) baluster is square section and has a larger bracket or leg set into the tread. The handrail is also wrought iron forged to a 'D' shape.

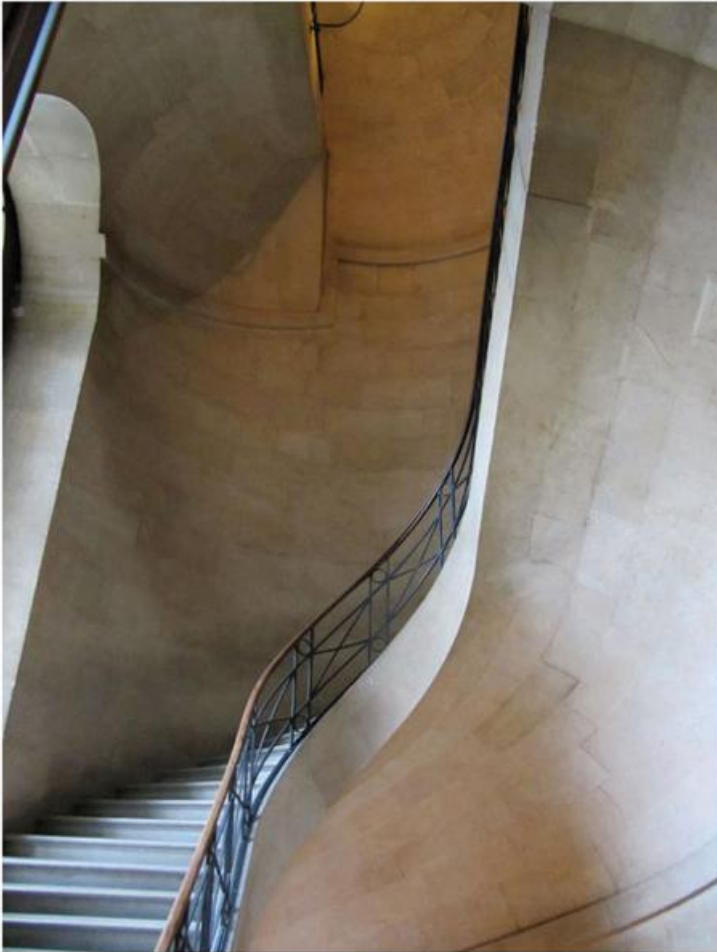
1.53 The suspended staircase in the Paris Observatory, c. 1670, by Claude Perrault. (Michael Tutton)

The culmination of this genre is the astonishing staircase in the Paris Observatory by Claude Perrault. Built in the 1670s, a masterpiece of stereotomy, it is aptly summed up by Perrault's own definition, 'the art of using the weight of stone against itself and supporting it in the air by the same weight that makes it fall' ([Figure 1.53](#)).

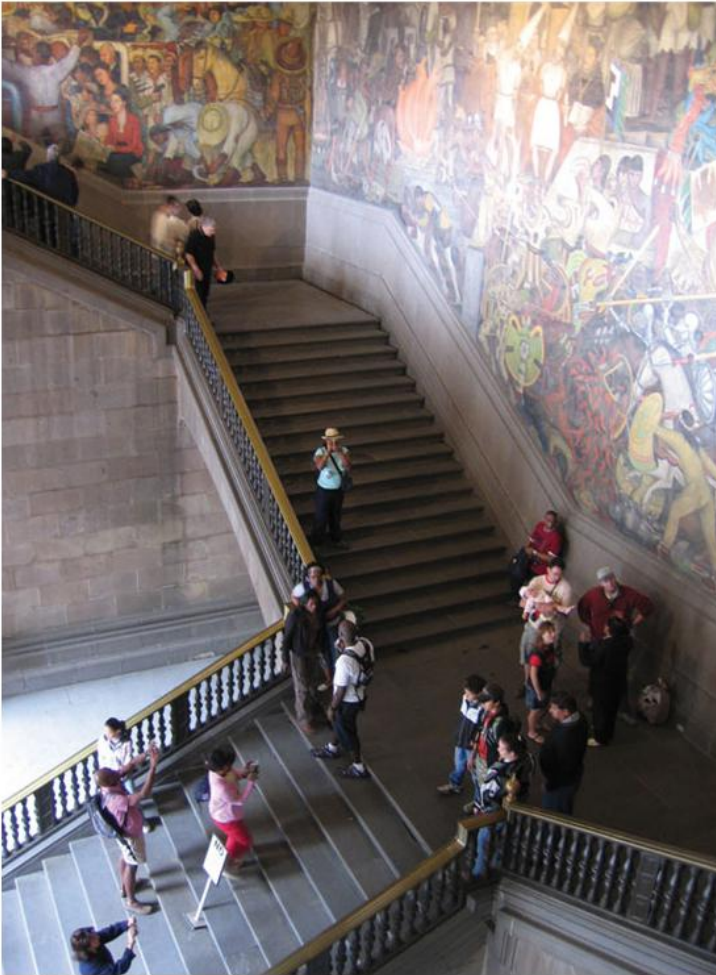
1.57 Palacio Nacional in Mexico City. The palace, built in the late seventeenth century after the former fortress on the site was destroyed during riots in 1692, is in a colonial baroque style. The staircase also contains the famous murals by Diego Rivera, painted between 1929

and 1935, depicting the history of Mexican civilisation. (Michael Tutton)

Spain exported her ideas to the colonies in South America. A particularly fine example of an open-well staircase, of the same type as the Alcazar, is in the Palacio Nacional in Mexico City (Figure 1.57). Another fine staircase is that in the School of Mines built 1797–1813 by Manuel Tolsa (1757–1816), a powerful baroque imperial staircase.

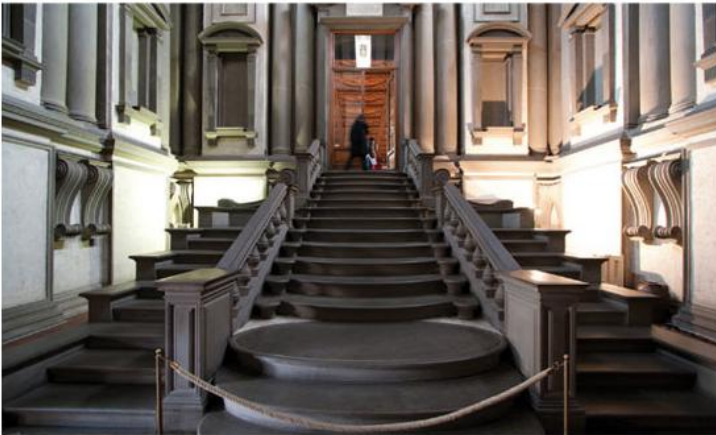
1.58 Staircase in the Biblioteca Laurenziana, Florence, 1524–1559, designed by Michelangelo. Commissioned by Pope Clement VII, it was the Pope who stipulated a

central staircase rather than twin stairs against the walls.
(Timo Orre)

The eminent architectural historian Ruldolf Wittkower suggests that the first completely enclosed staircase hall of Western architecture is the staircase in the Biblioteca Laurenziana in Florence, designed by Michelangelo, started in 1524 and not completed until 1559.⁵⁸ The staircases at the Escorial and the Alcaza are not in completely enclosed halls, they are semi-open on the ground floor, opening onto courtyards or cloisters. The design of the Michelangelo staircase was also groundbreaking in that it was centrally placed before the door into the library, rather than flights around the walls (Figure 1.58).

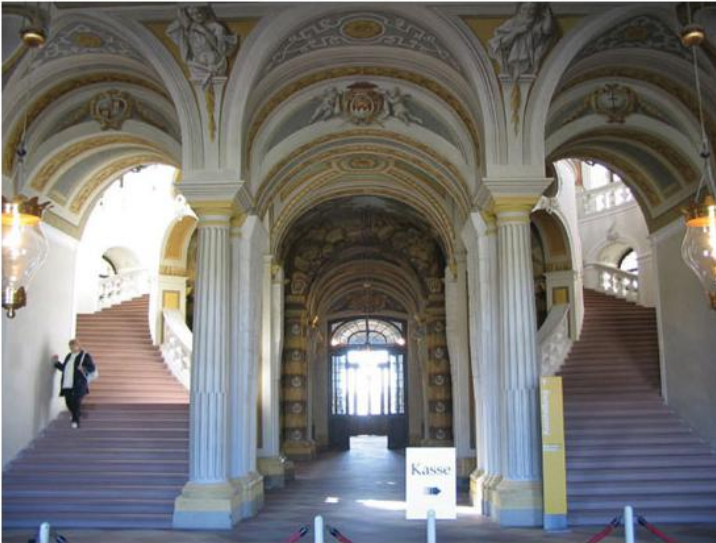
1.59 Schloss Bruchsal, Germany, by Balthasar Neumann. The palace was heavily damaged in the Second World War and the vault and staircase destroyed. It was restored and rebuilt in the 1970s with exacting precision and expert craftsmanship. (Martin8721, http://commons.wikimedia.org/wiki/File:Schloss_Bruchsal_Treppenhaus.JPG)

The Imperial staircases at the Escorial and the Alcazar set the scene for subsequent developments, but they are restrained in their design and decoration and exhibit a somewhat severe and particularly Spanish style: ‘modular uniformity, utilitarian placement and structural simplicity’.⁵⁹ At the opposite end of the scale and the apogee in sumptuous decoration are the Imperial staircases of the high Baroque and Rococo designed by the German architect Balthasar Neumann (1687–1753) for the German prince bishops at Bruschtal, Würzburg and Brühl. At Bruschtal, the residence of the Prince-Bishop of Speyer, Neumann made plans in 1731 for a staircase perhaps more daring than any of his others. Not an Imperial staircase as such, but it certainly evokes Pevsner’s phrase of ‘princely magnificence’.⁶⁰ The staircase within an oval stair hall comprises two opposing curved flights which meet at the landing which extends into an oval platform (Figure 1.59).

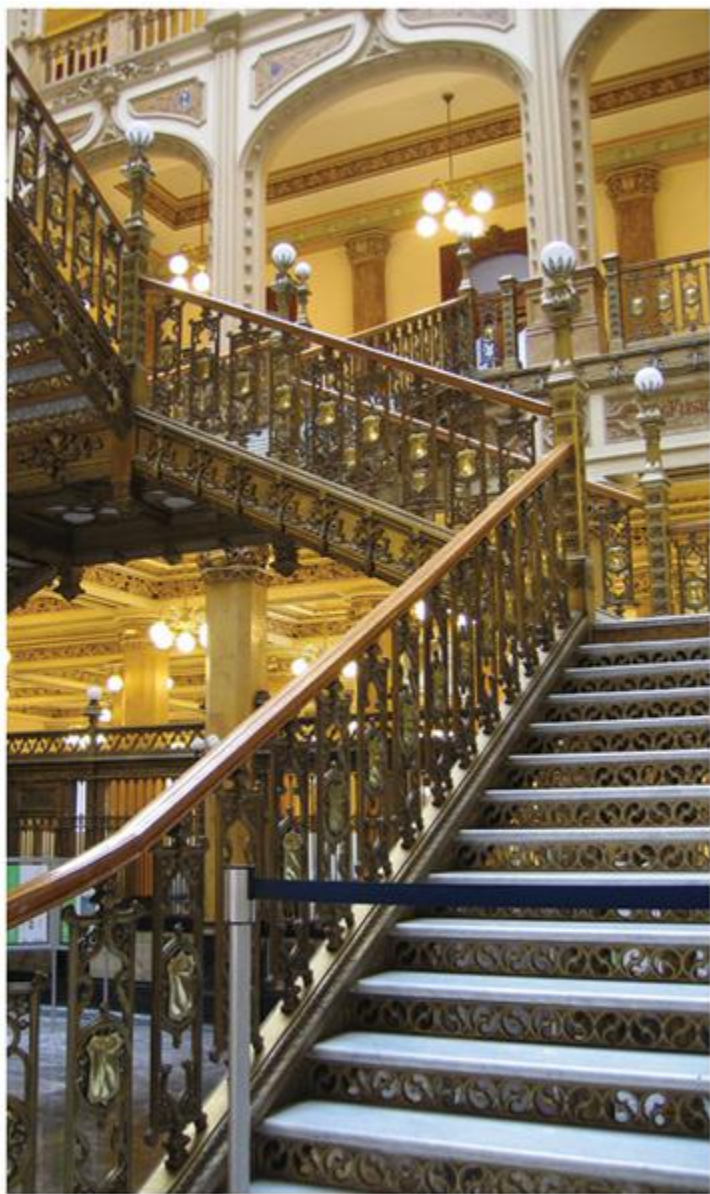
1.62 Palacio de Correos, Mexico City. A magnificent composition in cast iron and bronze of palatial splendour and proportions. (Michael Tutton)

Perhaps the most remarkable staircase in Mexico City is to be found in the main post office, aptly named the Palacio de Correos. Designed by the Italian-born architect and engineer Adamo Boari (1863–1928), its many flights and flying branches are an engineering tour de force in cast iron ([Figure 1.62](#)).

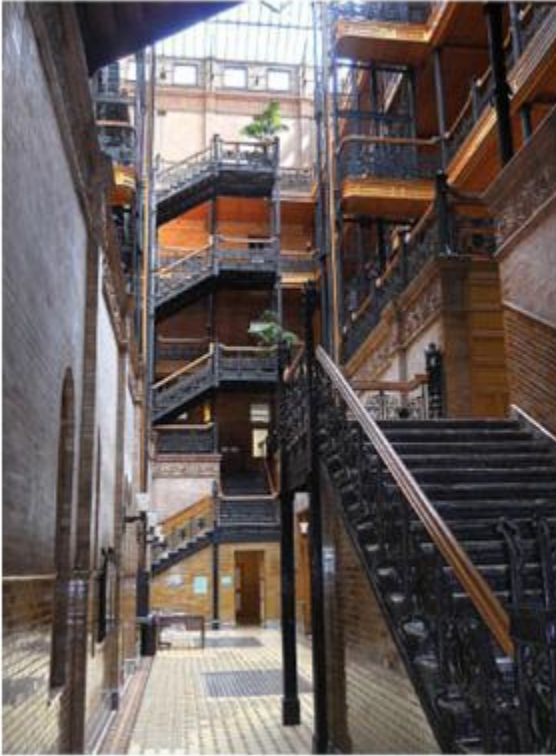
1.63 Los Angeles, USA, the Bradbury Building, ‘one of the most magnificent relics of nineteenth-century commercial architecture anywhere in the world’.⁶² (Gowittylb, [http://commons.wikimedia.org/wiki/File:Bradbury_Building,_Los_Angeles--interior_\(1\).JPG](http://commons.wikimedia.org/wiki/File:Bradbury_Building,_Los_Angeles--interior_(1).JPG))

In downtown Los Angeles the Bradbury Building, built 1889–1893, by George H. Wyman and Sumner Hunt. Behind its modest exterior lies a magnificent full-height, top-lit atrium containing an assembly of cast-iron balconies, stairs with marble treads, and open elevators (Figure 1.63).

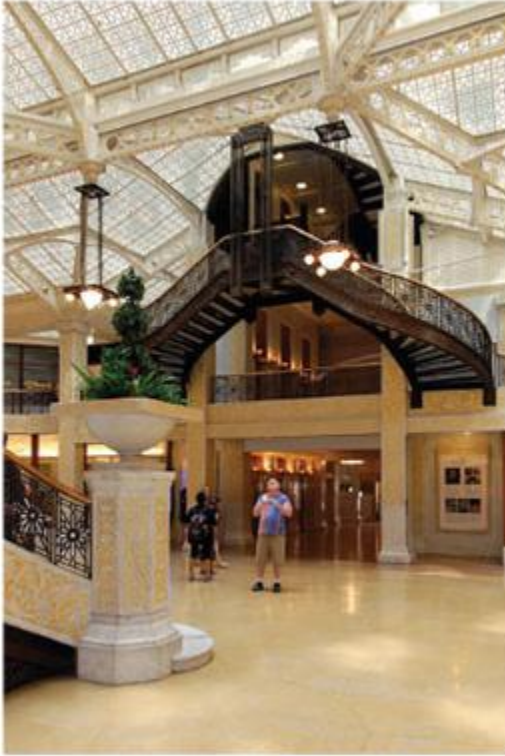
1.64 The Rookery, Chicago, USA. The building has undergone several major interventions, including those by Frank Lloyd Wright and William Drummond. The latter installed an iron suspended staircase with double flights from the first floor connected to a half landing, all protruding into and suspended over the main light court; from the half landing a straight flight connects to the second floor and the base of the oriel staircase. (Flaplane, [http://commons.wikimedia.org/wiki/File:The_Rookery_Building_court_\(Chicago,_IL\).jpg](http://commons.wikimedia.org/wiki/File:The_Rookery_Building_court_(Chicago,_IL).jpg))

A year or so earlier in Chicago, Burnham and Root were building The Rookery and its nine-storey-high oriel staircase, which climbs from the second to the eleventh floor, composed of half spirals connecting each landing. Here, again, cast-iron is used to great effect (Figure 1.64).

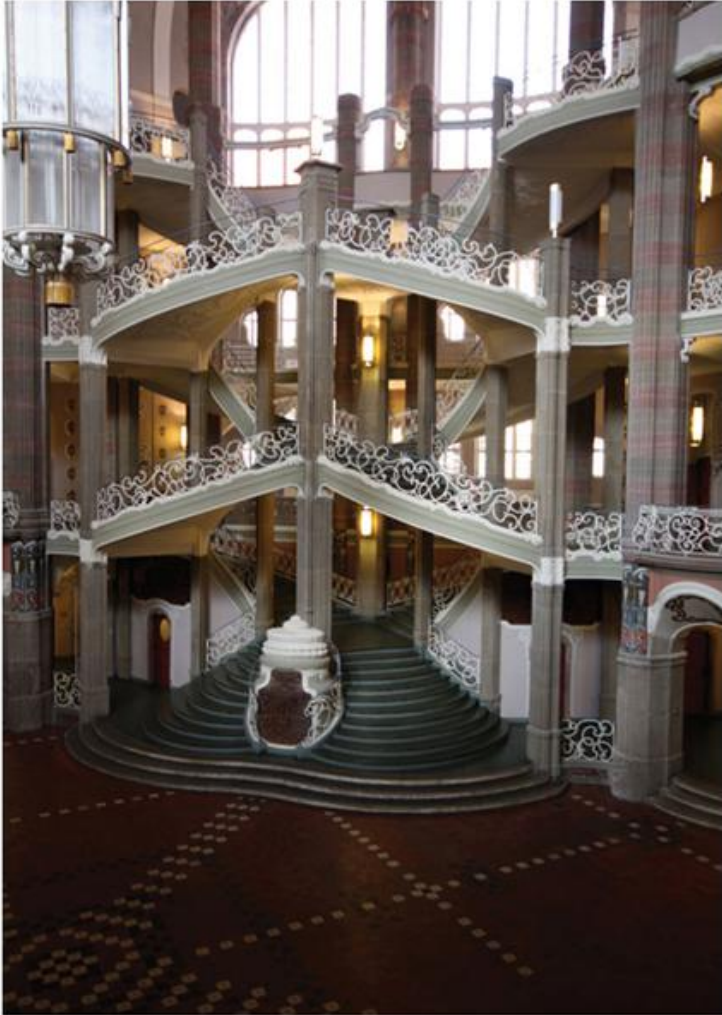
1.67 Berlin, Mitte district courthouse, one of a mirror image pair in the huge central atrium, complete with large stoves at the base. (Michael Tutton)

The vast High Baroque staircase hall or atrium, with some Art Nouveau elements, at the Mitte courthouse contains two opposing staircases of amazing intricacy, linked by a myriad of balconies supported on massive red and brown sandstone pillars (Figure 1.67). The Wedding district courthouse is much more romantically

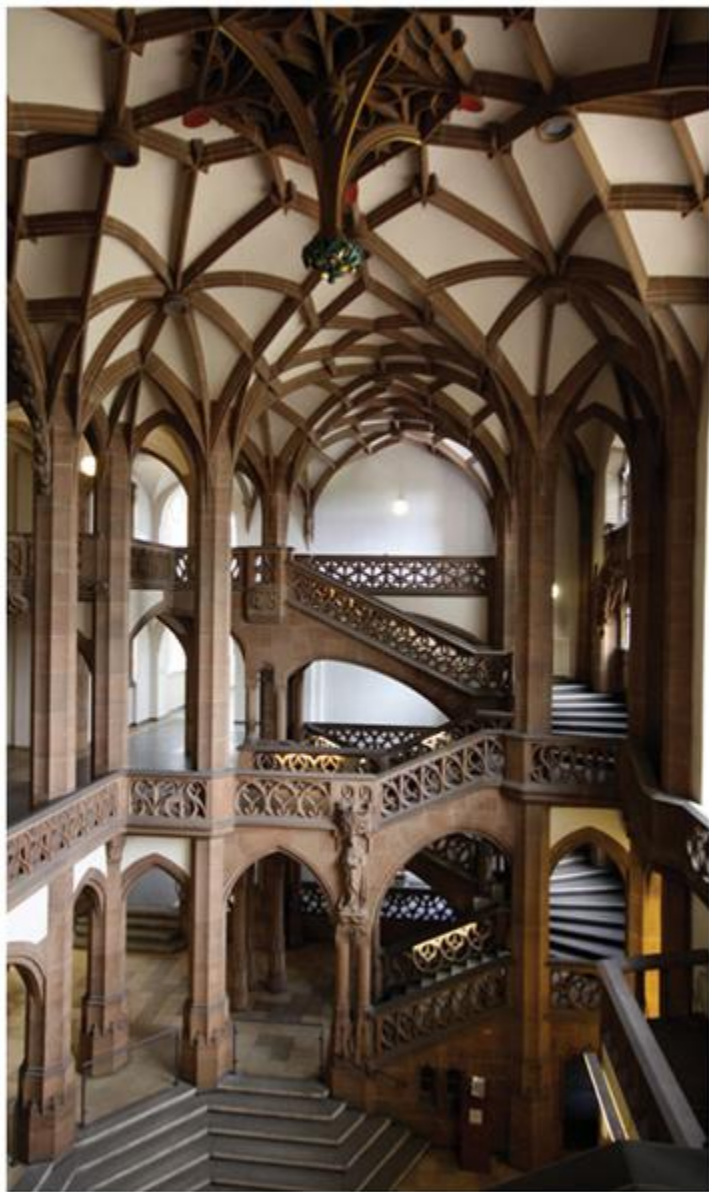
1.68 Berlin, Wedding district courthouse. The photograph is taken from the half-landing of the opposite staircase which mirrors the first. (Michael Tutton)

‘Gothic’. Here, two identical staircases with intricate carved balustrades rise each side of the full-height and vaulted entrance hall, in very German Empire Gothic in brown sandstone (Figure 1.68).

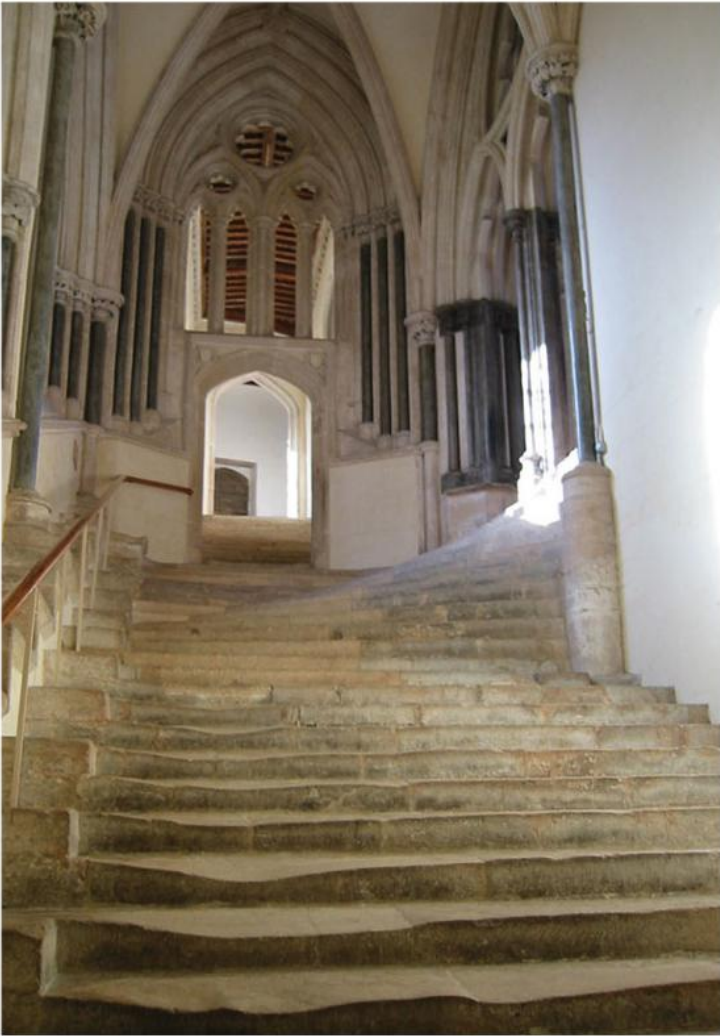
2.7 Cathedral Stair at Wells leading to Chapter House (right). (James Campbell)

In cathedrals the lifting of the east end of the church over a crypt led to dramatic straight flights of stairs up from the nave to the choir and down to the crypt, as at Canterbury or Old St Paul's. In Wells one of the finest Medieval staircases leads to the Chapter House (1264) (Figure 2.7).²⁰

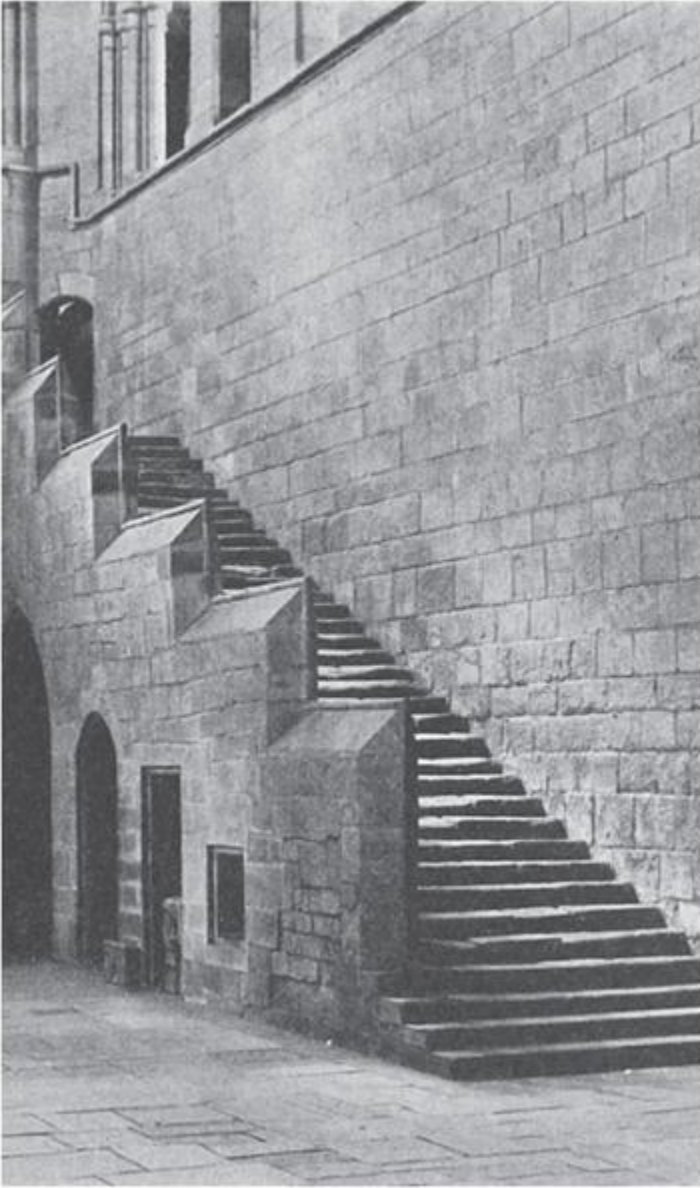
2.8 Hexham Priory staircase to dormitory. (Godfrey)

In monastery buildings, the stairs from the dormitory to the choir – the so-called night stairs – were usually

straight (e.g. Hexham Priory²¹ – [Figure 2.8](#)). This enabled half-asleep monks to make it down into the church safely for services held well before dawn. Many of these stairs survive in reasonable condition, although heavily worn.²²

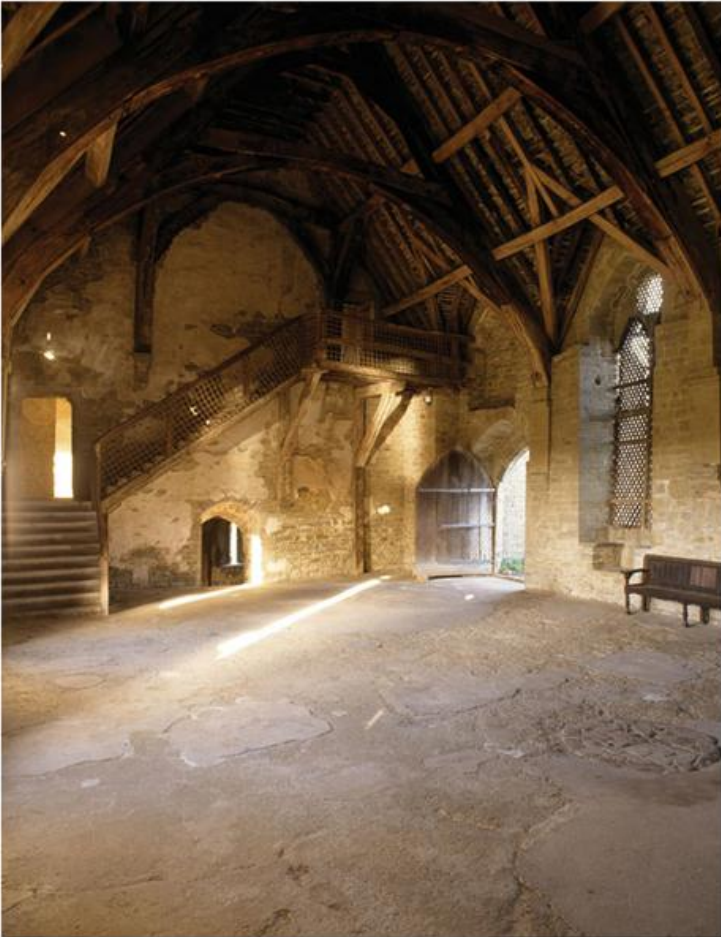
2.9 Stokesay Castle, staircase in hall. (*Country Life*)

Where the great hall was on the ground floor, the staircase to the withdrawing chamber was accessed from the high end of the hall, behind the high table. Often it was placed in a turret called an oriel (not to be confused with the oriel window which was later also a feature of the high ends of great halls). A remarkable survival of an original oak staircase, in this case on the rear wall of the hall, can be found at Stokesay Castle (c.1280) (Figure 2.9). It gives an idea of the likely method of construction of early timber stairs.²³ It consists of solid triangular steps supported on stout carriage pieces. A simple chamfered rectangular balustrade is supported on the minimum number of plain timber posts, one at each corner.²⁴ The stair is positively crude in its construction, without any of the decoration or carving that will characterise later English timber stairs. It may well have been typical.

ends of the treads into ‘strings’ on each side. We take this type of construction for granted, but surviving earlier stairs consisted of solid triangular treads supported from below on carriage pieces, e.g. Stokesay Castle, noted above. Another fine continental example can be seen on display in the Victoria and Albert Museum. It is not clear exactly when the transition from carriage pieces to side strings occurred. It seems likely to have been sometime in the sixteenth century.⁴⁰

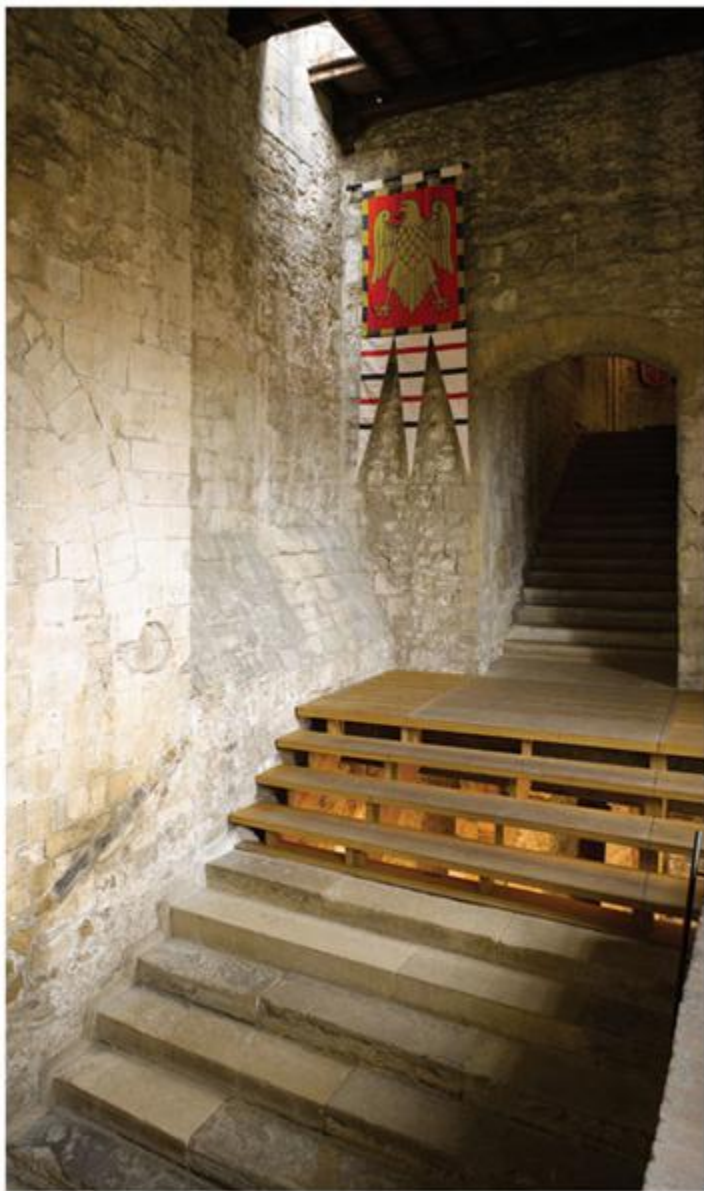
2.10 The entrance staircase to Dover Castle, originally with drawbridge where wooden stairs now are. (*Country Life*)

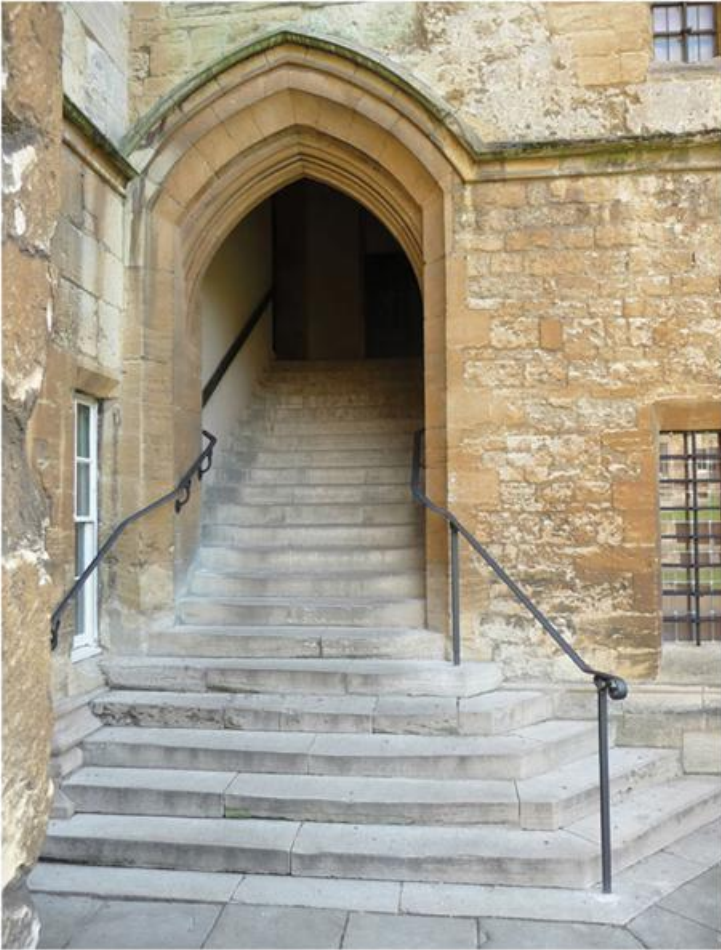
2.11 Staircase to dining hall, New College, Oxford.
(Stephen Oliver)

chapel and dining hall. The chapel and hall were normally, but not always, on the ground floor. When they were lifted up a floor, there was an opportunity for a staircase of some drama (e.g. dining hall, Magdalen College, Oxford; dining hall, Winchester College; dining hall, New College, Oxford (Figure 2.11)). However, some examples, such as the stairs to the dining halls at Merton College³⁰ or Christ Church, Oxford, and the stairs to the chapel at Eton,³¹ are actually misleading later additions. Medieval staircases to dining halls were generally internal, the external examples mostly dating from 1600 onwards. Alongside these larger elements were the lodgings or dormitories.

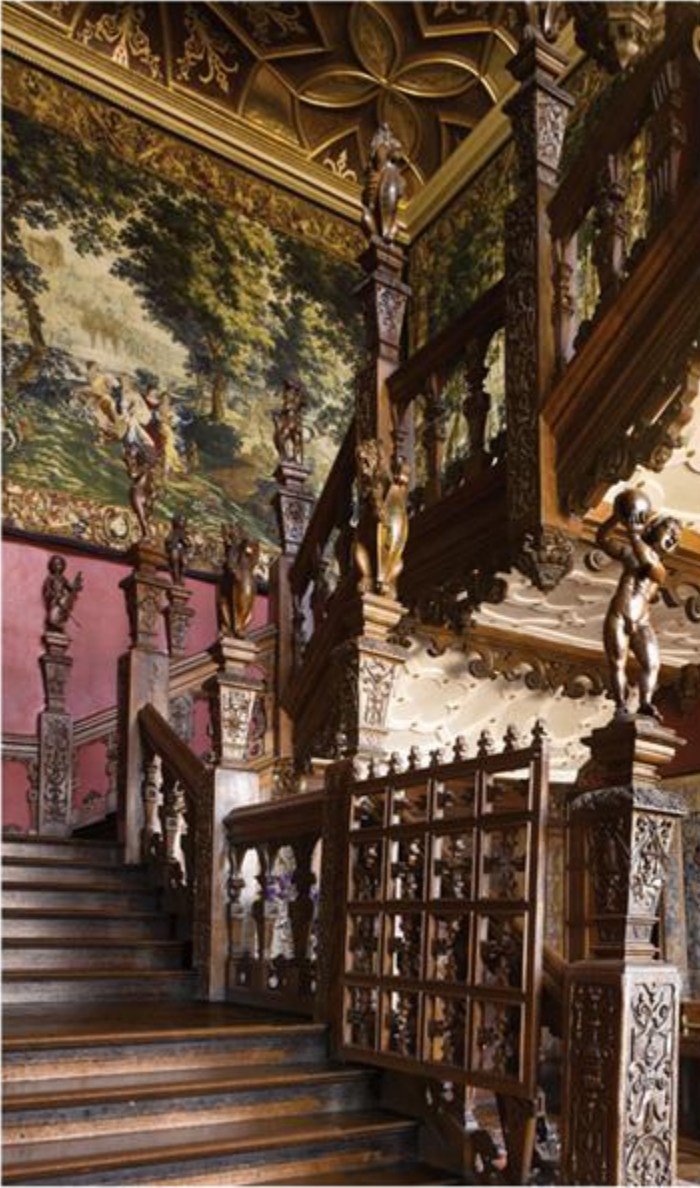
2.14 The great staircase at Hatfield. (*Country Life*)

grand timber staircases survive from before 1603. Fine Jacobean staircases are characterised by decorative sculptures on the newel posts. The great staircase at Hatfield (1612) is one of the most exuberant (Figure 2.14). A gently sloping set of five ‘cantilevered’ flights ascends through one tall storey. The balustrades are ‘square’ and richly carved. Sculpted animals and cherubim stand on top of the newel posts, which are themselves covered in decoration.⁴³

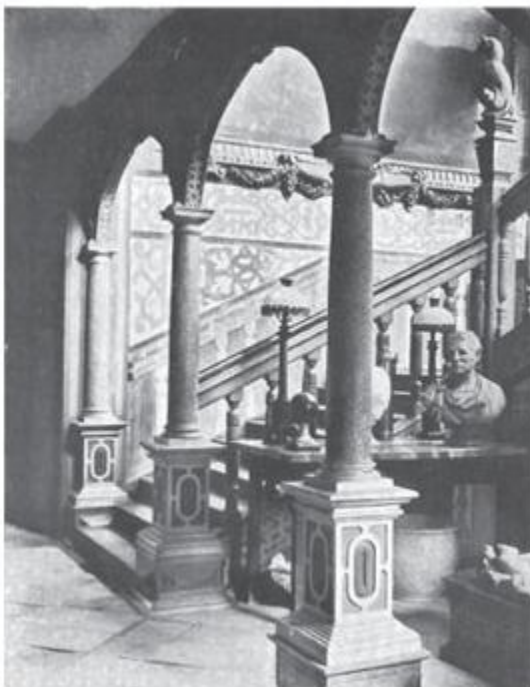
2.15 Knole in Kent, with decorated newels, but here the balusters are turned. (Lloyd)

Similar figures sit atop the newels of the open-well stair at Knole in Kent, but here the balusters are turned (Figure 2.15).⁴⁴ As we shall see in more detail in [Chapter 3](#), turned balusters will become more common as the century progresses, although richly carved square balusters remained popular for the most expensive stairs well into the Restoration period.

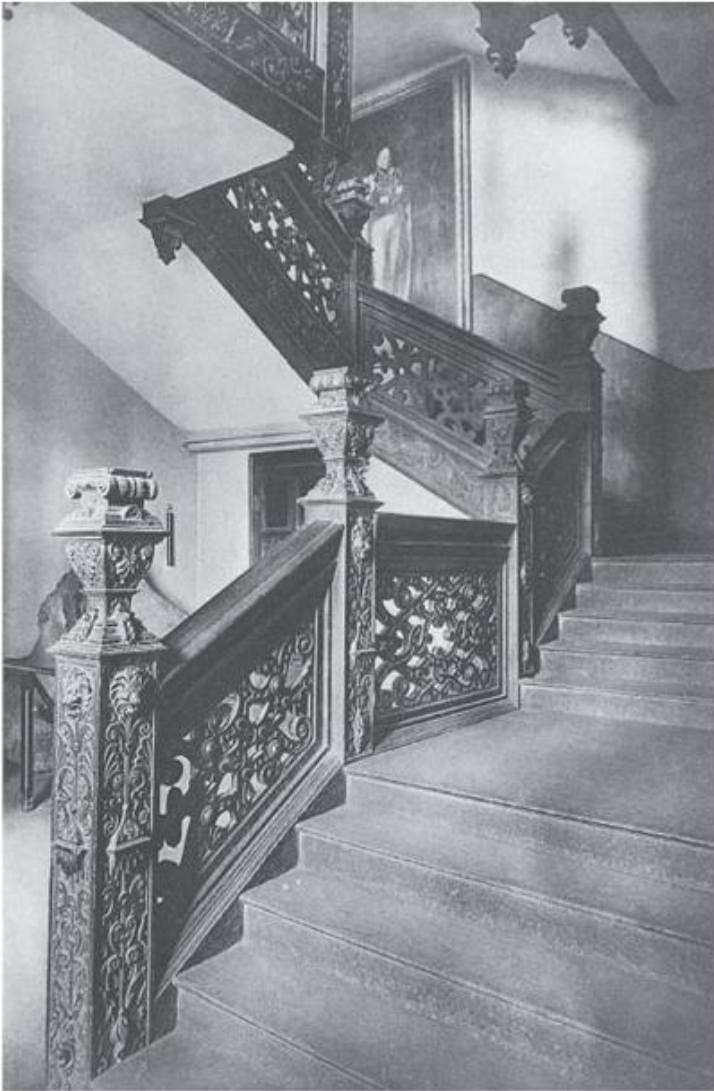
2.16 Strap work at Aston Hall. (Godfrey)

New types of decoration appeared in the 1630s: carved strapwork balustrades – examples are Aston Hall (1618–1635) (Figure 2.16) and Rawdon House, Hoddeson (1622) (Figure 2.17).⁴⁵ Sekler showed how these patterns can be related to illustrations in continental publications, particularly De Vries' *Panolpia seu arcmentorium* and De Cerceau's *Cartouches* and *Fleurons*. He also shows a similar staircase could be found in the Brewer's Hall in Antwerp, suggesting Flemish craftsmen may even have been involved in the construction of some British examples.⁴⁶ The fashion for carved balustrades had a surprising longevity, with examples still being found into the 1680s. Gradually, naturalistic foliage replaced the earlier strapwork, as at Tyttenhanger, Hertfordshire (c.1654), Sudbury Hall (1670) (Figure 2.18) and Cassiobury Park, Hertfordshire (1674–1680).

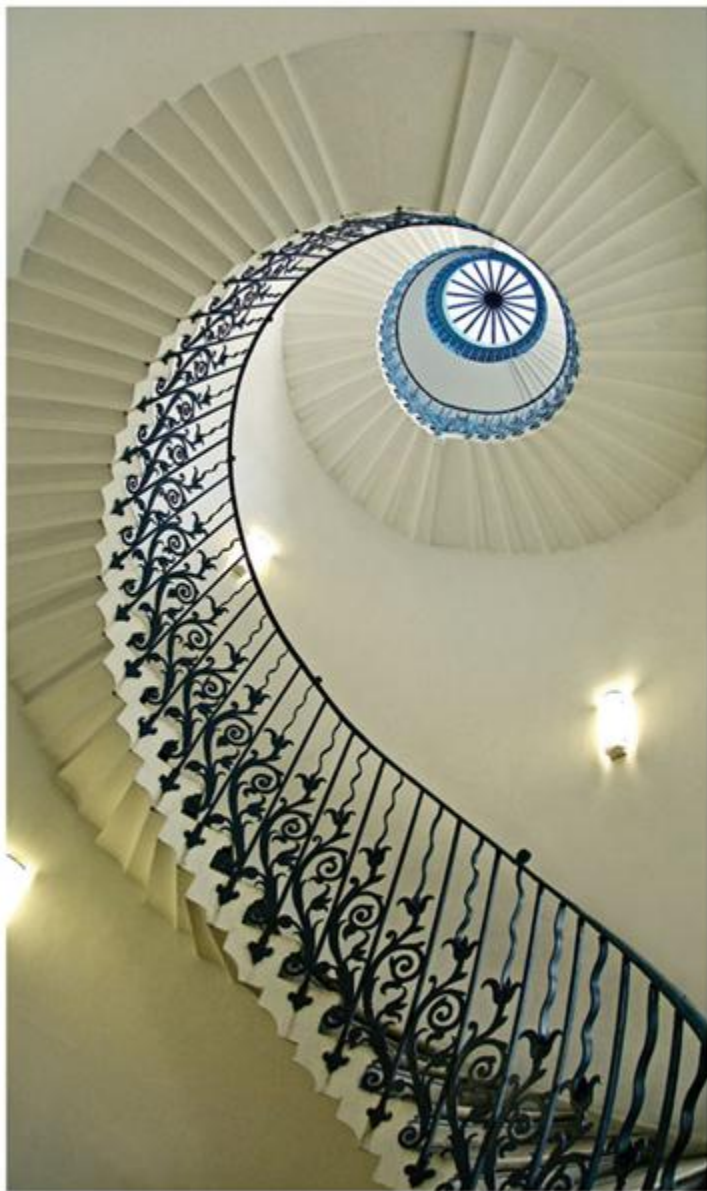
2.19 The Tulip Staircase. (© National Maritime Museum, Greenwich, London)

Jones had travelled twice to Italy and was familiar with Palladio’s work. The Tulip staircase is a circular and much more refined version of the Carita staircase (Figure 2.19). Jones’s stair is particularly delicate in its detailing, with an ornate iron balustrade. The treads are sculpted at the ends and underneath for decorative effect.

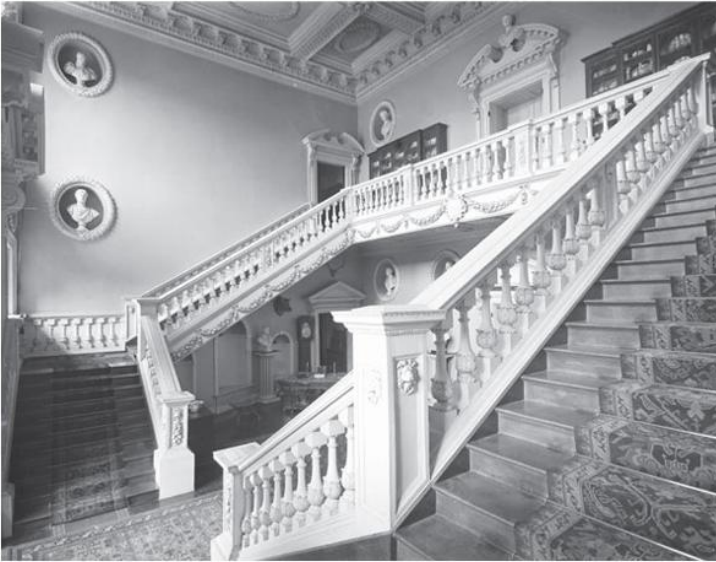
2.22 Coleshill (destroyed) by Roger Pratt. (*Country Life*)

One of the most famous early examples of a grand symmetrical staircase is that at Coleshill (destroyed) by Roger Pratt (Figure 2.22), where the entrance hall was entirely dominated by a huge double staircase. Here we have two symmetrical staircases, one on either side of a hall. The true Imperial stair – where a single flight divides and returns as two – is often cited as an eighteenth-century innovation. In fact, it does appear occasionally in the seventeenth century. John Webb built one at Gunnersbury House in 1658; there was one in Madam Boone's House in Lee, Greater London in 1670; and in the 1680s Wren proposed a grand Imperial staircase (never executed) in front of a great window for a country house in Tring.⁴⁸

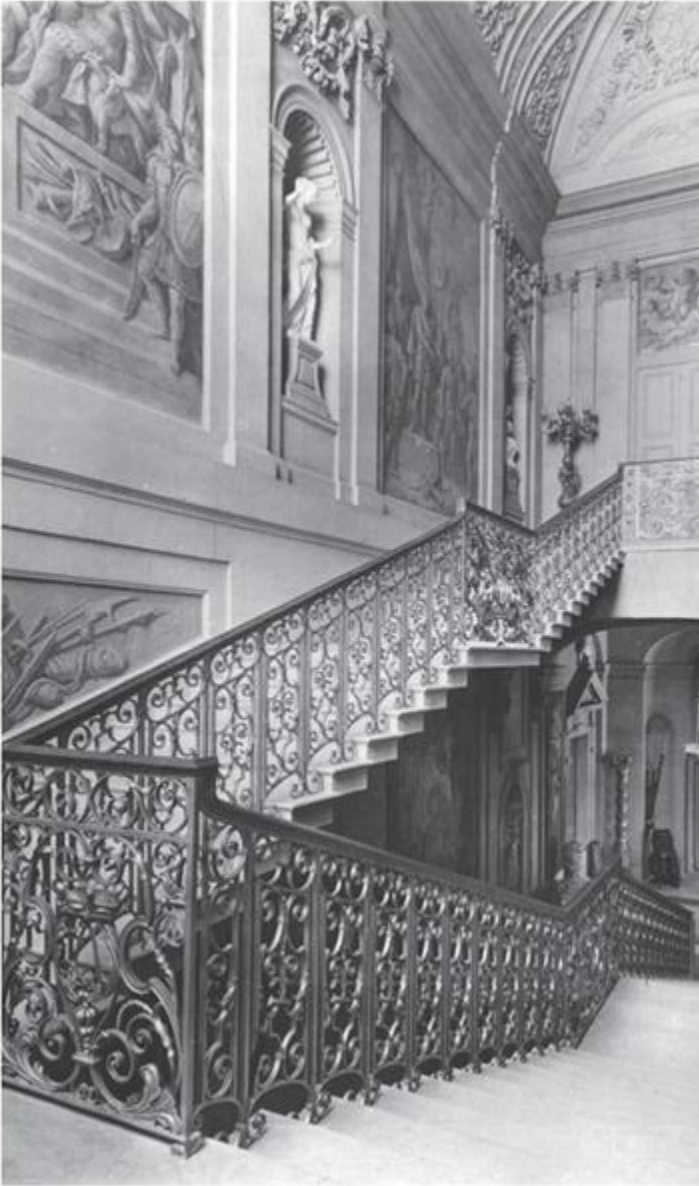
2.23 Easton Neston (1702–c. 1731). (*Country Life*)

All staircases need light and with all the early examples this was provided by windows. One popular solution was to put the staircase on one side of the building on plan. In this position, it would rise towards windows on one of the end facades. It would stop at a half-landing and then return to the centre of the plan at the first floor. This kind of arrangement is seen at Barnham Court

(c.1640),⁴⁹ Mawley Hall (c.1728)⁵⁰ and Easton Neston (1702–c.1731) (Figure 2.23).⁵¹ Although dramatic on the inside, this position made it difficult to compose symmetrical facades on the exterior: the ideal window position was midway between the floors. In the crudest examples the landing simply cut a window in half, but in most cases the lower window was omitted and a larger higher window was provided in its place.

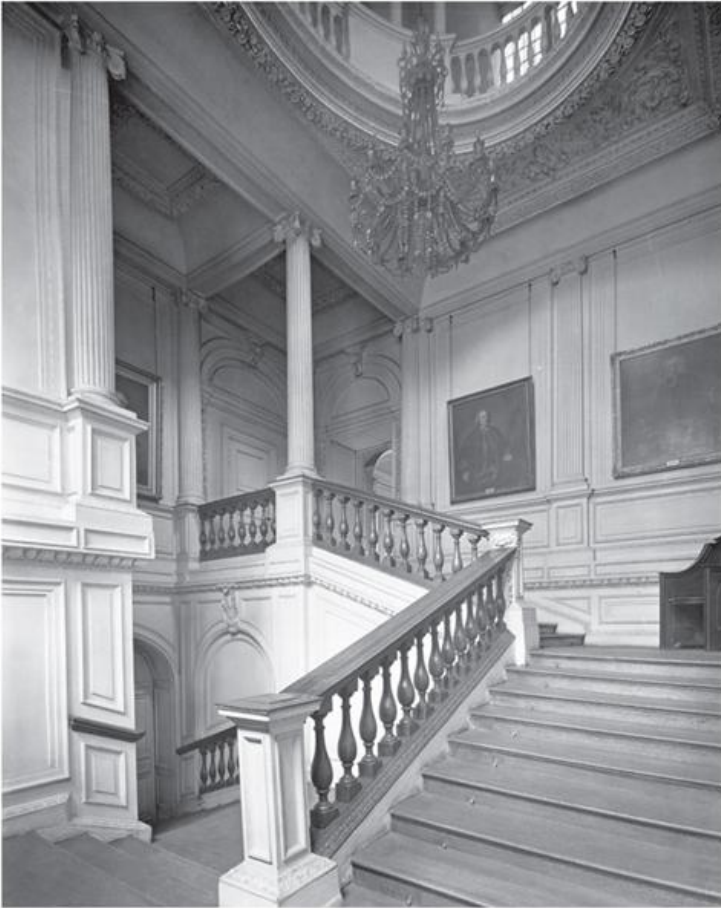
2.24 Ashburnham House, Westminster in 1662.
(*Country Life*)

The most dramatic and revolutionary solution to the problem was to have the staircase in the middle of the building and light it from above. This solution first appears in Ashburnham House, Westminster in 1662 (Figure 2.24). Here, an elegant classical stair climbs to the first floor in a top-lit hall, surmounted by a dome. The date and architect are both subject to debate. Current thinking is that it was designed either by John Webb (1611–1672) or William Samwell (1628–1726).⁵² This is probably the first example of a top-lit staircase in Britain. It was an extraordinarily prescient arrangement, but not one taken up elsewhere at the time. At Blenheim and Castle Howard, Vanbrugh lit the stair by borrowing light from the clerestory windows of the entrance hall and Talman drew a design for a circular stairhall surmounted by a dome (unexecuted).⁵³ But despite these precedents, the British staircase in the seventeenth century was typically lit from the side.

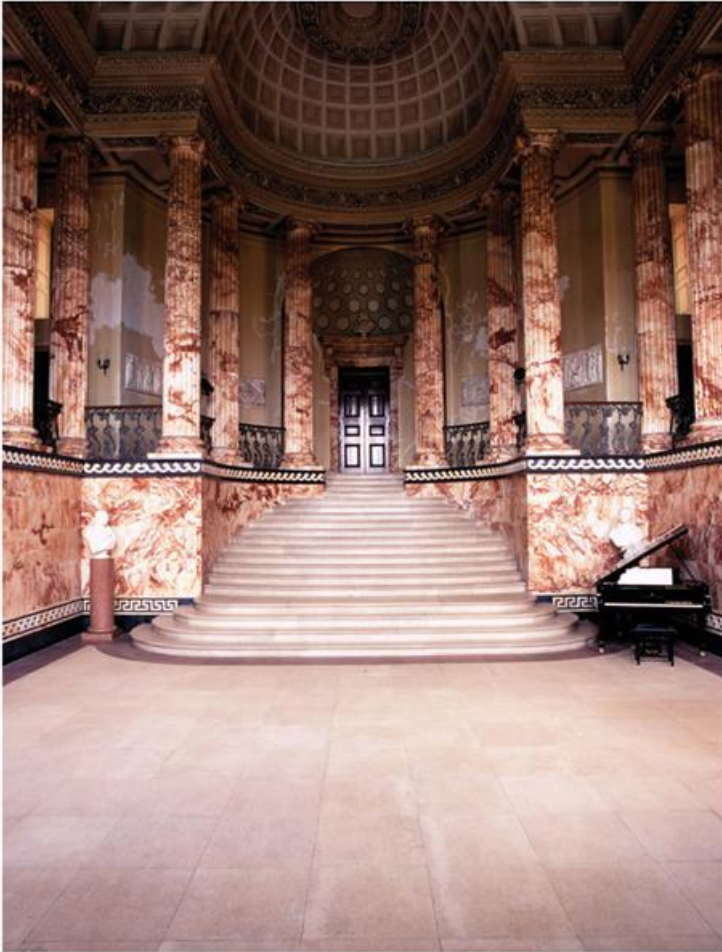
2.25 Holkham Hall, Norfolk. (*Country Life*)

Hall, Norfolk (Figure 2.25), where the visitor entered a huge entrance hall to be confronted by a dramatic single flight of curved marble stairs, which appear to flow out of the main salon door above, while galleries above give views back onto the entrance hall.⁵⁷ The hall is lit from windows in the entrance facade.

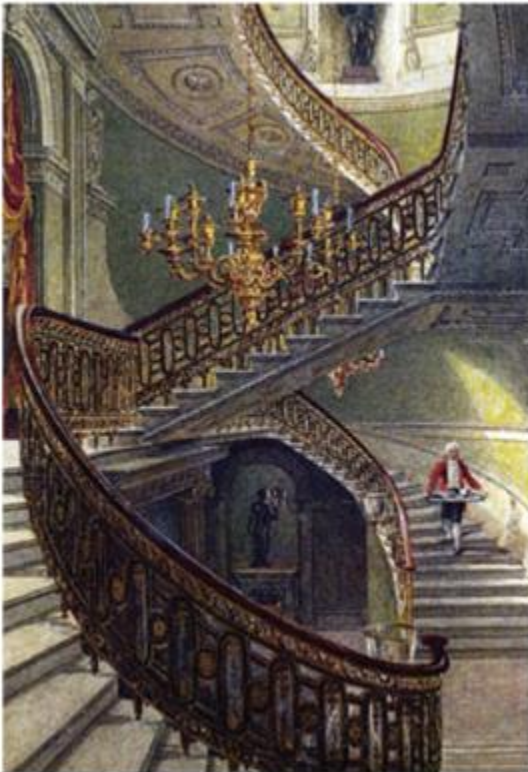
2.30 Holland's Carlton House (1784–1789).

most dramatic example, with a flying stair (two flights with a single central flight returning, followed by two more) (Figure 2.30).⁶⁵ The flying staircase was also used by Chambers at Melbourne House, London (1771, demolished) and Dundas House, Edinburgh (1771, demolished).⁶⁶ S.P. Cockerell's version at Sezincote (c.1805) survives (Figure 2.31),⁶⁷ as does St Pancras Chambers (Figure 2.32), where the theme is taken to its extreme in a series of flying staircases one above the other.

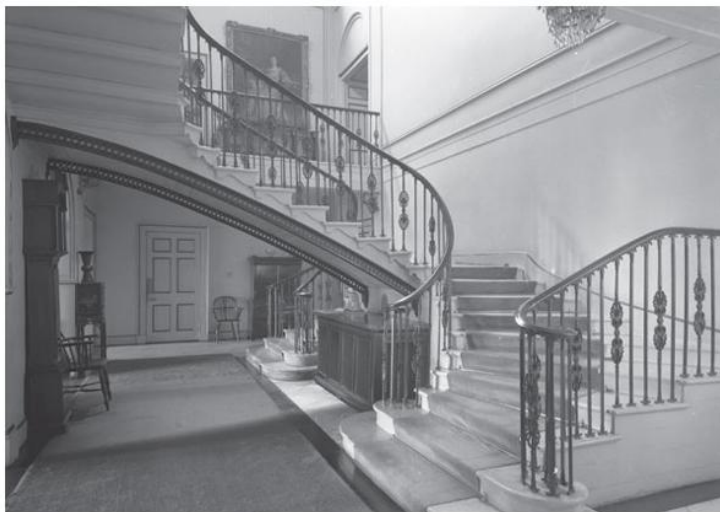
2.31 S.P. Cockerell's flying stair at Sezincote (c.1805).
(*Country Life*)
