Staircases

HISTORY, REPAIR AND CONSERVATION

Editors: James W. P. Campbell and Michael Tutton
Managing Editor: Jill Pearce

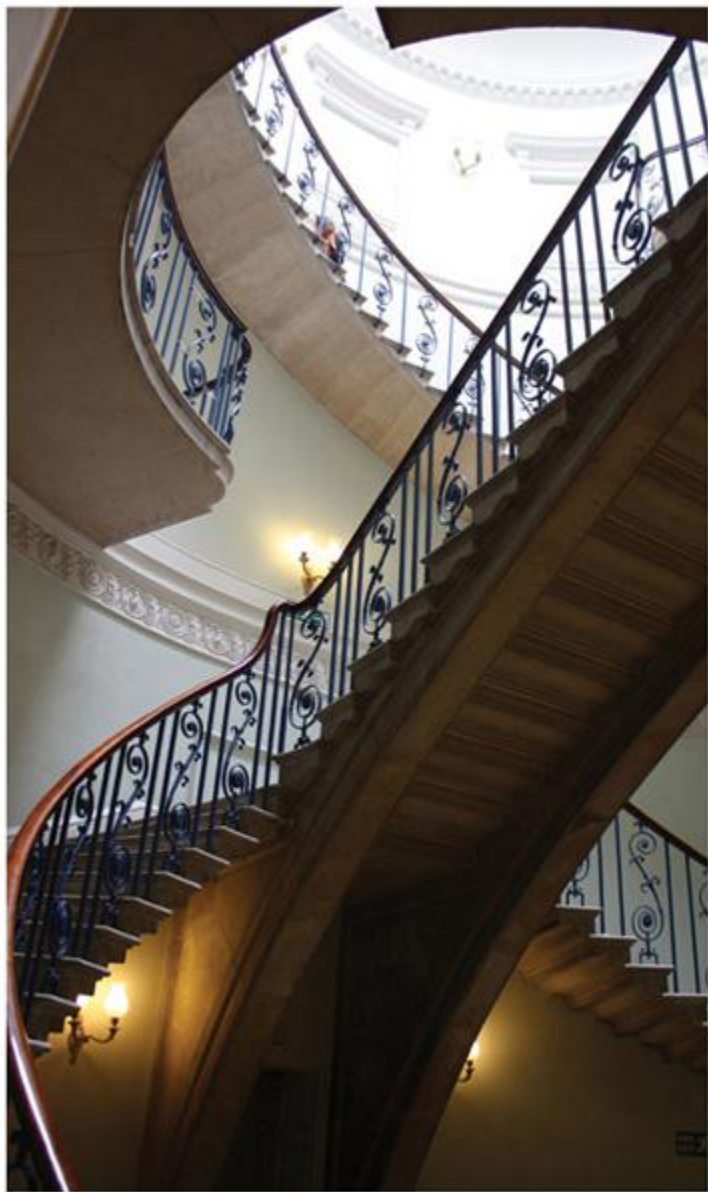
2.33 Somerset House, the Navy Office Staircase. (Michael Tutton)

In public buildings perhaps the best examples were again by Chambers. Somerset House involved a whole series of dramatic cantilever staircases. The Navy Office staircase (Figure 2.33), built *c.*1780, consists of two

curved flights in an oval well which meet and then continue in a single flying flight to the first floor. Also notable are cantilevered staircases in the Strand front in the Courtauld Institute, the east and west staircases, formally the Royal Society and Royal Academy staircases. These are both in semi-circular wells with curved flights to straight landings.

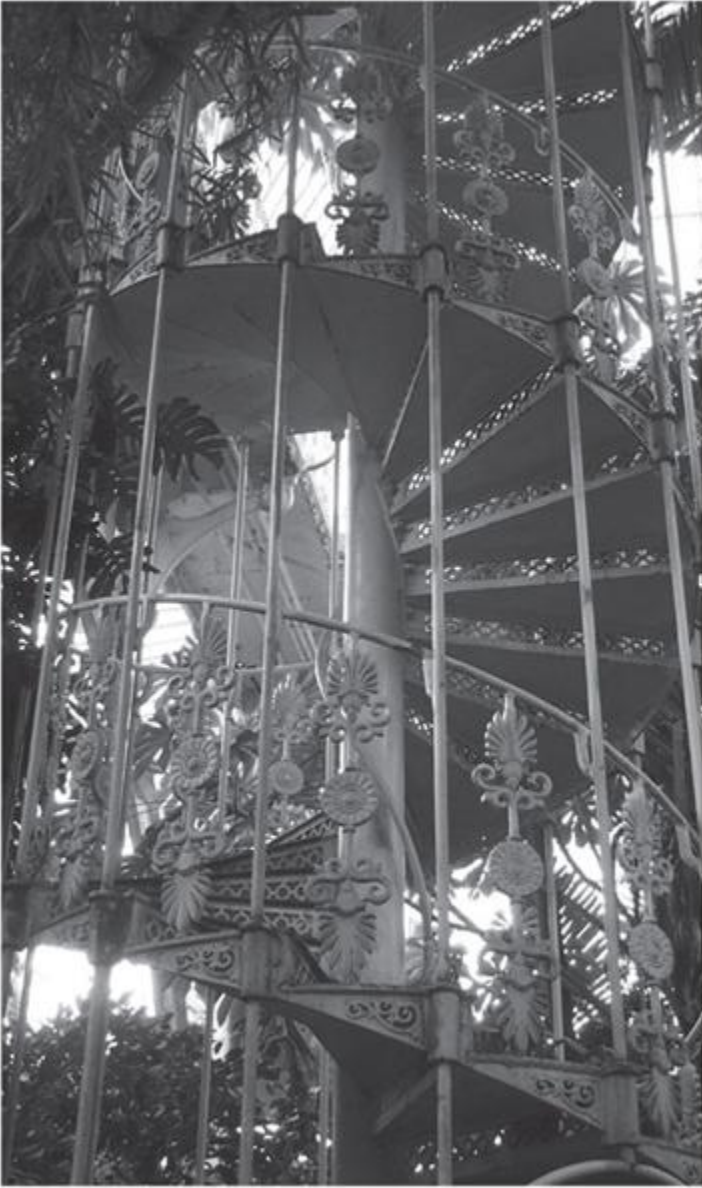
The spiral staircase in the Palm House (1844–1848) (Figure 2.41) at Kew is the most public example of an early cast-iron spiral stair. This type of stair was simple to mass-produce and by the 1850s similar designs were being shipped by English and Scottish manufacturers to the furthest ends of the earth. But perhaps no building better expresses both the Victorian spirit and the new structural possibilities of iron than the great staircase in Midland Grand Hotel (St Pancras Station, London) by George Gilbert Scott, built in 1870⁷² (Figure 2.32). This staircase is apparently simple on plan, with a straight flight at each floor rising to a half-landing and then branching into two symmetrical curvilinear flights. Such a simple description belies the incredibly complex views created in a stair that ascends in a rich crimson oval shaft through three storeys. It remains one of the world's most theatrical and exhilarating staircases. The Midland Grand Hotel also marks the end of an era in hotel design. The elevator did away with the need for a large staircase in a hotel building and later hotels cease to celebrate their existence.

2.41 Palm House (1844–48), Kew. (Ping Gong)

Iron staircases such as that at the Palm House at Kew (Figure 2.41) had to be prefabricated in the foundry, to be re-assembled on-site. By the middle of the century they were available from catalogues. Fire-proofing was their major selling point. Building regulations in the late nineteenth century were beginning to focus on this issue in public buildings. Iron stairs were thought to be one answer, with carriages designed to carry terracotta, stone or iron treads.

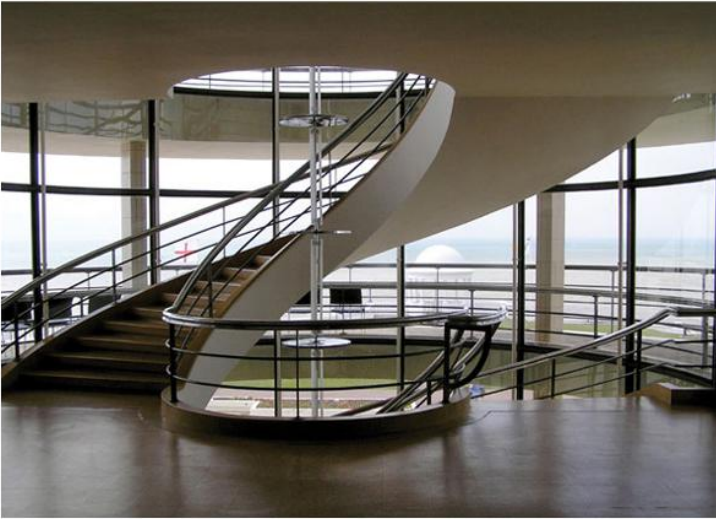
2.42 De La Warr Pavilion (built 1935). (Photograph by Richard Walker)

The early British Modernists rarely exposed the edge of the treads in their stairs, preferring strings that gave straight lines or smooth curves. In the De La Warr Pavilion at Bexhill on Sea, East Sussex, built in 1935 by the German architect Erich Mendelsohn (1887–1953) with the Russian Serge Chermayeff (1900–1996), the stairs consist of an apparently smooth spiral of concrete rising inside a glass drum. The concrete strings form a kerb to the edge of each tread so that the edge of the stair presents a smooth continuous strip to the outside world. The tubular ship-type handrails are almost invisible from outside the building, further reinforcing the impression that the stair is a smooth concrete spiral ascending within a curved glass cylinder (Figure 2.42).

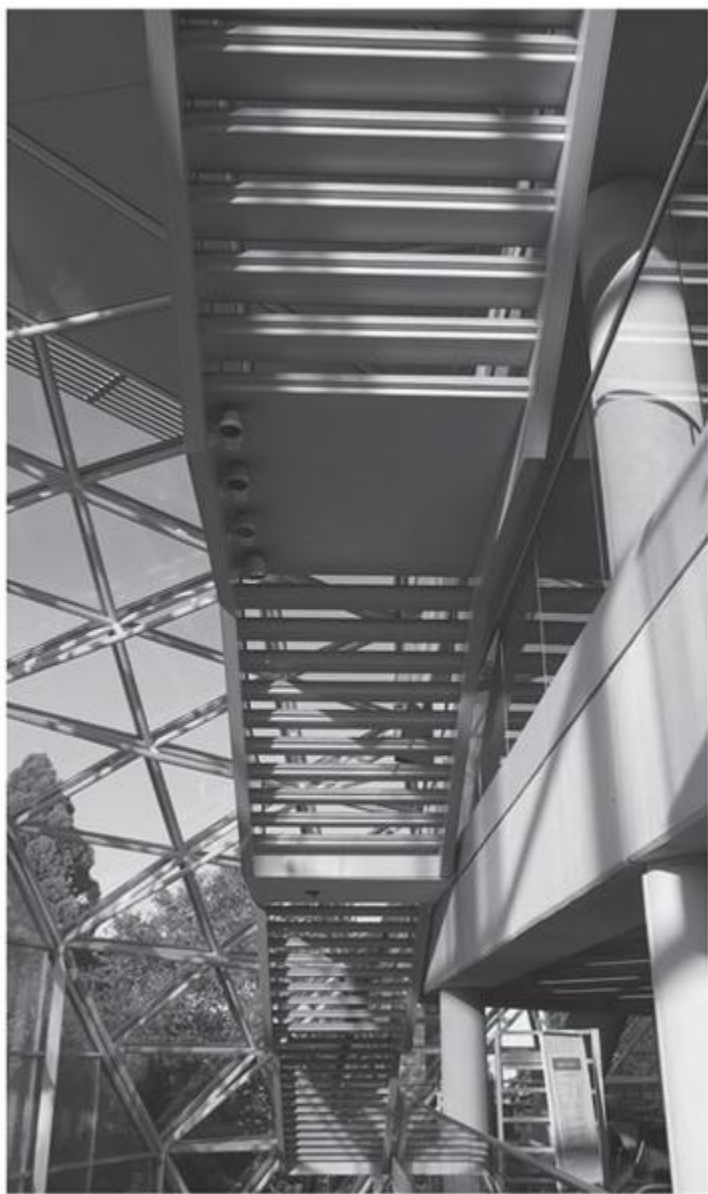
2.46 Law Faculty Library (1990–1995) for Cambridge University. (Ping Gong)

Library (1990–1995) for Cambridge University by Norman Foster where a series of flights cantilever over a large void ([Figure 2.46](#)).

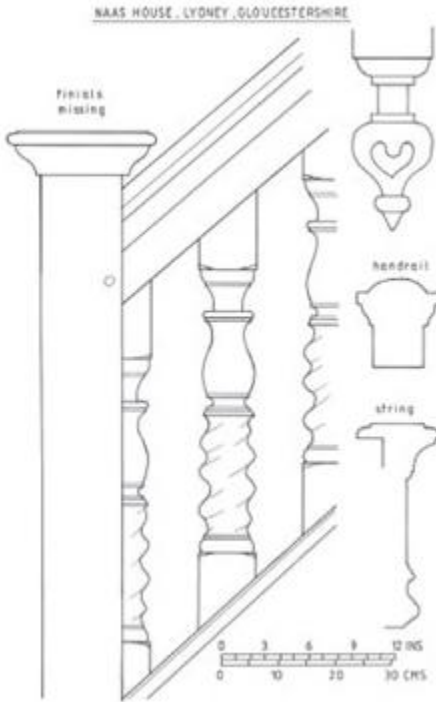
3.12 Naas House, Lydney, Gloucestershire. This house is undated, but the very chunky design of the balusters of the open-well stair suggests a date in the 1670s or early 1680s. The balusters are unusual, with the small vase element above the twisted shaft instead of below it. The handrail is also unusual, with its very simple profile and wide, curved top.

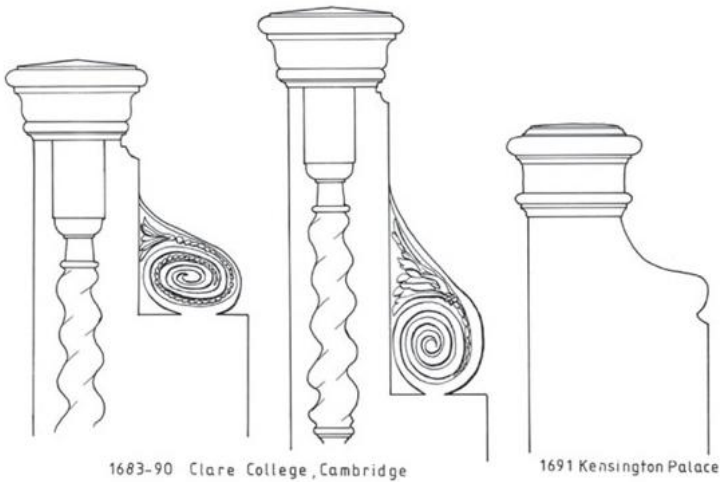
3.36 Dog-leg stairs may have double-width newel posts and some late seventeenth-century examples without finials have some form of curved bracket or console linking the two sections. The hall staircase at Clare College has two different designs, while a secondary stair at Kensington Palace (1691) has a simpler version.

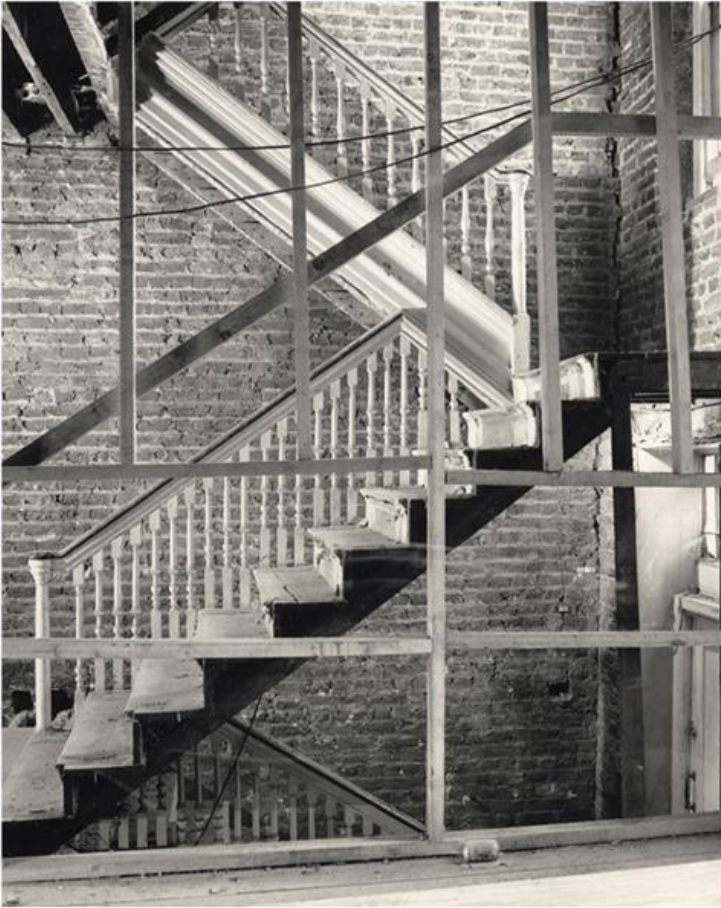
4.1 No. 37 Craven Street, Charing Cross, *c.*1730. An unusual view taken during the substantial refurbishment in the late 1980s of almost the whole eastern row of houses. All the wall panelling has been removed thus revealing the usually hidden structure of the staircase from the first to second floor. The difference between a cut and open string stair is clearly illustrated. (Courtesy of English Heritage)

decorative and latest designs will be found while on the second and third floors and above older, less fashionable patterns will be the norm. For example in 37 Craven Street, Charing Cross, a moderately expensive cut-string staircase with two balusters per tread ran from the entrance hall to the first floor, which was, of course, the principal social entertaining area of a London house. Upwards from there, on the second floor lay the family bedrooms, and so an older pattern closed-string stair design was used with only one, slightly different pattern baluster per tread (Figure 4.1).

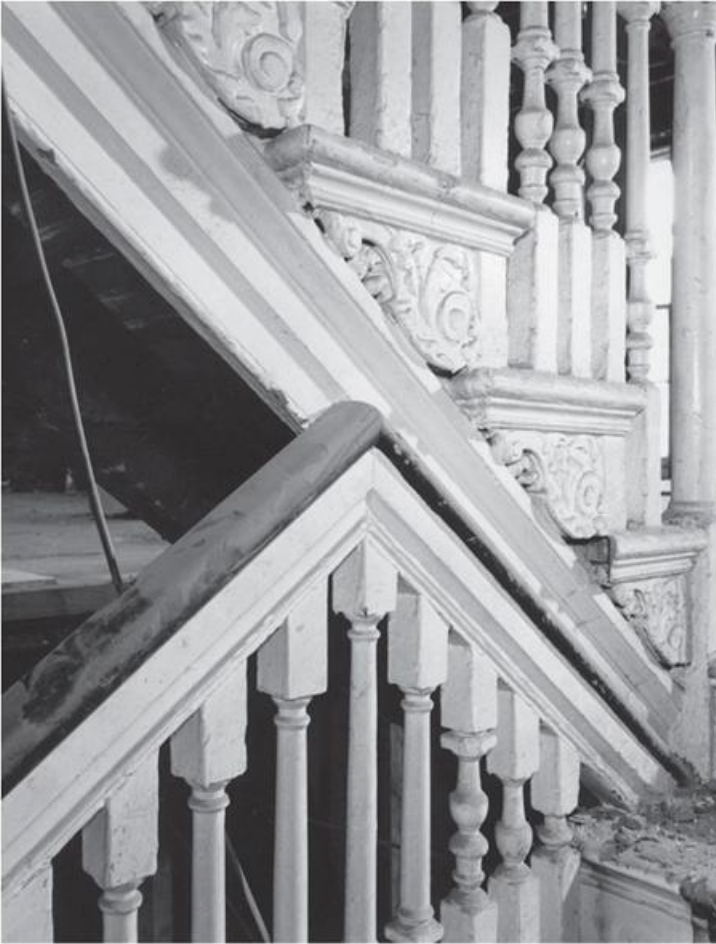
4.2 No. 37 Craven Street, Charing Cross, *c.* 1730. Detail of the meeting point on a dog-leg staircase of cut-string type. Made of pine, the handrail is stained dark brown to imitate mahogany. While there are three turned balusters per tread they are of the same pattern; however, the turner has had to take into consideration the shrinking of shape to keep the design coherent, hence the

short baluster in the angle. Note the thick paint layers covering the carved and turned details. (Courtesy of English Heritage)

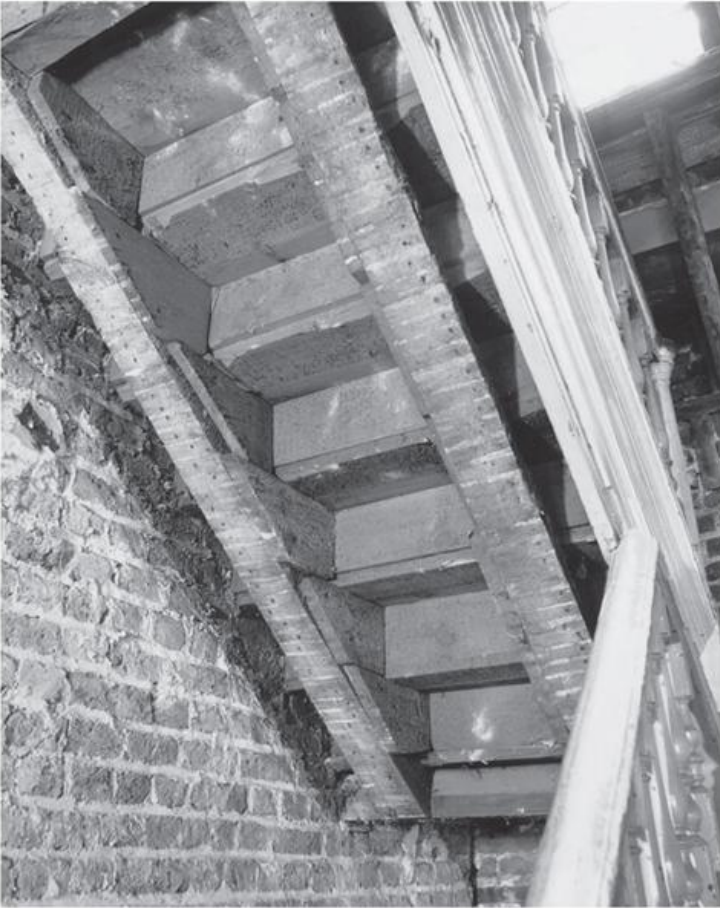
4.3 No. 37 Craven Street, Charing Cross, *c.* 1730. A view of the underneath of the closed-string staircase with its usual covering removed during a major conservation programme. It shows very well the substantial timber bearers or carriage pieces that support the actual weight of the staircase structure and which are normally hidden from view. (Courtesy of English Heritage)

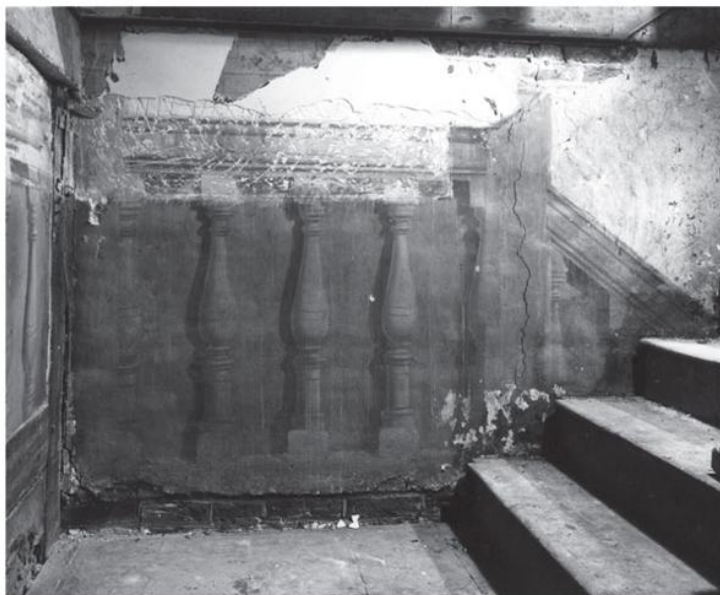
4.4 Lauderdale House, Highgate, *c.* 1650. Remains of the *trompe l'oeil* paint work imitating the turned wood balusters of a previous early seventeenth-century stair. Such schemes were popular and much cheaper than making it in timber. The photograph was taken during substantial repair work after a serious fire in the late 1960s. (Courtesy of English Heritage)

Lauderdale House, built in 1582. When restoration work was being carried out after a fire the remains of the mirror-painted staircase was found running in the opposite direction to the staircase there now (Figure 4.4)

As elsewhere in the country, the earliest staircases in London were constructed of oak; [Figure 4.4](#) of Lauderdale House shows what must have been a not uncommon late sixteenth-century stair. However, such was the city's expansion that there was insufficient oak and it was replaced by softwood imported from the Baltic, a change that was certainly underway by the mid-seventeenth century. Baltic timber was slow-growing due to the climate, but was easy to carve and turn, as it was quite soft. The slow growth meant the growth rings were close together and so any carved work was sharp and clean. The remains survive of a fine mid-seventeenth-century staircase from a house in Garret Lane, Wandsworth, South London, and it must have been made from some very large old trees, so substantial are the turnings and nailed-on mouldings ([Figure 4.11](#)). The trees would have been cut in winter when the sap was low and it was easy to slide them out over the snow or down the frozen rivers. The timber was loaded onto ships in ports all around the Baltic and brought down to

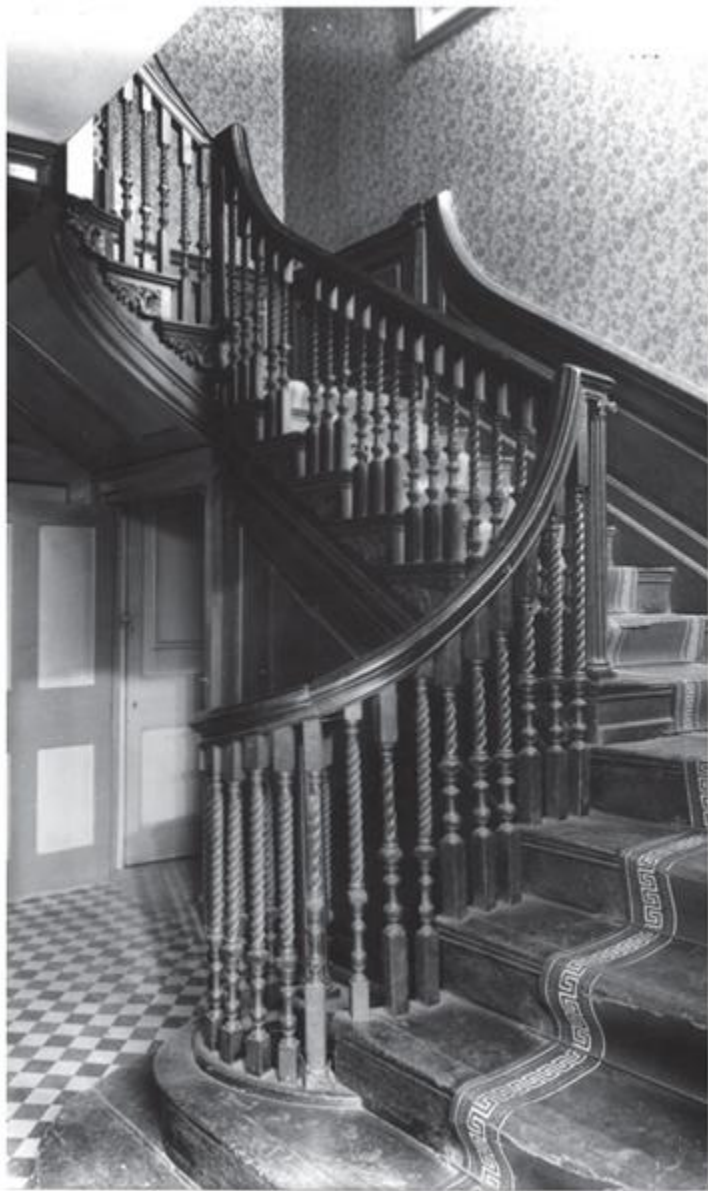
4.5 No. 14 Fournier Street, Spitalfields, Tower Hamlets, London. A photograph taken in February 1909, a fine ramped, cut-string staircase of *c.*1726; with three balusters per tread and fluted Ionic column newel posts and a magnificent curving curtail where the handrail sweeps sharply round the clustered balusters on the first tread. It was built for and by the master carpenter William Taylor. (Courtesy of English Heritage)

The great innovation in staircase design was the cut- or open-string stair (Figures 4.5–4.6). The cut-string staircase seems to have appeared in London by 1710. It

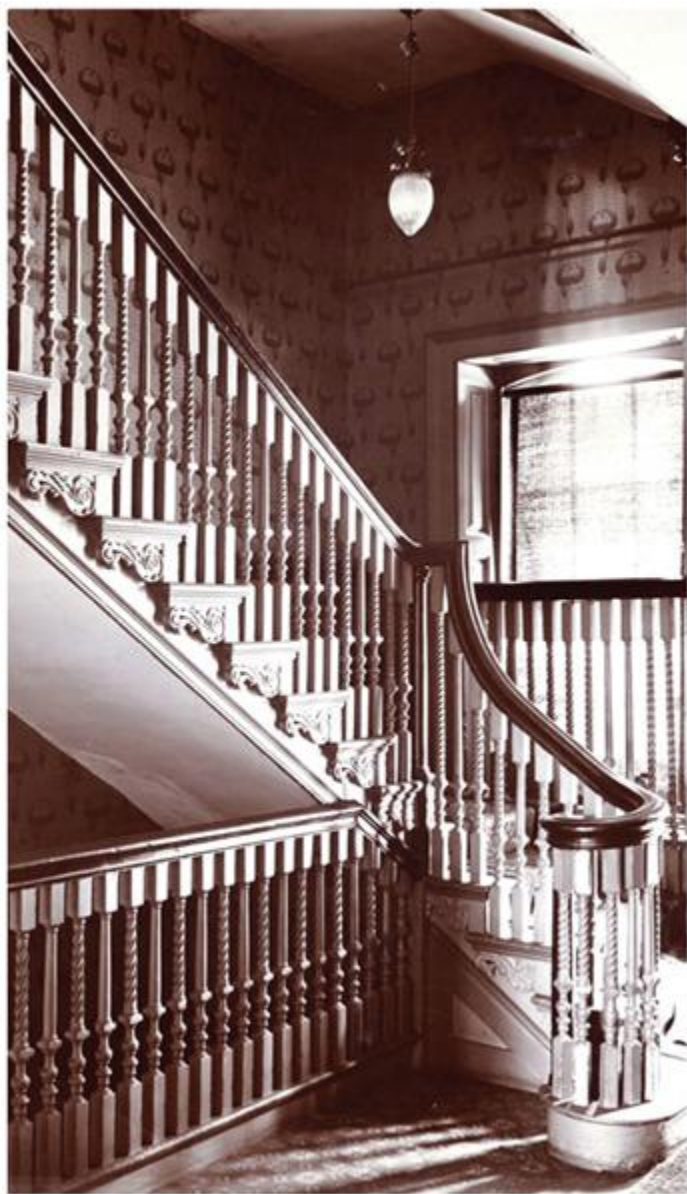
4.7 No. 2 Fournier Street, Spitalfields, Tower Hamlets; the house was formerly the rectory to the magnificent Christ Church Spitalfields, designed by Nicholas Hawksmoor, 1714–1729. As this house was built by the Church Commissioners it is unusually well documented by surviving accounts. Built in 1726–1728, the stair was made by Samuel Worrall at a cost of £40-10s-6d, with the 16 carved tread-ends measuring 9 inches by 4 inches, an extra £1-4s; to put this in perspective, a kitchen maid was probably paid around £3 per year, a clergyman about £40 and the very best French cook no more than £50–60. The photograph was taken in 1909. (Courtesy of English Heritage)

Quite advanced geometry was needed to lay out the new design, and it was usual for the joiner to assemble it 'dry' in the workshop as opposed to the carpenter, who could make the closed string stair directly on site. The handrail was also of a completely different shape as it needed to be 'ramped', that is, the handrail had to rise up steeply as it came to the top newel post of the first flight of stairs in order to keep the balustrade at a constant height; it is a quite distinctive aspect of early eighteenth-century stairs (Figures 4.5, 4.7, 4.8). Thus, the joiner had to be in some considerable way of business to undertake such a project.

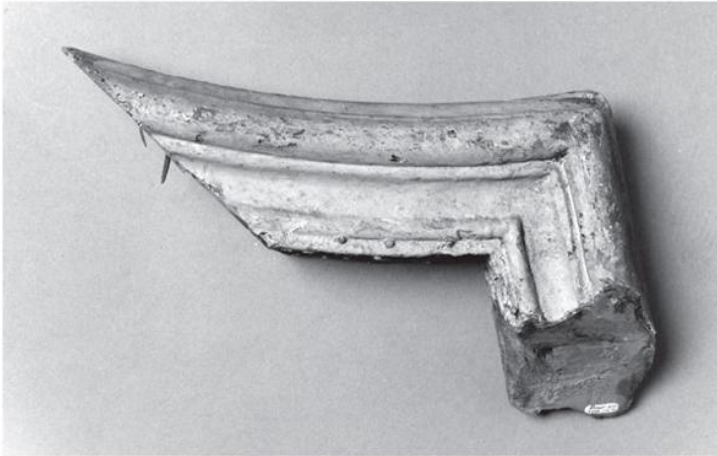
4.8 Detail of an early eighteenth-century handrail from a ramped staircase. Made from softwood imported from the Baltic, it is possible to see how such a sharply raked handrail was made; the short section fits into the newel post and is mitre-jointed to the curved section. This was then rub-jointed using glue and reinforced with nails

onto the long straight section. (Courtesy of English Heritage)

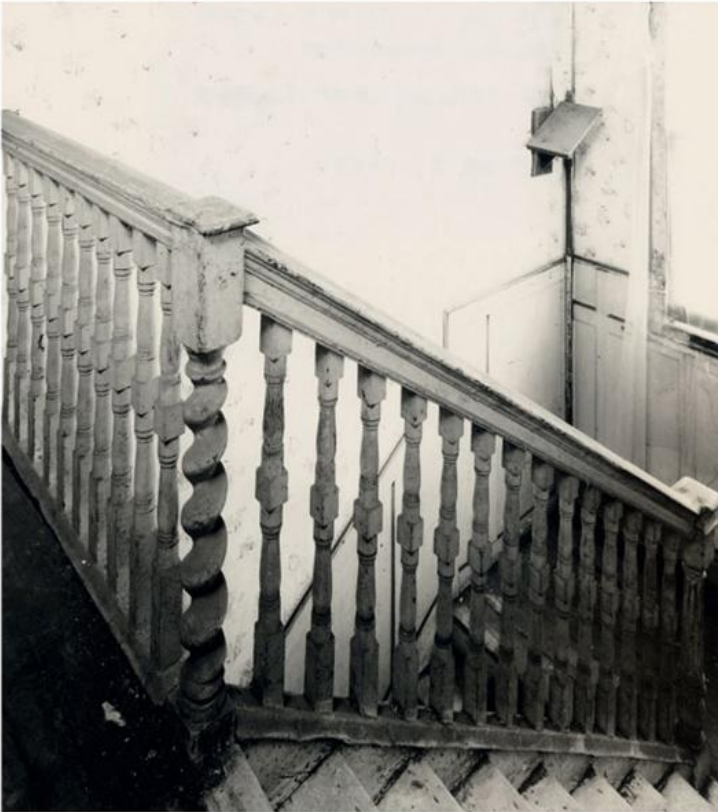
4.9 Albury Street, Deptford. Originally known as Union Street, Albury Street was laid out and built 1707–1710. In this photograph it is possible to see what happens commonly in London with houses that have had a hard life. The first occupants were shipwrights for the Royal Dockyard at Deptford, but it then slipped down the social scale into multi-occupation. The staircase is of the closed-string variety and the twist-turned newel post and substantial handrail are of 1707, but all of the balusters have been replaced, *c.* 1880, with turned balusters of a

very different profile to those originally fitted. While it is not at all unusual to find one or two replacements, this wholesale refitting is not common. (Courtesy of English Heritage)

During the transition to the ubiquitous dog-leg the most common was the open-well form as seen in the surviving houses in Albury Street, Deptford, South London, which were built *c.*1707–1710 ([Figure 4.9](#)).

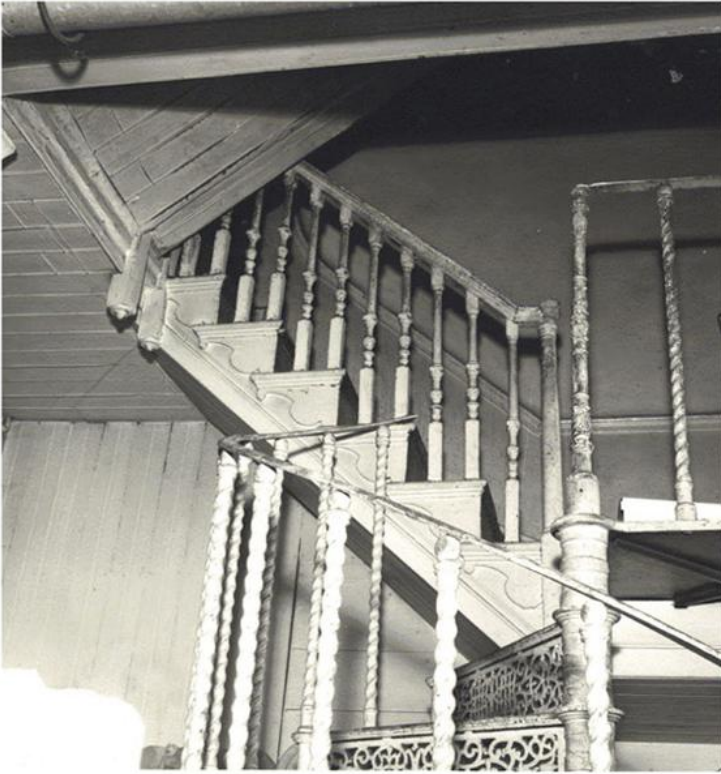
4.10 No. 173 Hoxton Street, Shoreditch. A view of the stairwell of a mid-eighteenth-century terrace house just outside the City of London. In the early eighteenth century Hoxton was an area of fruit, vegetable and flower gardens supplying the city. However, as the century progressed so the fields were built over. No. 173 Hoxton Street was built *c.*1750–1760, a two-bay-wide three-storey house with a smart cut-string staircase and a first-floor front room with a plaster modillion cornice; a small garden lay between the house and the street. By the middle of the next century the whole area had

declined, with considerably overcrowded housing; the gardens were built over to provide shops and the house subdivided. In this photograph taken in the 1970s a cast-iron spiral staircase has been inserted from the ground-floor shop – at this date a dry cleaners – up to the first floor where it is fixed to the original cut-string staircase with its silhouette tread-ends and turned balusters. Such architectural oddities are, or were, quite common in London, with the need to adapt houses to changing conditions. (Courtesy of English Heritage)

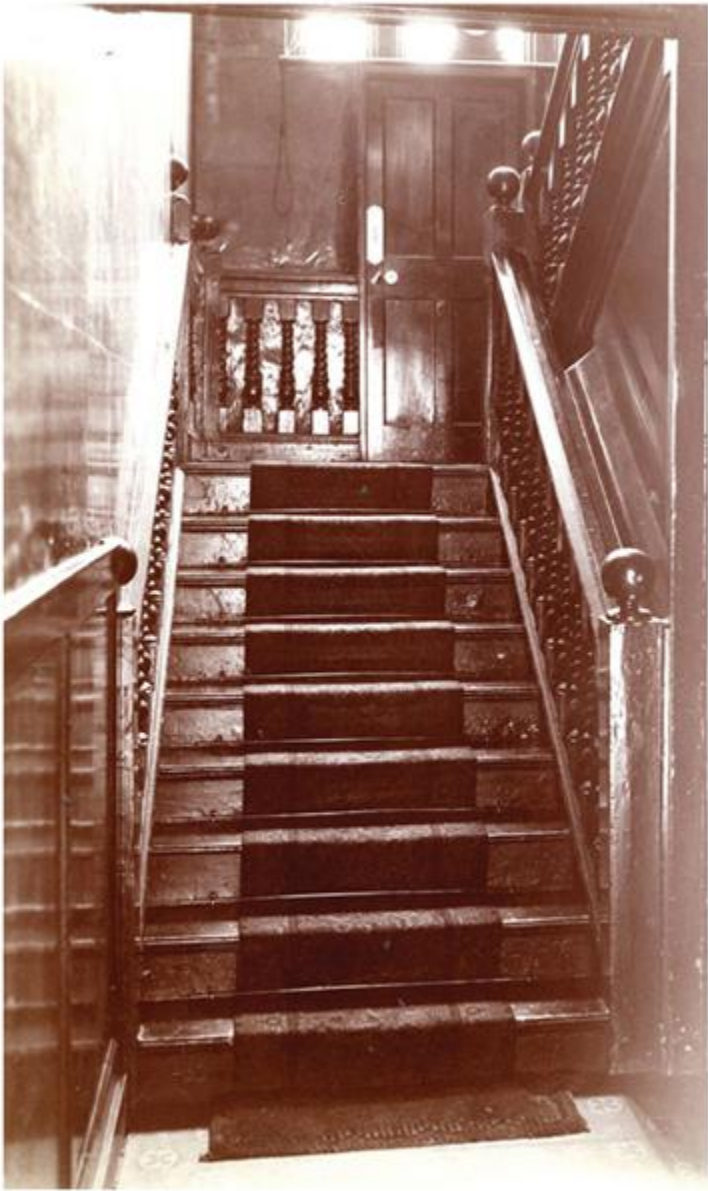
4.11 No. 14 Garrett Lane, Wandsworth, southwest London, *c.*1650–1660. Built in the mid-seventeenth century when the large house was surrounded by farmland, it was demolished in the early twentieth century. Whereas the picture of Lauderdale House (Figure 4.4) shows the design of the stair executed in paint, here the balusters, newel and handrail are replicated in softwood, a much more expensive option, especially as the turnings were made from substantial three-inch squares of Baltic softwood and the rest of the staircase made from similarly large scantlings. (Courtesy of English Heritage)

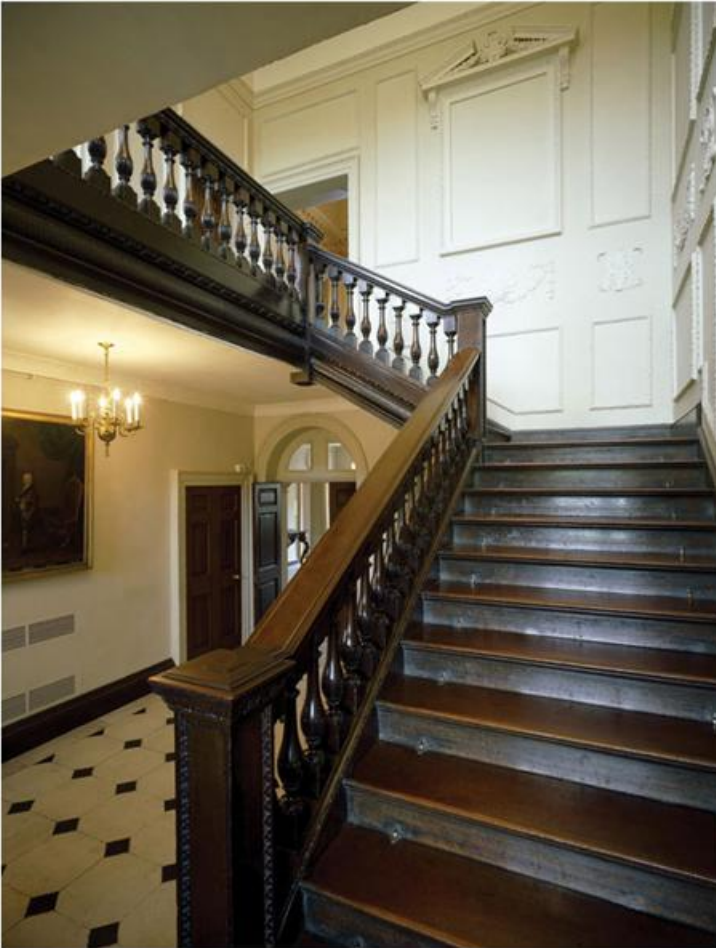
4.12 Marble Hill House, Twickenham, West London. A mahogany closed-string staircase, c. 1730. This is a very old-fashioned design and reflects the taste of at least the 1670s and probably earlier, but it is made of the newly fashionable West Indian mahogany. Even the flooring of the *piano nobile* is all constructed of this expensive timber. (Courtesy of English Heritage)

Next up the social scale was mahogany, imported from the Caribbean and Central and South America. The staircase in Marble Hill House, Twickenham, is quite possibly one of the first staircases made completely from mahogany (Figure 4.12). It is a beautiful wood capable of being crisply carved and taking a deep polish, but it was too expensive to be so used. The common use for mahogany was for handrails, especially in conjunction with wrought-iron balusters so popular in the last half of the eighteenth century. The use of mahogany became much more profligate in the nineteenth century, but the effect was also very rich.

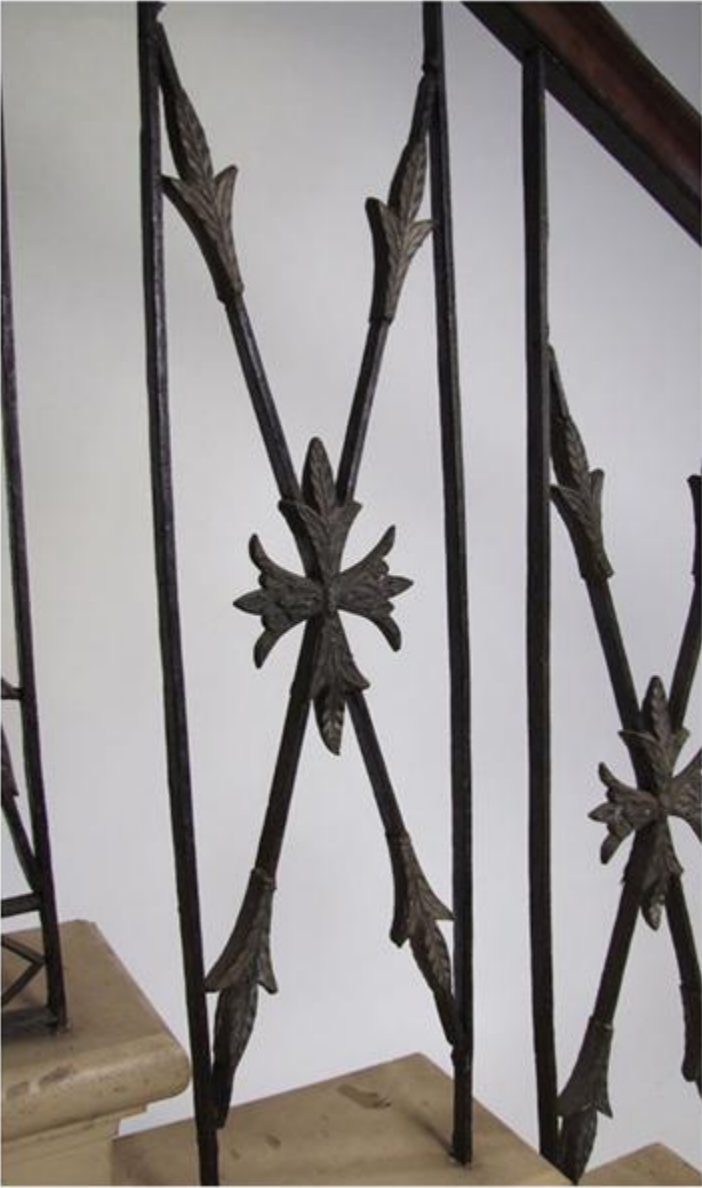
4.13 Cast lead decoration on a short section of staircase, *c.* 1780–1790. The ‘balusters’ are made up of two vertical wrought iron strips with an elongated X fire-welded to hold them together. Metal moulds, very similar to contemporary ice cream moulds, were placed around the iron strips and molten lead poured into the mould. (Courtesy of English Heritage)

House, Portman Square. The wrought-iron newel post and balusters have fine gilt bronze ornaments attached, such as rams' heads, urns and stylised honeysuckle flowers. However, on ascending several treads of the first flight the expensive bronze changes to cast lead, a somewhat cheaper material. The use of lead for applied decoration was quite innovative. The fire welding of thin iron strips is highly skilled; to join two strips and encase them in a cast lead ornament was a much easier solution (Figure 4.13).

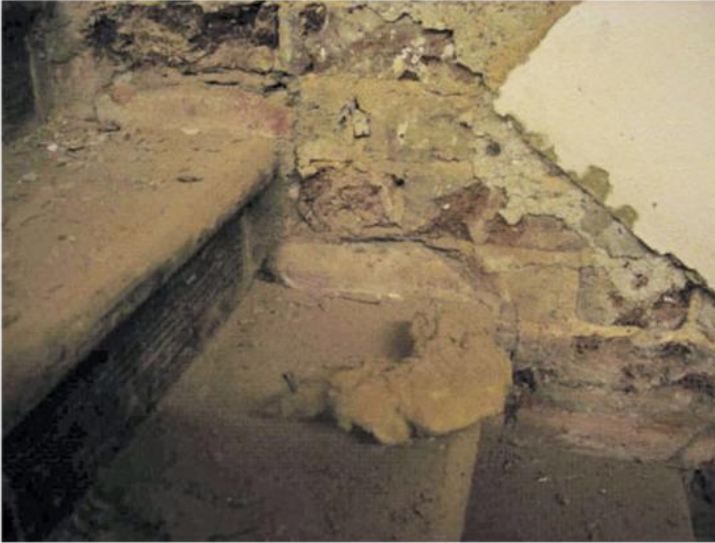
5.2 Evidence of cantilevered stair. (Michael Heaton)

Modification, repair or refurbishment will result in changes in the fabric and layout. The latter will usually be self evident, such as an added flight in a slightly different style, but the former will often have been obscured by skilful joinery or paint, requiring careful comparison of timber types, conversion methods or wear marks. Structures built in one operation usually display homogeneity of material, craftsmanship and wear, and variations in either of those will indicate modification, whether the structure is of timber, masonry or concrete. [Figure 5.2](#) demonstrates the insertion of a cantilevered staircase into the basement of an early nineteenth-century London terrace: the supporting wall is of hand-made stock bricks in an ash-rich lime mortar, but the treads are held in place by Fletton bricks in an OPC (Portland cement) mortar that have been cut to differing thicknesses to accommodate the different dimensions and rhythm of the new stair: it is, therefore, a replacement of the original stair.

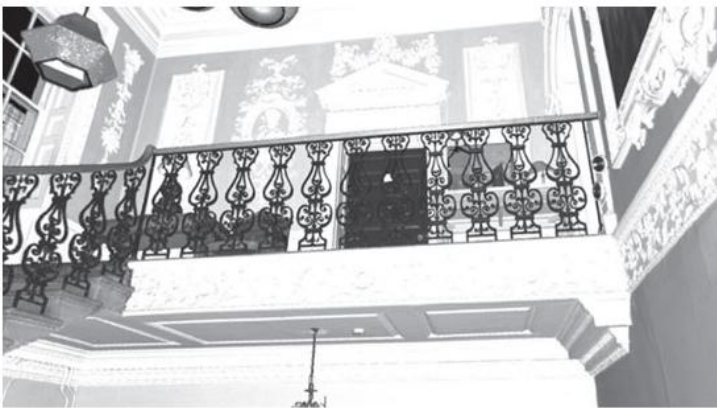
5.5 3D point cloud data set taken with a terrestrial laser scanner. (Image courtesy of Greenhatch Group)

Laser scanning is the fastest way of collecting large amounts of very detailed 3D data which can then be used to display the results in a 3D format. There are many types of terrestrial laser scanners and each type records hundreds of thousands of 3D points from a known position of orientation, with the result being a data set known as a 'point cloud'. These data sets are merged together to form a 3D image which can be selectively sliced and manipulated in AutoCAD packages to provide highly detailed orthogonal views both in plan and sectional elevation form, which can then be digitised (see [Figure 5.5](#)).¹⁹ However, with staircases there are limitations. The laser cannot see around corners or

through objects, so the scanning equipment will need to be moved and set up frequently, so the advantages of speed are diminished. Further, some laser scanning equipment can have trouble with reflective materials such as marble or gilded surfaces²⁰ It is, however, invaluable where 3D results are required for display or where detailed monitoring of condition is required over time. It will not necessarily improve the understanding of the staircase; that still requires a specialist archaeologist or buildings historian who will also need to ensure that the right data are being captured. This method of data capture is a highly specialised form of data recording with a very high initial outlay of cost and associated training required. However, the resulting point cloud data sets are becoming ever more usable in common drawing interface packages, and confidence in the integrity and accuracy of the data set would be exceptionally high. English Heritage maintains a list of specialist contractors who carry out laser scanning and have also published guidance on this technique.²¹

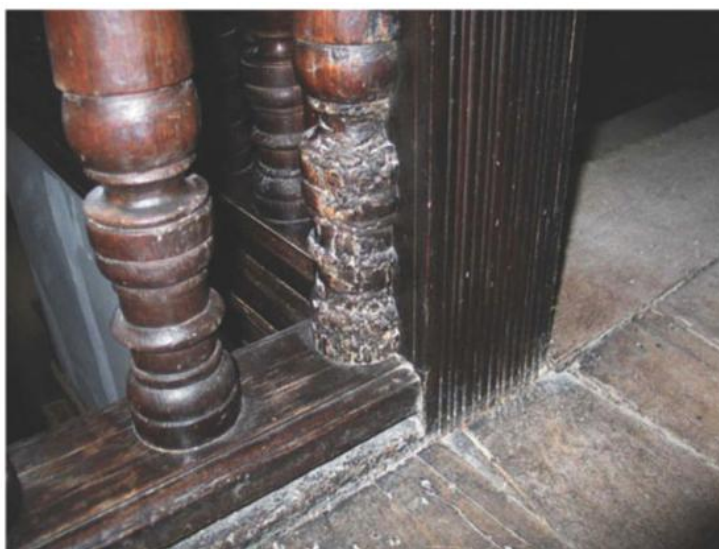
5.8 The good, the bad and the ugly. This baluster could not have been chewed *in situ*. (Michael Heaton)

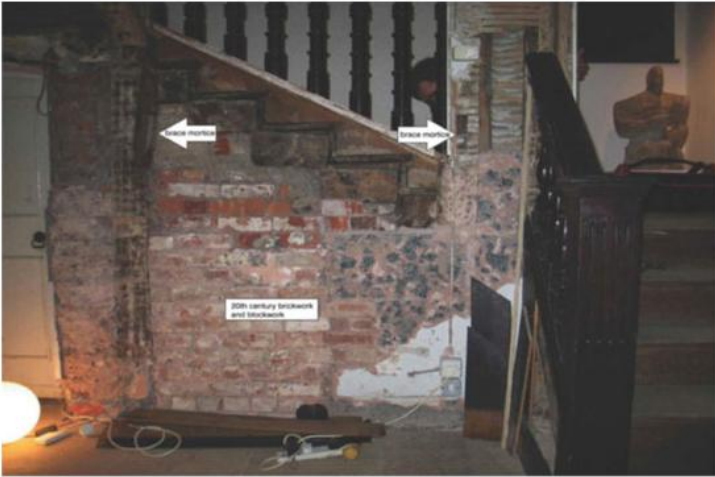
5.10 Second flight at Whitestaunton, showing the complete structural history. (Michael Heaton)

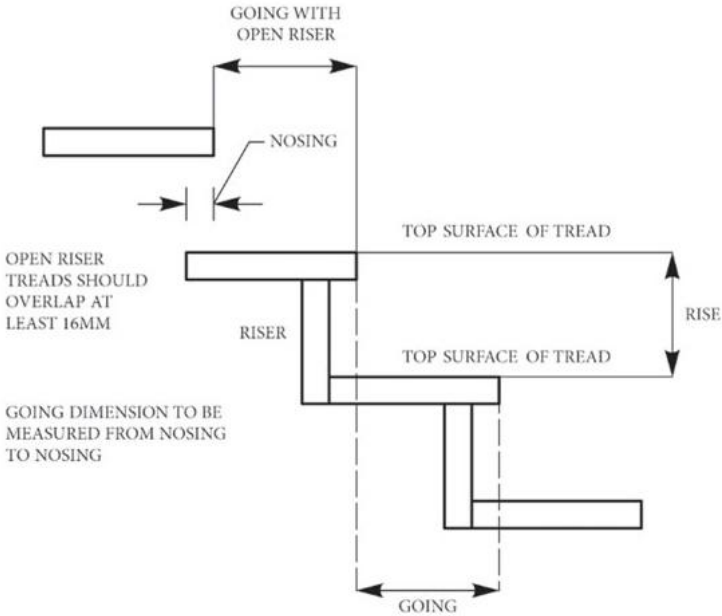
6.4 Definitions: goings and risers.

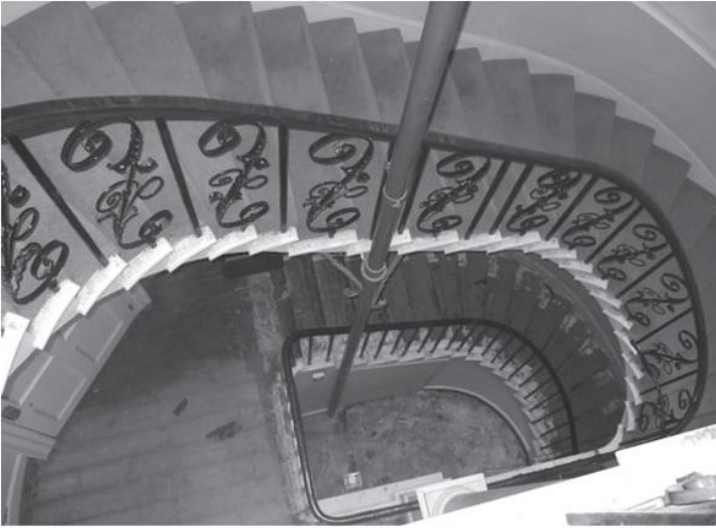
7.6 Stair with later iron column inserted, which the client wished to remove.

In a third example a cantilevered stair had been strengthened midway between one floor and another by the insertion of iron columns with cantilevered brackets (Figure 7.6).

The building concerned was originally a terraced house built in the eighteenth century, but it had been converted for use as offices since the mid-nineteenth century. It was to be converted back to a family house, and the strengthening columns were considered intrusive. The proportions of the stair generally were not unusual, so it should have been able to work without the strengthening. A feasibility study was commissioned to determine what defects had led to it being strengthened and whether there was an alternative and less visible way of achieving the same result. The design of the existing stair was much plainer than would have been typical of the eighteenth century, and plainer than the corresponding stair in the adjacent house.

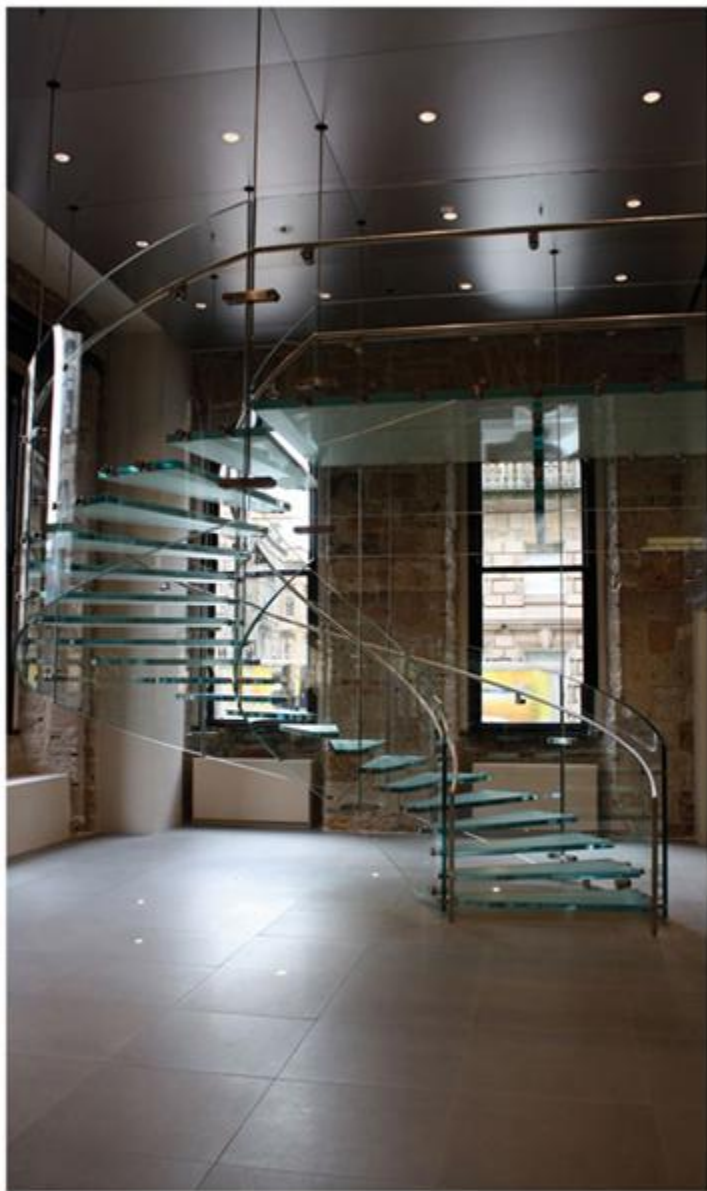
7.12 Composite glass and stainless steel staircase, Apple Store, Glasgow. (Michael Tutton)

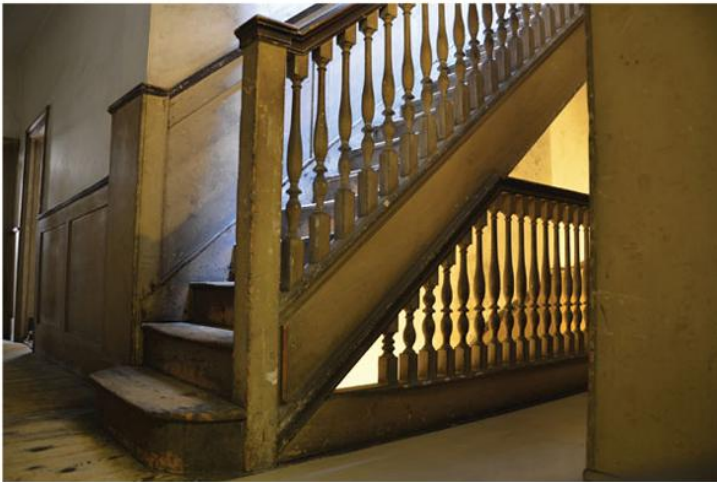
8.1 Surviving eighteenth-century paint on the back stairs at Kew Palace, London. To preserve its patina, the staircase is lightly dusted at infrequent intervals. (Lee Prosser)

Historically, paint varied in composition over time. Many early paints contained lead and were bound in oils such as linseed. Modern white tones in particular have been achieved by the addition of zinc or titanium dioxide, with the result that historic paintwork behaves differently over time, becoming discoloured or failing, dependent on age, composition and local conditions of light, temperature and other factors. Only in rare instances are historic paint layers exposed to view, such as at Kew Palace, where the eighteenth-century back stair has not been painted since *c.*1810 ([Figure 8.1](#)) The paintwork here is

particularly grimy and peeling, but is only infrequently dusted, as any form of cleaning is likely to detract from its charm and leave an unsatisfying finish. Some cleaning of painted surfaces is possible, but risks include the dissolving of soluble salts and the development of ‘blooms’ on varnishes. For bad stains, cleaning with sponges or erasers is an option.¹² A general rule, however, is to conduct small-scale cleaning tests with spirit, pure water or water with detergents in varying concentrations in order to establish any visual and physical effects.¹³ For ancillary decorative surfaces such as painted walls or wallpapers, specialist advice should be sought.

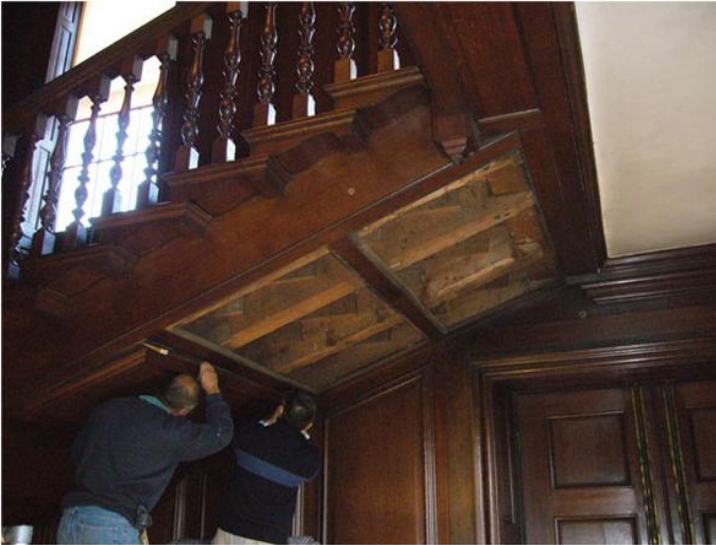
8.2 Kensington Palace, the Queen's Staircase; investigations to assess the structural integrity of this late seventeenth-century staircase. (Lee Prosser)

drastic response. For example, the appearance of beetle flight-holes is often met with panic and a standard response to spray or treat timber with chemicals, which might be wholly inappropriate for historic fabric. It is far better to weigh up possible solutions carefully and take expert advice for the best outcome, both financially and to benefit historic fabric. At Kensington Palace, small splits in the heavy decorative panelling of the Queen's Staircase were noticed. The cause was thought to have been the frequent movement of heavy objects like pianos from the ground floor to the State Apartments for functions and events. Before any remedial action was undertaken, the soffit panels were removed with the necessary permissions, and a structural engineer observed the exposed carriage beams with a piano being carried up and down. Normally a failed carriage beam might require strengthening with steel at considerable cost, but in this case it was concluded that the beams were flexing within normal tolerance, suggesting that the splits were natural, or caused by some other agency such as excessive central heating and dry air. In the event, the problem was not serious, but nevertheless, guidelines were modified, the heating turned down slightly and the movement of heavy items is now more closely supervised than before (Figure 8.2).

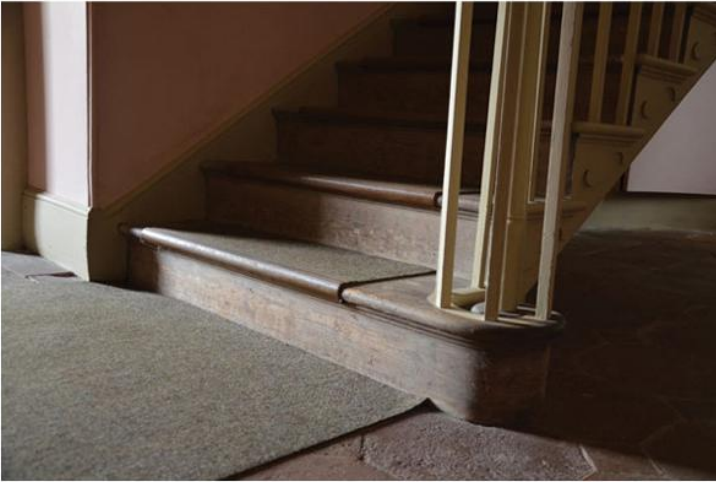
8.3 Mid-1970s carpet and nosings to a staircase of 1771, though originally installed in order to protect the timber, have proved irreversible due to the use of synthetic adhesives. (Lee Prosser)

against hazards and also cushioning the stair against vibration. There is also good historic precedent from the eighteenth century onwards for carpeted stairs; an early sign of affluence. However, carpets should be chosen and laid with care. Many have impermeable synthetic foam backing layers, which could cause ‘sweating’ and the trapping of moisture, and in time disintegrate, releasing chemicals which may react with the underlying surface. Similarly, more natural fibrous carpets or rugs can abrade stone and wood alike if not backed with a sympathetic, natural material. The method of fixing a carpet should also be chosen carefully. Stair-rods may require new and intrusive fixings, but modern adhesives are also unpredictable over time. On less important or service stairs, metal nosings and linoleum or synthetic coverings are often employed to prevent slipping and provide a protective cover, allowing more extensive wet cleaning where stairs are exposed to heavier use. These can be damaging, especially when metal strips need to be nailed or screwed into the treads, and modern glues are used, but less damaging alternatives are available. A thin protective carpet laid on the 1770s staircase at Queen Charlotte’s Cottage in the 1960s was stuck with modern synthetic glue which has failed in its original purpose, but also defied recent attempts to remove the residues. This illustrates the need for an assessment of reversibility in advance of any new or replacement measure (Figure 8.3).
