Staircases

HISTORY, REPAIR AND CONSERVATION

Editors: James W. P. Campbell and Michael Tutton
Managing Editor: Jill Pearce

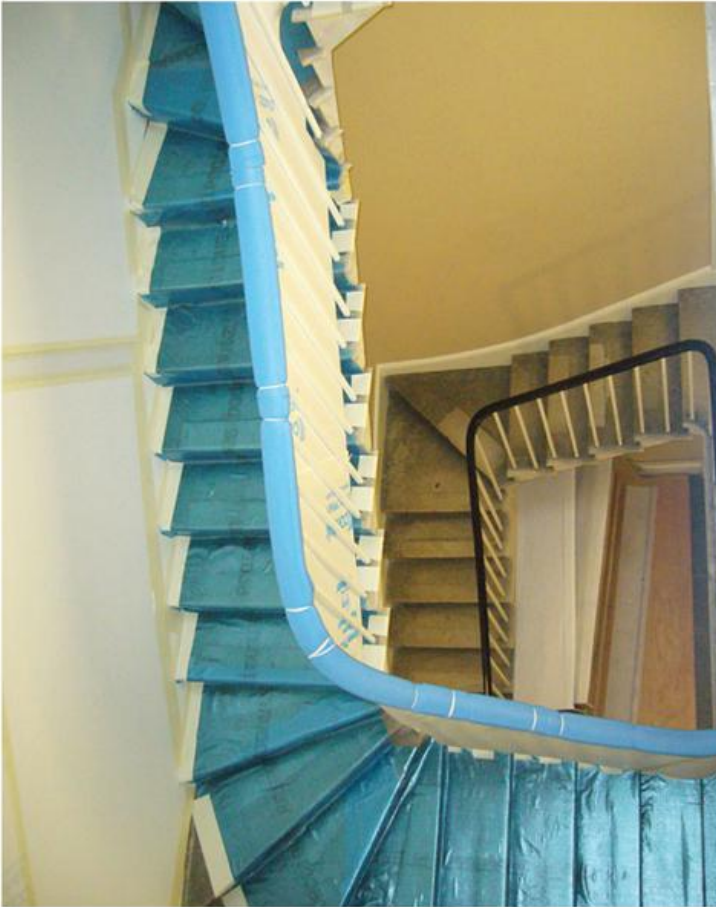
8.4 Protection in place during building works. This included pre-cut foam, applied to the handrail with cable-ties, ‘correx’ sheeting on the balustrade and a waterproof, plastic-coated textile, similar to carpet protector, applied over a floor fleece, itself held in place by low-tack tape for maximum reversibility. (Lee Prosser)

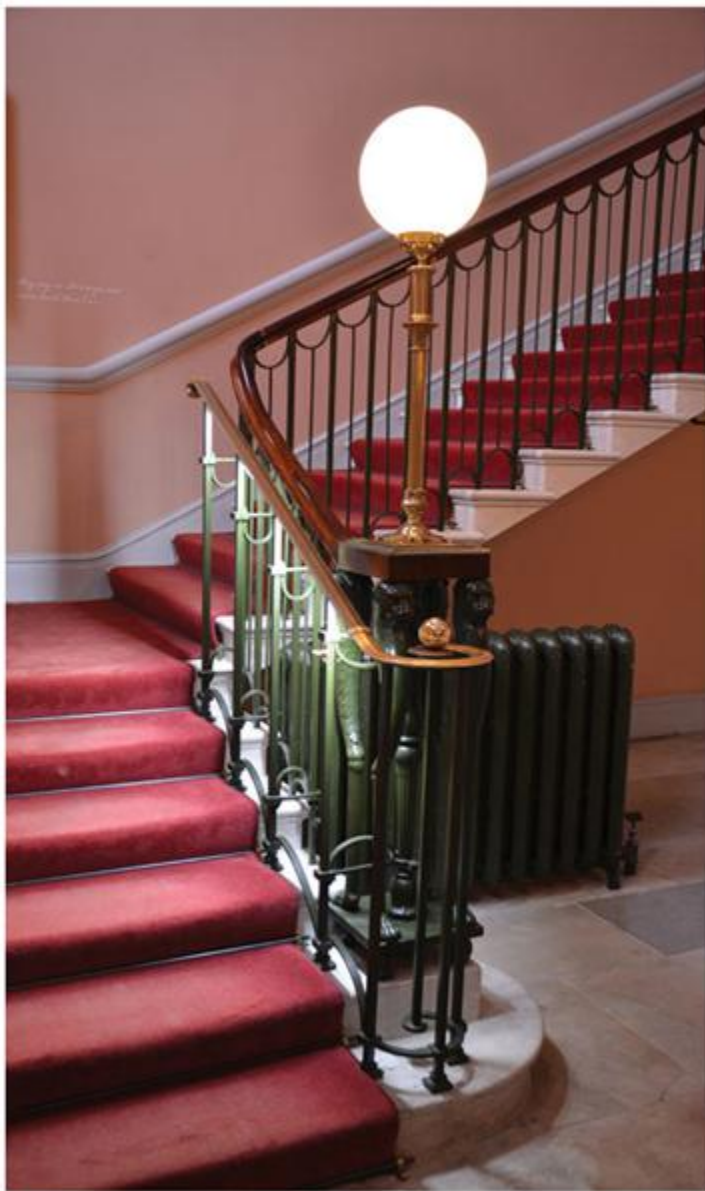
8.5 Kensington Palace, a secondary, reversible handrail added to a stair of 1807. The new balusters rest on the stone treads, and no other fixings are used. New is distinguished from the old by the use of different materials. (Lee Prosser)

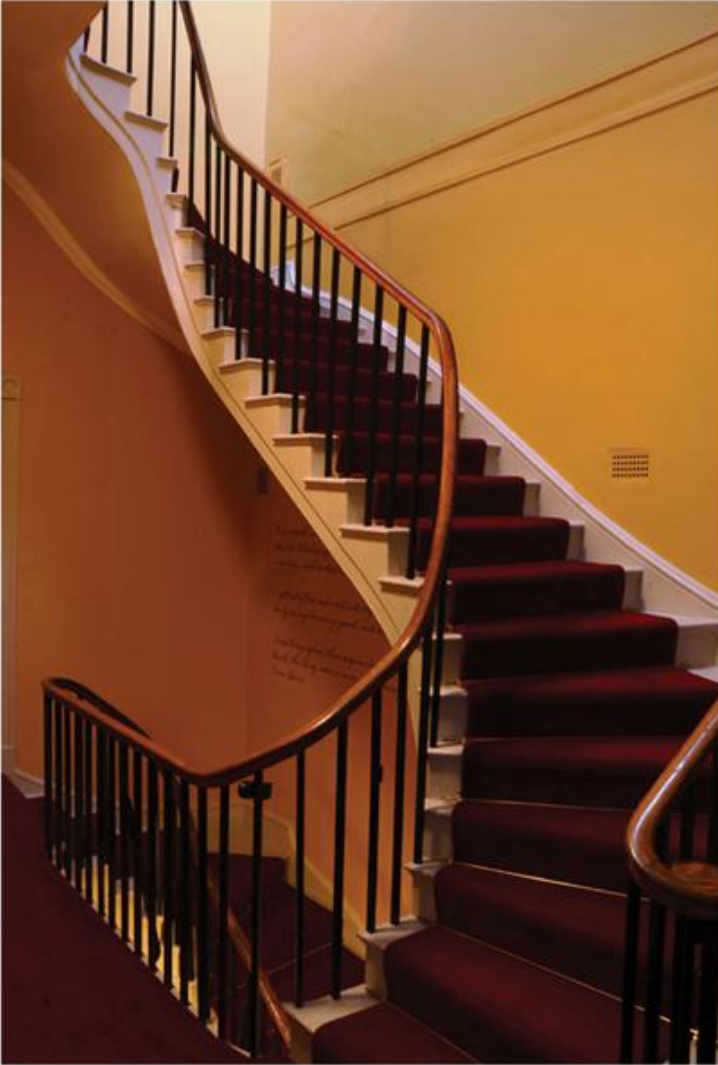
8.6 The steepness and flimsy construction of this staircase of 1819 created hazards, but its importance ruled out excessive strengthening measures. (Lee Prosser)

There are no firm and fast solutions to these problems, as each staircase presents its own problems and the many aspects of safety are beyond the scope and competence of this chapter. Owners should apprise themselves of any legal obligations with professional advice, and consult a conservation surveyor to consider options and alternatives. In almost all cases there are usually sympathetic, reversible alternatives which can achieve the same effect without the need to intervene in the historic fabric. Two examples from Kensington Palace illustrate the dilemma. The Red Stair is an early nineteenth-century domestic back stair, constructed by the architect John Nash in 1819, which was brought into general use as a convenient way to allow visitors to climb through three floors to follow the public route. The staircase is elegant and steeply ramped, but also fairly insubstantial, and within a short while sheer numbers had loosened many elements of the timber balustrade and caused cracks in the plasterwork to the underside, suggesting some form of structural stress or even failure. Possible solutions were examined, and remedial measures, such as the addition of balustrade brackets, the insertion of steel supports and a secondary handrail, were recommended. However, these interventions were considered too damaging and were rejected; instead the staircase was taken out of the public route and returned

to its earlier occasional use by staff who were aware of its fragility and limitations ([Figure 8.6](#)).

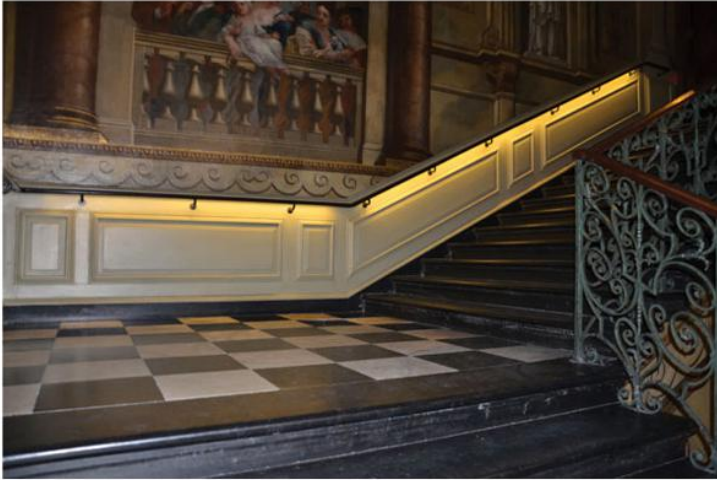
8.7 Kensington Palace, the King's Staircase. A secondary handrail, added for safety, accommodates an adjustable LED lighting system, though in such a sensitive space, the light levels need to be policed closely. (Lee Prosser)

Luckily, this could easily be accommodated, but the monumental 1690s King's Staircase was another matter, which could not be solved so easily. It has black marble treads, combined with low levels of natural light in order to protect extremely important wall paintings by William Kent. Several accidental falls and the use of the important ironwork balustrade for two-way traffic demanded a reassessment of safety measures which would respect the historic importance of the staircase while protecting and facilitating visitor safety. Monitoring and a full study of the historic fabric ruled out any intervention of the stair treads themselves, but showed that the dado panelling against the wall was probably of nineteenth-century date, and so considered of less historic importance than other elements. Consequently, a secondary handrail was bolted through the panelling to the underlying brickwork. Light levels were raised on one flight by modifying artificial light from a chandelier, while the darkest flight was illuminated from a small track of LCD lights beneath the new handrail. In this way, a sacrificial element – in this case the new handrail – could be modified in future when repairs or improved technology demanded further intervention, leaving the historic elements untouched. Monitoring continues, both to assess the effectiveness of the new measures, but also the additional pressure on the staircase, and possible extra

cleaning or protection which may need reassessment (Figure 8.7).

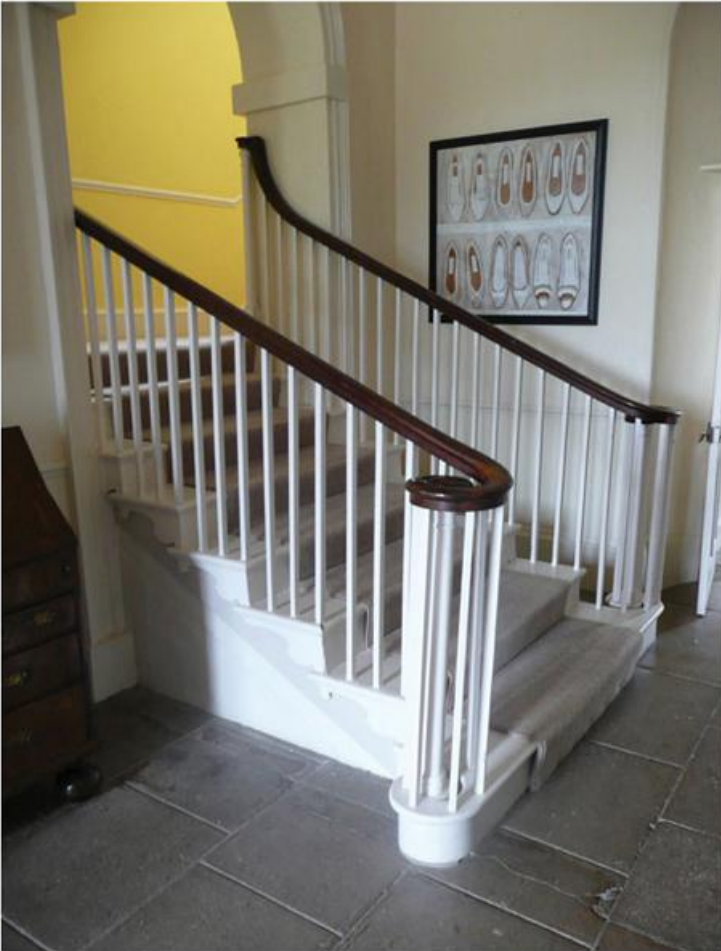
9.6 Dauntsey Park staircase before intervention. (Donal Channer)

The plan of this stair had been altered during a previous rearrangement of the circulation of the house at some point in the 1960s. The large open well had been filled in and floored over at the main landing level and the bottom flight turned through 90 degrees and inserted in the archway ([Figure 9.6](#)).

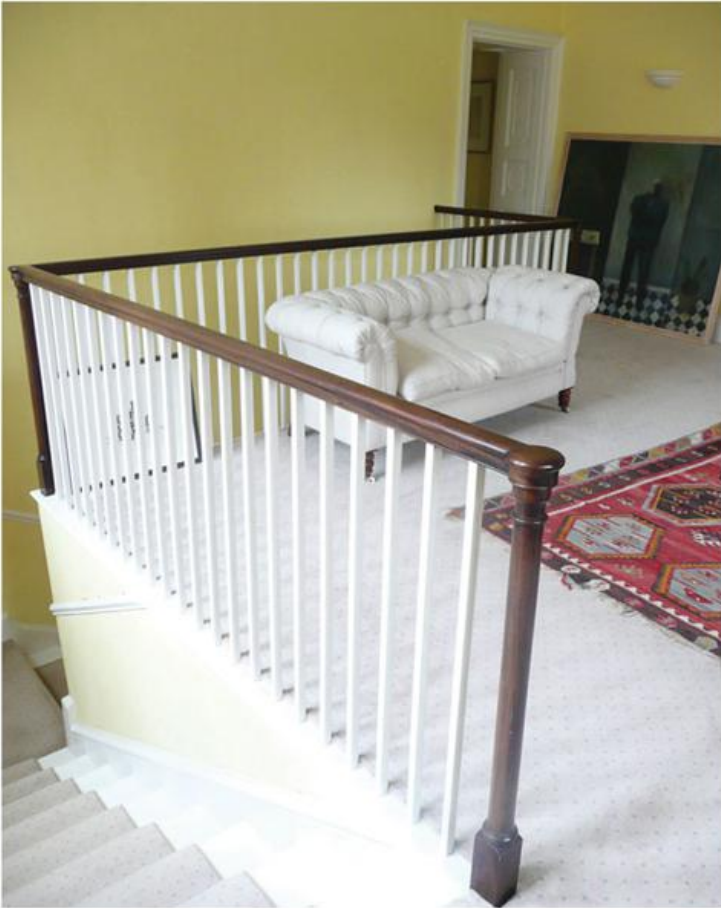
9.7 Dauntsey Park staircase, first floor with well infilled. (Donal Channer)

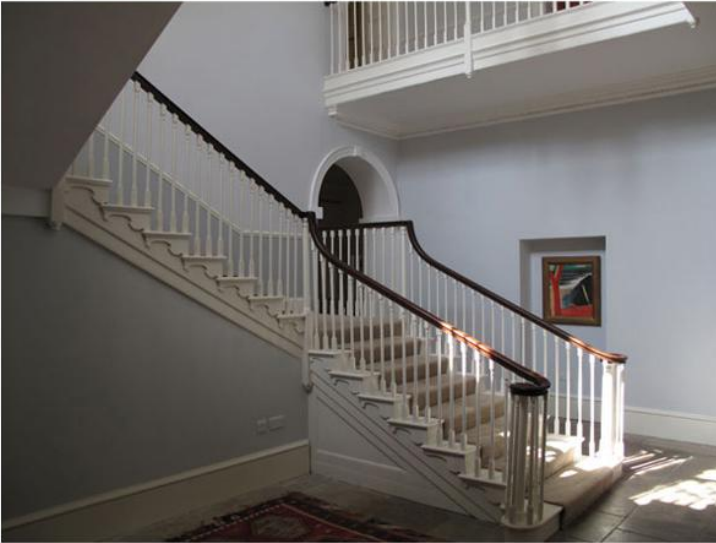
9.8 Dauntsey Park staircase at completion of adaptation works with open well. (Donal Channer)

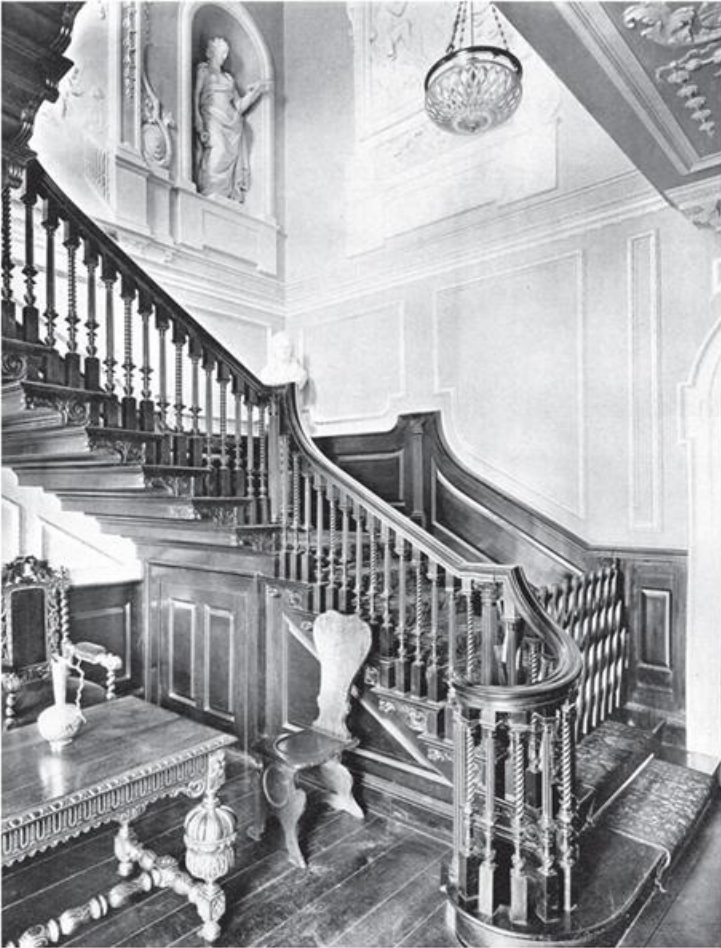
9.9 Pre-1920 photograph of the staircase at Queen Square. (Arthur Stratton, 1920, *The English Interior*)

An old photograph shows a three-flight cut-string stair with finely carved tread end brackets, an extended curtail step and a bottom flight enclosed with a spandrel panel and a cupboard (Figure 9.9). In the second and third flights the profile of the underside of the steps was that of the carved tread

ends, looking like cantilevered stone stairs. Other contemporary stairs have this shaped soffit but they have a panel at the end of the step with a bracket behind, which means that there is room between the steps and soffit for a carriage to support the treads and risers, but in the Queen Square stairs there was not enough space for a carriage. Inspection of the remains showed that the soffit was hollow but a string had been added below which provided the necessary structure. It also showed

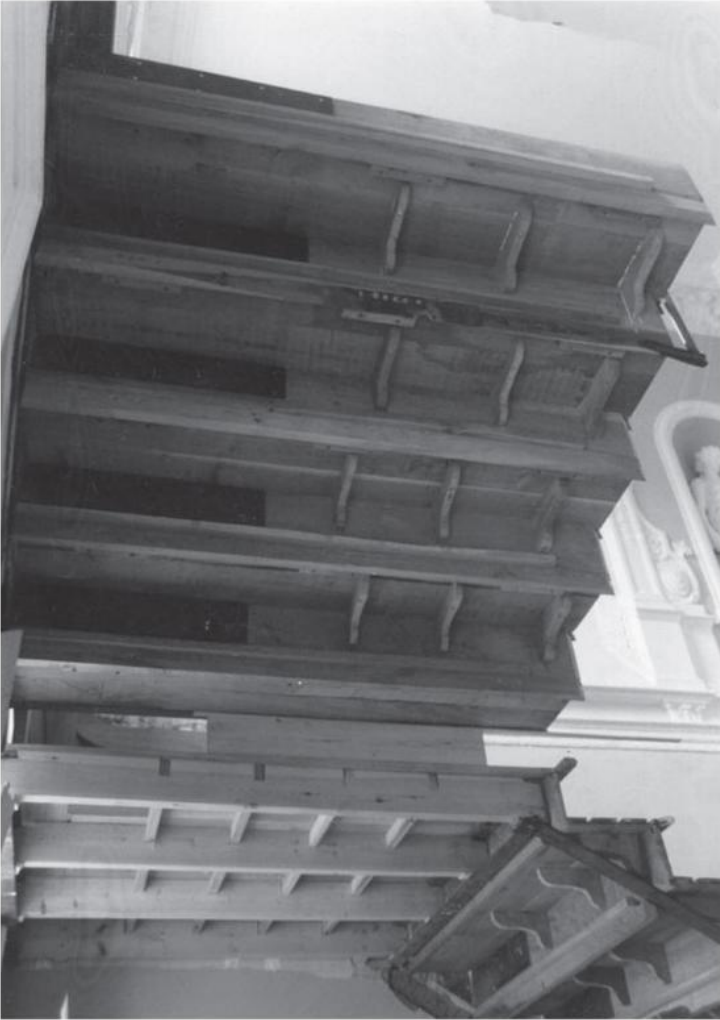
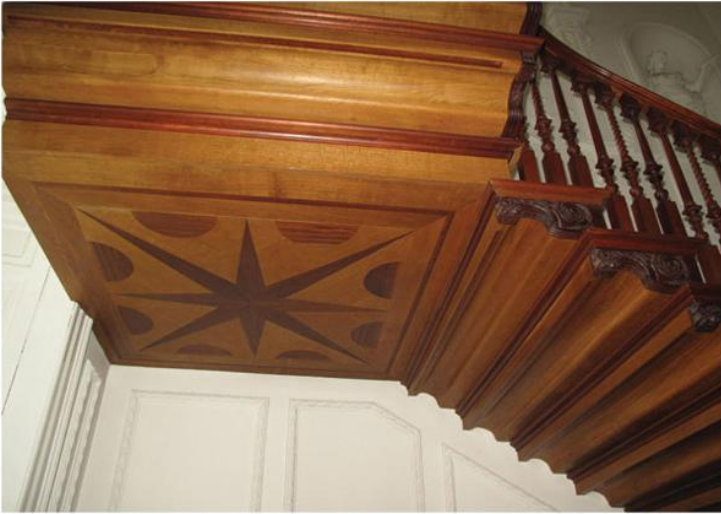
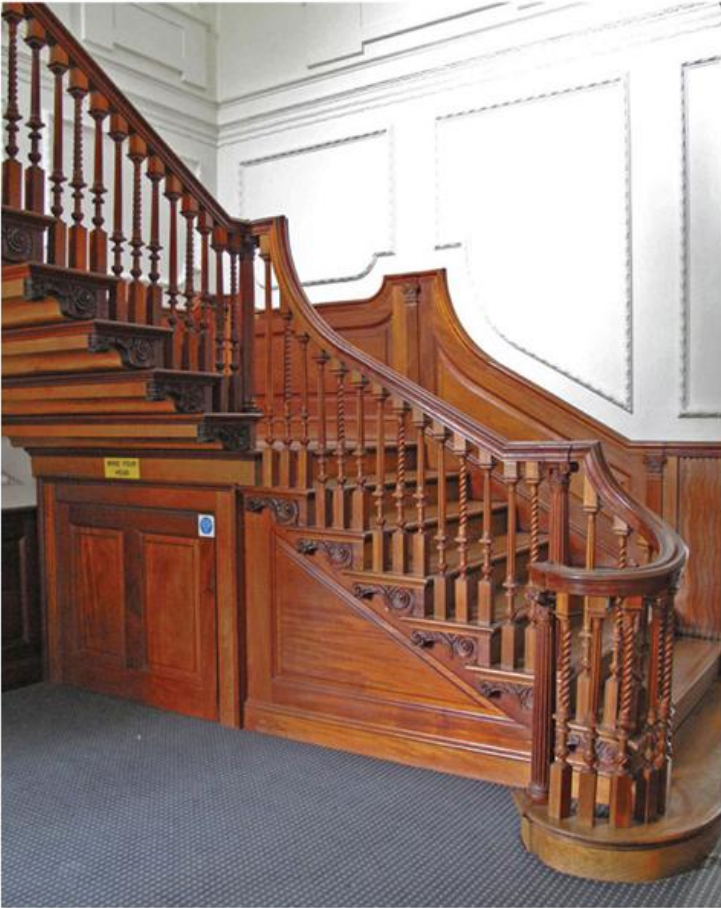
9.11 The Queen Square staircase under construction.
(Donal Channer)

9.12 Queen Square, the completed staircase showing the soffit of the second quarter-landing. (Donal Channer)

9.13 Queen Square, the completed staircase; compare with [Figure 9.9](#). (Donal Channer)

The aim was to make the stairs exactly as they were originally so they were not stained or coloured, but waxed and left to fade and darken naturally, which they have done in the 25 years since they were made and installed. Gratifyingly, the landings have small cracks where the original has cracks. (Figures 9.11–13)

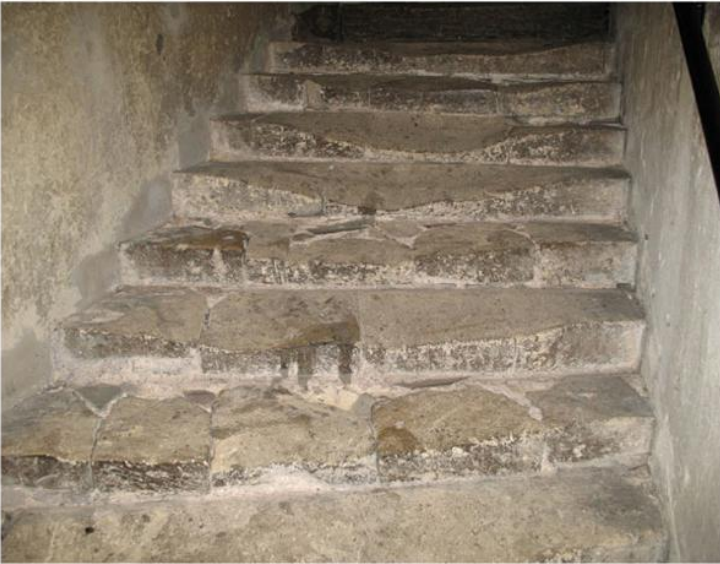
10.15 Worn treads. (Cliveden Conservation)

1. Wear through a history of pedestrian traffic forming indentation and loss, particularly to the central area of the tread (see [Figure 10.15](#)).
2. Structural movement causing vertical fractures within the tread (see [Figure 10.8](#)).
3. Expansion of the tails of ferrous baluster spindles ([Figure 10.1](#)).

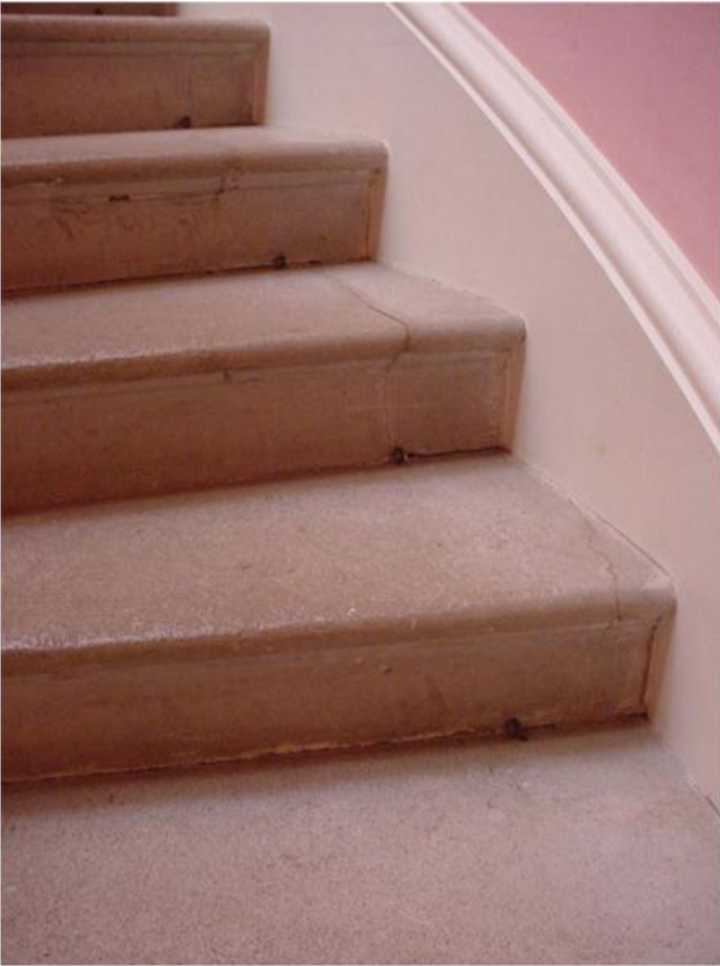
10.8 Structural movement resulting in fractured treads.
(Cliveden Conservation)

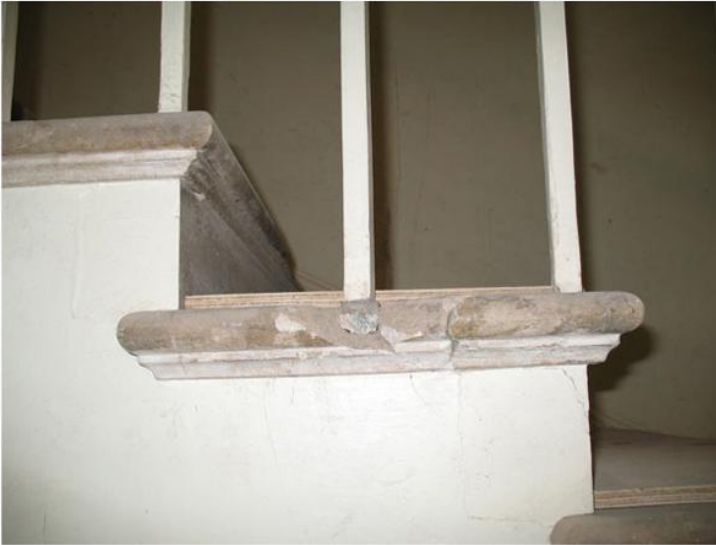
10.1 Expanding ferrous spindle tail, Sharpham House, Devon. See [Figure 10.3](#) for the finished repair. (Cliveden Conservation)

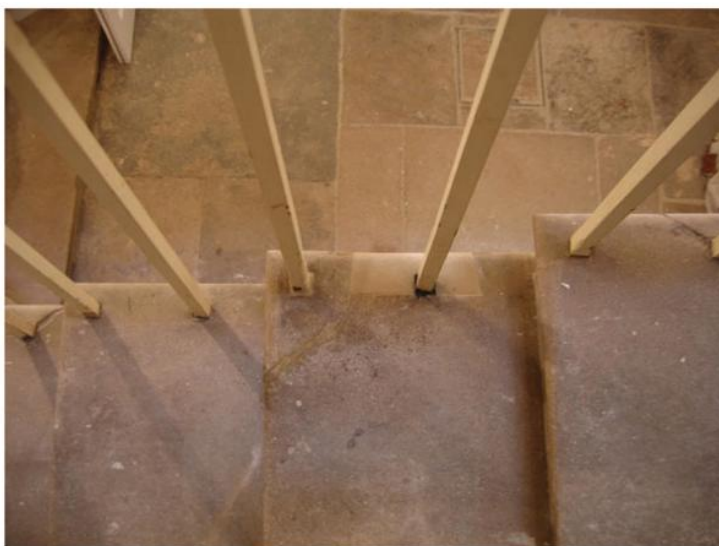
10.3 Pieced repair to nosing, Sharpham House, Devon. See [Figure 10.1](#) for the damage before repair. (Cliveden Conservation)

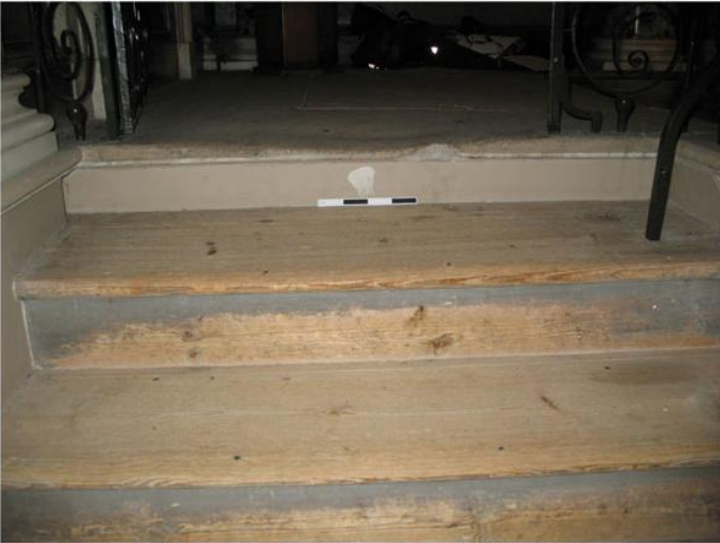
10.4 Worn top tread, Attingham House, Shropshire.
(Cliveden Conservation)

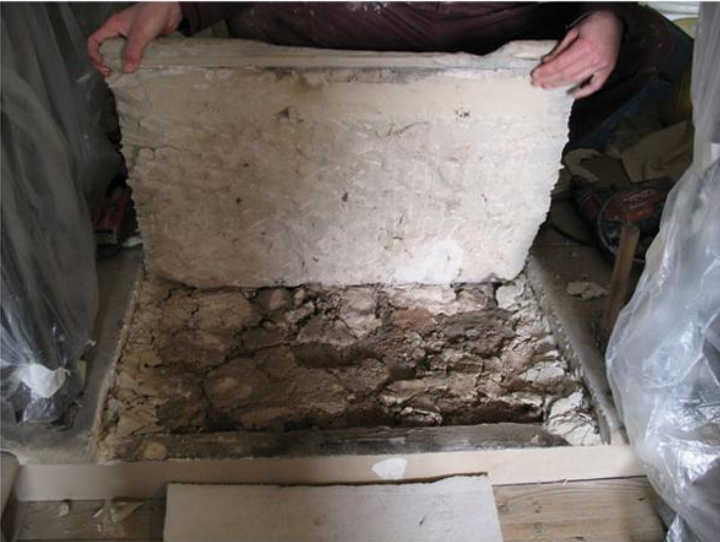
10.5 Central section of top tread released through stitch drilling. (Cliveden Conservation)

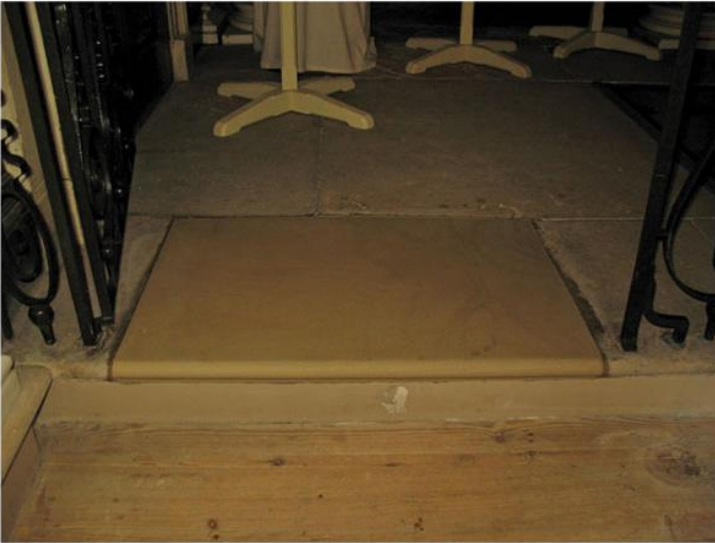
10.6 New Grinshill sandstone tread fitted, grouted and pointed. (Cliveden Conservation)

removed. The new joints can then be trimmed using hand chisels. The new stone can be prepared ensuring the original profile is accurately re-created. If the new stone is to blend seamlessly with adjacent worn flooring (as in the example below describing replacement of a top tread), it may be necessary to trim the surface to mimic the adjoining stones. With the stone prepared a full mortar bed can be prepared of a mortar appropriate to the location and situation. The stone and substrate should be thoroughly pre-wetted prior to setting. The joints, dependent on their size, should then either be grouted or pointed, with the surface cleaned before the mortar has a chance to set and leave unsightly smearing or staining.

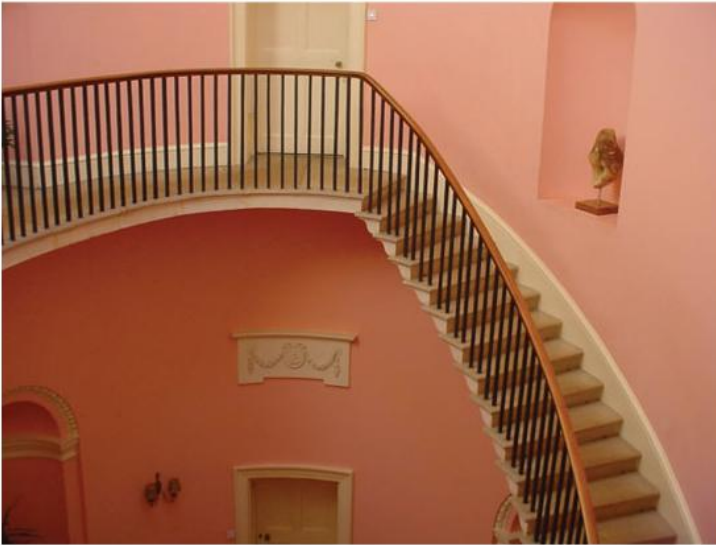
10.7 The grand elliptical staircase at Sharpham House.
(Cliveden Conservation)

It was Sir Robert's love of mathematics and geometry that helped him create this outstanding example of English Palladian architecture. His genius is most evident in the house's optically floating, elliptical cantilevered staircase – one of the most dramatic in England. The staircase is worked from fine-grained Portland limestone. The treads have a leading astragal nosing and a beautifully detailed ogee profile to their underside/soffit. The first flight leads to a 'hanging' landing and the principal rooms, from which a further flight of reduced width ascends to a higher landing.

Concern was raised primarily with regard to cracking which followed the outer wall line, to the lower treads of the lower flight of stairs. There were also a number of open ‘bed joints’ which exceeded the ideal. Following an initial stone survey that identified the defects, a structural assessment was undertaken which, following discussion with the stone conservation team, produced the specification and principles for repair.

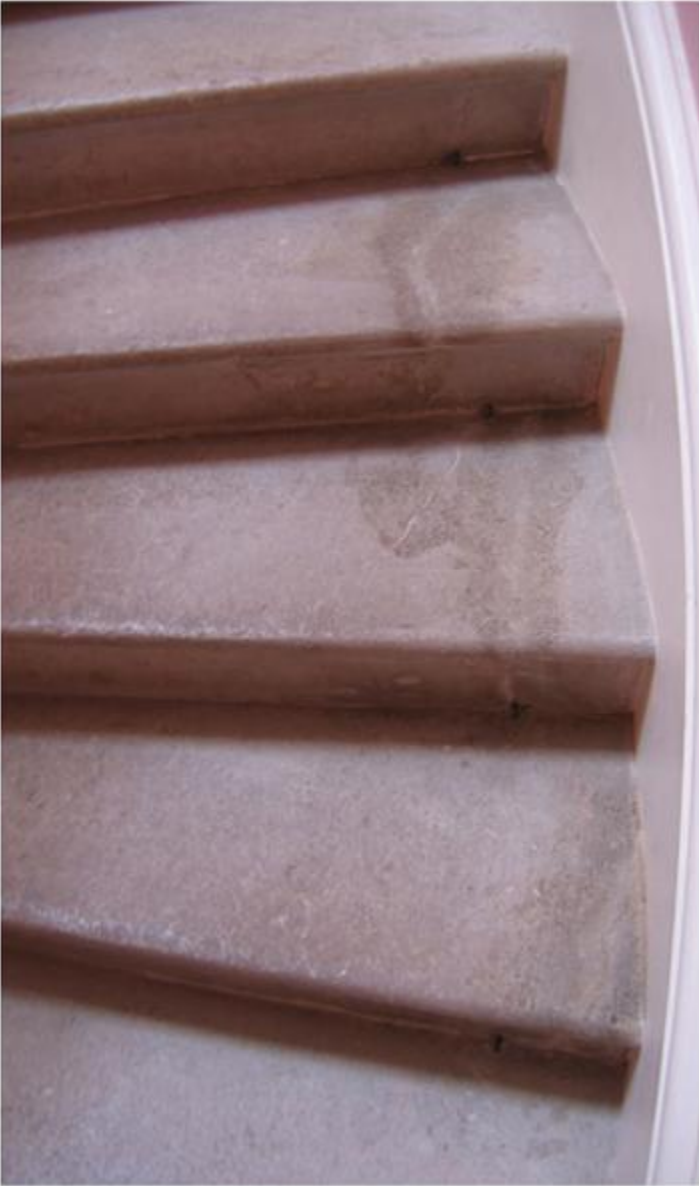
10.9 After works undertaken with surface fills completed. (Cliveden Conservation)

It was determined that the stairs were structurally sound and thought that the movement represented historic settlement; therefore a series of localised repairs were specified. These took the form of ‘cross pinning’ of the fractured treads through drilling from both below the soffit and at opposing angles from the riser. The dowels used were threaded stainless steel of differing lengths and diameters (6 mm and 4 mm). The holes were cleared using ‘bottle brushes’, residue was cleaned using a volatile organic solvent, acetone. The dowels were then set in place using an injection system of epoxy resin, which was ‘riddled’ into place using placement rods to ensure adhesion of the resin to stone and elimination of air pockets.

In conjunction with this action, the fractures were grouted. Prior to this they were thoroughly cleaned and dusted. The fissures were then flushed, initially with a solution of water and industrial methylated spirits (which acts to break the surface tension); this was followed by further water to ensure the surface did not rapidly ‘de-water’ the grout. A hydraulic lime-bound grout, based on NHL 3.5, with Portland stone dust sieved to <500 µm, run initially to a ‘thin cream’ consistency, was injected into the joints using a large-gauge veterinary syringe. Once the grout began to penetrate, the joints were stopped and packed using cotton wadding. The grout was then topped up as the material shrank back within the fissures, until this ceased.

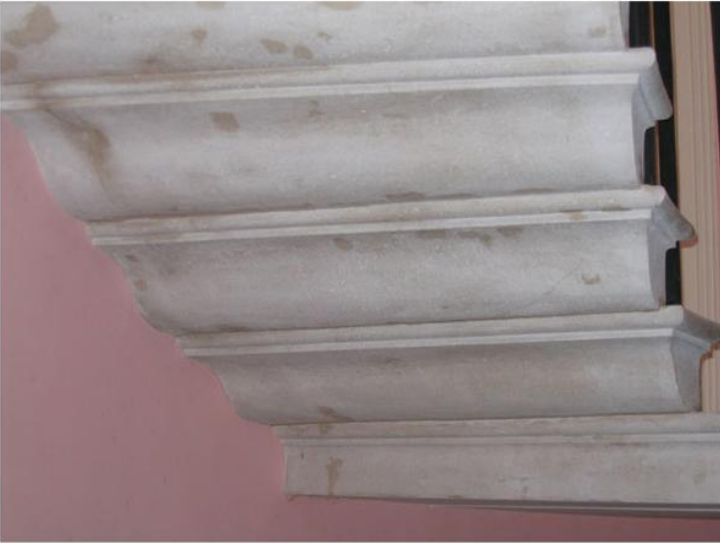
10.10 Beautifully worked soffit to stair treads, showing previous resin patch repairs. (Cliveden Conservation)

Due to the shallow nature of the subsequent fills required and the need for the repairs to withstand visitor traffic, the binder chosen was white cement, which was used in a 'weak' mix with carefully selected sands and Portland stone dust. Due to the surrounding patina and appearance of the building the surface of the mortar was toned during curing with small quantities of 'lime fast' earth pigments to minimise the visual impact of the repairs.

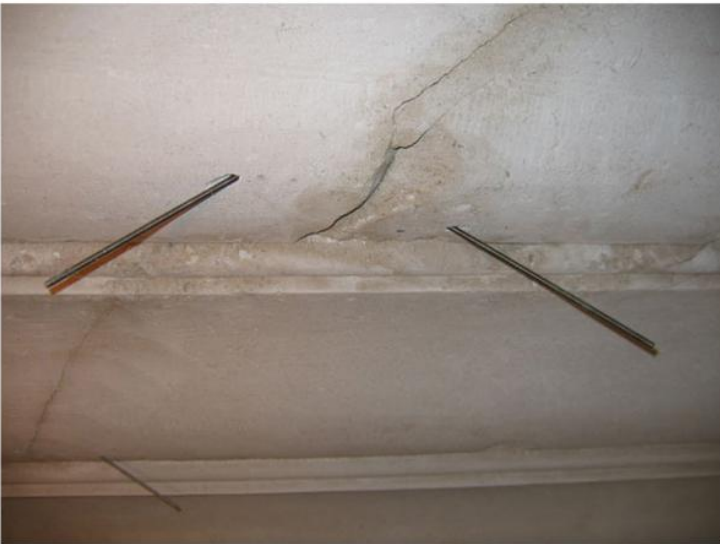
10.11 Insertion of stainless steel cross dowels.
(Cliveden Conservation)

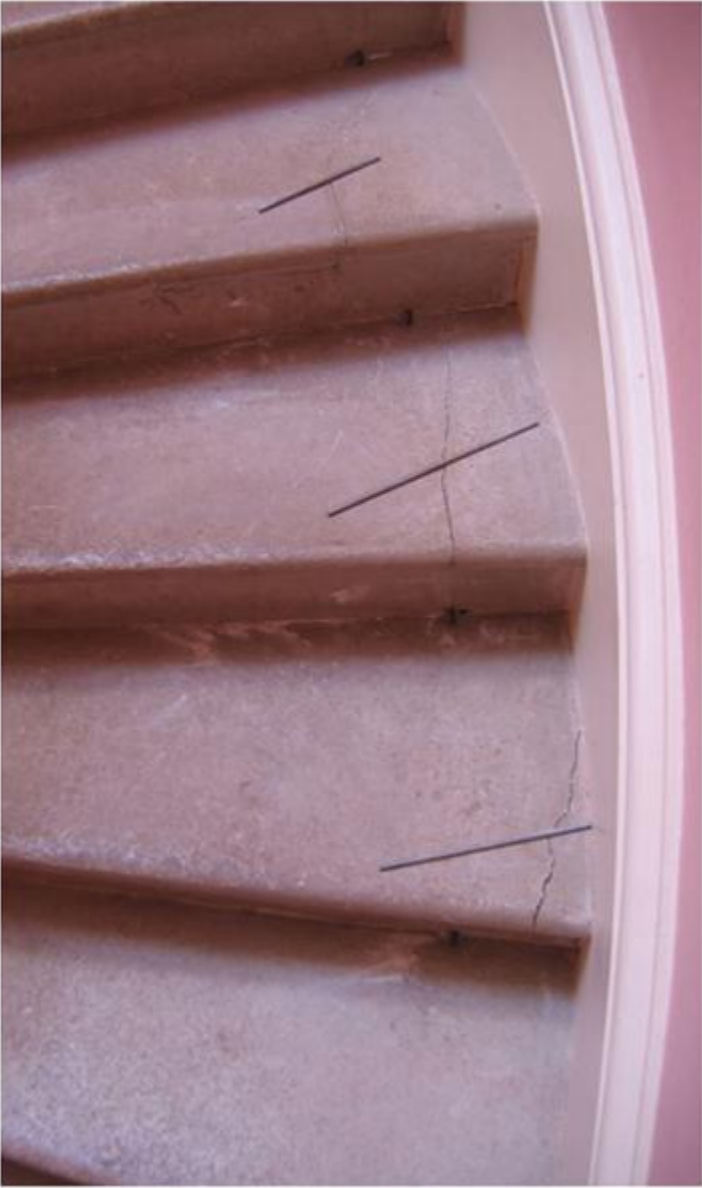
10.12 Indication of placement of dowels at risers.
(Cliveden Conservation)

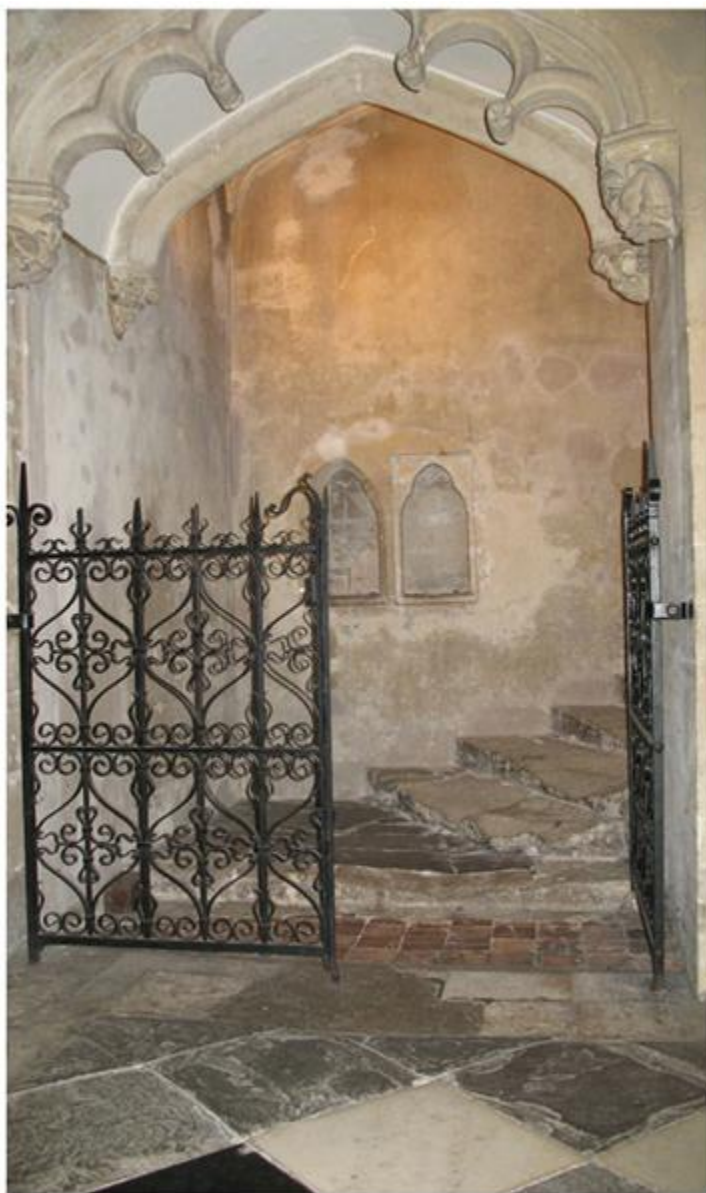
10.13 Base of stair before intervention. (Cliveden Conservation)

The construction of the stairs appears largely to belong to the original phase of building, which is reflected in the generally even wear pattern. Despite this pronounced wear to the stairs, the treads remain well secured and it was only the fill material to the treads and pointing to the risers that required attention.

The topography of the steps illustrated the level of traffic to which it had been subject over its lifetime. The pattern of wear was, as one would expect, principally down the centre and along the leading edge of each step.

The principal areas of concern regarding the condition of the stairs as a whole related to the widespread and general loss of mortar from joints between the stonework. Although heavily worn, the underlying structural stability of the stairway was sound.

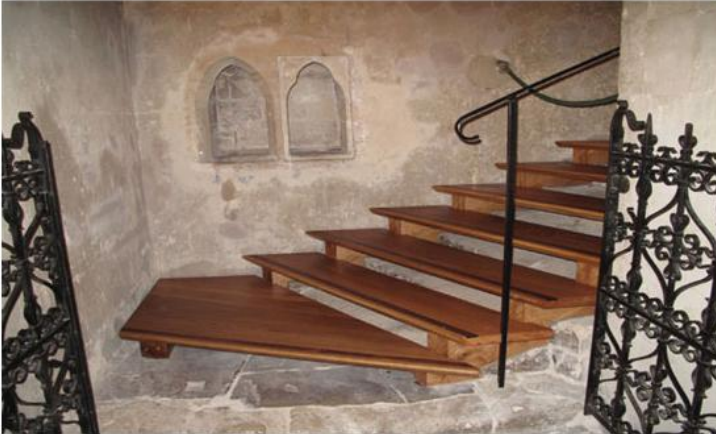
10.14 New stair in place. (Seymour & Bainbridge)

The much worn stone stair wasn't safe to use but the timber stair over provides even treads.¹³

The oak stair was designed with treads supported on two strings, which were carefully scribed to fit the profile of the stair, with a minimal number of fixings into the stonework. A layer of inert padding, Plastazote©, was used to separate the oak from the stone and to take up undulations. The treads were kept clear of the walls so that they float over, rather than cover the stonework, which remains visible,

and can be vacuumed. The timber stair is designed in such a way that it can be taken away with only the fixing holes to be made good.

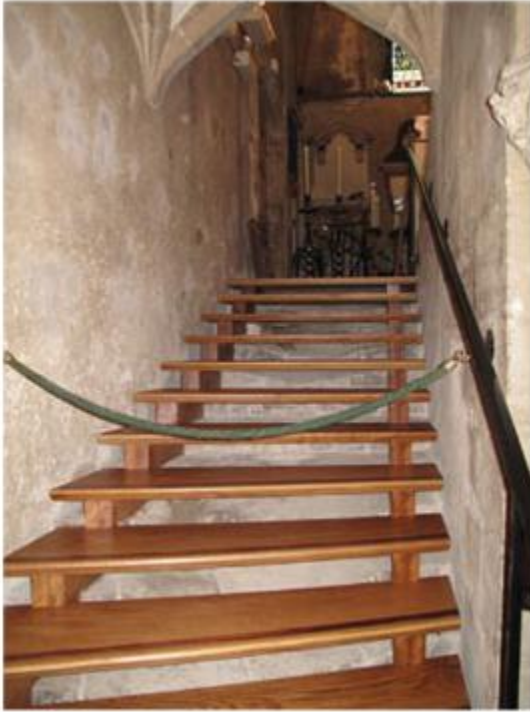
10.16 New stair. (Seymour & Bainbridge)

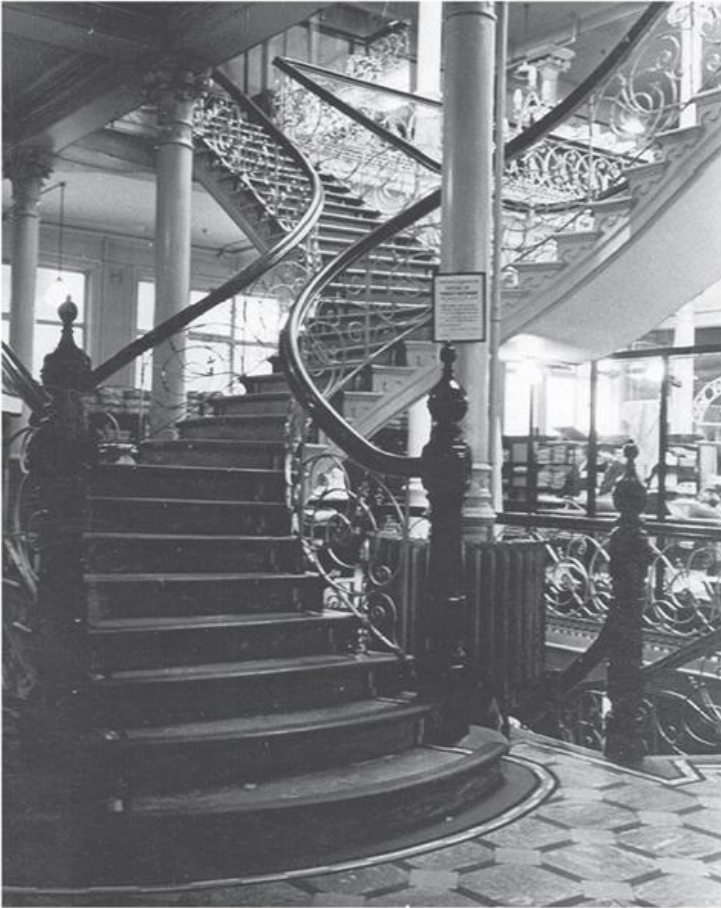
11.1 Switzers Store, Grafton Street, Dublin. A fine example of a decorative staircase, apparently unsupported, which can only be constructed by using the strength and malleability of an iron or steel core. (James Sutherland)

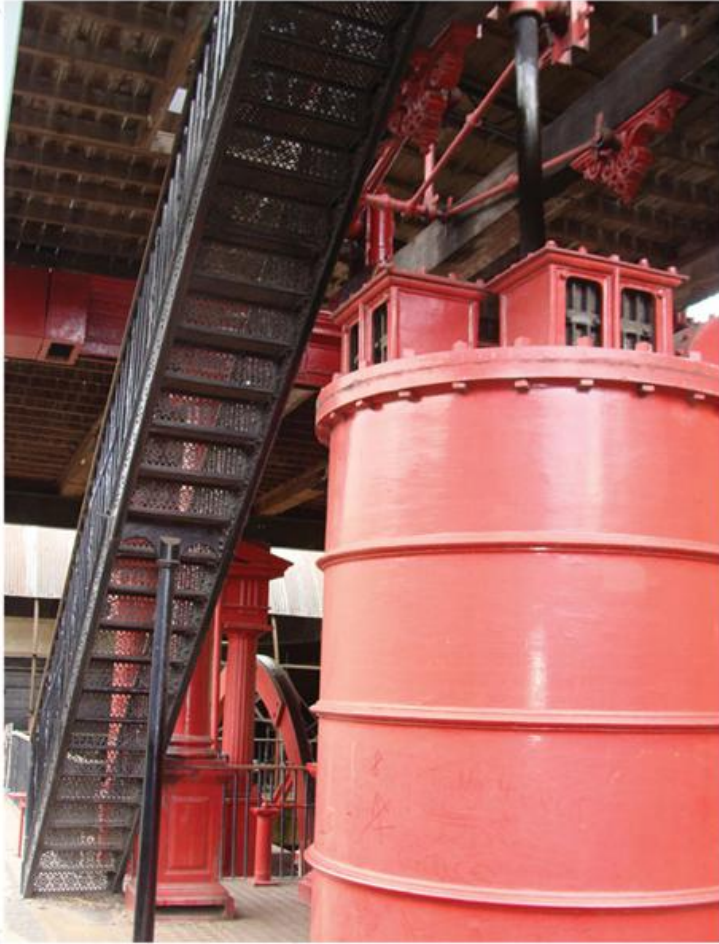
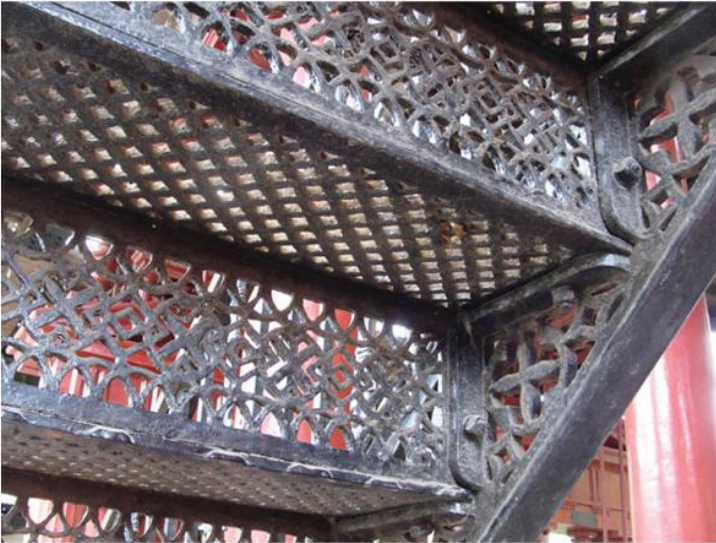
11.2 David and Sampson blowing engines, Ironbridge Gorge Museum. An exceptionally long cast-iron staircase giving access to the upper floors of blowing engines manufactured by the Lilleshall Company Ltd in 1851. (Geoff Wallis)

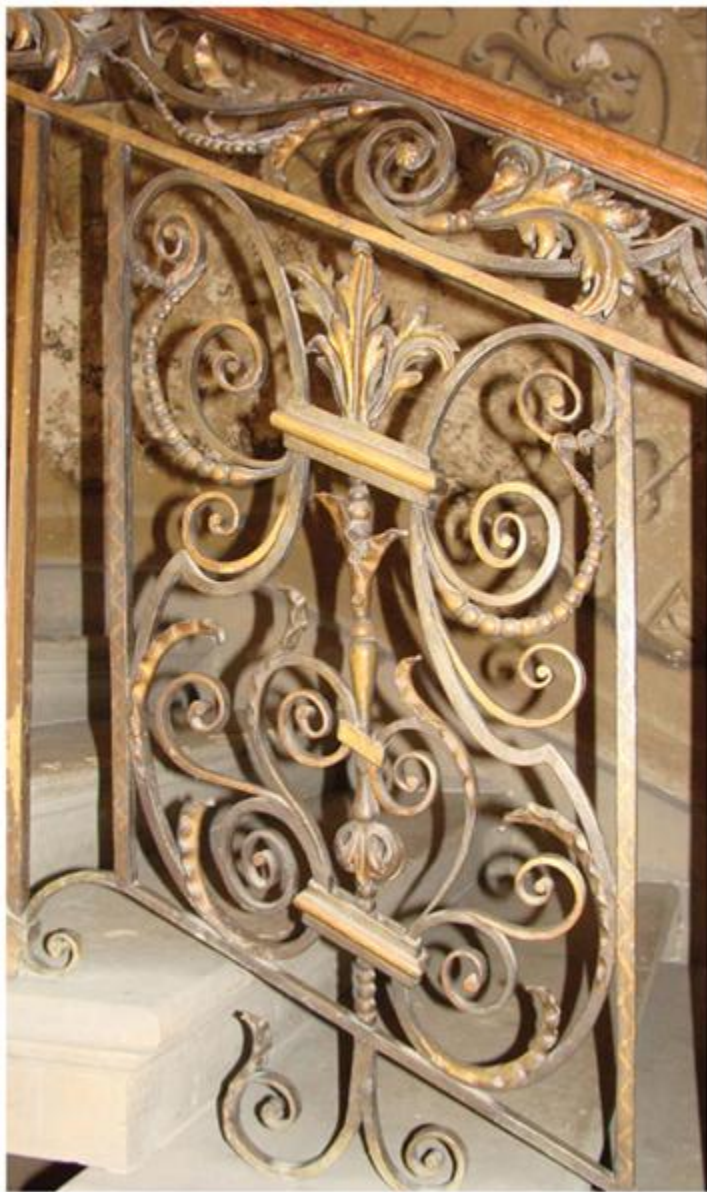
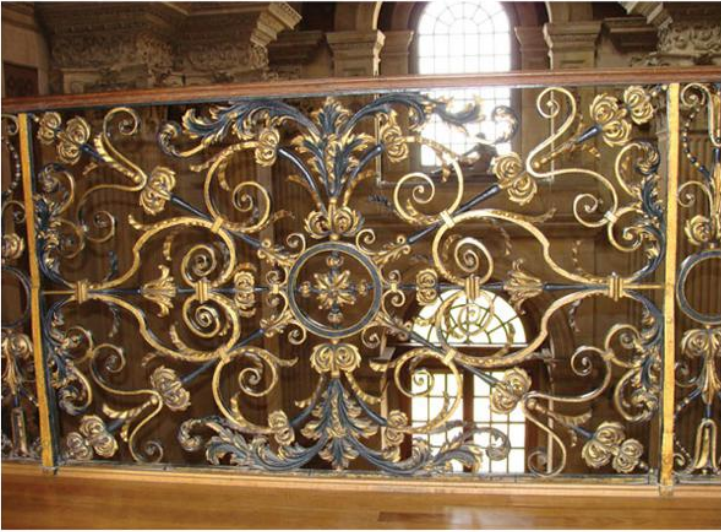
11.3 Castle Howard, York. The most decorative balustrades were commissioned by the nobility and gentry as a sign of status and wealth. These early eighteenth-century balustrades are forged by a master blacksmith using only wrought iron. Scrolls, water-leaves, beading and acanthus leaves are riveted or fire-welded together or secured by decorative collars. Panels are assembled into frames secured between the stair treads and an iron core-rail, which carries a moulded mahogany capping or handrail. Much early paint and gilding survives, which is of the same historic significance as the ironwork itself. (Geoff Wallis)

The non-ferrous metals such as copper, lead, zinc and, later, aluminium are weaker than the ferrous metals, so were usually used only decoratively on balustrading. Gilding was also an important decorative element on balustrades (Figure 11.3).

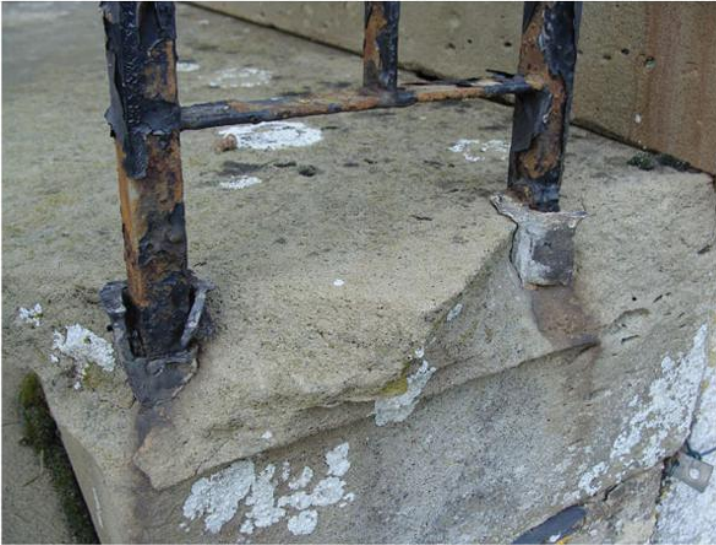
11.4 Damage to stonework. Typical failure of a stone tread due to rusting of outdoor wrought-iron balusters. After the ironwork has been removed, a new piece of stone may be doweled to the end of the tread. If additional strength is required, recycled wrought-iron extensions may be welded to the balusters. After cleaning and painting, ironwork is re-fixed in new holes, secured by molten lead poured in and dressed tight. (Geoff Wallis)

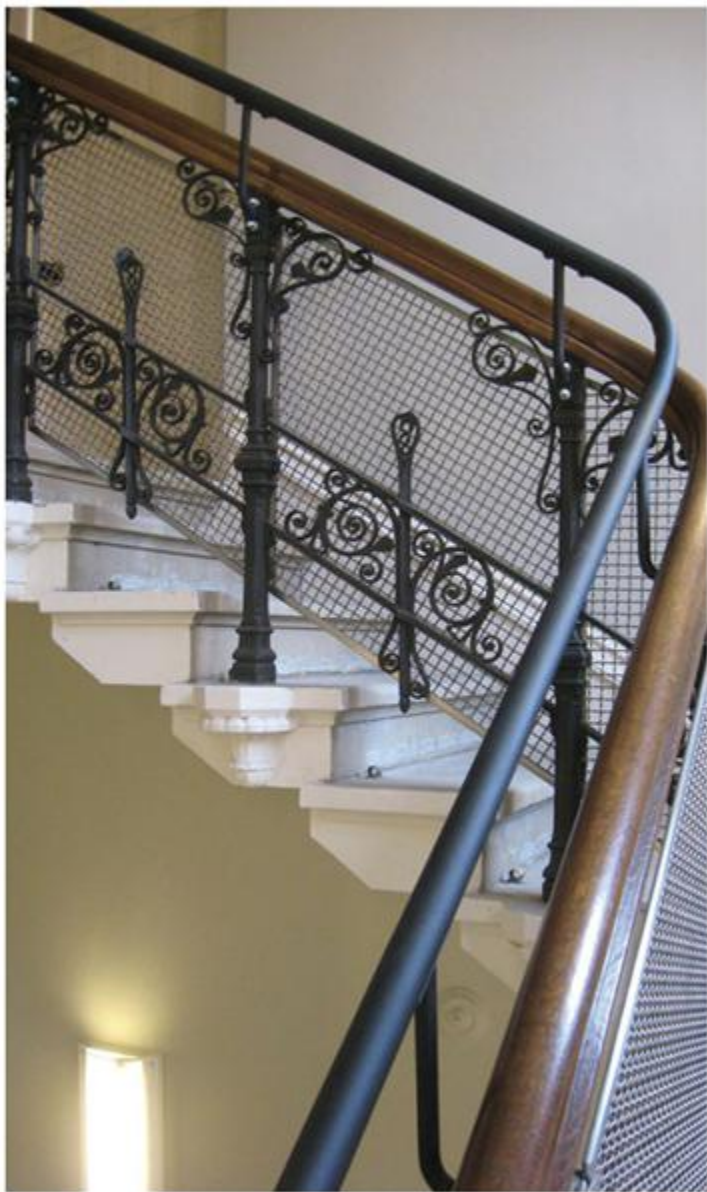
11.5 St. Pancras Chambers, Kings Cross, London. Historic balustrading may fall below the safety standards reasonably expected on staircases nowadays, but upgrading can be difficult and obtrusive. Here, a traditional woven mesh has been added to reduce the size of voids, and a secondary handrail clamped on to raise handrail height, both being reversible additions. (Michael Bussell)
