Staircases

HISTORY, REPAIR AND CONSERVATION

Editors: James W. P. Campbell and Michael Tutton
Managing Editor: Jill Pearce

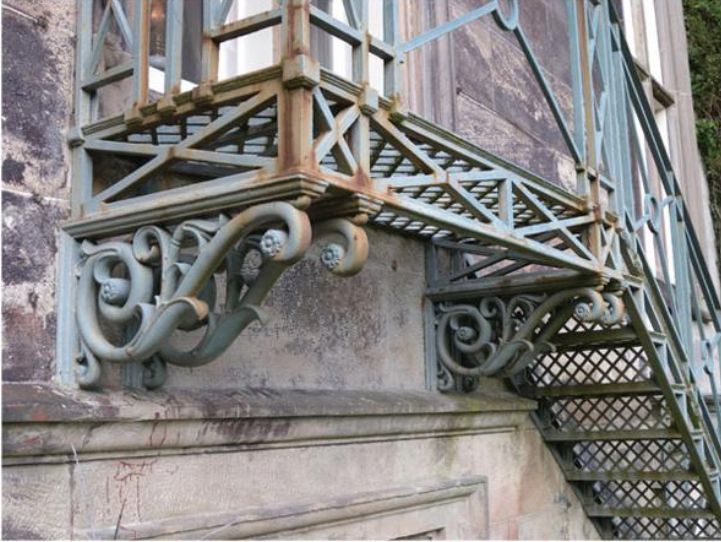
11.6 Muckross House, County Kerry, Ireland. Rust staining is unsightly but not damaging, and does not require metalwork to be dismantled, which should be confined to situations where components or their joints are structurally unsound and cannot be treated *in situ*. (Rupert Harris Conservation)

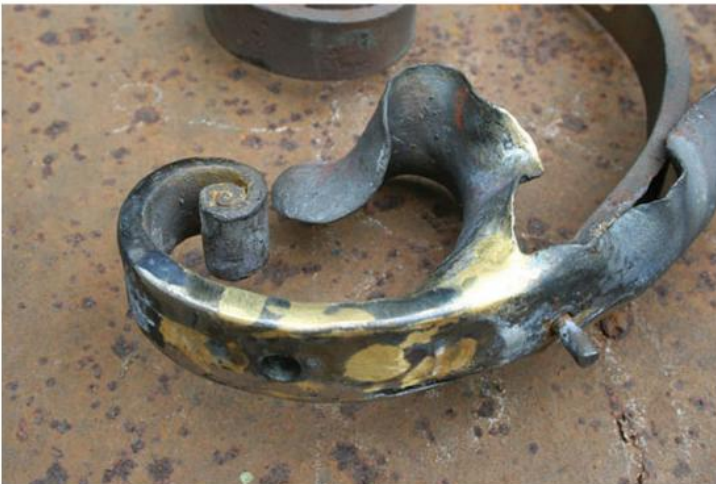
11.8 Repair to a wrought-iron balustrade component. Decorative wrought ironwork subject to severe corrosion

can be repaired by use of gas or electric welding techniques. Components should be renewed only as a last resort, using the original material. (Chris Topp)

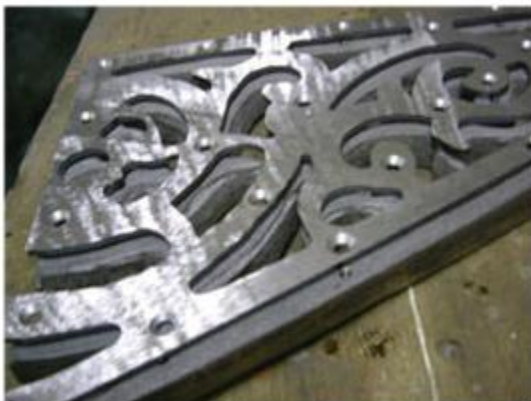
11.9 Regent's Quarter, Kings Cross, London. As part of a major refurbishment, cast-iron staircase treads needed to be strengthened and cracks repaired unobtrusively. The outline of the original tread was traced and followed by an automatic laser-profiler to cut strengthening plates from 3 mm steel exactly matching the originals. These were painted and bonded to the underside of treads, secured by small countersunk machine screws. The sizing and siting of fastenings drilled into small sections of cast iron must be chosen carefully to minimise the weakening of the component being strengthened. (Geoff Wallis)

A strong and discreet repair can often be achieved by bolting a steel or brass plate across a cracked cast-iron component on a hidden face ([Figure 11.9](#)). Plates must be bedded on red lead or on a two-pack epoxy putty to exclude water, and can be secured with countersunk screws flush with the surface for a neat appearance. Repair plates can often be sited on the insides of staircase strings, on the back faces of risers, and under treads. Pierced risers and treads can be plated unobtrusively by use of a thin plate containing holes cut out on an automatic gas or laser profiler.

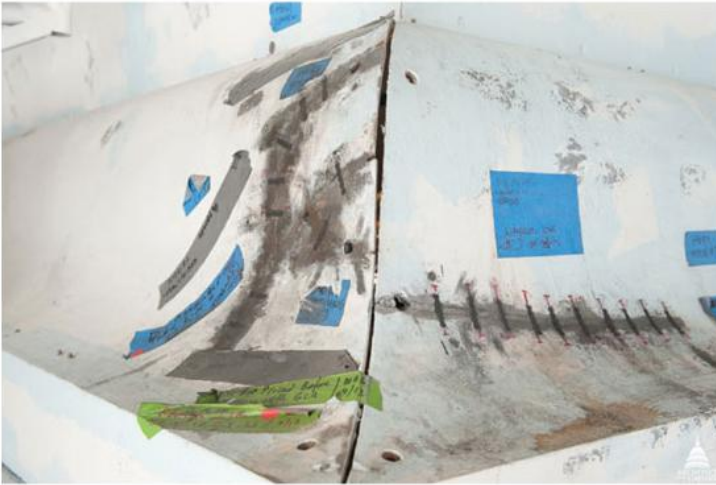
11.10 Example of metal stitching. This is not part of a staircase but shows repairs to the dome of the US Capitol building, Washington, DC, which clearly shows the process. ('Architect of the Capitol' US government work, www.flickr.com/photos/uscapitol/7203655282/in/photostream)

Stitching is a modern version of a traditional technique for repairing cracked cast iron. Holes are drilled across the crack and slotted, and then a ferrous lock or 'stitch' is driven into the slot to tie the sections together. Further slots and stitches are installed across the crack, which is then sealed with interlocking studs screwed in ([Figure 11.10](#)).

The process offers the advantage of requiring only portable hand tools, so is safe to use on historic sites. The repair is hermetically tight without the use of sealants, is heat-resistant and is invisible on completion, all stitches and studs being set within the thickness of the repaired metal.
