Handbook of Materials Failure Analysis

With Case Studies from the Aerospace
and Automotive Industries

Abdel Salam Hamdy Makhoul

Mahmood Aliofkhazraei

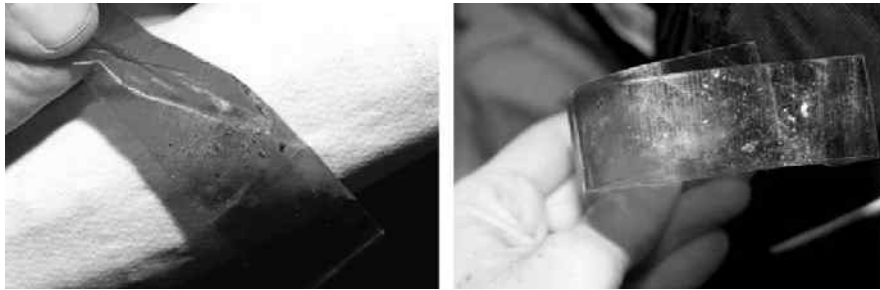
FIGURE 3.4

On-orbit images of debris samples on polyimide tape that needed to be returned to Earth for failure analysis.

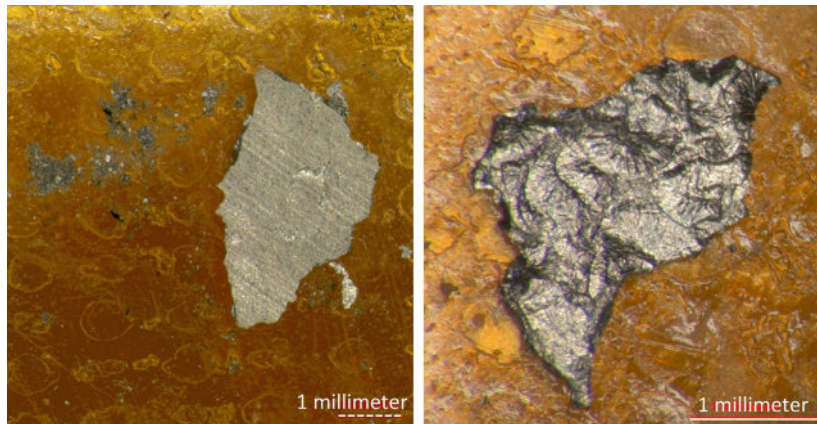
FIGURE 3.6

The three pieces of polyimide tape collected by astronaut Tani and returned to Earth were photodocumented and initially observed in a stereomicroscope. The particles sizes for the debris ranged from very fine particulate less than 100 μm up to approximately 1 mm. The first significant observation was apparent machine markings still present on the surface of some of the larger fragments and fracture features visible on other fragments (Figure 3.6). Additionally, the debris was classified as fine particulates, flattened agglomerations, and large chips. The debris had a slight magnetic response [13].

Stereomicroscopic inspection revealed that the shards included both original surface finish (left) and fracture features (right).

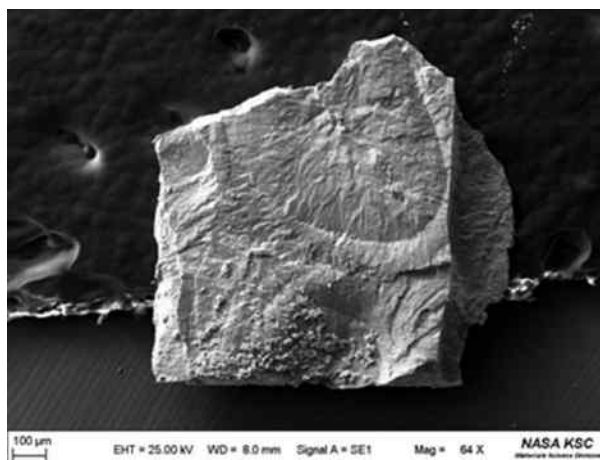
FIGURE 3.7

SEM observation of the debris revealed the clues that started to tell the story about what had happened to the SARJ race ring. The machine markings on some of the larger fragments were again confirmed via the SEM and when one of these fragments was flipped over, fracture features were revealed. The debris shards displayed classic evidence of Hertzian contact stress failure, with fracture paths parallel to the outer surface [14]. These fracture features were relatively brittle in nature, resembling a progressive failure with crack arrest marks clearly evident (Figure 3.7). Niobium-rich precipitates, verified via EDS and typical for this alloy, appeared at the subsurface initiation sites of the fractures.

SEM micrograph of a larger starboard SARJ chip showing subsurface crack initiation at Nb-rich precipitates and crack arrest marks.

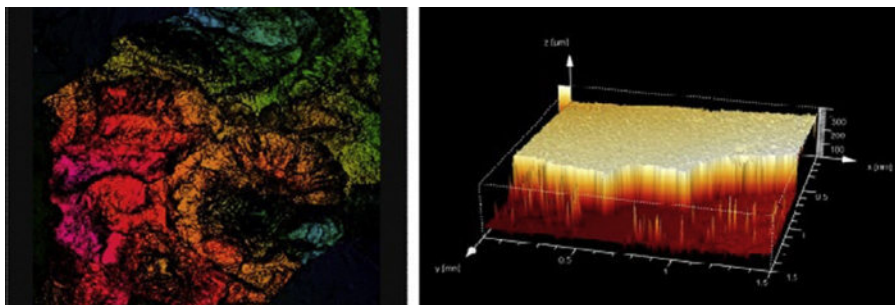
FIGURE 3.8

Laser confocal microscopy (Figure 3.8) and metallography were both used to characterize the thickness of the debris, which indicated that the debris generation was limited to the nitride case. However, M&P engineering was concerned by the observation of extrusion-like damage and agglomerated fine particulate, which indicated that further damage was occurring and failure of the race ring could be exacerbated by the presence of this debris.

Laser confocal microscopy was utilized to nondestructively measure the thickness of the starboard SARJ debris.

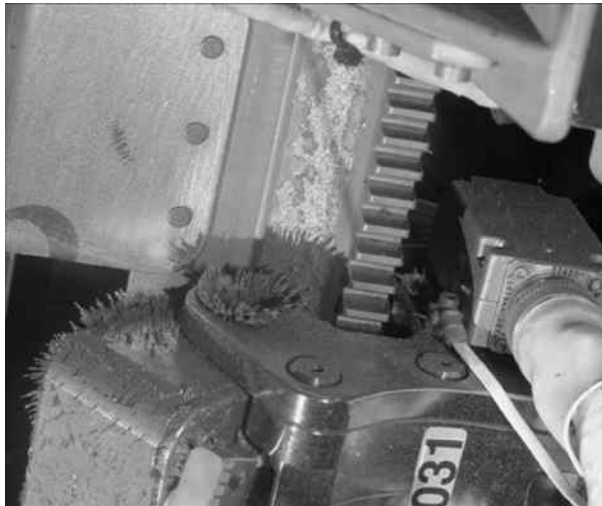
FIGURE 3.9

In December of 2007, approximately a month after the original failure analysis at the KSC laboratory, Expedition 16 astronauts Dan Tani and Peggy Whitson performed a nearly 7-h EVA which focused on inspecting the starboard SARJ race rings and bearings beneath 16 of the 22 drive lock assembly covers. Various amounts of the similar types of debris were observed, while one of the TBAs was removed for evaluation back on Earth. During EVAs 13 and 14, 29 tape samples, containing hundreds of fragments of debris, were collected. High-resolution photographs of the raceway surfaces revealed surface degradation with debris adhering to the TBAs (Figure 3.9).

On-orbit photograph of one of three raceway surfaces of the starboard SARJ during Expedition 16 EVA showing damage to the race and magnetized debris on the TBA.

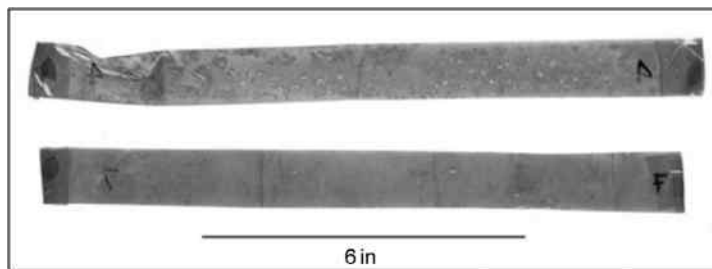
**FIGURE 3.10**

Photograph of two representative SARJ sample tapes from the Expedition 16 spacewalks showing dust-like fine debris covering the majority of the adhesive tape surface as well as some larger fragments that were evident when visually inspected.

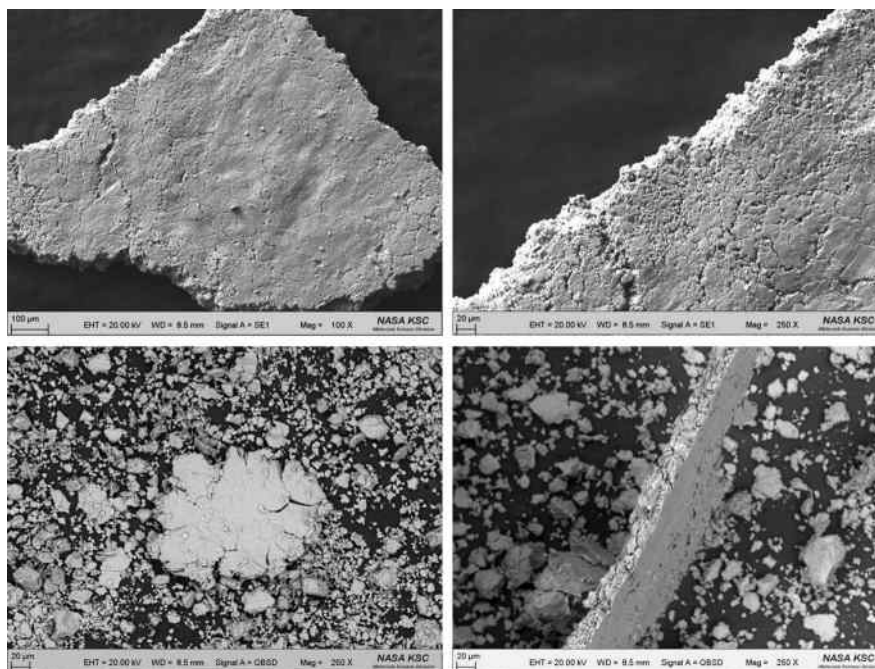
**FIGURE 3.11**

Representative SEM micrographs of agglomerated (top) and extruded (bottom) SARJ particles from Expedition 16 EVA.

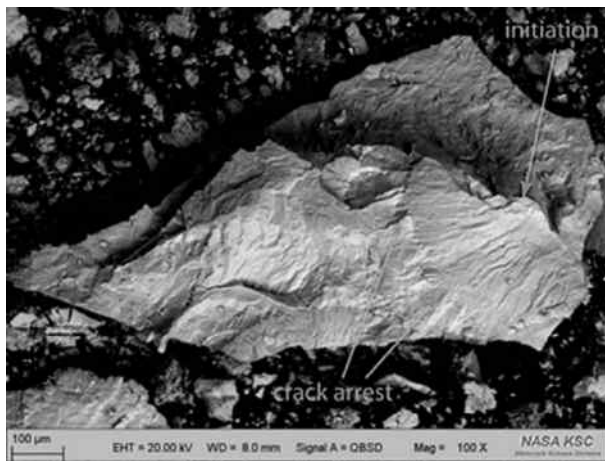
FIGURE 3.12

Fracture features of the Expedition 16 EVA samples were similar to those from the original STS 120 samples, with subsurface crack initiation and crack arrest marks.

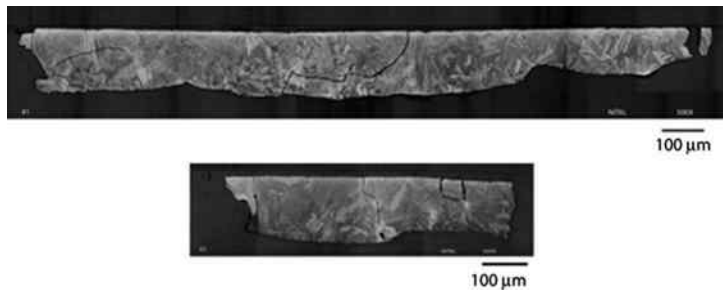
FIGURE 3.13

to stay within the SARJ, causing the larger chips to be pulverized and then agglomerate. An additional conclusion by the investigation team was that the SARJ design had a kinematic susceptibility to tip due to roller mistracking, which, combined with the high frictional forces, led to high roller-edge stresses and resulted in the 15-5PH race surface spalling at the nitride case [20].

Etched starboard SARJ fragment showing transgranular crack propagation and fracture within the nitride case of the 15-5 PH race surface.

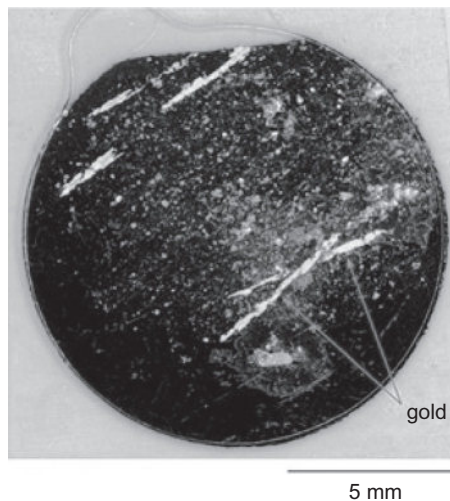
FIGURE 3.14

Of particular interest to the Agency-wide investigation team was the presence of gold plating that was the intended lubricant for the contact surface between the 15-5PH race ring and the 440C TBA rollers [19]. The gold plating should have been metallurgically bonded to the substrate, but Figure 3.14 shows that microscopy tape could easily detach the plating in ribbons. Additional investigation by the engineering team revealed that the loss of gold plating was occurring on flight spares, and that artificially aged samples from new gold-plated rollers were experiencing a loss of adhesion due to corrosion at the interface between the plating and substrate. The resulting inadequate lubrication led to high levels of friction and contact between the race ring and the rollers. As subsurface loads transitioned to the case/core interface of the nitride race ring, spalling initiated at subsurface discontinuities, specifically niobium-rich precipitates which acted as stress concentrators. It was theorized that weak magnetic forces in the microgravity environment caused the debris

Stereomicroscope image of TBA sample, taken from an inner 45 roller surface. Gold plating was observed flaking off of the roller sides as samples were prepared.

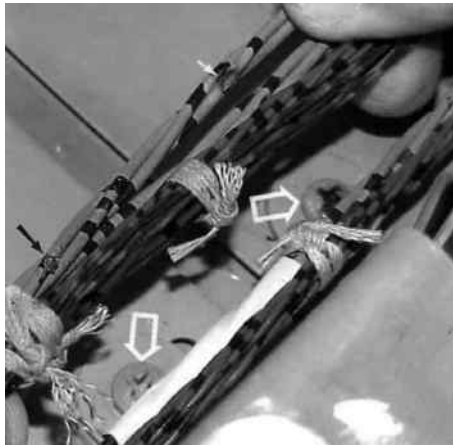
**FIGURE 4.2**

Following a successful mission, the Columbia returned to Earth on July 28, 1999; post-flight inspection revealed that a main engine controller wire had arced against the head of an adjacent screw (Figure 4.2). Likewise, a second area of exposed conductor was observed on the same wire approximately 2 in. away from the arced region. The second area of damage was also located above a nearby screw.

Arced wire (solid white arrow) and nearby damaged area (solid black arrow) with associated screws (open white arrows) in the midbody aft port-side lower wire tray 11/12 frame.

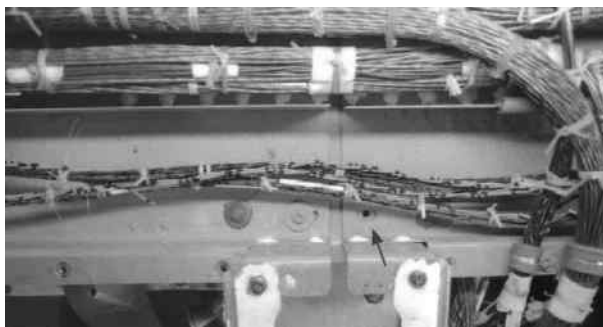
FIGURE 4.3

A failure analysis was initiated to determine the cause of the main engine controller's short circuit. The shorted main engine controller wire and nearby damaged wire were located in the midbody aft port-side lower wire tray 11/12 frame (Figure 4.3). Both the arced screw and the screw beneath the second damaged area had exposed base metal where the screw head slots had been deformed. It should be noted that the wires 180° from the damaged areas appeared undamaged.

Shorted wire bundle with arced screw removed (arrow) in the midbody aft port-side lower wire tray 11/12 frame.

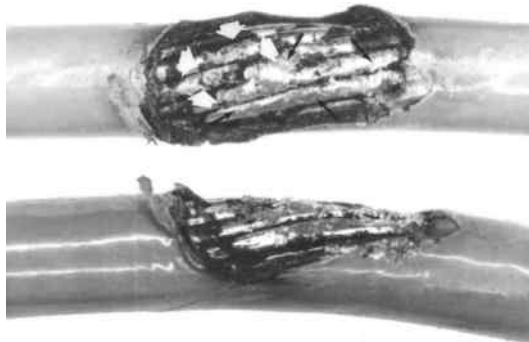
FIGURE 4.4

Visual and low-magnification examinations of the various wires were performed. The arced conductor wire (Figure 4.4) displayed several areas of mechanical damage adjacent to areas that appeared melted, corresponding to the region of arc tracking. Dark deposits of apparently burned material were evident over much of the exposed areas. Deposits were also evident covering some of the nearby mechanically damaged area. The topcoat adjacent to the shorted area appeared deformed. Similar examination of the screw head that the wire arced against revealed a definite region of arc-tracking damage (Figure 4.5). Raised areas of bare base metal were also evident on the sides of the slots in the screw head; these raised areas were devoid of paint.

Rotational view of shorted wire displaying arced region (white arrows) and mechanically deformed region (black arrows).

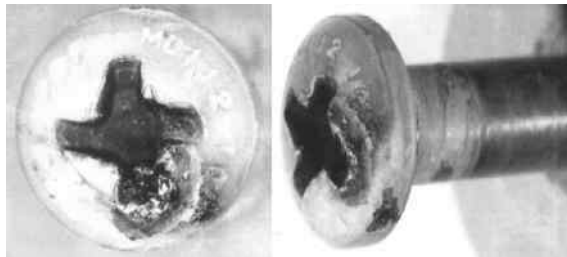
FIGURE 4.5

Screw head displaying arc tracking and raised areas.

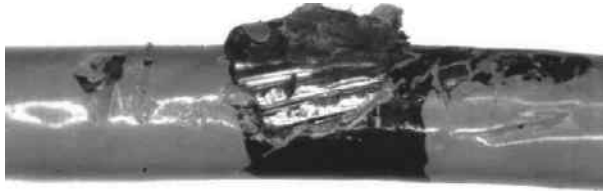
FIGURE 4.6

Macroscopic examination of the second damaged area revealed that the insulation had been pushed up (Figure 4.6). Mechanical gouges on the conductors were observed. The directionality of the mechanical damage in this area corresponded well to that of the mechanical damage in the arced region.

Mechanically damaged area approximately 2 in. from the shorted section of the main engine controller wire displaying deformation of the conductors and topcoat.

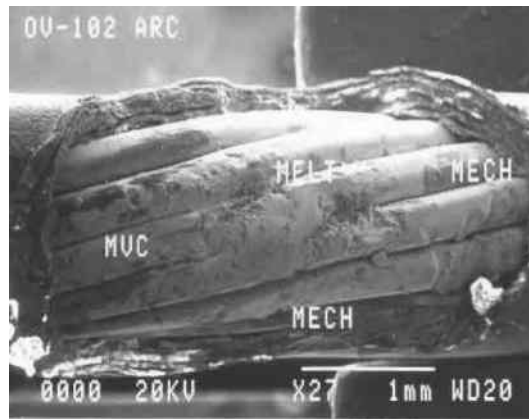
FIGURE 4.7

SEM micrograph of the damaged region of the shorted wire. Mechanical damage is evident on the conductors (denoted "MECH"). The melted region is between the "MELT" and "MVC" zones. Magnification: 27 \times .

Next, the wires were analyzed via scanning electron microscope (SEM), energy-dispersive X-ray spectroscopy (EDS), and electron spectroscopy for chemical analysis (ESCA). SEM analysis of the shorted wire verified that the polyimide insulation was missing in the arced area, with the wire's conductors clearly evident (Figure 4.7). It should be noted that the damaged insulation was even and smooth, as opposed to serrated. Three distinct topographical features were evident on the shorted wire: a mechanically damaged zone, a melted zone, and a zone displaying microvoid coalescence (MVC). The mechanically damaged zone appeared gouged (Figure 4.8). The damage was directional, roughly tangential to the length of the wire. The central portion of the exposed area contained a mixture of mechanical damage and melted metal (Figure 4.9). The melting was confined to the outer layer of wire strands and did not appear to penetrate to the inner strands. The final region of the exposed area displayed MVC (Figure 4.10), typical of ductile overload. The overload area corresponds to the region where the wire actually melted and fused with the screw head

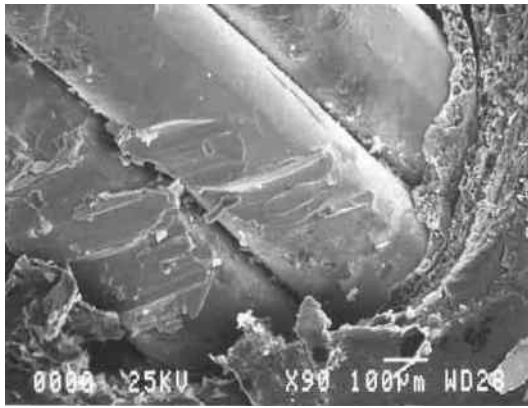
FIGURE 4.8

SEM micrograph of shorted wire displaying mechanical damage to the conductors. Magnification: 90 \times .

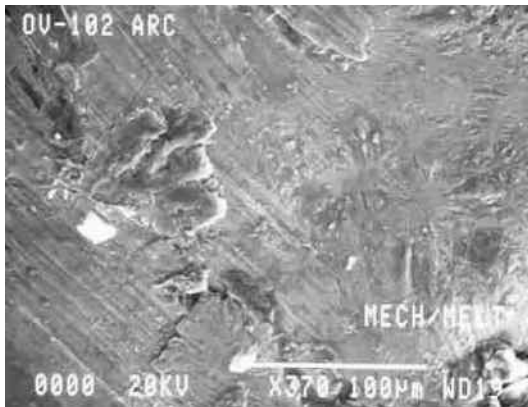
FIGURE 4.9

SEM micrograph of shorted wire illustrating mechanical damage and thermal damage. Magnification: 370 \times .

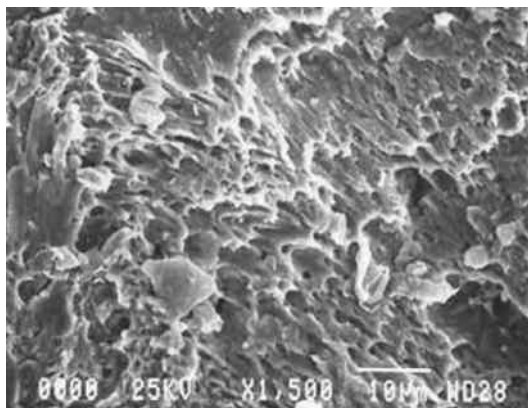
FIGURE 4.10

SEM micrograph of shorted wire displaying MVC, typical of ductile overload. Magnification: 1500 \times .

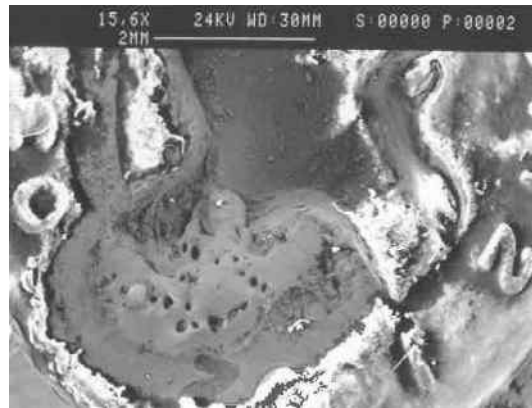
FIGURE 4.11

SEM micrograph of shorted screw head displaying area of resolidified metal and MVC. Magnification: 15.6 \times .

(Figure 4.11). SEM examination of the damage 2 in. from the shorted region of the controller wire showed evidence of mechanical damage but no arcing (Figure 4.12).

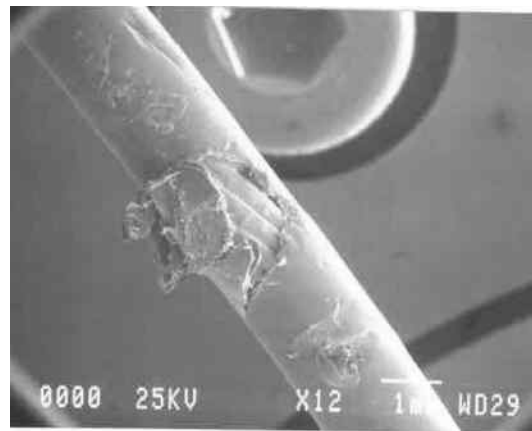
FIGURE 4.12

SEM micrograph of a second damaged area from the shorted wire. The conductors appeared mechanically damaged, with the topcoat pushed back. Magnification: 12 \times .

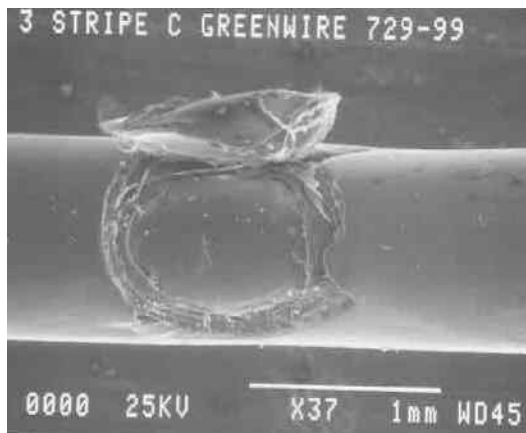
FIGURE 4.14

Of the seven additional wires removed for analysis, neither damage to the conductor nor serration of the insulation was noted (Figures 4.13 and 4.14).

SEM micrograph of additional wire typifying topcoat and insulation damage. Magnification 37 \times .

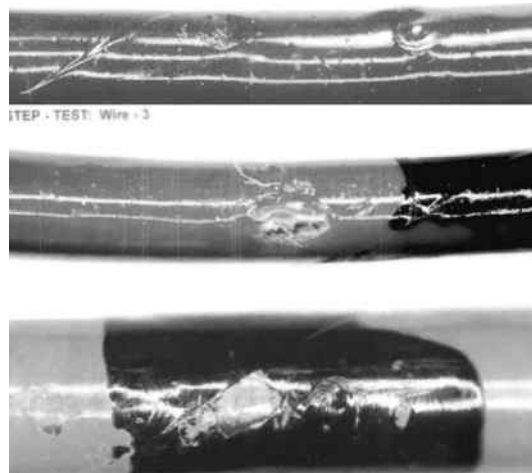
FIGURE 4.15

conductor damage was observed (Figures 4.15 and 4.16). However, subsequent step testing performed after the primary investigation was concluded did cause damage to the conductor. Vibrational testing at frequencies ranging from 20 to 2000 Hz and loads varying from 600 to 2100 g damaged the conductor in the 2100 g range. Single event drop testing meant to simulate a sharp object impacting the bundle carried out with drop heights of 1-3 ft and loads of 900-20,000 g did not damage the conductor until 19,050 g were added to the impacting tool. Additional vibrational abrasion and drop testing verified that the convoluted tubing would be damaged before any damage to the conductor would occur.

Typical step-test damage.

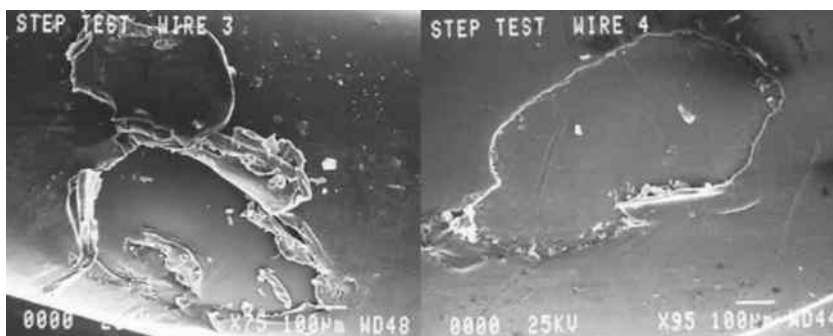
FIGURE 4.16

SEM micrograph of step-test exemplars. Mechanical deformation of insulation is evident with no damage to conductor. Magnification: 75 ×, 95 ×.

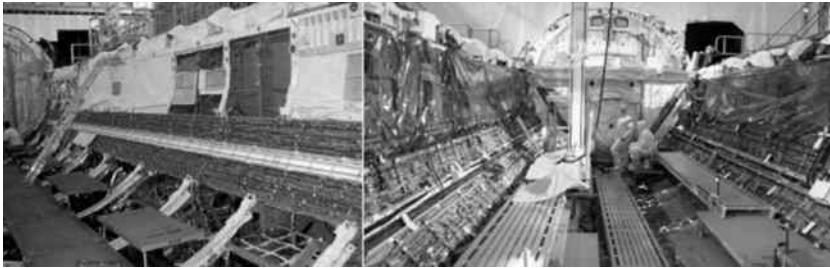
FIGURE 4.17

Orbiter midbody before inspection and during wiring inspection. Tags indicate areas of potential damage to the wiring.

unprecedented inspection of wiring throughout the orbiter fleet was undertaken. Accessible areas as well as critical hard-to-access locations were examined using inspection mirrors, flashlights, and $10\times$ magnification. Manipulation of the wiring was kept to a minimum to lessen the likelihood of introducing any further damage. Between the four orbiters, the Atlantis, the Columbia, the Discovery, and the Endeavour, approximately 3000 suspect indications were identified (Figure 4.17) [5]. Of the 3000 discrepancies, nearly 500 involved exposed conductor. Of the exposed conductors, approximately 150 had mechanical damage, although no additional instances of arc tracking were reported.

Following the inspection of the orbiter fleet's wiring, several lessons were learned. It was recommended that similar screws adjacent to wire bundles be examined to make sure no metal was raised on the screw heads, and also that no screws have bare metal exposed. If any were found, the screws were to be replaced or the raised areas smoothed and the screws repainted. The use of convoluted tubing was recommended as beneficial, both as a physical protection for the bundles, as well as an insulator for any conductors which might become exposed.

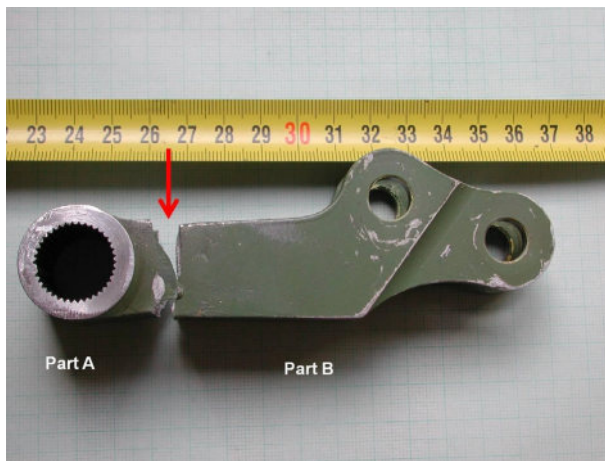
FIGURE 5.2

Macrograph of the two broken pieces of the lever reverse. Zone of failure is denoted by arrow.

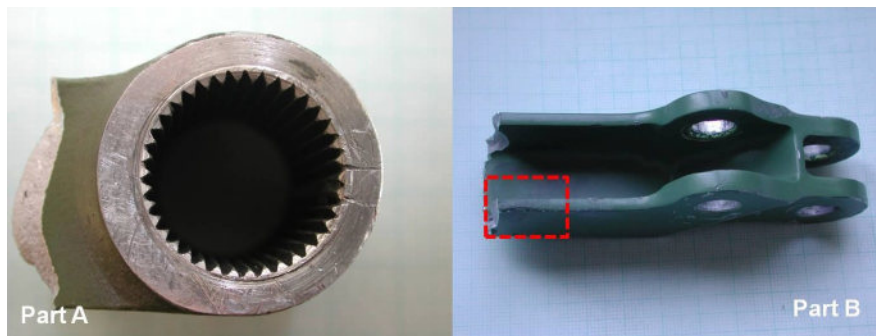
FIGURE 5.3

Macrograph showing plastic deformations of the part A and part B.

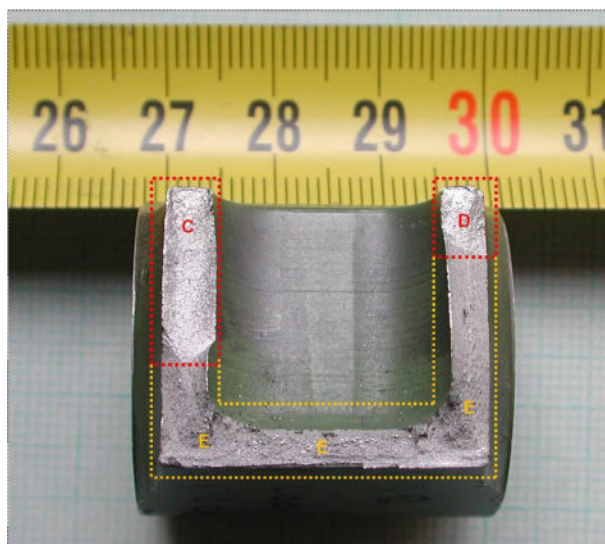
FIGURE 5.4

Macrograph showing zones C, D, and E on fracture surface. Part A.

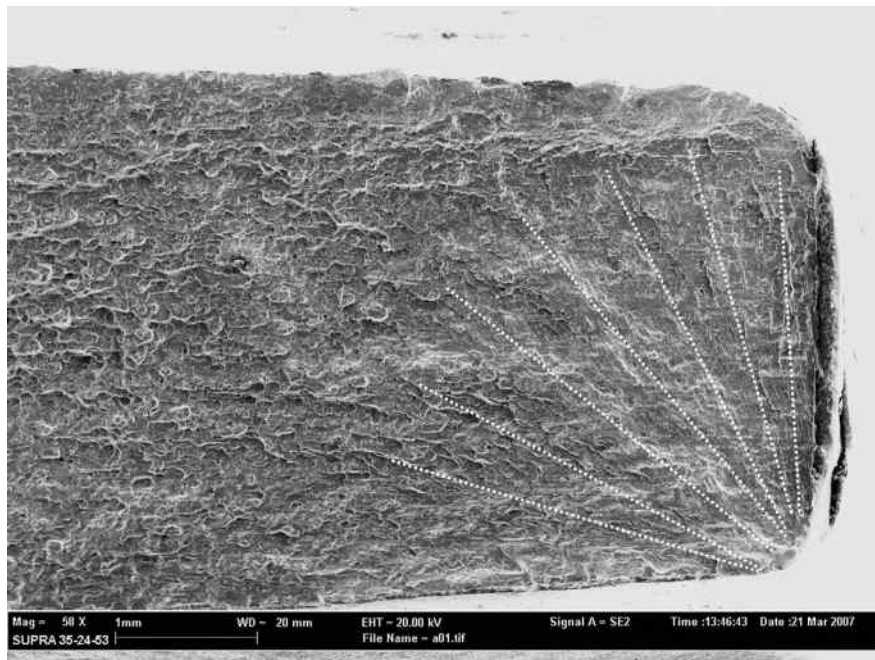
FIGURE 5.6
SEM micrograph of C zone at a location close to the initiation point.

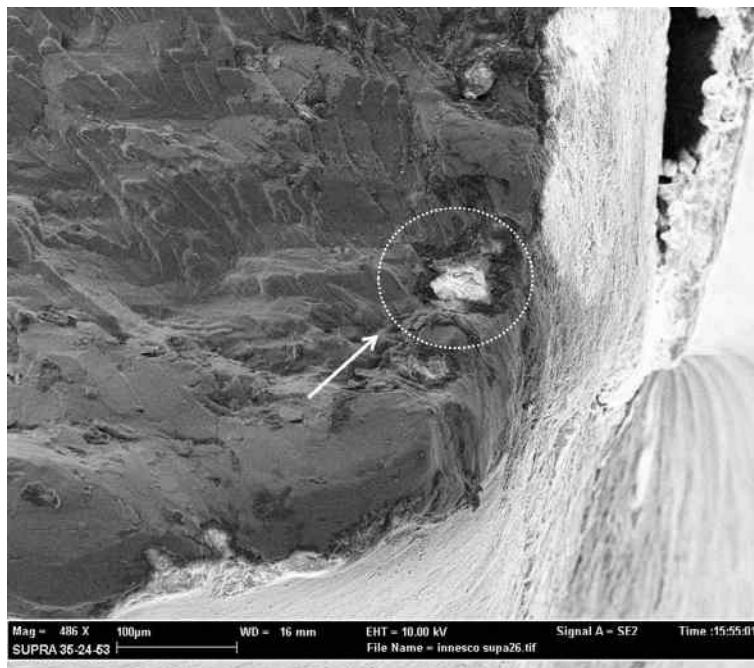
FIGURE 5.9

SEM micrograph at the crack origin site. Cracking initiated at a pit indicated by arrow. Zone C.

deformation. The striations spacing as well as deformation gradually increased further from the suspected origin site. Tracing back the fatigue evidences, it was identified to be at the internal edge. Detailed microscopy of the site showed presence of a corrosion pit approximately 100 μm deep (see [Figure 5.9](#)). A very similar pattern as observed above was found in zone D, representing approximately 8% of the total fracture surface. Conversely, microscopic examination of the initiation site located at the internal edge did not uncover corrosion pits or other anomalous initiating sources. Finally, in zone E, covering approximately 73% of the fracture surface, the predominant pattern was quasi-brittle cleavage rupture, thus representing the final fracture by overload of the lever reverse.

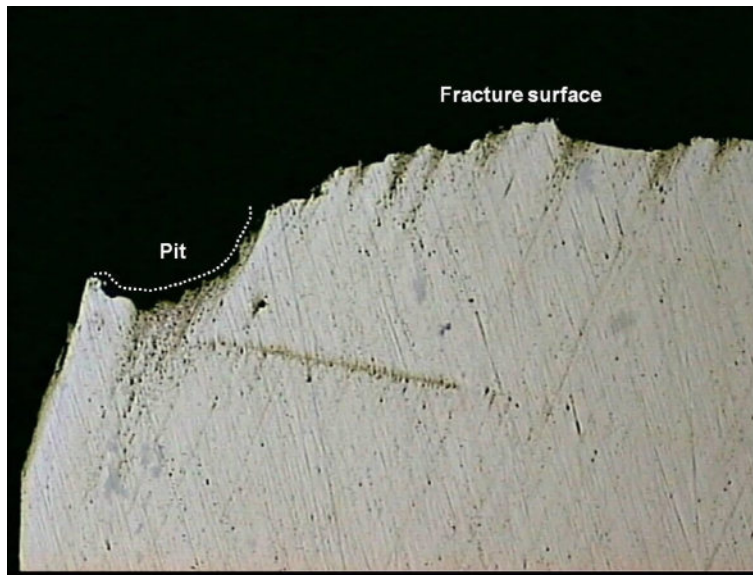
FIGURE 5.10

Microstructural examination of the lever reverse was performed on two longitudinal sections of part B in orthogonal direction to the fracture surface. The microstructure revealed features typical of a forging fold with elongated grains and intermetallic phase's precipitates located at grain boundaries (see [Figure 5.10](#)). In addition, at the internal edge of the zone C a corrosion pit approximately 100 μm deep was found. No discrepancies were found at the internal edge of zone D.

Optical micrograph showing corrosion pit at a location close to the internal edge. Zone C. 200 \times .

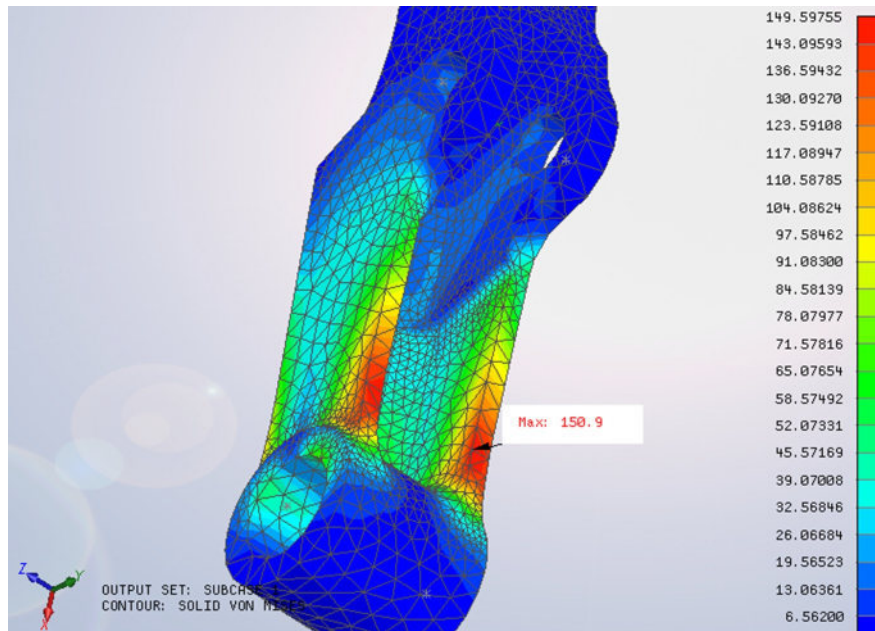
FIGURE 5.11

To estimate the force acting in static conditions as well as to identify the stress distribution on the lever reverse a FEA was carried out. Using principles of fracture mechanics, the critical crack size measured on the lever reverse for the deepest one and published fracture toughness data for 7075-T6, resulted in a maximum stress of 81 MPa per fracture, corresponding to 2760 N as the acting force. This is consistent with that found by introducing defects in the lever reverse model deduced from fractographic evidence and repeatedly applying an external load to reach the UTS at the crack tip. In addition, applying the same force to the model in normal conditions, i.e., without consideration of defects, resulted in a stress value of approximately 151 MPa at the internal edges, thus representing the most stressed areas (see Figure 5.11). This stress approaches the fatigue endurance limit of the material under consideration (160 MPa). Furthermore, the results obtained were also used to estimate the total cycles to failure by using Neuber's equation and was equal to approximately 5500 cycles.

FEA model showing the most stressed areas of the lever reverse.

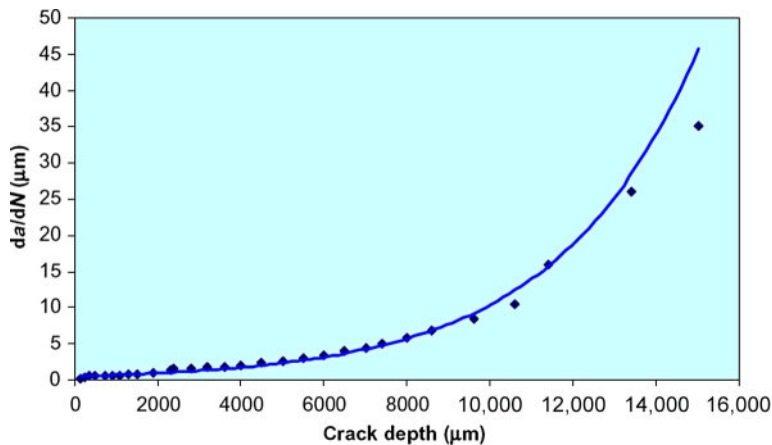
FIGURE 5.12

between 150 μm from the internal edge to approximately 1.5 cm, corresponding to the final overload failure. The general trend is shown in Figure 5.12 and the number of cycles obtained by integrating the exponential curve is of approximately 5900 cycles.

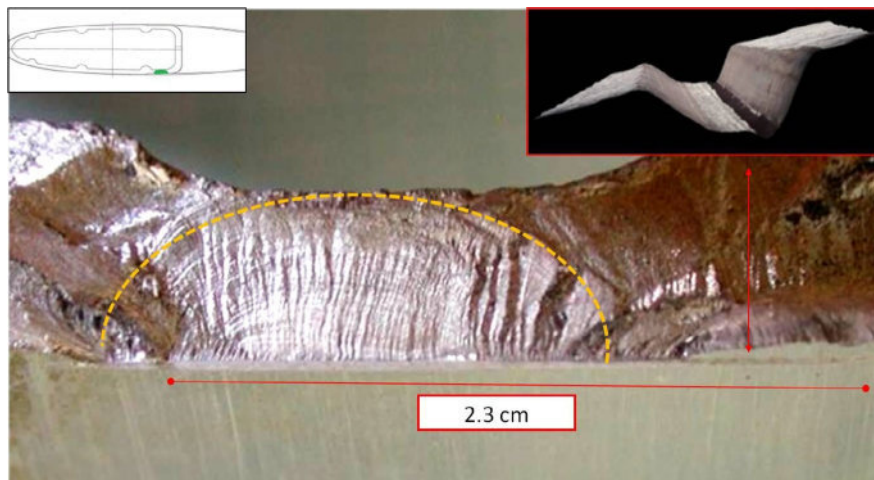
FIGURE 5.14

The blade fracture occurred between pockets 16 and 17 at the lower corner of the spar section (Figure 5.14, section view, green area). Fractography conducted by means of optical and electronic microscopes showed a progressive fatigue phenomenon.

Zone A was characterized by an incision located on the outer surface and perpendicular to the blade’s longitudinal axis (Figure 5.14, top left, detail of spar section view). The incision was v-shaped (Figure 5.14, 3D reconstruction); it was 2.3 cm in length and 190 μm in depth. Multiple initiation points were found at the incision vertex. From these, beach marks typical of fatigue crack growth departed creating a semi-elliptical front (dashed line in Figure 5.14). The grain morphology was smooth, fine, and bright. After the fatigue achieved the “through-the-thickness” condition, it propagated toward the leading edge and along the backwall (Figure 5.15, top right, detail of spar section view) with flat, coarse grains and beach marks (Figure 5.15).

Blade fracture surface.

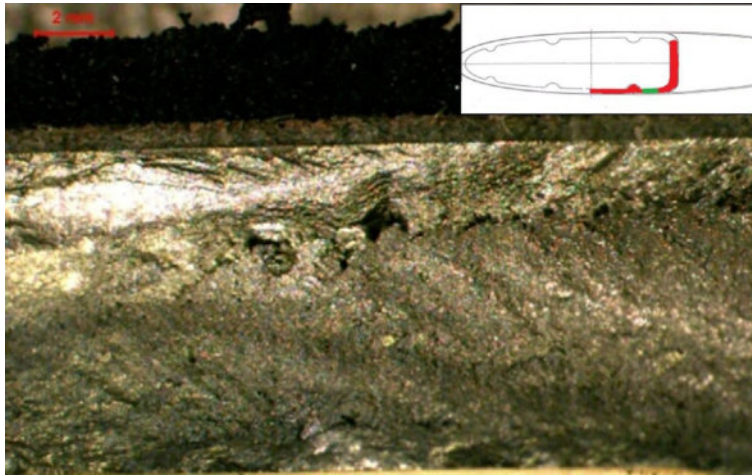
FIGURE 5.15

Fatigue propagation toward the leading edge and along the backwall blade.

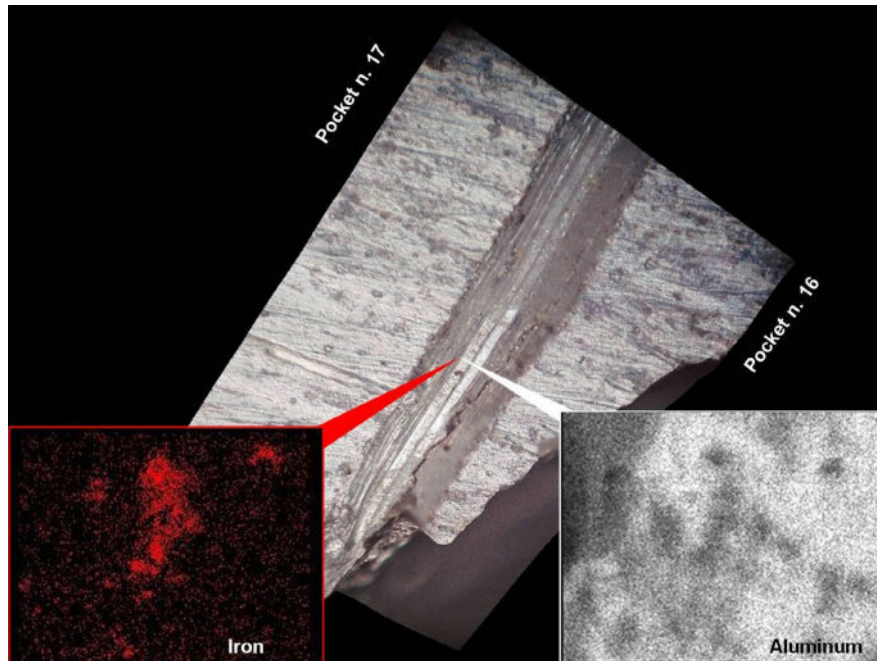
FIGURE 5.16

The composition homogeneity was verified at the initiation area by an X-EDS microprobe attached to the FESEM. An abnormal presence of iron was found in the incision (Figure 5.16).

Abnormal presence of iron found inside the incision.

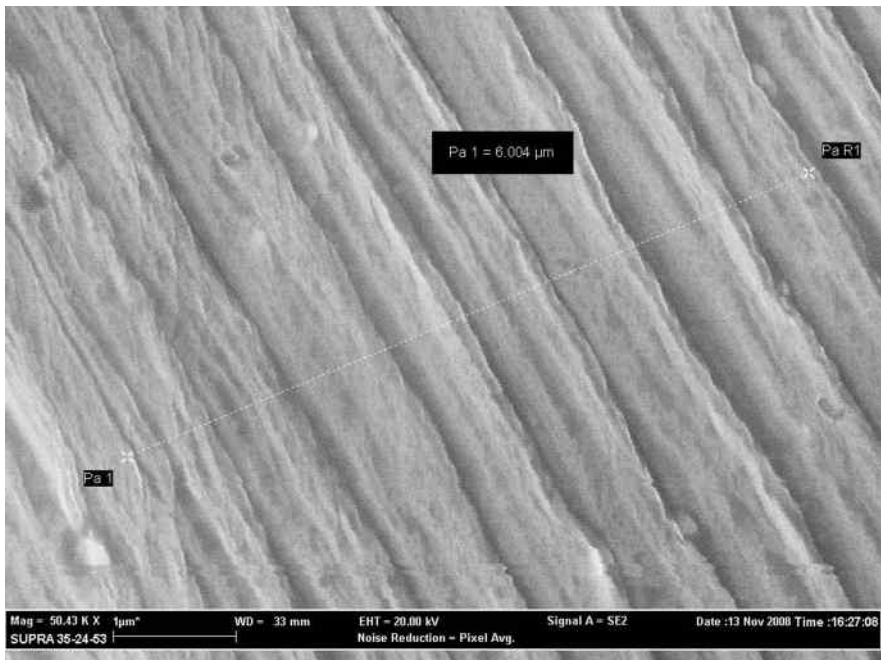
FIGURE 5.18

Striation groups.

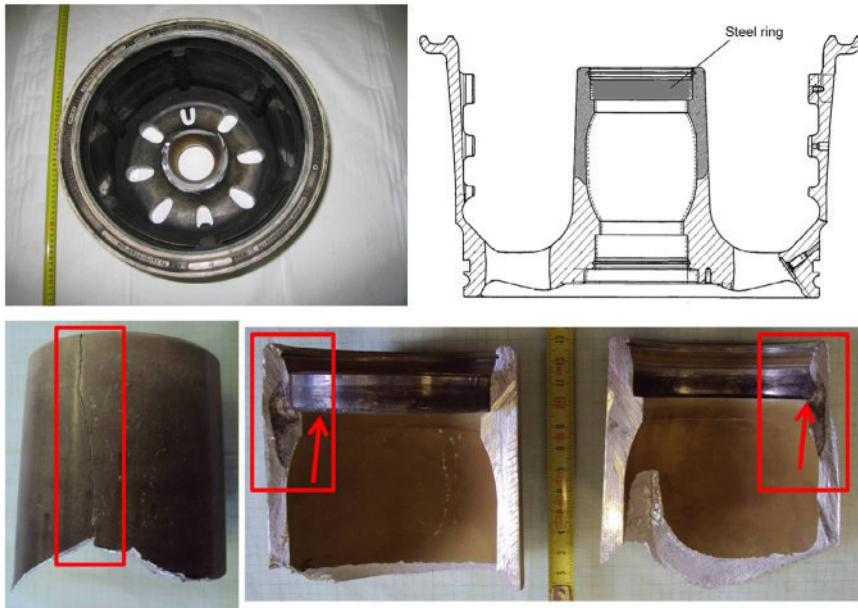
FIGURE 5.19

Fatigue crack in the AA2014 T6 AMX main wheel.

The part of the bearing cup that is in contact with the hub housing is a cold installed steel ring (Figure 5.19). Metrological tests ascertained that the diameter was on average 5 μm larger than the design drawing value.

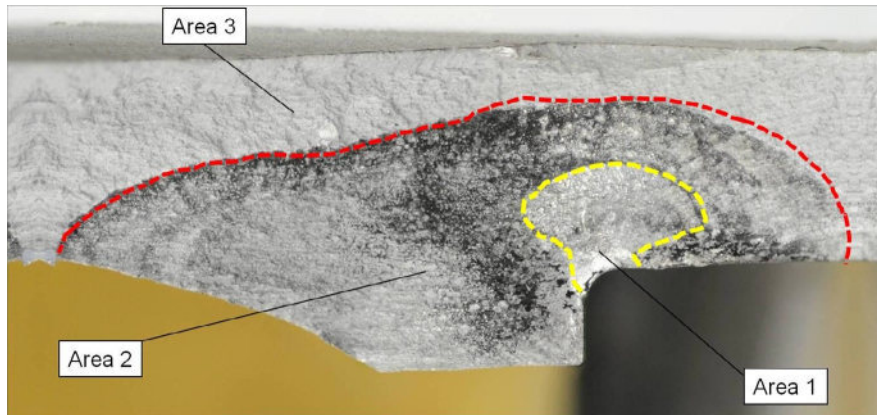
**FIGURE 5.20**

The failure of the main wheel occurred at the hub housing which is approximately cylindrical in shape. The fracture started from the lateral surface arriving to the root, where the hub housing is joined to the main wheel body. Thus, the fracture surface was divided in two zones, named A and B. Zone A was at the hub housing root. It was rough, dull, characterized by coarse grains, and it was oriented at about 45° to the transversal section. Moreover, a plastic deformation, associated to the final phase of wheel failure, was observed. Therefore, Zone A was the region of the final, unstable fracture. Zone B was characterized by a crack located along the hub housing lateral surface. In this area, three zones with different morphological features, described in Figure 5.20, characterized the fracture surface.

Fracture surface, area numbering.

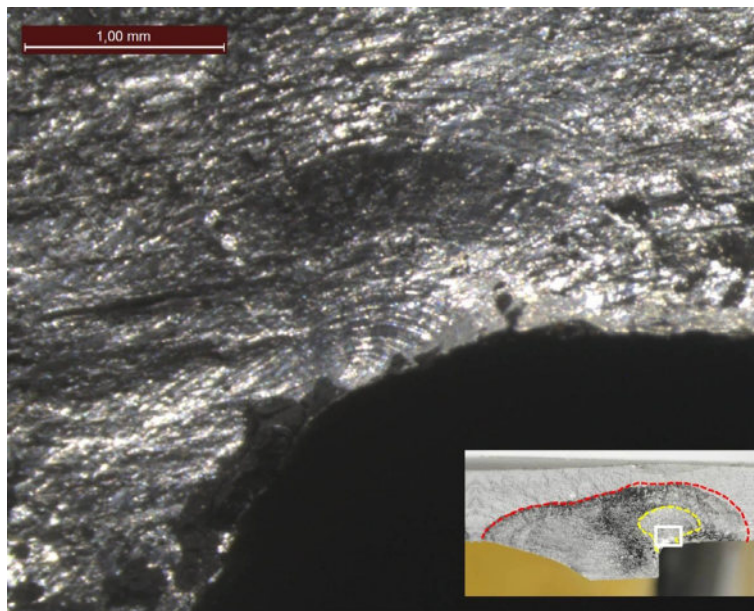
**FIGURE 5.21**

Area 1: Flat, smooth, and bright with beach marks typical of fatigue crack growth (Figure 5.21). These beach marks were concentric to the initiation point and located on the inner corner of the bearing cup housing. This area was roughly circular with 6.5 mm radius. Beach mark spacing was almost constant, about 40 μm .

Area 1.

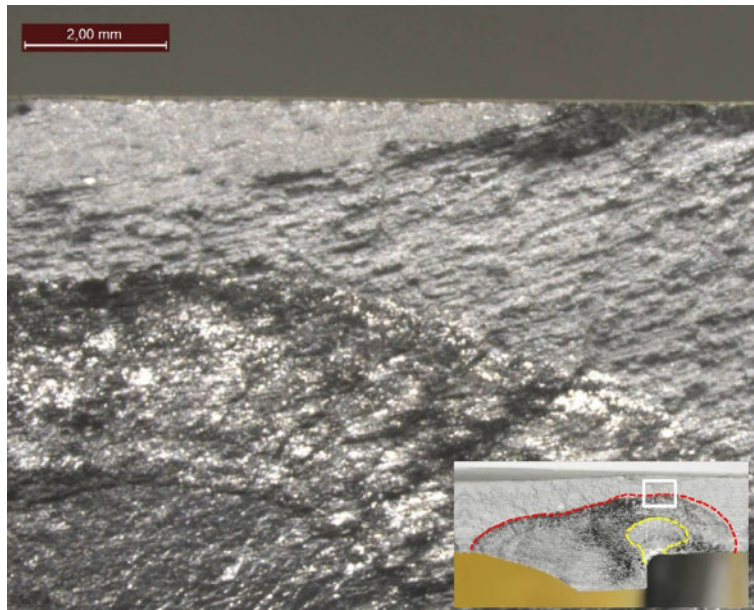
FIGURE 5.22

Area 2: Flat, coarse grains, containing beach marks (Figure 5.22). Fatigue propagated in this area approximately 10 mm toward the bearing cup and approximately 25 mm in the opposite direction.

Area 3: Rough, dull with coarse grains without beach marks and without black residue. These features are consistent with zone 3 being the area in which the final

Areas 2 and 3. Boundary line in red.

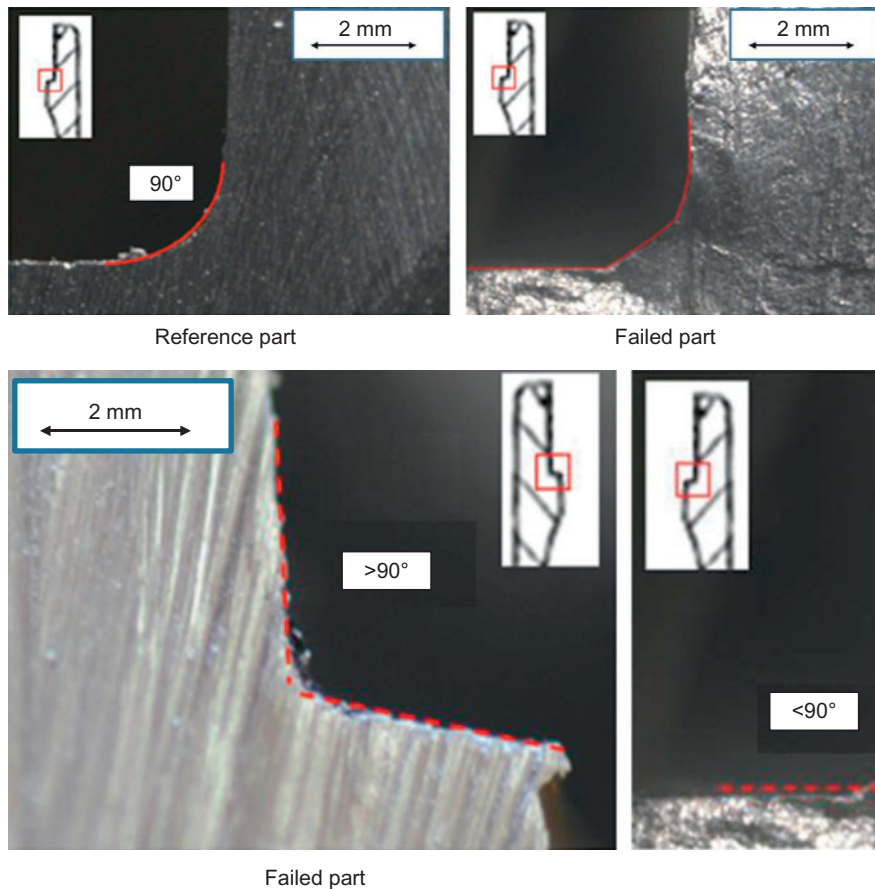
FIGURE 5.23

phase of the failure occurred. The morphology of the bearing cup housing inner corner was compared with a reference part without defects to gather evidence of the cause of fatigue crack initiation. The comparative observation indicated that the initiation point presented deformations (see sharp transition in [Figure 5.23](#), top). As those defects seemed to indicate faulty installation of the bearing cup, further analyses proceeded to ascertain whether similar features could be found on the diametrically opposed section. Deformations were present and the corner angle was greater than 90° ([Figure 5.23](#), bottom).

Curvature comparison. Top figures: fatigue initiation point comparison: failed wheel (right) and reference wheel (left). Bottom figures: featuring of failed wheel in two diametrically opposite points.

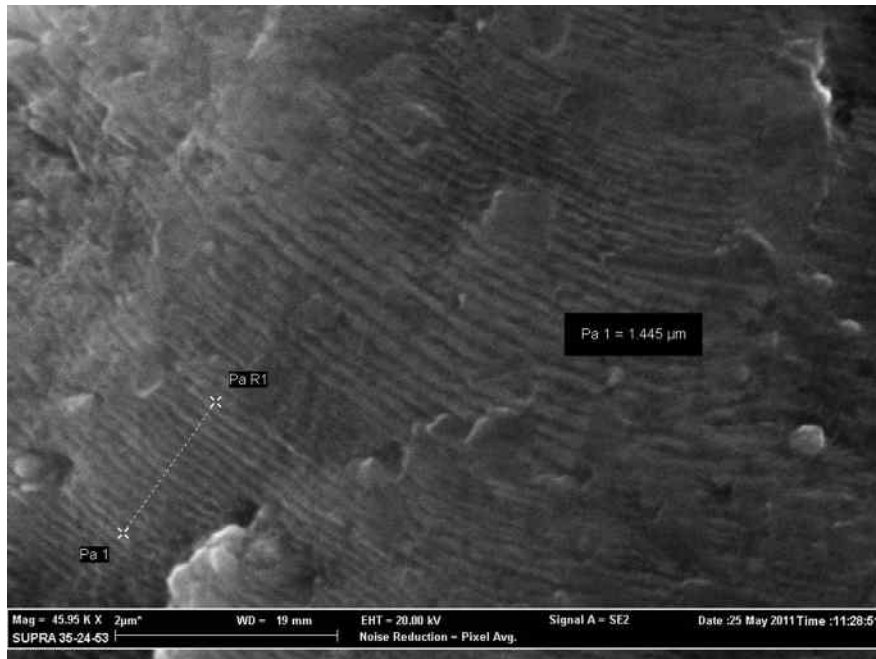
FIGURE 5.24

Fatigue striations in Area 1.

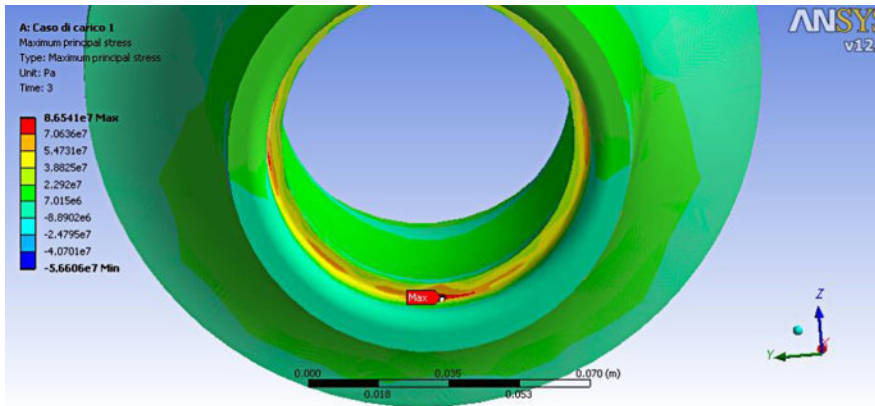
FIGURE 5.25

Stress at the fatigue initiation point.

airplane weight on the wheels due to the in-service operations would have led to about 300 MPa at the initiation site (Figure 5.25). This stress level would be higher than the AA2014-T6 fatigue limit, 125 MPa. Therefore, FEA demonstrated how the misalignment of the bearing cup led to the fatigue initiation.

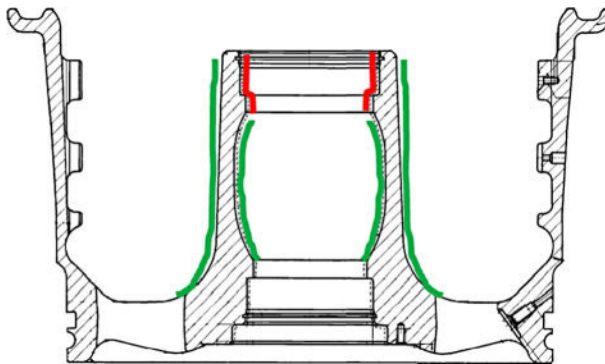
FIGURE 5.26

The main wheels are monitored for structural integrity by eddy current inspections performed only on the external surface (dashed line in Figure 5.26) but they cannot be performed under the bearing zone (line in Figure 5.26). However, no fault was

Eddy currents inspections: accessible area (dashed green line) and not accessible area (dashed red line).

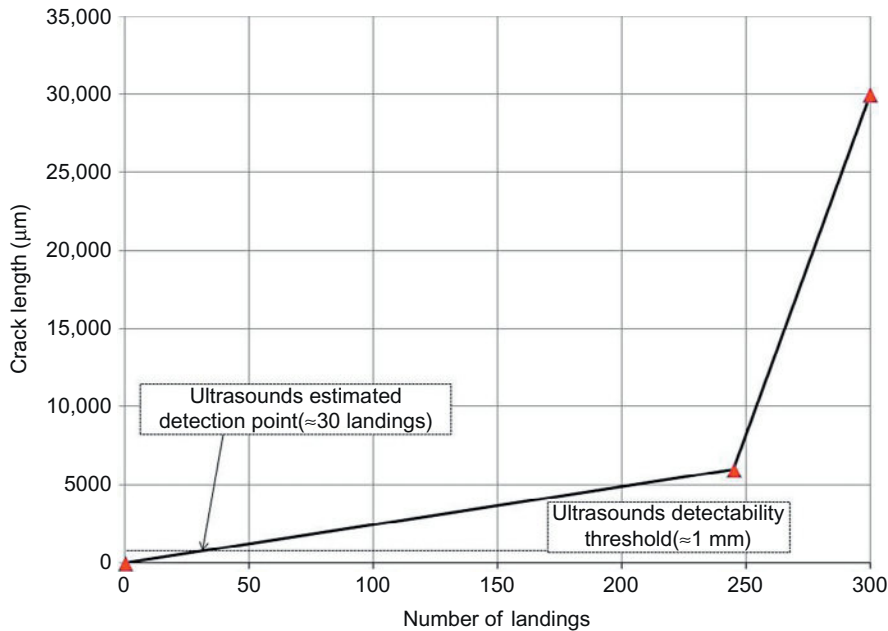
FIGURE 5.27

- (3) 299 landings, failure of the wheel (crack longer than 25 mm);
- (4) The chart in [Figure 5.27](#) was drawn by a linear interpolation of these points (0-241 and 241-299 landings). The linear assumption is realistic in Area 1 of the fracture surface where experimental observation confirmed almost constant average beach mark spacing. Therefore, the cumulative number of landings in the area is approximately a linear function.

Thus, due to the lower detection limit of a 1 mm crack, it is presumable that ultrasounds would allow early detection of a fatigue crack beginning on the inner corner of the housing hub after about 30 landings (arrow in [Figure 5.27](#)).

Fatigue history chart: crack length versus number of landings.

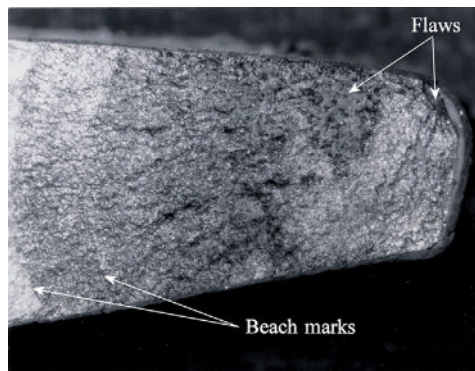
FIGURE 6.2

The crack was located on the port face of the center housing on the central web between the gearbox base and the attachment flange for the output housing. Examination of the fracture surfaces revealed river markings emanating from a small surface breaking casting flaw on the “nose” of the web, beach markings were also visible, see [Figure 6.2](#). It was evident from these features that the crack was due to fatigue and that the crack had initiated at the casting flaw. It had then propagated through the web intersecting a number of other casting flaws. In particular, one very large flaw measuring ≈ 2 mm in diameter was only a few millimeters away.

Image showing one of the fracture surfaces of the fatigue crack in the Port Central Web of the ZE41A housing in Failure Investigation 1.
