Handbook of Materials Failure Analysis

With Case Studies from the Aerospace
and Automotive Industries

Abdel Salam Hamdy Makhoul

Mahmood Aliofkhazraei

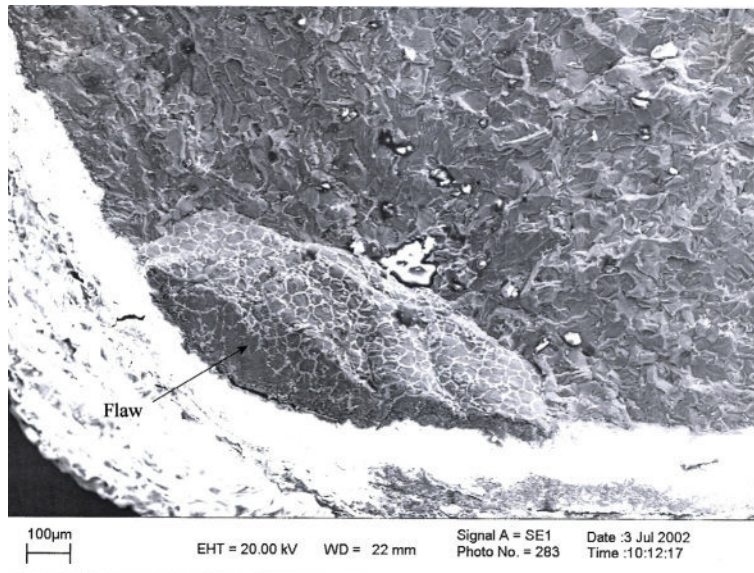
FIGURE 6.3

SEM image showing the casting defect in the origin region of the ZE41A housing web fatigue crack evident during Failure Investigation 1.

The fatigue crack was measured to be 11 mm long and it encompassed the full thickness of the web. The flaw at the origin was approximately 0.9 mm long and 0.3 mm deep.

SEM examination of the fracture surface revealed that the crack origin region exhibited a relatively smooth “as cast” surface with a visible grain structure; see [Figure 6.3](#). This was interpreted as a very small cold shut at the casting surface, possibly resulting from the presence of an entrapped oxide film. Other flaws evident on the fracture surface were also examined and were found to be of a similar appearance to that at the origin.

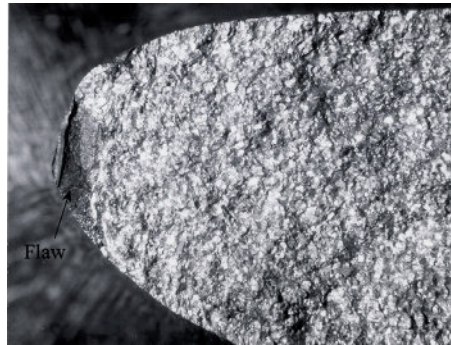
FIGURE 6.4

Image showing one of the fracture surfaces of the crack in the port forward web of the WE43A housing examined in Failure Investigation 2.

The crack had propagated 13 mm from the nose of the web and there was evidence of a curved crack front at a couple of locations, suggesting that the crack was due to fatigue.

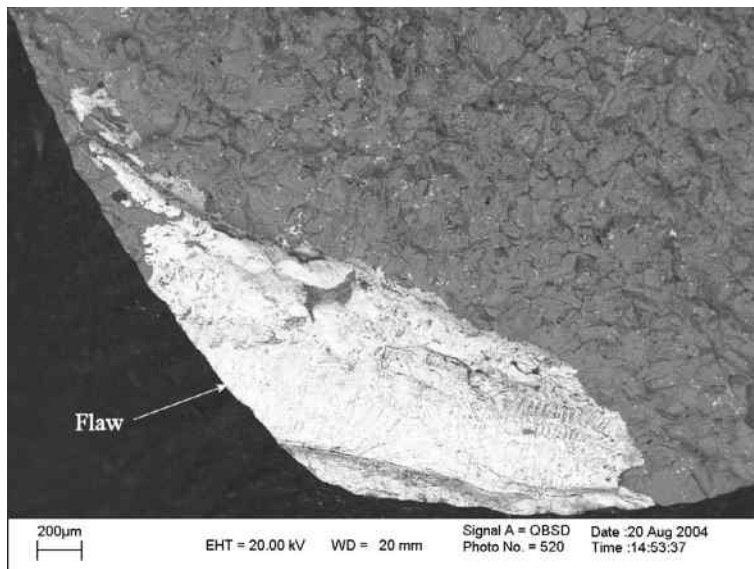
**FIGURE 6.6**

The defect at the nose of the web measured ≈ 3 mm in width and extended ≈ 1 mm below the surface (see [Figure 6.6](#)). Imaging utilizing the back-scattered electron (BSE) imaging mode to provide contrast based on atomic weight, revealed the defect to have a relatively smooth surface in relation to the rest of the fracture. It was also evident on both halves of the fracture. This imaging technique also indicated that the defect was rich in higher atomic number elements. This was confirmed using the attached Princeton Gamma Tech IMIX EDX analysis system which revealed the significant presence of yttrium and neodymium and the minor presence of magnesium.

SEM BSE image showing the casting defect at the origin of the web fatigue crack on the WE43A housing examined in Failure Investigation 2.

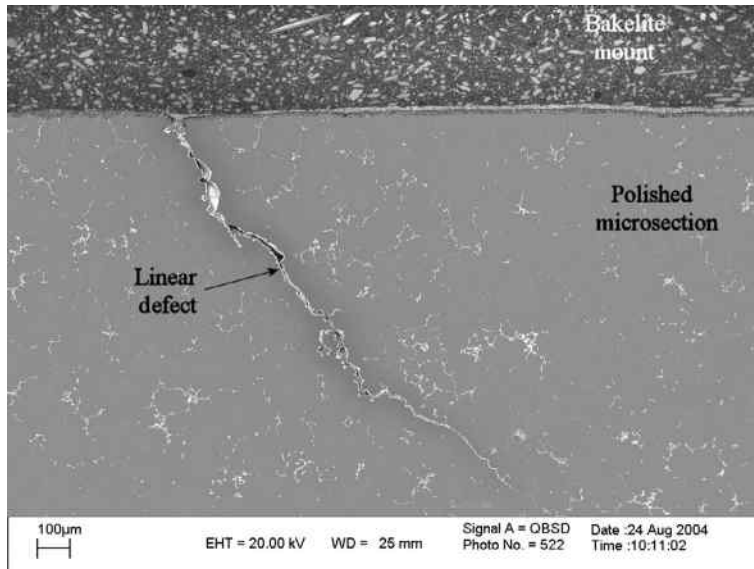
FIGURE 6.7

BSE imaging revealed that this feature was a “linear defect” measuring at least 1.5 mm in length and that the two surfaces of this had the appearance of a “skin” that was rich in higher atomic number elements; see [Figure 6.7](#). EDX analysis revealed it to be rich in yttrium and neodymium, similar to the flaw at the crack origin. [Figure 6.8](#) shows a region of this flaw where the “folds” in the yttrium-rich “skin” are clearly visible.

SEM BSE image showing the linear casting defect in the region adjacent to the cracked web on the WE43A housing examined in Failure Investigation 2.

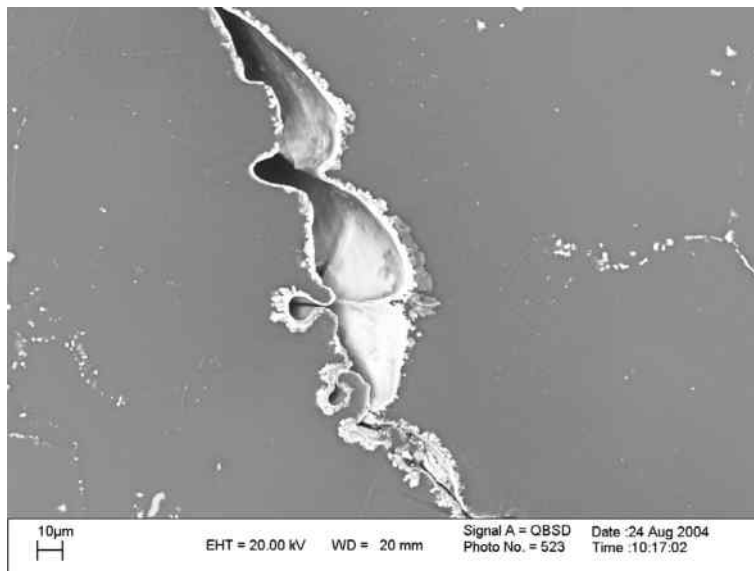
FIGURE 6.8

SEM BSE image showing a fold in the skin-like linear casting defect in the WE43A housing examined in Failure Investigation 2.

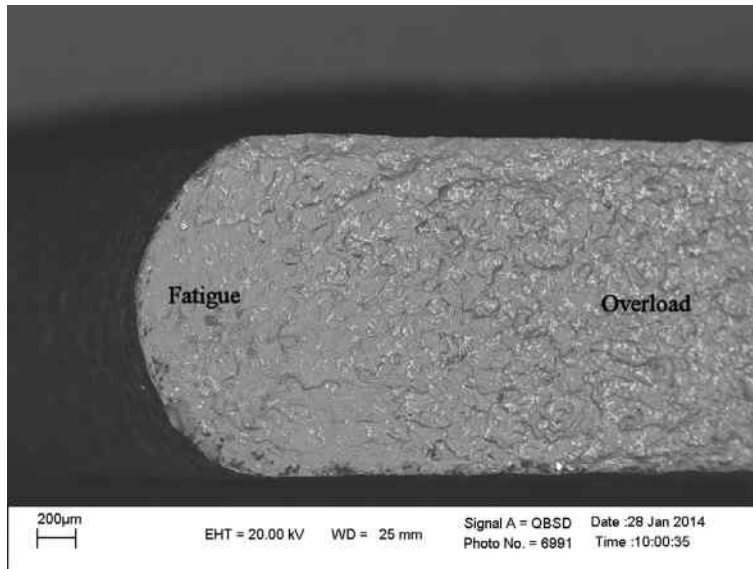
FIGURE 6.12

SEM BSE image of a fatigue specimen from the WE43A housing examined during Failure Investigation 3.

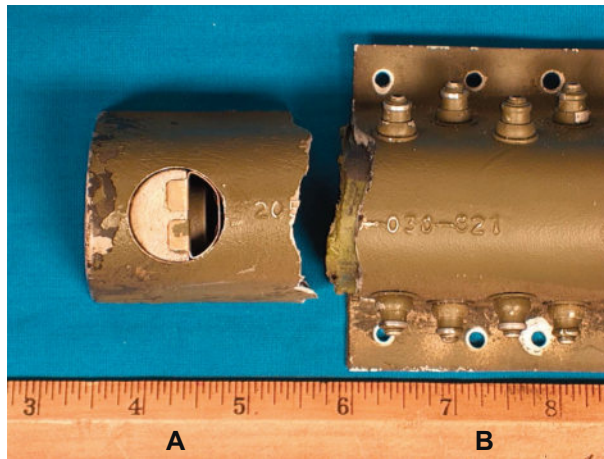
**FIGURE 7.1**

The two broken pieces of the longeron, in the as-received condition.

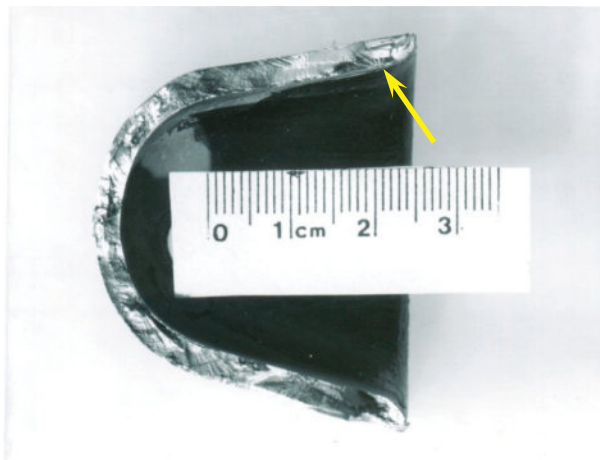
**FIGURE 7.2**

Low-magnification fractograph of fracture half A. Arrow denotes crack origin and beachmarks formed over approximately 80% of the entire fracture surface.

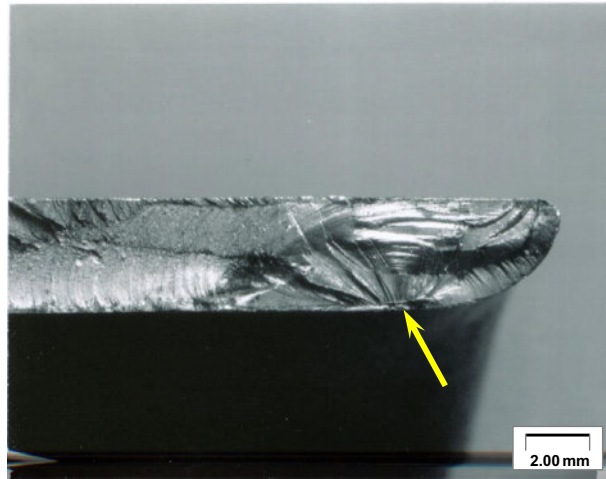
FIGURE 7.3

Enlargement of fracture origin of section A. Note the radial lines converging to a single area identifying the crack initiation site and the many finely spaced beach marks propagating outward from the fracture origin (arrow).

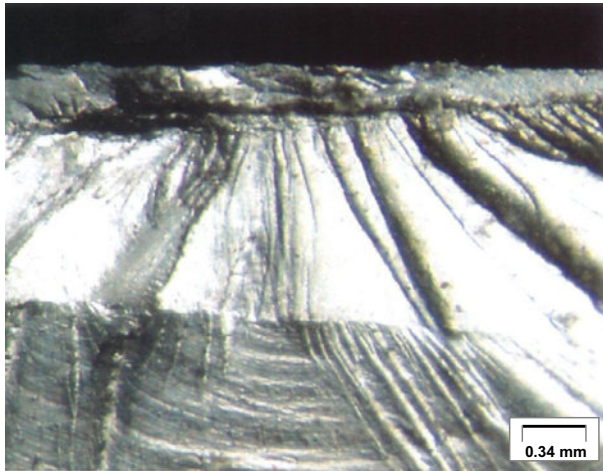
**FIGURE 7.4**

Closer examination of the crack initiation site of fracture half A revealed an anomaly that did not contain any discernable crack arrest markings or other features normally associated with a fracture surface.

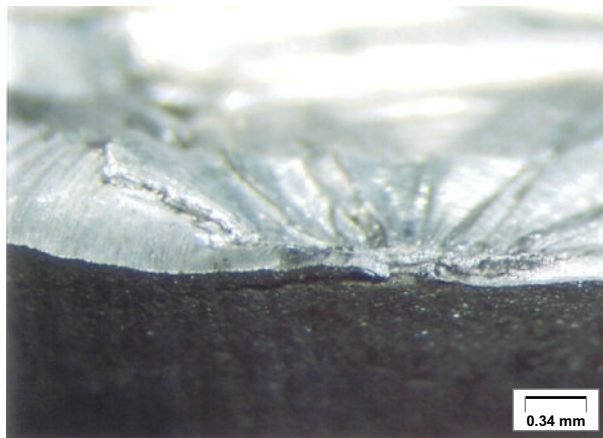
**FIGURE 7.5**

Closer examination of the crack initiation site of fracture half B revealed an anomaly that did not contain any discernable crack arrest markings or other features normally associated with a fracture surface.

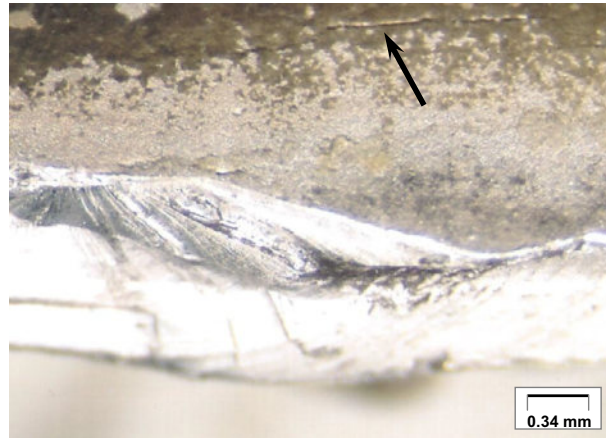
**FIGURE 7.6**

Surface anomalies found below the crack origin, running parallel to the fracture.

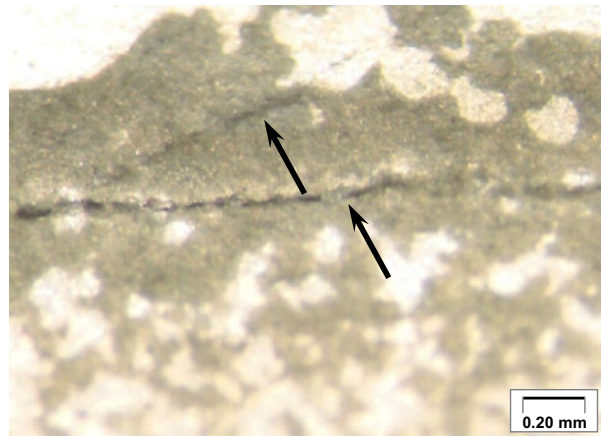
**FIGURE 7.7**

The defects (arrows) noted in [Figure 7.6](#) extended into the surface of the material and contained paint in some areas, substantiating they were the result of manufacturing.

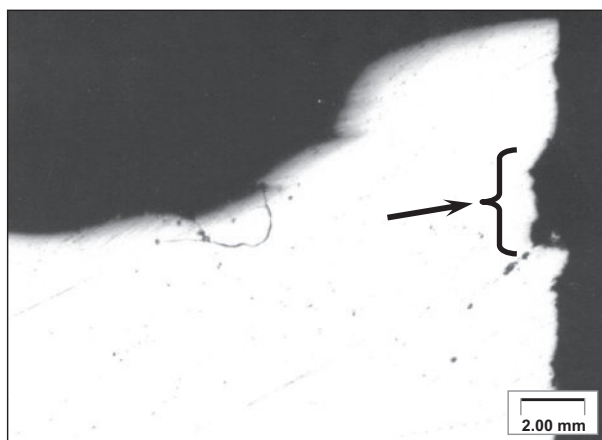
FIGURE 7.8

A cross-section taken through the crack origin in the as-polished condition. Note the recessed area identified by the arrow, which is the anomaly observed previously in [Figure 7.5](#). The width of the defect was approximately 0.004 in.

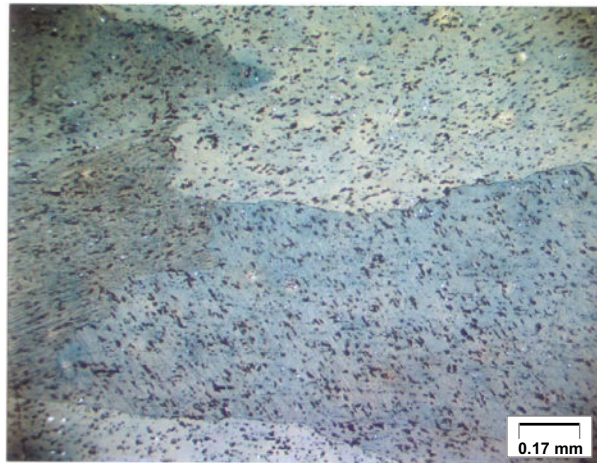
**FIGURE 7.9**

A cross-section through the center of the “U” was etched with Keller’s reagent to reveal the microstructural features of the material. The material was typical of a T6 temper and did not contain any other inherent material defects. Magnification: 60 \times .

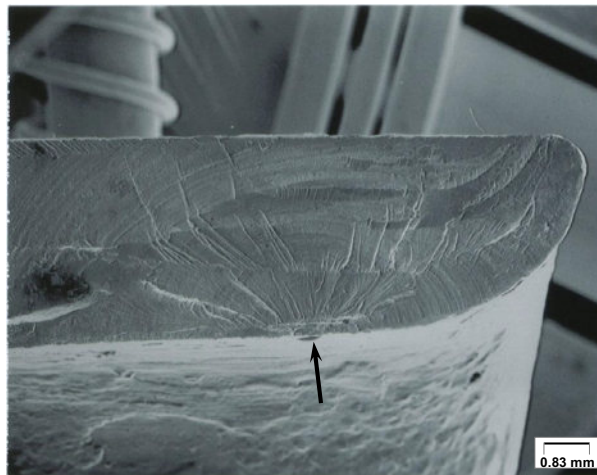
**FIGURE 7.10**

SEM fractograph of fracture half A. Note that the radial lines converge to a small area on the lower edge of the fracture surface as oriented in the fractograph (arrow). This area was located on the concave (inside) surface of the longeron. Beachmarks emanate from this region outward toward the opposite side and to the left of the fractograph continuing across approximately 80% of the entire fracture surface. The fracture morphology was irreconcilable at the point of crack initiation and what appeared to be an oxide was present.

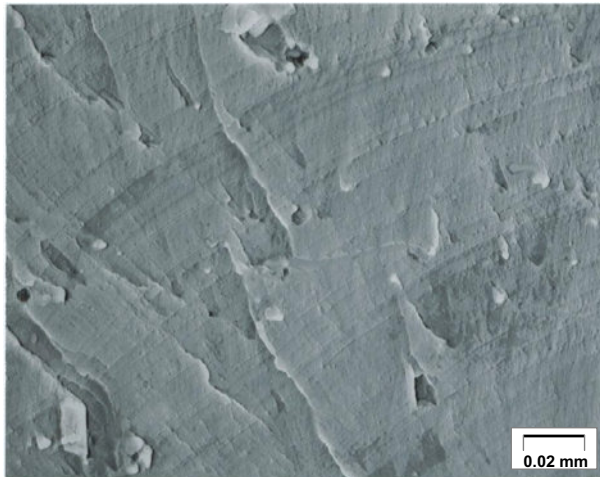
**FIGURE 7.11**

SEM fractograph of fracture half A showing that the fatigue striations predominate over most of the fracture surface confirming that crack propagation was the result of cyclic loading. The striation spacing varied as did the morphology within the fatigue region.

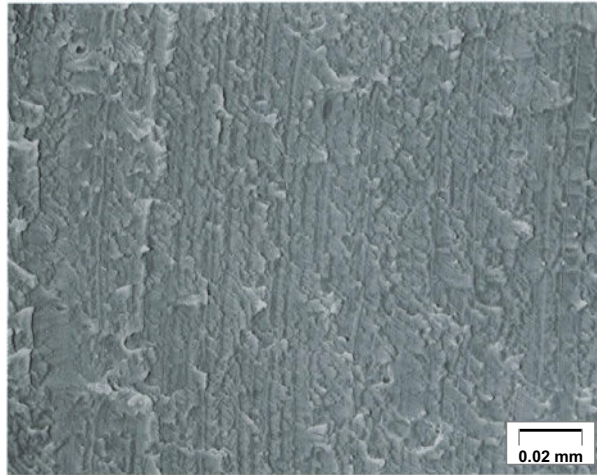
**FIGURE 7.13**

SEM fractograph of fracture half A showing distinct regions of transgranular fracture.

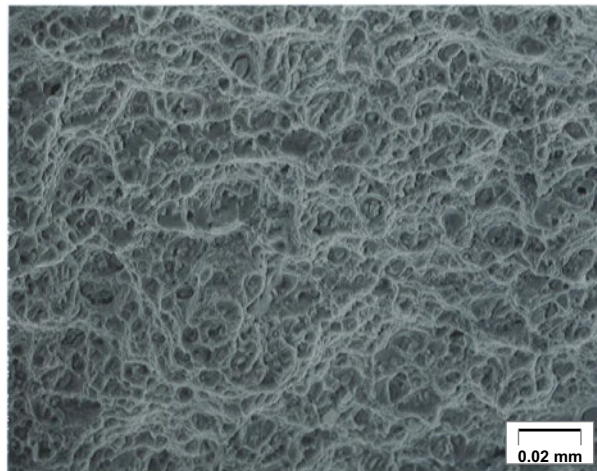
**FIGURE 7.14**

SEM fractograph of fracture half A showing areas adjacent to those shown in [Figure 7.13](#), toward the outer edges of the advancing crack front, that often consisted of a dimpled morphology. The final fracture region at the opposite end of the “U” shaped part also contained a predominately dimpled morphology, indicative of overload conditions.

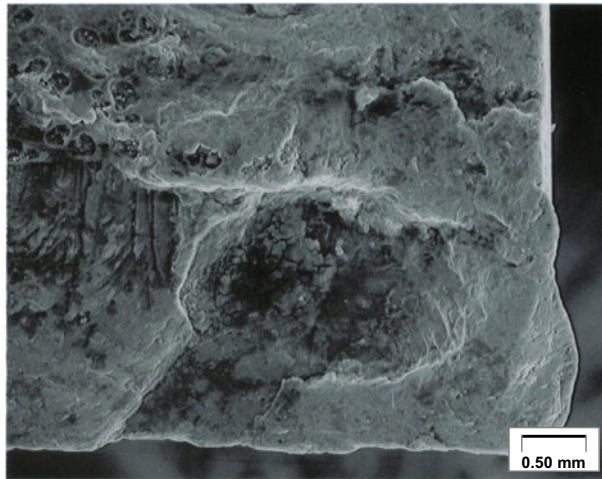
FIGURE 7.15

An enlargement of an unmounted cross-section taken through the crack origin of fracture half B. The fracture morphology was irreconcilable at the point of crack initiation and what appeared to be an oxide was present.

The crack initiation site contained an irreconcilable fracture morphology that was covered with what appeared to be a discontinuous heavy oxide layer. EDS analysis revealed the presence of a large oxygen concentration as compared to the remaining fracture surface. The chemical composition of a polished section of the material was also used for comparative purposes and contained a very small oxygen peak. Therefore, it was reasonable to deduce that the layer in question was rich in oxygen. In addition, the thickness of the oxide layer, as well as the physical shape of the area encompassed by it, suggested that it formed by an alternative means other than atmospheric corrosion or fretting. The remaining fracture surface contained the effects of atmospheric corrosion in the form of dark oxide product which was clearly distinguishable from the oxide contained at the crack origin. Fretting would have produced minute, dark oxide particles, and which would have been caused by some type of mechanical action, but this was not observed. The alleged oxide layer and its morphology were consistent with that of a forming defect, such as a lap. Further evidence substantiating this claim was the other laps found on the concave surface of the part during stereoscopic examination (Figures 7.6 and 7.7). A series of these cracks were located adjacent to the crack origin and extended parallel to the fracture. Such a defect would have provided a suitable site for fatigue crack initiation and propagation.

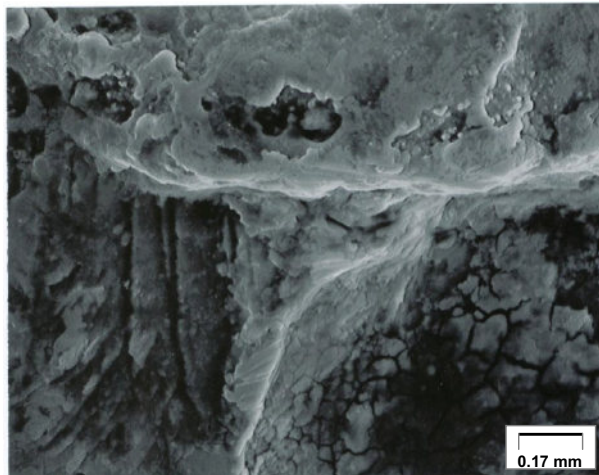
FIGURE 7.16

Photograph of the same area shown in [Figure 7.15](#) at higher magnification. Energy dispersive spectroscopy (EDS) was performed to compare the chemical composition of the alleged oxide product with that of the polished cut surface and also with other areas of the fracture away from the origin.

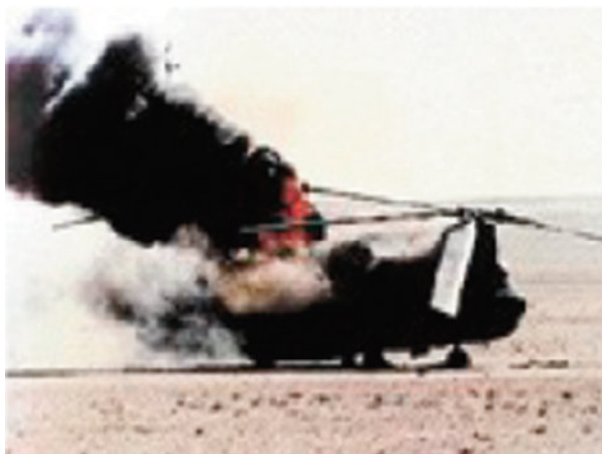
FIGURE 7.17

A metallurgical investigation of a CH-47D Chinook spiral bevel gear that had catastrophically failed leading to a controlled crash of the aircraft at Ft. Meade, MD was performed after the part was recovered from the crash site (Figure 7.17). The component was fabricated from VASCO X2M carburized steel and it failed due to a fatigue crack, which originated from grinding cracks. The failed component was double carburized. The grinding cracks formed from a microstructure that contained excessive carbides and was the result of an unauthorized grinding operation of the chamfer adjacent to the damping ring groove [10]. This grinding operation was performed in order to meet dimensional requirements and was the final step of the manufacturing process. This sequence was outside the approved specification because a subsequent nital etch inspection was required after any grinding operation to detect thermal damage. In addition, the part would also be required to be stress relieved and subsequently shot peened. The excessive carbides were formed during the carburization heat treatment and were the result of too high a carbon potential. Optical and electron microscopy of the case and core microstructures were performed and the grinding burns were characterized. Figure 7.18 shows an example of the carbide distribution as a result of a low-carbon potential treatment, associated with a certain gear manufacturer, while Figure 7.19 shows that of a high-carbon potential treatment associated with defective gears. Note the difference in carbide distribution between the two. Figure 7.20 shows the ground surface of a defective gear. There is evidence of a rehardening burn (lightly etched surface layer) as well as retempering burn (darker etching layer below the rehardening zone). This region is shown at higher magnification in Figure 7.21. Metallographic examination, combined with microhardness testing, revealed a deeper than acceptable case in the

Catastrophic failure of the CH-47 spiral bevel gear.

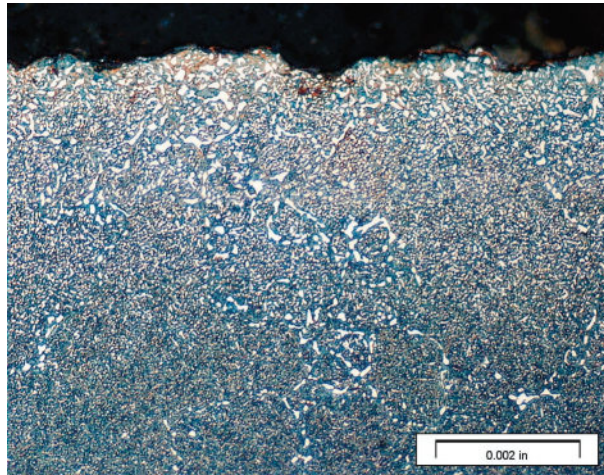
**FIGURE 7.18**

Typical carbide distribution within the case of a gear heat treated with a high-carbon potential (1.2%). Magnification: 500 \times .

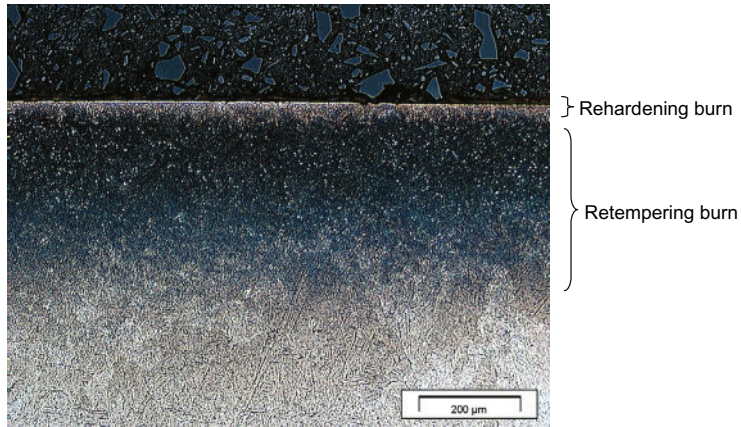
FIGURE 7.20

Rehardening and ret tempering grinding burns. Magnification 200 ×.

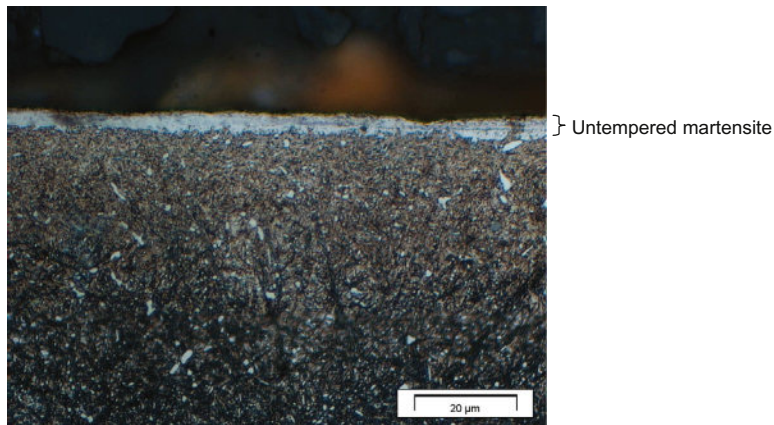
FIGURE 7.21

The rehardening burn shown in [Figure 7.12](#) at higher magnification Note the layer of untempered martensite at the surface. Magnification 1000 ×.

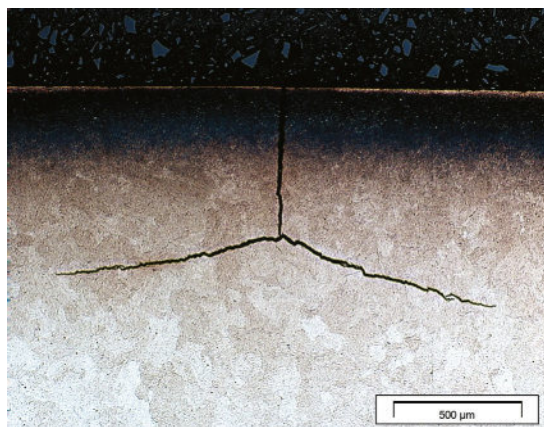
FIGURE 7.22

damping ring groove region (origin location). It was later learned that this region was mistakenly subject to a double carburization during processing. A grinding crack was also examined as shown in [Figure 7.22](#). The shape of the crack suggests separation of the case and core. The core structure ([Figure 7.23](#)) consisted of a duplex structure of free ferrite and tempered martensite.

A grinding crack indicative of defective gears. Crack branching appears to suggest case/core separation. Magnification 50 ×.

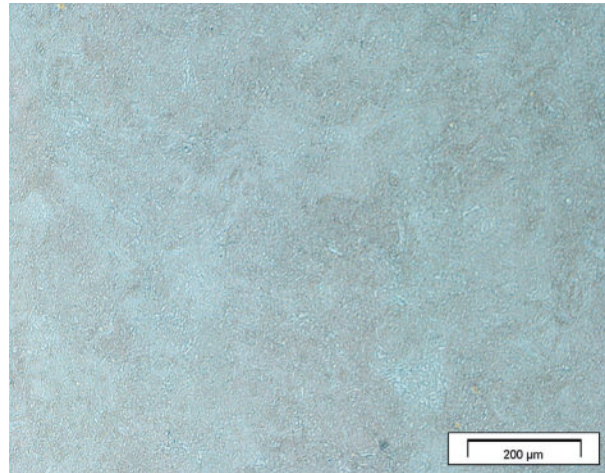
**FIGURE 7.23**

Typical core microstructure of the carburized gears. Magnification 100 \times .

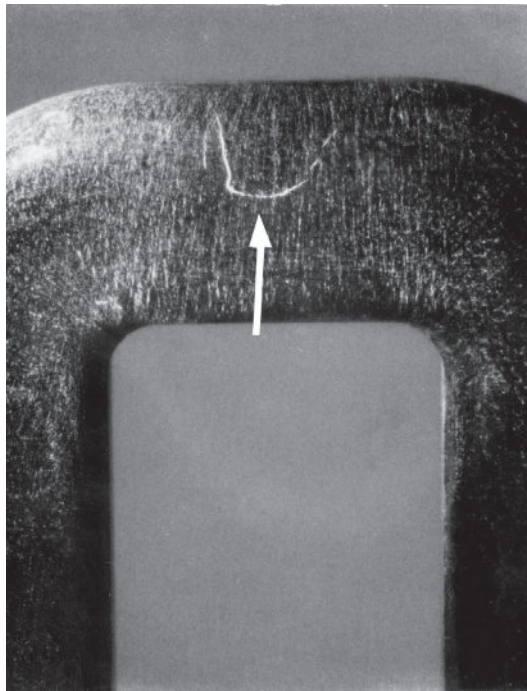
FIGURE 7.27

Black light photo of a forging seam located on the bail section of a lug.

Inadequate process control was found to be the root cause of the suspension lug failures. There were two distinct deficiencies uncovered that involved inadequate controls of certain aspects of the manufacturing process. The first was related to the forging operation and the other to the MPI. Forging laps were eliminated by incorporating a forging lubricant while decreasing the impact energy. The MPI inspection was required on 100% of the parts yet 20% of them contained forging laps that were cause for rejection. An extensive inventory screening process was necessary to prevent any more defective lugs from being used in service, whereby the parts that were supposedly previously magnetic particle inspected were subjected to an additional 100% inspection, consisting of a central conductor shot, as well as a head shot (Figures 7.28 and 7.29). The head shot was added to the MPI procedure. Thousands of lugs were scrapped as a result of this re-inspection, and the warranty clause was invoked by the NAWC.

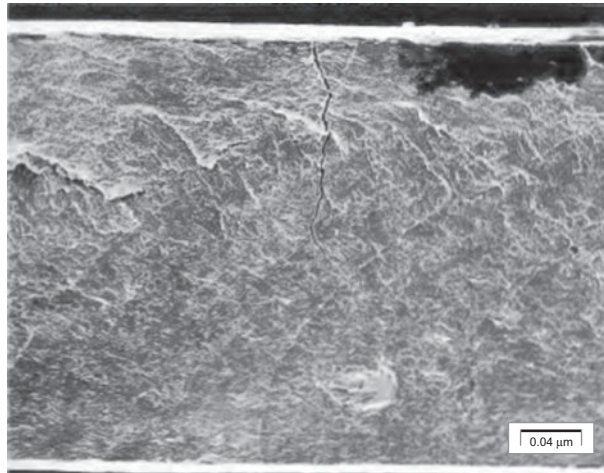
FIGURE 7.30

Secondary cracking noted on a strap pack laminate.

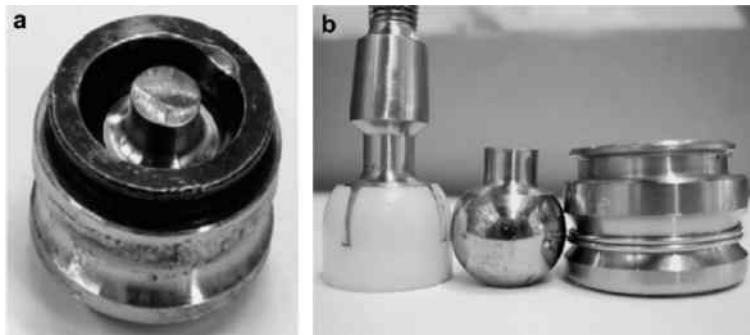
**FIGURE 8.3**

This case describes the analysis and investigation of the causes of the sudden failure of a MacPherson strut suspension system ball joint. The axis of the ball joint element showed a complete fracture, which occurred midway between the top and bottom section changes of the element, as shown in [Figure 8.3](#).

Ball joint element. (a) Failed ball joint in the cage. (b) Failed and new ball joints out of the cage [8].

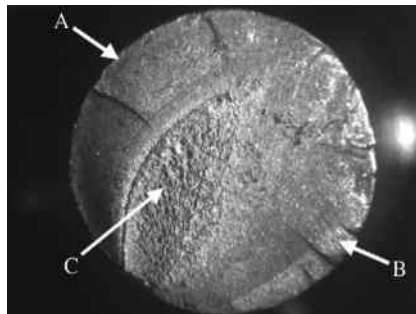
**FIGURE 8.4**

Figure 8.4 shows a macroscopic image of the fractured surface of the ball joint obtained by optical microscopy. Three different characteristic zones of the fracture are identified in the figure as Zones A through C. Zones A and B indicate opposed zones where the crack growth started. These zones showed a smooth and curved appearance or beach marks. These zones are a clear indication of fatigue failure of the material. Furthermore, in Zones A and B can be appreciated fracture features pointing toward the center of the fracture. These ratchet marks are typical of fracture on elements subjected to high-stress concentrations. Zone C on the other hand shows a rough surface, indicating the final fracture zone of the element; this zone occupying approximately one quarter of the cross-section of the element.

Fracture surface of the failed ball joint [8].

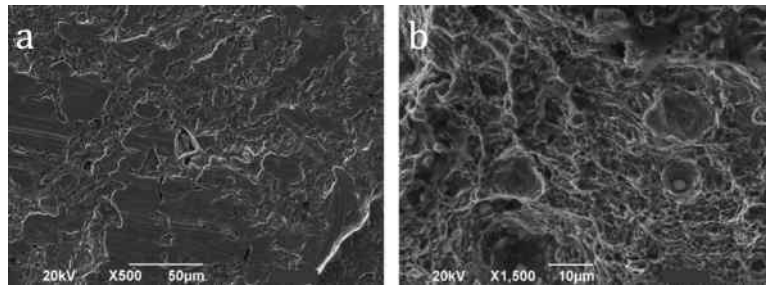
**FIGURE 8.5**

Figure 8.5 shows the fracture zones of the element, where the smooth surface and the beach marks characteristics of fatigue crack propagation can be appreciated, corresponding to Zone A (Figure 8.5a). On the other hand, Figure 8.5b shows Zone C, where the micro-voids characteristic of final ductile fracture of the element can be appreciated.

SEM micrographs of fracture surface. (a) Zone A and (b) Zone C. [8].

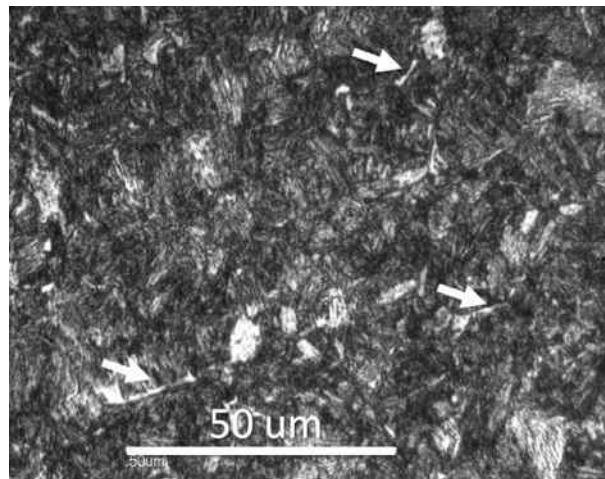
**FIGURE 8.6**

According to chemical composition analysis by OES, the ball joint was manufactured using AISI-SAE 5140 steel. Figure 8.6 shows the microstructure of the ball joint element. This micrograph shows a microstructure formed mainly by tempered martensite with acicular grains of ferrite on the grain boundaries (white grains indicated by arrows).

The presence of tempered martensite indicates that the material suffered a heat treatment of quenching and tempering. Despite of the beneficial effect of increasing material toughness of ferrite in low-carbon steels [25–27], it has been found that acicular ferrite can decrease the fracture toughness and mechanical strength of heat treated steels when it appears on tempered martensite grain boundaries [28,29], as in the present case. The presence of acicular ferrite on grain boundaries can also induce a

Microstructure of the material. Etched with Nital 2% [8].

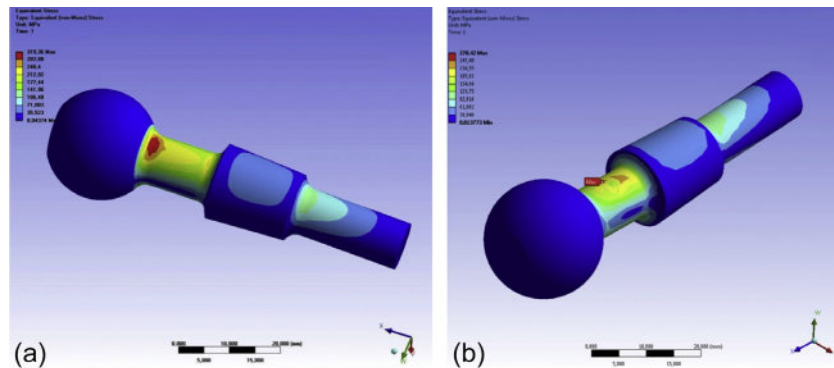
FIGURE 8.7

Equivalent Von Mises stress distribution of the ball joint. (a) Without contact support and (b) with contact support [8].

The analysis and calculations of maximum stresses were performed both with and without the contact support patch, in order to highlight the places of higher stresses in the element. The contact support between the axis of the element and its cage was modeled as frictionless because the failed element surfaces did not show any indications of fretting or wear suggesting friction between them. [Figure 8.7a](#) shows the stress distribution on the ball joint element without the contact support patch in place. In this case, the maximum stress was found on the section change between the ball and the axis. This stress reached a maximum value of 319 MPa approximately. On the other hand, [Figure 8.7b](#) shows the stress distribution on the element including the contact support patch. In this case, the maximum stress was found on the contact region between the axis of the element and its cage. This stress reached a maximum value of 278 MPa approximately, which is lower than the bulk fatigue endurance limit of this steel under normalized conditions, which reaches to a value of 416 MPa [31]. However, this stress is close to the endurance limit found using Murakami's Equation (8.1) for the acicular ferrite present in the grain boundaries of the material. Also note that the place where this stress is reached corresponds to the place where the fracture occurred in the ball joint element (see [Figure 8.3](#)). The smooth beach marks accompanied by ratchet marks and a small fracture zone (one quarter of the cross-section of the element) confirm that the element suffered high-stress low-cycles fatigue conditions initiated at the acicular ferrite on the grain boundaries, followed by fatigue crack growth.

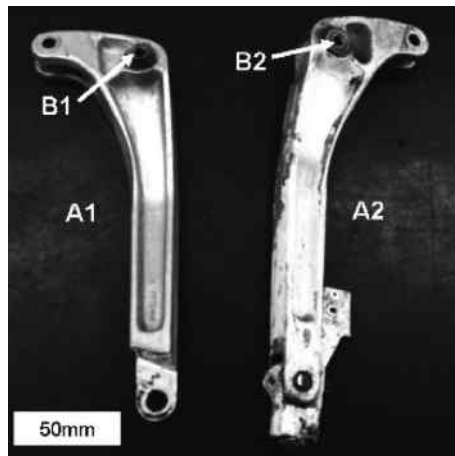
FIGURE 8.9

Figure 8.9 shows the two linkages as received for analysis after the accident. Linkage A1 shows fracture of the bottom clevis, with bolt B1 fractured at one end. Linkage A2 on the other hand, was received with clevis bolt B2 fractured at both ends.

Landing gear left and right locking linkages A1 and A2, respectively. Also shown is the location of the respective failed bolts B1 and B2 [22].

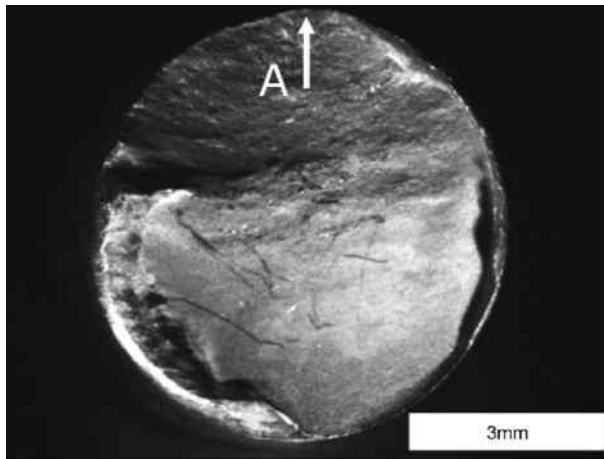
FIGURE 8.10

Stereographic examination of the fractured surface of bolt B1 reveals a typical mode II or shear loading fracture, with the arrow indicating the zone where the fracture began (Figure 8.10).

Stereoscopic micrograph of the fractured surface of bolt B1. The arrow points toward the fracture initiation [22].

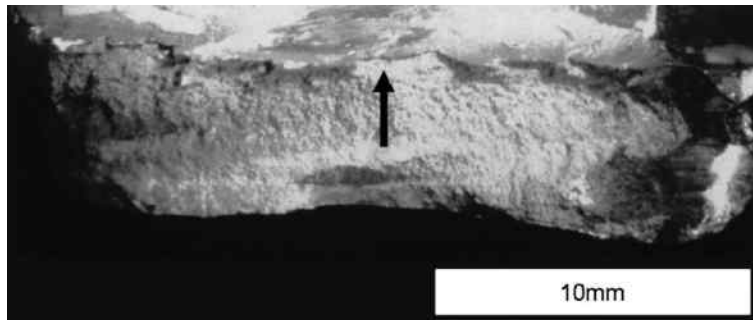
FIGURE 8.11

Figure 8.11 shows the fracture surface of the failed clevis of linkage A1. The fracture surface indicates crack-opening mode-I loading failure, initiating the crack at the internal surface of the element as indicated by the arrow.

Stereoscopic micrograph of the fractured surface of the clevis of linkage A1. The arrow points toward the fracture initiation [22].

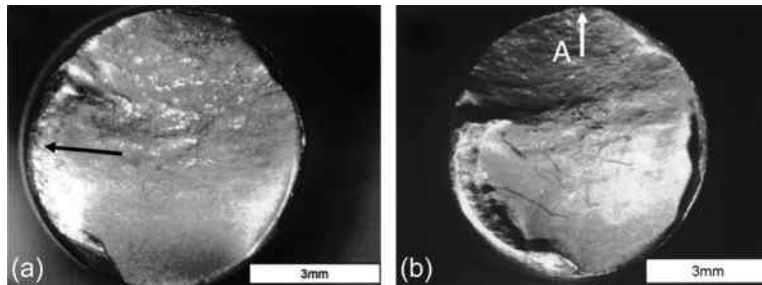
FIGURE 8.12

Figure 8.12a shows the fractured surface of the left-hand side tip of bolt B2. This surface displays similar characteristics to the fracture surface shown in Figure 8.10 for bolt B1, with shear fracture mode prevailing, also accompanied by bending of the left-hand side tip of the bolt. Figure 8.12b, on the other hand shows the fracture surface of the right-hand side of bolt B2. This surface exhibits different characteristics when compared with the respective fractured surfaces of the bolts analyzed previously, with a less rough appearance in Zone A (see Figure 8.12b). This zone also displays what appear to be fatigue beach marks, which along with the straight

Fracture surface of bolt B2. (a) Left-hand side and (b) right-hand side [22].

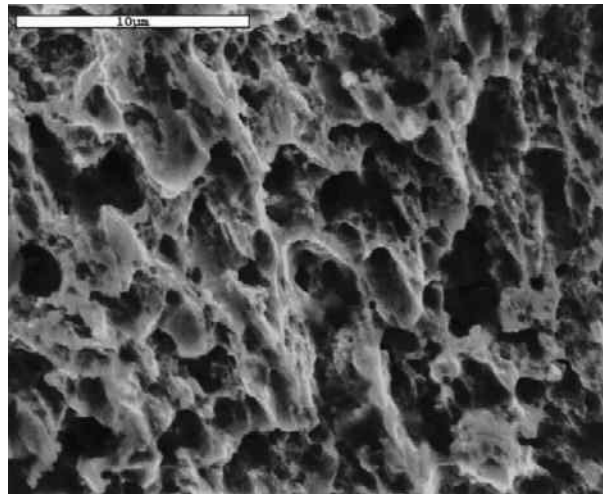
FIGURE 8.13

SEM micrograph of Zone A in Figure 8.12, showing ductile shear fracture [22].

right-hand tip fracture could indicate a pre-existent crack in the bolt. However, higher magnification SEM analysis revealed that the failure was indeed caused by shear loading mode as for the other fractured bolt surfaces and no evidence of fatigue was found, as shown in Figure 8.13. These apparent fatigue marks can be misleading and care must be taken in order to assess a realistic failure cause.

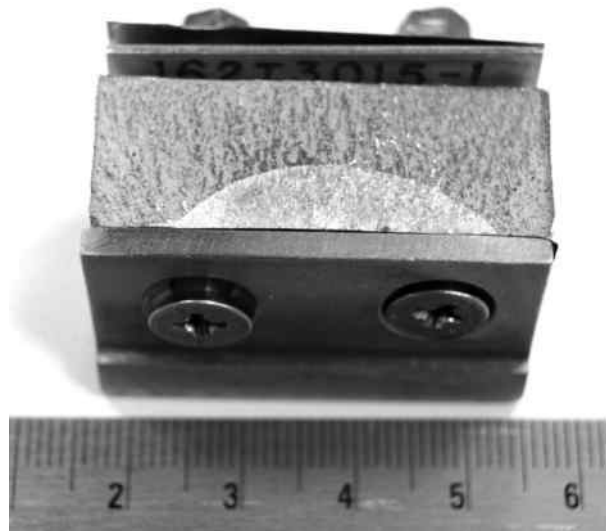
FIGURE 8.15

This case describes the analysis and investigation of the causes of the failure of the nose-landing gear AFT lock-link of a Boeing 767-200 aircraft. Figure 8.14 shows the nose-landing gear of the aircraft. The AFT lock-link was fractured as shown in Figure 8.15. The element was manufactured using a 7175 Aluminum alloy.

Failed AFT lock-link with support plate in place.

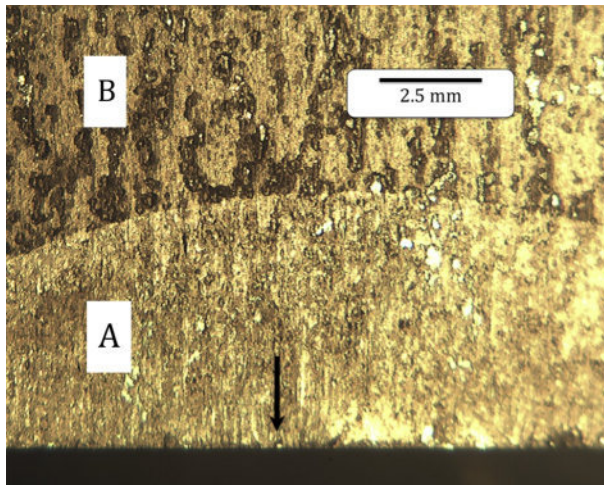
FIGURE 8.16

Figure 8.16 shows the fracture surface of the landing gear, appreciated by optical microscopy. This fracture shows two distinctive zones, one clear and semi-circular zone denoted as Zone A, and a darker zone, denoted as Zone B. The fracture began at

Fracture surface of the AFT lock-link.

the lower part of [Figure 8.16](#), as indicated by the arrow. This zone coincides with the placement of the support plate of the element.

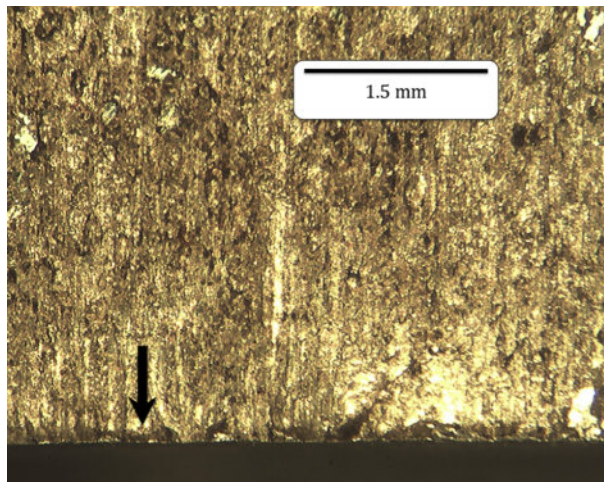
FIGURE 8.17

[Figure 8.17](#) shows Zone A; here the ratched marks can be appreciated, indicating high stresses in the contact area of the support plate.

Fracture surface of the AFT lock-link, Zone A.

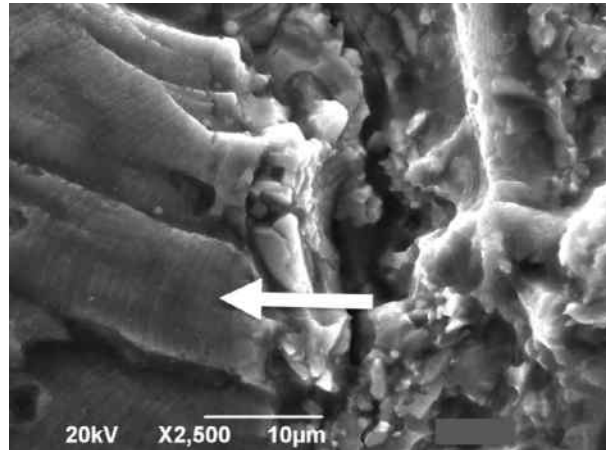
FIGURE 8.18

[Figure 8.18](#) shows a SEM image of Zone A, where the arrow indicates the fatigue crack growing direction. It can also be appreciated that the fatigue crack growing direction runs parallel to a precipitate located at the center of the image.

SEM fracture surface of the AFT lock-link at Zone A. The arrow indicates fatigue-growing marks.

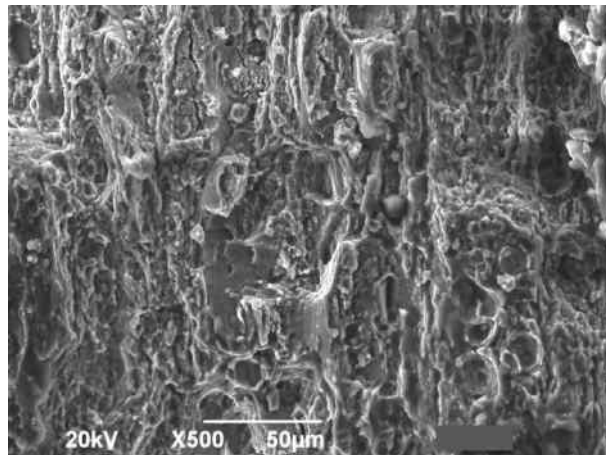
FIGURE 8.19

SEM fracture surface of the AFT lock-link at Zone B.

Figure 8.19 shows the fracture surface of the element on Zone B. Here, the surface is characteristic of ductile fracture with vertically aligned precipitates.

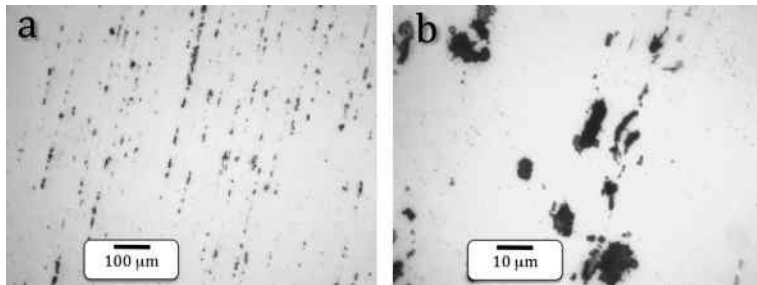
FIGURE 8.20

Figure 8.20 shows a metallographic specimen etched with nitric acid (25%) in a zone near to the fracture. Here, the aligned FeAl_3 (dark gray) and MgZn_2 precipitates (black) inside an aluminum-rich matrix can be seen.

Microstructure of the AFT lock-link showing aligned precipitation of MgZn_2 and FeAl_3 . (a) low magnification and (b) high magnification.

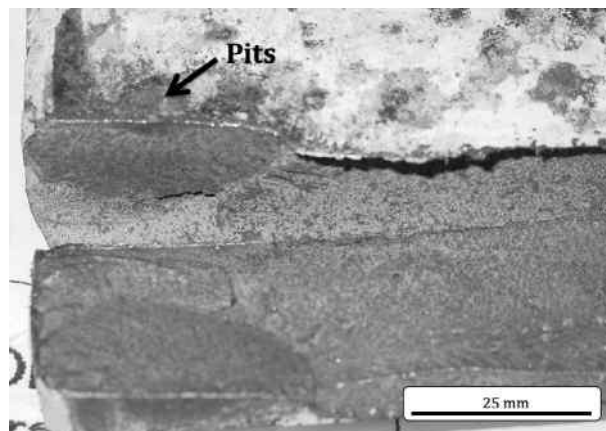
FIGURE 8.23

Figure 8.23 shows the two fracture surfaces of the cantilever spring. Here, the corroded surface on top of the cantilever with pits near the fracture surface can be appreciated.

Top view cantilever spring fracture surfaces.

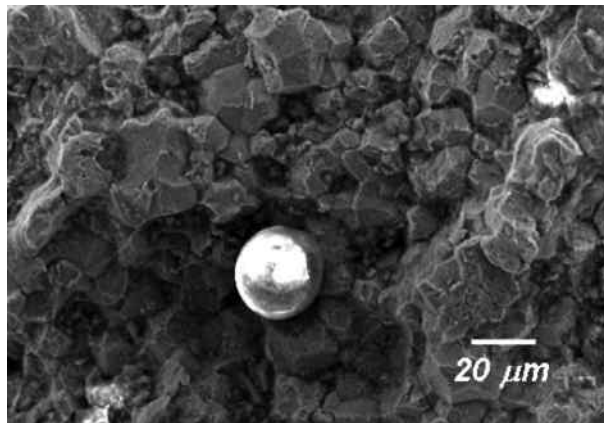
**FIGURE 8.24**

Figure 8.24 shows the fracture surface of the spring. Here, the fracture shows two characteristic zones, denoted as A and B. Zone A is where the crack started, and the arrow points toward the point where the crack started to grow, which corresponds to a pit cavity. Zone B, on the other hand is the region of the element, which supported the loads at the final stages of crack growth of the element, as indicated by the river lines.

Fracture surface of the cantilever spring.

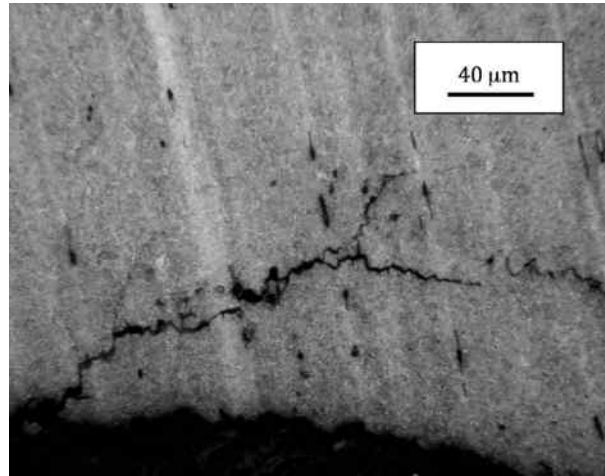
**FIGURE 8.26**

Figure 8.26 shows one intergranular corrosion crack growing from a pit on the surface of the cantilever spring. These kinds of cracks were found consistently in different zones near the surface and the fracture zone of the element.

It can be concluded that the failure of the cantilever spring was caused by a defective protective coating in order to prevent surface corrosion. The corrosion pits created intergranular corrosion of the material that further grew cracks due to cyclic loadings during take offs and landings of the aircraft.

Intergranular crack growing from the element surface on Zone A.

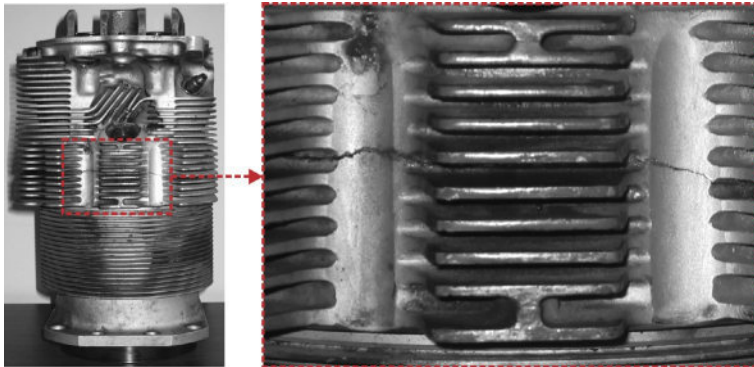
FIGURE 9.4

The damaged cylinder assemblies, photographed in the as-received condition, are shown in [Figure 9.4](#) and [9.5](#). As seen from the aforementioned figures, both CHs had cracked between the fifth and the sixth cooling fins. The clearly visible crack

Cylinder assembly photographed in the as-received condition with close-up view of the crack in the CH I (Failure Case I).

had an approximately 0.5 mm width and extended about 80% of the CH circumference. The crack propagation plane in the failed CHs runs through the position of the top plane of cylinder barrel (Figure 9.6).

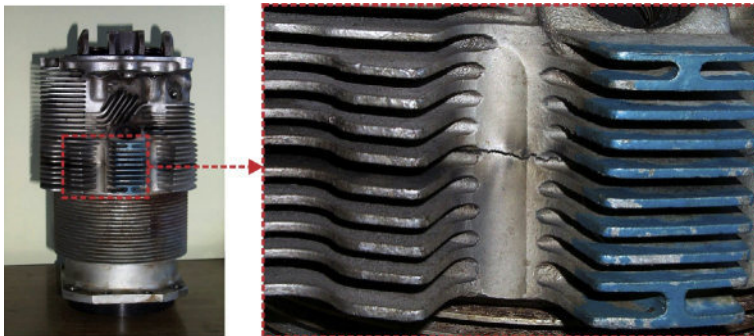
FIGURE 9.5

Cylinder assembly photographed in the as-received condition with close-up view of the crack in the CH II (Failure Case II).

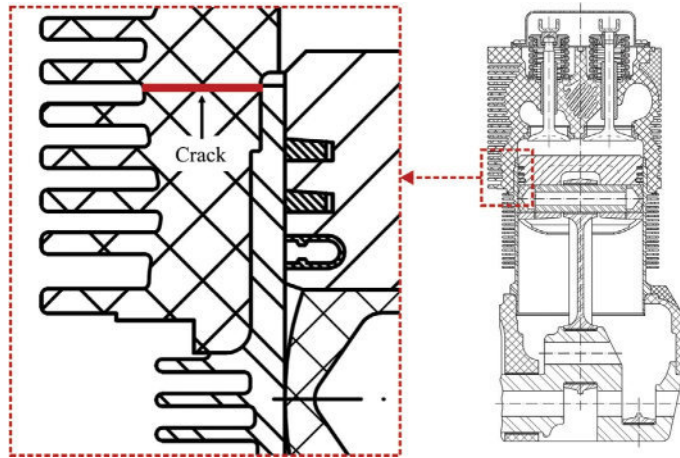
FIGURE 9.6

Schematic drawing of cylinder assembly, piston, and valve components with close-up view of the crack position in the CH.

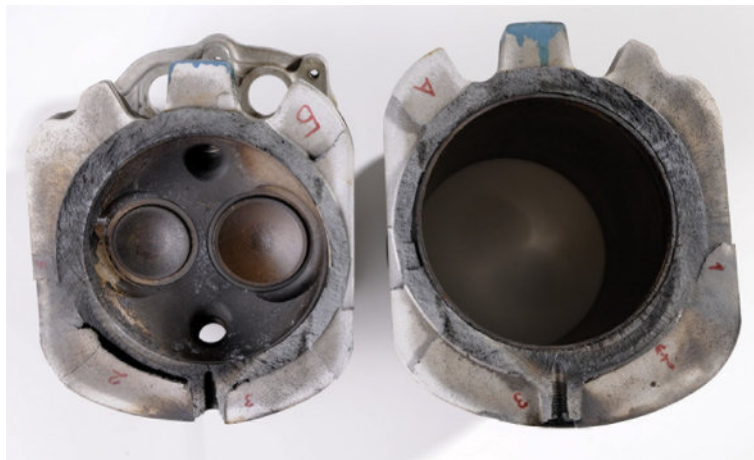
FIGURE 9.7

The initial visual inspection of the mating fracture surfaces of the CH I (Figure 9.7), using the unaided human eye, indicated the presence of five different morphologies, marked as A, B, C, D, and E in Figure 9.8. The sector A, located on the exhaust side of the CH I, showed a flat and smooth surface. Features characteristic of fatigue fracture can be clearly distinguished. These are ratchet marks, which represent steps between fatigue crack regions propagated from different origins (the larger of them

Mating fracture surfaces of the CH I obtained after the crack was mechanically opened.

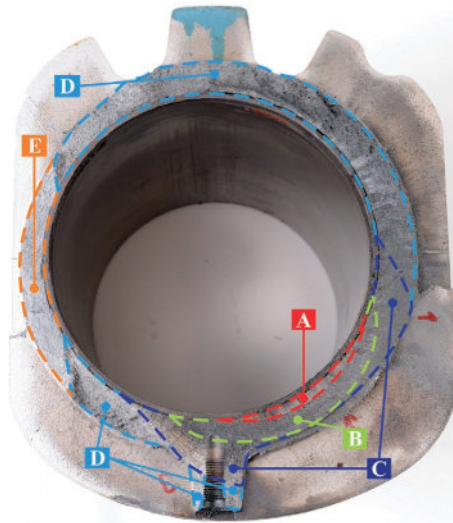
FIGURE 9.8

Macrograph showing characteristic morphologies on the fracture surface of CH I.

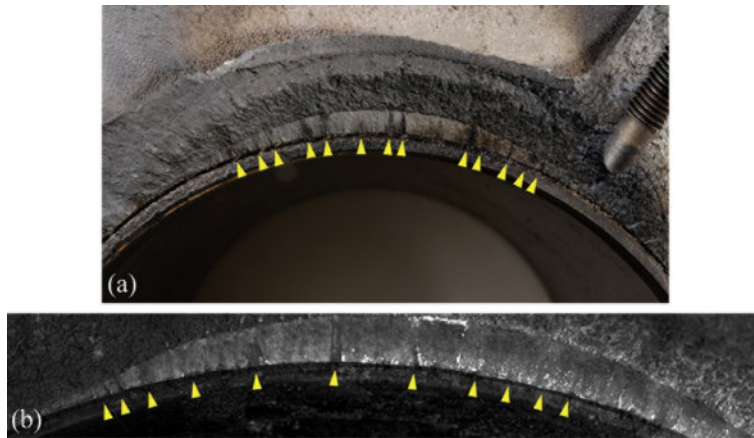
**FIGURE 9.9**

are marked with arrowheads in [Figure 9.9a](#)). The additional examination of fracture surface of the sector A under stereomicroscope confirmed that the fatigue crack initiated from different origins located on the inner edge of the CH I ([Figure 9.9b](#)). The fatigue crack had propagated slowly over this sector. The sector A has an obvious thumb-nail-shaped boundary with the sector B. The main macroscopic feature of the slant fracture surface of the sector B ([Figure 9.10a](#)), approximately 45° to the CH I axis, is a rough and dull texture, which suggests ductile fracture under mostly

(a) View of the sector A of the fracture surface depicting ratchet marks (arrowheads) and (b) stereomicrograph showing the sector A of the fracture surface with multiple ratchet marks along the inner edge of the CH I (arrowheads).
