Handbook of Materials Failure Analysis

With Case Studies from the Aerospace
and Automotive Industries

Abdel Salam Hamdy Makhoul

Mahmood Aliofkhazraei

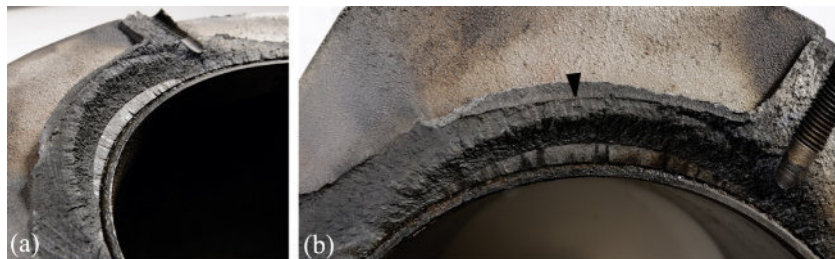
**FIGURE 9.10**

tensile loads. Moreover, a narrow rim of overstress fracture extends around almost the entire outer circumference of the slant fracture. However, in this stage of fracture life, the crack depth reached the outside surface of the CH I (arrowhead in Figure 9.10b). The sector C of the fracture surface revealed the presence of macroscopic crack beach marks (arrest lines), which suggest that the crack propagated in a fatigue mode (Figure 9.11). The sector D represents the fracture surface of unstable fracture with a rough, dull, and coarse grained morphology, where the overload was the main fracture mechanism. This final overstress fracture of the CH I wall occurred when the crack had reached a critical size. The sector E covers about 20% of cross-section of the CH I. Actually, this sector is area of mechanically forced open fracture characterized by the bright appearance resulting from the reflective qualities of cleaved crystals. In addition, the visual inspection disclosed a varying degree of exposure of the fracture surface to the combustion gases. Consequently, almost the entire fracture surface of the CH I, except sector E, was significantly contaminated by these gases. No evidence of macroscopic plastic deformations was found on the fracture surface.

(a) Macrograph showing the slant fracture surface of the sector B and (b) place where the crack depth reached the outside surface of the CH I (arrowhead).

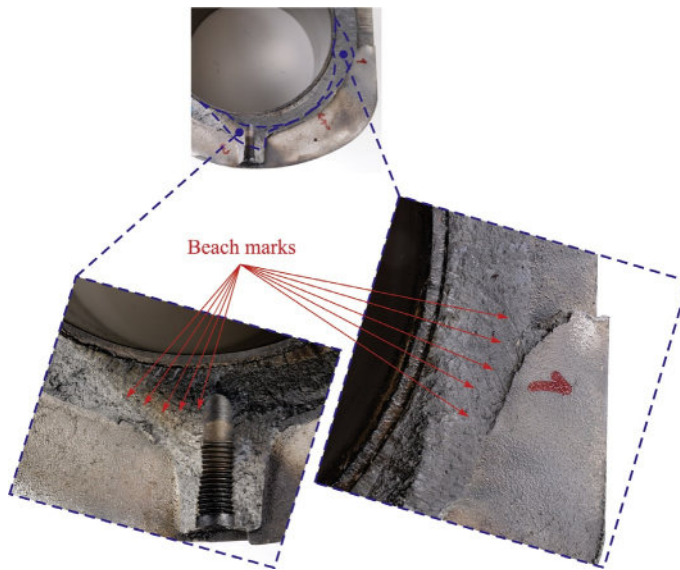
FIGURE 9.11

Macrograph montage of the sector C of the fracture surface showing the fatigue beach marks.

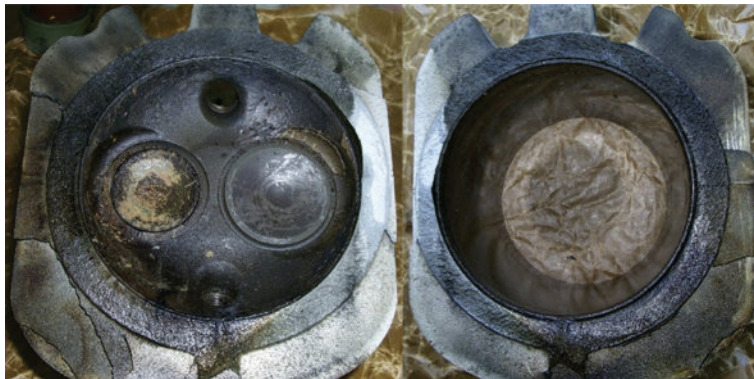
FIGURE 9.12

Three distinct areas of apparent morphologies were noticed on the mating fracture surfaces (Figure 9.12) of the CH II (marked as A, B, and C in Figure 9.13). A rather smooth and flat surface of the sector A, with clearly visible beach and ratchet marks (Figures 9.14 and 9.15), undoubtedly evidenced that the fatigue was involved. This sector extends about a quarter of the CH II circumference and appears to cross the

Mating fracture surfaces of the CH II obtained after the crack was mechanically opened.

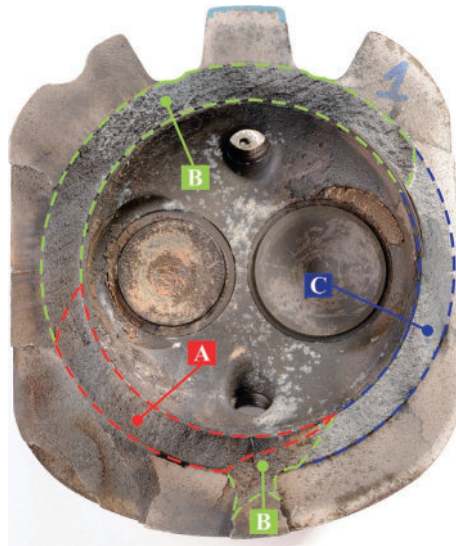
FIGURE 9.13

entire thickness of the CH II wall in the middle. By tracing back the beach marks, the fracture origin area was also found to be at the internal surface of the CH II. The fracture surface of unstable fracture, sector B, exhibited a rough, dull with coarse grainy morphology, which is common for an overstress fracture mode. This final overstress fracture of the CH II wall occurred when the total area of the crack had reached a critical size. The sector C of fracture surface, obtained after the crack was mechanically opened, was characterized by the bright appearance due to reflective qualities of cleaved crystals and represented about 25% of the CH II cross-section. Similar to the Failure Case I, areas of apparent fatigue and overstress fracture (sectors A and B) were also significantly contaminated by combustion gases. No evidence of macroscopic plastic deformations was found.

Macrograph showing characteristic morphologies on the fracture surface of CH II.

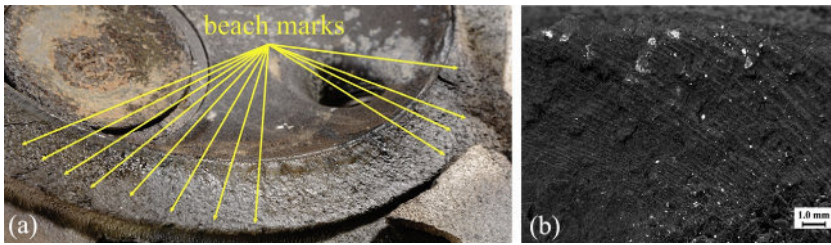
FIGURE 9.14

(a) Macrograph showing beach marks in the sector A of the fracture surface of CH II and (b) stereomicrograph of beach marks in the sector A.

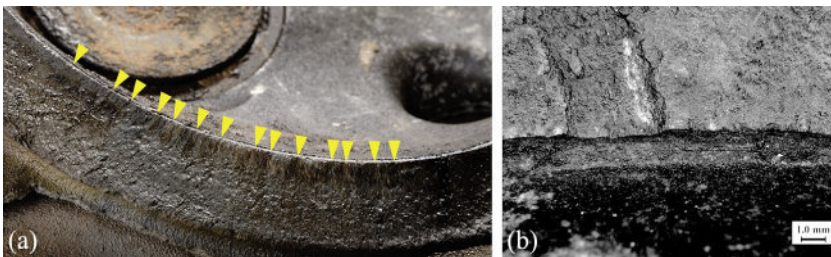
FIGURE 9.15

(a) Macrograph showing ratchet marks in the sector A of the fracture surface of CH II (arrowheads) and (b) stereomicrograph of ratchet marks in the sector A.

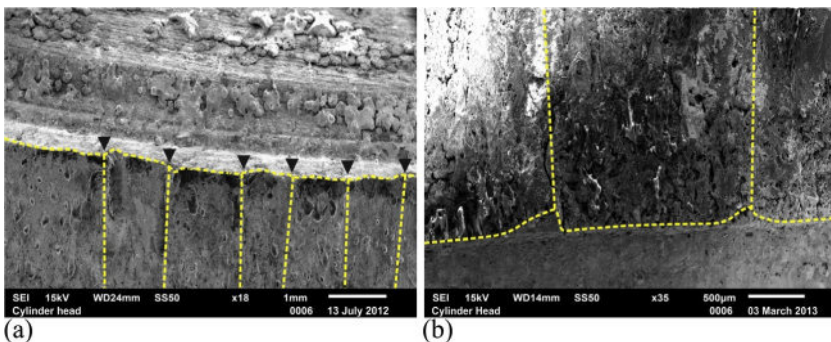
FIGURE 9.16

of deposits, the SEM examination of the most interesting areas of the fracture surfaces (sector A on fracture surfaces of the CH I and the CH II) revealed the fine ratchet marks along the entire fracture nucleation region on the both CHs inner surfaces (Figure 9.16a). In addition, this confirmed the macroscopic observation about the existence of multiple fatigue fracture origin sites (Figure 9.16b).

(a) Fatigue fracture surface of the sector A of CH I shows evidence of fine ratchet marks (arrowheads) and (b) one of the multiple fatigue origin sites on the inner surface of the sector A of CH II.

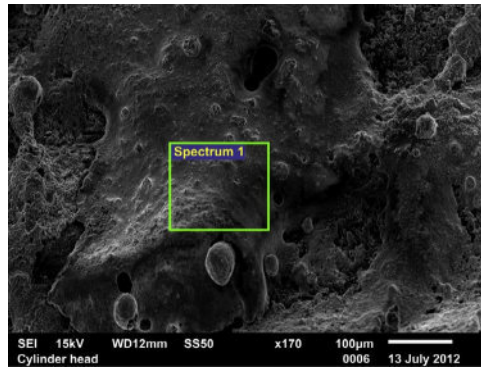
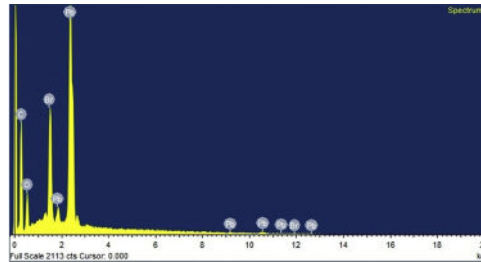
FIGURE 9.17

EDS analysis indicated that deposits on the fracture surfaces, clearly visible on SEM images (Figures 9.17a and 9.18a), contained high concentrations of lead and bromine (Figures 9.17b and 9.18b), which undoubtedly suggested that they originated from combustion of aviation gasoline. Aviation gasoline normally contains lead, while bromine is an additive, which scavenges lead by forming volatile lead bromine [9].

(a) Fatigue fracture surface of the sector A of CH I covered by deposits and (b) EDS spectrum from deposit (region marked in (a)).

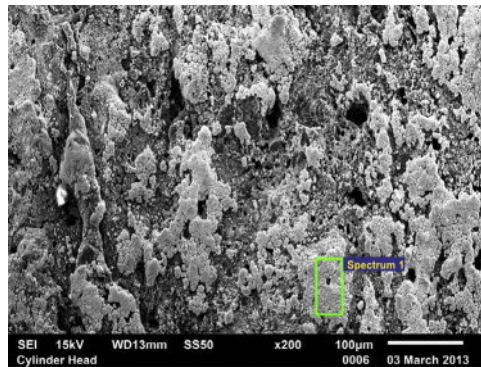
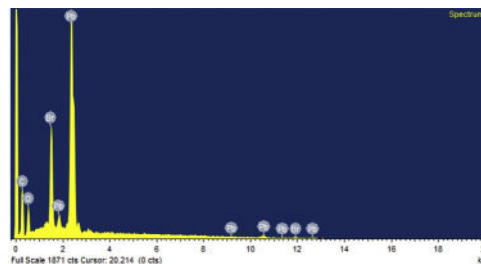
FIGURE 9.18

(a) Fatigue fracture surface of the sector A of CH II covered by deposits and (b) EDS spectrum from deposit (region marked in (a)).

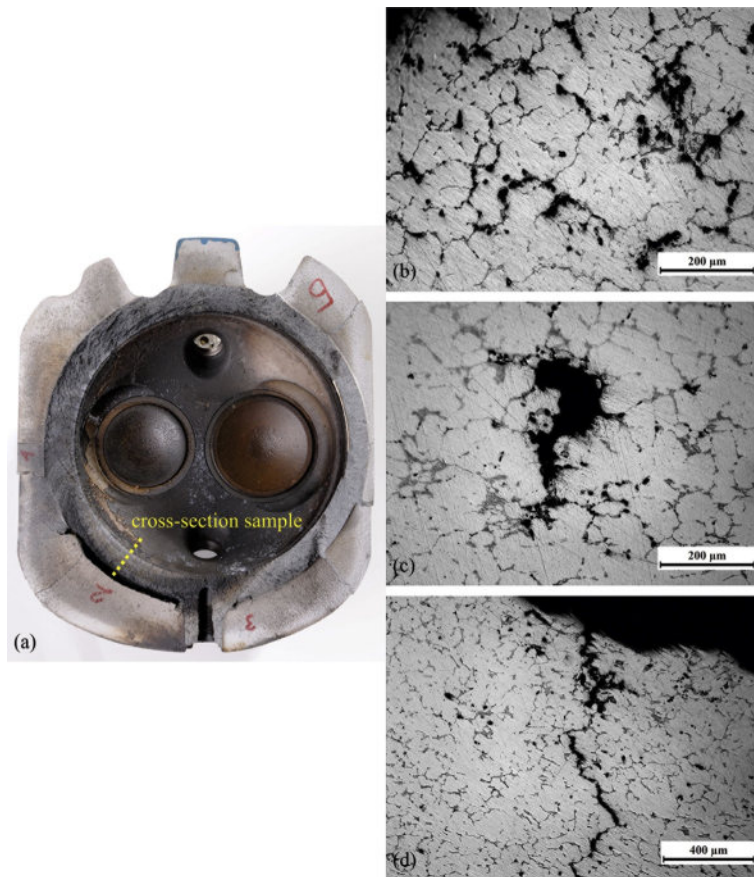
FIGURE 9.19

Metallographic examination of the casts was performed on five longitudinal sections of the CHs (one section of the CH I and four sections of the CH II) in a direction perpendicular to the fracture surface. The samples were prepared at the locations indicated by dotted lines in Figures 9.19a and 9.20. These locations approximately corresponded to the main fatigue crack origins. The sections were examined in the as-polished condition under light microscope. They discovered a presence of casting defects in both CHs materials. A large amount of microporosity, in form of grouped shrinkage pores surrounded by primary dendrites and eutectic phase [10], was found near to the both CHs surfaces (Figures 9.19b and 9.20). Some of these microporosities reached approximately 400 μm in length (Figure 9.19c). Intergranular cracks, formed by linking up of other shrinkage pores in material, were also observed (Figure 9.19d). The

(a) Macrograph of fracture surface of CH I with location where metallographic sample was taken, (b) grouped shrinkage pores in CH I material, (c) typical shrinkage pore (black) surrounded by primary dendrites (white) and eutectic phase (gray needles in a white matrix), and (d) intergranular crack due to the linking of shrinkage pores.

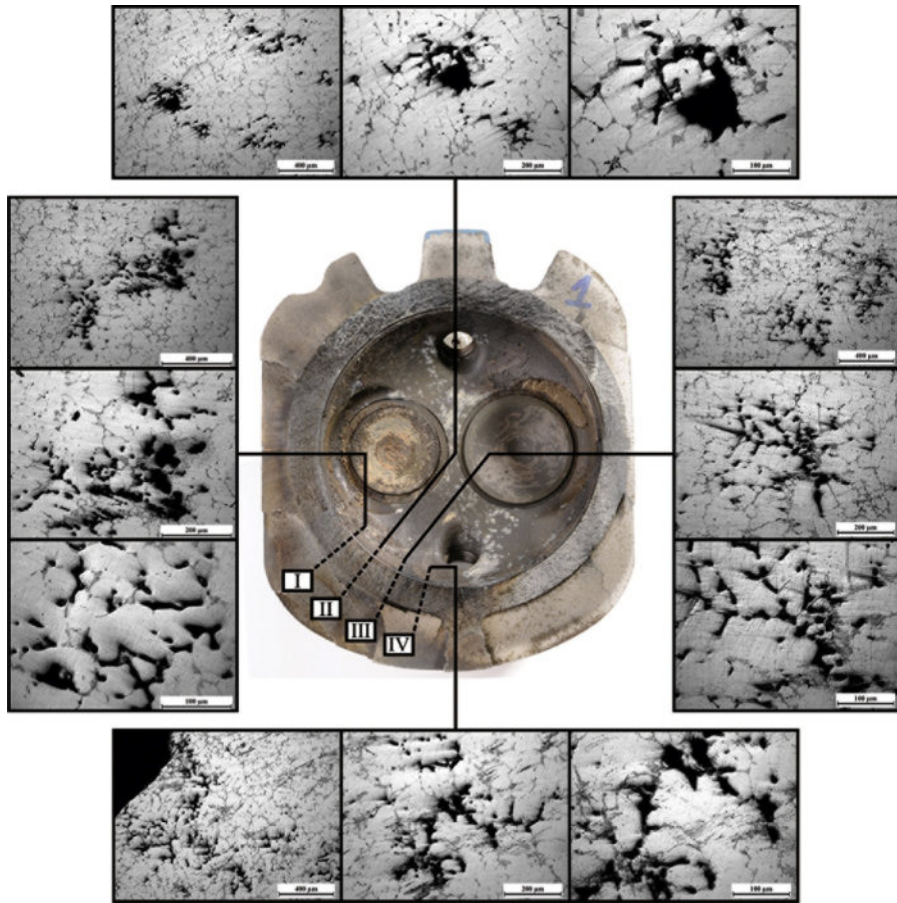
FIGURE 9.20

Macrograph of fracture surface of CH II showing locations where metallographic samples were taken with optical micrographs of samples I-IV.

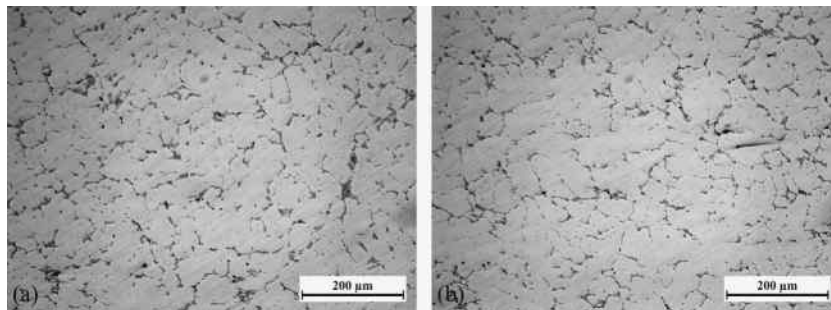
FIGURE 9.21

microstructure revealed the typical structure of an aluminum-copper casting alloy with intermetallic phases precipitates located at the grain boundaries [11] (Figure 9.21).

(a) Optical micrograph of the CH I microstructure and (b) optical micrograph of the CH II microstructure.

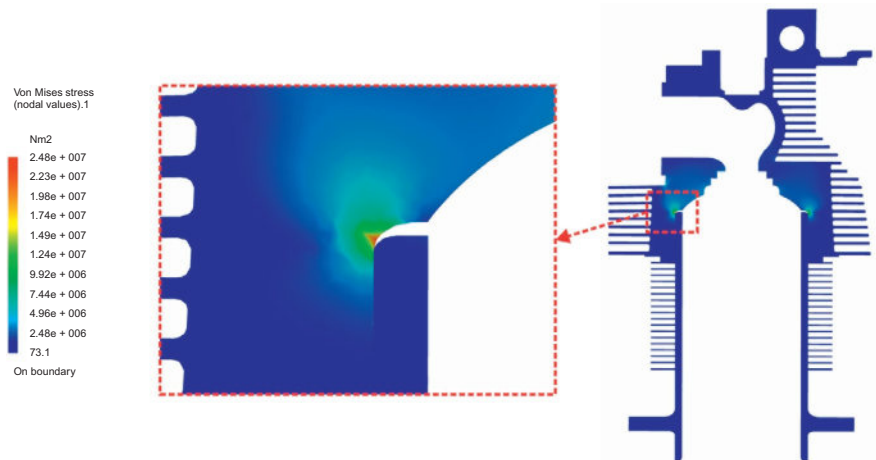
FIGURE 9.24

The stress distribution of the cylinder assembly was obtained according to the Von Mises stress criterion. The FE analysis confirmed that the crack origins were located at the most stressed area of the cylinder assembly (i.e., on the inner flange fillet of the exhaust side of the CH). The stress maximum value is 24.8 MPa, which is less than yield strength of 242.0 aluminum-casting alloy. However, this stress in combination with high concentration of shrinkage pores can lead the crack to initiate. The node where stress reaches the maximum value, [Figures 9.24](#) and [9.25](#), corresponds to the central portion of sector A, [Figures 9.8](#) and [9.13](#).

Stress distribution on the longitudinal section of the FE model through the node with maximum stress value.

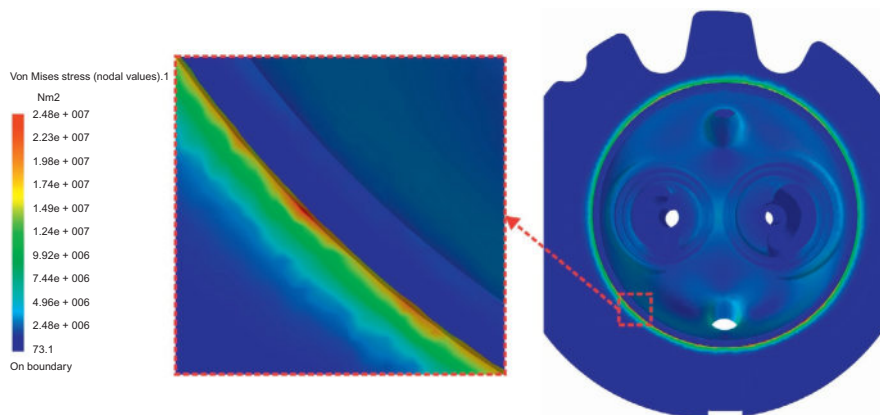
FIGURE 9.25

Stress distribution on the cross-section of the FE model through the node with maximum stress value.

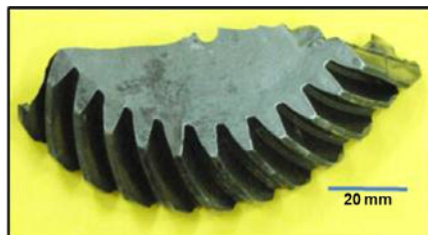
FIGURE 10.1

An abrupt failure of an engine bevel pinion was reported during test runs. Prior to the failure, the component completed approximately 1300 h of testing. Strip examination after the event revealed that a portion of the spiral bevel pinion of engine gear box was fractured (Figure 10.1) and ejected out of the test setup. This caused secondary damages to the front cover plate of the test assembly. The balance portion of the bevel pinion remained positioned in the pinion housing (Figure 10.2). However, the rotation of the bevel pinion was arrested. The engine pinion housing was sheared into two halves (Figure 10.3). Top end splines of the vertical quill shaft (mating with engine bevel pinion) were found completely worn out and the bottom splines (mating with engine gear box bevel pinion) were intact (Figure 10.4).

Fractured spiral bevel pinion piece found outside the test setup after failure.

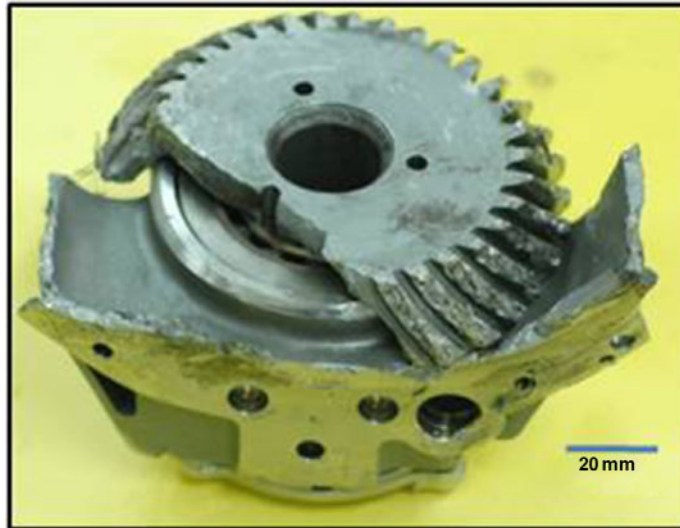
FIGURE 10.2
Fractured bevel pinion in the housing.

The bottom portion of the pinion housing was still holding a portion of the bevel pinion after the failure (Figure 10.2). Extensive damages (impact and abrasion marks) were noticed on this part as well (Figure 10.12).

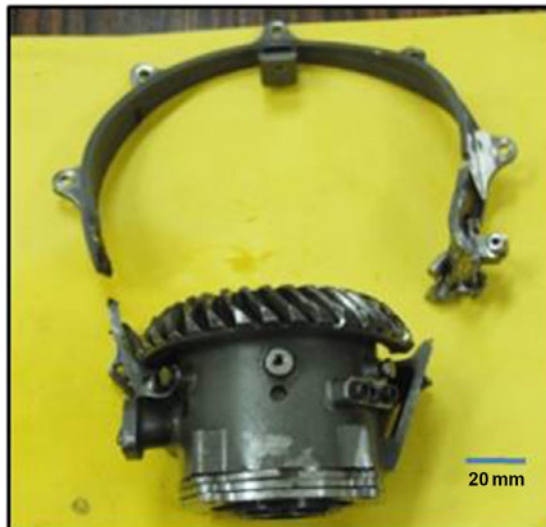
FIGURE 10.3
Photograph of the pinion housing after the failure.

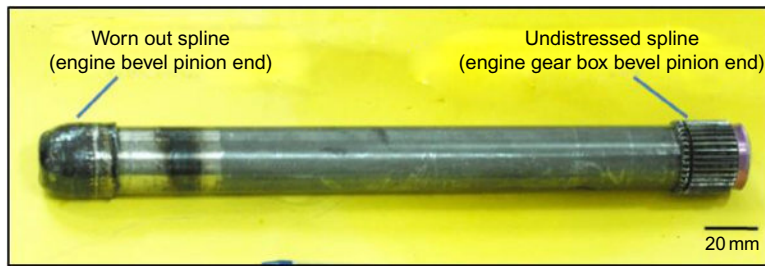
FIGURE 10.4

Photograph of the vertical quill shaft showing worn out splines and bluish tint on the shaft.

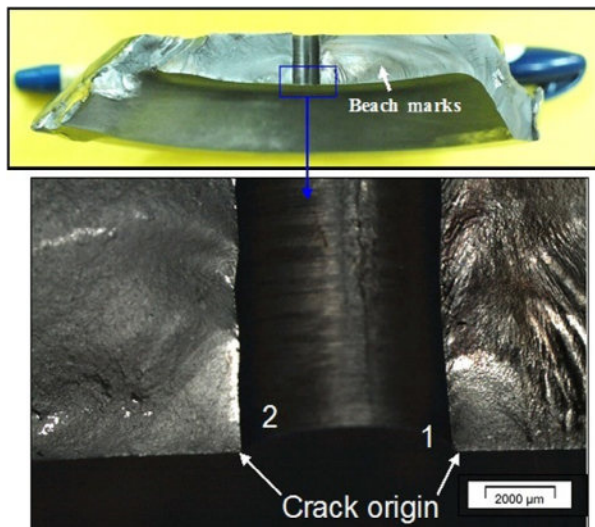
FIGURE 10.5

The fractured piece of the bevel pinion was observed visually and under stereo-binocular microscope (Figure 10.5). The fractured surface revealed the presence of “clam shell marks” or “beach marks” indicating that the bevel pinion has failed in a progressive mode (i.e., fatigue). Tracing back the orientation of the beach marks, the crack origin was found to be at the bottom surface of the gear wheel where an extraction hole was present. It may be noted here that one crack front was at the right side of the extraction hole which was found to propagate almost the entire length up

Fractured surface of the failed bevel pinion showing beach marks and fatigue crack origin.

to the gear teeth (with crack origin at location 1 as shown in Figure 10.5). One more crack front was present at the left side of the extraction hole (crack origin region indicated as 2 in Figure 10.5). In this case, the fatigue crack was found to propagate a short distance (approximately 15-20% of the fractured surface). The remaining area was found to have fractured by overload. A third crack front was identified at the gear teeth region; i.e., at the extreme end of the first crack front (Figure 10.6). The crack propagation area for this crack front was also relatively smaller than the first crack front. Considering the fact that fatigue crack propagation region was higher for the first crack front than the third crack front, it appeared most probable that the crack front “1” had originated first and then propagated. As it reached the gear teeth root region, the high-stress concentration at this region had resulted in the third fatigue crack origin.

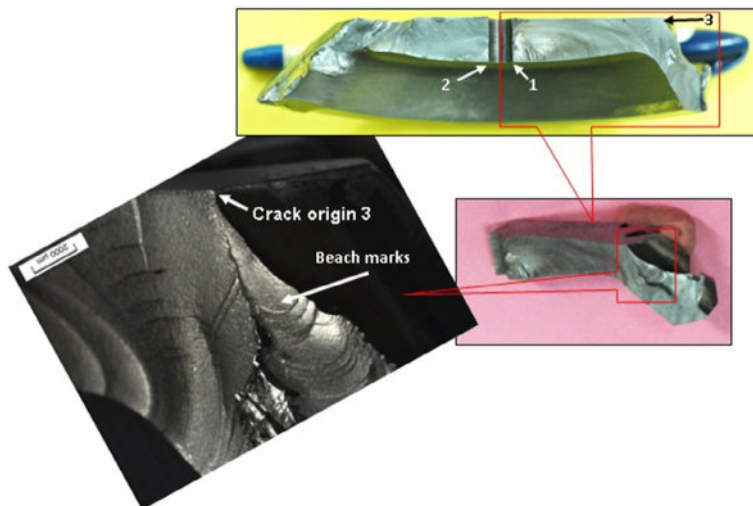
FIGURE 10.6

Fatigue crack at the gear teeth root region.

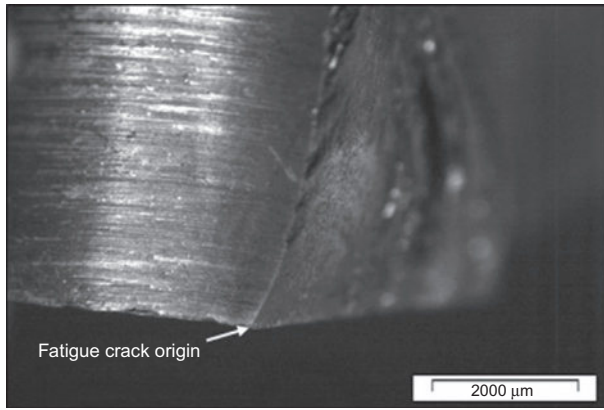
FIGURE 10.7

The extraction hole was studied further to ascertain if any abnormalities were present which might have caused the fatigue crack initiation. The extraction hole surface at the fatigue crack origin region was free from any distress (Figure 10.7).

Condition of the extraction hole at the fatigue crack origin 1.

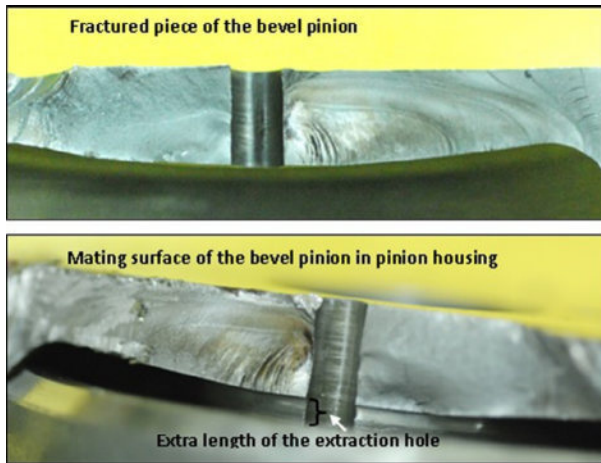
FIGURE 10.8

Mating fractured surfaces of the bevel pinion showing more length at one side of the extraction hole.

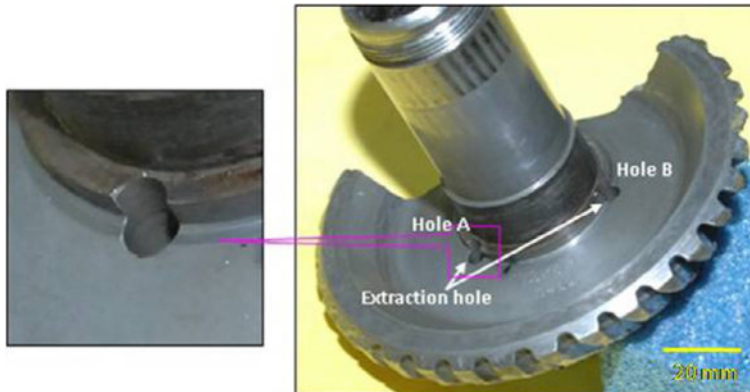
FIGURE 10.9

Extraction hole geometry at the bottom of bevel pinion (gear shaft-gear wheel junction).

checked for presence of any abnormalities under stereo-binocular microscope. Both of them exhibited the presence of cracking around the gear shaft extending from both the corners of the “L”-shaped contour of the hole (Figures 10.9 and 10.10). Hole “A” revealed the existence of multiple cracks from the edge. This observation was later reconfirmed by magnetic particle inspection (MPI). Sharp machining marks were also observed near hole “A.”

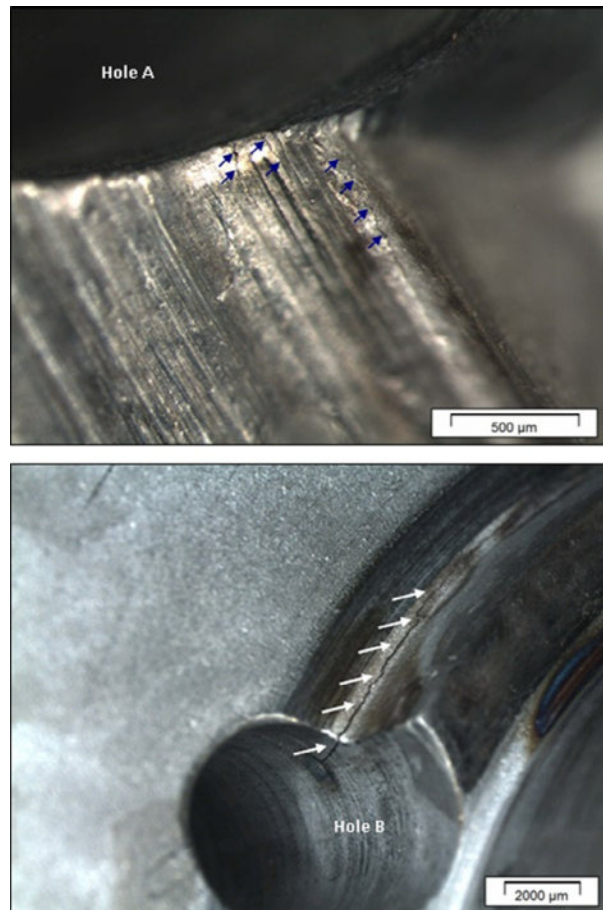
FIGURE 10.10

Crack (indicated by arrows) at edges of the extraction hole of the bevel pinion.

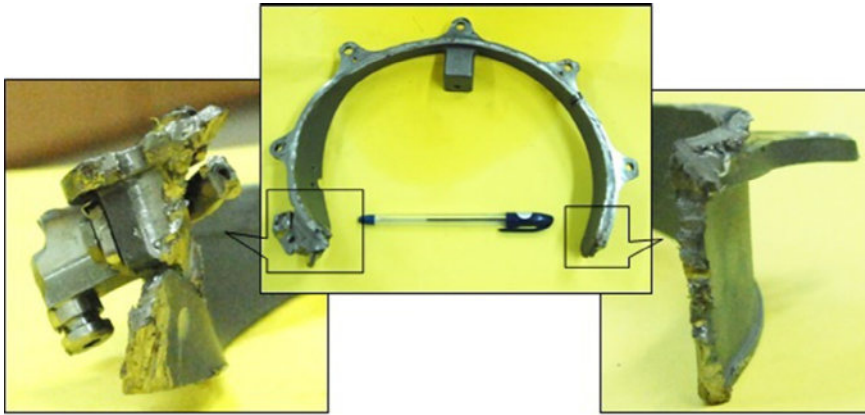
**FIGURE 10.11**

The pinion housing was found to have fractured into two pieces (Figure 10.2). The top portion of the pinion housing was deformed. The edges of the fractured piece revealed evidence of shearing (Figure 10.11) indicating that failure of the pinion was secondary in nature.

Top portion of pinion housing after failure.

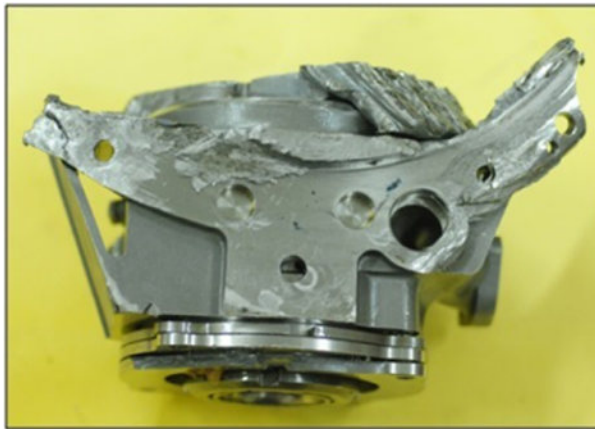
**FIGURE 10.12**

Secondary damages on the pinion housing.

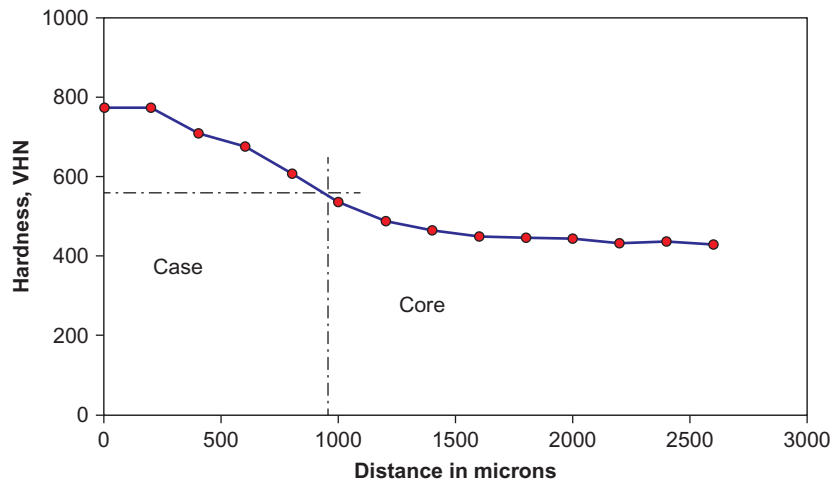
FIGURE 10.13

A suitable sample was cut from the gear and prepared metallographically for a microhardness measurement. The case hardness on the flank region of the gear teeth was 62-63Rc, where as core hardness was 42-44Rc. Case depth was found to be around 0.9 mm (Figure 10.13) and meeting the specification requirement. Core hardness indicated that the material was in hardened and tempered condition. Optical microstructure also revealed the presence of a tempered martensitic structure at the core (Figure 10.14).

Microhardness profile at one of the gear teeth flank region.

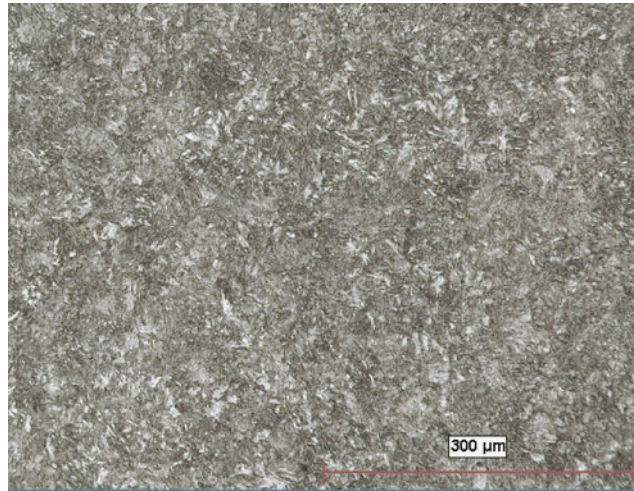
FIGURE 10.14

Microstructure of the gear material at core revealing tempered martensitic structure.

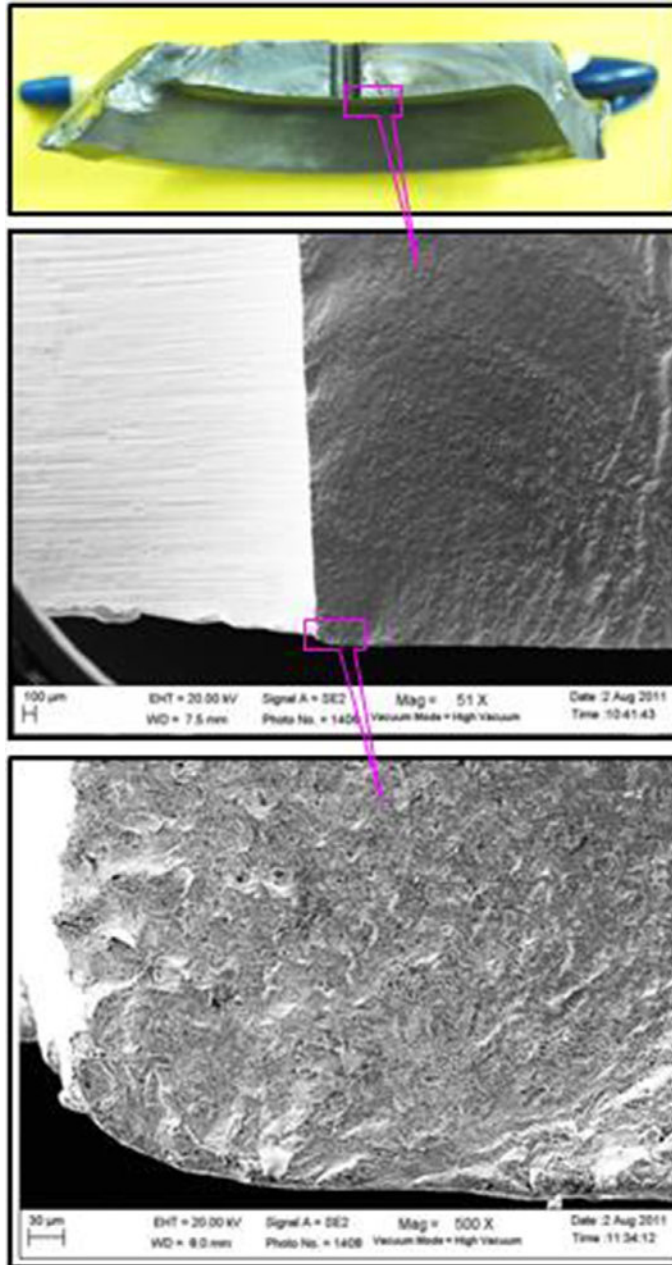
FIGURE 10.15

crack front “1” (Figure 10.5) under SEM is presented in Figure 10.15. Semi-quantitative composition analysis using energy-dispersive spectrum (EDS) at the crack origin region also confirmed that the composition was conforming to the low-alloy case-carburizing grade steel (Table 10.1).

Crack origin “1” under scanning electron microscope.

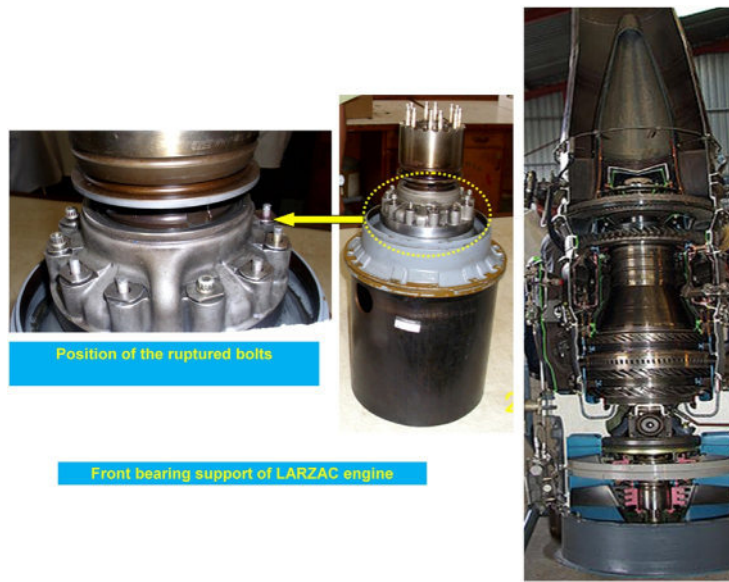
FIGURE 11.1

The LARZAC engine with the position of the ruptured bolts.

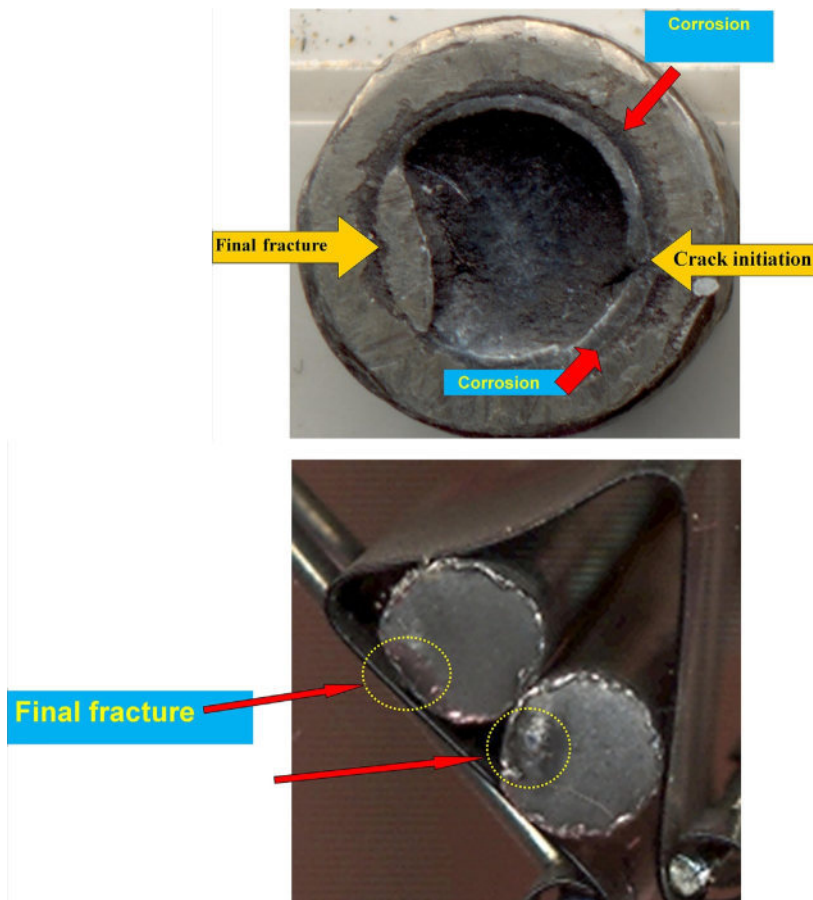
FIGURE 11.2

Macrograph images for the damaged bolts (head (above) and shank (down)).

Physical examination of the bolts specimen showed severe fracture in addition to some dark areas that could be originated as corrosion products (Figure 11.2). The occurrence of fracture has been confirmed in all bolts specimens. In some samples (Figure 11.2), the crack initiation zone has also been identified.

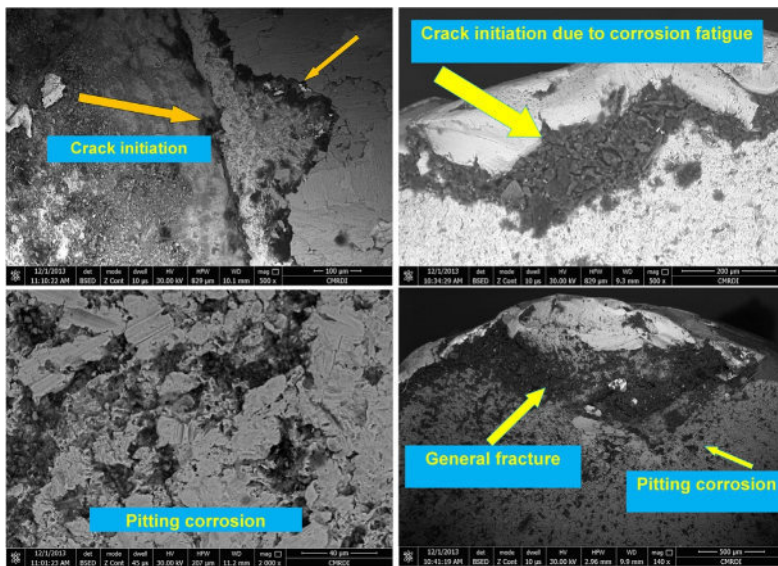
FIGURE 11.3

SEM analysis of the bolts showing well-defined pitting corrosion and fracture.

deposits. SEM analysis of the bolts specimen showed well-defined pitting attack and transgranular fracture which point to the occurrence of corrosion and severe vibration. The cracks initiation and fracture have also been evidenced (Figure 11.3). SEM-EDS analysis revealed formation of pitting corrosion which can be attributed to the presence of high chloride and sulfur content as explained in Section 3.3.

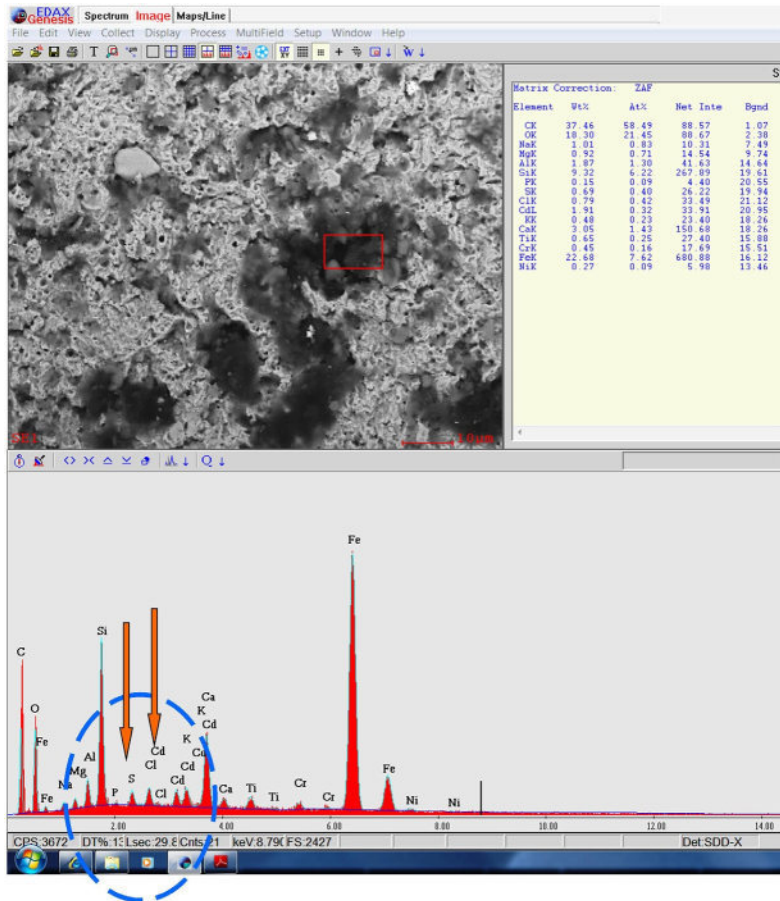
FIGURE 11.4

The microprobe analysis of the deposits (dark color) formed at the pitting corrosion areas was performed using EDS. EDS provides specific information on the chemical composition of the deposits, which can be correlated with data on media contamination and the chemical composition of the bolts material. The analysis of deposits formed at the bolts specimen revealed presence of corrosive sodium chloride and sulfur at the pitting zones (Figures 11.4–11.6). Chloride and sulfur are well-known reasons for occurrence of pitting corrosion on steel substrates.

Surface analysis using EDS of the deposits formed over the pitting zone.

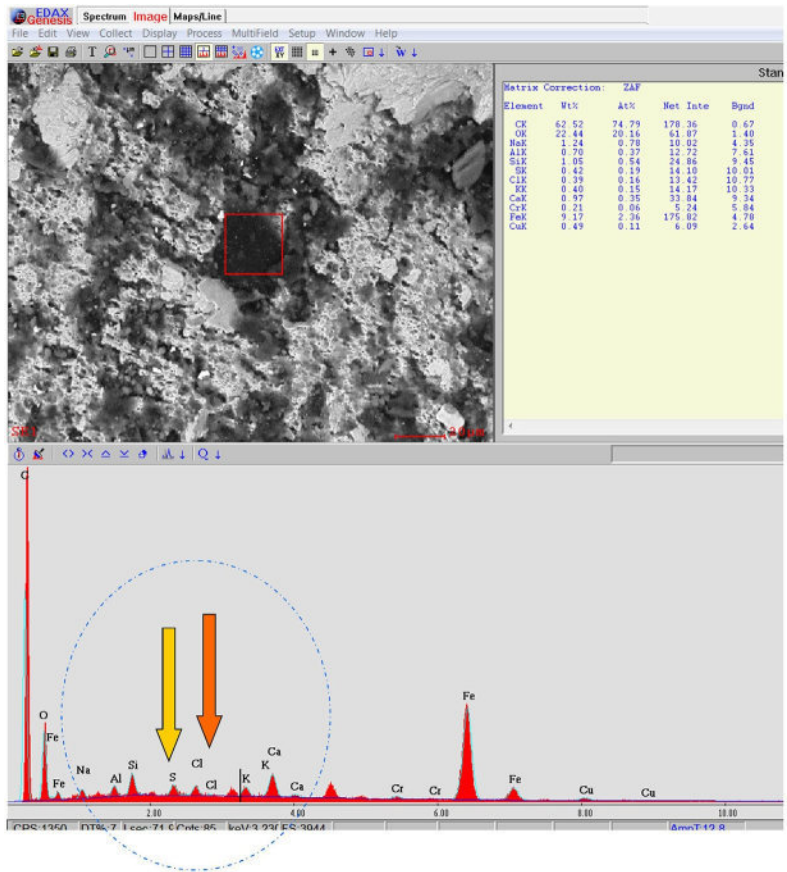
FIGURE 11.5

Surface analysis using EDS of the deposits formed over the pitting zones.

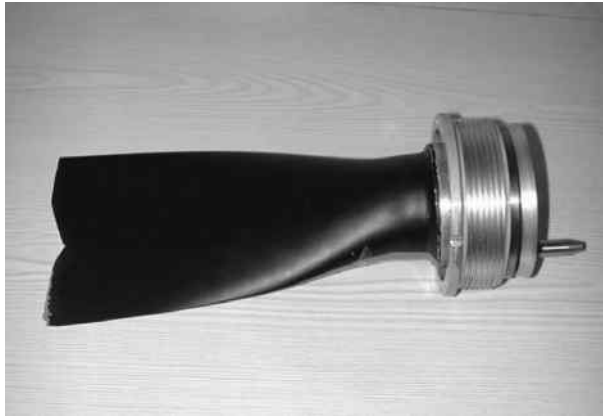
**FIGURE 13.3**

The fracture line separated the blade into two pieces. The upper piece was lost during the accident and the lower piece stayed connected to the propeller hub. Fracture was located at one third of the total length from the blade root as seen in [Figure 13.3](#). There were many deformation points on the blade surface as given in [Figure 13.4](#). The deformed areas provided the intense clue that the failure was induced by foreign object damage.

Broken propeller blade.

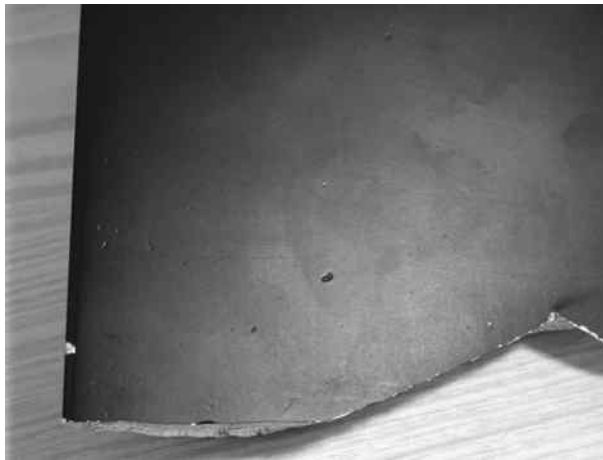
**FIGURE 13.4**

Deformation points on the blade surface.

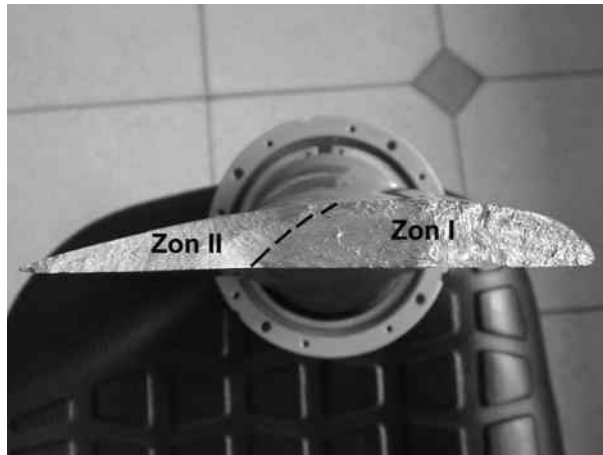
FIGURE 13.5

Crack surface had two different planes which were tagged by Zone-I and Zone-II as given in Figure 13.5. Zone-I was at the leading edge side and perpendicular to the XZ plane, whereas Zone-II was at the trailing edge side and had about 45° angle to the XZ plane as seen in Figure 13.6. The surface characteristics of these two planes were relatively different. Zone-I had brighter surface due to its smooth surface, whereas Zone-II had dull surface resulting from roughness making the light less reflected.

Zone-I and Zone-II on the crack surface of the propeller blade.

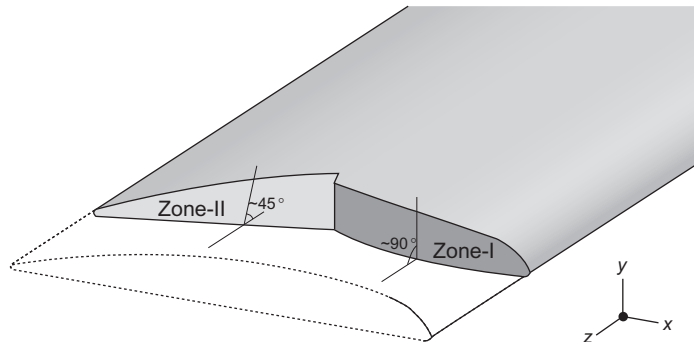
FIGURE 13.6

Characteristics of the crack surface.

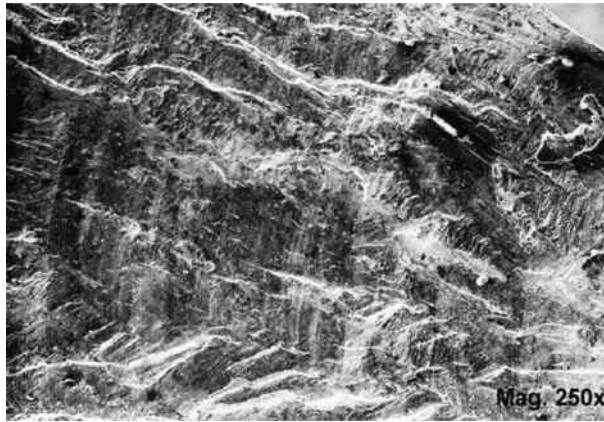
FIGURE 13.7

SEM image of the propeller blade Zone-I.

Examination of the Zone-I showed that the fatigue striations were obvious under the microscope as seen in [Figure 13.7](#). These striations were in the semi-elliptical circles form and result of the cyclic loadings. The striation circles overspread from a center point, which was the starting point of crack propagation, located at the lower surface of the blade. Generally, cracks launch from a surface flaw rather than in-body flaws and cyclic loadings accelerate the crack growth process. These flaws can be scratches, notches, burrs, or dents where the local stresses are prone to increase. Geometrically, these kinds of discontinuities cause notch effect by the effect of increased local stresses and facilitate the microcrack formations. Once a crack starts off, it moves on until failure of the structure. In addition to this, since the discontinuities are formed as a result of an impact, strain hardening takes place on the impact areas. Locally strain-hardened areas increase the hardness of the material and initialize brittle crack propagations easily [12].

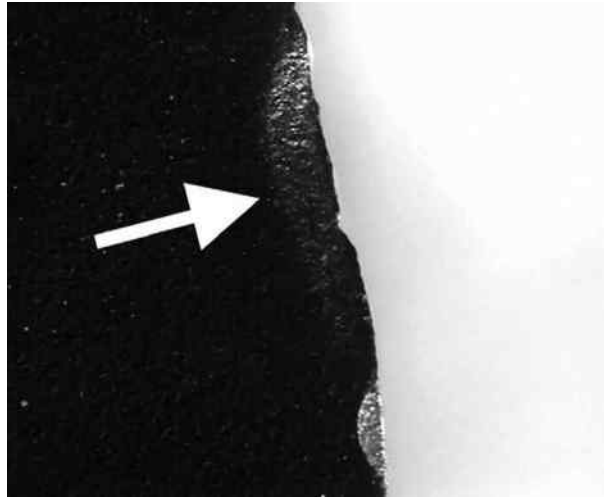
**FIGURE 13.8**

In the broken propeller blade case, the starting point of the crack was a dent on the lower surface as shown in [Figure 13.8](#). The dent size was explained by a depth of 140 μm and a width of 3060 μm .

Crack propagation point.

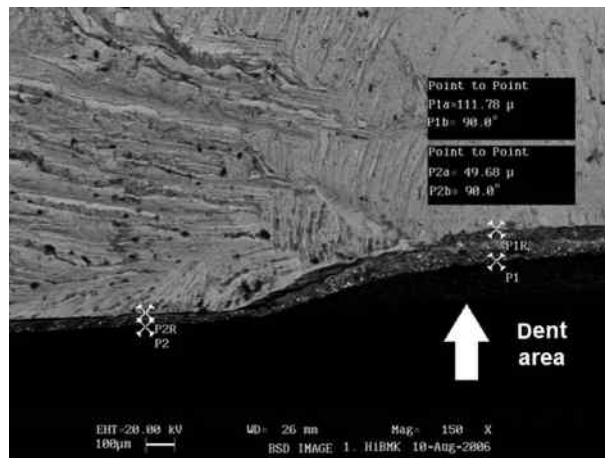
**FIGURE 13.9**

After discovering the crack propagation source, investigation was focused on this point to reveal the root cause. The findings were weird that the dent was covered by paint. [Figure 13.9](#) shows the SEM image of the paint layer on the dent area.

Maintenance reports showed that the propeller was inspected 50 flight hours before the accident. In the inspection process, blade paint was removed from the part surface and then inspection was performed against the surface problems. However, there was no defect detection in the maintenance reports. If the dent had been formed before the last inspection, residual paint should have been on the crack surface. Because after the inspection, the blade was painted again therefore, the microcracks on the dent area must have included paint debris. On the contrary, microcracks were such tiny that the paint could not penetrate into despite the capillary effect [13].

SEM image of dent area.

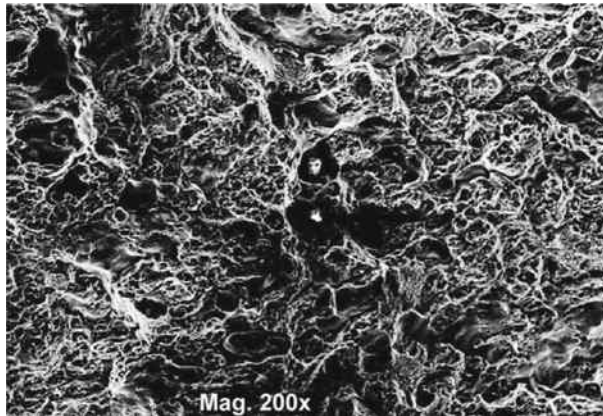
FIGURE 13.10

SEM image of the propeller blade Zone-II.

In the examination of Zone-II, the crack surface had dimpled appearance as seen in Figure 13.10. This kind of crack surface including little holes indicated a ductile-type fracture under monotonic loadings [4].

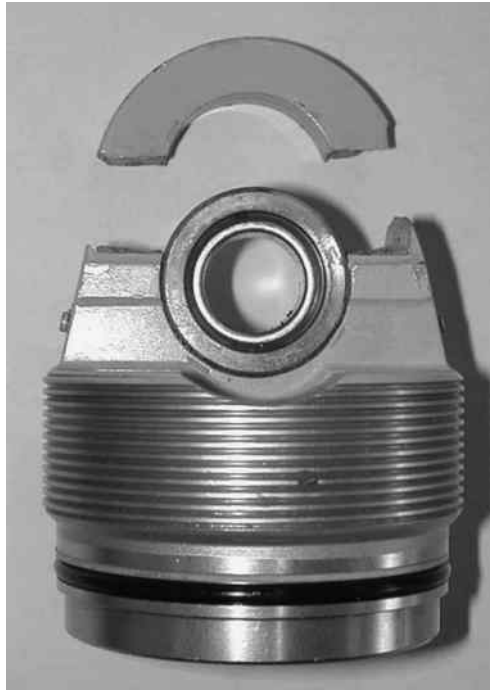
FIGURE 13.13

In this case study, one of the flaps lost the mobility during the flight. Fortunately, the aircraft could make the landing safely and the investigation procedure was carried out to find the root cause of the problem. First inspection revealed that the cap section of the actuator rod was broken. The rod had a ball bearing inside the hole drilled on the cap section and the failure occurred near along the diameter of the hole. [Figure 13.13](#) shows the failed section of the actuator rod.

Macroscopic examination showed that the cap section of the rod was broken clearly and that there were no evidence of dent, scratch, or deformation neck in the vicinity of the crack. General condition of the rod was good out of the crack zone. There was no evidence of dirt explaining corrosion on the crack surface. Corrosion on the parts can cause fatigue damages particularly in contact surfaces (e.g., surface between hole and ball bearing). Therefore, avoiding of contact fatigue is very important for the structural reliability. Corrosion fatigue is formed by the combined effect of cyclic stress and corrosive environment in the structure. This term should not be confused with stress corrosion crack. In corrosion fatigue, corrosion decreases the strength of the material and

Failed section of the actuator rod.

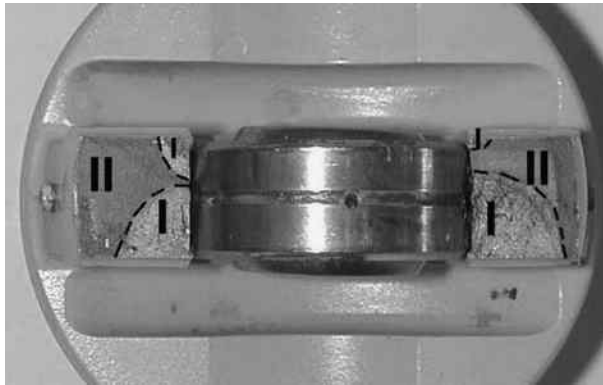
FIGURE 13.14

At the beginning of the investigation, the crack surface was divided into two regions due to different surface characteristics. The smooth regions with shiny appearance were labeled by Zone-I and the dull regions were labeled by Zone-II as seen in Figure 13.14.

Zone-I and Zone-II on the crack surface of the actuator rod.

Loading characteristic was also understood from the investigation that the cap section of the rod was subjected to double bending in the service. There were four crack initiation sites on the fracture surface. Furthermore, as seen in [Figure 13.14](#), the fatigue areas (Zone-I) were wider at the bottom side than at the upper side of the fracture surface that unsymmetrical bending acted on the component.

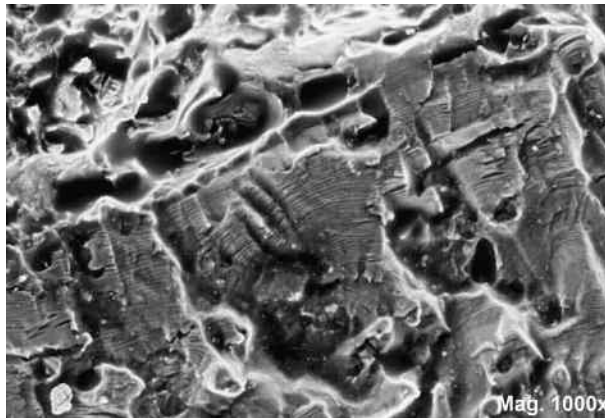
FIGURE 13.15

In the microscopic examination, stereo microscope and SEM images were employed. The images were evaluated and for Zone-I, it was stated that there were fine fatigue striations which were stemmed from cyclic loading as seen in Figure 13.15. Propagation points of the striations indicated that V-shaped dents around the hole had started the crack growth (Figure 13.16). The V-shaped dents were formed at the junction of the hole and the ball bearing to fix the bearing secure inside the hole.

SEM image of the actuator rod Zone-I.

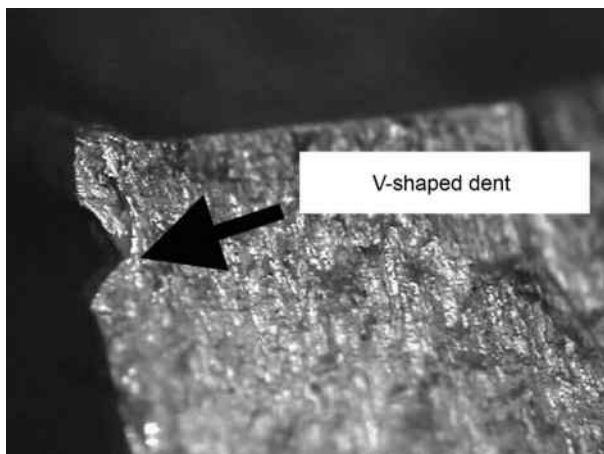
FIGURE 13.16

V-shaped dent as crack propagation point.

According to the investigation results, fatigue crack initiation was stemmed from the V-shaped dents which were design errors to constraint the ball bearing in the hole. Microcracks nucleated in the sharp root of the dents and propagated by the effect of cyclic loadings in the part. Finally, the cross-sectional area was so reduced that the rod cap ruptured.
