Handbook of Materials Failure Analysis

With Case Studies from the Aerospace
and Automotive Industries

Abdel Salam Hamdy Makhoul

Mahmood Aliofkhazraei

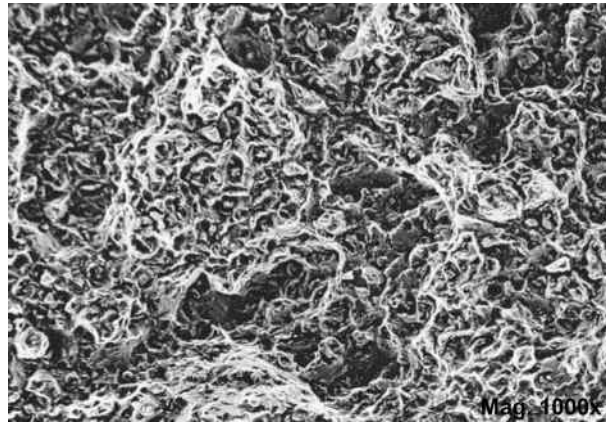
**FIGURE 13.17**

In the Zone-II examinations, the failure was explained as a typical ductile fracture. SEM images showed that the Zone-II had rough surfaces including equiaxial dimples as shown in Figure 13.17. These surface characteristics explained that the component was subjected to uniaxial tensile loading rather than shear loading. Because, ductile materials develop microvoids inside the body and since the loading

SEM image of the actuator rod Zone-II.

acts perpendicular to the fracture surface, the microvoids are elongated in the normal direction of the fracture surface. Fracture line intersects the microvoids and they are seen as spherical dimples under the microscope. However, in the shear loadings, dimples are seen in elliptical or C-shaped form because of the horizontal elongation of the microvoids with respect to the fracture surface.

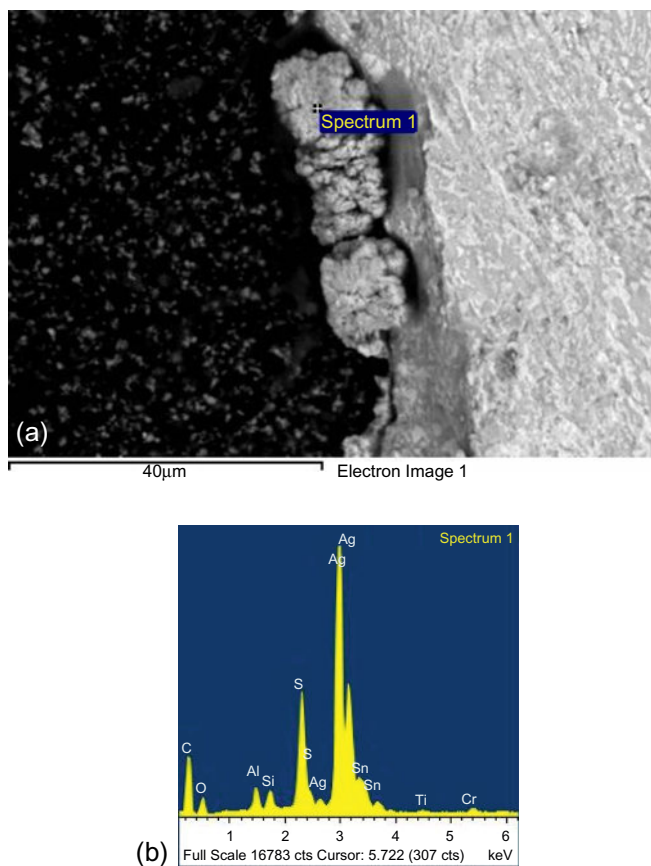
**FIGURE 15.1**

In this example, thin film resistors were reported to be failing for high resistance or electrical open; resistors were electrically measured with a digital multi-meter and were found to be open or exhibiting exceedingly high resistance. Scanning electron microscopy/energy dispersive spectrometry (SEM/EDS) analyses of the resistor showed evidence of a nodule growth at the termination solder metallization/resistive element interface consistent with silver sulfide corrosion (Figure 15.1). Cross-sectional examination confirmed the formation of silver sulfide (corrosion) at this interface which resulted in an open between the solder termination and the resistive element on both ends of the resistor (Figure 15.2).

15.1(a) Silver nodules were analyzed as shown at location of spectrum 1. The spectrum, 15.1(b), indicates that the nodules are silver sulfide as indicated by the high levels of silver (Ag) and sulfur (S) at the resistor termination (other detected elements are consistent with the package construction).

Two approaches at remediation are common in such cases: seal the components to minimize atmospheric exposure or eliminate the sources of the sulfur-containing gases. In this, and many other examples, it has been found easier to eliminate the sulfur sources than sealing the components. Of course, to achieve such an outcome the sources of sulfurous gases must be identified. Gas chromatography/mass spectrometry (GC/MS) methods are ideal for such purposes, and as a result, a number of likely candidates native to the system including a dampening foam judged to be the most likely source were screened.

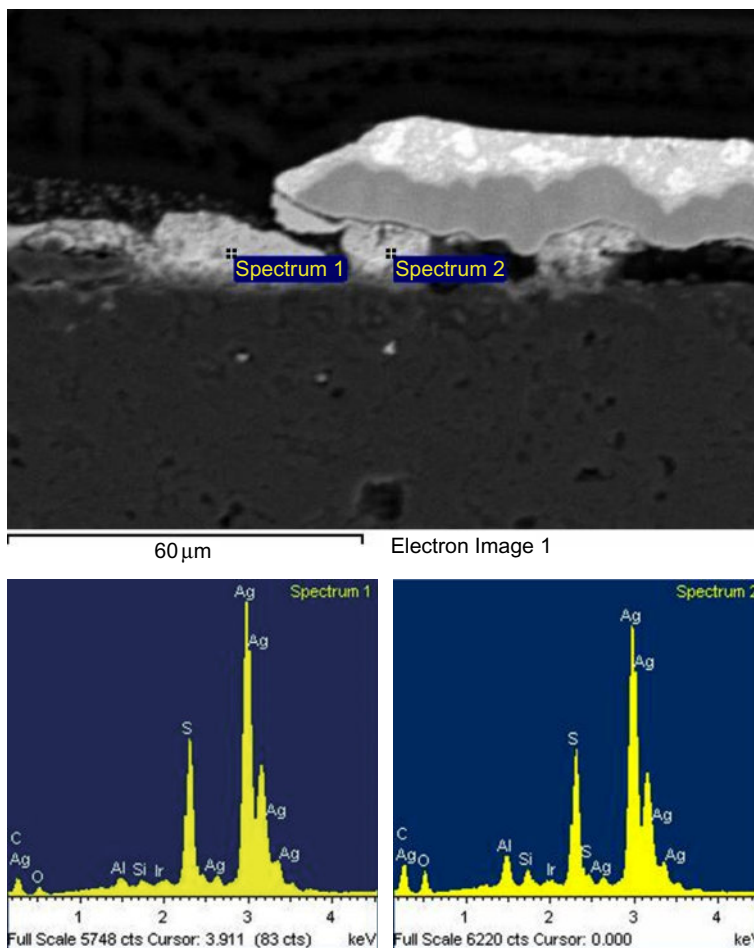
FIGURE 15.2

The elemental spectra, as obtained from areas indicated in the image (spectrum 1 and spectrum 2) of the termination in cross section, show that the electrical contact has been compromised at the termination by formation of silver sulfide (Ag and S in the spectra).

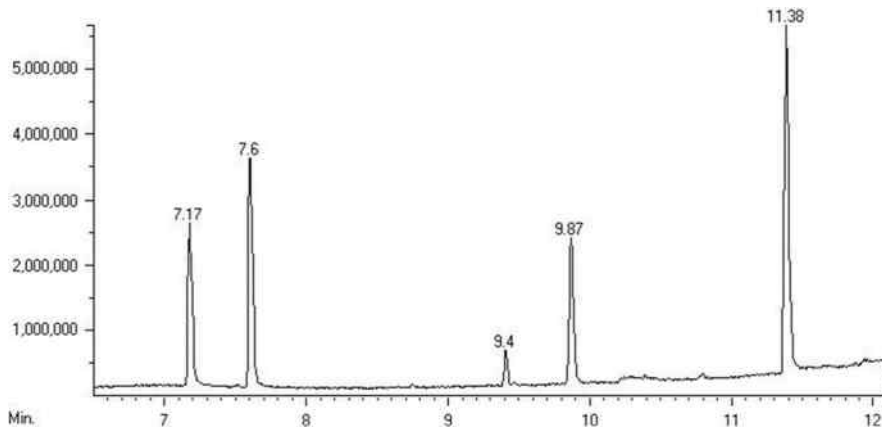
**FIGURE 15.3**

In the chromatogram displayed in [Figure 15.3](#), each peak represents a different detected gas. The compounds represented by each peak are identified from the corresponding mass spectra. For example, hydrogen sulfide was identified as shown in the mass spectral database match in [Figure 15.4](#). Other sulfurous gases such as sulfur dioxide, methane thiol, carbonyl sulfide, and carbon disulfide were also identified.

Chromatogram of evolved gases.

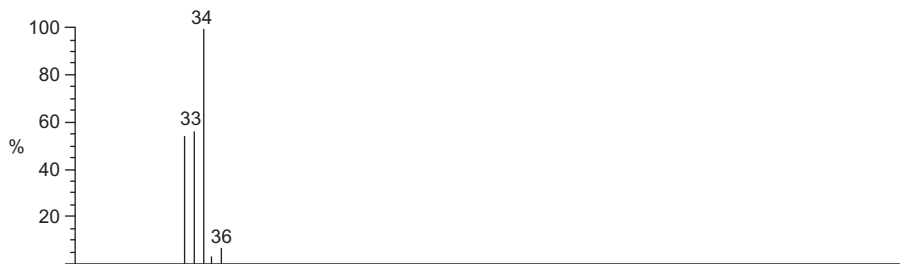
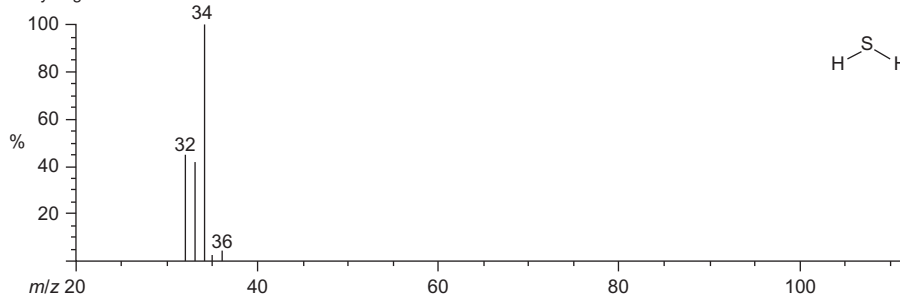
**FIGURE 15.4**

Database match of mass spectrum recorded from sample (top) to reference spectrum of hydrogen sulfide (bottom).

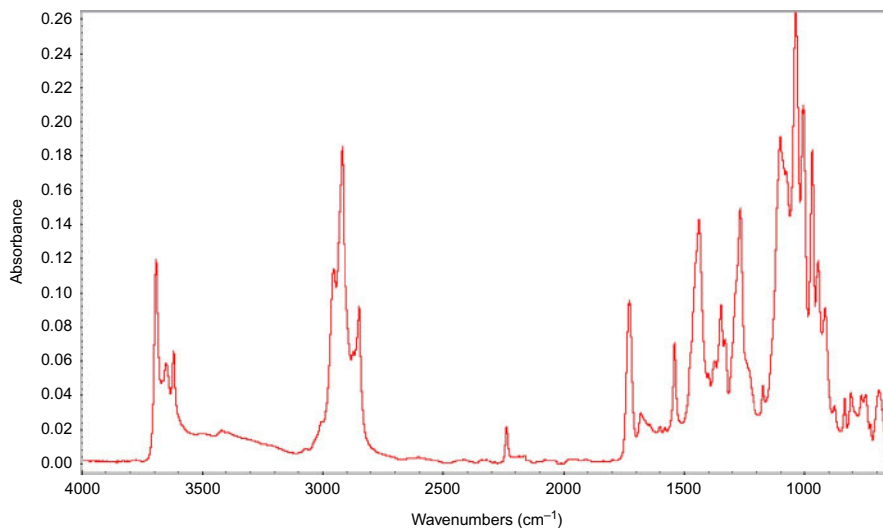
**FIGURE 15.5**

Infrared spectrum of dampening foam.

The infrared spectrum displayed in Figure 15.5 of the dampening foam, shown to be the sulfurous gas source, shows that it is silicate mineral filled (large bands centered around 1000 and 3600 cm^{-1} are from the filler). Additionally, the band centered around 2220 cm^{-1} is also very informative showing that this is likely a nitrile rubber blend. Figure 15.6 displays the infrared spectral database matching results of the nonsilicate bands showing that the foam is in fact a rubber blend that contains acrylonitrile as part of the formulation.

It should be pointed out that not all olefins are vulcanized using sulfur. However, it has been our experience that batch variation can occur such that when purchasing a blend from a supplier at time x it may not be sulfur vulcanized, but at time y it may be. Care must be taken to specify sulfur-free polyolefins if sulfur gas generation is deemed problematic.

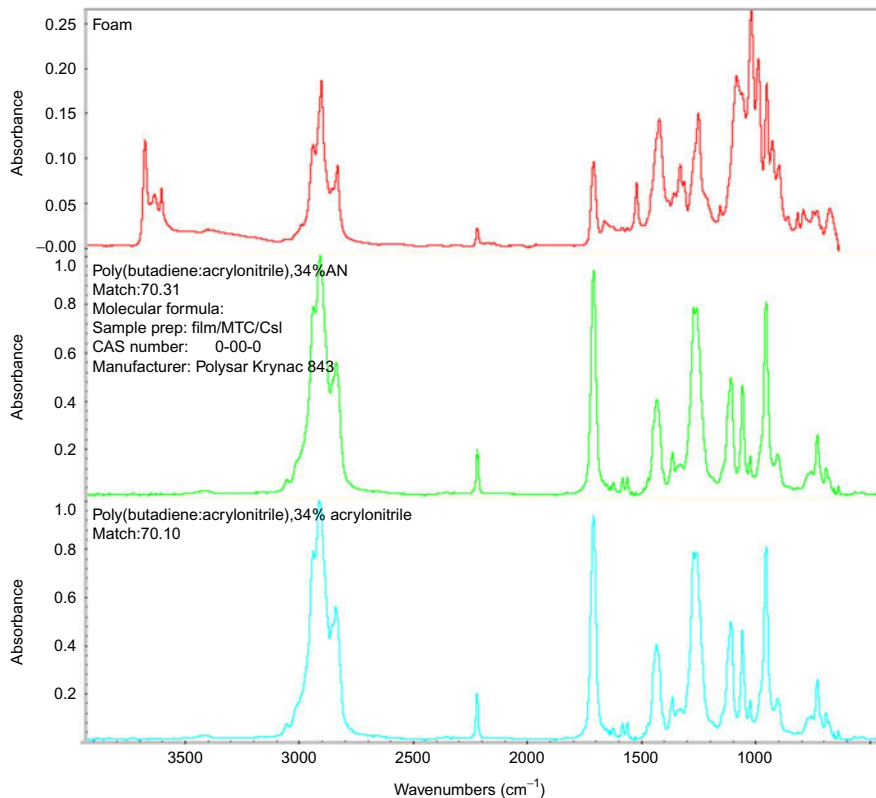
**FIGURE 15.6**

The foam spectrum matches butadiene acrylonitrile blend reference spectra.

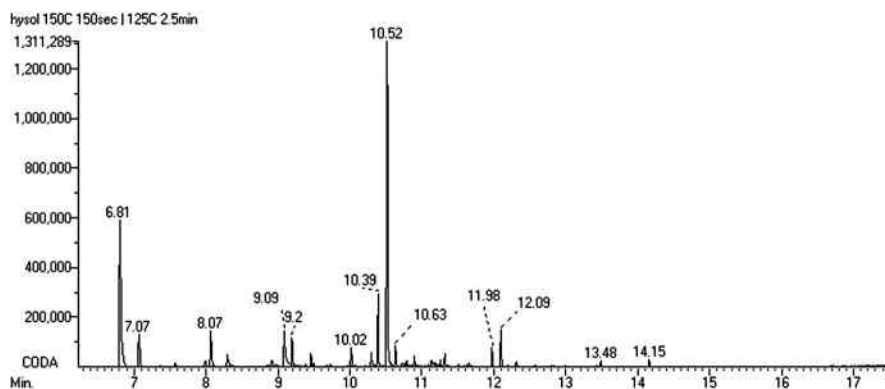
FIGURE 15.7

As applied, the adhesive could be expected to be exposed to temperatures ranging from ambient to 250 °C. Additionally, complicating the analyses and the application, the adhesive is exposed to ultra-high-vacuum conditions during use. Initial testing was performed using thermal stripping methods via placing the adhesive directly in the carrier gas stream of the GC and heating for predetermined times at predetermined temperatures (no samples were heated for longer than 2.5 min, 300 °C max. temperature tested). The chromatogram collected when the adhesive was stripped at 150 °C is displayed in Figure 15.7.

Typical chromatogram of material released from adhesive when tested using thermal stripping methods.

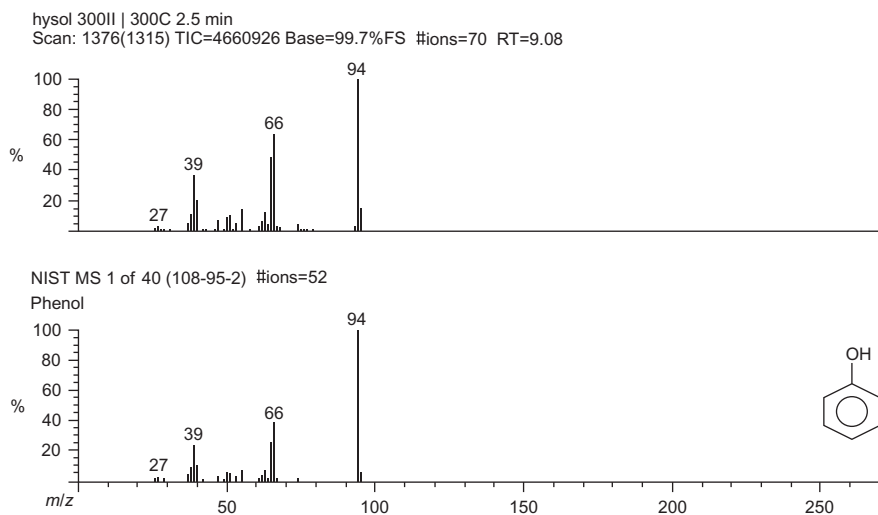
**FIGURE 15.8**

Phenol identified from mass spectral database matching.

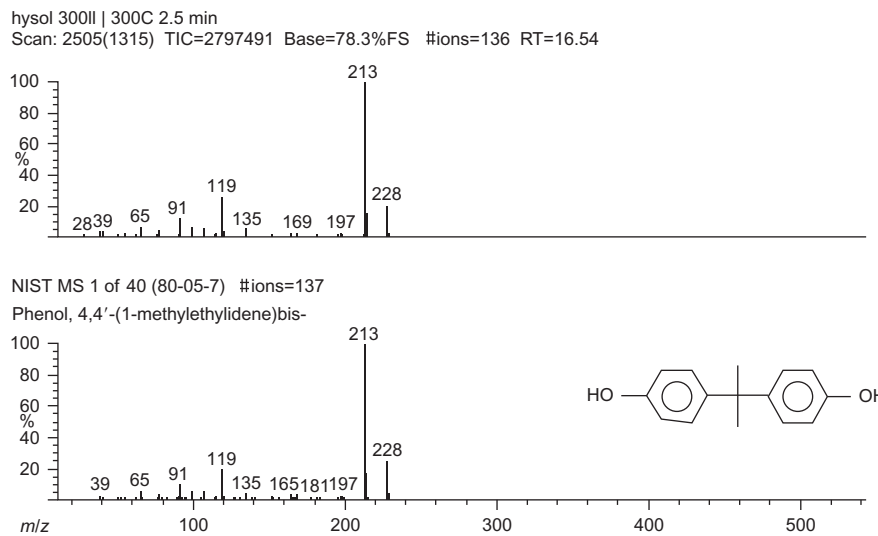
**FIGURE 15.9**

Bisphenol-A identified from mass spectral database matching.

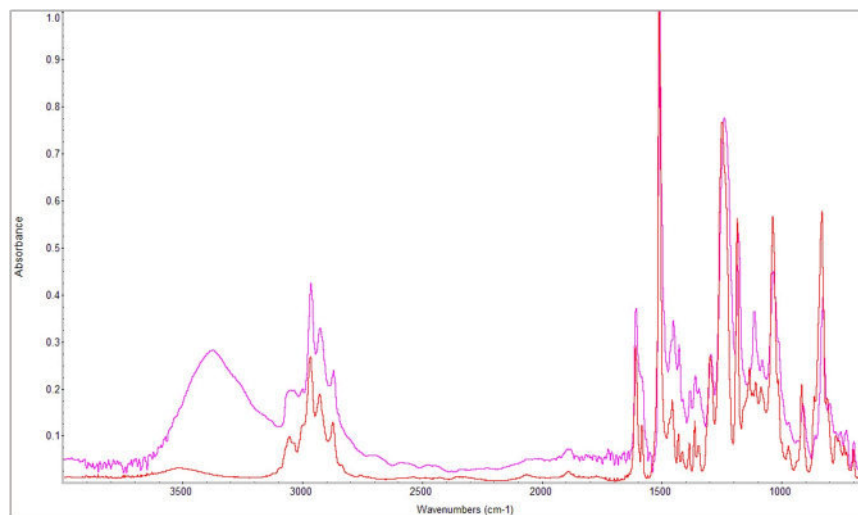
FIGURE 15.10

The infrared spectra displayed in [Figure 15.10](#), indicating that the residue was primarily composed of epoxy ethers and some silicones, where initially very hard to explain. This results from the fact that the data collected thus far had not identified any such materials. While the GC/MS data collected from the condensed materials explained the infrared spectra (following discussion), it still could not explain how initial screening missed the detection of these compounds.

Comparison of calculated spectrum of an EPON-type epoxy with contributions from a phenyl/methyl silicone (red) to the spectrum of the condensable materials (purple).

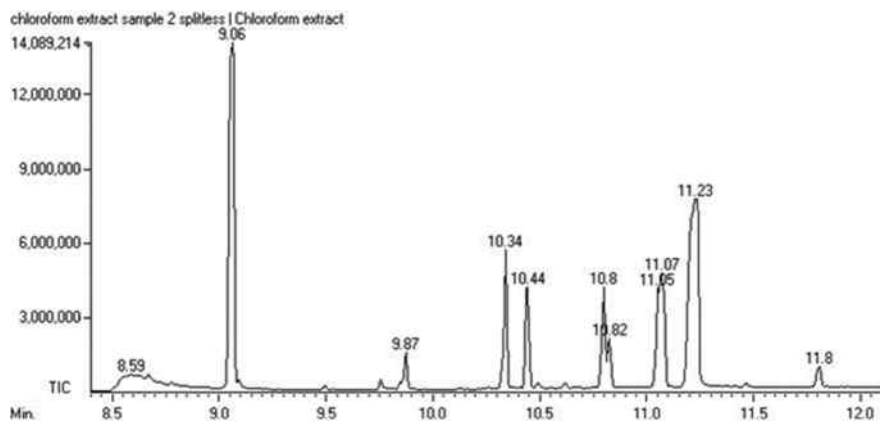
FIGURE 15.11

Compounds detected in the chromatogram displayed in [Figure 15.11](#) are of those that were condensed on cooled (25 °C) aluminum collectors when the test samples were heated under ultra-high-vacuum conditions (the residues were dissolved in chloroform and injected for analysis). Bisphenol-A, which was expected, was identified; however, the remainder of the materials were reactive epoxies and phenyl/methyl silicones ([Figures 15.12](#) and [15.13](#)).

Condensable materials chromatogram.

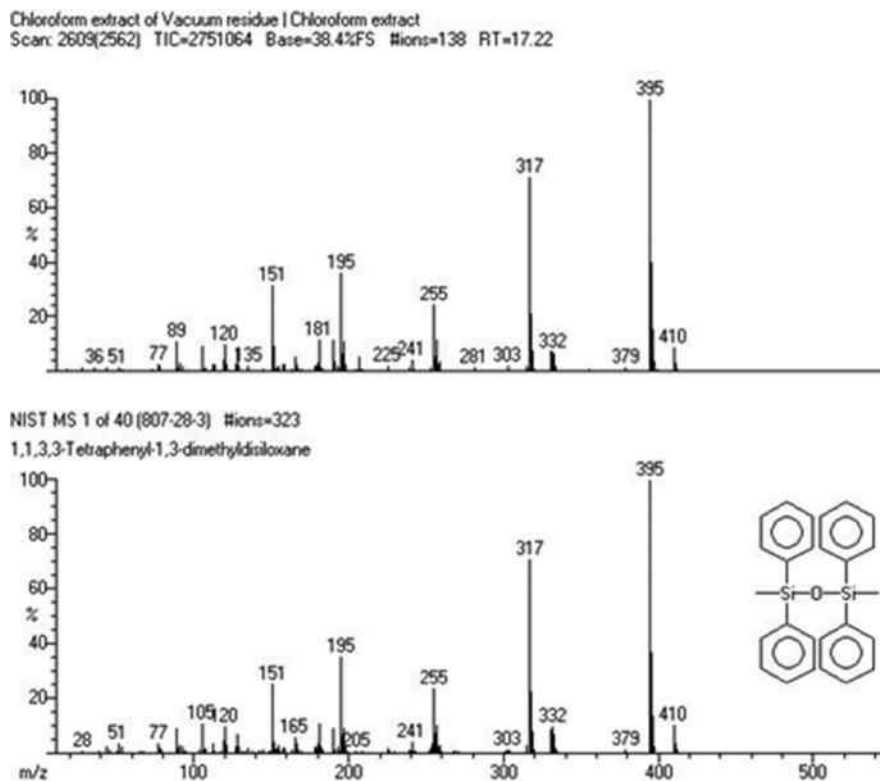
FIGURE 15.12

It was quickly determined that the silicone contribution was from the diffusion pump oils used with the vacuum system of the condensable materials test equipment. Additional analyses, not presented herein, showed that these silicones were fully

A phenyl/methyl silicone identified from mass spectral matching.

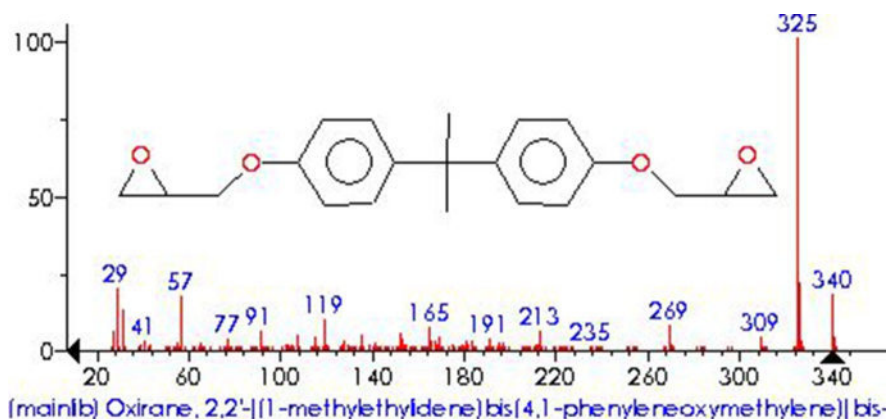
FIGURE 15.13

Diglycidyl ether of Bisphenol-A (an EPON-type epoxy).

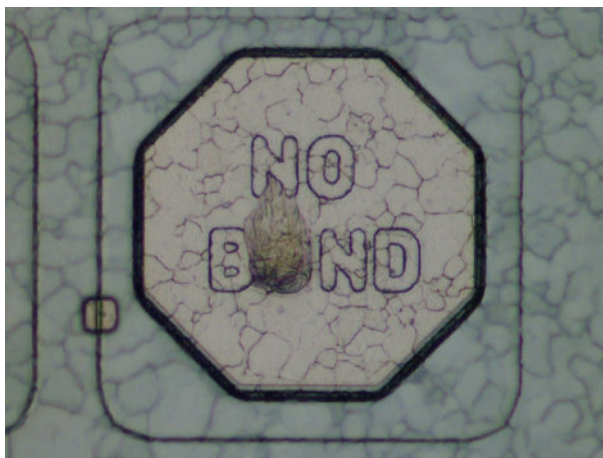
FIGURE 15.14

The devices in this case are dies from wafers used for higher level component construction. The dies are tested using probes which make contact with the die pad surfaces (Figures 15.14 and 15.15). Test failures reached 100% for some wafers and extensive failure analyses were initiated. SEM/EDS was chosen as the initial investigatory technique. Both the pad surfaces and the test probe tips were thusly characterized (Figure 15.16).

Probe mark on die after test failure.

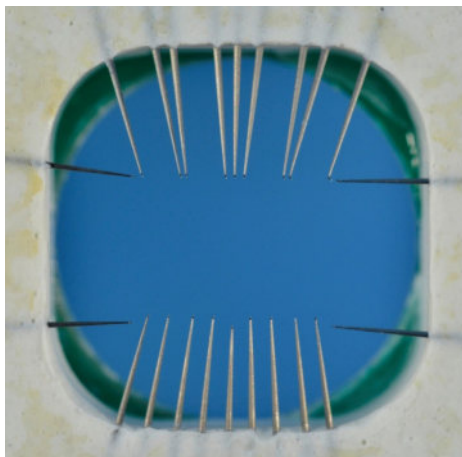
FIGURE 15.15

Probes used to test die.

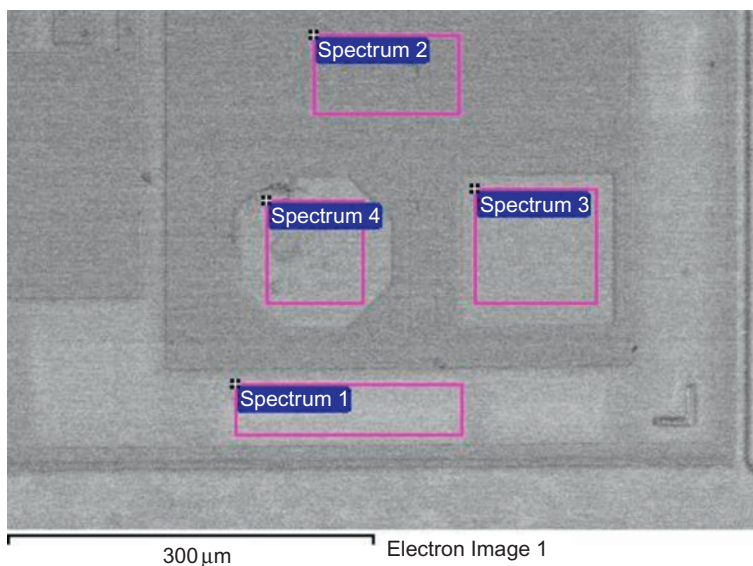
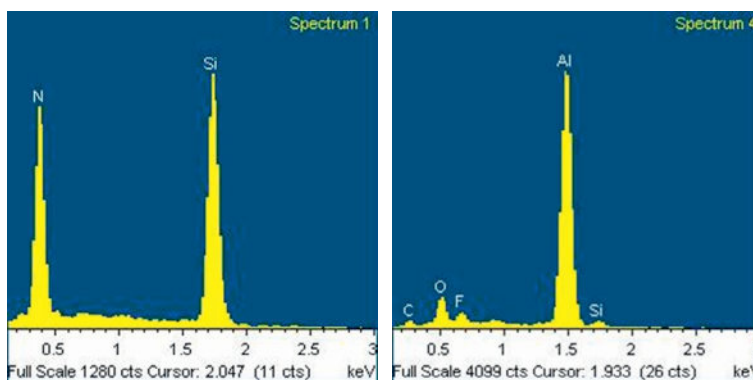
FIGURE 15.16

Spectrum 1 displayed in Figure 15.16 is that of a noncontact surface of the die. It is consistent with the expected silicon nitride passivation. Spectrum 4 is of a contact surface. Of particular note is the detection of fluorine which was completely unexpected (C, Al, and Si were easily rationalized, while detection of O was troublesome). When the probe tips were analyzed (not shown), sulfur was detected in addition to fluorine. Neither fluorine nor sulfur was expected. At this stage, it was clear that contamination at electrical contact surfaces was the cause of the test failures.

EDS analyses were obtained by rastering the areas shown for spectra 1 - 4. Spectrum 1 is of a non-contact area and displays the expected elements Si and N of silicon nitride passivation. Spectrum 4 is of a contact area and the detection of carbon (C), oxygen (O), and fluorine (F) in addition to the aluminum metalization are indicative of the presence of contamination.

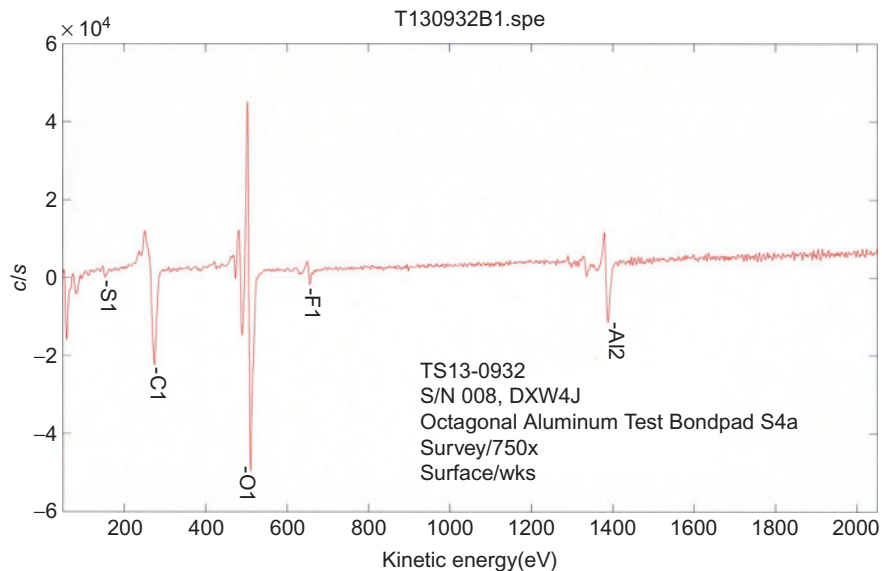
FIGURE 15.17

The Auger spectrum displayed in [Figure 15.17](#) is similar to the previously presented EDS spectra in that carbon, oxygen, fluorine, and aluminum are detected (in this case, sulfur is also detected), however, also plotted is the kinetic energy of the ejected Auger electrons. This energy is what yields insight into the chemical bonding, or environment, of these species.

Analysis of the fluorine binding energy yielded the following conclusion: “The data showed that the F 1s peak appears to be at one binding energy (BE), which indicates that the majority of the F atoms are in the same chemical state. The measured BE was ~ 687.0 eV, which is approximately 1.0 eV higher than the reported standard value for $\text{AlF}_3 \cdot 3\text{H}_2\text{O}$. This BE is 2.0 eV less than that for perfluoroalkane materials, indicating that it is not likely to be present as such. There is evidence that some

Auger spectrum from bond pad surface.

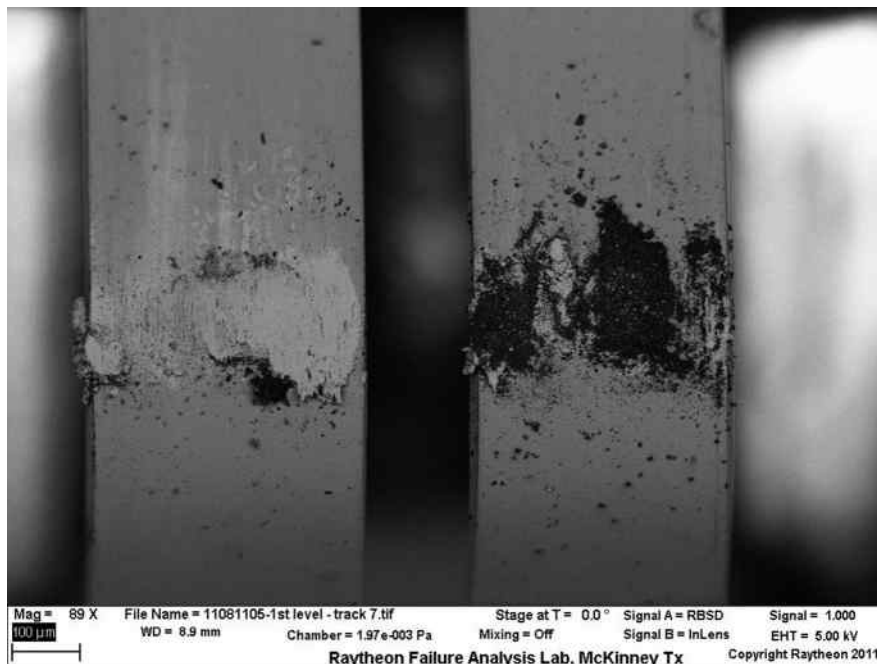
FIGURE 15.18

Displayed in [Figure 15.18](#) is the condition of the brush contact surfaces as revealed by SEM imaging. The lighter colored areas, at the contacts interfaces (contact was made at a region in the middle of image), result from the presence of gold which was transferred from the platter contacts. The darker residues result from the presence of lower atomic weight elements such as silicon, oxygen, and carbon. [Figure 15.19](#) was a typical EDS spectrum recorded from these areas.

SEM image of residues on brush surfaces.

Corrective actions included changing of the platter polymer to one that was not silica particle filled, removing silicone potting materials from the construction, and application of a different contact lubricant. These measures, along with others, lead to complete resolution of these failures.

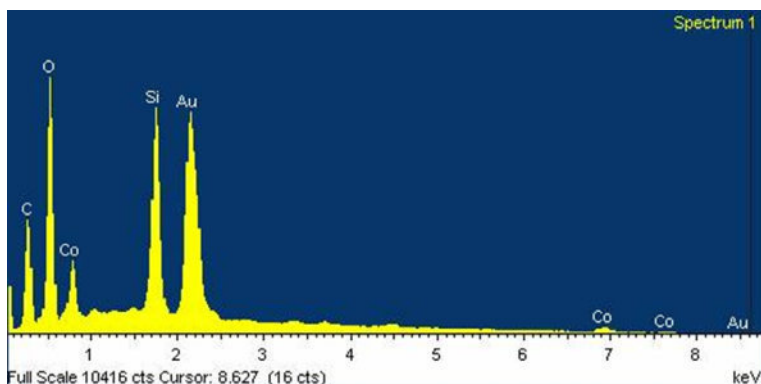
FIGURE 15.19

Typical EDS spectrum of residues on brush contacts.

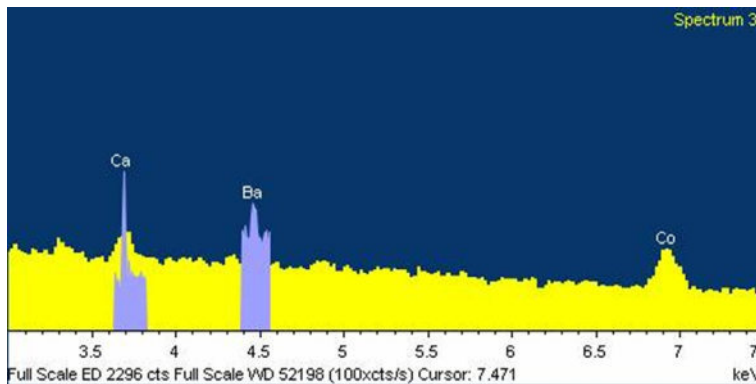
FIGURE 15.20

Figure 15.20 shows that barium and calcium were detected in the contact residues. This supported the supposition that grease additives contributed to the residue formation.

WDS spectrum showing the presence of calcium (Ca) and Barium (Ba) in the contact surface residues.

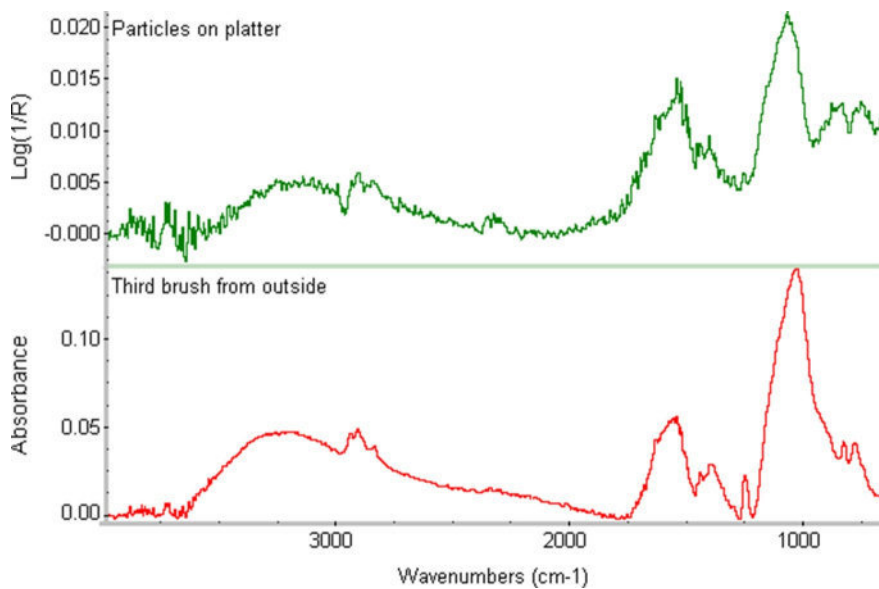
FIGURE 15.21

The spectra displayed in Figure 15.21 are indicative of the presence of both carboxylate salts (bands above 1200 cm^{-1}) and silica and/or silicone materials (bands below 1200 cm^{-1}). The carboxylate salts were rationalized as being present in the form of the aforementioned grease additives. On the other hand, the source of silica/silicones was not immediately clear.

Typical infrared spectra recorded from residues.

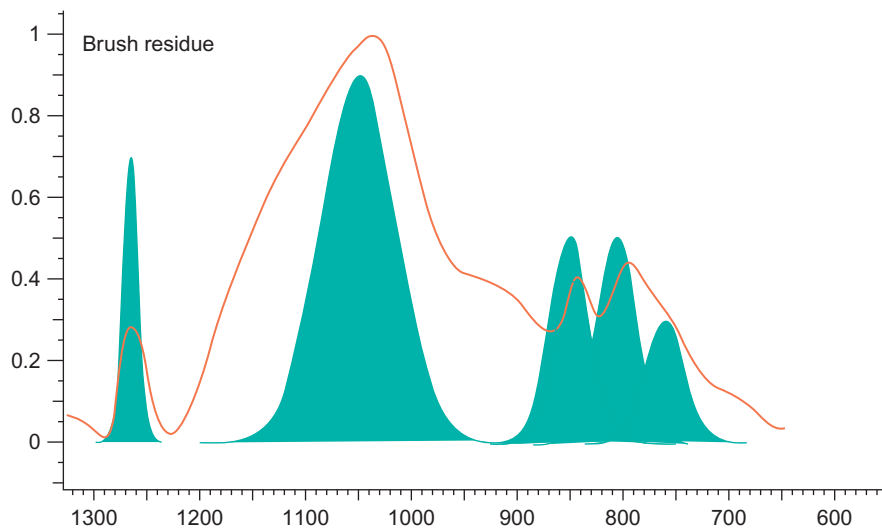
FIGURE 15.22

Analysis of silica/silicone region of FTIR spectrum.

Careful analysis of the intensity data of the various peaks from the collected spectra, applying mathematical modeling, revealed that both silica and silicones were present at the contact surfaces. As these are both electrically insulative, their presence could help explain the failures. Furthermore, consultation with the manufacturer revealed that the assemblies had several potential sources of silicone contaminants (most being potting compounds).

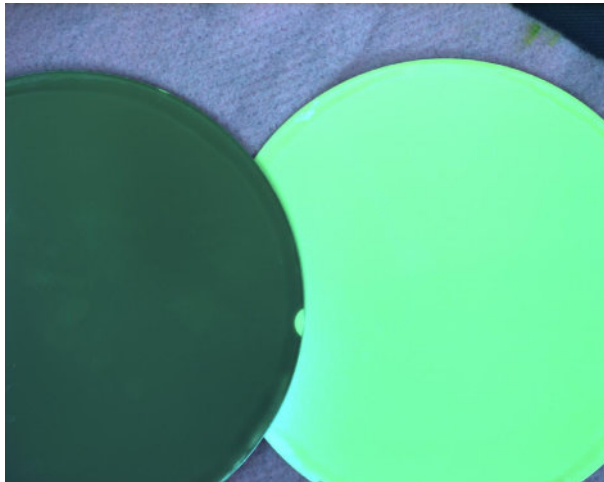
FIGURE 15.23

The wafers displayed in [Figure 15.23](#) are polyimide coated; the light green wafer represents the appearance prior to a plasma-etching step while the darker green wafer is of the appearance after the etching. Etching was performed to increase adhesion of additional layers of polyimide, which were to be subsequently applied, and to clean the surface. The customer’s supposition was that the procedure had created carbon black, via decomposition of the polymer, leading to the darker appearance. There was also concern that any type of contamination would alter the properties of the coatings.

Polyimide-coated wafers. The darker sample is post-plasma etching.

On-site investigations, as well as discussions with the customer, revealed that the wafers were held in place with devices that were coated with thin layers of titanium and tungsten coated on top of aluminum. The failure mechanism was determined to be deposition of the element oxides as a result of the plasma-etching process. Care to minimize exposure of this material to the plasma environment eliminated the failures.

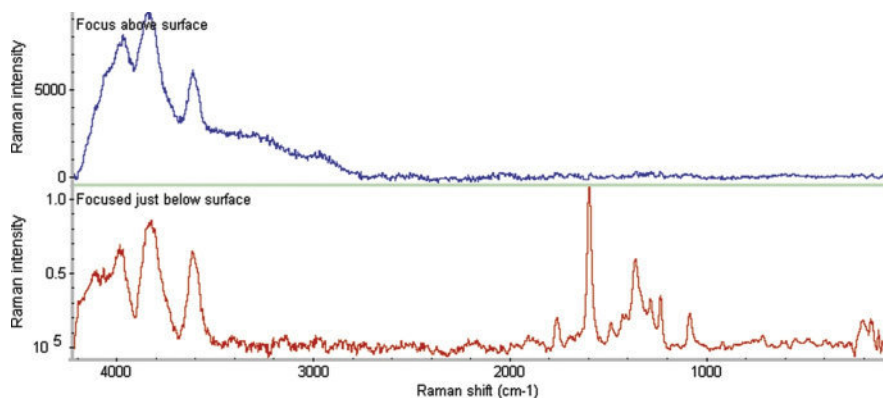
FIGURE 15.24

The top spectrum displayed in Figure 15.24 was collected from the dark sample surface and shows the presence of alumina (the bands above about 3500 cm^{-1} are plasmon bands resulting from exciting alumina with a 532-nm laser). Conspicuous by its absence are any bands associated with elemental carbon—this seemingly discounts the initial hypothesis. On the other hand, when the laser was focused into the sample, bottom spectrum in Figure 15.24, polyimide bands are also observed. This demonstrates that alumina is a surface contaminant residing on the polyimide surface. The sample which was not etched did not have indications of the presence of surface alumina.

Top spectrum was collected when defocused above the dark wafer sample. The bottom spectrum was collected when focused into the sample.

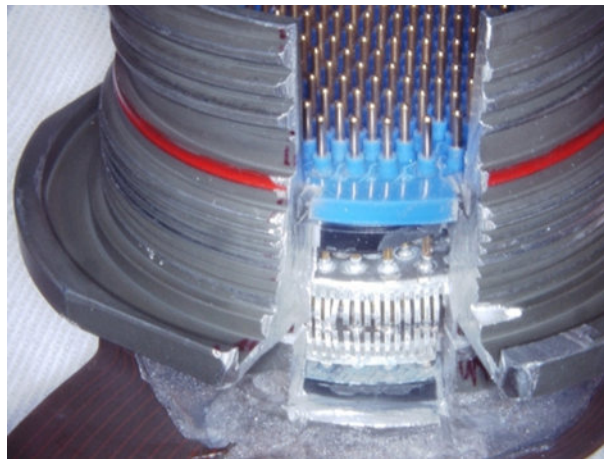
FIGURE 15.25

The connector displayed in Figure 15.25 has three distinct cavities internal to the construction. Additionally, a silver metal grounding ring encircles these cavities. Closer inspection revealed extreme corrosion and electromigration between the pins and from some pins to the case (Figures 15.26–15.28).

As shown, Figures 15.25 and 15.26, electromigration of lead from tin/lead solder as well as silver from the grounding frame was noted on the internal cavity surfaces of the connector. For such phenomena to occur, the connector must have had power applied while wet, or at least with significant humidity present [13]. Discussions with the customer revealed that the flex circuits and connectors had passed through an in-line cleaner system. This led to the belief that the ingress of cleaner chemicals, which cannot be washed out by the DI rinse phase, accounted for the failures. The saponifier, in particular, would accelerate these phenomena as it is both corrosive and an electrolyte. Chemical investigations started with the collection of Raman

Overall construction of connector after a section was removed.

The findings of in-line cleaner marker compounds, as revealed by analysis of the relevant mass spectra, verified that ingress into the connectors coupled with applied voltage lead to the reported failures ([Figure 15.30](#)). Remediation in this case involved purchasing screw caps from the supplier which were put over the tops of the connectors prior to exposure to in-line cleaning operations thusly eliminating cleaner intrusion.

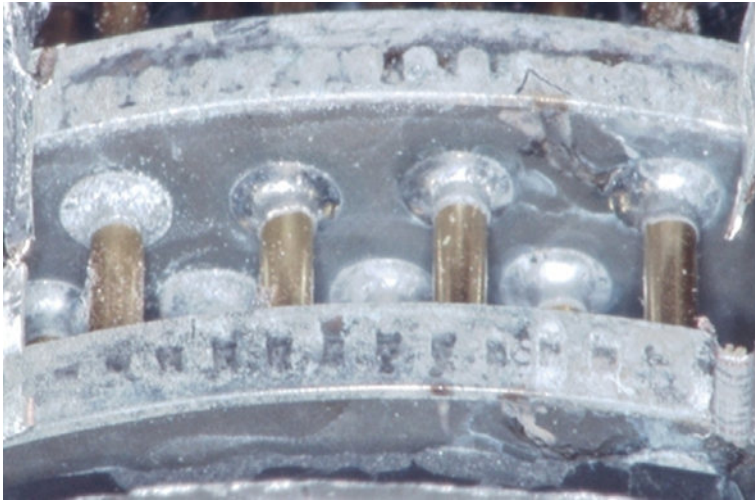
FIGURE 15.26

Note white corrosion residues.

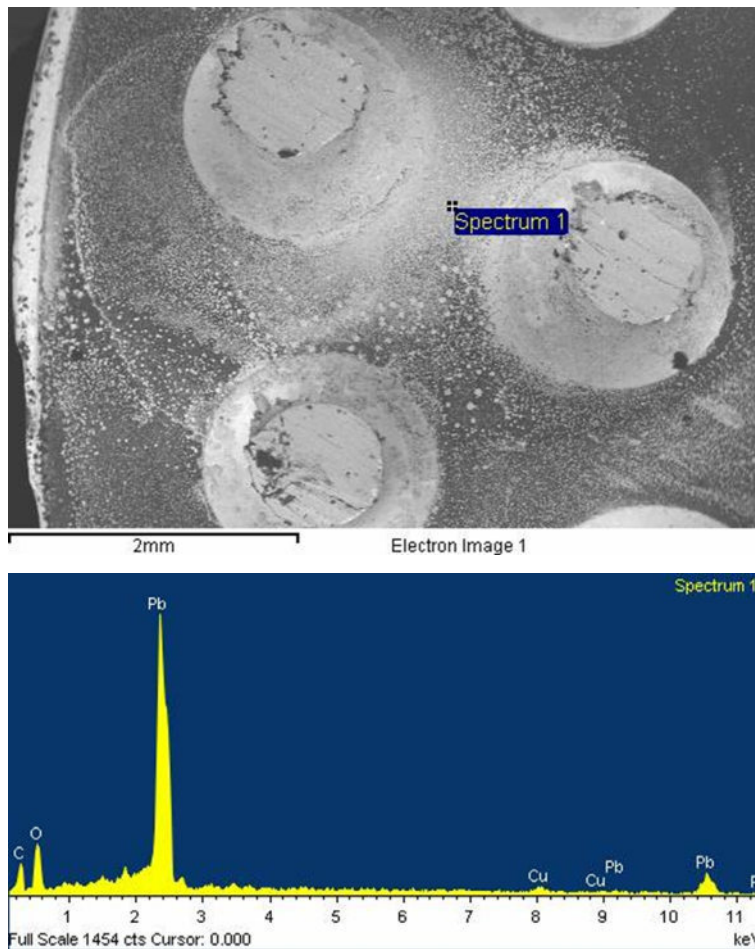
FIGURE 15.27

Spectrum 1, collected from the spot indicated in the image, shows that electromigration of lead occurred between pins.

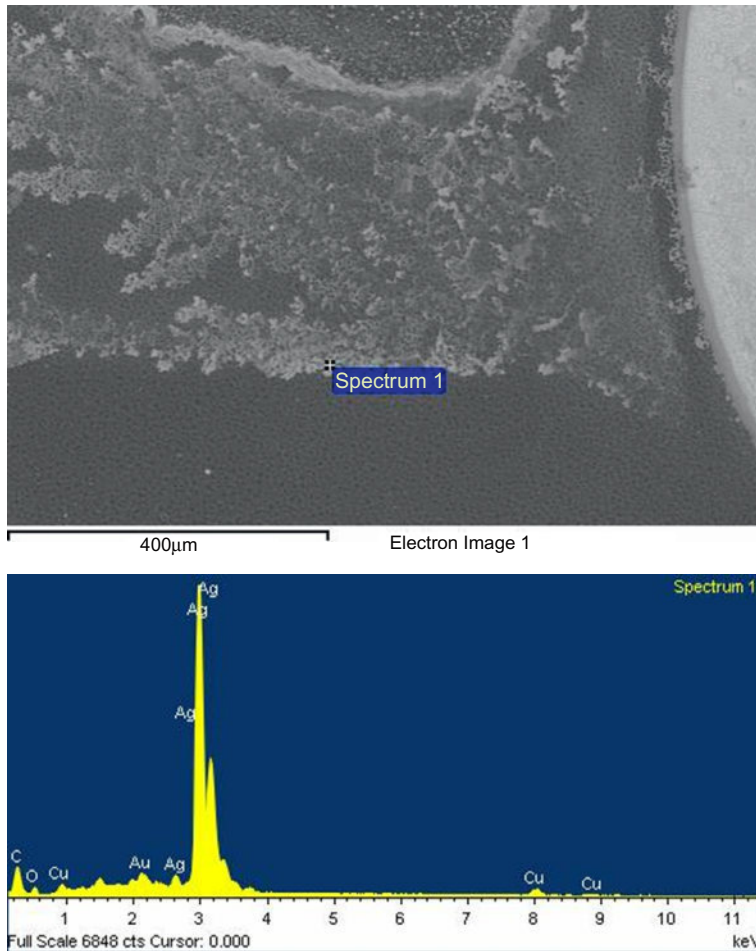
FIGURE 15.28

Spectrum 1, collected from the spot indicated in the image, shows that electromigration of silver occurred between a pin and the case.

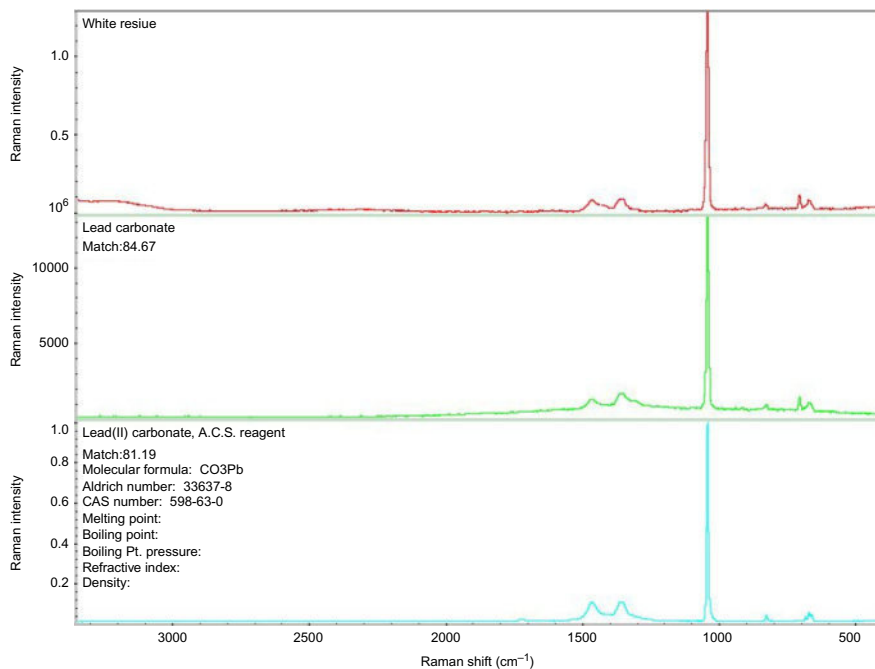
FIGURE 15.29

The Raman spectral data presented in [Figure 15.29](#) indicate that the residue is largely composed of lead carbonate, an expected corrosion product. However, this does not yield insights into how the electromigration leading to corrosion occurred. To further test the assumption of in-line cleaner ingress, GC/MS methods were chosen.

Raman spectrum of white residue between pins (top) database matches to lead carbonate (bottom two spectra).

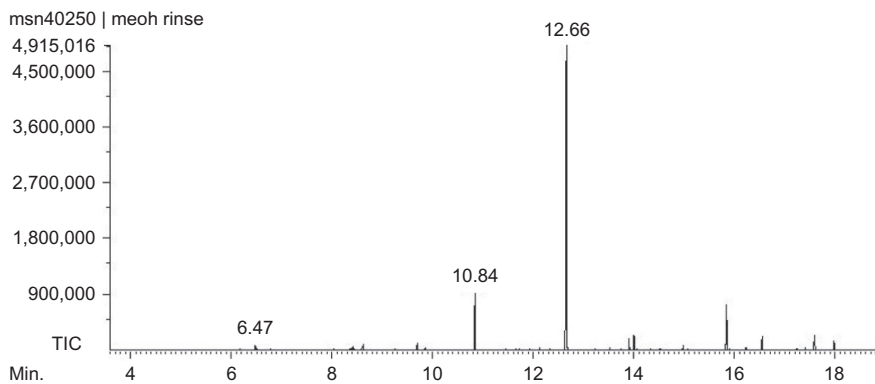
FIGURE 15.30

The labeled peaks were identified from the mass spectra as components of the in-line cleaner.

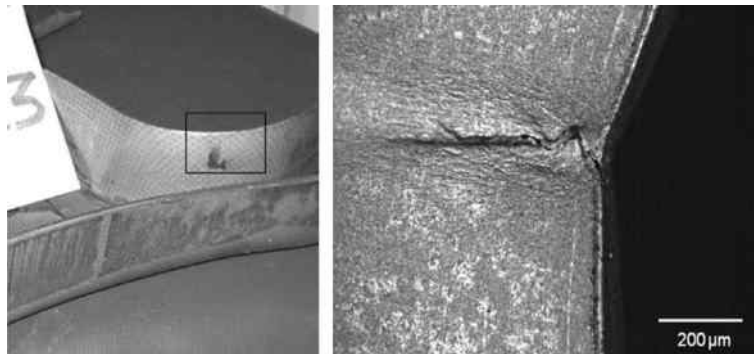
**FIGURE 16.2**

The issues pertaining to fatigue are the key limiting factor to the wider use of high-performance steels in demanding structural applications. The majority of steel components produced for service as automotive structures are primarily manufactured using the mechanical blanking process. This can produce a rough cut-edge which results in the formation of a fatigue crack initiation as shown in [Figure 16.2](#).

Suspension arm with a mechanical cut-edge fatigue crack emanating from a point of high stress.

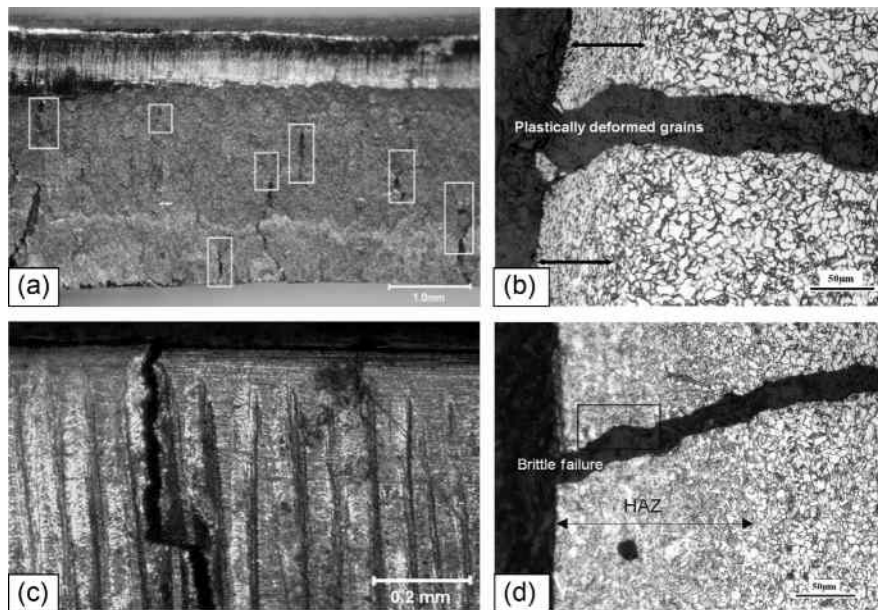
**FIGURE 16.11**

Micrograph of DP600 cut-edges with (a) the formation of multiple crack initiations from a mechanical cut-edge, (b) micrograph of a mechanical cut-edge fatigue crack initiation, (c) micrograph of the initiation of a laser cut-edge fatigue crack, and (d) micrograph of a fatigue crack initiating from the trough of a cut-edge.

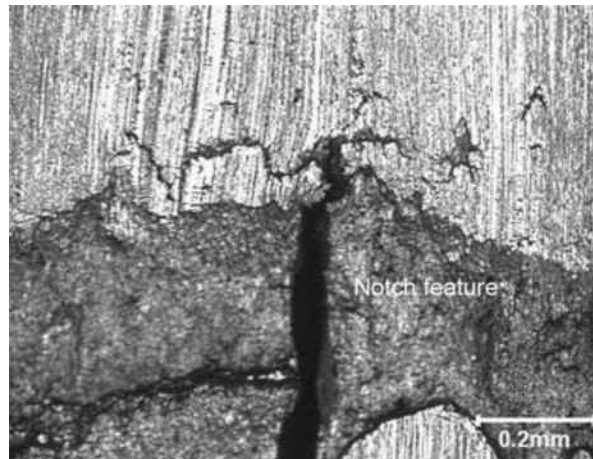
FIGURE 16.16

Surface of the fatigue crack initiation from a mechanical cut-edge notch.

However, the more the crack grew into region II growth, the more the inconsistent it became as shown by observations made of the crack tip behavior. Microstructural examination of the crack growth revealed the elongation of grains at the region where the crack initiated as shown in Figure 16.16. This indicates that under the process of sinusoidal loading there is a localized region of plastically deformed grains, which have been deformed before the formation of the region I crack growth.

At a load of 20 kN, mechanical cut-edge cracks were observed to initiate from notch features. This suggests that it is the cut-edge surface properties that are of critical importance particularly under HCF testing. These observations suggest the reason why mechanical cut-edges displayed a dramatic decrease in fatigue life.

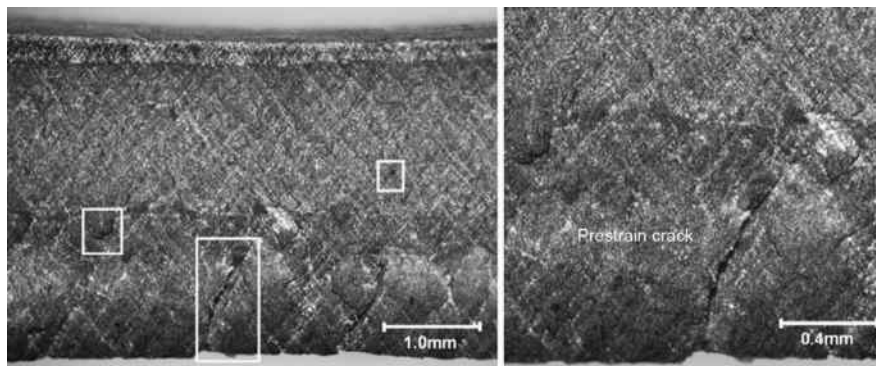
FIGURE 16.21

Micrograph of a mechanical cut-edge surface after an 8% prestrain has been applied.

of 5%, there is a large increase in fatigue life over mechanical cut-edges that have not been prestrained. At a prestrain of 8%, mechanical cut-edges as shown in Figure 16.21 display a number of prestrain-induced cracks at the rougher lower region of the mechanical cut-edge, and these features resulted in a large reduction

in life over all cut-edge types. The influence of prestrain can have characteristically damaging effect on the fracture zone of mechanical cut-edge surfaces. The imperfections in the lower region of the fracture zone are where, under prestraining, cracks can open up into a larger rupture.

At a prestrain of 8%, there are a number of cracks that have formed toward the bottom of mechanical cut-edges and occurred when strain limits of the cut-edge were exceeded. Therefore, the size of the fractured zone is important in terms of understanding the fatigue performance, as it is the roughest region of a mechanical cut-edge and has the presence of tensile residual stresses. Rapid transformation of austenite to martensite at first is due to the nucleation sites introduced by the deformation. However, an excessive strain can retard the transformation, eventually bringing it to a halt as is the case at higher 8% level of strain. This mechanical stabilization process later is a characteristic feature of displacive transformations.

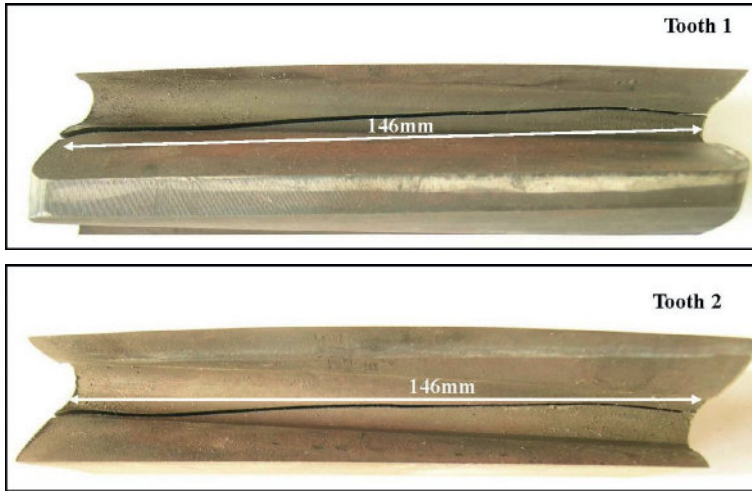
FIGURE 17.1

Two cracked gear-teeth are shown in [Figure 17.1](#) as they were received. Visual inspection revealed that the cracks were situated at the groove root and were along the axial direction. The cracks were found throughout the entirety of the grooves and the axial length was about 146 mm. Fracture surfaces of two cracked teeth prepared by opening cracks showed similar fractographic features, as shown in [Figure 17.2](#). Dark brown fracture surfaces and the presence of oxidation film on the fracture surfaces suggest that the fracture surfaces underwent a process of high-temperature oxidation after the cracking of the gear-teeth. No obvious plastic deformation was observed on the fracture surfaces. The fracture surfaces close to the groove showed opposite chevron crack propagation markings [1,2], as marked by dotted arrows in [Figure 17.2](#). The chevron points toward the origin of the fracture. Hence, it can be determined that the crack origins were about 3.3-3.5 mm from the groove and

As-received cracked teeth.

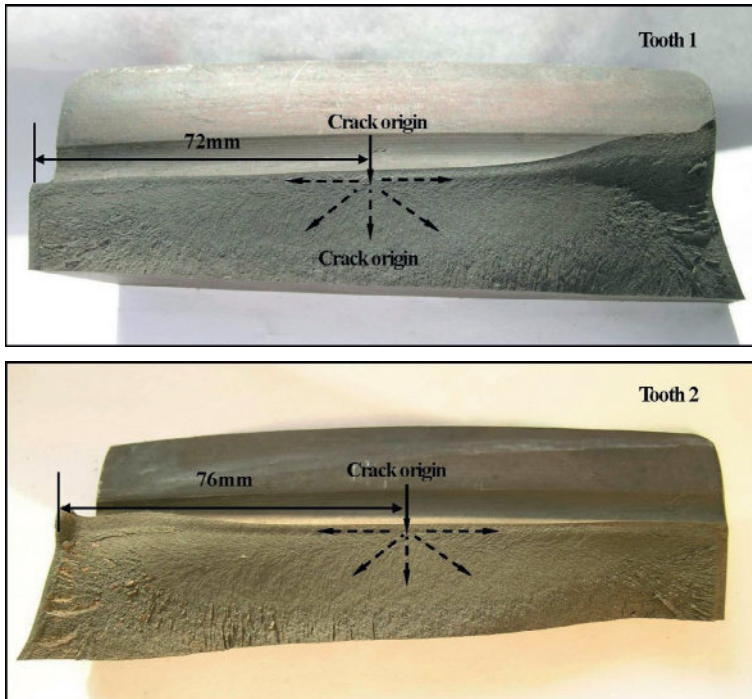
FIGURE 17.2

Macro-fracture surfaces.
