Handbook of Materials Failure Analysis

With Case Studies from the Aerospace
and Automotive Industries

Abdel Salam Hamdy Makhoul

Mahmood Aliofkhazraei

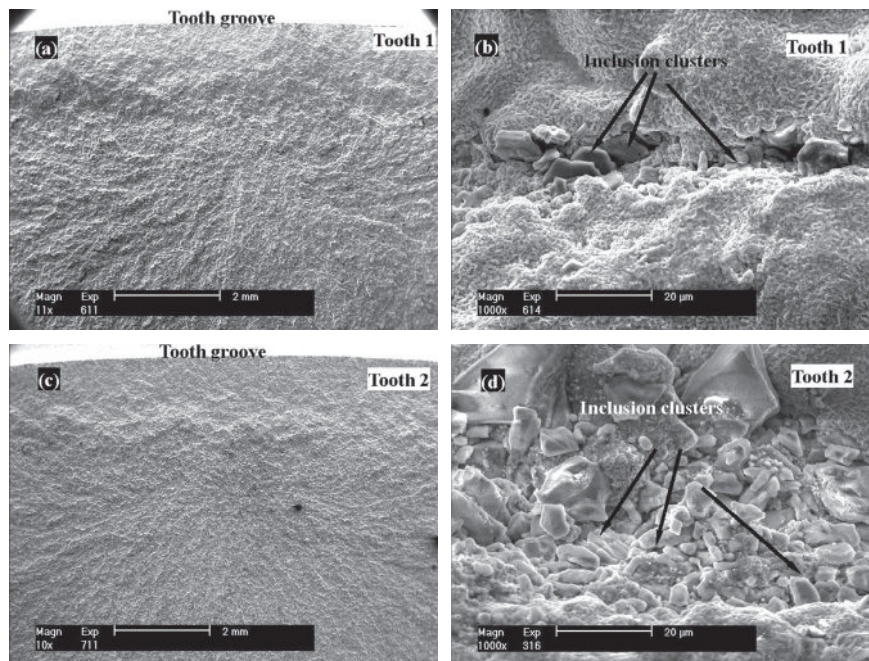
FIGURE 17.3

A discontinuous oxidation layer was found covering on the fracture surfaces, but the point-like feature in crack origins and radioactive crack propagation marks were clearly revealed by scanning electron microscope (SEM) (Figure 17.3a and c). After the fracture surfaces were cleaned repeatedly by supersonic vibration in acetone solution, large nonmetallic inclusion clusters containing numerous small particles of 5-30 μm in diameter were found in multiple locations of the crack origin regions (Figure 17.3b and d). Based on the morphology and the present position of the particles, it can be deduced that the particles in the crack origins did not originate from the coverings on the fracture surfaces, but were from the raw material. These inclusions are of the type generally associated with ingot segregation patterns. Energy dispersive X-ray (EDX) analysis (Figure 17.4) indicated that the particles were mainly Al_2O_3 complex metallurgical inclusions.

SEM observation on fracture surfaces: (a,c) general view, (b, d) showing inclusion clusters in crack origins.

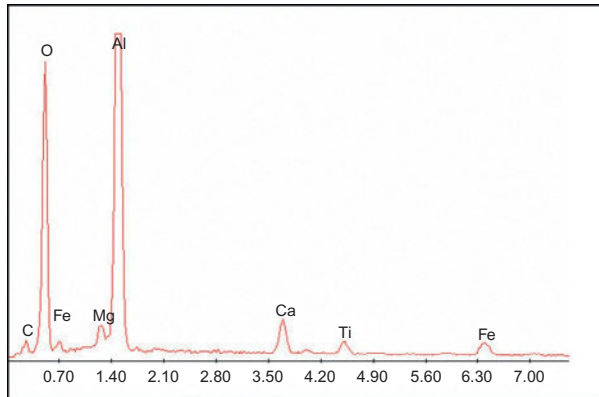
FIGURE 17.4

EDX spectrum taken from the inclusions in the crack origin (tooth 2).

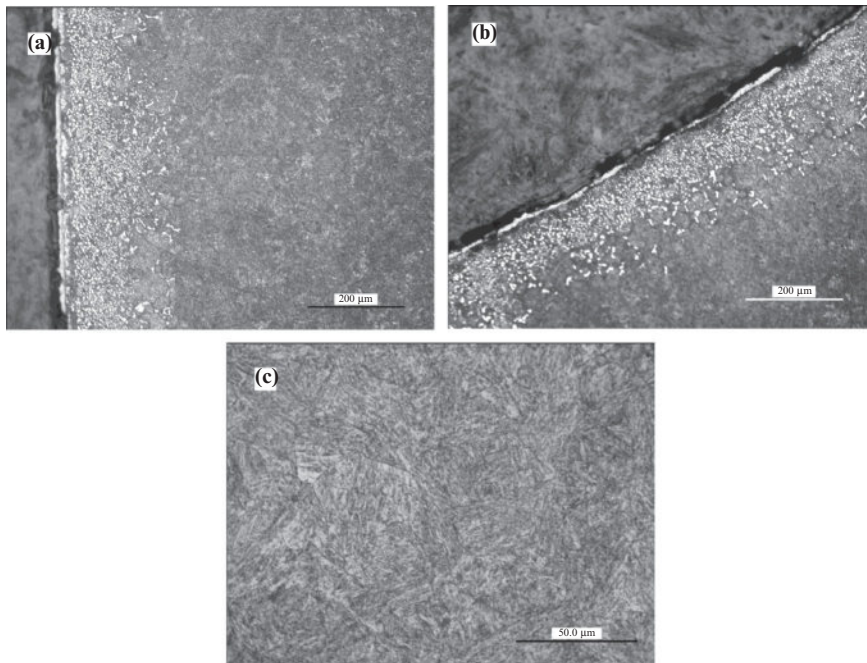
FIGURE 17.5

The cross-sections of the cracked teeth close to the crack were prepared for metallurgical examination. The microstructure of the tooth profile region and the core for the two cracked gear-teeth revealed same metallurgical features. The representative photographs showing the carburized layer are shown in Figure 17.5a and b. The

Microstructure of cracked tooth (tooth 1): (a) carburized layer (pitch region), (b) carburized layer (groove region), and (c) core.

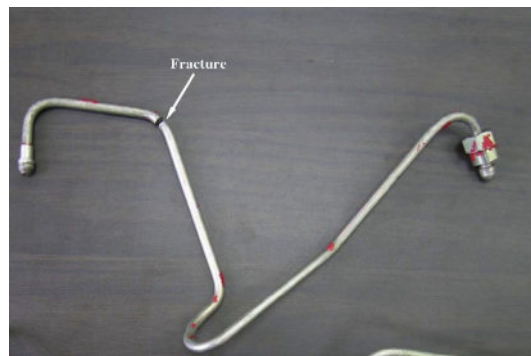
FIGURE 17.6

From [Figure 17.6](#), it can be seen that the fracture occurred at a bending position. SEM observation of the fracture surface revealed the beach marks ([Figure 17.7a](#)) and the fatigue striations ([Figure 17.7b](#)) reflective of fatigue crack propagation. From the bowing direction of the beach marks, it can be determined that the fatigue crack

Cracked fuel injection pipe.

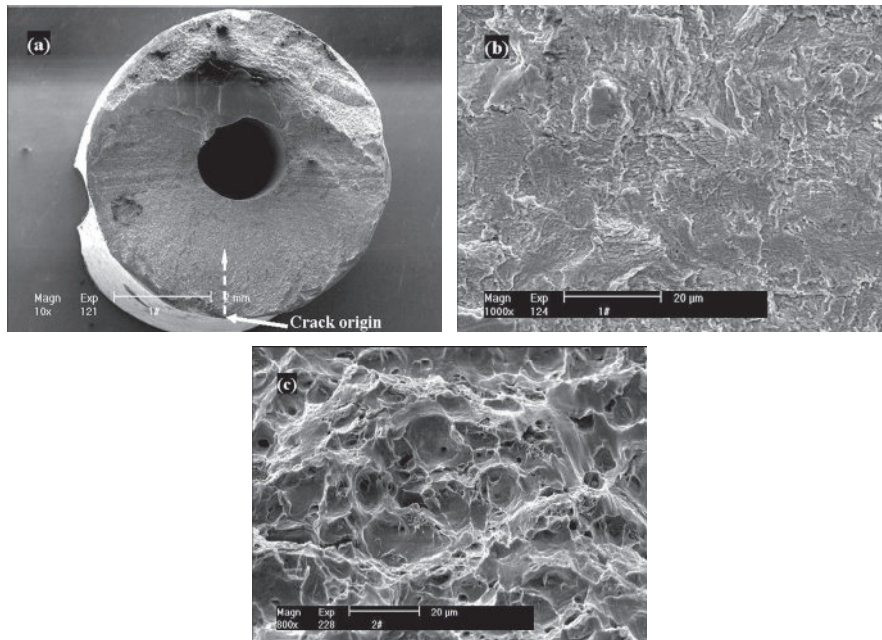
FIGURE 17.7

SEM observation on fracture surface of pipe: (a) general view; (b) crack propagation zone showing fatigue striations, and (c) final fracture zone showing dimples.

origin initiated from the concave side of bending fillet and propagated toward the convex side along the radial direction, as marked by dotted arrows in [Figure 17.7a](#). It is suggested that the unidirectional bending fatigue is the dominant failure mechanism of pipe. The dimples are presented on the instantaneous fracture zone ([Figure 17.7c](#)). The final fracture area is about one-third of the whole fracture and the larger final fracture area suggests that the load which pipe bore was greater before fracturing.

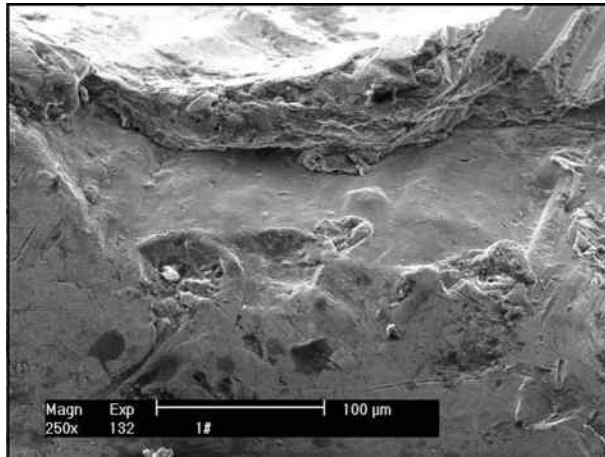
It is highlighted that the original machining dent was revealed on the external wall of the pipe in the crack origin region ([Figure 17.8](#)) by SEM.

FIGURE 17.8
SEM observation on external wall of pipe in crack origin zone showing machining dent.

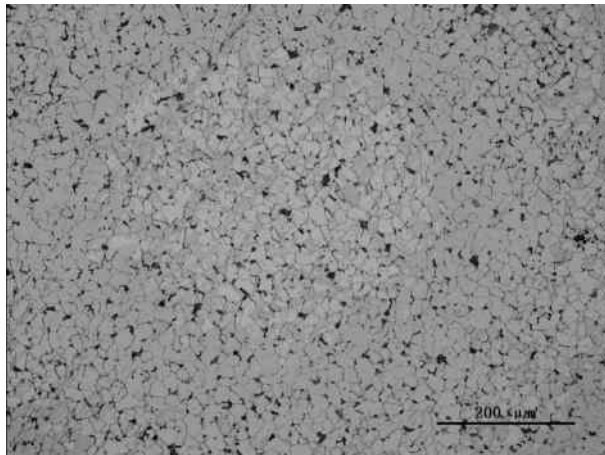
The microstructure of the radial section close to the crack origin was observed by optical microscope (OPM). The microstructure of the pipe was composed of ferrite and a small amount of pearlite ([Figure 17.9](#)) without the occurrence of decarburization on the surface of pipe wall, which is the normal microstructure of this grade of steel. Additionally, the chemical composition of pipe material corresponds to the specification.

FIGURE 17.9
Microstructure of cracked pipe material.

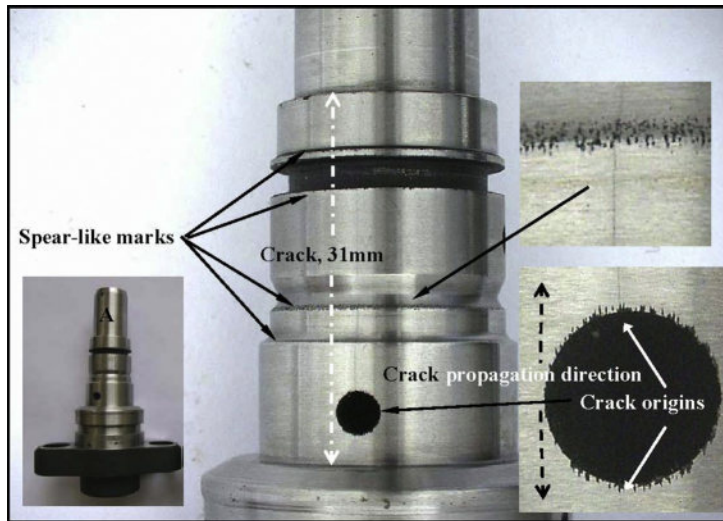
FIGURE 17.10

Cracked plunger-sleeve.

The plunger-sleeves were examined both visually and with the aid of a stereomicroscope. This examination revealed that all the cracks appearing on the failed plunger-sleeves were along the axial direction of the plunger-sleeve and through the oil-hole. A representative cracked plunger-sleeve is shown in [Figure 17.10](#). The crack at the upper and lower edges of oil-hole was not well aligned and the width of the crack decreased in distance from the oil-hole. It was concluded that the crack originated from the upper and lower edges of oil-hole and propagated oppositely along the axial direction. A lot of black spear-like marks along the axial direction were found at the fringe of oil-hole and the transitional steps of different journals (seen in [Figure 17.10](#)).

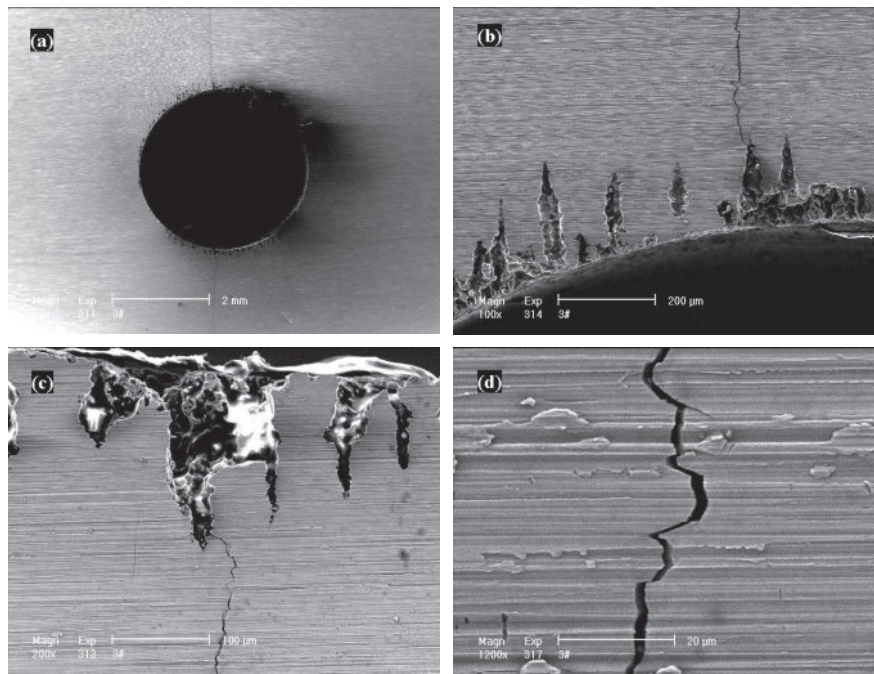
FIGURE 17.11

SEM observations indicated that the black spear-like marks at the fringe of the oil-hole were spear-like blunt openings along the axial direction ([Figure 17.11](#)). It was noted that the main cracks at the edges of the oil-hole initiated from the spear-like openings ([Figure 17.11b and c](#)). The main crack at both edges of the oil-hole was sharp and the crack presented as tortuous ([Figure 17.11d](#)).

SEM observation on external surface in oil-hole region showing black spark-like openings and main cracks: (a) general view, (b) at upper edge, (c) at low edge, and (d) tortuous crack morphology.

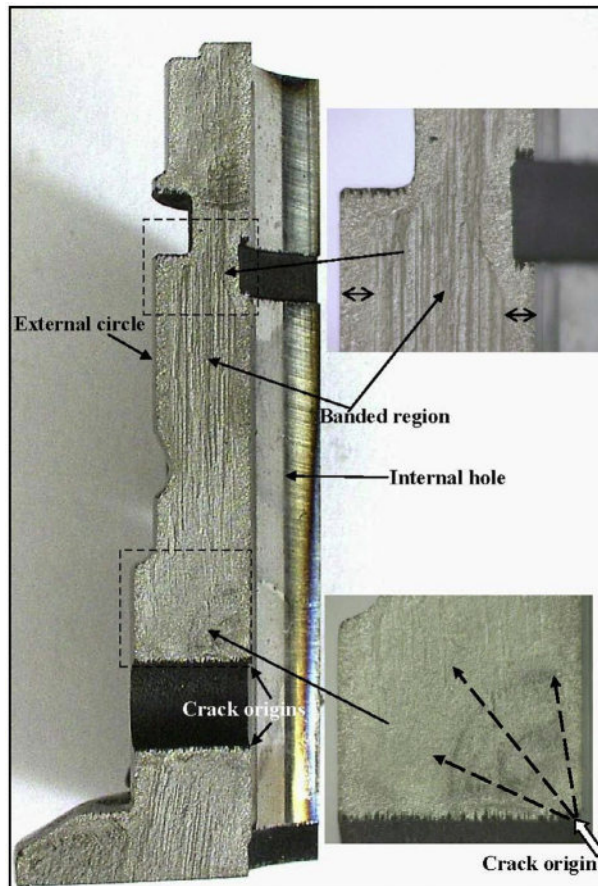
FIGURE 17.12

The fracture surface was prepared by pulling the crack apart. Intensely concentrated black spear-like marks appeared at the edges of the interface between the radial machining section and fracture, as shown in [Figure 17.12](#).

Beach marks showing fatigue crack propagation [2] were seen in the region close to the oil-hole. From the orientation of beach marks, the crack's origins initiated from the internal wall of the oil-hole edge and propagated toward the external circle (indicated by dotted arrows in Figure 17.12). The axial banded region was exhibited in the middle of the fracture (marked in Figure 17.12). The crystalline fracture morphology can be observed within about 0.5 mm range from the internal hole and the external circle surfaces (marked by double arrows in Figure 17.12).

Macro-fracture surface of cracked plunger-sleeve.

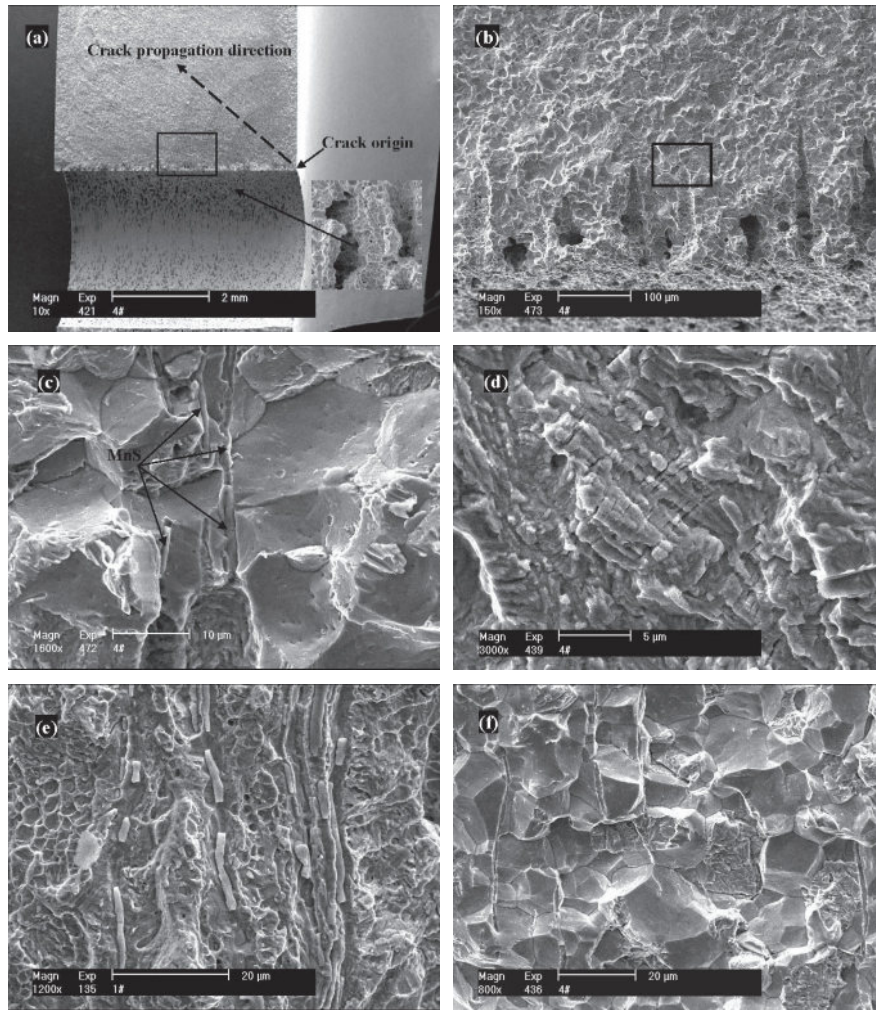
FIGURE 17.13

SEM observation indicated that the fracture surface was smooth and in the crack origins close to internal hole, the crack propagated mainly in the intergranular mode (Figure 17.13b and c). Fatigue striations were observed in the crack propagation region (Figure 17.13d). The axial banded region in the middle of the fracture contained some axial rod-like inclusions (Figure 17.13e). It is concluded that the plunger-sleeve started to crack in the intergranular mode and propagated in fatigue.

The spear-like openings also appeared on the fracture surface connected with the oil-hole (Figure 17.13a–c). There are mostly the elongated inclusions on the extended lines of the spear-like openings (Figure 17.13c). It is suggested that the spear-like openings must be related to the elongated inclusions.

It was noted that a lot of pits along the axial direction are presented on the internal surface of oil-hole (seen in [Figure 17.13a](#)).

Intergranular fracture morphology was revealed in 0.4-0.5 mm regions from the surface of the internal cavity and external circle ([Figure 17.13f](#)), which is related to the presence of the carburizing layer [8,9].

SEM observation on fracture surface: (a) general view, (b) boxed region in (a) showing intergranular cracking and spear-like pits and openings, (c) boxed region in (b) showing spear-like pits connecting with elongated MnS inclusions, (d) crack propagation region showing fatigue striations, (e) middle region on the fracture surface showing axial banded structure, and (f) intergranular fracture morphology in carburized depth of external circle.

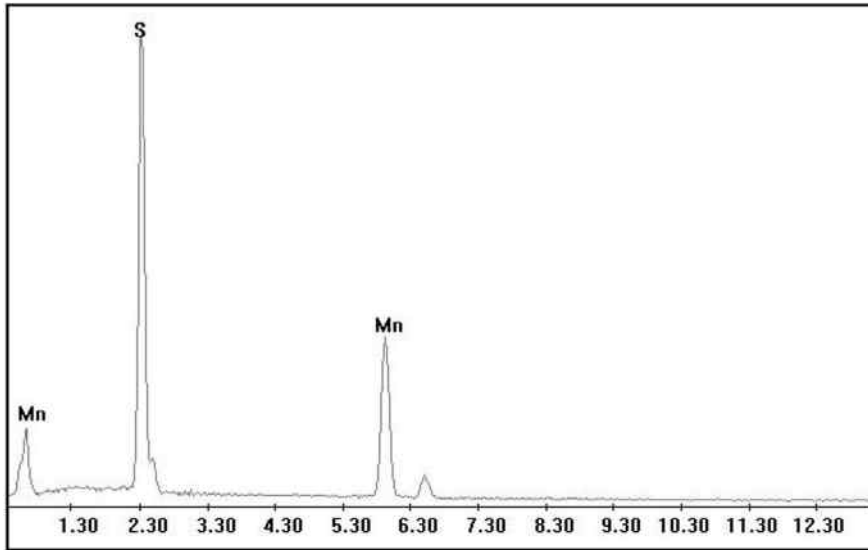
**FIGURE 17.14**

EDX analysis ([Figure 17.14](#)) performed on the axial elongated inclusions on the fracture surfaces and in the core material revealed that the elongated ones were sulfide of manganese, MnS.

EDX spectrum taken from the inclusions on the fracture surface (Figure 17.13e).

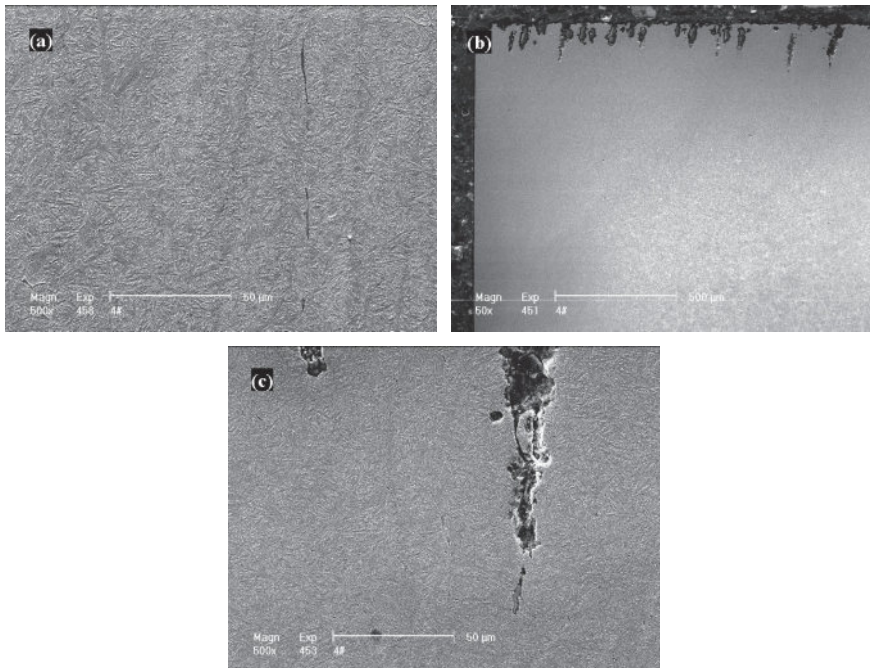
**FIGURE 17.15**

The longitudinal section of the plunger-sleeve was prepared for metallurgical examination. The core microstructure is composed of tempered martensite and fine elongated MnS inclusions were seen along the axial direction of the plunger-sleeve (Figure 17.15a). The carburized layer is composed of martensite and retained

Microstructure of failed plunger-sleeve: (a) core, (b, c) surface layer region of oil-hole.

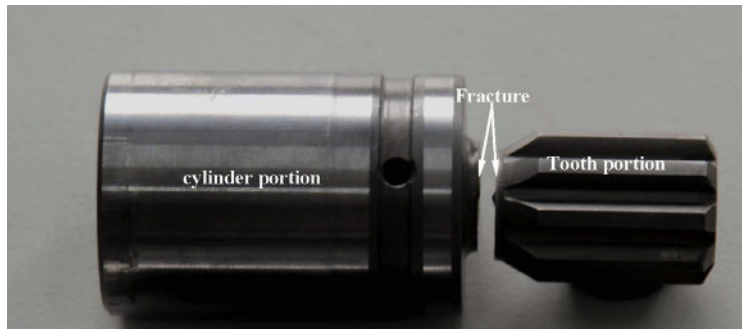
**FIGURE 17.18**

A truck diesel engine splined-shaft fractured after being in service for 7-8 h. The as-received fractured splined-shaft is shown in [Figure 17.18](#). It can be seen that the transverse fracture occurred at the root fillet between the tooth portion and the cylinder portion and no obvious macro-plastic deformation was observed. The failed splined-shaft was made from 20MnCr5 steel. The external surface of a spline-shaft is required to be carburized. The surface hardness is specified as HV_{10} 675-770 and the depth of carburized layer as 0.30-0.80 mm.

Fractured splined-shaft.

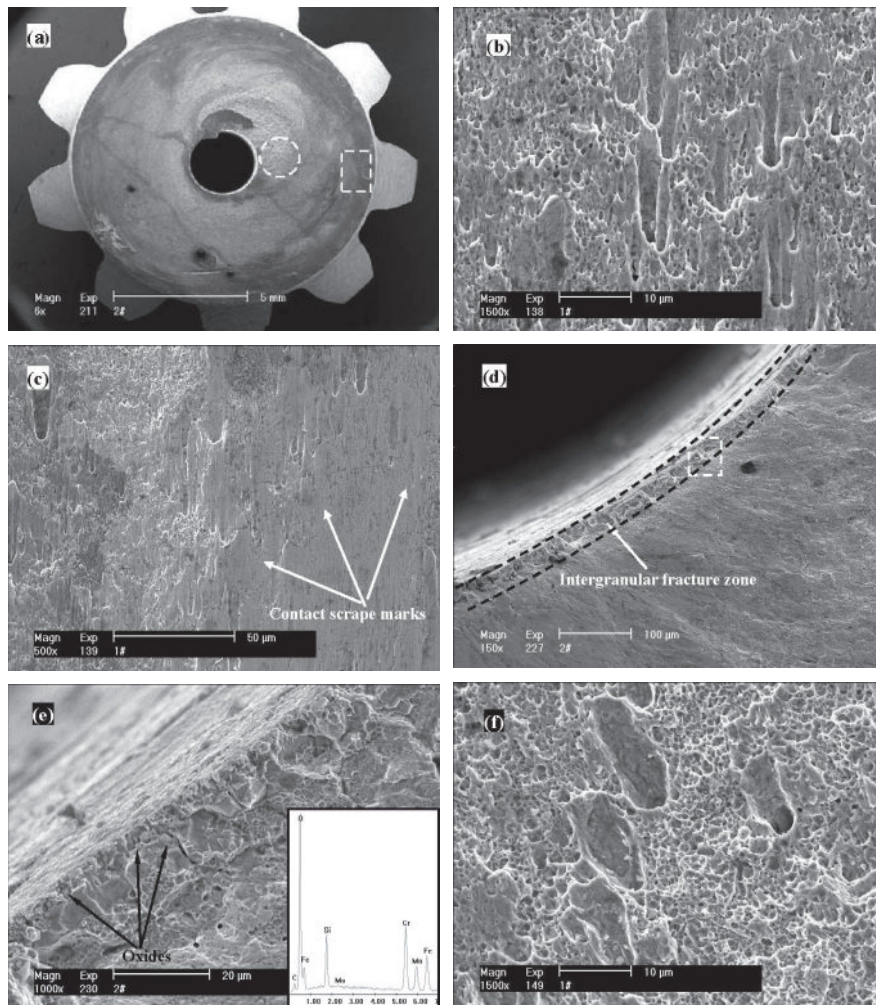
FIGURE 17.19

High-powered SEM observation indicated that the fracture surface exhibited generally circular parabola shallow dimples (Figure 17.19b) and contact scrape marks along the dragged direction of the parabola dimples appeared in the local regions of fracture (Figure 17.19c). It was noted that within about 20 μm from the internal hole, the fracture morphology was brittle, and in particular, intergranular, as shown in Figure 17.18d and e. The intergranular facets found were associated with dimples or ductile tears [12,13], and some particle-like substances were found on the intergranular facets (marked by arrows in Figure 17.19e). EDX analysis indicated that these particle-like substances were oxide compounds of Cr, Mn, Si (seen illustration in Figure 17.13e). Additionally, in the instantaneous fracture region close to the hole, deeper parabola dimples were observed (Figure 17.19f).

The fracture surface of the failed splined-shaft, especially on the outer periphery, had been worn intensely, so the fractographic features representing a carburized surface were not revealed. However, the presence of the intergranular decohesion features on the fracture surface of internal hole implied some brittle failure mechanism occurred on the splined-shaft and the brittle fracture may relate to the case layer on the splined-shaft. To investigate the relation of intergranular fracture to the case layer, a fracture was manufactured artificially. The semicircle transverse section was removed from the tooth portion and a transverse notch was

SEM observation on fracture surface and EDX spectrum of inclusions: (a) general view, (b) boxed zone in (a) showing parabola dimples, (c) showing scrape marks, (d) region close to internal hole, (e) boxed zone in (d) showing intergranular facets associated with dimples and precipitates and EDX spectrum, and (f) circled zone in (a) showing dimple morphology in the instantaneous region.

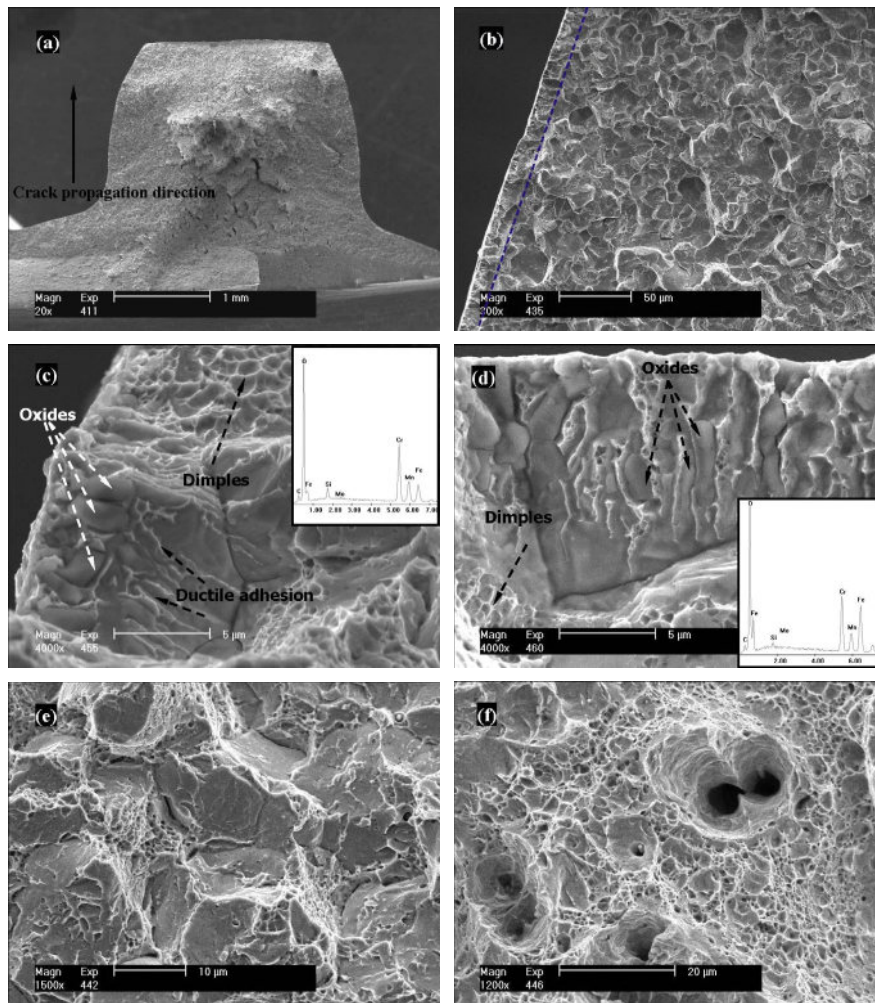
FIGURE 17.20

made in the matrix by spark-cutting, then section from the matrix was broken off toward the tooth portion to obtain identical orientation fracture with the original fracture of the failed splined-shaft. Low-magnified SEM observation indicated that the fracture surface had a different appearance in the outer and inner regions (Figure 17.20a). In the outer region of 0.7-0.8 mm from the surface the fracture

SEM observation on the fracture surface prepared artificially and EDX spectrum of inclusions: (a) general view, (b) showing the interface corresponding to internal oxidation layer, (c) showing intergranular facets associated with the oxides and dimples (at the flank) and EDX spectrum, (d) showing intergranular facets associated with the oxides and dimples (at tooth groove) and EDX spectrum, (e) showing intergranular fracture in subsurface corresponding to carburized layer, and (f) showing dimple morphology in the middle region.

surface was brittle but ductile in the tooth center. High-magnified SEM observation revealed that in the carburized area of about 0.5 mm from the surface, the fracture mode was predominately intergranular (Figure 17.20b). An obvious interface was revealed at the location of about 20 μm from the surface (marked in Figure 17.20b

by dotted line). However, a close examination of [Figure 17.20c and d](#) showed particle-like or rod-like substances at the intergranular facets. As proven by EDX analysis, these substances were also oxide compounds of Cr, Mn, and Si (seen in illustration in [Figure 17.20c and d](#)). It is highlighted that the dimples or ductile tears were observed at separated grain facets ([Figure 17.20c and d](#)). The fractographic features were similar to those presented in the internal hole region of the serviced fracture of splined-shaft. This indicated that the cracking occurred by microvoid coalescence alongside grain boundaries, typical of a crack propagation by a ductile intergranular mode [[12,13](#)]. This behavior is known to result from highly localized plastic deformation within relatively “soft” zones alongside grain boundaries [[14](#)], e.g., troosite or pearlite network [[14](#)]. It is well known that the occurrence of the internal oxidation on the carburized layer can induce the formation of nonmartensitic structure alongside the grain boundaries, e.g., pearlite, troosite, or bainite [[14](#)]. The following microstructure observations will demonstrate the appearance of a thin film of nonmartensite structure on the grain boundary in the case layer. The presence of nonmartensite structure alongside grain boundaries becomes relatively “softer” than the acicular martensite. In summary, the above results indicate that the fracture mechanism was ductile intergranular cracking related to precipitation of intergranular oxides. The oxide particles were not presented on the intergranular facets in subsurface, but dimples were still observed on the individual intergranular facets ([Figure 17.20e](#)). The middle region of the tooth was characterized by a dimpled ductile fracture ([Figure 17.20f](#)).

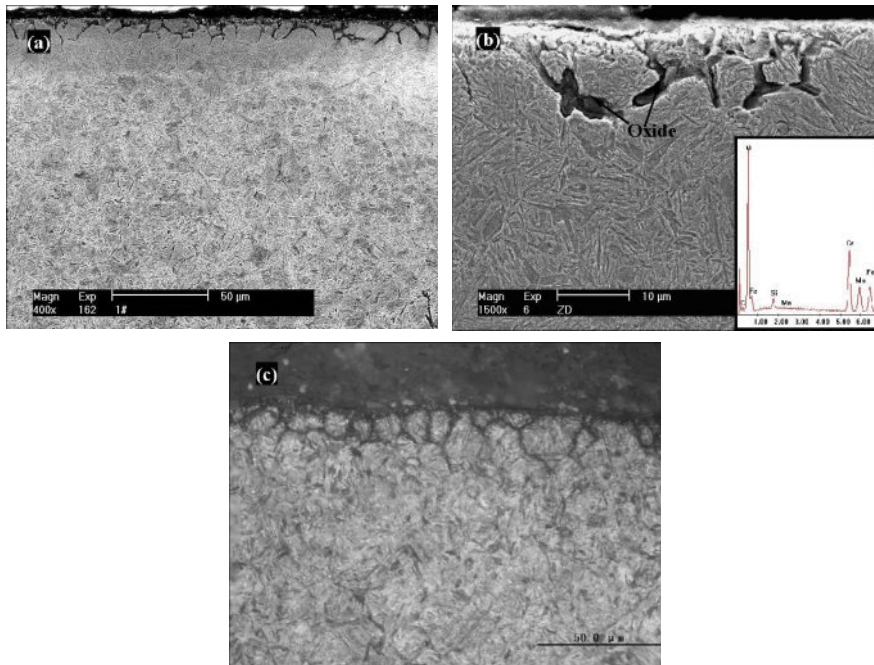
**FIGURE 17.21**

Longitudinal and transverse sectional microstructures were observed by OPM and SEM. A typical microstructure of the carburized layer in the etched condition is shown in [Figure 17.21](#). As shown, the microstructure of carburized layer mainly consisted of the tempered acicular martensite and the retained austenite without intergranular network-like carbides. It was found that black intergranular network-like structure were presented in the carburized layer of the external surface and the internal hole surface of the splined-shaft ([Figure 17.21a](#)). Precipitates were seen along the grain boundaries ([Figure 17.21b](#)). As proven by EDX analysis, these precipitates were also oxide compounds of Cr, Mn, and Si (seen in illustration of [Figure 17.21b](#)), in accordance with the precipitates on the intergranular facets of the fracture surface. It is suggested that the internal oxidation near the surface occurred, which is a typical phenomenon in gas-carburized steel [[14](#)]. The depth of internal oxidation is approximately 20 μm . It is highlighted that the region of

Microstructure of carburized layer and EDX spectrum of inclusions: (a) SEM observation showing internal oxidation morphology (tip region), (b) showing oxides in the grain boundaries and EDX spectrum, and (c) OPM observation showing nonmartensite thin film alongside the grain boundaries in the internal oxidation zone.

internal oxidation presents grain boundary “cavities” (Figure 17.21a and b), which is suggested that these oxidized grain boundaries were favorable sites for crack initiation. Nonmartensite structures were clearly observed in OPM, as shown in Figure 17.21c. From Figure 17.12c, a thin film of “dark phase” [15] of about 1-µm thick alongside grain boundaries was revealed in the internal oxidation layer, whose metallurgical features were identical with nonmartensite as described in the documents [14–17], troosite, or pearlite. The microstructure of core was primarily composed of tempered lath-martensite.

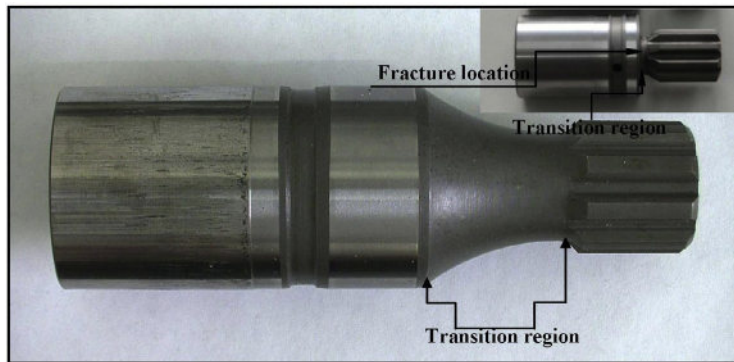
FIGURE 17.22

In service, the splined-shaft bears torsion load. In general, the torsion shear stress increases from the center of the shaft to the surface along the radial direction. The outmost surface of the splined-shaft bears greater shear stress. Literature indicates that cracks usually form 45° under torsional nature of loading imposed on a component [19], while, the failed splined-shaft was not in this instance. The tooth end of splined-shaft was fully bound up by the sleeve and the shaft end was fixed tightly in the internal hole of the driving gear. From the design construction of the splined-shaft, the axial free length is relatively short (merely 6.0 mm at the fillet, see in [Figures 17.18](#) and [17.22](#)), equivalent to a pure notch in construction.

It should be pointed out that the presence of intergranular internal oxidation in the case layer is not enough to cause the splined-shaft to rupture prematurely. However, in combination with greater stress concentration at the fracture location resulting from over-short axial free length between the tooth portion and the cylinder portion, the probability of such an event is considerably increased. Similar failure did not occur on a new type of splined-shaft which had a suitable transition between the tooth and the cylinder (Figure 17.22), despite the occurrence of internal oxidation in the case layer.

Improved splined-shaft with long transition between the tooth and the shaft.

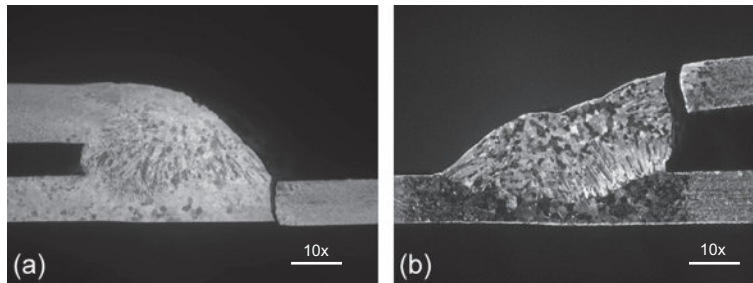
**FIGURE 18.2**

Welds are used to join pipes to other pipes or components such as catalytic converters, resonators, and mufflers. The weld is both a geometric and metallurgical stress riser. The heat affected zone in the parent material around the weld is an area of large grains which has lower fatigue life. The most common failures occur by initiating at a weld toe and propagating through the parent material in the heat affected zone of the weld or at the weld root and propagating through the weld and/or the parent material. Both the weld toe and root create a geometric notch that is a stress riser for fatigue initiation. The difference in microstructure between the weld, the parent material, and the heat affected zone in the parent material is a metallurgical stress riser. Examples of these failures can be seen in [Figure 18.2a and b](#).

Fatigue failure at (a) weld toe and (b) weld root.

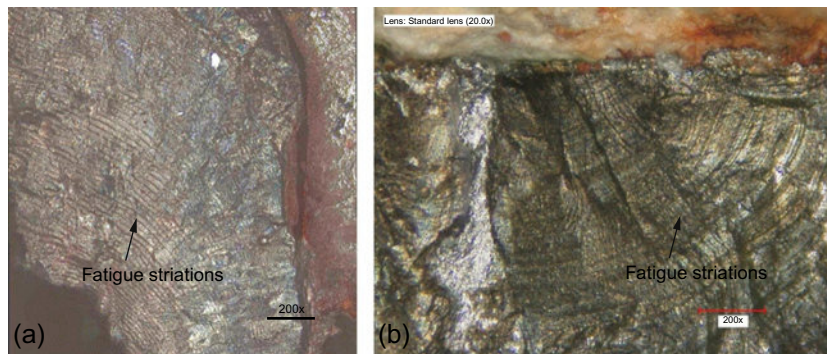
**FIGURE 18.3**

Fatigue is evidenced by striations on the fracture surface as seen in [Figure 18.3a and b](#). Striations are not always visible under lower magnification. Larger striations

Fatigue striations on fracture surfaces.

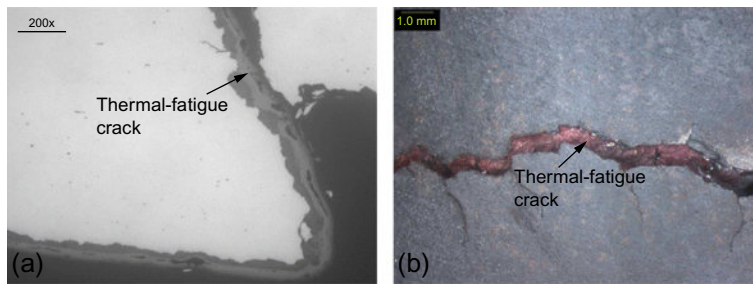
**FIGURE 18.4**

Thermal fatigue occurs at elevated temperatures and usually in combination with mechanical fatigue. Thermal fatigue consists of oxidation penetrating the material and forcing open a crack. Continued heating will propagate the crack through a cycle of oxidation opening the crack. These are typically trans-granular with multiple branch cracks filled with oxidation. Examples of thermal-fatigue cracks are shown in [Figure 18.4a and b](#).

Thermal-fatigue cracks.

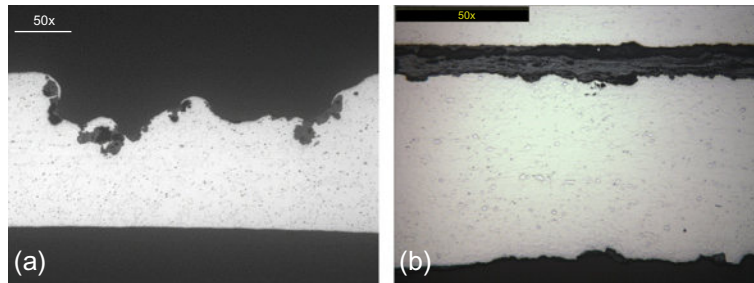
**FIGURE 18.5**

(a) Pitting corrosion on ferritic stainless steel and (b) crevice corrosion between two layers.

perforating and by acting as an initiation site for cracking [26]. Unlike general metal loss, which is defined as relatively uniform thinning over a significant area, localized metal loss such as pitting and crevice corrosion can vary significantly within a given area. Pitting corrosion is the most common and usually occurs at a surface imperfection as small as inclusions in the raw steel corrosion. Once corrosion initiates at a location, it can serve as a catalyst for more rapid corrosion resulting in a pit. Early in a corrosion environment, it is not unusual to see multiple spots of corrosion with adjacent areas having no corrosion attack. With continued exposure, the corrosion will eventually spread over an entire part. Crevice corrosion occurs when two materials are placed together and moisture wicks between the layers. This condition results in accelerated corrosion due to the trapped moisture and any corrosive materials in the moisture. Examples of pitting corrosion and crevice corrosion are shown in [Figure 18.5](#).

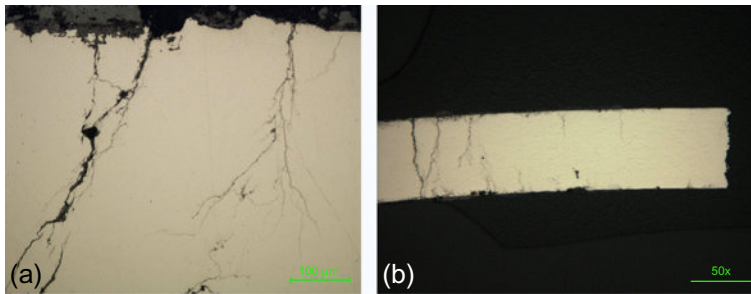
**FIGURE 18.6**

While austenitic or 300 series stainless steels have superior corrosion resistance to the ferritics due to the addition of nickel in the alloys, the cost is usually higher and the risk of stress corrosion cracking is present. Stress corrosion cracking (SCC) occurs in materials that are susceptible (like austenitic stainless steel), under stress, and exposed to halogens including chlorides found in road salt or ocean air. The stress may only be residual stress from forming the material as well as static and dynamic stresses on the exhaust system on the vehicle. SCC cracks usually start very small and may open up as the stress on the material increases. The cracks are usually trans-granular and often have multiple branch cracks. Ferritic stainless steel is not susceptible to SCC. [Figure 18.6](#) shows the stress corrosion cracking patterns in austenitic stainless steels.

Stress corrosion cracking (SCC) in austenitic stainless steels.

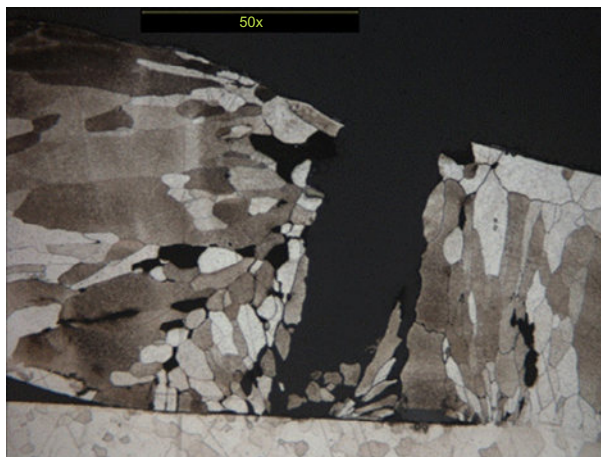
**FIGURE 18.7**

failure. Ferritic stainless steels used in exhaust systems are stabilized with titanium and/or niobium (also known as columbium) in combination with low carbon content. Titanium and niobium have a greater affinity for carbon than chromium so that titanium and/or niobium carbides and/or nitrides are formed preferential to chromium carbides and/or nitrides. This allows the chromium to be available to provide corrosion resistance. Austenitic stainless steels are also susceptible to sensitization. Improper gas shielding during welding may allow nitrogen from the air to be absorbed in the weld. The excess nitrogen can exceed the needed ratio of carbon/nitrogen to titanium/niobium resulting in sensitization. [Figure 18.7](#) shows the inter-granular corrosion due to sensitization of a ferritic stainless steel weld.

Inter-granular corrosion due to sensitization of a ferritic stainless steel weld.

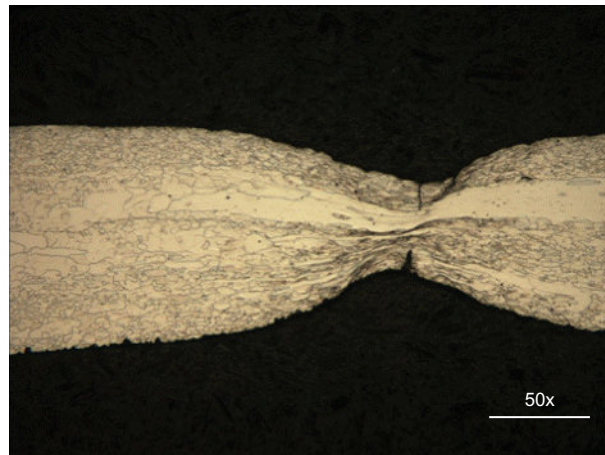
FIGURE 18.8

A tensile failure may also be called a ductile failure. This simply occurs when the stress on a component exceeds the strength of the material. In exhaust applications, the main consideration is the temperature to which the system is exposed. Selection of an appropriate material and thickness of the structures alleviates any concern for tensile failures. In some cases, if a crack (e.g., fatigue crack) has propagated to a degree such that the remaining load-carrying cross-section is no longer able to carry the load, it breaks suddenly through the tensile failure mechanism, as so-called overload failure. Figure 18.8 shows an example of failure (necking and cracking) under tensile loading.

Tensile/ductile failure.

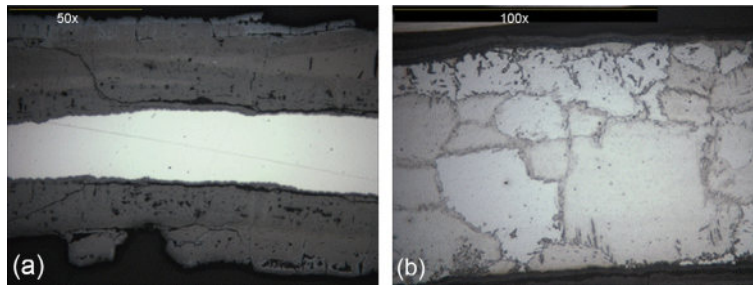
FIGURE 18.9

(a) Heavy oxidation from high temperatures and (b) grain growth and grain boundary liquation.

will also result in exaggerated grain growth and may result in a condition known as grain boundary liquation. Figure 18.9a and b shows the severe oxidation and grain boundary liquation, respectively.

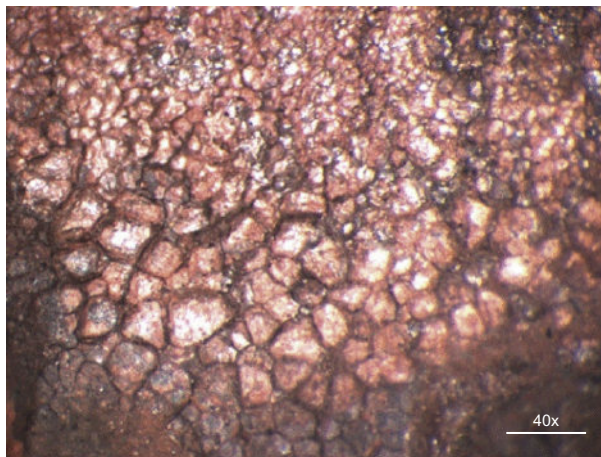
FIGURE 18.10

The use of urea as a reductant for SCR systems has introduced another corrosion concern. Ammonia is formed in the process and at high temperatures can result in intergranular corrosion termed as “dusting.” This condition has been found in the lower alloy content ferritic stainless steels and austenitic stainless steels and is more severe at elevated temperatures. Higher chromium content ferritics stabilized with niobium has been found to be the optimum material for urea applications. Figure 18.10 shows the corrosion pattern caused by urea dusting in a 409 stainless steel.

Urea dusting of 409 stainless steel.

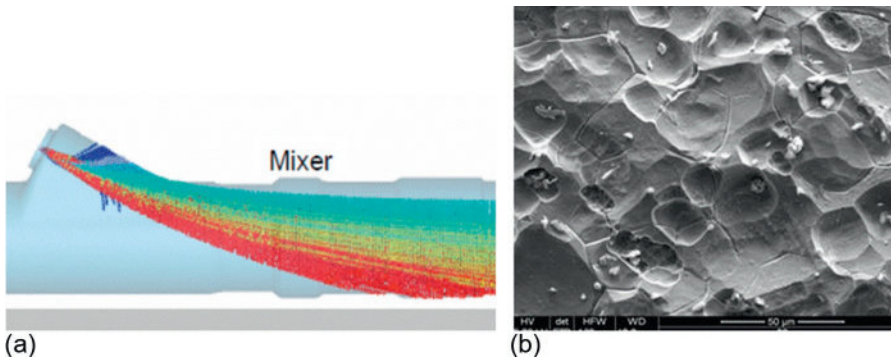
FIGURE 18.11

(a) Spraying simulation and (b) damage erosion-corrosion inner surface of an exhaust system.

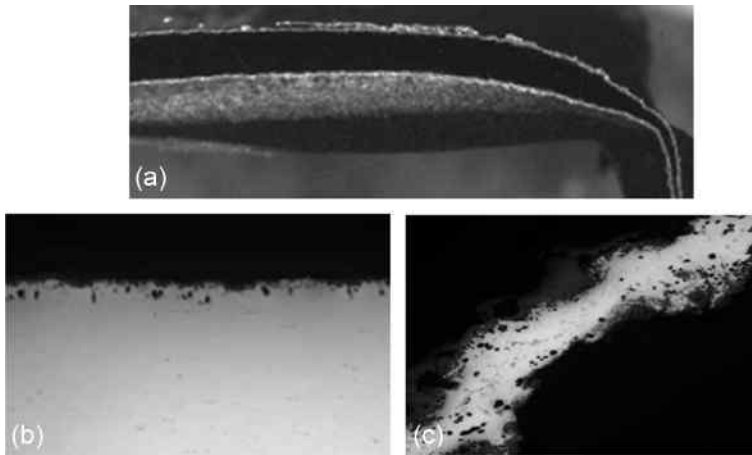
FIGURE 18.12

High-temperature oxidation-erosion, (a) wall-thinning, (b) modest eroded surface, and (c) severely eroded surface.

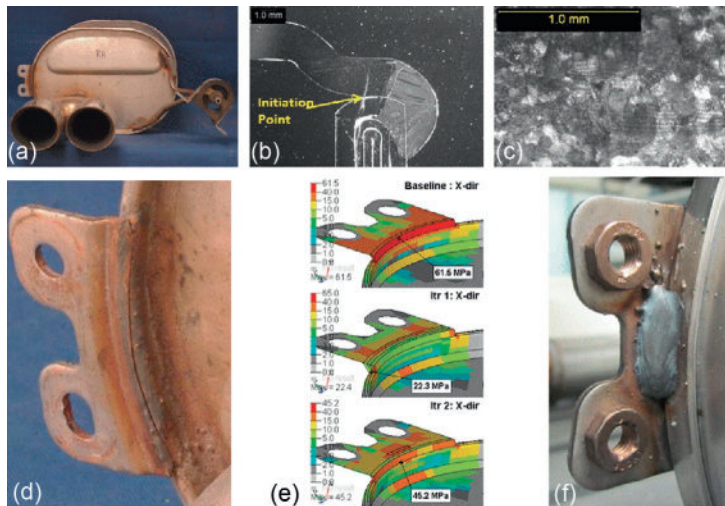
FIGURE 18.17

Left-hand (LH) and right-hand (RH) muffler assemblies bolted to each other by a bracket welded to the outlet head bead, were experiencing failures of the brackets while on the vehicle. A right-hand muffler assembly, which shows the placement of the bracket on the muffler head bead, is shown in Figure 18.17a. Analysis of

(a) Right-hand (RH) muffler assembly, rear view, (b) bracket weld cross-section, (c) fatigue striations, (d) baseline weld, (e) stress contour plot, x-direction, and (f) iteration2: bracket with 15 mm weld.

the parts showed that the failures were the result of fatigue and the cracks initiated at the root of the weld, [Figure 18.17b](#), and propagated through the bracket to head bead weld. The weld cross-section, with the initiation point noted on the image, is also shown in [Figure 18.17b](#). Fatigue striations were visible on the fracture surfaces and are shown in [Figure 18.17c](#). The originally designed weld setup consists of a weld extending the full length of the bracket on the rear face (when in vehicle position) after failure is shown in [Figure 18.17d](#).

To remedy the failures, additional welds were considered to lower the stress on the bracket weld. FEA analysis was performed on the original weld design (Baseline), [Figure 18.17d](#) the original weld with the addition of a full-length weld on the front bracket face (Iteration 1), and the original weld with the addition of a 15 mm weld centered on the front bracket face (Iteration 2). The FEA analysis showed a stress reduction in Iteration 1 and Iteration 2 when both axial force and torque were applied to the bracket. [Figure 18.17e](#) shows a stress contour plot of x-direction axial force between the three weld scenarios with the area of highest stress noted. After consideration for the manufacturing and assembly process, the 15 mm weld was selected for additional testing as it showed a reduction in stress and had a reduced chance of interfering with the function of the bracket.

Bench testing of brackets with the original weld and Iteration 2 samples was performed to compare the fatigue durability of the two weld designs. The Iteration 2 test parts exceeded the cycles of the baseline parts in both vertical and longitudinal testing and the new weld design was implemented to resolve the bracket failures. [Figure 18.17f](#) shows the forward edge of the bracket from a left-hand (LH) muffler after the application of the 15 mm weld.

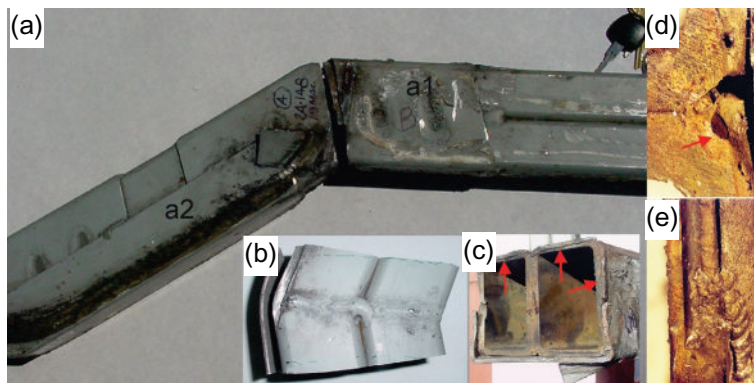
FIGURE 19.1

Failure of the transversal stiffener in a front-engine transit bus. (a) Shows the failed part, which was reinforced by plates which were welded onto the original design (a1 and a2). (b) Shows a reference part without failure. (c) Presents the cross-section of the failed part. The arrows indicate the weld material, which covers the structural section only superficially. (d) Indicates a low-quality joint, with inclusions and discontinuities between the weld and base metal and incomplete penetration of the weld material into the union between the two hollow sections. (e) Likewise indicates an incomplete weld which fails to fully join both sides of the structural section.

In the case of the transverse stiffener, square butt joints were produced from the same material as used in the original product; one set of samples was manufactured using the E6013 electrodes used by the subcontractor and one set using E7018 electrodes as deemed more appropriate by the present authors. Five tensile samples were produced from each set, with the welding seam at the center. For the E6013 electrode, an ultimate tensile strength of 380 MPa was obtained with an elongation at failure of 4.6%, for the E7018 electrode, the values were 470 MPa and 7.2%, respectively. In the first case, fracture occurred in the weld, in the second case, it was the base material that failed in a ductile manner.

In both cases presented above, the failure mode was fatigue (Figures 19.3 and 19.4). In the first one, fatigue propagation was strictly limited to the weld material for the simple reason that the metallurgical union between weld and base material was almost nonexistent, as seen in Figures 19.1c and 19.5a. Only a thin overlay connects the two halves of the structural section. In the same way, the reinforcement plates applied to the original design are so poorly welded that their effect is negligible. The reason for the failure is the selection of the welding electrodes, which provide insufficient strength and poor penetration of the base material by the welding seam, but allow relatively fast production rates. The problems are exacerbated by the extremely poor execution of the welds, as evidenced by their macroscopic appearance and the presence of oxide inclusions and shrink porosity.

It is concluded that in the first case, extreme cost-cutting through materials selection and the use of unqualified labor is entirely responsible for the failure. In the second case, process control is also insufficient and the use of underqualified labor may be a factor. However, considering the specific initiation sites for fatigue, design changes may be required to provide additional stiffness to the frame around the doors of the bus, with the goal of reducing the stress concentrations in the corners of the unions between the hollow sections.

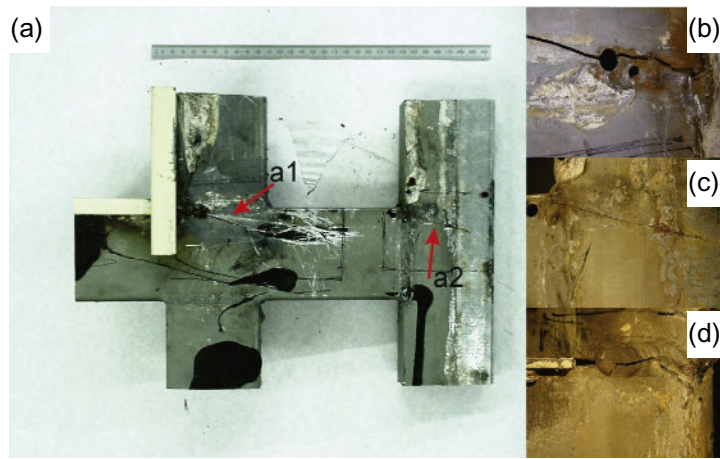
FIGURE 19.2

Cross and T-junction of the portal of the descent door of a transit bus. (a) Presents the assembly with cracks marked by arrows a1 and a2. (b) Gives a close-up of crack a1, which runs through a hole drilled in the profile. The origin of the crack is found in the weld joint seen in the left-hand side of (b); the holes, which were drilled to affix accessories in the bus interior after production did not seem to affect the propagation of the fatigue cracks in any significant manner. (c) Presents a close-up of crack a2, while (d) shows the origin of the crack in the weld material of the T-joint.

failed T and cross unions of welded sections retrieved from the frame around the descent (rear) door (notice the cross union consists in fact of two separate T-joints).

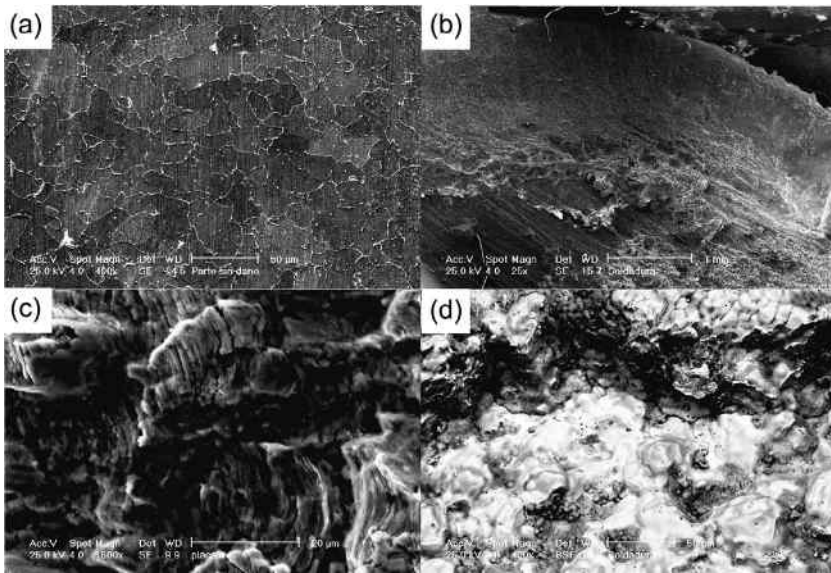
FIGURE 19.3

SEM-images corresponding to the failure shown in [Figure 19.1](#). (a) Shows the typical microstructure of a low-carbon steel. (b) Presents a fatigue failure of the weld, as evidenced by the detail in (c) The lower part of (b) presents the surface of the structural profile which still shows the cutting marks produced when the section was cut to size during manufacturing and was not affected by the welding. (d) Shows a part of the fracture surface within the weld material where oxide inclusions and shrinking porosity are found.
