Handbook of Materials Failure Analysis

With Case Studies from the Aerospace
and Automotive Industries

Abdel Salam Hamdy Makhoul

Mahmood Aliofkhazraei

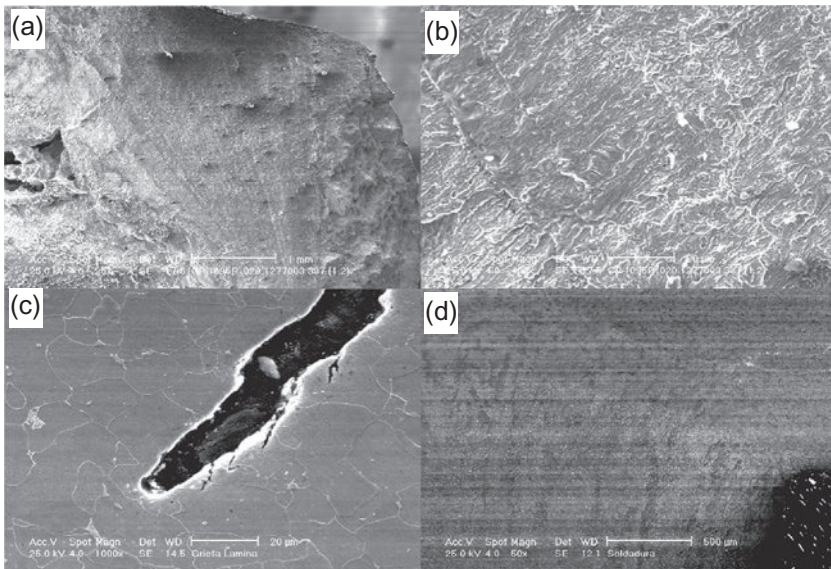
FIGURE 19.4

SEM-observations of the hollow structural sections of [Figure 19.2](#). (a) Shows fatigue crack propagation through the profile wall, the complex propagation pattern as observed in (b) indicates a strong shear component in the loading cycle. (c) Shows a blunted crack tip in a typical low-carbon steel microstructure. (d) Shows the weld, the HAZ and base material in a continuous transition which indicates the formation of a sound metallurgical joint.

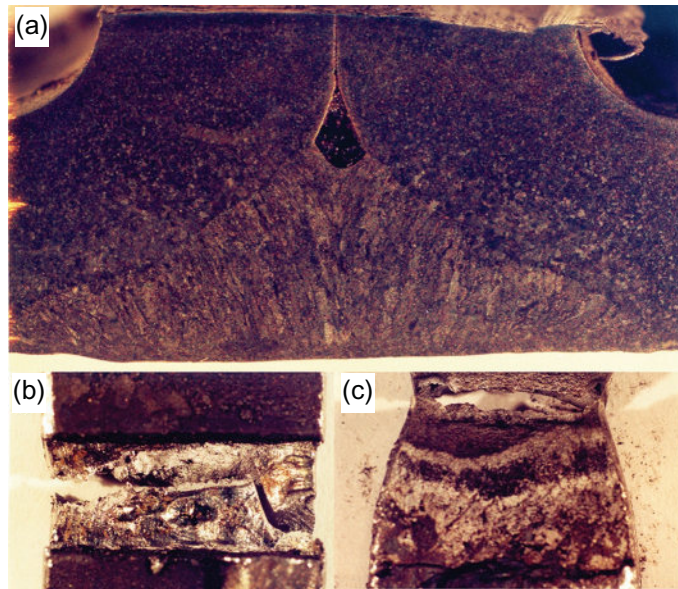
FIGURE 19.5

(a) Presents a cross-section of the welds used in the transversal stiffener. No weld penetration is observed, the heat-affected zone is small and recognized by some limited grain growth. (b, c) Represent butt joints after tensile testing. In (b), the E6013 electrodes used in production were employed; the sample fails through the weld material. In (c), an E7018 electrode was used, which causes tensile failure to occur in the base metal while the weld material is intact.

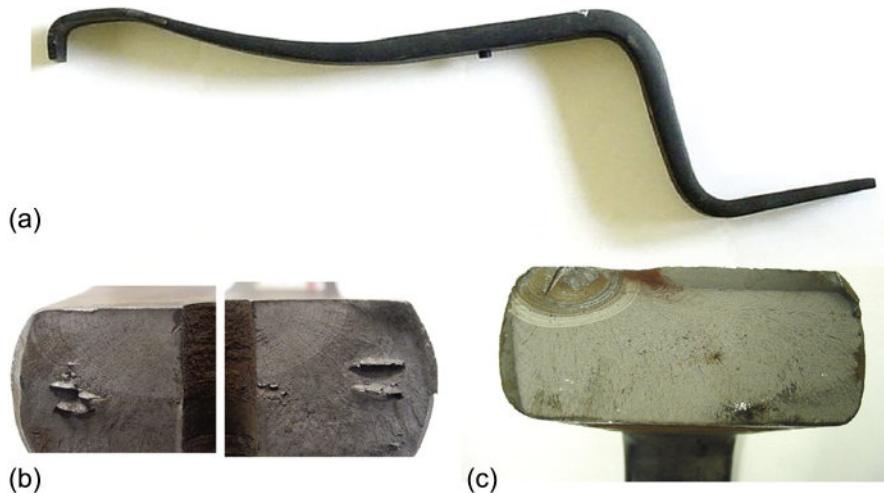
FIGURE 19.6

(a) Represents the original design of the Z-bar. The horizontal dimensions of the part, as pictured, are 1.2 m. The pin at the center locks into the top of the rear axis assembly. (b) Presents the failure due to the addition of a bolt to the right of the pin, the bolt was used to add a reinforcing plate to the original design. Notice the delamination failure in parts of the section outside the concentric fatigue marks. (c) Corresponds to fatigue failure initiated by fretting between the reinforcement plate and the original part.

pin locking into the rear axis assembly, which is allowed to pivot when the bar is bent. Two clamps (not shown) assure rigid contact between the rear axis assembly and the Z-bar. The horizontal extension at the right supports an air suspension unit. [Figure 19.6a](#) presents the original design of the part. Fracture occurred systematically in the sharp bend to the right of the central pin. As an improvised remedy, this section was “reinforced” by drilling two holes through the section and retrofitting a steel plate with bolts. After this “correction,” failure became even more frequent. The reasons can be seen in [Figure 19.6b, c](#). In [Figure 19.6b](#), the corners of the drilled hole serve as the stress concentrators for fatigue. In [Figure 19.6c](#), fretting wear between the bolted plate and the original Z-bar served as the fatigue initiator.

Chemical analysis indicated that the material corresponds to the required AISI5160 specification. However, a hardness of 39 HRC was measured, as compared to the design specification of 44.5–48.5 HRC. This corresponds roughly to a yield strength of 1.2 GPa as compared to the 1.4 GPa specified in the design. Additionally, the material showed a strongly banded microstructure with large longitudinal inclusions. The latter are the cause of the delamination features observed in the brittle fracture zone of [Figure 19.6b](#).

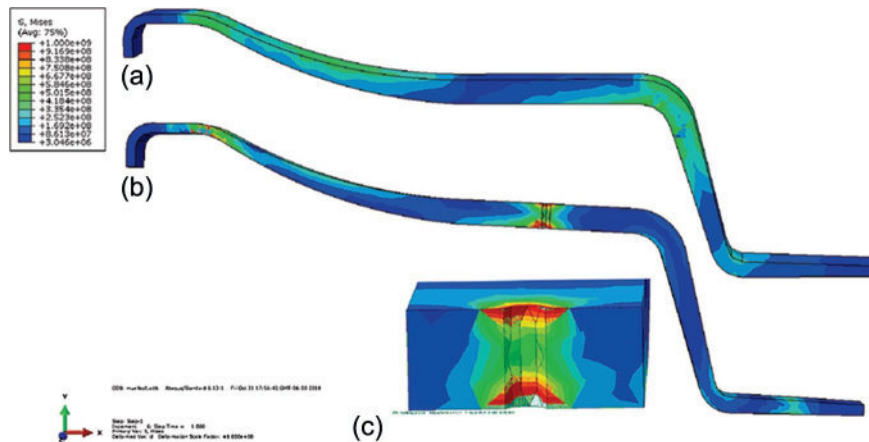
FIGURE 19.7

[Figure 19.7](#) represents the finite-element analysis of the original design as well as the effect of the additional hole. It is seen that in the curved sections of the bar, the stress reaches 500 MPa. Given the strength of the material as derived from hardness

Finite element analysis of the Z-bar. (a) Represents the original design. The simulation was made for loads of 75 kN, which is twice the static design load. Stresses of 500 MPa are reached in the bent parts of the bar. (b) Presents the same simulation with a single bolt hole. Its presence alters the distribution of the stresses and provides stress concentrations (c) at the point where fatigue initiation was observed (Figure 19.6b).

measurements, this stress level could be below the fatigue limit of the material. However, dynamic effects were taken into account by multiplying the static service load by a factor of 2. This factor may be too low to simulate operation conditions, especially if road conditions are bad. A full analysis of the vehicle dynamics would be required to answer these questions into detail. Also, overloading of the bus cannot be excluded. The large inclusions, the banded microstructure, and the insufficient hardness of the material may also be contributing factors in the failure. A simulation with the bolt hole present shows the significant stress concentration at the position of fatigue initiation seen in Figure 19.6b. The absolute values of the stresses in this case are not representative, as the precise data on the reinforcing plate were unknown to the authors. However, comparison of Figure 19.6 to Figure 19.7 is sufficient to explain why the “correction” of the design exacerbated the failure problem, as a new stress raiser was introduced at a critical position of the component.

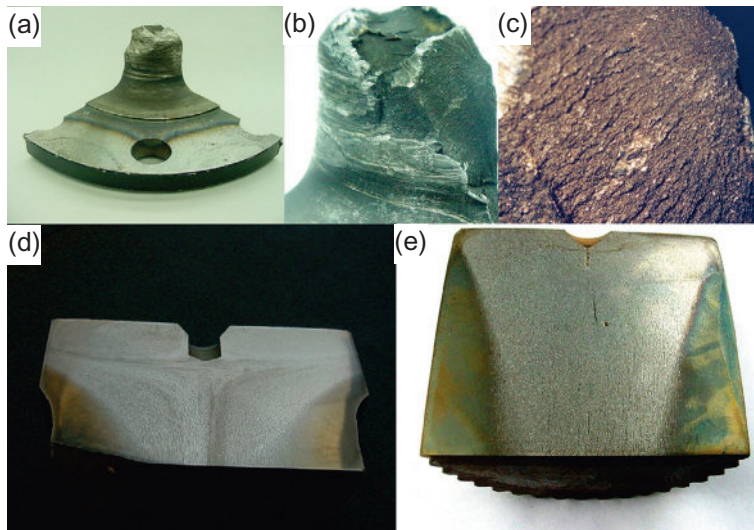
FIGURE 19.8

Fractured truck axle. The fracture originated from a flaw which was almost cut away by improper handling of the part before starting a professional failure analysis (a, b). The fracture surface has a complex morphology and emanates from a single point near the surface, as shown in (c). Macro-etched sections of a reference part (d) and of the opposite end of the axle (e) provide an impression of some of the metallurgical aspects of the case. The quenching depth can easily be determined; (d) shows clear evidence of the complex flow pattern induced by the forging process, while (e) indicates a strongly banded microstructure with centerline porosity and inclusions.

along the interlocked halves of the broken shaft. The geometry of the fracture is significantly more complex than what is expected in fragile failure under torsion (Figure 19.8b). The Chevron-marks in Figure 19.8c point toward the initial flaw.

Metallographic analysis of the shaft indicated poor metallurgical quality of the steel. In Figure 19.8d and e., macroetching revealed a banded microstructure with centreline porosity. Both effects indicate inadequate cooling conditions after ingot casting and, while the former defect can be eliminated by prolonged homogenization, porosity, and the accompanying oxide film remain present even after forging. Porosity and large inclusions were also present in a reference piece which was chosen at random from available stock. Additional evidence of poor steel quality was found in the form of a 10-mm long internal crack intersecting the fracture surface (which means the crack was originally longer than what could be measured) (Figure 19.9a). Abundant oxides were present in the crack zone (Figure 19.9b), while oxide-free parts showed the presence of two parallel microcracks, bridged occasionally by transverse cracks (Figure 19.9c). Martensite colonies were not intersected by the defects, but delimited by them, indicating the flaw was present before quenching.

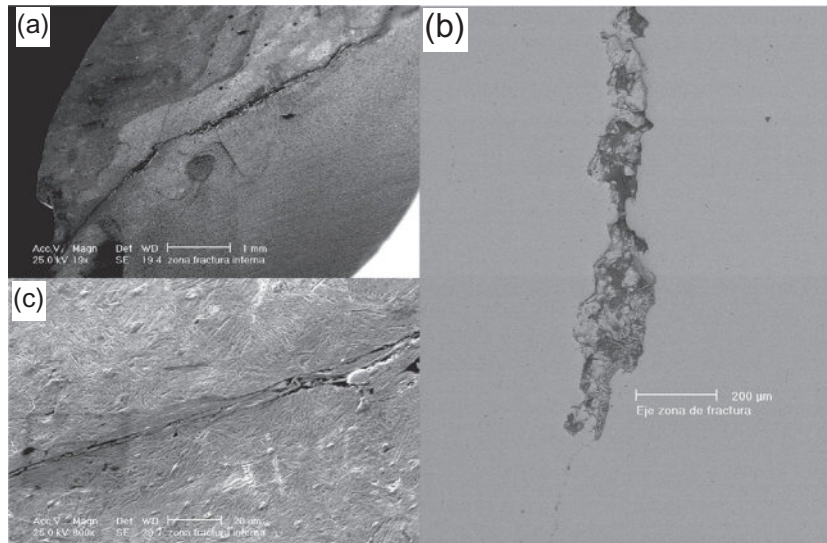
FIGURE 19.9

SEM-observation of truck axle. (a) Shows a large flaw intersecting the fracture surface which is at the left. (b) Shows significant oxide inclusions, (c) shows the thin cracks connecting different zones of oxide inclusions along the defect.

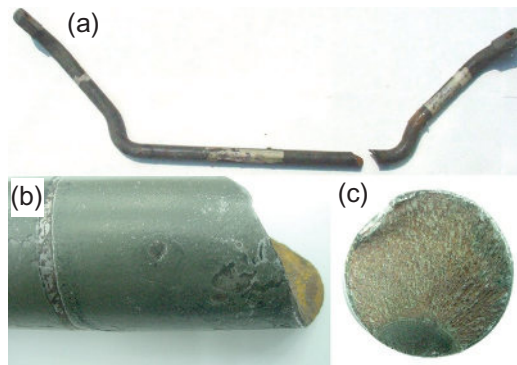
FIGURE 19.11

(a) Represents the entire torsion bar. The horizontal dimensions of the part, as pictured, are 2.4 m. The bar is attached by pins to the wheel assembly on both ends and supported to the chassis by clamps which are separated from the bar by rubber sleeves. (b) Shows the position of the clamps. Point-like contact damage and fretting damage are observed at the surface in the fracture zone. (c) Shows the concentric fatigue pattern and the chevron marks from the ensuing brittle failure.

Failure occurred in three different coaches in short succession. The coaches had between 333,000 and 375,000 km of service. The torsion bars show a typical pattern of a semi-elliptical fatigue crack emanating from a point at the surface followed by brittle fracture under torsion (Figure 19.11). Brittle fracture occurs at relatively small extents of fatigue crack propagation. In two out of three cases studied, the initiation point had the characteristic features of an indentation and together with other types of surface damage it was concluded that metal-metal contact occurred in this zone, which corresponds to the area where the bar is clamped to the chassis. In the third case, fatigue was initiated outside the clamping zone, at a point where the curvature of the bar was strongest. The material of the bar corresponds to AISI 5155 steel with increased Cr-content and shows a homogenous bainitic microstructure, with very limited banding and without large inclusions. A uniform hardness of 44HRC was measured, indicating a high-quality material subject to excellent thermal treatment.

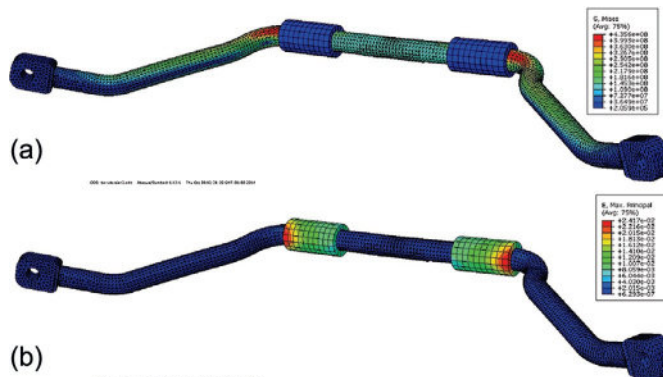
FIGURE 19.12

Finite element models of the torsion bar. (a) Represents the Von Mises equivalent stresses which are maximum at the points of maximum curvature of the part. (b) Represents the strain in the sleeves, which can take fairly high levels.

Finite element simulations of the torsion bars are presented in Figure 19.12. Figure 19.12a shows the stress analysis under operating conditions of a torsion bar, taking into account the presence of rubber sleeves at the point where the bar supports the chassis. The maximum stress occurs at the point of maximum curvature, which corresponds to the failure of one of three cases studied. Figure 19.12b shows the corresponding strains. If the rubber sleeves are substituted by two rigid supporting points, maximum stresses occur at these contact points while the stress in the curvature of the bar is unchanged.

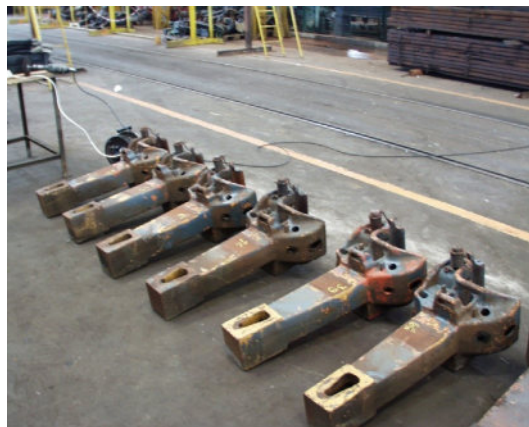
FIGURE 20.2

A significant number of failures have occurred in mechanical components (couplings) of the coal freight trains (Figure 20.2) which led to disruption of service and economic losses. The couplings were obtained by sand casting process, with ASTM A148 90-60 specifications [11], and the owner being a multinational thermo-electric company, Tejo Energia S.A Company.

Out of service cast steel railway couplings.

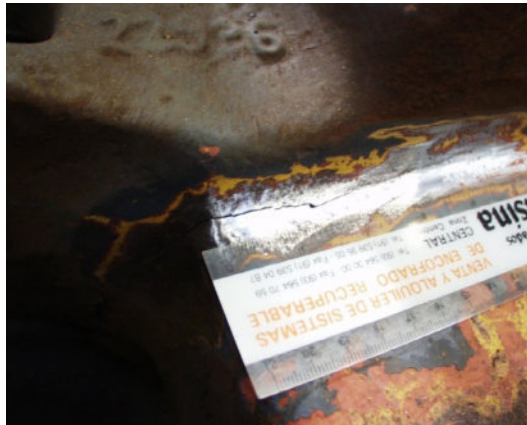
**FIGURE 20.3**

The cracks exhibit the classical mechanisms of fatigue cracks under dynamic loads. Cracks, detected during the maintenance work, propagated from the transition radius between the “head” and the “body” of the railway coupling (Figure 20.3), which is a zone of stress concentration.

Crack localization.

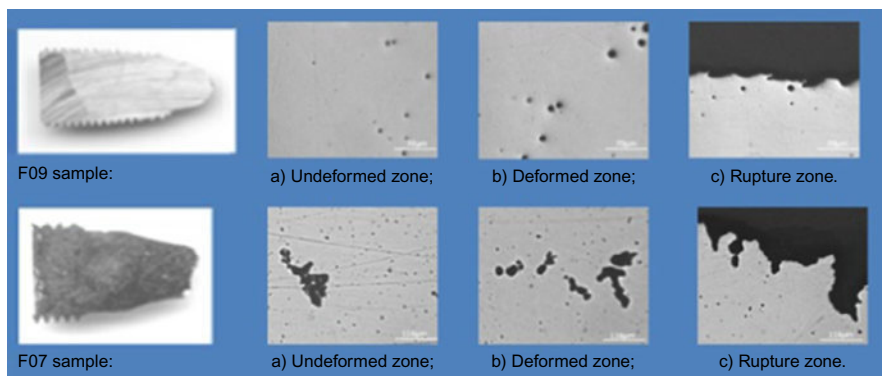
FIGURE 20.7

Microscopy observations of longitudinal sectional view of specimens tested to the fatigue were made. The results of specimens 7 and 9 can be observed in Figure 20.7. The conclusions of the microscopy observation was that there is a direct relationship between fatigue resistance, size distribution, and porosity, expressed by a marked decrease in the fatigue life of samples containing larger pores and distribution of non-metallic inclusions.

Microscopy observations of longitudinal sectional view of F07 and F09 fatigue specimens.

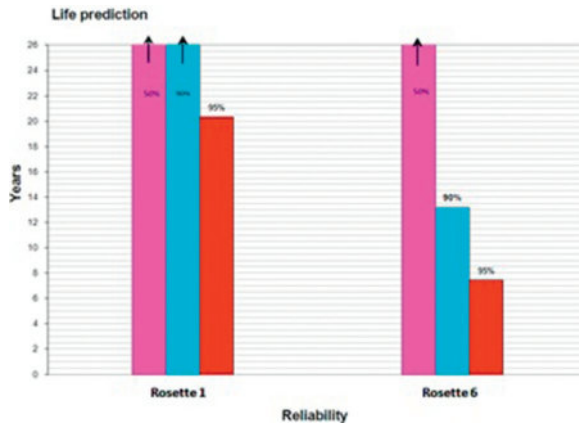
FIGURE 20.19

Life prediction, in years, considering the most critical rosettes 1 and 6, for the reliabilities of 50%, 90%, and 95% (Equations 20.10–20.12) are presented in Figure 20.19. It can be observed that for 95% of the reliability, rosette 6 has a life prediction of 7 years, while the life prediction for reliability of 90% is that of 13 years. The author has determined that by the life predictions for all the other rosettes with the respective cumulative frequency distribution of equivalent stress ranges, it can be concluded that for reliabilities upper than 95% the life prediction is higher than 26 years [6].

Life prediction for railway casting steel couplings.

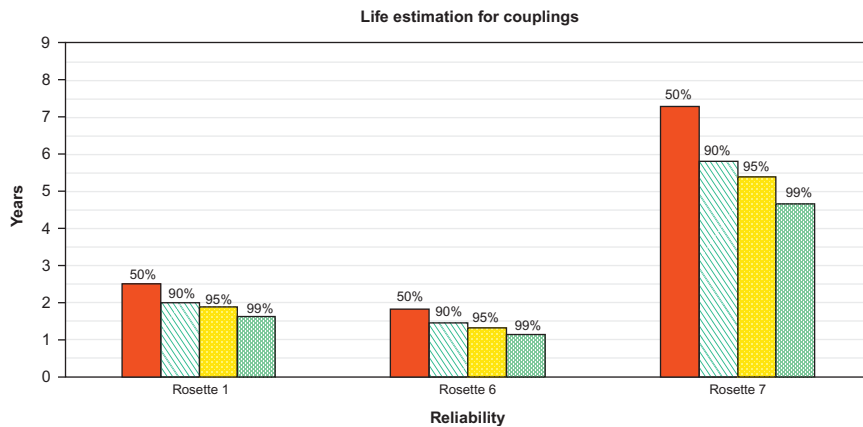
FIGURE 20.21

Life prediction for railway casting steel couplings using Goodman equation.

Life prediction using the data acquisition of rosettes 1, 6, and 7 is shown in Figure 20.21 where can be observed that for all rosettes and all reliabilities the life prediction is low; lower than 2 years for rosette 6 and lower than 7.5 years for rosette 7 (the “nominal” one).

From the maintenance service records, is known that cracks do not appear on rosette 7 zone, so the Goodman equation on this case does not apply as it is too conservative. Nevertheless is known that cracks appeared on rosettes 1 and 6 zones, so the life prediction using Goodman equation for all the reliabilities presented in Figure 20.21, was confirmed by the maintenance service record. Therefore, by Figure 20.19, it can be said that, for this study case, life prediction using Palmgren-Miner Rule modified by Haibach is too optimist and cannot be used.

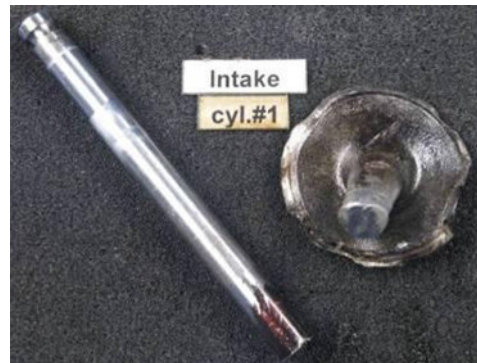
FIGURE 21.3

This part presents a case study for a failure analysis of a broken intake valve. This fracture took place in a gasoline engine (designed for passenger cars) during an endurance test (entitled 500 h general cycles). During this durability test, the engine torque reduced sharply and therefore, the test was stopped after 161 h. After more investigations, it was observed that one of intake valves in the cylinder number 1 was broken. This event also caused other damages on the piston and the cylinder head. These failures in the intake valve are shown in [Figures 21.3](#) and [21.4](#).

This damage in the valve was repeated three times in the same engine. The first time occurred after 242 h of such a durability test. This failure took place in the

The broken intake valve in a gasoline engine during an endurance test [2].

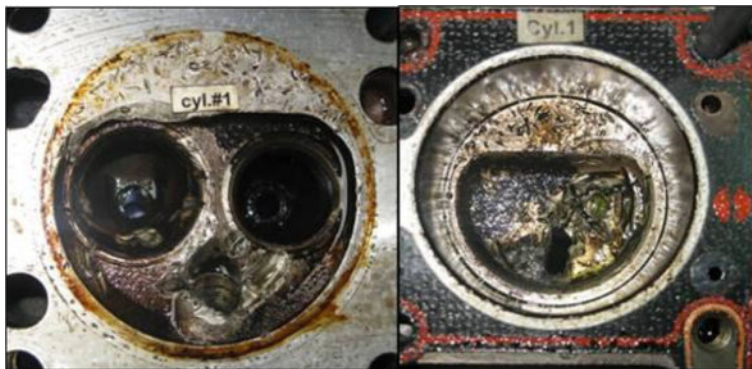
FIGURE 21.4

Damages on piston and cylinder head faces according to failures [2].

Higher temperature leads to excessive thermal expansions in the valve shaft. Then, the valve can be exposed to the misalignment and therefore can be exposed to an external bending force. As the valve rotates; while the engine is working, this force becomes a reversed cyclic loading in the valve shaft. Finally, the valve can be locked in its guide due to an unallowable deformation. This locking of the valve system causes the valve to remain opened and then causes crashing of the piston and thus, leads to damages in both the piston and the cylinder head (as shown in [Figure 21.2](#)).

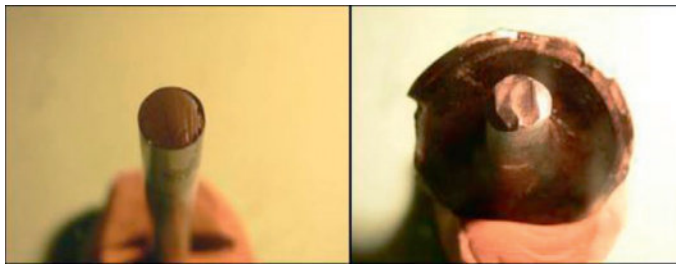
FIGURE 21.6

In the first step, the fracture surface of the broken intake valve was investigated as shown in [Figures 21.6](#) and [21.7](#). In these figures, beach marks can be observed due to cyclic loadings and the fatigue fracture. As it is known, the valve rotates when the engine works and a reversed bending load is applied to the valve shaft. The fracture surface on the valve shaft shows macroscopic lines, which illustrate the cracks growth path. On the other side of the valve shaft, the fracture surface was damaged due to the impact after the failure in the engine.

The fracture surface of the broken intake valve with beach marks [2].

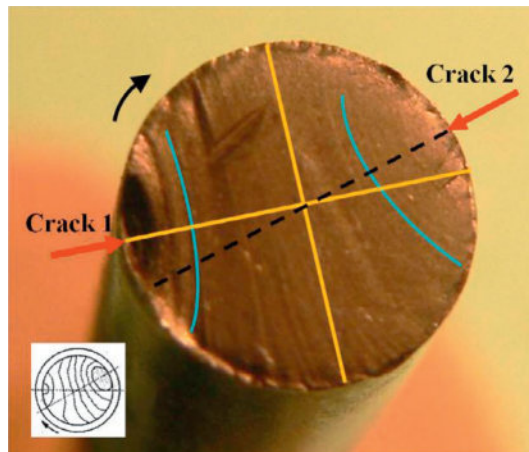
FIGURE 21.7

A visual inspection of beach marks on the valve shaft surface shows two crack initiation zones (as illustrated in [Figure 21.5](#), in two left and right sides). These regions are demonstrated with arrows (entitled “Crack 1” and “Crack 2”) in [Figure 21.5](#). As shown in [Figure 21.5](#), cracks initiate at the outer surface of the valve shaft. This phenomenon occurs mostly in HCF regime. Then, this pattern shows a fully reversed bending as the loading type in the valve system [12]. In other words, the mean stress is zero and the stress ratio is minus one ($R = -1$). This bending force is applied due to the misalignment, reported in [Table 21.2](#). As mentioned before, this misalignment can be produced by thermal deformations due to hot working of the engine.

Beach marks and crack initiation zones on the valve shaft surface [2].

The microstructure of the material has a conformation with the specification (the standard map) of the valve system. As it can be seen in Figure 21.7, there exist no unusual pores or defects due to the casting process or the heat treatment process in the material of the valve shaft.

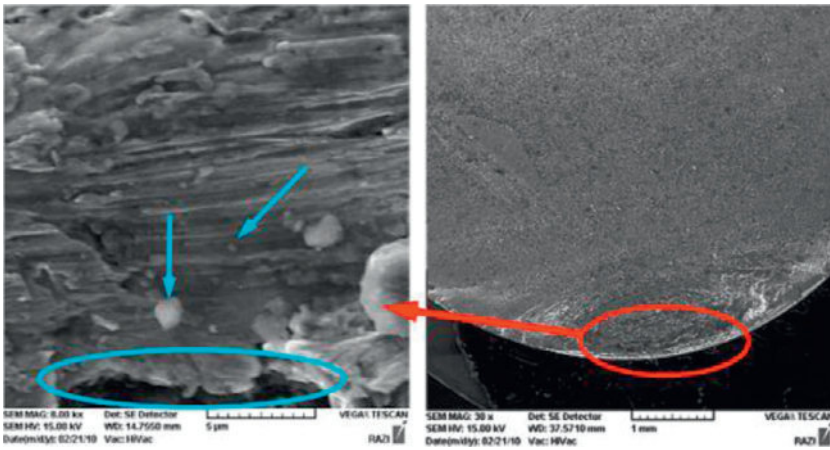
FIGURE 21.8

SEM images of the fracture surface are shown in [Figure 21.8](#). A defect near the outer surface of the valve shaft (shown in the right side of [Figure 21.8](#) which is that

region entitled “Crack 1” in Figure 21.7) existed which could cause a crack initiation. This zone is a three-dimensional dislocation which has become active during the fatigue failure. In addition, the oxide and carbide particles can be probably observed (shown by arrows in Figure 21.8) near the crack initiation zone.

SEM images of the fracture surface with different magnifications [2].

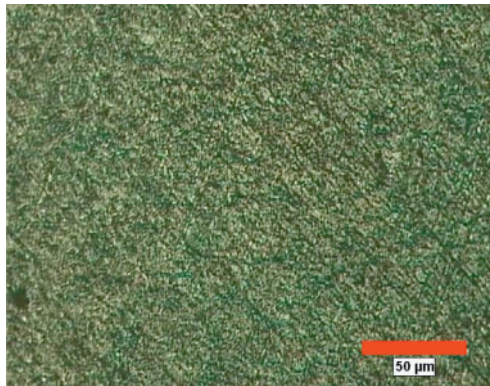
FIGURE 21.9

In Figure 21.9, it can be seen that the microstructure of the valve shaft material consisted of a tempered martensite [3,12]. This microstructure confirms the heat treatment process, which is also revealed by the hardness. As mentioned before, the material of the intake valve shaft is made of 1.4718 steel (X45CrSi9-3) which includes chrome and silicon elements [9].

The microstructure of the valve shaft made of 1.4718 steel (X45CrSi9-3) [2].

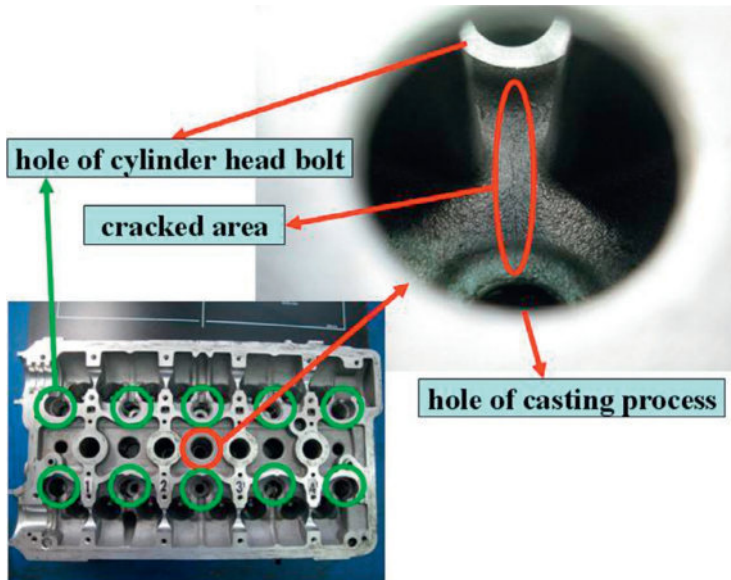
FIGURE 21.10

The cracked zone is shown in [Figure 21.10](#). Checking cooling and lubricating systems of the engine showed no issue. The differences between coolant inlet and outlet temperatures were constant during the endurance test, and there was no leakage. Twenty hours before stopping the engine, the ECU sensed a knock and both the engine torque and engine power decreased because of retarding of the ignition time. After checking the engine performance condition by the defect analyzer device, it was found that there were no knocks. This was due to the crack initiation and decreasing of the cylinder head stiffness. It should be mentioned that until 300 h of the endurance test, the fuel type was gasoline and was then changed to the compressed natural gas type. As a result, the mean power of the engine increased from 100 to 110 kW, which could be a cause of higher thermal stresses.

The cracked zone on the cylinder head [13,14].

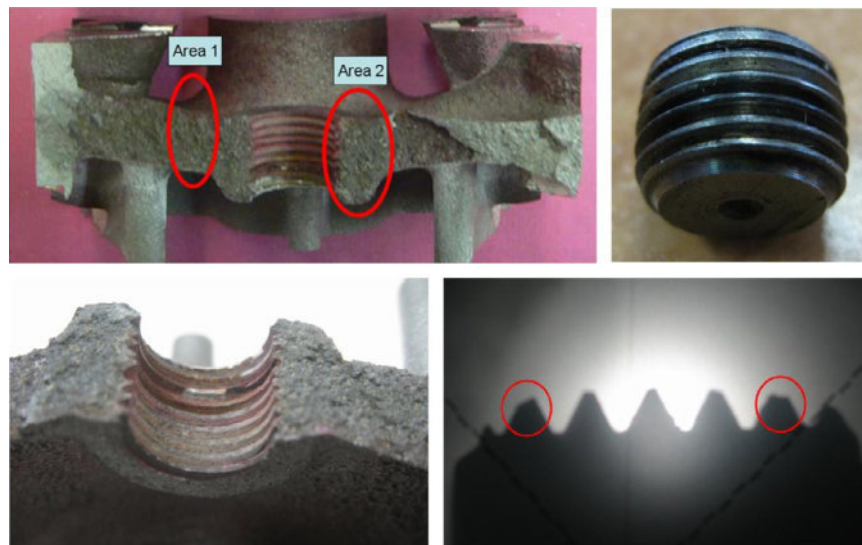
FIGURE 21.12

The bolt type that was tightened in the hole was DIN-906, which had a conical shape. In [Figure 21.11](#), its dimensions are shown. Results of measuring the bolt diameter and the bolt length as well as the thickness of the cylinder head (area 1 and area 2 in [Figure 21.12](#)) showed a good conformance to drawings. There was no plastic deformation noted during the visual inspection of bolt threads. However, within the hole, the threads were deformed. It should be mentioned that the material of the bolt is steel alloy in comparison to the hole made of the aluminum alloy. The bolt pitch according to a straight line was 1.5 mm; however, for the hole thread, pitches were 1.50, 1.49, 1.52, 1.49, 1.46, and 1.51 mm, which indicated the plastic deformation.

The shape of the bolt and the hole [13,14].

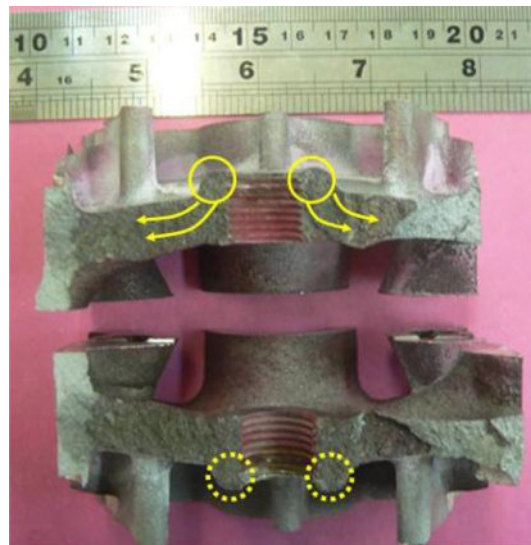
**FIGURE 21.13**

The surfaces after opening cracked zone [13,14].

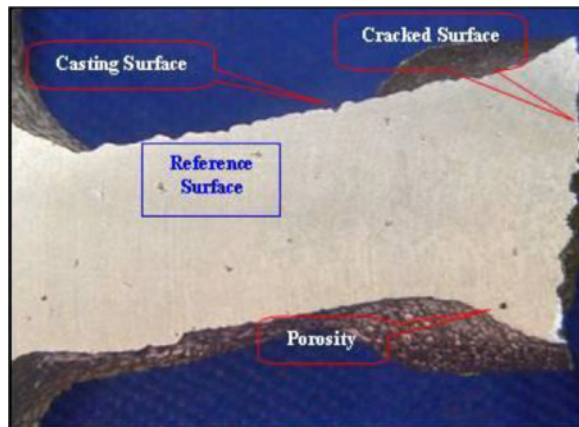
**FIGURE 21.14**

To investigate the microstructure and the heat treatment of the cylinder head material, a part of the cylinder head near the cracked zone was separated (as shown in Figure 21.14). Fractographical pictures [18,19] were taken after grinding, polishing, and etching the specimen surface in Keller's reagent for 10 s. In Figure 21.15, it is seen that the microstructure of the cylinder head material consisted of a solid solution of aluminum-silicon (the rich phase was made of aluminum) and a uniform distribution of a eutectic silicon phase and intermetallic phases. In general, the microstructure conforms to the standard [20,21], but pores, which are near the surface, could be a place of the stress concentration and could be a site of crack initiations during cyclic thermomechanical loadings.

According to the standard [20], the allowable limit for the porosity is 5% in a reference surface (which is 3 mm by 4 mm). In addition, 500 μm is the limit between micro- and macro-porosities. A macro pore is a pore, which could be seen visually without any microscope. The porosity was measured as 3% for the surface in Figure 21.14, which is below the standard limit [20]; however, the diameter of pores

The zone below cracked surface [13,14].

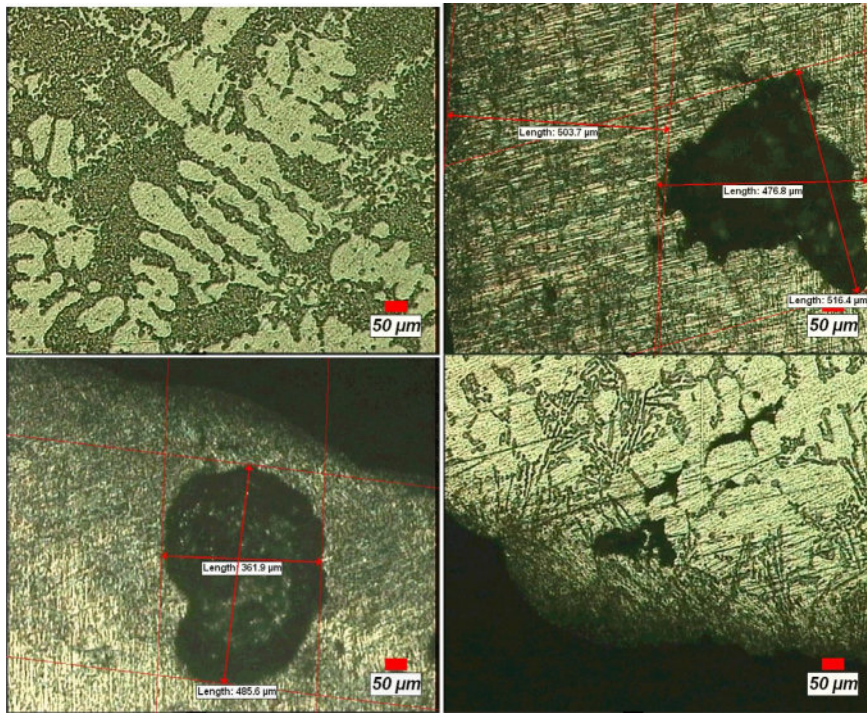
FIGURE 21.15

Microstructures of cracked zones [13,14].

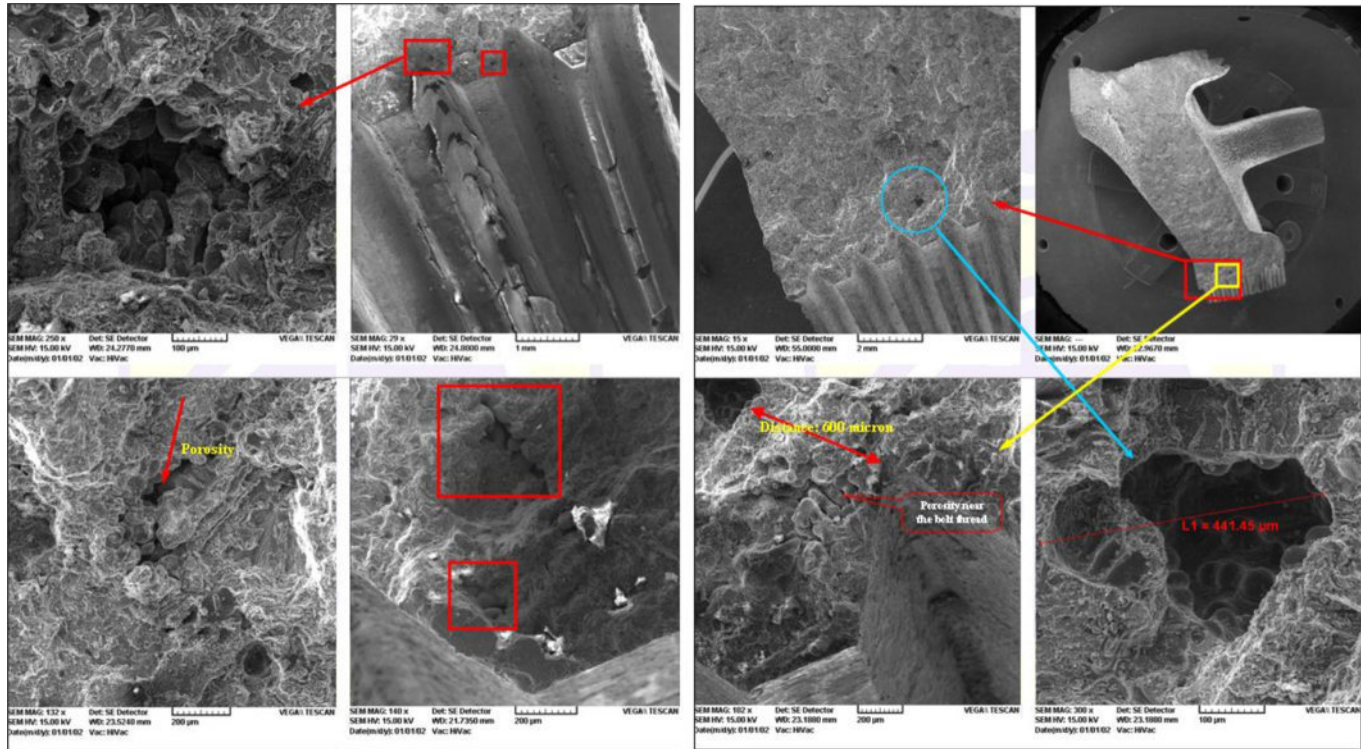
FIGURE 21.16

Results of SEM investigations near the cracked surface [13,14].

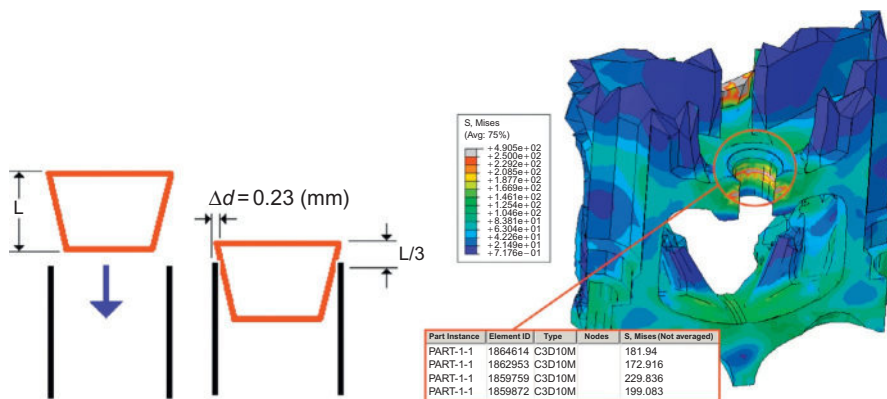
FIGURE 21.18

- Cracks initiated from the interior wall of the hole on the cylinder head and propagated through the thickness.
- The chemical composition of the failed cylinder head basically corresponded to the specified range except for higher silicon content.
- Higher silicon content causes higher hardness, higher strength, and lower elongation of the material.
- Casting pores were seen on the fracture surface, where their volume fraction was in the range of the standard [20]; however, diameters were more than the allowable amount, to some extent. In addition, deformations on threads were also observed.

Dimensions of the bolt and the hole and Von-misses stresses around the hole [13,14].

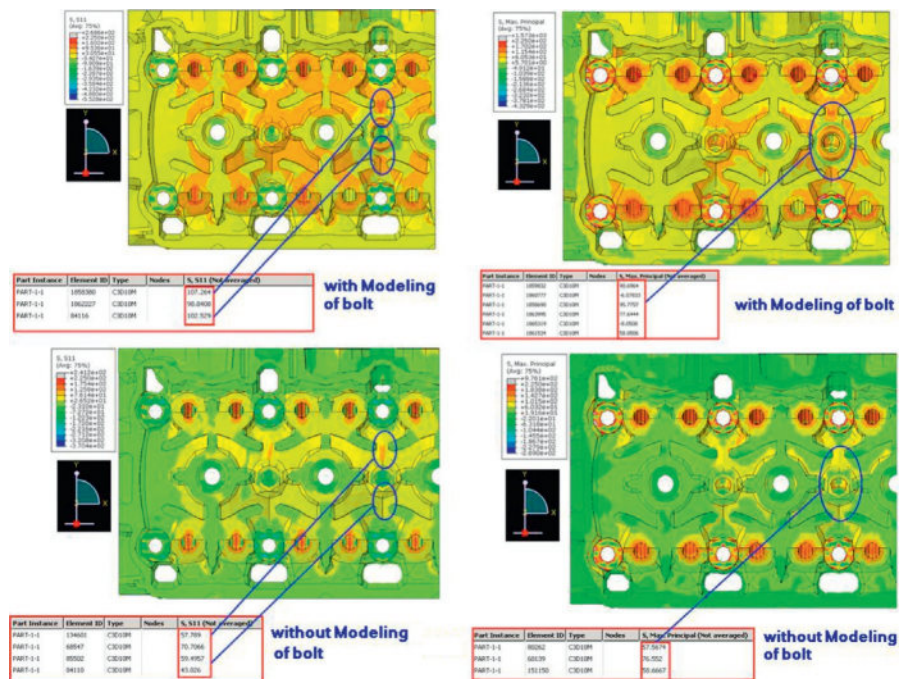
FIGURE 21.19

Stress distributions including stress component in x-direction and maximum principal stress around the hole [13,14].
