# FAILURES IN CONCRETE STRUCTURES

Case Studies in Reinforced  
*and* Prestressed Concrete

Robin Whittle

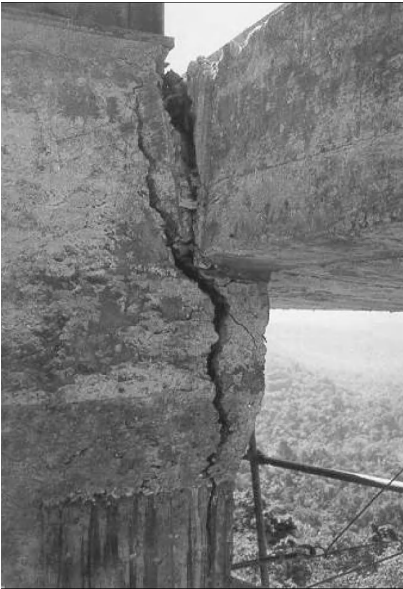
A collapse occurred involving the connection of a heavy concrete gutter (1 m wide) to the supporting columns. The structure consisted of a series of reinforced concrete edge columns supporting steel trusses that spanned the width of the building. Edge beams spanned between the columns to support the concrete gutter. Figure 1.1 shows the collapse of the gutter. Although the edge beam had been designed and detailed to resist the full load from the gutter (bending moment, shear, and torsion), this had not been carried through to the joint. Figure 1.2 shows where the edge beam just started to tear away from the column and Figure 1.3 shows the top of a column where the edge beam has separated and fallen off.

**Figure 1.2** Edge beam starting to separate from column.

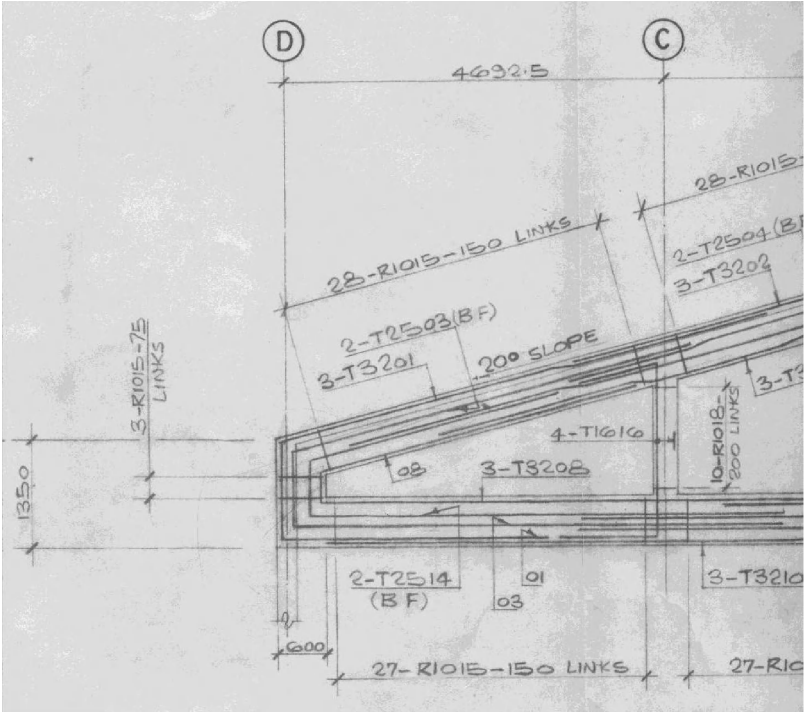
A project team requested a second opinion about the design of the bottom boom of a 19 m span reinforced concrete truss. The project team considered that the tension would cause unsightly cracking. A drawing (see Figure 1.6 showing the detail of part of the truss) and the analysis of the truss were provided. Much attention had been given to this design and special care had been taken to ensure that the stresses in the concrete were low.

Figure 1.6 Detail of part of truss.

It was also apparent that the detailing required some changes. Figure 1.6 shows the main T32 bars, drawn as if they could be bent with sharp corners when in fact the minimum inner radius of bend required ( $3.5 \times$  diameter of bar) is 112 mm. When drawn to scale, it became clear that the concrete would fail in two places as shown in Figure 1.8.

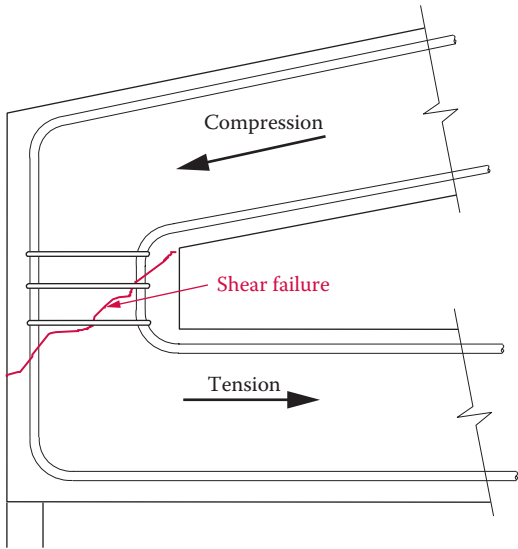
The request was to check the design of the bottom boom. This check was carried out and it became apparent that the shear strength of the end vertical post connecting the top and bottom booms (see Figure 1.7) was inadequate. The section dimensions were  $b = 230$  mm and  $d = 460$  mm.

Figure 1.7 Shear in vertical post at end of truss.

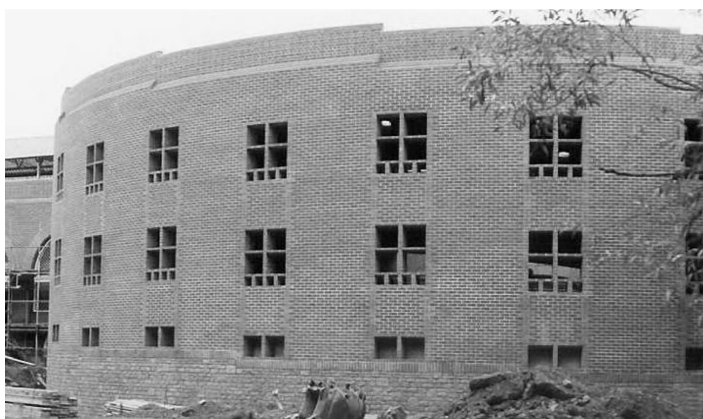
The construction of this car park (see Figure 1.9) was nearly complete. The parapet and slab of the circular ramps were supported on two columns diametrically opposite each other. The torsion and cantilever effects of the loads caused wide cracks in the supporting columns. Although these columns were damaged with shear cracks, it was considered that if the cantilever and torsional effects from the ramp could be reduced, then the columns could be repaired without risk that the cracks would return. This was achieved by inserting steel circular columns half way around at every level throughout the height of the structure (see Figure 1.10). In order to ensure that these new columns would take the correct load, flat jacks were introduced at each floor level (see Figure 1.11).

*Figure 1.9* Car park with circular ramps.

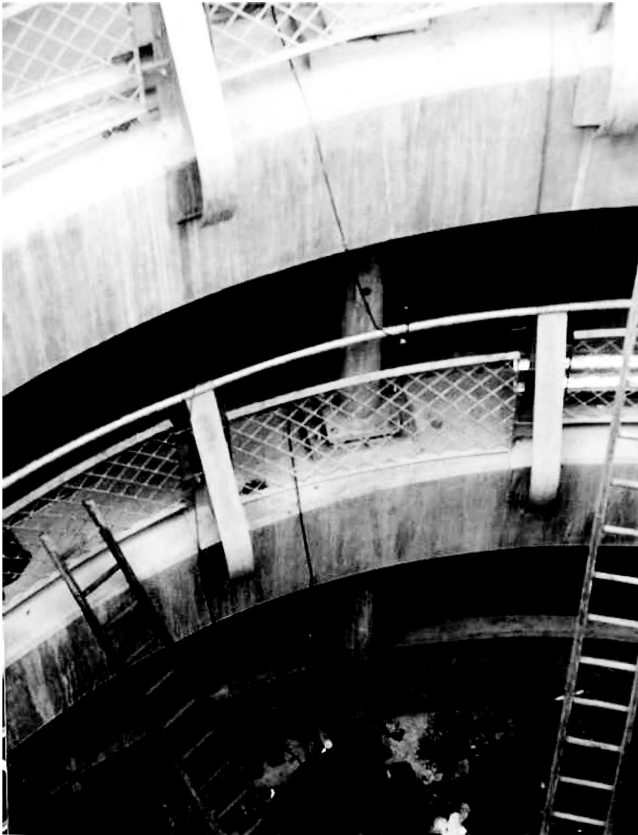
*Figure 1.10* Additional steel columns.

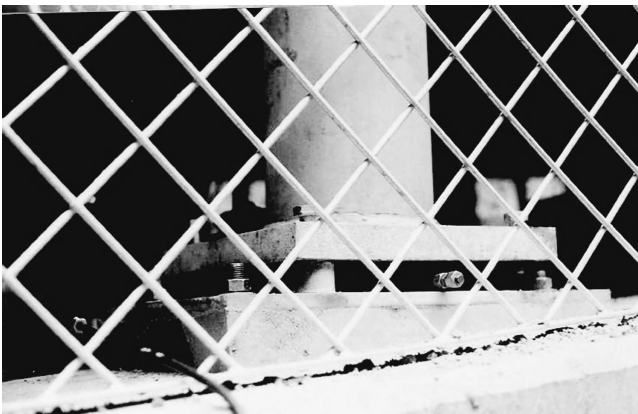
*Figure 1.11* Flat jacks fitted under each new column.

All the flat jacks were connected up to a single pump and pressure gauge. Epoxy resin was pumped into each of the flat jacks at the correct pressure and allowed to harden. This ensured that the correct load had transferred to the new steel columns at each level.

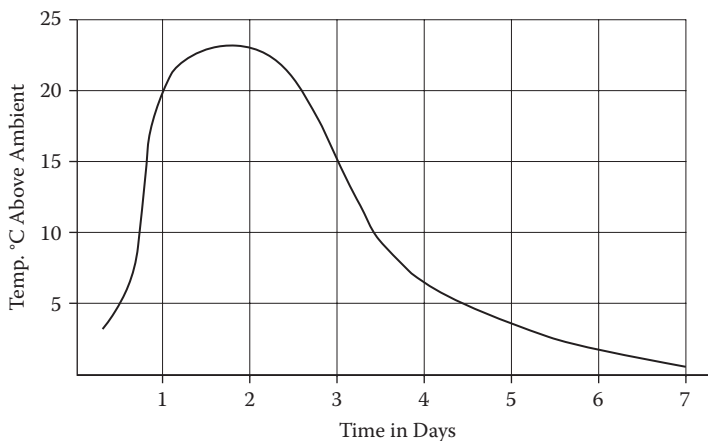
peak temperature since the beams tried to expand while heating up. A typical curve for one of the beams, giving the temperature rise and fall over time, is shown in Figure 1.15.

**Figure 1.15** Typical early temperature rise and fall in concrete beam.

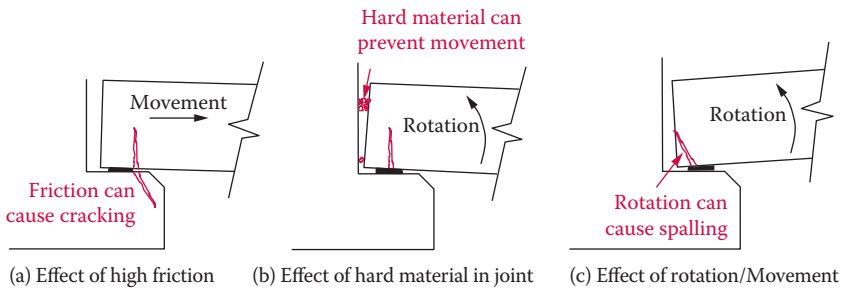
**Figure 1.22** Examples of potential failures at movement joints.

In general, if the bearing material creates large friction forces, these can lead to large tension stresses in both the support and the precast slab or beam (see Figure 1.22a). Neoprene bearings or similar should be used to avoid this.

If the space between the precast slab or beam and the face of the supporting member is not adequate for the required movement or it fills with hard material over time, cracking will occur (see Figure 1.22 b). If the effects of movement and/or rotation cause the line of action to move too close to the edge of the support, local spalling can occur (see Figure 1.22c).

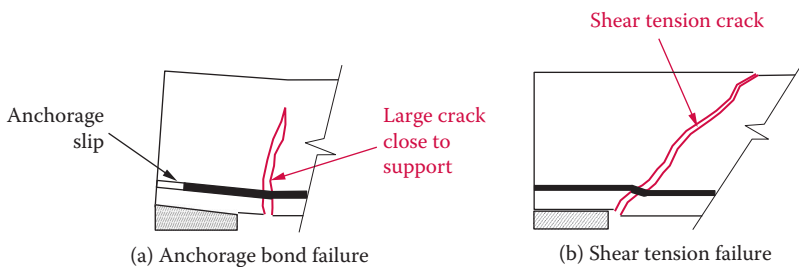
**Figure 1.23** Types of end failure of hollow core units.

A further problem arises where hollow core units are used. Any cracking that occurs close to their ends is likely to cause anchorage bond or shear failure of the unit (see Figure 1.23). Anchorage bond failure may occur because the cracking close to the support does not allow the full anchorage resistance to develop and the prestressing strands start to slip. This causes the crack to grow until the unit fails (see Figure 1.23). Hollow core units are inherently vulnerable to the effects of cracking close to the support as their shear resistance relies on the tension strength of the concrete. Unlike a solid section, a cross section available for shear resistance of these elements is much reduced due to the presence of the cores.

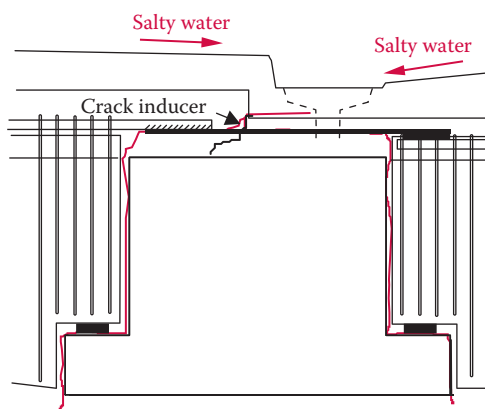
The structural screed laid over the whole deck was designed with a step over the welded plate above the spine beam. The final screed, incorporating a waterproof membrane, was laid to falls. The drainage points were situated at the ends of the spine beams. Figure 1.27 shows the final arrangement through a section. The step in the screed created a crack inducer for the tension stresses at the top of the cantilever and water draining off the

Figure 1.27 Section through completed deck.

car park was likely to permeate it. In winter, this water was likely to be combined with de-icing salts. The risk of corrosion of an important part of the structure was high. By the time this problem was realized, it was considered too late to change the design and form of construction. Instead the depth of the waterproofing membrane was increased.

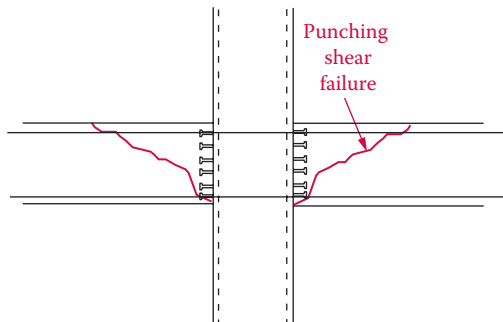
The designer's proposal was to use shear studs welded to a steel column to transfer the load from the concrete flat slab to the column (see Figure 1.32). However, with this configuration, a punching shear failure could occur with only the bottom row of studs providing any shear resistance. All the other shear studs would remain in the cone of concrete attached to the column (see Figure 1.33). To avoid such a failure, two options provide sensible solutions:

Figure 1.33 Punching failure of slab.

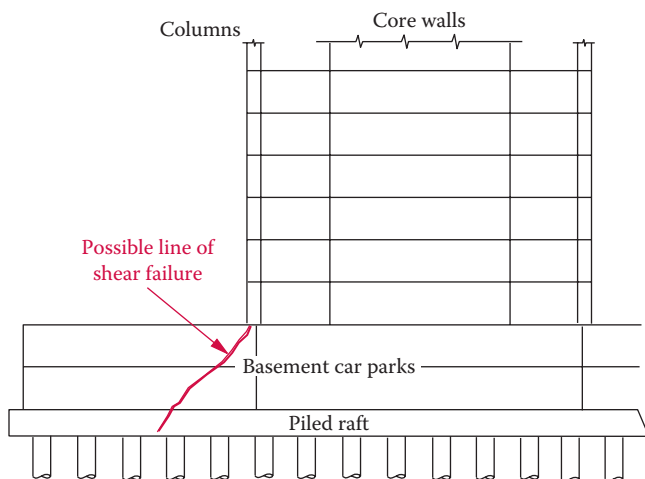
The design of the raft assumed that the walls of the two-level basement car park would act with the raft over the piles to transmit the shear and bending forces to the outer piles. The walls of the basement had almost full height openings, placed one above the other, and contained only nominal reinforcement. The combined strength of these walls plus the 1.5 m thick slab was inadequate to transmit the loads (see Figure 1.36).

Figure 1.36 Arrangement of piled raft and basement car parks.

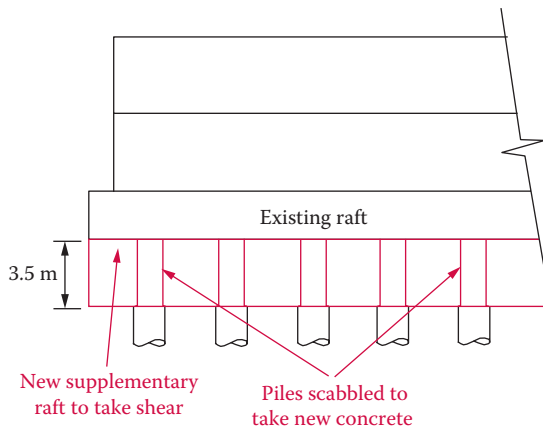
**Figure 1.37** Schematic arrangement of new raft.

The mistake was discovered whilst the tower block was being constructed. The remedial work required a new raft to be constructed beneath the existing one (see Figure 1.37). The new design relied on the composite action of the new and old rafts. All the existing surfaces of concrete were scabbled and further reinforcement was laid between the existing piles. Placing of concrete for the lower part of the new raft was carried out conventionally.

To achieve good bond with the bottom of the existing raft, the upper part of the new raft was packed with single sized aggregate and then grouted with a retarded and fluid cement paste. The grout was introduced under pressure to the back of the pour through a complicated system of metal pipes pinned to the underside of the existing raft. The method produced a wall of grout that extended from top to bottom of the pour and flowed forward toward the peripheral shutters with the top surface behind the bottom. Pipes were so placed to let the air out in front of the grout surface, then indicate where and when the grout arrived, and then allow grouting to continue from immediately behind the advancing wall of grout. Grouting was continuous until the work was complete.

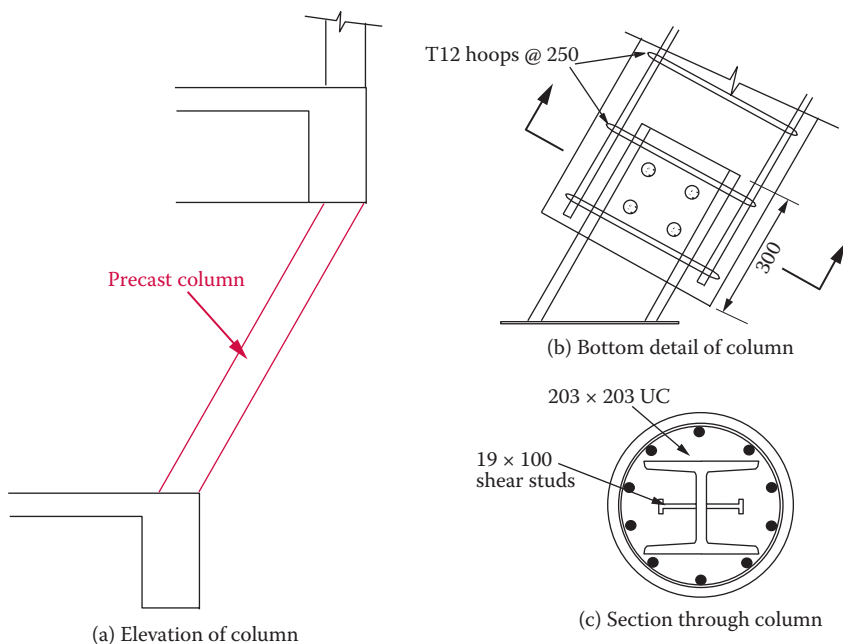
**Figure 1.38** Sloping precast column.

into the bottom of the precast element to simplify the connection detail to the beam below. During construction, it was realised that the design of this connection was unsafe due to insufficient bond capacity and anti-bursting steel.

The short stub consisted of a  $254 \times 254$  UC section that extended into the column about 300 mm. The stub had four  $19 \times 100$  shear studs welded to each face of the web (see Figure 1.38b). The links surrounding the stub column were T12 hoops at 250 mm pitch. No other anti-bursting reinforcement had been provided.

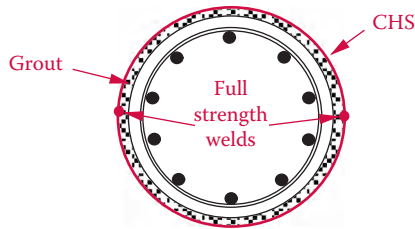
Figure 1.39 Remedial work.

The remedial action was to encase the existing column with a steel circular hollow section, 457 mm diameter, of the same length. This was cut into two halves along its length and then welded in place with full strength welds along the full length. The space between the steel and precast columns was then grouted up (see Figure 1.39).

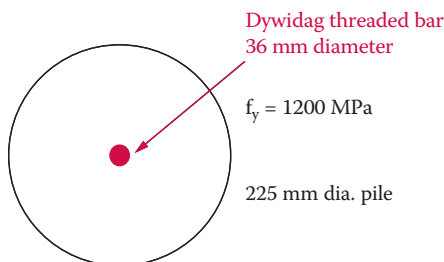
**Figure 3.3** Proposed pile with Dywidag bar as reinforcement.

An engineer was hoping to reduce the number of piles required for a building by providing reinforcement with much higher strength than required for normal high yield bars. Figure 3.3 shows a section through a 225 mm diameter pile with a proposed Dywidag threaded bar 36 mm in diameter (Dywidag Systems International, Munich). The yield stress  $f_y$  of such a bar is 1200 MPa.

Before going into production it was decided to check the load carrying capacity with a test pile. The result was that the pile failed at a similar load to that of a pile with normal reinforcement with  $f_{yk}$  of 460 MPa.

After some thought, the reason for the unexpected low pile strength became apparent. The actual concrete compression stress–strain diagram is similar to that given in Part 2 of *BS 8110*<sup>1</sup> and Figure 3.2 of *BS EN 1992 (EC2)*<sup>2</sup> and differs in shape from that used in ULS design in that, instead of having a plateau of maximum stress, it peaks at about 0.002 strain. This strain is close in value to that of the yield strain of normal reinforcement ( $500/200000 = 0.0025$ ). This means that the maximum resistance of the concrete occurs at the same strain when the reinforcement reaches its yield stress (maximum resistance).

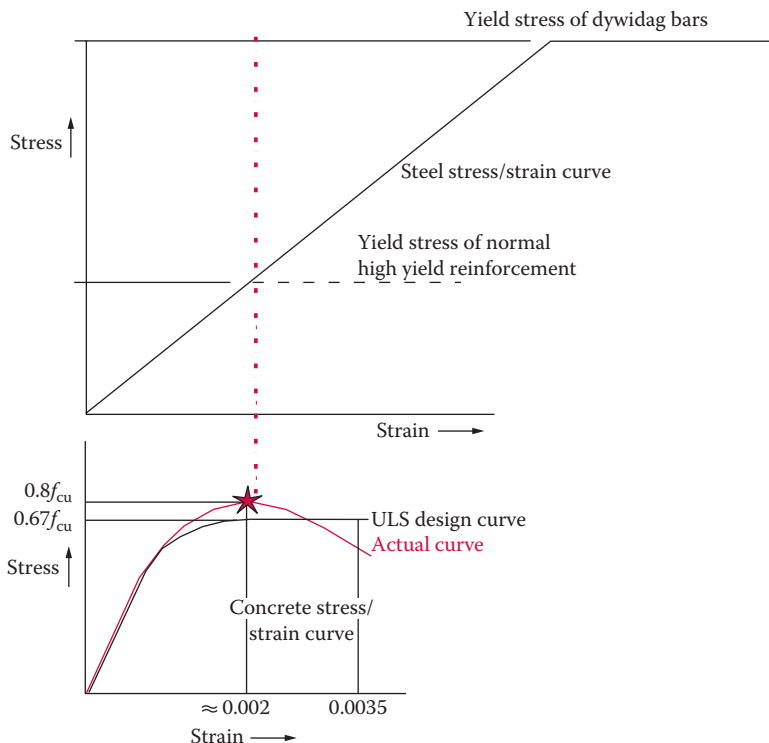
Figure 3.4 Stress–strain curves for concrete and steel.

The yield stress of a Dywidag bar is about 1200 MPa which corresponds to a yield strain of  $1200/200000 = 0.006$ . This compares with the ultimate strain of the concrete of 0.0035, so the concrete will fail in a compression test long before the Dywidag bar reaches its yield strain or stress. Figure 3.4 shows this graphically.

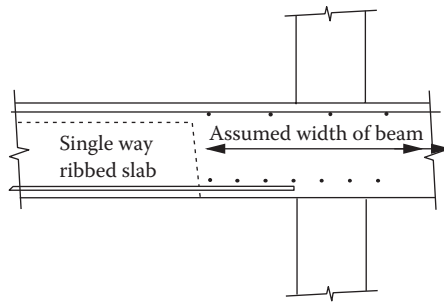
Figure 4.2 Section through broad beam.

The depth of the broad beam was the same as the trough slab and the design wrongly assumed that it could be considered a one-way slab and therefore did not require links (see Figure 4.2).

In order for the edge of the beam to be considered in the design as the support face, the vertical force from the load on the ribbed slab had to be

transferred to the top of the beam. Vertical reinforcement should have been provided for this. Links in the broad beam (in addition to any links necessary for shear resistance) could have provided sufficient resistance.

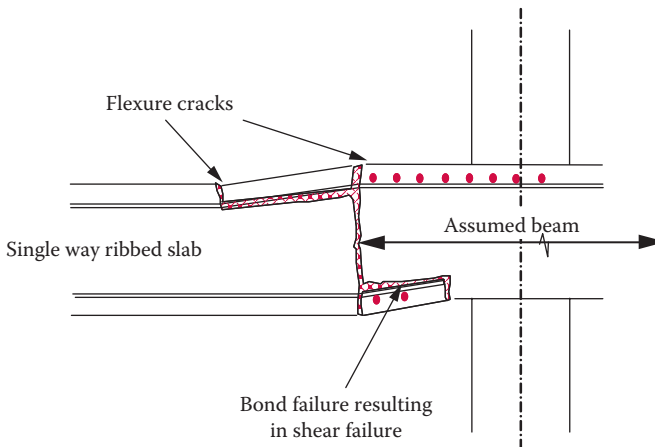
Figure 4.3 Section through ribbed slab at failure.

Failure of the ribbed slab occurred at the support with the broad beam (see Figure 4.3). Complete collapse was avoided by immediate temporary propping. The sequence of the failure was likely to be:

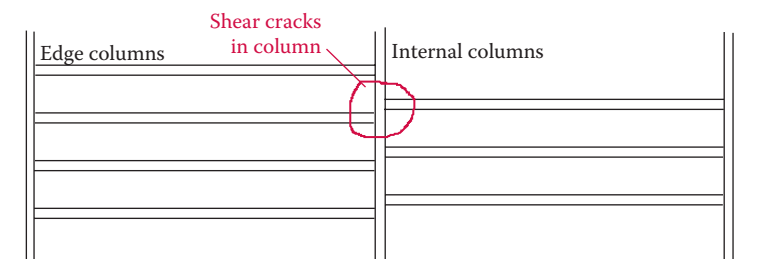
**Figure 4.4** Structural elevations of beams and columns of car park.

Figure 4.4 shows the beams on the sides of the internal columns. They are stepped to allow ramping between levels (as is often the case). The internal columns were much stiffer than the edge columns and in consequence the support moments and shear forces within the column were high compared with the edge columns. The column shear forces caused large shear cracks (up to 2 mm) within many of the columns.

Although a failure mechanism was not present, a problem occurred from repairing the cracks. As soon as the car park filled with vehicles after the repair, the cracks reopened and eventually the deterioration of the column concrete could have led to a collapse.

The design had been carried out to the existing code of practice of the time which did not have specific clauses for shear in columns. By the time remedial work was carried out, new code clauses in place required shear checks of columns. The design of this particular joint was inadequate to the new clauses. The insurance company required remedial work to be carried out so that the building would comply. This was considered to be so costly that the decision was made to demolish the existing structure and replace it with a new design.

**Comment** — Although the existing design code did not cover this particular situation, the designer should have been aware of the problem and taken action in the design to prevent overstressing within the joint. This is an example of common practice in the 1960s and 1970s when many engineers extrapolated the existing clauses of the codes of practice for situations outside the scopes of the codes.

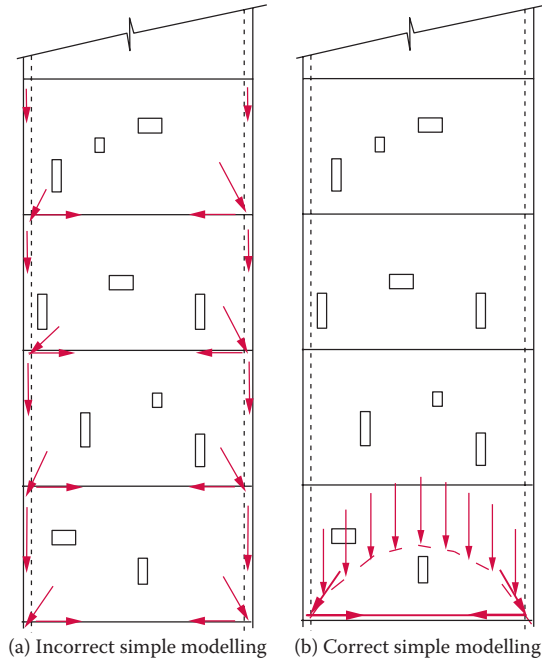
Figure 5.4 Multi-storey shear wall.

A multi-storey shear wall required so many openings (windows, doors, etc.) that the load path became very complicated. The designer assumed that the load would flow to the corners and then track vertically down the edge of the wall (see Figure 5.4a). In fact, since the wall was built in situ as a homogeneous structure, strain compatibility caused the load to flow back into the full width of the wall. The result was that several storeys of load

were supported by a deep beam that transferred the load to its end supports (see Figure 5.4b).

The limiting height of the natural arch of a deep beam ( $0.6 \times \text{span}$ ) was not considered (see Figure 5.4b) and this resulted in the omission in the design of much of the reinforcement needed for the bottom tie. Construction had reached several floors up by the time the mistake was recognised and this led to a redesign of the wall during construction and heavy remedial work. Each part of the wall required careful re-appraisal. This led to the requirement of much more reinforcement at each floor level. The bottom corner reinforcement details required special attention to ensure that the junction between the tie and compression struts was adequately designed.

**Comment** — The consequence of missing this simple principle of deep beam behaviour before construction reached such an advanced state meant that it required the redesign of the structure and reprogramming of construction which were extremely costly.

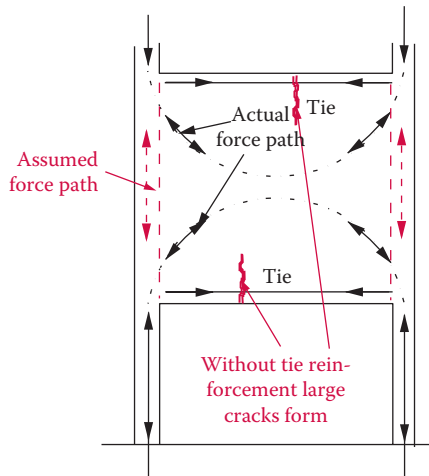
Figure 5.5 Modelling deep beams.

Figure 5.5 shows in a simple diagrammatic form how the force paths automatically flow out and back again. The assumed force path down the edges would not require ties at top and bottom, but without these the actual force path would cause large cracks to open up from the top and bottom surfaces. Even after cracking, the angle struts would still exist and so would the consequential horizontal component. Without sufficient tie force to resist, the support joint would move outward and eventually failure would follow.

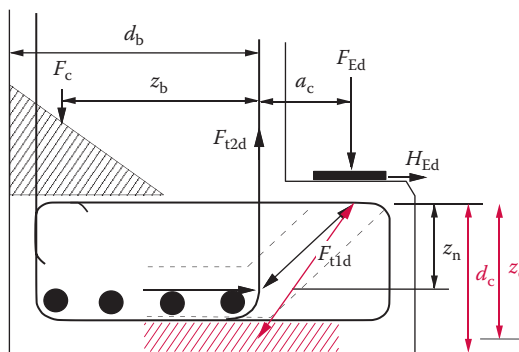
Figure 5.6 Nib attached to bottom of a beam.

Where nibs are attached to the bottom of a beam it is important to understand the load path of the forces. Figure 5.6 shows a typical section of such a nib.

The conventional assumption for a short cantilever of  $d_c$  and  $z_c$  (shown in red in Figure 5.6) is unsafe for such a nib. The design compression zone for such a model would be close to the bottom face of the beam and likely to fall outside the beam reinforcement (both the links and main reinforcement). Strut-and-tie modelling is helpful to explain why this is so. The strut (shown in red in Figure 5.6) would just cause the cover to the reinforcement to spall off. The strut must be supported mechanically by the reinforcement of the supporting beam (shown in black in Figure 5.6). The effective lever arm becomes much smaller and the tension force in the nib top reinforcement much larger than assumed by the short cantilever approach.

It should also be noted that the force in the supporting links of the beam,  $F_{t2d}$ , is likely to be much greater than the applied load on the nib,  $F_{Ed}$ , to satisfy equilibrium. For the situation shown in Figure 5.6, it is conservative to assume the compression acts at the centroid of a triangular stress block. Hence the force in the link, in addition to any shear, may be calculated as follows:

**Comment** — There are probably many nibs of this type that have been designed incorrectly and survive because of built-in safety factors and the fact that the load assumed in the design has not occurred.

The error described in this case study was found in the design of a nib for a very prestigious project. It was very fortunate that it was discovered before construction started.

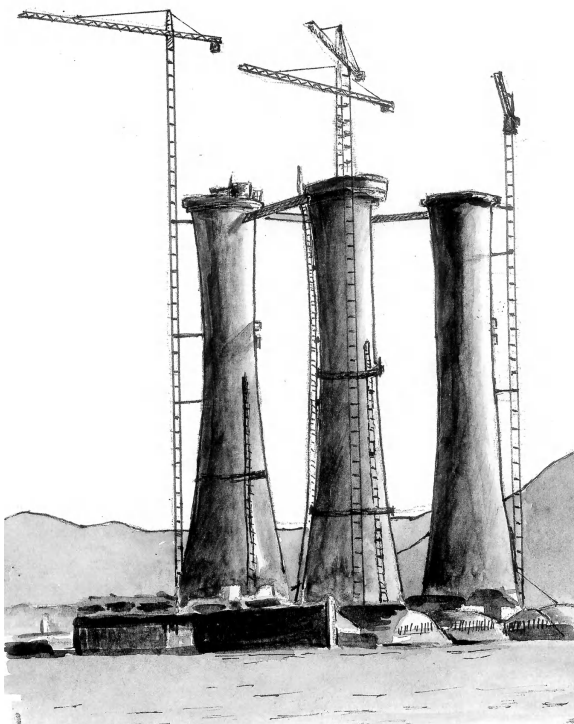
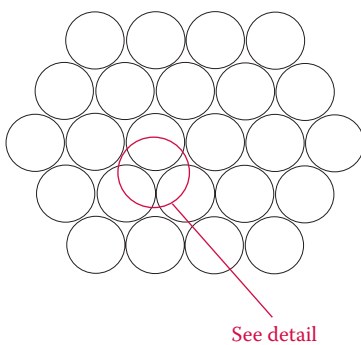
The platform included a large cellular concrete structure below the three towers as shown in Figures 6.1 and 6.2. During construction, the platform underwent submerging for deck mating after which the plan was to raise it again and tow it to its final position in the oil field. It was during the submerging prior to deck mating that one of the tri-cells failed. This caused flooding of the structure and further uncontrolled sinking that led to an implosion of the structure and complete collapse.

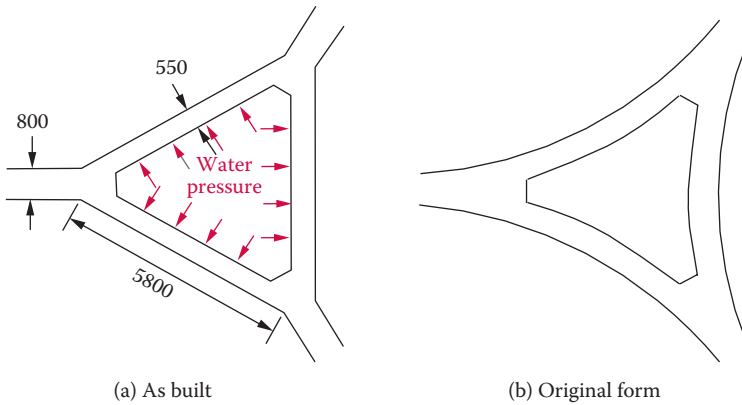
Figure 6.3 Detail of tri-cell.

Figure 6.3 shows a detail of the tri-cell wall that was designed to resist the water pressure when the cellular base was submerged. Figure 6.3b shows the original form of the cells with cylindrically shaped walls. The natural arch action provided by that geometry was not present in the modified form shown in Figure 6.3a.

The analysis of the cell structure was carried out using a finite element software package. The accuracy of the analysis was reduced as the arrangement of the quadrilateral elements meant that those in the region of the tri-cell corners were distorted from the ideal square shape. This led to errors in the results. It was realised after the failure that the shear stress results from the analysis were in error on the unsafe side.

The critical shear section was reinforced with T-headed bars. The software package gave the required areas of reinforcement, and the design required that the length of the T-headed bars would extend across the full

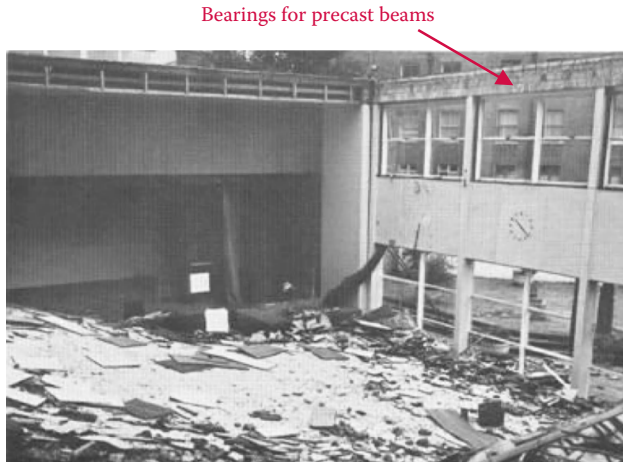
**Figure 6.5** Assembly hall showing edge beam that supported the precast beams. (From Scott, G.A., *Building Disasters and Failures*, Construction Press Ltd., Lancaster, 1976. With permission.)

The principal cause of the collapse was inadequate bearing for beam seatings and deterioration of concrete at beam ends. The hall was one of the first buildings found to have suffered from the effects of high alumina cement (HAC; see Section 7.4).

**Comment** — This was an example of inadequate design and poor detailing of the end bearing nibs built into the supporting beam for the precast beams. The reduction in strength caused by HAC left no margin for temperature effects. The combination was likely to have triggered the collapse.

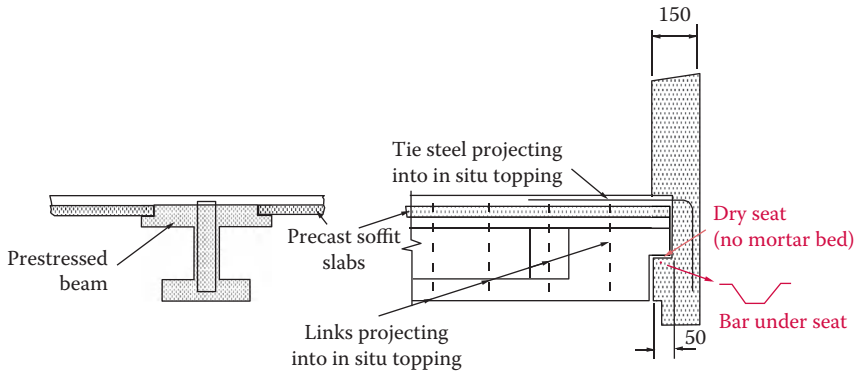
Figure 6.8 Prestressed beam and support.

The roof was constructed of prestressed precast concrete beams made with HAC spanning 12.6 m, supporting precast concrete slabs acting as permanent formwork for an in situ concrete topping (see Figure 6.8). The outer ends of these beams rested in 50 mm deep pockets cast into the vertical inside faces of the edge beams. In addition to these, the edge beams had recesses just below their seatings. These encroachments on the already narrow section led to the adoption of a reinforcement arrangement that had no main steel under the seating pockets for the prestressed beams.

The cause of this collapse was a disastrous combination. The columns and edge beams were precast as T units (with webs facing outward). The architect had, in order to obtain a dark colour, specified HAC concrete to be made with aggregate that was highly alkaline. The specification had been mistyped or misread to call for one part HAC to four parts sand to two parts aggregate (these mix proportions were confirmed by analysis after the event). Cores drilled from one of the T units after the collapse revealed strengths as low as 7 MPa and some could not be extracted in one piece.

The depth of seating for the pretensioned roof beams satisfied the code requirement for bearing pressure, but left no margin for erection tolerances or temperature effects. There was inadequate reinforcement detailed under the beam seatings, and as the T units were cast with external faces down, even that reinforcement was displaced downward, away from the seating ledge.

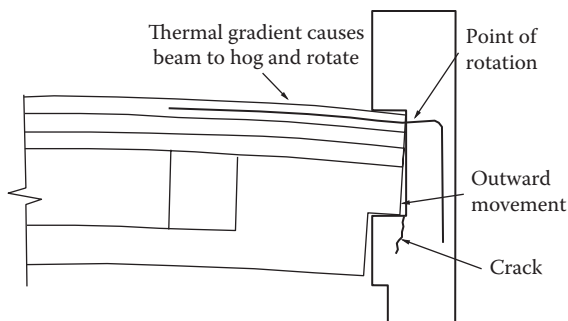
Figure 6.9 Detail at support.

The actual mechanism that led to the failure was found to be thermal hogging of the prestressed beams. The tie steel projecting from the edge beam into the in situ topping acted as a hinge, and the end rotation accompanying the thermal flexure between the two extremes corresponded to a horizontal movement at the level of the seating of approximately 2 mm. This caused cracking of the bearing nib as shown in Figure 6.9. The tension stress in the concrete support reduced its shear resistance sufficiently to cause the failure. The prestressed beam had been made with high alumina cement and although it aggravated the situation it was *not* the cause of the failure.

On another building, an identical detail was found, but the edge beams were constructed with ordinary Portland cement concrete. In that case, a crack similar to the one shown in Figure 6.9 was found, but presumably the reinforcement had not been badly displaced, as full collapse had not occurred. This did, however, demonstrate that HAC was not the primary cause of the collapse of this roof, but accelerated the cracking until collapse had become inevitable.

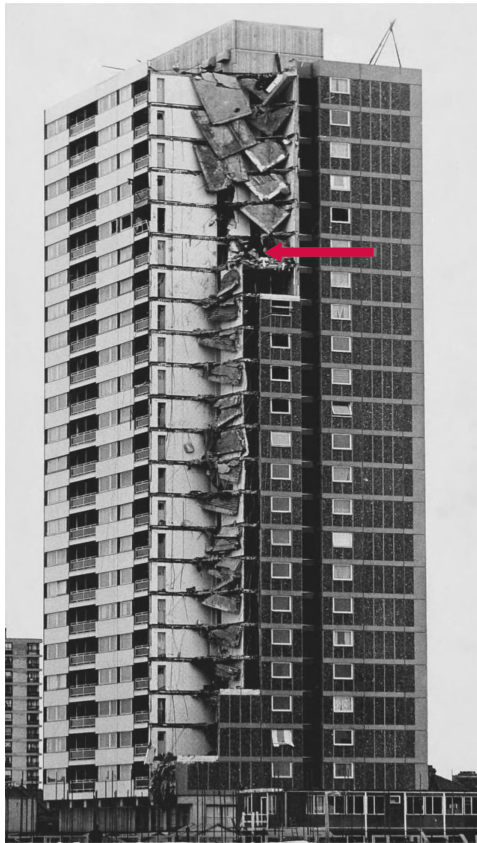
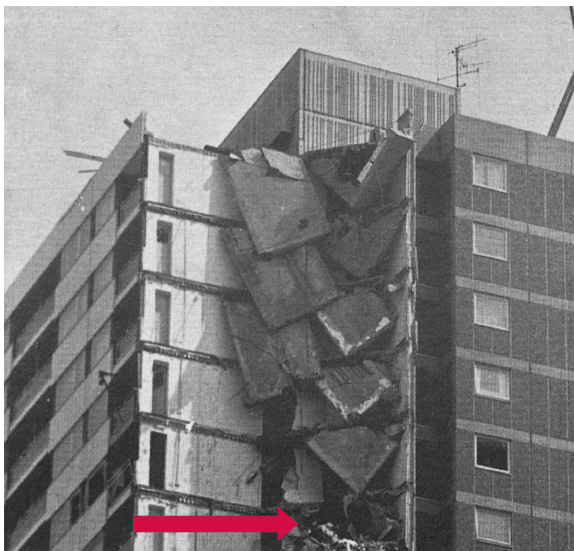
In the early hours of 16 May, 1968, a gas explosion in a bathroom on an upper floor shook a building, resulting in the instantaneous collapse of part of one wing (see Figure 6.10). Four people were killed. Figure 6.11 shows a closer view of the upper floors after the explosion.

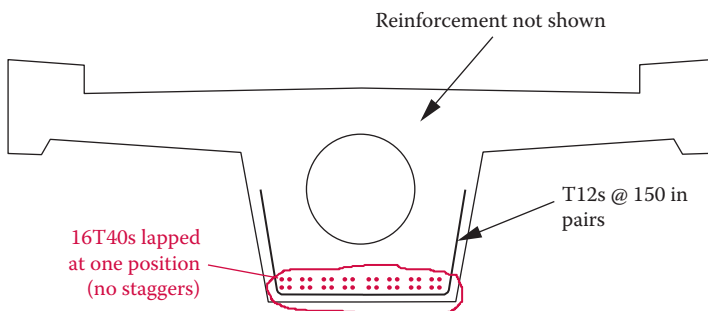
Figure 6.12 Section through footbridge.

A footbridge was being constructed over a motorway. The bridge had two spans with an in situ concrete T-section deck (see Figure 6.12). The span lengths were 20 and 40 m. After removing the formwork and props, two large transverse cracks (2 and 3 mm) appeared in the sides and soffit of the longer span. The cracks occurred at the positions of the laps of the main bottom reinforcement.

The reinforcement had been detailed so that all the main bars in the bottom, 16 T40s, were lapped at positions of high stress. It is generally considered poor detailing practice to lap bars in positions of high stress and lapping

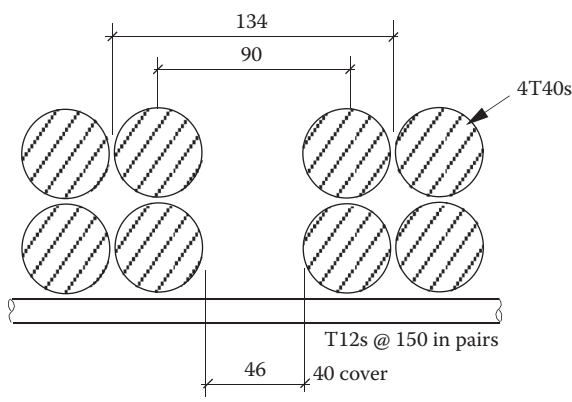
Figure 6.13 Layout of bars at laps.

all the bars in a congested situation compounds the error. The bars were cranked to allow them to be as close as possible (see Figures 6.13 and 6.14). Links, T12s @ 150 in pairs enclosed all the main bars. No extra links were provided at the laps or cranks.

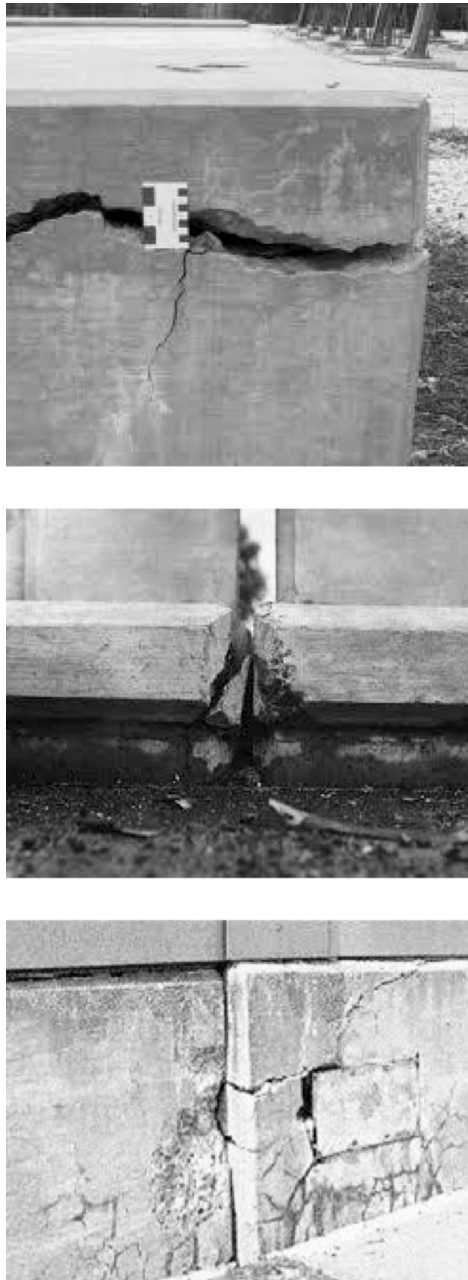
- Presence of alkali-silica reactive aggregates
- Crack pattern (often appearing as three-pointed star cracks)
- Presence of alkali-silica gel in cracks and/or voids
- $\text{Ca}(\text{OH})_2$  depleted paste

In mainly unidirectional reinforced members, the cracks become linear and parallel to the reinforcement. The degree of cracking depends on the amount of confining reinforcement, i.e., links, etc. One major concern was that ASR caused cracking that led bits of concrete to fall off structural elements and hit people below. This led to demolition of the structures in some cases. Examples of ASR effects are given in Figure 7.6.

*Figure 7.6* Examples of alkali-silica reaction. (Top: From the US Department of Transportation Highway Administration; middle: From Dr. Ideker, <http://web.engr.oregonstate.edu/~idekerj/>; bottom: From the US Department of Transportation Highway Administration.)

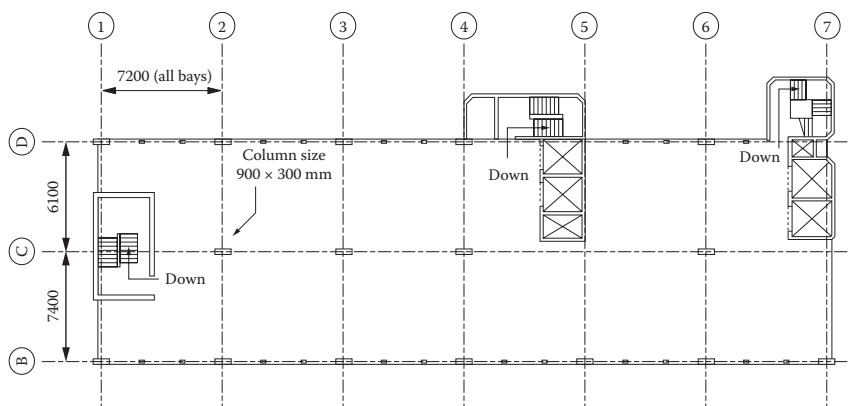
Figure 8.1 Structural layout of hotel floor.

Figure 8.1 shows the structural layout of a typical flat slab floor. The depth of the slab was 250 mm. The spans along the building were 7.2 m and across the building were 6.1 and 7.4 m. The top surface of the slab was very uneven and did not appear to have been levelled (by hand or power float). In some places, boot marks had been left. Cracks (generally not larger than 0.3 mm width) occurred on the upper surface radiating from the corners of the columns with one or two small cracks running tangentially. Large cracks (up to 1 mm width) appeared at some of the construction joints. The deflection of one of the slab bays of an upper floor was large—over 75 mm.

**Excessive deflection** — In order to understand how the excessive deflection had come about, it was necessary to check not only the design, but the in situ concrete strength, reinforcement details, and cover to the reinforcement as built. This check found that the only factor not as specified was the top cover to the reinforcement near the column supports. This was found to be on average 30 mm more than specified. This reduced the moment of

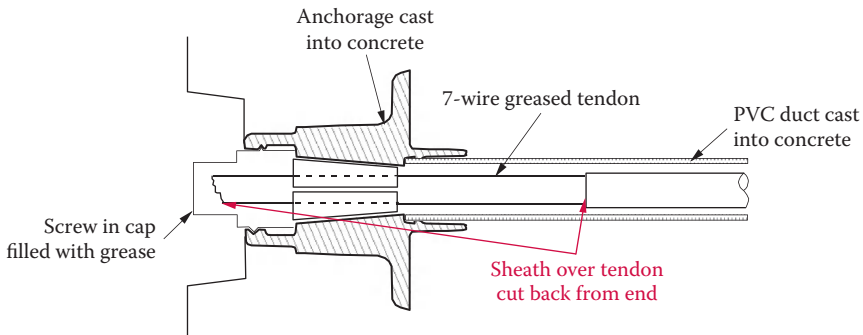
Figure 8.7 Detail of anchorage zone.

**Sheathing and grease** — The sheath and grease provided a continuous covering of the tendons up to the anchorage zone. In order to attach the prestressing jacks and insert the wedges, the tendons were stripped of the sheathing for some distance (see Figure 8.7).

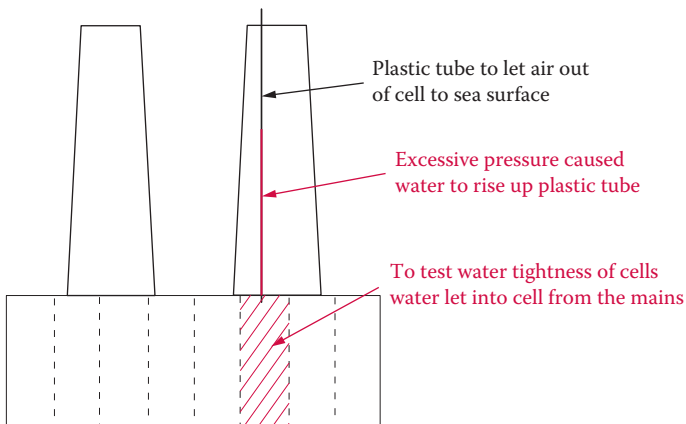
*Figure 8.12* Water tightness test during construction.

were made during construction to test the water tightness of the cells. The intention was to fill each one of the cells to its top only. Each cell was constructed with a plastic tube that led to the top of the shafts to allow air to escape from the cell when it was filled during the final installation. The main water supply used to fill cells was capable of providing a pressure much more than that required, and the water level was allowed to rise up the plastic tube (see Figure 8.12).

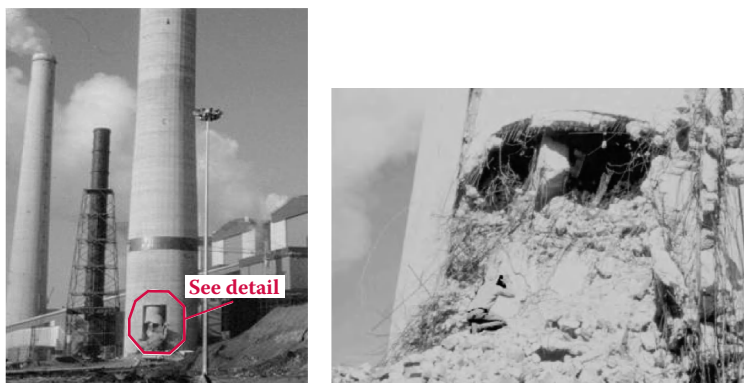
**Figure 8.20** Debris from collapsed flue. (Courtesy of Alan Steele.)

Above the roof slab at the top, the flues were also clad externally with brickwork. The bricklayers had just finished capping the last flue when a fracture lower down caused the top half of one of the flues to slide down, disintegrate, and fill the bottom of the wind shield with debris that spilled out of the portal for that flue. One worker was killed (see Figure 8.20).

The fracture surfaces on the concrete fragments in the debris seemed more square and sharper than expected. This was later explained as a feature of sudden disintegration of high-strength concrete by impact, as opposed to the slow failures observed in laboratory tests. Cores were taken

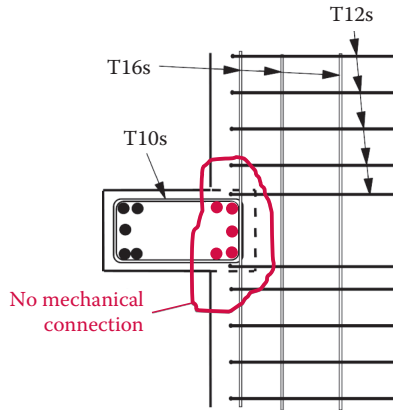
Figure 9.3 Actual layout of reinforcement.

The reinforcement arrangement intended for this joint is shown in Figure 9.2. Construction reached the second floor when a young graduate visited the building to gain some site experience. He reported back his concern about the reinforcement layout along the edge of the slab that was about to be concreted. Figure 9.3 shows what he saw. There was no mechanical link between the slab and the column reinforcement! It was immediately realised that not only had this occurred at all edges of the slab on the second floor, but also on the first floor that was completed several weeks earlier.

**Comment** — One of the reasons this situation occurred was that no check had been made in the design office to ensure that a mechanical link could be made. In fact, when the cover and the actual size of bars were taken into account, it was clear that the reinforcement could not fit as intended. The fabricator of the reinforcement fitted the bars as close to the correct position as possible without thinking that a mechanical link was essential.

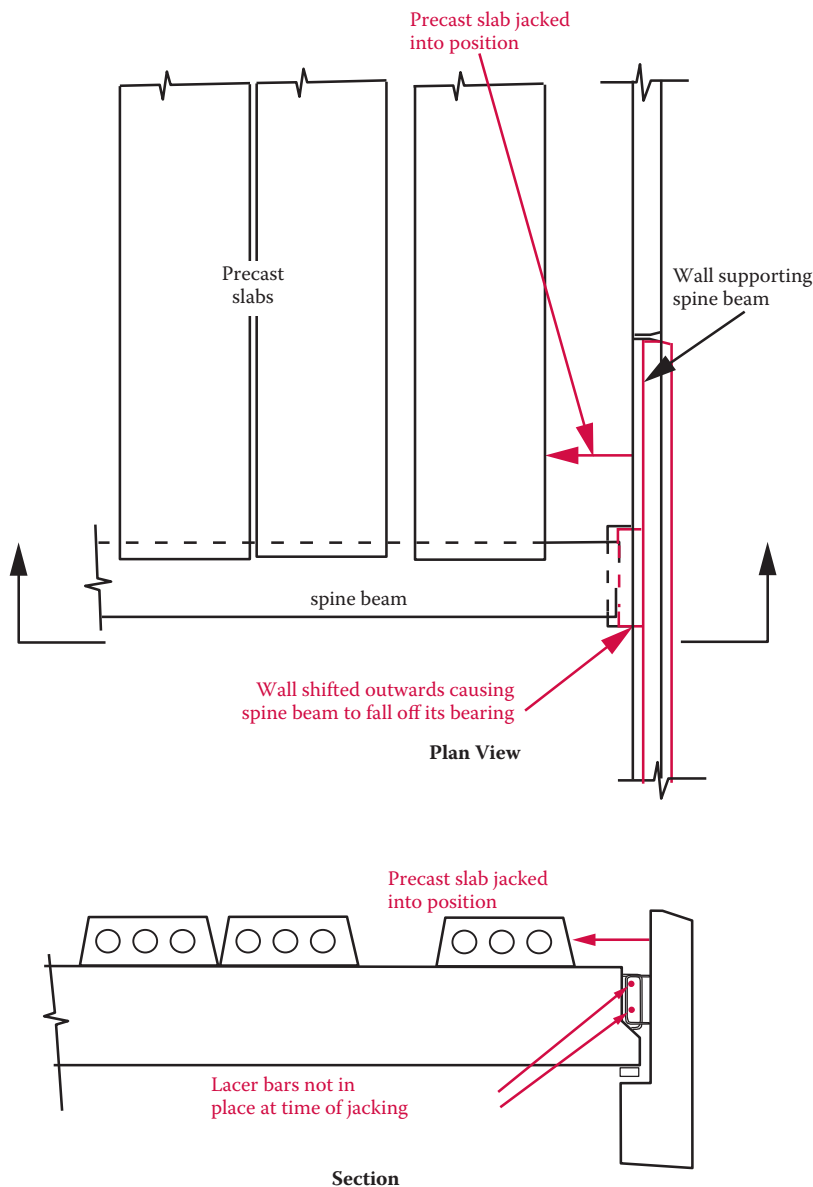
Figure 9.5 Adjusting positions of precast planks.

the wall panel supporting the end of the spine beam (see Figure 9.5). This caused the spine beam to lose its bearing and led to the collapse of the floor. The connection between the spine beam and the wall panel had been designed to have two overlapping U bars locked together with lacing bars threaded through the space between them. These lacer bars had not been inserted at the time of erecting and laying of the floor elements. If they had been in place, they would have prevented the wall panel from moving away from the spine beam.

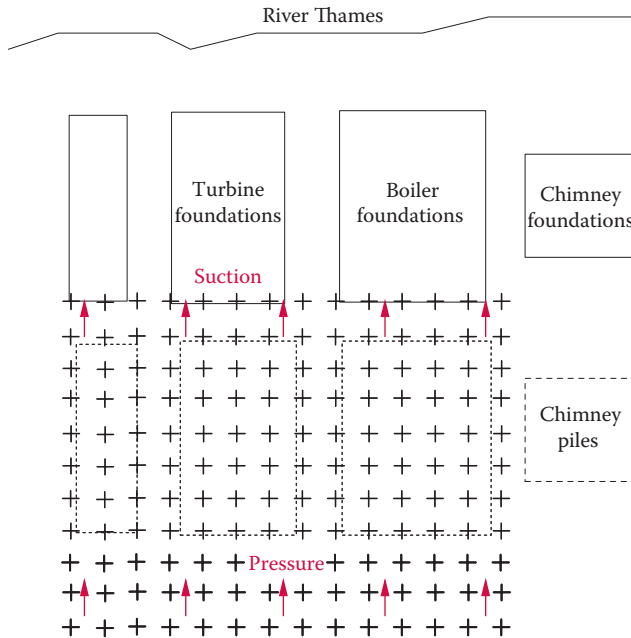
Figure 10.3 Diagram showing cause of movement.

A year after the start of piling, when concreting of the foundations progressed about a third of the way along the site, it was discovered that the tops of the piles that were still exposed were moving. *Measurements showed that the movement was up to 1.5m!*

It took some weeks to fully understand what had happened. Figure 10.3 shows a plan of the site and attempts to demonstrate the situation. The steady addition of piles into the ground built up ground pressure. This pressure was applied increasingly from one direction. At the same time, the excavation for the foundations of the structure closest to the river released any ground pressure that built up. The combination of these two major actions caused the movement.

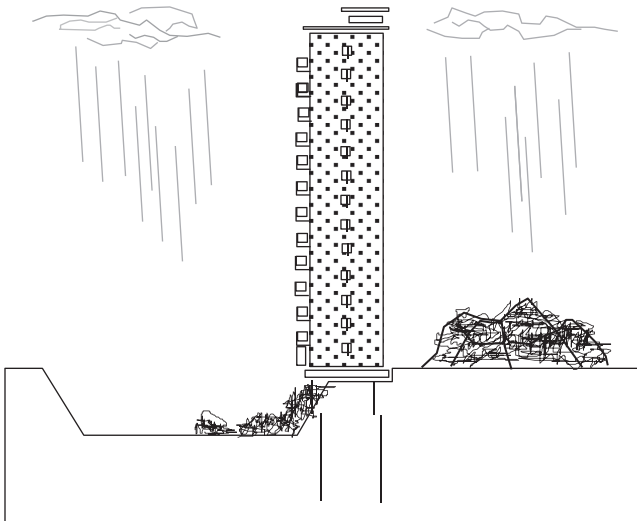
Figure 10.5 Diagrammatic view of pile shear failure.

An underground car park was to be added to one of several residential tower blocks. Excavation commenced on the south side of the block and the excavated soil was piled on the north side to a height of 10 m (see Figure 10.4). A heavy rainfall occurred some time after the excavation finished and it increased the lateral ground pressure on the piles. The building began to move sideways toward the excavation. This caused the piles to fail as their shear resistance was exceeded (see Figure 10.5). The building became unstable as it moved toward the excavation and eventually fell over (see Figure 10.6).

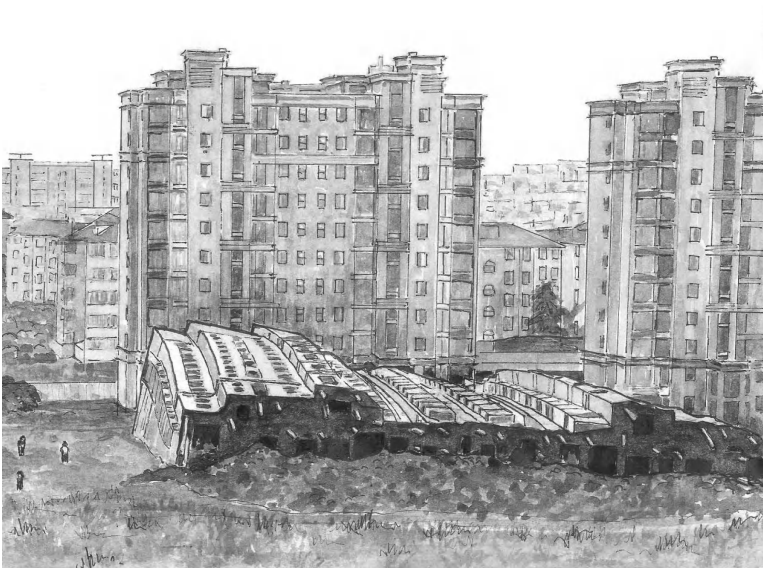
*Figure 10.7* View of underside of collapsed building. (Courtesy of Gillian Whittle; redrawn from Reuters, <http://www.telegraph.co.uk/news/worldnews/asia/china/5685963/Nine-held-over-Shanghai-building-collapse.html>.)

It was very fortunate that the other tower blocks were not close enough to cause a domino effect. Figures 10.7 and 10.8 show how close this tower block was from its neighbours. Figure 10.8 shows a close-up view of the piles that failed in shear. The piles were made of circular hollow unreinforced concrete. They were constructed with short lengths at the top with solid reinforced sections (see Figure 10.9).
