# FAILURES IN CONCRETE STRUCTURES

Case Studies in Reinforced  
*and* Prestressed Concrete

Robin Whittle

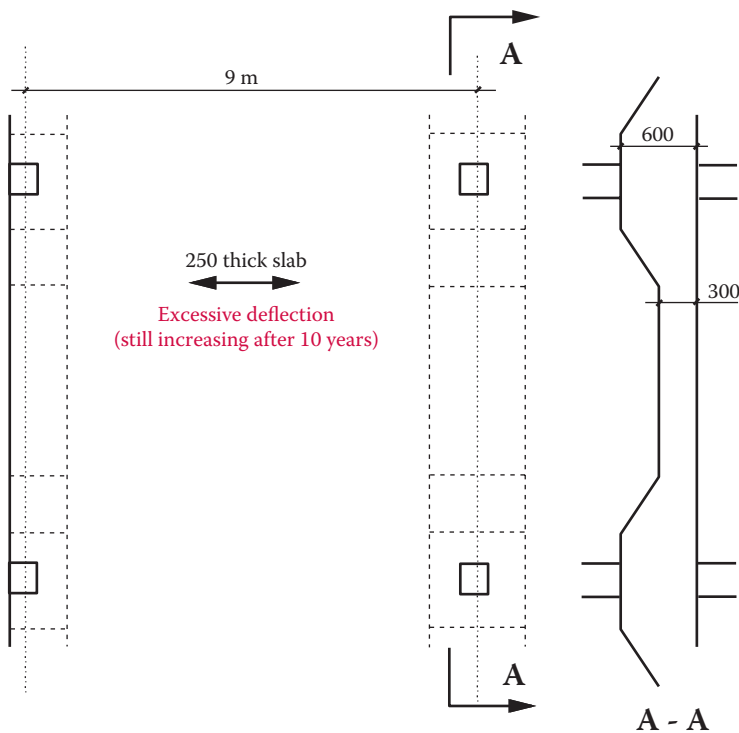
Figure 11.1 Plan and section of typical end bay.

The visit to site included the inspection of the slab close to a column. The screed had been removed to expose the top surface of the structural slab. On close inspection, the reinforcement appeared to be badly rusted and breaking through the top surface. As a crude check of the hardness of the concrete surface, it was scratched with a penknife. Quite unexpectedly, the blade of the knife penetrated into the concrete surface right up to the hilt! A further check of the soffit of the slab gave a similar result.

diameter) that were separating from the surface. One such piece came away as it was being examined. Although the slab had been designed to span one way, the supporting beam was sufficiently flexible for the slab to behave more like a flat slab. The ‘flying saucers’ appeared in the compression areas of the soffit and were considered to be the effects of spalling. It was clear that the slab in question required immediate additional support and the rest of the building required core testing.

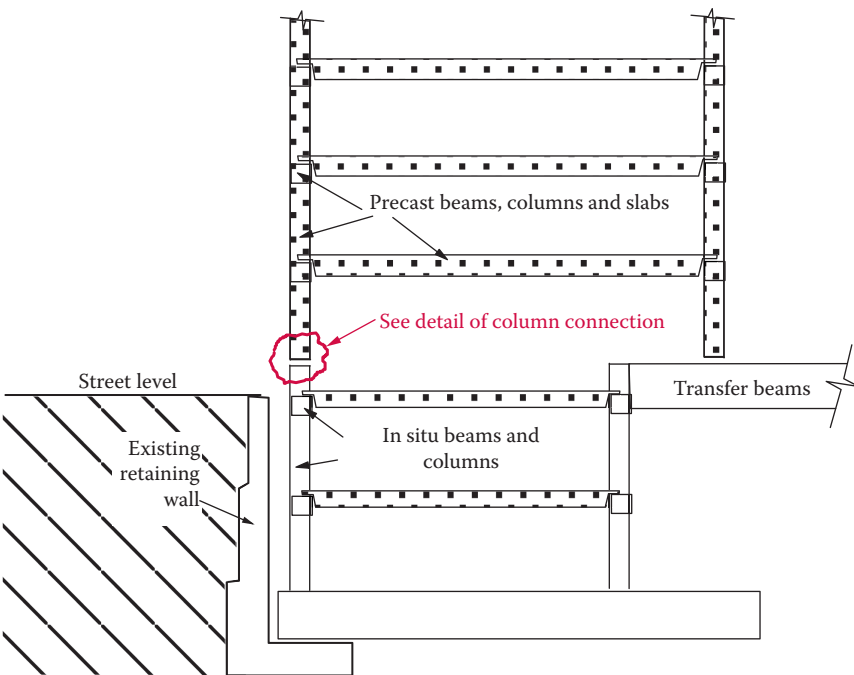
Figure 11.2 Section through lower part of building.

This building was constructed with precast elements above ground. Below ground, the foundations, columns, and beams were constructed in situ (see Figure 11.2). Construction had reached an advanced stage when cracks appeared in the in situ columns just below the connections with the precast columns.

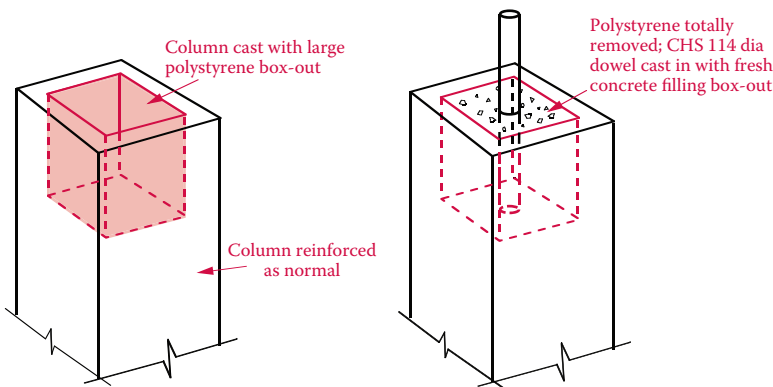
Figure 11.3 Intended construction of top of in situ column.

The construction of the in situ columns should have proceeded as shown in Figure 11.3. The central circular hollow section (CHS) dowel was cast into the top of the in situ column ready to receive the precast column.

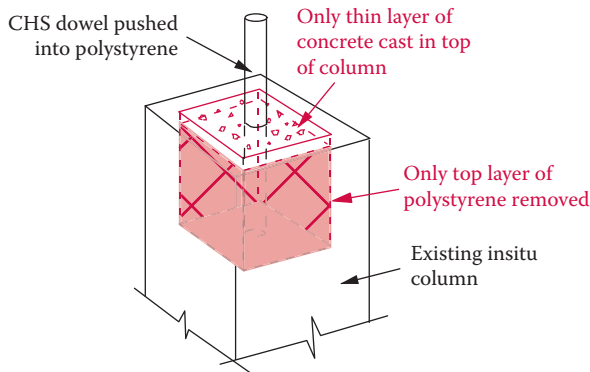
Figure 11.4 Actual construction of top of in situ column.

In order to check that the concrete in the box-out was in place as intended, holes were drilled through each face. It was discovered that the polystyrene had been left in and only a thin layer of concrete had been placed at the top (see Figure 11.4).

The load in the precast column from seven floors above transferred to the outer rim of the in situ column. This load was intended to be taken by the whole section of the in situ columns. However, the thin layer of concrete at the top of the box-out and the polystyrene below were quite incapable of taking any significant load. The outer shell of in situ concrete that had to take the load became overstressed and consequently cracked, providing the first sign of imminent failure (see Figure 11.5).

**Comment** — Although the act that caused the problem was not intended to cause collapse of the building, it was, in the author's opinion, a deliberate act to leave most of the polystyrene box-out. This was done to save time and effort for the contractor. It was extremely fortunate that the fault was found before collapse of the building occurred.

In order to repair the tops of the in situ columns, the load from the precast building had to be removed. This was achieved by providing props and

jacks close to the existing precast columns at each floor level and creating a new load path to the ground. This released the load on the in situ columns below and allowed the required remedial work—reconstruction of the tops of the in situ columns—to take place.

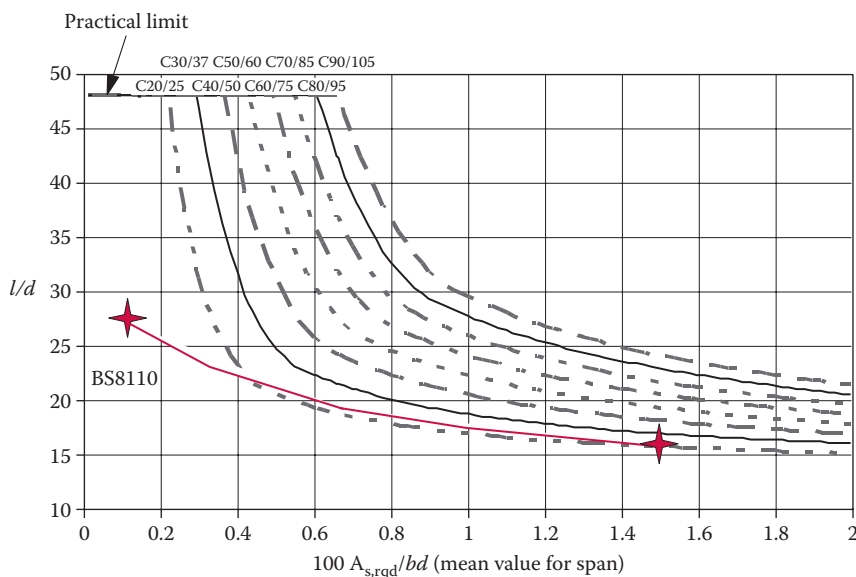
Figure 13.2 Effect of concrete strength on span and effective depth ratios.

Professor Beeby, who provided the supporting information for the existing code clauses, was asked whether it was appropriate to make an adjustment to the span and/or effective value for the strength of concrete. After further research, he provided an expression to include this variable. Figure 13.2 shows a plot of the expression that was adopted in the technical report and later, in 2004, was also included within *Eurocode 2*.<sup>2</sup>

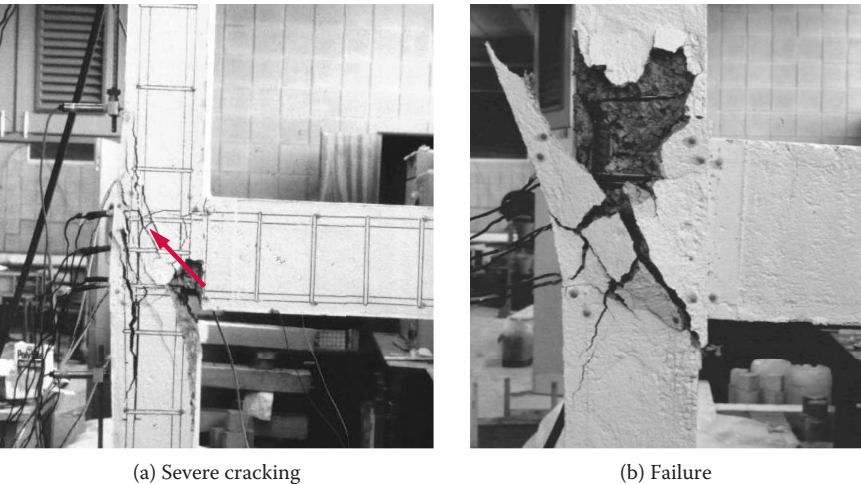
*Figure 13.3* Loading column joint to failure. (Courtesy of Richard Scott.)

were halved. A slot was cut down the centre of each of bar and the strain gauges placed along one bar at varying pitches (as little as 50 mm) and glued into position. The two halves were then joined to simulate a single complete bar. All the wires from the strain gauges were led out of the ends of the bars to a control box. Figure 13.3 shows one of the tests at the point where the joint failed.

Different arrangements of reinforcement were detailed and tested. One important result showed that if the beam top bars were bent upward in the column, with gravity loading on the beam, the joint resistance was drastically reduced compared with the bars bent down. The reason is that the high compression force created within the joint was not resisted by the enclosing bar as shown in Figure 13.3a.

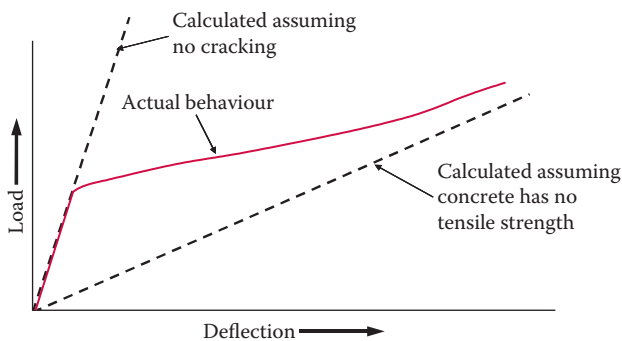
Figure 13.6 Effect of concrete tension stiffening on deflection of slabs.

The solution to this problem came about as a result of a chance meeting with Prof. Andrew Beeby two years later. He suggested that he and Dr. Richard Scott carry out tests at Leeds and Durham Universities to examine the concrete tension stiffening effects in more detail. The project was an unmitigated success and resolved the problem with respect to the Taywood Engineering slab. It revealed that what had been considered short term effects of tension stiffening lasted much less time than assumed and that the long term effects took over after a few days. Figure 13.6 shows how tension stiffening affects the behaviour of a concrete element.

The knock-on effect of that project has been a significant change in the application of the British and European codes. Each of these codes stated that tension stiffening is halved in the long term. Until recently, *long term*

was assumed to be several years after loading instead of the actual few days. This means that for design purposes the long term value should almost always be used.
