Understanding Bridge Collapses

Björn Åkesson

Consulting Engineer, Fagersta, Sweden

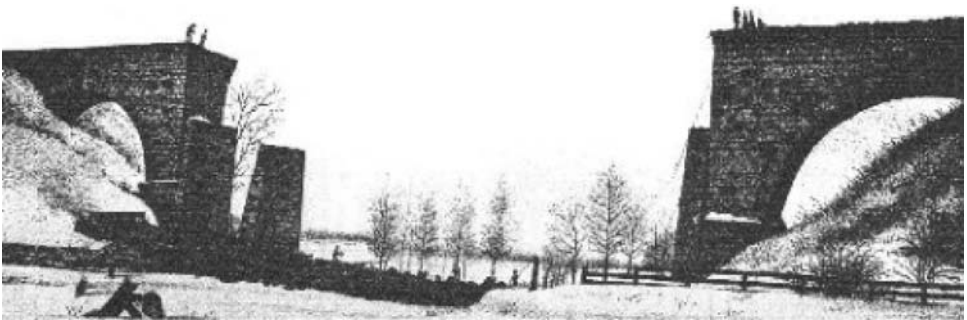
The following day the charred remains of the bridge and the train lay twisted beyond recognition in the river bed below (Fig. 2.4).

Fig. 2.4 The day after the collapse. The extra brick pier that is seen close to the left-hand abutment is from the earlier wooden bridge at this site. (<http://home.alltel.net/arhf/bridge.htm>)

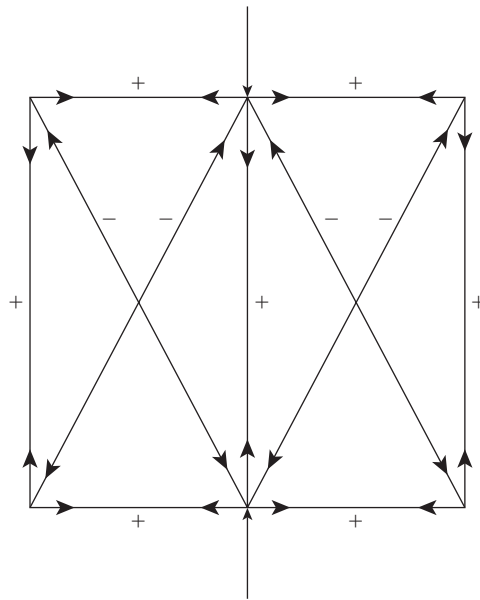
Fig. 2.7 By tightening the verticals (and by doing so, compacting the truss) the diagonals became subjected to compression.

vertical bars, one by one. By turning the nuts at the threaded ends of the bar, tension was induced because of the elongation, hence subjecting the diagonals to compression due to the compacting of the truss (Fig. 2.7).

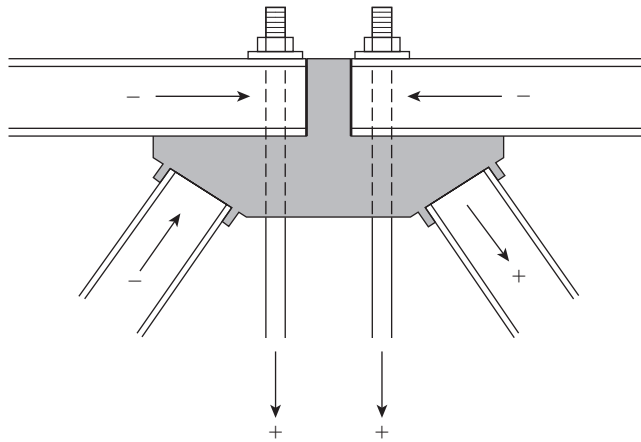
Fig. 2.10 The principal truss joint design of the Ashtabula Bridge – a cast-iron angle block in between the individual members (diagonals, verticals and horizontal chords).

As the diagonals in the Ashtabula Bridge were somewhat loosely fitted to the joints in the panels during assembly, they relied upon the prestressing (read: compacting) to function properly during loading of the truss. The tension diagonals could only carry load below the prestressing level (as a reduction of the compression), and were not able to withstand the full tension capacity of its members (due to the inadequate fastening to the joints).

The joint between the diagonals and the upper and lower chords had the following principal design – a cast-iron angle block supporting, and transferring the forces between the members in the truss (Fig. 2.10).

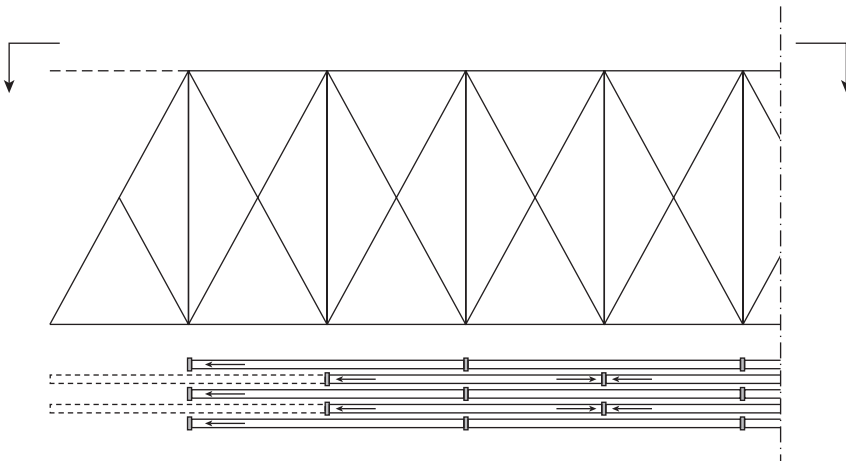
Even though the bridge was considered to be very strong and robust, it was judged “too experimental” by another involved engineer, Mr Charles Collins, and experimental it certainly was. Both the chords and the diagonals consisted of *separate* wrought iron I-girder elements (Fig. 2.11).

Fig. 2.11 The top (compression) chord of the Ashtabula Bridge.

In every other joint in the upper chord, the I-girders were fitted to the lugs on the cast-iron angle blocks by using shims – i.e. thin plates – to fill the small gaps there during the assembly (see Figs. 2.10 and 2.11). In a sense the entire bridge resembled more a gigantic model construction kit – such as a Meccano without nuts and bolts – rather than a normal steel truss of modern standards, which is having the members properly and securely fixed to the joints. Perhaps Amasa Stone had too much of his inspiration coming from the wooden Howe trusses.

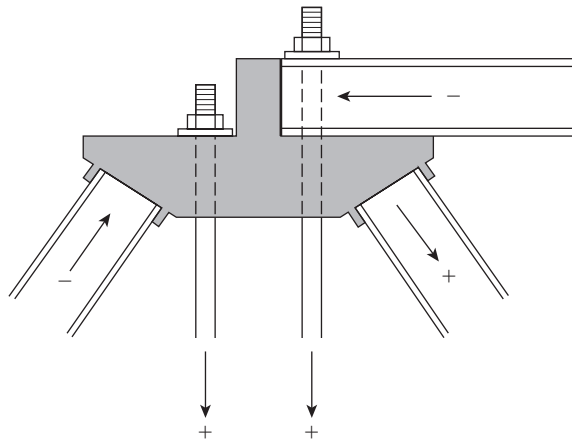
However, during the passage of the west bound train to Cleveland on the evening of 29 December 1876, the Ashtabula Bridge suddenly collapsed. An inquest was immediately summoned in order to find the answer to the collapse, and this investigation would last for more than two months. It was found that the bridge had been badly maintained, poorly inspected, and not properly designed with respect to the truss members (e.g. by applying load from the floor-beams to the upper chord between the truss joints, and by having relied upon separate elements to act as a unit), but above all, that the entire load-carrying capacity rested upon the small cast-iron lugs at the truss joint angle blocks. They discovered, after having salvaged some key parts from the wreckage of the bridge superstructure that one of the two lugs at the second upper chord joint had been broken off (Figs. 2.14 and 2.15).

There were five lugs at both ends of the upper compression chord that were having one-sided loading – the two in the second joint were having I-girder elements on either side, however, the two I-girders continuing to the abutment (see Figs. 2.5 and 2.11) are only “zero-bars” with respect to the truss action. The remaining lugs – all having

Fig. 2.15 The one-sided horizontal loading from the upper chord I-girder member to the cast-iron lugs at the ends (see also Fig. 2.10).

active members on both sides (see Fig. 2.10) – had only to transfer (by shear) the small difference in member forces between the horizontal I-girders. It was considered without any risk to choose cast iron for the angle blocks (containing the lugs), as they were to be subjected to compression only, however, the five lugs at the ends must have been somewhat overlooked in the design process. After eleven years of in-service loading one of the lugs broke, which resulted in an instant over-loading of the remaining I-girders in the chord. As the upper chord consequently became eccentrically loaded, it began to buckle outwards in the transverse lateral direction (first perhaps as separate units, and then finally as a complete “package”). There was limited capacity of the upper chord to withstand this excessive loading as the compression members of the bridge had been designed with respect to a stress criterion only, and not with respect to the risk of buckling. (Further, there is the simultaneous transverse vertical loading from the floor-beams.) One could also assume uneven load distribution in between the I-girder elements – prior to the breaking of the lug – due to difference in contact pressure to the lugs. The engine drivers had also for many years experienced a “snapping sound” when trains were passing over the bridge, indicating perhaps that even small gaps (due to the loss of shims) were present between certain compression elements in the bridge (upper chord as well as diagonals). There had also been inspection reports of misalignments – the girder elements were in many cases not meeting the lugs completely straight. Anyway, the upper chord failed in buckling, which resulted in the progressive failure of the entire second truss panel, transforming the inner statically indeterminate truss from a load-carrying structure to a complete mechanism (Fig. 2.16).

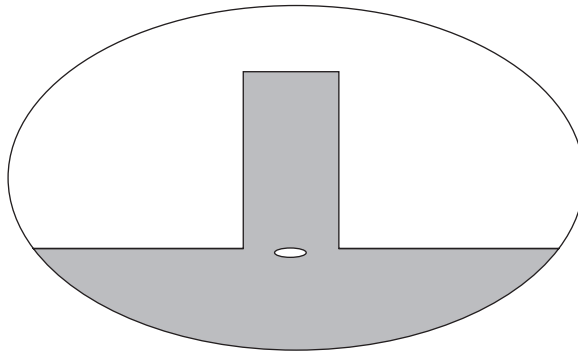
The inquest correctly pinpointed the broken lug as the initiating point for the collapse, but it was not until later that it was found – when examining the lug more in detail – that it contained a large flaw. An air hole (void) was found in the broken lug (Fig. 2.18).

Fig. 2.18 When the broken lug was examined a large embedded air hole was found.

acts as a stress raiser due to the stress concentration effect. The transition zone between the lug and the main body of the angle block is also a region where cooling is slow after casting – in such zones there is not only the risk of voids forming (due to “suctions” because of uneven shrinkage of the metal during solidification), but also the formation of large grains, the accumulation of slag inclusions and other impurities, which all result in extra brittle behaviour in such zones. Given this knowledge, it was just pure chance that the lug did not break at first loading.

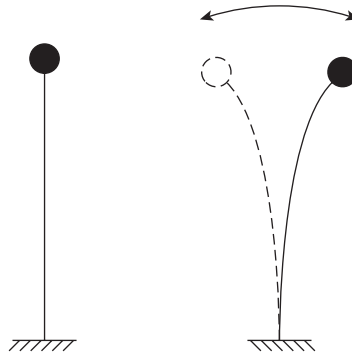
Fig. 3.12 A model of the Tay Bridge as a top-heavy cantilevering structure, which for sure it was.

Let us consider the weight of the bridge spans and that of the train as a concentrated mass on top of the cantilevering truss column (Fig. 3.12).

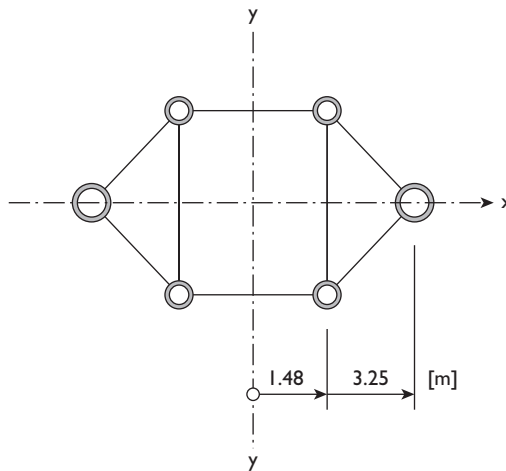
In order to determine the natural frequency of the truss columns for the high-girder bridge section of the bridge, we need first of all to find the second moment of area of the cross-section around the y -axis, as the deflection for the wind is along the x -axis (Fig. 3.13).

Fig. 3.13 The cross-section of the cantilevering truss column (see also Fig. 3.5). As a qualified guess the two exterior cylinders are those having the diameter of 460 mm, and the four interior having the diameter of 380 mm.

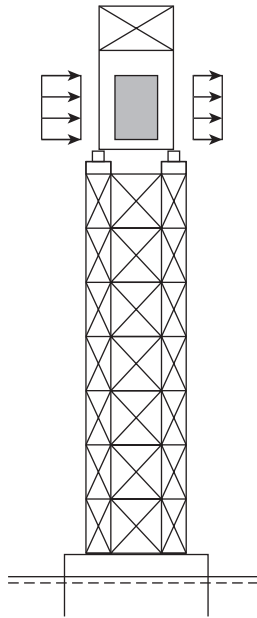
The wind was blowing very hard on the evening of the 28 December 1879 as the mail train approached the Tay Bridge from the south. The structure itself was of course subjected to the wind pressure, but the incomparably largest wind loading came when the train entered the bridge, and as it climbed towards the high-girder section the structure was strained to the utmost. Twenty-seven metres high up in the air – as a huge elevated signboard exposed to wind – there was pressure on the windward side of train as well as suction on the leeward side (Fig. 3.14).

Fig. 3.14 The wind loading on the train twenty-seven metres high up in the air.

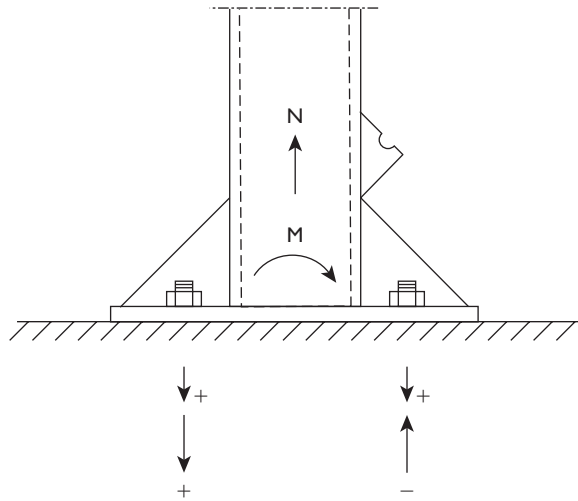
Ten out of twelve truss columns fractured at the base (to the piers) due to a sudden loss of anchorage (one after the other) and the remaining two fractured some few metres above the base. As the diagonals had lost their strength – during the eighteen months the bridge had been in service and during the final stages of the progressive collapse – the loading at the base of the cylinders changed from being pure normal forces to the combination of normal force plus bending moment, neglecting the shear force being present. Here only the action coming from the horizontal wind load is shown (not considering the vertical compression coming from the weight of the train) (Fig. 3.16, see also Fig. 3.11).

Fig. 3.16 As the diagonals were lost the loading at the base of the cylinders increased dramatically. Also shown above is the fractured gusset plate where the diagonal had been connected.

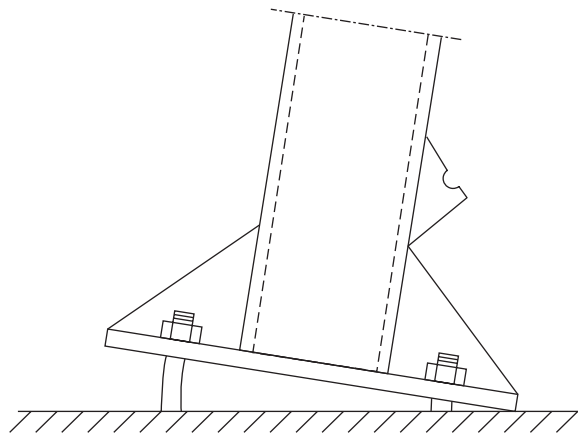
Fig. 3.17 Elongated and deformed anchorage bolt on the tension side of the cylinder base plate.

As a consequence the anchorage bolt at the tension side became overstressed (Fig. 3.17).

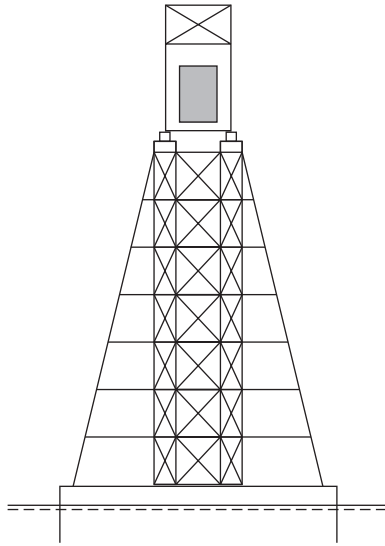
The Court of Inquiry concluded that “the fall of the bridge was occasioned by the insufficiency of the cross bracing and its fastenings to sustain the force of the gale”, and indeed so it was. The high-girder section of the bridge would definitely have benefited from an extra pair of straddling legs (like the intuitive position of a human body expecting a horizontal thrust), stabilizing the truss columns and drastically lowering the strain due to severe winds (Fig. 3.19).

Fig. 3.19 An extra pair of straddling legs would most probably have saved the Tay Bridge.

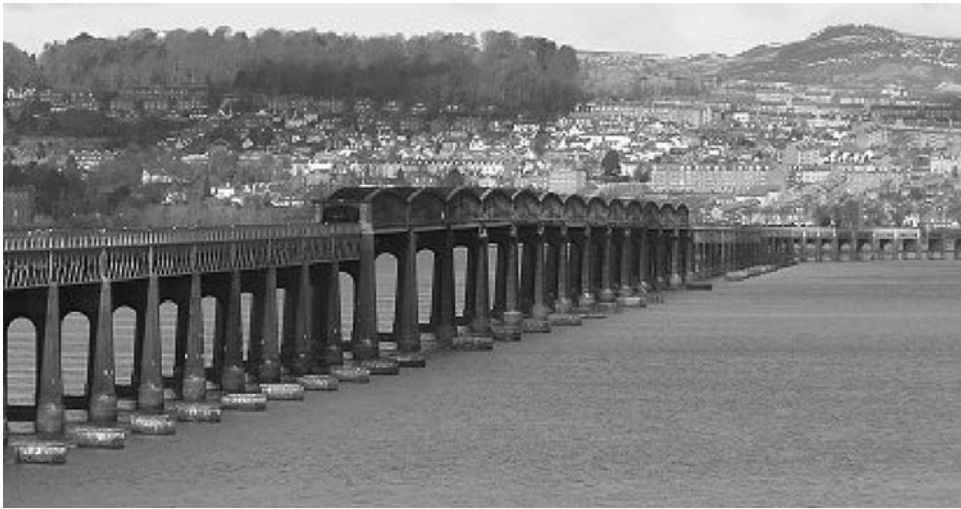
Fig. 3.21 The new railway bridge over the Firth of Tay, built in 1887, having the same number of high-girder spans as the old bridge. (www.mccrow.org.uk/TaysideToday/TayBridges/TayBridges.htm, with kind permission of Malcolm McCrow, photographer and copyright holder)

new bridge had very strong and stable intermediate supports – wrought-iron tubular arches – not only coming from the wind loading requirements, but also because of the increased width of the track superstructure (Fig. 3.21).

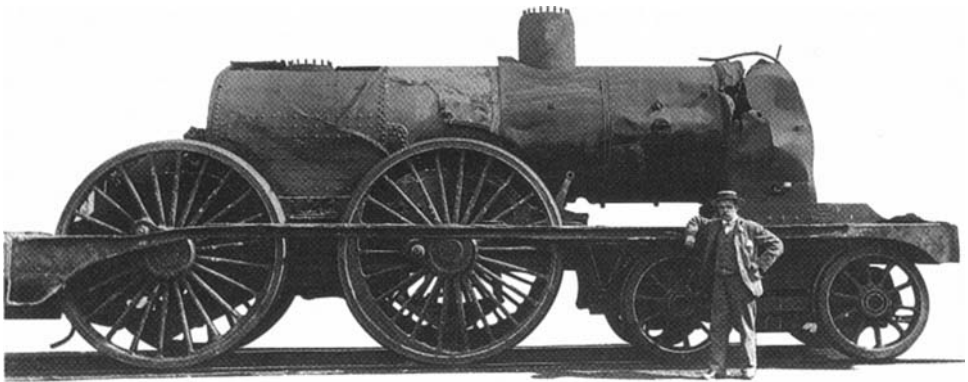
The deck girders from the old Tay Bridge were not the only parts that were re-used, but also the engine of the mail train was taken into service again, as it was salvaged from the wreckage of the bridge and repaired (Fig. 3.22).

Fig. 3.22 The engine that was salvaged from the collapse of the Tay Bridge – “The Diver” as it was called. (Yapp, N.: 150 Years of Photo Journalism)

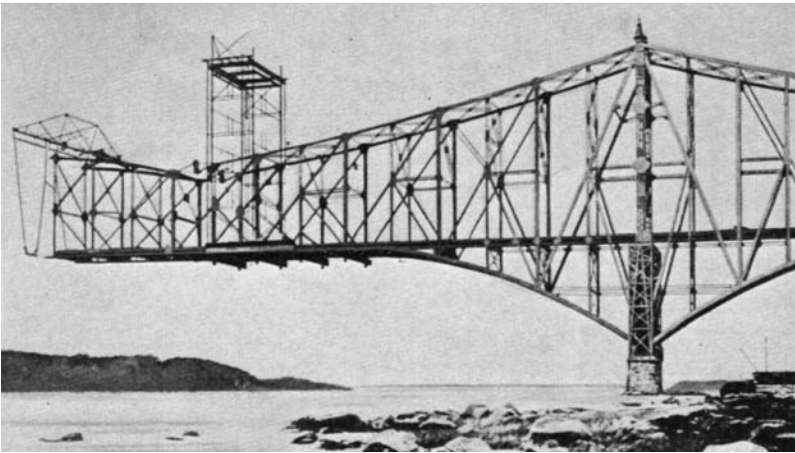
In late summer of 1907 – three years after the start of the construction of the steel superstructure – the cantilever arm reached 223 m out over the river (Fig. 4.8).

Fig. 4.8 The south cantilever arm and the first three panels of the suspended span of the Quebec Bridge extending 223 m out over the St. Lawrence River in late summer of 1907 (see also Fig. 4.9). In comparison to the massive Forth Bridge (see Fig. 3.23) this structure looks for sure anything but “bulky”. (Hammond: Engineering Structural Failures – the causes and results of failure in modern structures of various types)

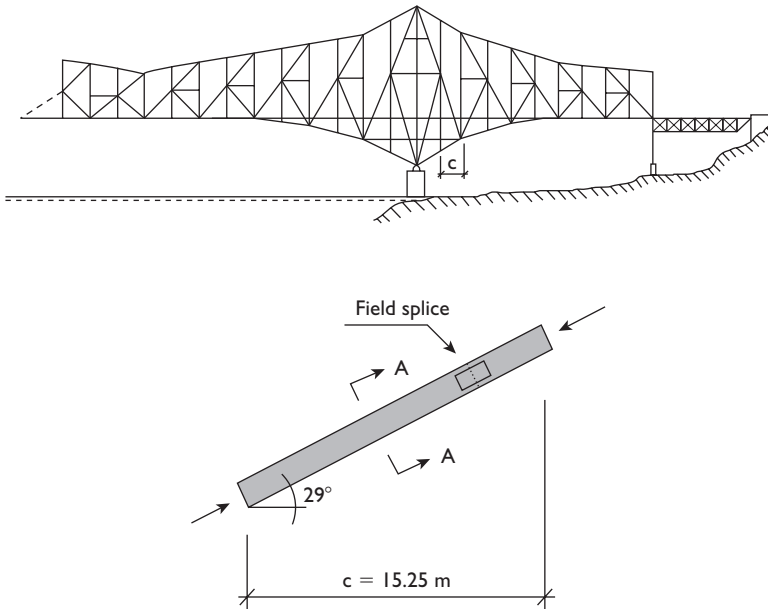
In mid summer of 1907 the first signs of distress in the steel superstructure began to show – a field splice in the ninth panel lower compression chord on the left-hand side of the anchor arm (member A9-L) had become distorted (Fig. 4.10).

Fig. 4.10 The lower compression chord in the ninth panel of the south anchor arm (member A9-L), where distortion of the field splice was detected in July 1907.

At the end of August – when the cantilever had been extended further out over the river, increasing the stresses even more in the truss members – it was found that the out-of-plane bending of chord A9-L had increased from some 20 mm to alarmingly 57 mm. Even though this deformation – representing an out-of-plane deflection of $L/305$ (the length L of the member being 17.44 m) – is hard to detect by the naked eye, it was a clear signal that something was quite wrong. And visible signals were also given, as rivets for the transverse bracing members (the diagonal and horizontal L-profiles – see Fig. 4.12) began shearing off – a clear evidence of the excessive out-of-plane bending taking place. Realizing the danger McLure immediately travelled to New York on the 27 August to consult with Cooper (telephoning was judged to be too risky – there was always the possibility that the telephone operator would listen in and reveal the situation to the newspapers). Cooper, realizing the danger of the situation, wanting the construction to come to an immediate halt, telegraphed to the Phoenix Bridge Company: “*Add no more load till after due consideration of facts*”. However, the contractor (i.e. the Phoenix Bridge Company) was under great pressure not to delay the construction, so the work continued by unfortunately moving an erection crane one step further out on the cantilever. If they had listened to the message from Cooper,

In late afternoon of 29 August 1907 – just some 15 minutes before the working day was over – the entire bridge collapsed (Fig. 4.13), starting with the buckling failure of the A9-L lower chord of the south anchor arm.

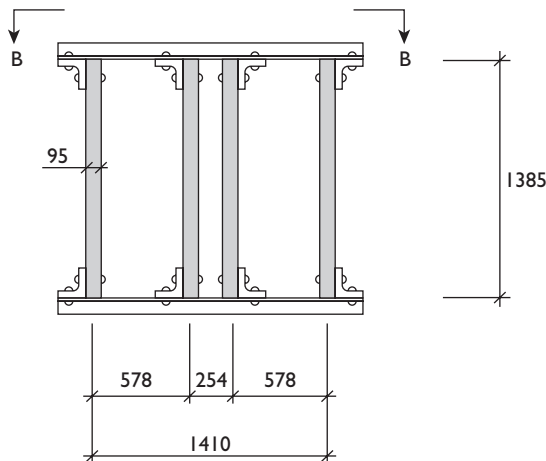
While the Forth Bridge had circular tubes the Quebec Bridge had riveted built-up rectangular truss members. The lower compression chord in panel nine of the south anchor arm consisted of four parallel steel plates, $95 \times 1385 \text{ mm}^2$ (each consisting of four 23.8 mm thick plates being clamped together by rivets) (Fig. 4.11).

Fig. 4.11 The cross-section of the anchor arm lower compression chord in panel nine (section A-A in Fig. 4.10).

We will in the following study the buckling resistance of the lower compression chord and see why and how it failed. If we look at the cross-section (see Fig. 4.11) we have – with respect to the stiff direction of the individual web plates – a possible buckling mode in the in-plane direction (i.e. in the vertical direction, parallel to the plane of the web plates). We could calculate the critical buckling load (having a buckling length, L_{cr} , equal to the length of the member, L) according to (Eq. 4.1):

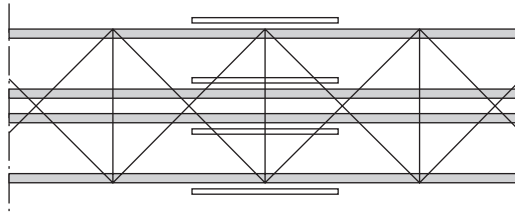
Close to the upper joint of the compression chord in panel nine (at a distance of some 20% of the member length) the web plates were spliced with cover plates (see also Fig. 4.10) (Fig. 4.12).

As the lower chords of the anchor arm initially were subjected to tension – when the falsework was removed and the span became simply supported – and the normal force soon changed to compression as the cantilever arm grew outwards, it was decided to temporarily use bolts in order to allow for the structure (the anchor arm) to develop all of its deformations (read: the gradual elongation/compression of the upper and

Fig. 4.12 The web splice (spliced in field and not in shop) of the lower chord in panel nine – section B-B in Figure 4.11, i.e. the top view (however, rotated 90°). Also shown are the stabilizing members in the transverse direction – crossing diagonals and horizontals of small L-profiles.

lower chords) before riveting the plates tight together. The anchor arm was quite simply judged to be allowed to adjust itself to the changing load, otherwise secondary constraints could have been developed. However, by taking this measure the buckling strength of the lower compression chords became affected negatively. Besides having observed local distortion of the plates in the field splice, it was discovered in the beginning of August 1907 that chord A9-L was slightly bent out-of-plane as well. The representatives of the Phoenix Bridge Company claimed that the deformations were the result of an incident which had taken place in 1905, when this particular chord had been dropped and bent in the storage yard. Bridge inspector McLure – Cooper’s assistant at the bridge site – was, however, convinced of that the deformations had taken place *after* that the chord had been installed, and he was supported by Cooper who suggested that it was most probably a hit damage during construction. In the discussions it was more a matter *when* the chord had been bent rather than if this in any way could affect the safety of the bridge. The concentration was also focused on the construction of the cantilever arm, and not to the more or less already completed anchor arm, so the matter was perhaps not given the highest priority.

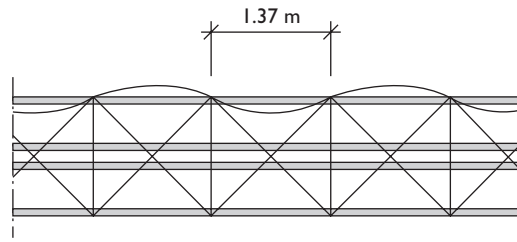
Fig. 4.14 The possible failure mode of an individual web plate buckling independently of the others.

distance between the horizontals (once again neglecting the top and bottom L-profiles for the sake of discussion) (Fig. 4.14 and Eq. 4.4):

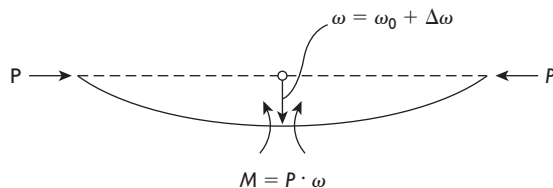
Fig. 4.18 Additional bending in an axially loaded strut due to initial out-of-straightness.

In contrast to the theory – where the initial transverse deflection ω is assumed to be zero, and remains so until P_{cr} has been reached – real structural members (such as struts subjected to compression) are always *imperfect* (with respect to shape and material), which makes the load/displacement-relationship differ from that of the ideal theory. For example does the inevitable out-of-straightness make the behaviour become softer and the ultimate load to become much lower. As soon as a load is applied upon an imperfect strut – having a certain initial out-of-straightness ω_0 – there will be an increase of the deflection due to so-called second order effects, so that a bending moment will be produced (Fig. 4.18).

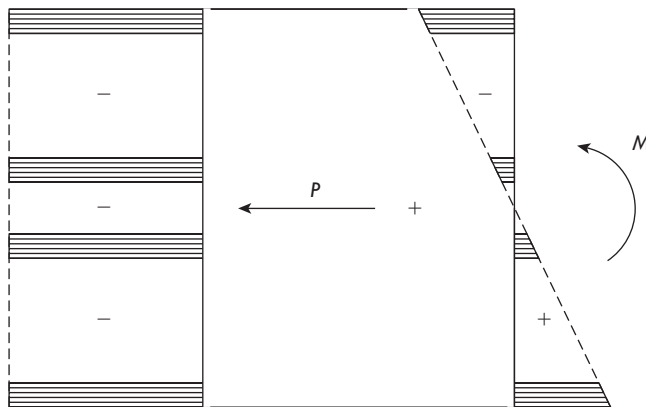
The effect is the worst on the concave side (see Figs. 4.18 and 4.19) where the combined effect of the compressive stresses is the highest. In comparison to the behaviour of an ideal strut real struts will experience a softer load/displacement-relationship because of this effect, and the ultimate load will become much lower than the elastic critical buckling load. There will be an earlier initiation of yielding which lowers the stiffness (and the load-carrying capacity) of the strut – the outer parts will become “soft” due to the yielding, because the stress/strain-relationship of steel is horizontal after yielding has occurred. The ultimate load is consequently becoming lower as the initial out-of-plane displacements increases (as the initiation of yielding starts earlier).

Fig. 4.19 The stress distributions for to the applied axial normal force and the additional bending in the out-plane-direction.

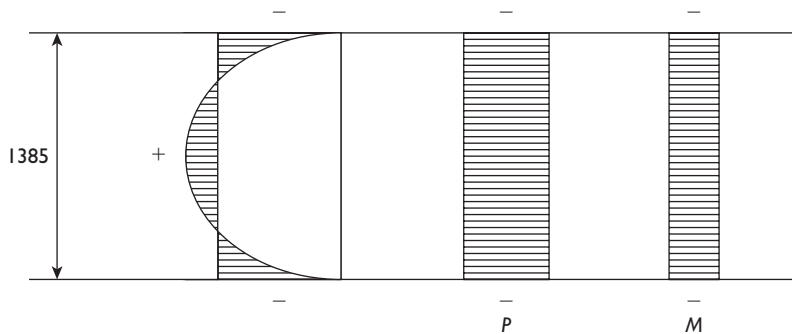
Fig. 4.20 Principal distributions of the residual stresses together with the stress distributions produced by the normal force and the out-of-plane bending for the uttermost web plate on the concave side.

already hardened and stiff outer parts (i.e. the edges). This difference in cooling rate will produce residual (i.e. remaining) tensile stresses in the inner parts and counterbalancing compressive stresses (close to the magnitude of the yield stress of the material) at the edges (Fig. 4.20).

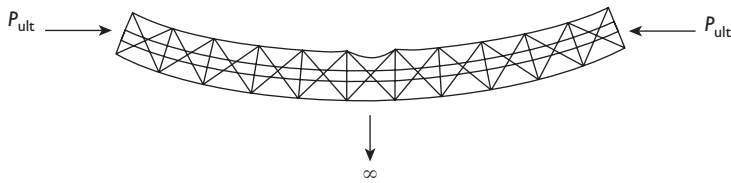
Fig. 4.21 Local buckling of the web plate on the concave side triggered most probably the collapse.

For the case of the built-up sections of the Quebec Bridge yielding of the web plate at the concave side (for out-of-plane bending) was probably not the triggering factor for the collapse of the chord, instead local (Euler) buckling in between the horizontals of the transverse stiffening truss was more probably the initiating cause – starting with the web plate on the concave side having the highest combined effect of normal force stresses and secondary bending stresses (besides the presence of the residual stresses) (Fig. 4.21).

As local buckling of the web plate on the concave side took place then there was nothing to stop the collapse of the chord (the remaining three web plates in the damaged panel were unable to carry the load as the eccentricity of the normal force increased drastically). The whole loading procedure was just like a gigantic full-scale load test until failure; a step by step increase in load and a simultaneous monitoring of the deformations, just as it is done in a laboratory – the only difference being that here it was performed in field conditions, in a real load-carrying structure. Starting with an already damaged (read: initially bent) chord there was a gradual increase in loading – and out-of-plane deflections – until the ultimate load-carrying capacity was reached (Fig. 4.22).

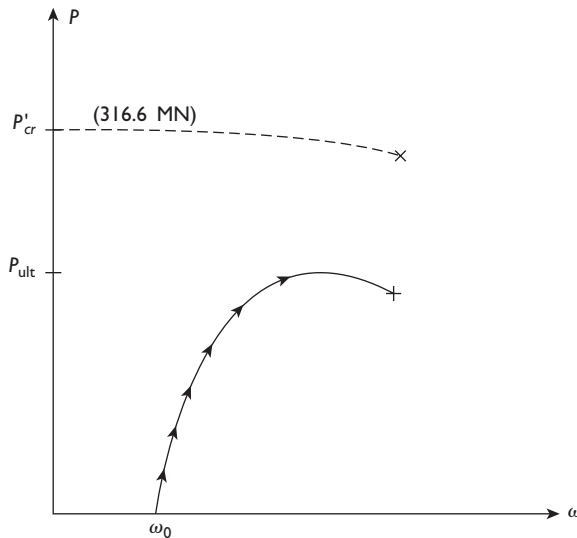
Knowing what we know today of the stability of built-up chords – and also knowing what we know of the outcome – the maximum design load-carrying capacity should only have been a fraction of the ultimate load, however, at that time when the Quebec Bridge was built Cooper was convinced that the capacity was sufficient (relying upon full composite action). The stiffening truss was expected of having adequate strength and stiffness, but instead it was its weakness and lack of rigidity that made the chord (and the bridge) to collapse. As the out-of-plane deflection of the chord increased the strain on the stiffening truss members increased. Each diagonal and horizontal had only a single rivet at each end, making the shearing stresses (as well as the bearing pressure) becoming high, as the loading and the deflections of the chord increased. Prior to the collapse there were also reports of rivets shearing off, and that decreased the load-carrying capacity (and the stiffness) of the stiffening truss even more. The final failure of the chord could also have been preceded by the rupture/buckling of some of the stiffening truss members.

Fig. 4.22 The true load/deformation-relationship (in principal), well below that of the theoretical response assuming an ideal and perfect chord. The actual loading procedure was just like following a gigantic load test until failure.

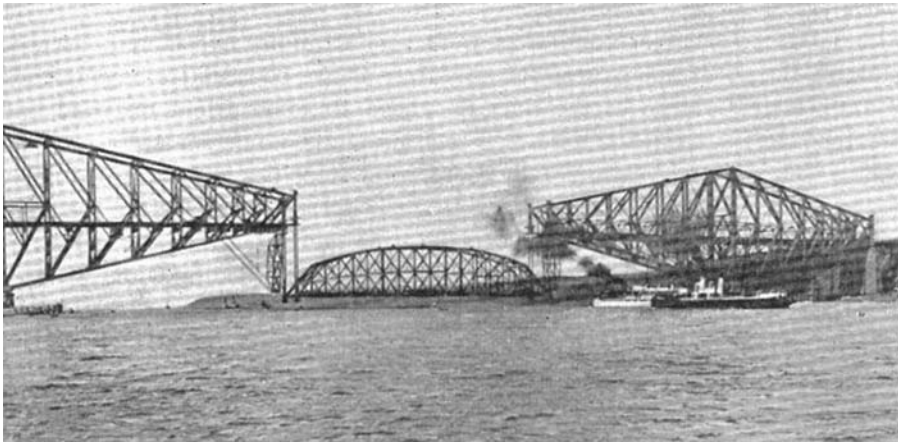
Fig. 4.24 The suspended span lifted free from the barges and hanging in between the two cantilever arms. (Hammond: Engineering Structural Failures – the causes and results of failure in modern structures of various types)

It had been decided to lift up the central suspended span from a barge (or six of them, to be exact), instead of – as in the first bridge – having one half of the suspended span reaching out from the end of the cantilever arm. In this way the maximum free cantilever length became reduced, thus lowering the maximum compression (and tension) chord forces during erection. The suspended span, 195 metres long – slightly shorter than in the original bridge – having a weight of more than 5000 tons, was to be lifted up in position – 46 metres above the water level – at least, that was the intention. In September 1916 the construction of the suspended span was completed, and it was then shipped to the bridge site and floated in underneath the two cantilever arms. After the barges had been safely anchored, the lifting operation could commence. First the four corner ends of the suspended span had to be connected to the lifting hangers, and then hydraulic jacks could begin to lift up the span in steps of 60 centimetres at a time (Figs. 4.24 and 4.25).

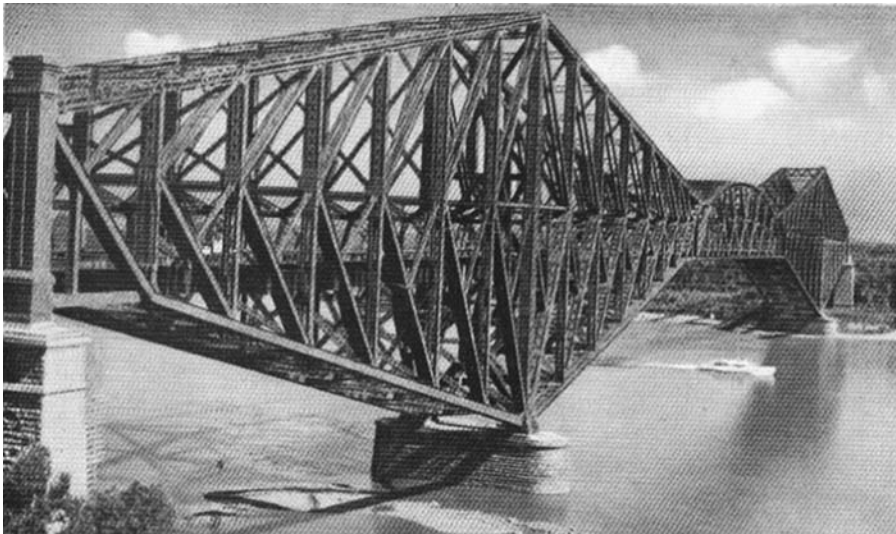
Fig. 4.27 The Quebec Bridge over the St. Lawrence River in Canada, the longest cantilever bridge in the world.

The bridge is still in service today, and remains actually, with its main span of 549 metres, the longest cantilever bridge in the world (Fig. 4.27).

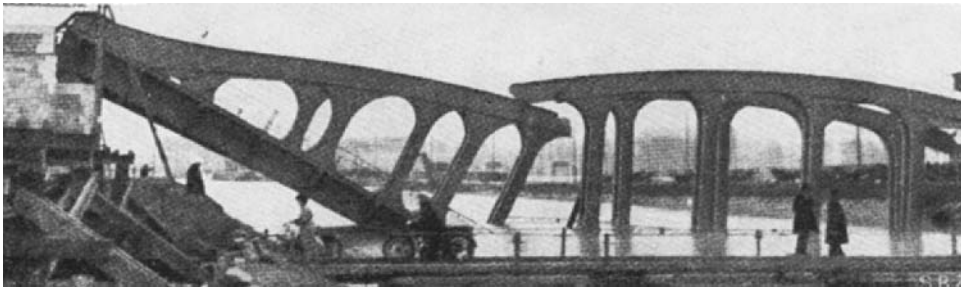
On a cold morning in March 1938, the Hasselt Road Bridge in Belgium suddenly and unexpectedly collapsed and fell into the Albert Canal, less than two years after its completion (Fig. 5.1).

Fig. 5.1 The collapse in March 1938 of the Hasselt Road Bridge over the Albert Canal in Belgium. (Stålbygge. Utdrag ur Stålbyggnad, programskrift 11)

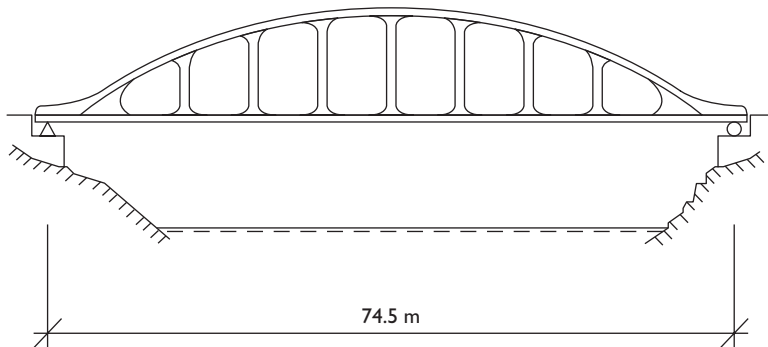
The bridge was of the Vierendeel type (invented by the Belgian engineer Arthur Vierendeel), having a span of 74.5 metres (Fig. 5.2).

Fig. 5.2 The Vierendeel bridge over the Albert Canal near the city of Hasselt, close to the border of Germany, some 70 kilometres east of Brussels, the capital city of Belgium.

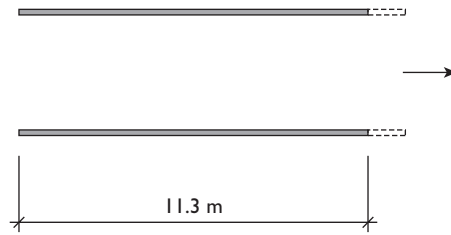
It was not until some 20 years later, in 1961, that the exact cause was put forward, and it was shown that Professor C. Forssell was correct in his assumptions. Professor Hjalmar Granholm, at Chalmers University of Technology in Göteborg, had devoted some time and effort in bringing light to the cause, and he could prove that the bending

Fig. 6.7 Buckling direction, i.e. in the stiff direction of the flanges.

stiffness of the built-up flanges were too weak to resist lateral buckling. If we – for the sake of discussion – start by calculating the bending stiffness of the two flanges (as a coupled pair) in order to find the critical buckling load, assuming *full interaction* between the joined timber parts, we find (Eqs. 6.1 and 6.2, Fig. 6.7):

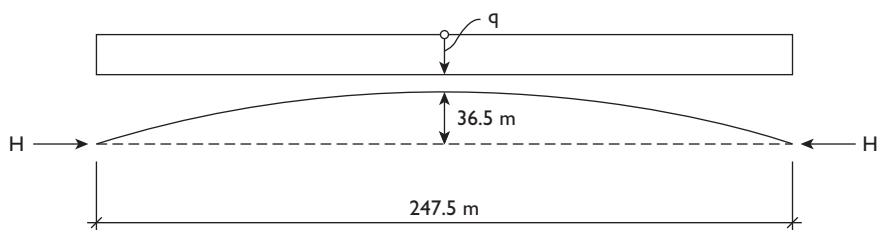
If we use the actual values for L and f (see Fig. 6.8), we finally have the critical buckling load, where we have assumed full interaction between the individual timber elements in the flanges (Eq. 6.4, Fig. 6.8):

Fig. 6.8 The span length and rise of the timber arch.

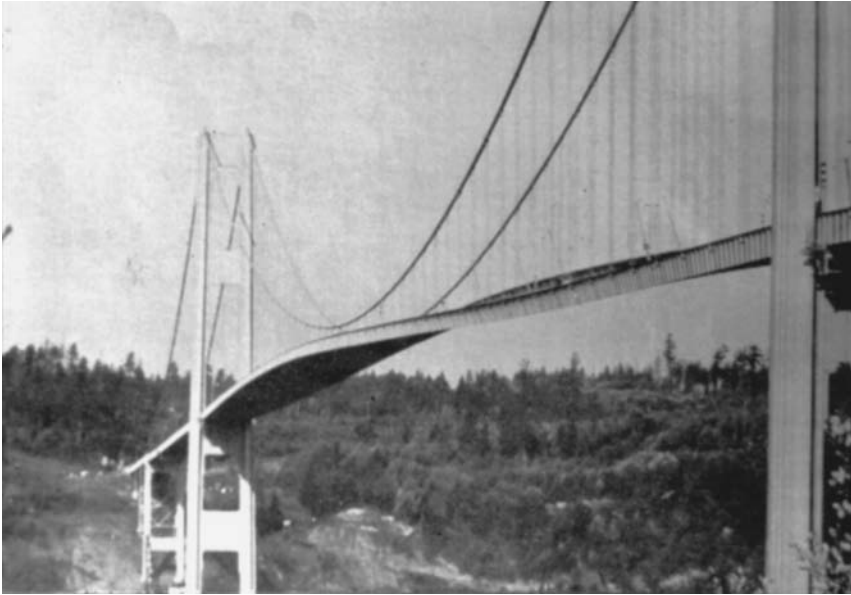
Fig. 7.4 The twisting motion of the main span. (University of Washington Libraries, Special Collections, UW 21413)

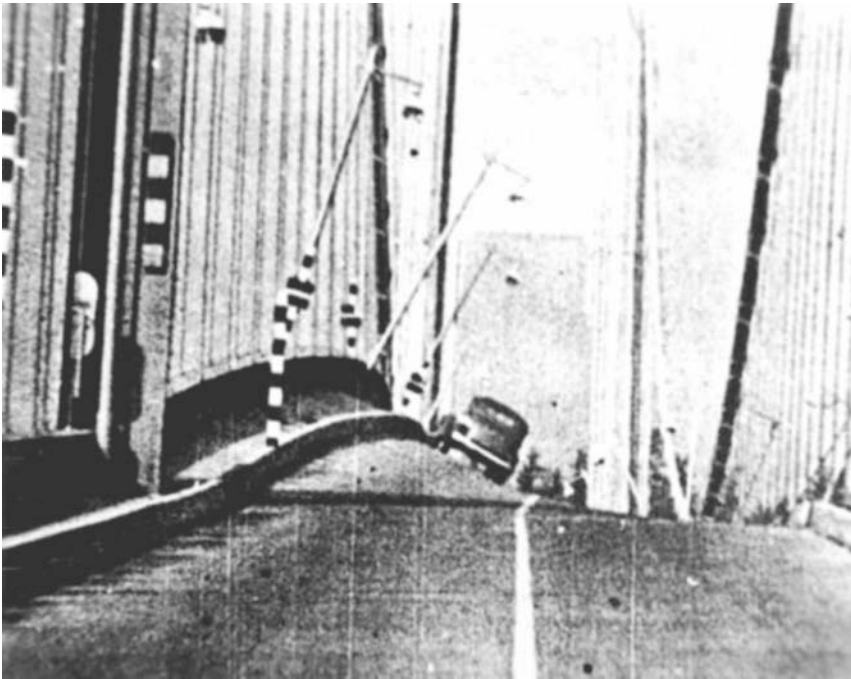
"The motion pictures of the twisting span are unforgettable, and the distortions they depict, in character and magnitude, are almost unbelievable. The span twists in gigantic waves, and it is difficult to realize that the girders were made, not of rubber, but of structural steel having a modulus of elasticity of 29,000,000 pounds per square inch (200,000 MPa)." (Fig. 7.5).

Fig. 7.5 A still from a classic live film of the twisting span, showing a car left out on the bridge, abandoned by a newspaper reporter. (University of Washington Libraries, Special Collections, UW 21429)

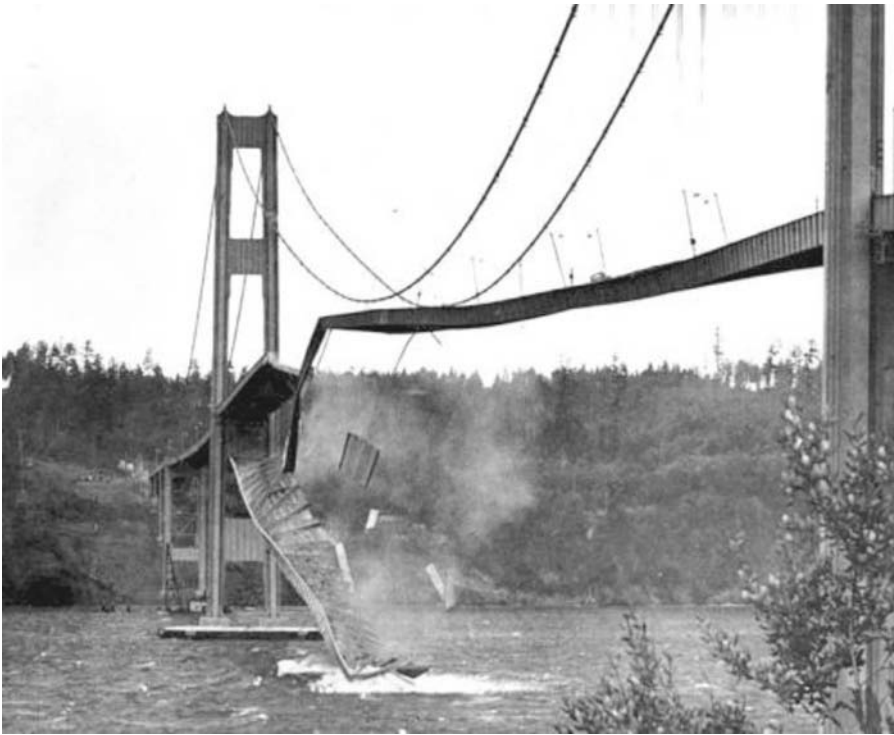
"For a half hour and more, the steelwork and concrete slab took this terrific punishment. Something was bound to give way. At 10:30 came the first break: one floor panel at mid-span broke out and dropped into the water 208 feet (63 m) below. The twisting, writhing motion continued. Spectators on the shores were herded to a safer distance away from the span. At 11 A.M. the real breaking up of the span occurred; 600 feet (183 m) of the main span near the west quarter-point tore away from the suspenders, the girders ripping away from the floor like a zipper; part of the falling bridge floor turned upside down before the entire falling mass hit the water, sending up spray to a great height." (Fig. 7.6).

Fig. 7.6 The first part of the collapse, where 183 metres of the main span tore away from the vertical hangers (suspenders) and fell into the waters below. (University of Washington Libraries, Special Collections, UW 21422)

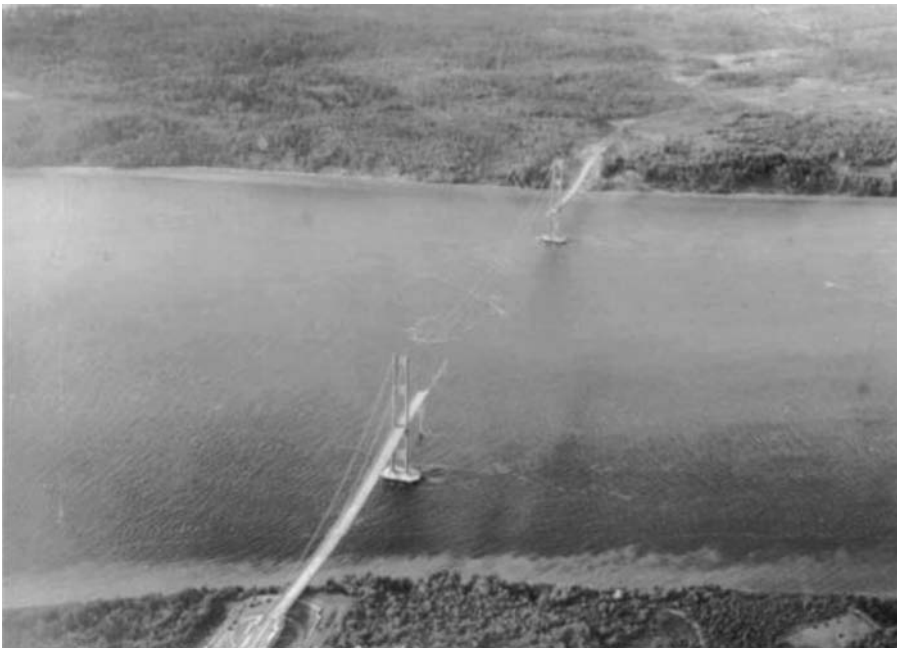
Apart from some short ends of the bridge deck only the two suspension cables remained of the main span (Fig. 7.8).

Fig. 7.8 The collapsed Tacoma Narrows Bridge – aerial view looking west, a rather sad and dreary sight. (University of Washington Libraries, Special Collections, UW 26818z)

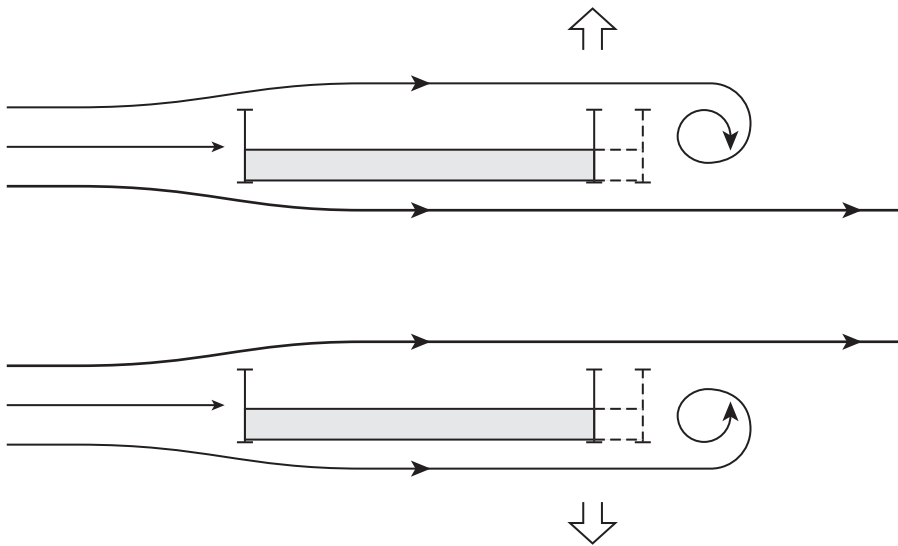
Fig. 7.9 Vortex shedding at a steady air flow.

The committee concluded that the bridge had been properly designed according to the present codes, and with adequate stiffness and strength for *static* wind pressure – for wind speeds close to three times more than the wind of that fatal morning in November 1940 – however, not taking into consideration the possibility of *aerodynamic instability*. Wind tunnel testing confirmed that the bridge was very susceptible to a phenomenon known as vortex shedding (at least known to aerodynamicists at that time). A cross-section such as the Tacoma Bridge deck – having a small width in relation to its length, and a very flexible stiffening girder, consisting of solid web plates – is especially sensitive to the formation of vortices (whirlpools) in a steady air flow, which appear at regular interval (i.e. at a constant frequency) at the back of the deck (on the leeward side). This phenomenon creates alternating suction in the transverse direction to the wind, perpendicular to the bridge deck, subjecting it to pulling forces up and down (in the vertical direction) at regular frequency, while, at the same time, the bridge is pushed horizontally by the steady wind (Fig. 7.9).

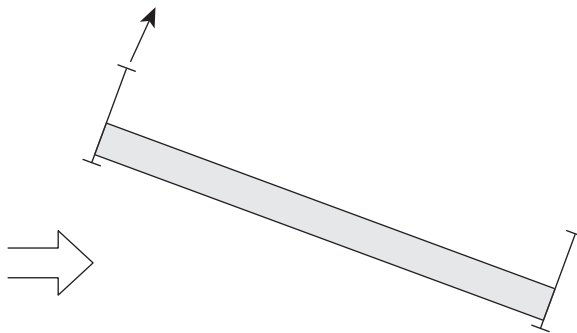
As the torsional deformation of the deck well has started then there is also a tendency of the wind acting as a driving force, as the surface of the deck is exposed (however, in the opposite direction the wind is stabilizing – pushing down instead of pushing up) (Fig. 7.14).

Fig. 7.14 Wind acting as a driving force with respect to torsional oscillation.

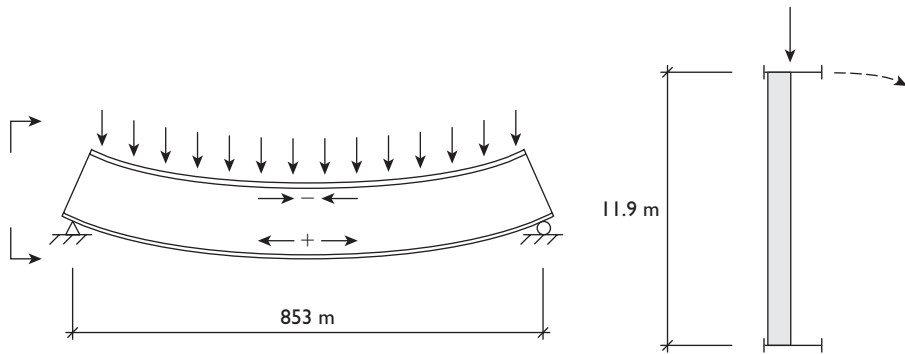
A triggering factor with respect to the torsional oscillations – besides vortex shedding – may also have been a phenomenon which is called lateral/torsional buckling. As the wind is pushing the bridge deck horizontally, the two end girders act as two flanges – separated apart by the deck – in a deep beam (which is on the flat). Compression stresses are formed in the end girder at the windward side and tension stresses in the other end girder at the leeward side, and the compression flange could buckle transverse to the wind loading direction (if the wind is strong enough that is) (Fig. 7.15).

Fig. 7.15 The 853 metre long bridge deck as a simply supported deep beam (should in fact be continuous in three spans), with possible lateral/torsional buckling risk.

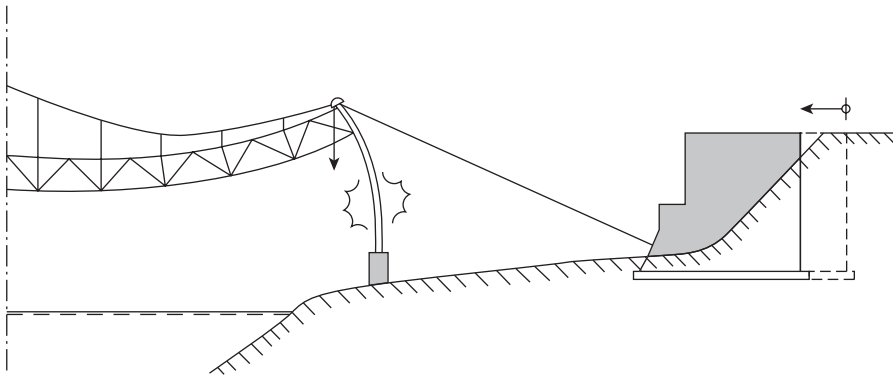
Whether the actual slide of the north abutment was because of a reduced capacity to resist the pulling force of the cables – because of the saturation of the ground – or that a landslide had been initiated, taking the abutment and the surrounding soil (or perhaps even the mudstone) with it, has not to this day been established. The actual collapse sequence was, however, as follows; as the abutment slid forward the cables slackened – transferring the self-weight of the end span to the end span itself (which deflected just as the end span of the Tacoma Narrows Bridge did – see Fig. 7.7 for comparison – however, this time not because of the lack of counterbalancing weight from a collapsed main span). The cable bent became eccentrically loaded and deformed heavily under the combined action of bending and axial normal force, which made it buckle and break (Fig. 8.12).

Fig. 8.12 The deformation of the cable bent as the abutment slid.

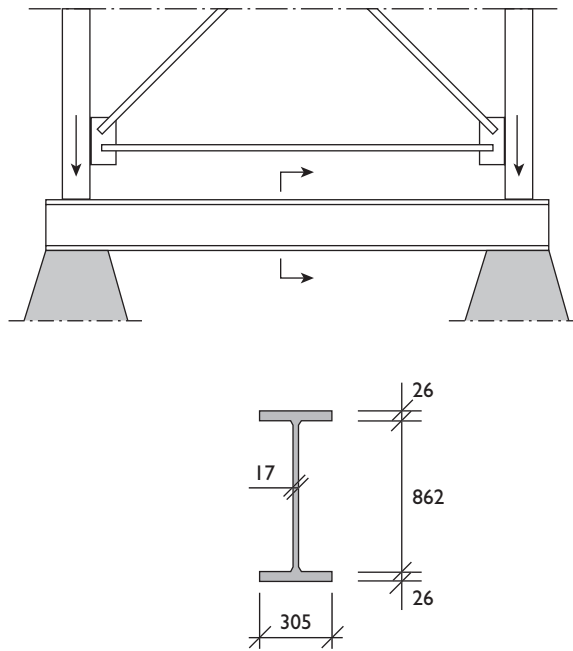
When the anchor span fell the adjacent span also collapsed, as it lost its support when the pier was pulled away. A total of 18 workmen and engineers were killed. A Royal Commission of Inquiry investigated the cause of the collapse and soon found the answer. It was not the buckling capacity of the temporary truss that was inadequate, as could have been expected; instead it was found that the lower transverse beam at the bottom of the falsework truss had failed. The purpose of this beam was to distribute the concentrated load – coming from the vertical members of the truss – in order to spread it over a larger area on top of the piles. The profile – or profiles, for there were probably more than one, lying parallel close to each other as a grillage – was a wide-flanged rolled standard steel girder (36 WF 160) (Fig. 9.5).

Fig. 9.5 Cross-section of the transverse girder.

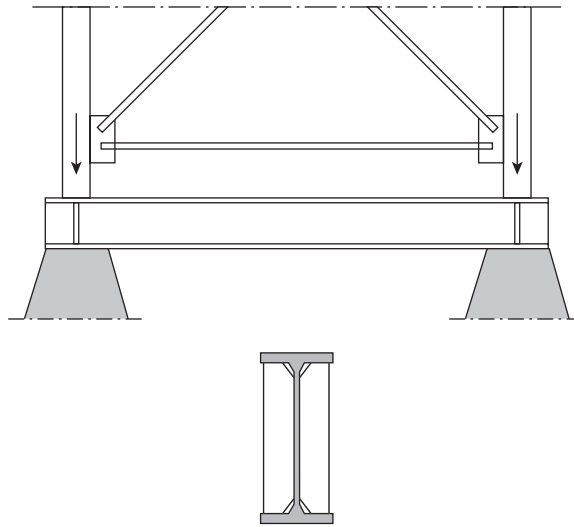
Fig. 9.9 Vertical web stiffeners at the load application points would have saved the bridge, but were unfortunately missing.

A couple of two small web stiffeners at each end of the transverse girder should have saved the bridge (stabilizing the web and the upper flange in these locations (Fig. 9.9).

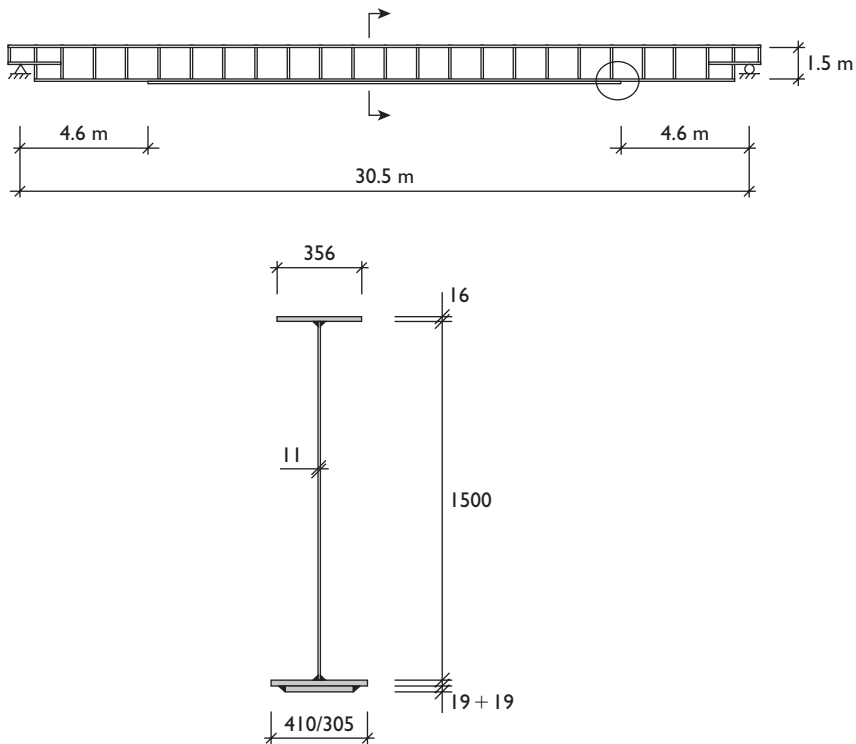
Fig. 10.3 Elevation and cross-section of the *outer* girders of the second span on the south end of the bridge. The inner girders had 356 millimetre wide cover plates, which were terminated 5.3 metres (instead of 4.6 metres) from the ends.

winter's morning, as a 45-ton heavy vehicle was passing over the second span on the western carriageway – having approached the bridge from the south – this span broke and collapsed. The span was 30.5 metre long and the I-girders were reinforced by extra cover plates attached to the tension flange in the maximum-moment region (Fig. 10.3).

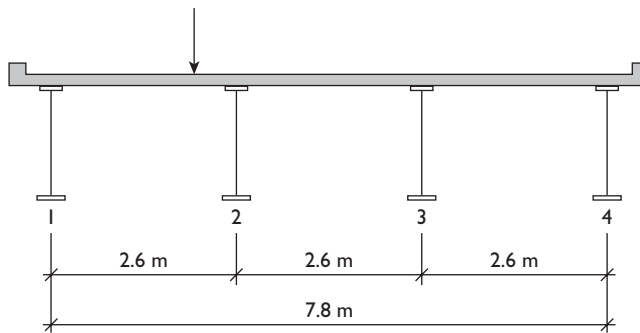
When the lorry passed over the second span on the western carriageway the position was in between girders number one and two (Fig. 10.5).

Fig. 10.5 Cross-section of the second span on the south end of the Kings Bridge, and the approximate position of the lorry that initiated the collapse.
