Understanding Bridge Collapses

Björn Åkesson

Consulting Engineer, Fagersta, Sweden

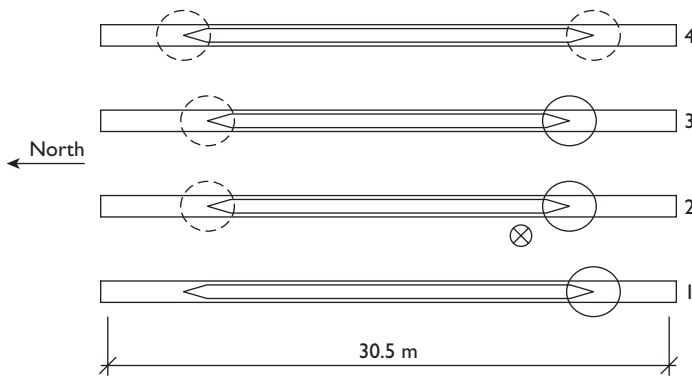
In three positions the crack was complete, i.e. had propagated across the entire depth of the girder (the south ends of girder No. 1, 2 and 3) and in four positions the crack had arrested in the web below the upper flange (the south end of girder No. 4, and the north ends of girder No. 2, 3 and 4) (Fig. 10.8).

Fig. 10.8 Complete fracture in the south ends of girder No. 1, 2 and 3, and partial fracture of the south end of girder No. 4 and of the north ends of girder No. 2, 3 and 4. For the sake of simplicity the flanges have been turned upside down – the flange widths have also been enlarged (in relation to the span length).

existing cracks had in general a width equal to the width of the cover plate end (i.e. 80 mm) and extended as far as through the flange plate and 25 millimetres up into the web. In one case though, at the south end of girder No. 2, the crack had propagated a long distance up into the web (1100 mm), as well as having fractured the entire lower flange – thus having a load-carrying capacity being more or less completely gone already from the start (or perhaps more probable, some time during the first winter, that is, in 1961). At the time of the failure of the span, one year later, the three remaining intact girders were not able to carry the heavy load so they broke (at the same time as the net-section of girder No. 2's south end also broke). The combined effect of a heavy vehicle, impact loading, existing cracks and low temperature (it was $+7^{\circ}\text{C}$ that morning, and $+2^{\circ}\text{C}$ during the night) made the girders break. The Royal commission

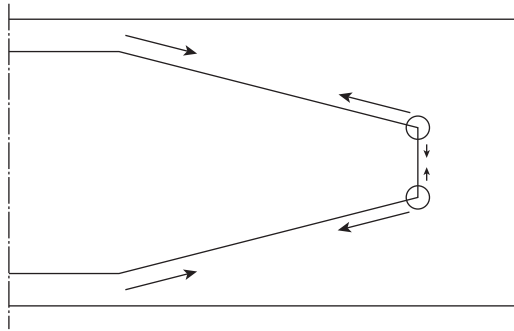
When the weld cools, and the contraction is restrained by the surrounding cold metal, small micro-cracks will form (as well as the forming of residual tensile stresses – counterbalanced by residual compressive stresses in the surrounding metal). One way of limiting the formation of these cracks (and the residual stresses) is to preheat the metal pieces to be joined; however, regions which still are especially prone to crack are corners, because of the combined effect of the start/stop-procedure of the welding and the restrained contraction thereafter during cooling (Fig. 10.11).

Fig. 10.11 The corner regions, where the probability for crack initiation is the highest. Here the combined effect of residual tensile stresses in the transverse and longitudinal direction is the highest.

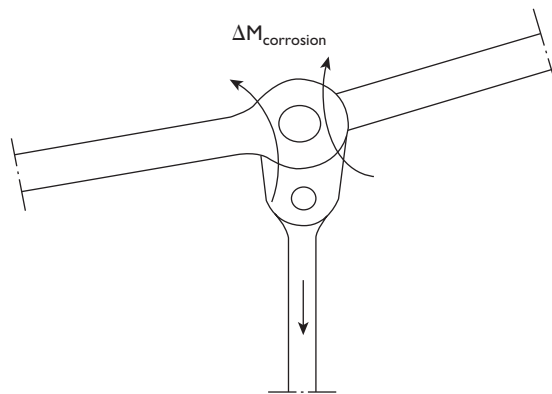
In an almost 40-year-old structure, where the maintenance was said to have been poor, there was also the possibility that adjacent eye-bar plate surfaces in the upper hanger joints (see also Fig. 11.8) had rusted stuck. If this was the case then rotation

of the eye-bar elements would have been prevented, introducing secondary bending stresses into the joint (as well as to the eye-bars) as soon as traffic load was carried by the hanger (Fig. 11.13).

Fig. 11.13 Secondary bending stresses are introduced if the joint has rusted stuck.

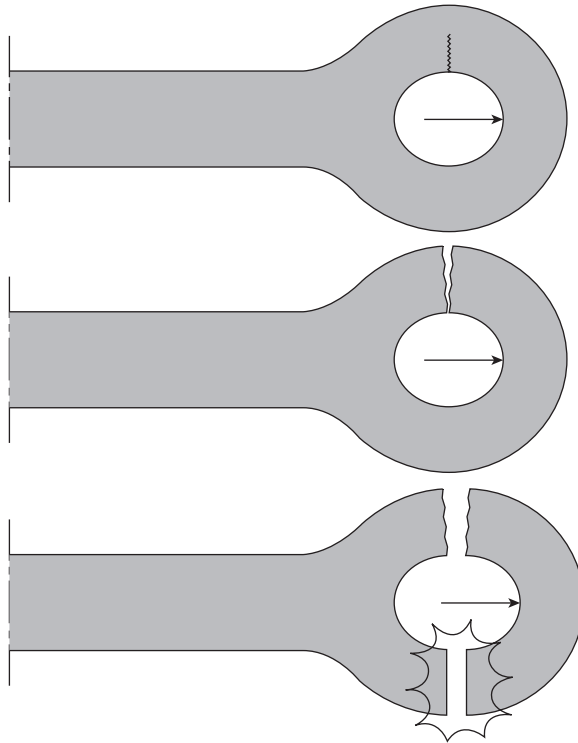
The most probable failure sequence was as follows; a fatigue crack in the upper portion of the eye-bar end (see Fig. 11.12) continued to grow upwards, perpendicular to the applied tensile stress (see Fig. 11.9), for each new loading cycle (of heavy vehicles passing the bridge) – gradually increasing the stress concentration effect (and hence the crack propagation rate) – until, finally, it reached a certain critical length and net-section (brittle) failure of the upper half occurred. The entire load was then carried by the lower portion, which deformed rapidly under the combined action of tension and bending, and broke more or less immediately in a brittle manner (Fig. 11.15).

As all the loading was then transferred to the remaining and intact eye-bar this had to carry twice the load as before, and above all, being now eccentrically loaded. It did not take that many additional loading cycles before it had worked itself free from the pin, resulting in the complete separation of the chain link, and the eventual collapse of the entire bridge. There were many other highly stressed locations though on the eye-bar chain link that could have preceded the failure of this particular member, but the combined effect of high repeated loading (not necessarily the highest), corrosion that both increased the sliding friction between hole edge and pin, and that prevented rotation of the joint that produced secondary bending stresses, and above all, the existence of a flaw in the material at the region where the stress concentration effect was the highest – the last parameter being the most important one in explaining why there is such a high uncertainty to pinpoint an exact crack location point. But then, the failure *had* to come at the north side of the bridge as only two out of three possible lanes were in use – the south side lane was transferred into a sidewalk, so the traffic

Fig. 11.15 A probable failure sequence.

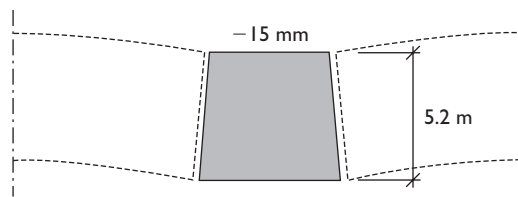
When the two cantilever ends met in the middle, the final section had to be adjusted due to the temperature deformations the bridge had been subjected to during the day. The weather had been sunny and warm, which made the bridge, in addition to the elastic bending deformations, to bend down a little bit extra. The final closing section had to be shortened 15 mm at the top (due to this additional temperature deformation) in order to fit into the gap between the cantilever ends (Fig. 12.6).

Fig. 12.6 The final closing section in the centre part had to be adjusted due to temperature deformations in the bridge.

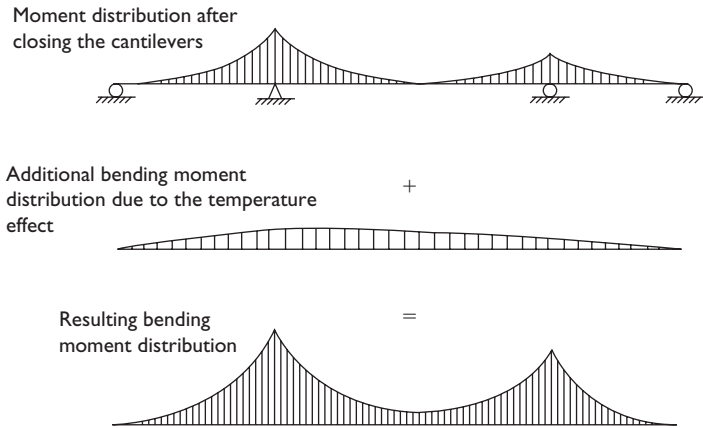
In the late afternoon, when the two cantilever ends had been joined, there was, however, not enough time left to lower the inner supports, instead it was decided to wait until the next working day. Due to the temperature deformations described above, there was a situation in the evening that had given an *increase* in the temporary moment distribution, instead of the desired decrease that would be the case if the supports had been lowered (Fig. 12.8).

By the unfortunate decision of not immediately lowering the inner supports, and the unlucky effect from the temperature drop, there was a situation – the night of 6 November – where the lower flange was subjected to *compression* over the entire length of the bridge (due to the negative bending moment). This fact, together with

Fig. 12.8 The *resulting* moment distribution due to the temperature effect (*before* the intended lowering of the inner supports).

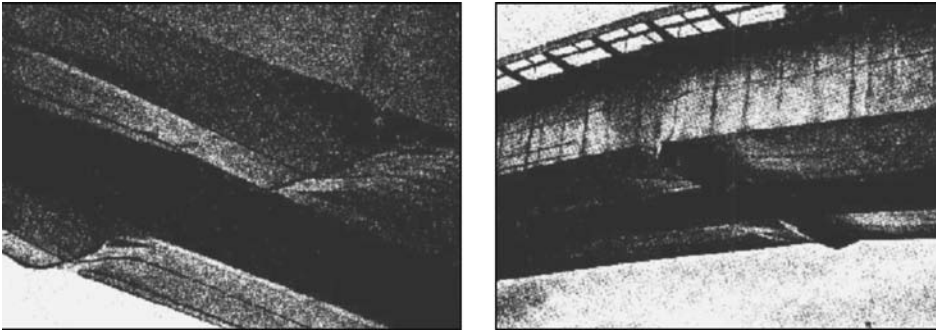
Fig. 12.10 The parts having the major buckles – close to the inner support of the main span, and in the centre part of the first span. (Aurell/Englöv: Olyckor vid montering av stora lådbroar. Väg- och Vattenbyggaren)

The buckle in the central region of the inner span came where the final section was located, however, this piece was not severely damaged (even though this section was not as strong as the rest of the bridge, due to the fact that it was assembled without the lower and upper flange plates, i.e. having only four vertical web plates). The other two buckles – the one in the main span close to the right-hand inner support (the farthest to the right), and the one in the centre part of the first span – were, however, so large that more or less true hinges were formed in these positions (inwards going buckles in the vertical web plates, and outwards going – V-shaped – buckles in the lower flanges). In the detail photos one could see the proportion of the damages in these two locations (Fig. 12.10).

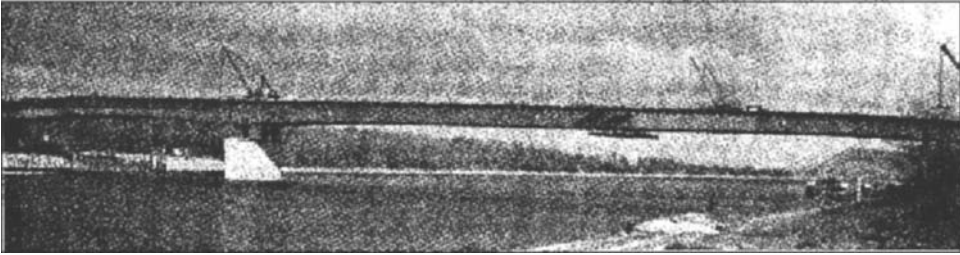
In the photo of the bridge below, the deformed and upwards bent outer span can be seen to the left, as well as the downwards deflected main span (compare this deformation to the mechanism in Fig. 12.14) (Fig. 12.11).

Fig. 12.11 The downwards deflected main span and the upward bent outer span (to the left). (Aurell/Englöv: Olyckor vid montering av stora lådbroar. Väg- och Vattenbyggaren)

Thanks to the inbuilt damage tolerance of the system (read: robustness) the bridge could be saved, even though it was heavily distorted, and was later taken into use again (after replacing the damaged parts). The rebuilt bridge, which today goes under the name of the Prater Bridge, obtained a permanent settlement of about 700 mm in mid-span of the centre span (read: a reduced camber) as a direct consequence of the damages.

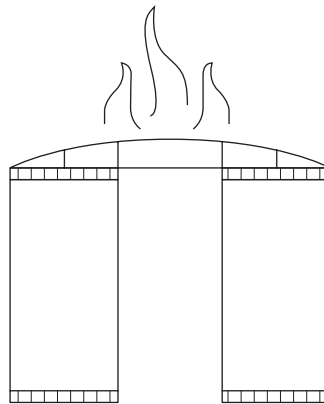
Fig. 13.12 The wooden roof, which protected the two tubes, was put on fire.

modern box-girder bridges were built, mainly in post-war Germany. The Britannia Bridge carried heavy and modern traffic loading without having to be strengthened, and continued to do so until 1970 (after 120 years of faithful service), when the wooden roof – which had been added to the original structure to protect against rain – accidentally was put on fire. On the evening of 23 May 1970, two boys, looking for bats close to the entrance at the south end of the bridge (at the mainland), dropped a burning torch which first ignited the tar-coated roofing felt, and then spread to the timber boards (Fig. 13.12).

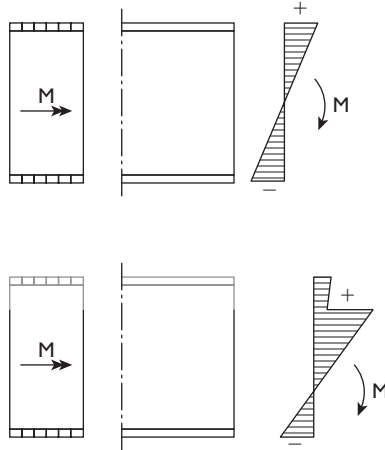
The two end spans had smaller deflections, but the two main spans were deflecting 49 and 71 centimetres respectively. The statically indeterminate system had been transformed into a statically *determinate* system (i.e. becoming four simply supported box girders, instead of the continuous system it originally was). Perhaps it was the decision by Stephenson in 1850 to prestress the tubes that saved the bridge from a total collapse (see Fig. 13.5). Possibly the sagging did not consist only of the spans being simply supported, but most probably irreversible plastic deformations due to the heating of the tubes contributed as well. As the upper part of the tubes (i.e. the top flange) was heated, the wrought iron material softened, resulting in a decrease in stiffness, which reduced the effective cross-section of the tubes as well as lowering the neutral axis. The stresses on the upper tension side (for the negative bending moment regions over the intermediate supports) thus increased markedly (Fig. 13.16).

As a result of this combined effect there is a high probability that the tension stresses exceeded the yield limit of the material, leaving irreversible plastic strain deformations in these parts. If the tension stresses were even higher it could also explain why these regions cracked open, but most certainly the cracking was due to restricted contraction during cooling (almost the same mechanism as why micro-cracks in welds are being formed). When the tubes became hot, and the deflections increased, this resulted in large tensile strains in the upper half of the tubes (over the supports). As the fire died out, and the wrought iron material wanted to contract, it was then restricted by

Fig. 13.16 As the upper part was heated, and lost its stiffness, the tension stresses for the negative bending moment regions increased – both because of the reduced net-section and also because of the neutral axis being lowered.

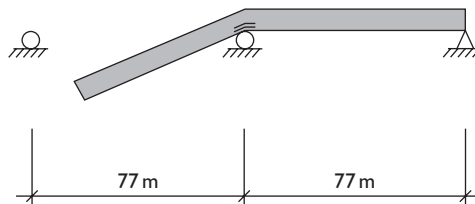
Fig. 14.4 Collapse of the second span on the south end of the bridge.

The designer, Freeman, Fox & Partners, had with great success a couple of years earlier used a trapezoidal cross-section at the construction of the Severn Bridge (a 988 metre long suspension bridge) and at the construction of the Wye Bridge (a 235 metre long cable-stayed bridge), and wanted to continue with this successful concept. The box-girder bridge cross-section of the Cleddau Bridge was – in contrast to the Fourth Danube Bridge – stiffened in the longitudinal direction by the use of more buckling stiff and torsion-rigid stiffeners. The assembly of the second span on the south end of the bridge, was just before the collapse cantilevering out 61 metres, and the final section (closing the gap of 77 metres) was just to be launched out as the bridge buckled over the inner support, and the huge arm fell 30 metres to the ground (killing four people) (Figs. 14.4 and 14.5).

Bridge had no such extra inbuilt safety during construction, as the system still was statically *determinate*. As soon as this hinge was produced (read: the buckling at the inner support) a mechanism became the result. At the investigation it was established that an inadequately stiffened diaphragm had initiated the buckling over the support.

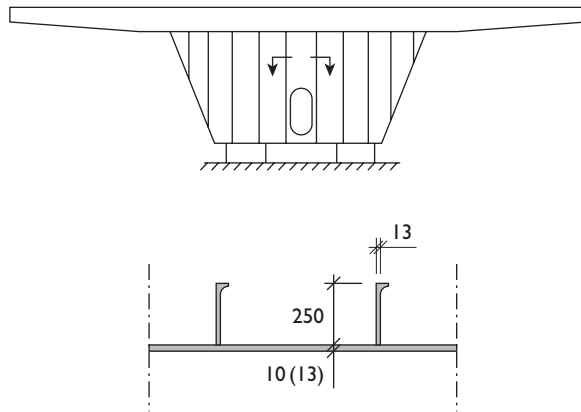
Diaphragms are made up of a solid plate in box-girder bridges (having for a centrally located manhole though, for the passage of inspection personnel), and these are positioned at a regular interval in the longitudinal direction (normally 8–12 m) in order to ensure a sufficient torsional stiffness of the cross-section. The diaphragms are stiffened, especially over the supports, as they are in these positions subjected to large concentrated forces. In the Cleddau Bridge, the diaphragm plate was stiffened with so-called bulb-flat stiffeners, having the dimension $250 \times 13 \text{ mm}^2$. The plate itself was 10 mm thick in between the bearings, and 13 mm locally over the bearings and for the inclined outer parts (Fig. 14.6).

Fig. 14.6 The stiffened diaphragm plate of the box-girder over the inner support.

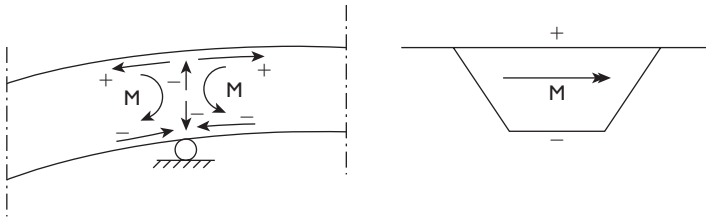
Fig. 14.11 Additional vertical reaction force (in the diaphragm plate) was induced due to the curvature effect.

Besides the two-axial stress state – due to the transfer of the shear force from the inclined webs – there were a number of other factors that even more increased the stresses over the support. There was, for example, the additional compression in the diaphragm plate caused by the curvature (coming from the bending deformations because of the deflection of the cantilever arm) (Fig. 14.11).

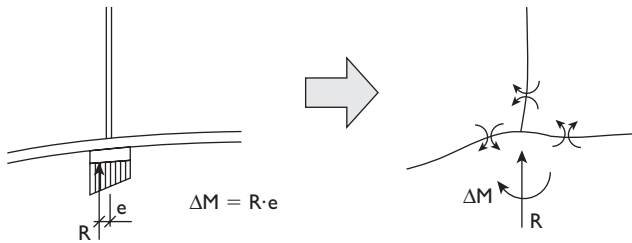
Fig. 14.12 Eccentric loading of the bearing pad induced local bending in the lower flange plate and in the diaphragm plate.

In addition, the 40 mm wide bearing plate also became eccentrically loaded as a local eccentricity was induced because of the curvature. This eccentricity made the lower flange plate (of the box-girder cross-section) and the diaphragm wall to become subjected to a bending rotation (Fig. 14.12).

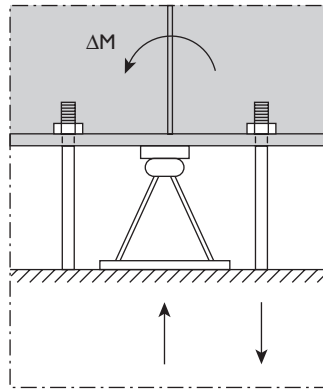
In the investigation it was also found that the “holding-down bolts” – which at a later stage of the erection (cantilevering of the third span) should prevent lifting of the bearings – had been tightened. The effect of this tightening probably made the supports becoming fixed, which additionally increased the vertical reaction force over the supports (Fig. 14.13).

Fig. 14.13 Tightening the bolts (which were needed in holding down the box-girder bridge first when cantilevering out the *third* span) already at this early stage meant that an additional reaction force was introduced (due to the clamped condition).

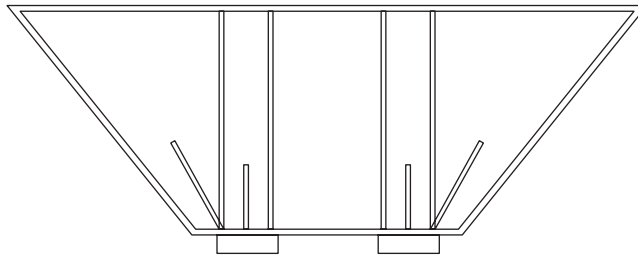
Fig. 14.14 The configuration of a *modern* box-girder bridge diaphragm plate, having extra stiffeners in the highly stressed regions.

All these effects taken together created excessive loading of the diaphragm locally over the supports, which made the diaphragm plate and its stiffeners buckle, followed by the buckling of the web plates, and ultimately the collapse of the entire cross-section. The design codes at that time was quite clearly inadequate with respect to proper construction of diaphragm plates, and the designers were also not fully aware of the complexity regarding the action of the same. Today the diaphragms are not only having larger thicknesses and stronger stiffeners, they are also locally provided with extra stiffeners where the stress concentrations are the highest (Fig. 14.14).

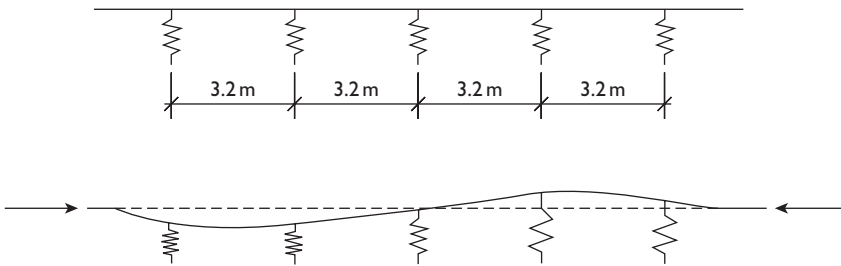
Fig. 15.10 Buckling of the longitudinal stiffener, being supported by flexible transverse cross-beams.

longitudinal stiffener (closest to the free edge) had buckled, due to the flexibility of the transverse cross-beams (which did not act as rigid supports, as they were flexible cantilevers) (Fig. 15.10).

This flexibility of the transverse cross-beams made the longitudinal stiffener have a buckling length longer than the distance between the cross-beams. The deflections of the cross-beams were 50–75 millimetre, and it was this flexibility that contributed to the buckling of the plate edge, and also explains why the deflection of the same became as large as 380 millimetre. In addition, a weak splice of the longitudinal stiffener also contributed to the reduced buckling strength. Each 16 metres the longitudinal stiffeners were spliced by using a simple single-lap joint, having a rectangular plate $100 \times 12.5 \text{ mm}^2$ overlapping the two bulb-flat stiffener edges. By this choice of configuration a local weakness was inserted – the overlapping plate was not only smaller in dimension (than the bulb flat stiffeners), it was also eccentrically positioned, and last, but not least, not welded to the upper flange plate, which made it less strong in the transverse out-of-plane direction (the same applies for the deck plate). This detail had thus a markedly reduced strength in transferring axial load from one end of a longitudinal stiffener to the other (Fig. 15.11).

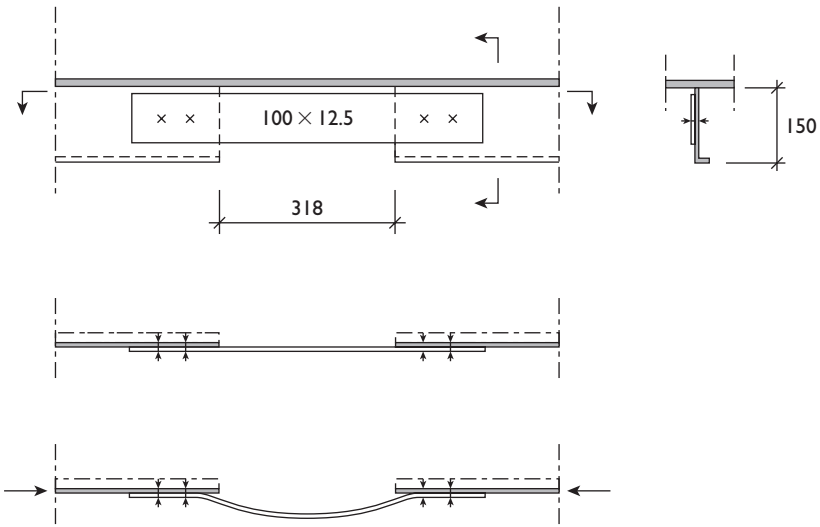
Fig. 15.11 The rather weak detailing of the longitudinal stiffener splices (each 16 metres).

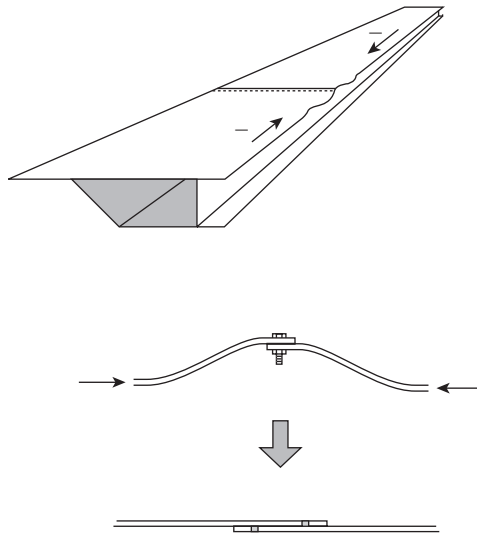
Fig. 15.12 By removing the bolts in transverse splices (of the deck plate) the buckles were removed when the plates slipped under each other.

order to “relieve” the inbuilt stresses, which were the cause of the buckling – the plates would then slip under each other, and by doing so straighten out the buckled plate. This was a step that worked quite satisfactorily for the east span (Fig. 15.12).

New holes had to be drilled – or the enlargement or re-drilling of already existing – in order for the bolts to be inserted again (note that the size of the buckle and consequently the slip between the plates is heavily exaggerated in the drawing above).

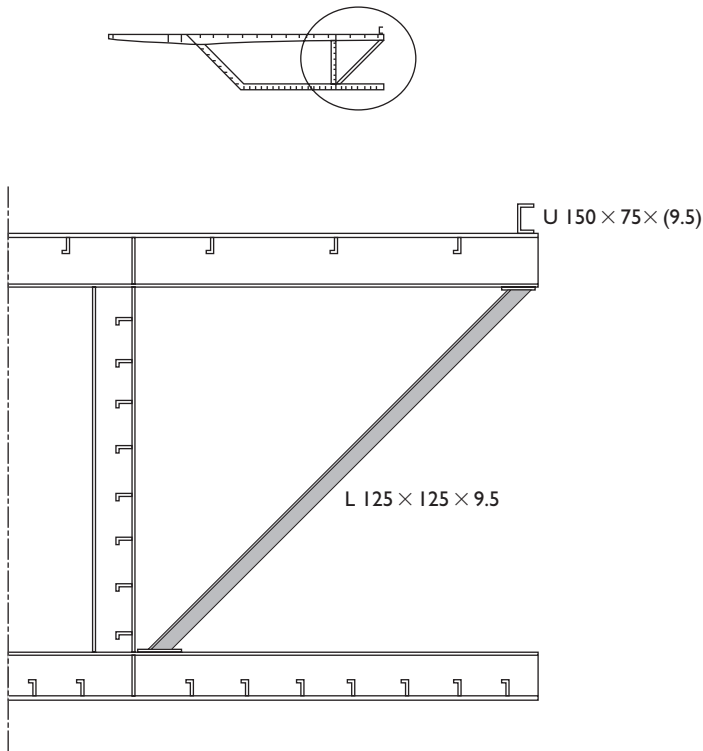
Fig. 15.13 The upper flange edges of the bridge halves on the west side were stiffened by an extra longitudinal, and the transverse cross-beams were supported by an additional diagonal.

For the continued assembly of the bridge halves on the *west* side, the free flange edges were stiffened with an extra longitudinal, and each cross-beam was supported by a diagonal – all due to the lessons made from the buckling of the east girder span (Fig. 15.13).

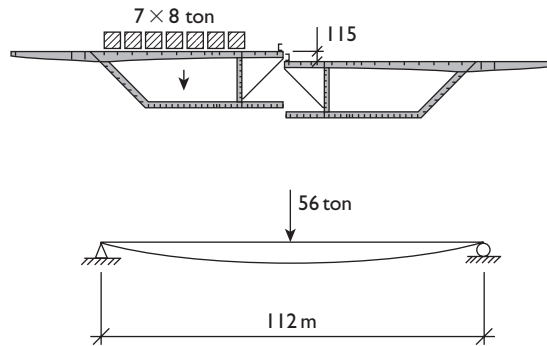
At the assembly of the west girder halves in the air, this extra reinforcement proved to be efficient, and there was initially no problem with buckling of the upper flange. Instead another problem arose when the two halves were to be joined together – due to tolerances that were exceeded, and a difference in deflection, there was a vertical gap of 115 millimetres in mid-span between the two halves. There had been a similar problem also for the east span, however, due to a smaller distance the discrepancy was evened out by the help of jacks. A distance of 115 millimetres was too much for jacks to even out, so they had to come up with another idea this time. Unfortunately then somebody suggested that heavy concrete blocks were to be placed in mid-span on the girder half to be deflecting down (Fig. 15.14).

The extra strengthening of the free edge – that showed to be sufficient for loading coming from self-weight alone – showed to be *insufficient* for the additional loading coming from this temporary loading of the concrete blocks (the bending moment in

Fig. 15.14 An extra loading of 56 tons was put on one of the girder halves to even out the difference in deflection.

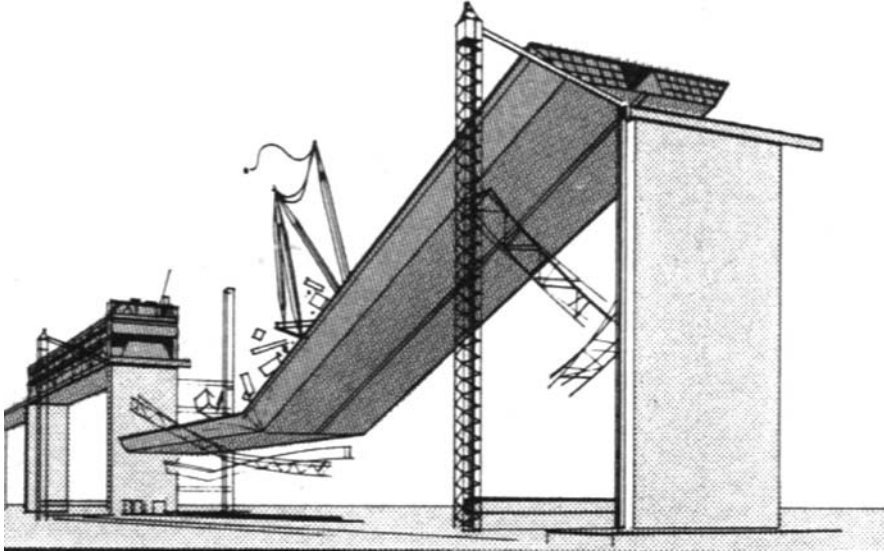
Fig. 15.17 A vivid drawing of the actual collapse. See also the back cover illustration. (Paul: När den stora bron rasade. Det Bästa 1972)

one by one – the difference though, in comparison to the east span, being that the buckle was much larger now and the loading heavier. As more and more bolts were removed, the stress increased on the remaining active part of the upper flange of the bridge – not only due to the loss of cross-sectional area, but also due to the gradual lowering of the neutral axis. After 16 bolts had been removed, there was a visible reduction of the buckles (through slipping of the plates), but there was also the effect that some of the remaining bolts were squeezed tight – because of the increased upper flange stress – which made the continued loosening more troublesome. When 37 bolts had been removed the inevitable collapse of the cross-section started – a buckle spread in the transverse direction (across the width of the bridge) due to the overloading of the net section, and the vertical web also buckled in its upper part (where it was subjected to compression). The remaining bolts of the upper flange sheared off due to the excessive shearing forces between the plates, and this was followed by a slow sinking of the left-hand bridge half (compare Fig. 15.15), which was now carried by the right-hand bridge half (the intact half) alone as there had been some connecting of the two halves earlier. However, as the loading of this right-hand bridge half also became too much for it to carry, it gave way for the excessive loading and the entire bridge fell some 50 metres to the ground – 36 people were killed on this tragic accident 15 October 1970. Just

as the case was for the Cleddau Bridge in Milford Haven – where the buckling of the diaphragm produced a hinge that transformed the statically determinate system into a mechanism – this “man-made” hinge made the simply supported girder span of the West Gate Bridge collapse to the ground (the clearly visible hinge – as folding of the upper flange – can also be seen in the photo in Fig. 15.18) (Figs. 15.16, 15.17 and 15.18).

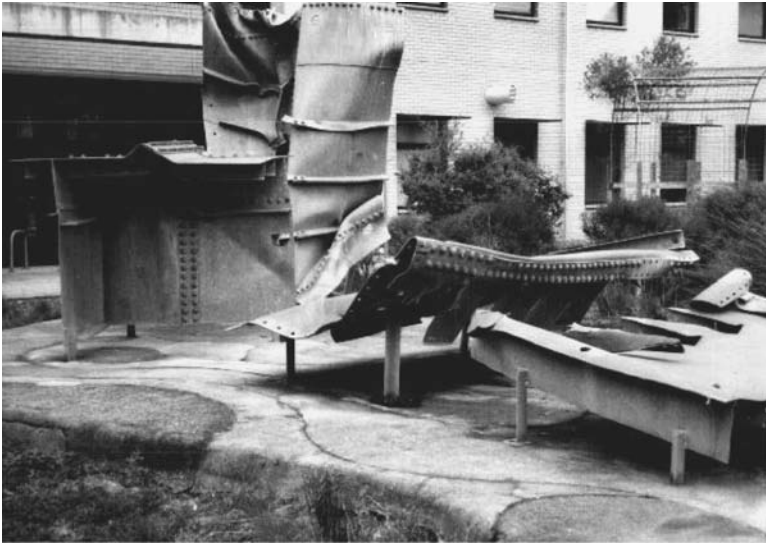
Fig. 15.20 Some removed and saved parts from the collapsed West Gate Bridge at Monash University in Melbourne, Australia. (With kind permission of Bo Edlund)

If you ever visit The Monash University, Department of Civil Engineering, in Melbourne, then take the opportunity to study some of the remaining parts from The West Gate Bridge. Some “scrap pieces” have been saved there, outside the building, as a reminder of the importance of remembering bridge failures, and to learn from the mistakes made. On the left in the photo one can, for example, see the buckled deck plate at the longitudinal stiffener splice (Fig. 15.20).

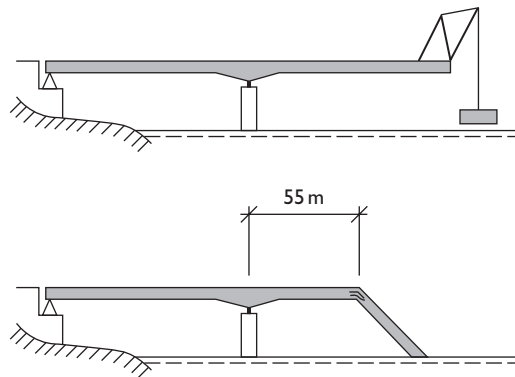
Fig. 16.4 During erection of the main span – using the free cantilevering technique – the cantilever arm buckled approximately half-way out and fell into the River Rhine.

In order to minimize the obstruction to boat traffic, it was chosen to cantilever out the centre span from both directions (just as for the Danube Bridge). The cantilever arm was about 100 metres long, and it was only the erection of the final section remaining (an 18 metre high lift of a 16 metre long and 85 ton bridge element from the water level), as the cantilever arm collapsed approximately halfway out (Figs. 16.4 and 16.5).

The negative bending moment in the cantilever arm, because of the loading coming from from the self-weight of the girder, the weight of the crane, and the new girder element (plus the additional inertia forces as the cantilever arm must be assumed to have been set in swaying), created too much compression for the lower flange to carry, which buckled and transformed the statically determinate system into a mechanism.

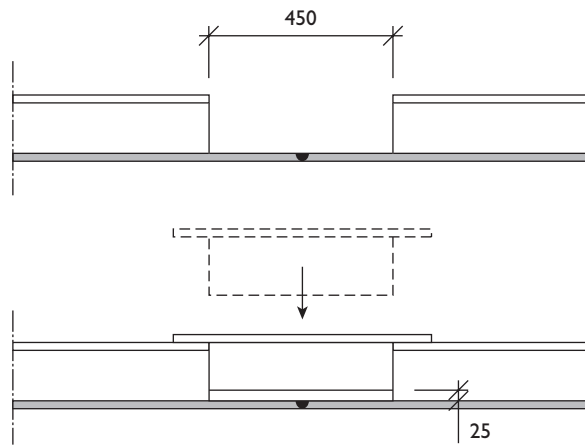
As the longitudinal stiffeners were to be made intact again (i.e. continuous over the joint), the choice was to “hang” a T-profile on to the edges of two adjacent stiffeners, instead of filling the gap with an exact profile. The intention was (and quite rightly so, looking at the problem from one point of view) to avoid crossing welds which is a weakening factor concerning fatigue and brittle fracture strength (Fig. 16.7).

This choice of configuration created a free vertical distance of 25 millimetre between the inserted profile and the flange plate, which unfortunately did show to be the direct reason why buckling was initiated. Almost the same type of splice had been used at the West Gate Bridge (see Fig. 15.11), however, not being the “triggering factor” for the collapse (as it did show to be here).

Fig. 16.7 The unfortunate choice of splicing longitudinal stiffeners.

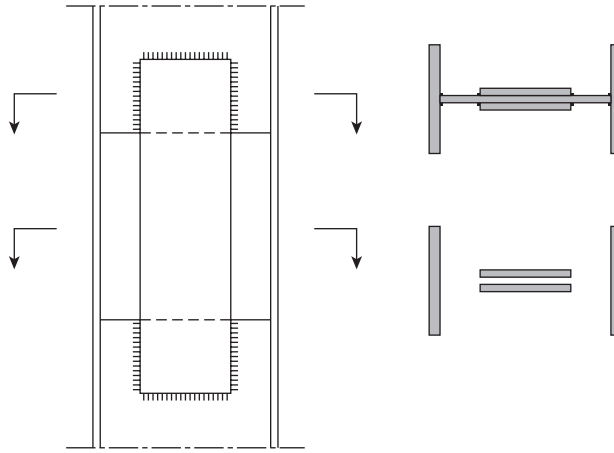
Fig. 16.9 A simplified model that could be used to explain and to understand the behaviour of the weak splicing of the longitudinal stiffeners in the box-girder bridge bottom flange – an axially loaded column having the web spliced with two cover plates over a free gap.

cross-section. As a similitude one can consider a column, that has a very special splice where the web is missing, and that the web has been replaced with two separate cover plates (Fig. 16.9).

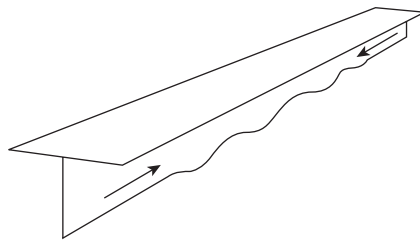
Fig. 16.12 The free and unstiffened lower edge of the inserted T-profile (in the gap) was a weak part with respect to normal stress buckling.

An additional effect, that also most certainly was not considered, was the weakness of the inserted T-profile, which had a an outstanding vertical part that was free and unsupported, and this made it prone for normal stress buckling along its lower edge (just as the case was for the free flange edge of the West Gate Bridge girder halves) (Fig. 16.12).

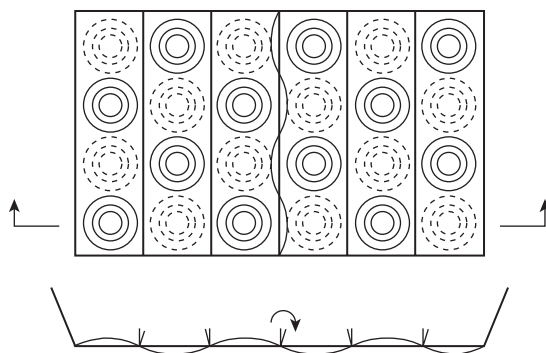
Fig. 17.14 The sine-wave buckling pattern in the flange plate has the effect on the longitudinal stiffeners that they tend to rotate in a sine-wave pattern as well.

From the results we see that the longitudinal stiffeners also were given too small dimensions, so the bridge was quite clearly doomed to fail during erection. And even if consideration is made regarding a more refined global buckling model – where for example the influence of the stiffening effect from the flange plate in the transverse direction is taken into consideration – there are more reducing effects that have to be considered which *lower* the load-carrying capacity. In order for a longitudinal stiffener to function as a rigid nodal point at buckling of the flange plate, it has not only to be sufficiently stiff in the out-of-plane direction (i.e. in the vertical direction relative the plane flange plate), but also be torsional stiff in order not to deform in the transverse direction due to the plate buckling (Fig. 17.14).

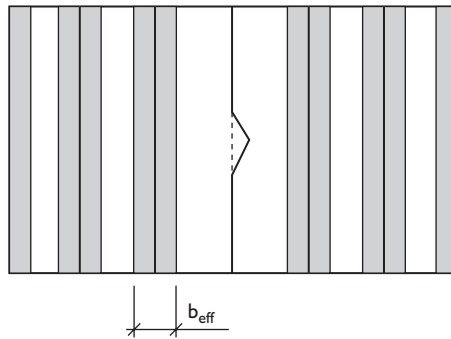
And if one longitudinal stiffener is eliminated, it also means that the total load-carrying capacity of the flange plate is reduced (as the effective width of the plate decreases) (Fig. 17.16).

Fig. 17.16 The negative effect on the overall ultimate load-carrying capacity of a stiffened plate because of a locally damaged stiffener.

Thus, the advice is never to choose flat bars as longitudinal stiffeners (as was done not only in the Zeulenroda Bridge, but also in the Fourth Danube Bridge, see Chapter 12) because of the above-mentioned reasons. Besides a negligible rotational (torsional)

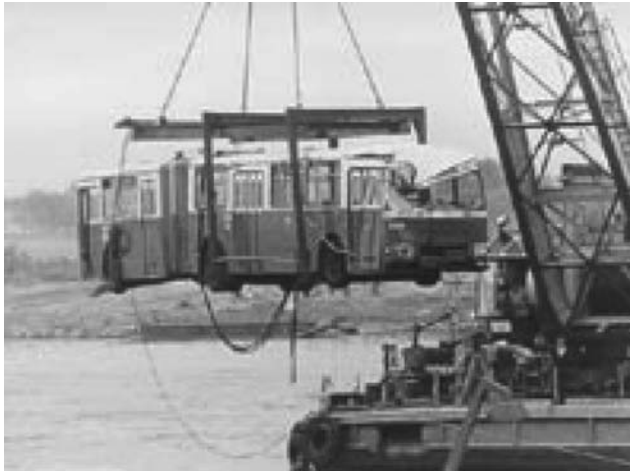
And yet another similarity to other bridges that have failed; just like the Tay Bridge, where the engine was saved and later put in use (see Chapter 3, Fig. 3.22), the bus on the Reichsbrücke the morning the bridge collapsed was salvaged, repaired and again taken into service (whether or not the bus driver continued to drive the same bus the story does not tell) (Fig. 18.14).

Fig. 18.14 The bus that was salvaged from the Danube River.
(www.wien-vienna.at/geschichte.php?ID=737)

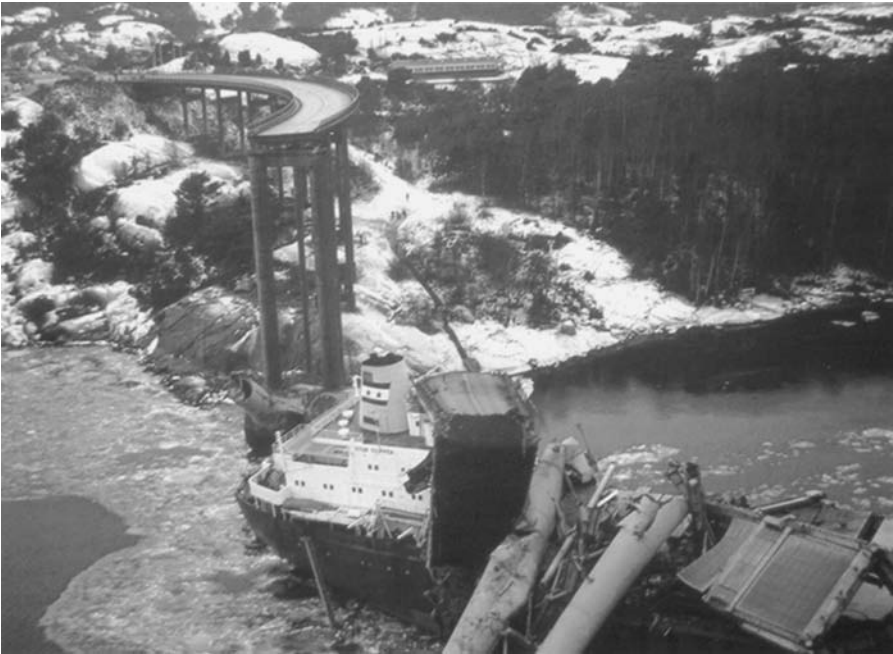
Uddevalla, hit the bridge only some 35 metres from the west abutment (i.e. on the Almö side) (Fig. 19.8).

To the despair of the ship's crew seven cars went over the edge before the traffic was stopped – the personnel tried in vain to warn the motorists by shooting signal rockets. Eight people died, and no one survived the fall into the water.

Fig. 19.8 The collapse of the Almö Bridge. (Tjörnbron. The Swedish National Road Administration. With kind permission of Lennart Lindblad)

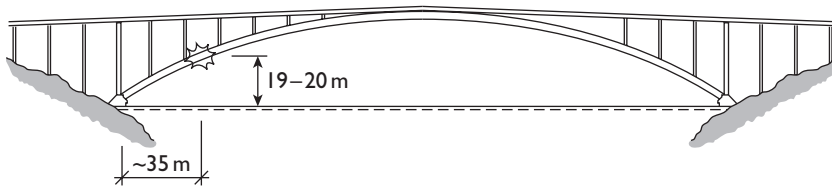
Fig. 19.9 The location where the bridge was hit by the Star Clipper gantry crane.

The ship hit the bridge tubes with its overhead gantry crane at a height of approximately 19–20 metres above the water level (some 35 metres from the shore) (Fig. 19.9).

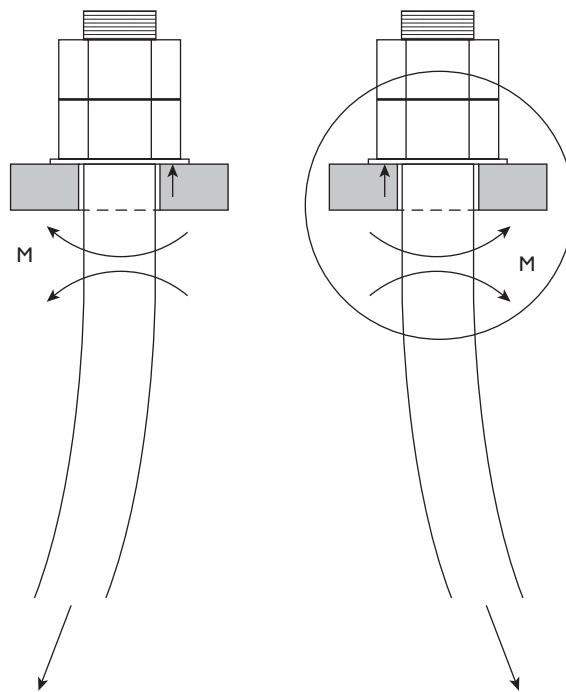
Fig. 20.10 Secondary bending of the hangers due to the inability of the pin joints to rotate.

to the arch, and as the hangers always were “vertical” there could not be any problem, could it? But, the inability of the pin joints to adjust to the rolling load on the bridge deck, led to back-and-forth bending deformations of the hangers (Fig. 20.10).

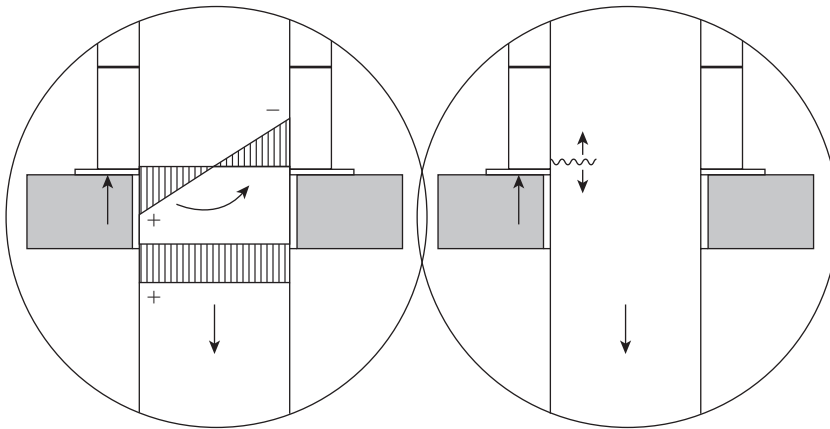
It is true that these secondary bending deformations (in the longitudinal direction) were very small, but over the long run (read: after a sufficient number of loading cycles, perhaps several millions) a fatigue crack was initiated in one of the hangers (Fig. 20.11).

If such a crack is left unattended (and it is impossible in this case to do anything else, as this connection is “enclosed” and hidden inside the arch) then it will propagate until the critical crack length is reached and the net-section will fracture in a brittle manner. And it would not have mattered if the steel would have been more fracture tough (read: ductile, being of a more modern standard) it would still have failed, the process taking just a little longer time.

Fig. 20.11 Secondary bending stresses, in addition to the normal tension stress, will eventually initiate a fatigue crack (see also Fig. 20.10).

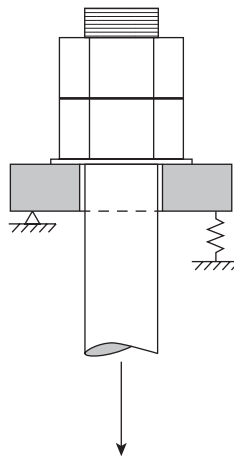
Fig. 20.12 The support conditions – a difference in stiffness due to the single diaphragm plate (see also Fig. 20.7).

It was the hanger closest to the abutment of the northwest corner of the bridge that failed first, being the shortest (i.e. more axial stiff than the rest of the hangers), thus experiencing more dynamic effects than the longer and softer hangers. The rolling load coming from north (or south for that matter) will also produce a more type of “shock loading” to the first hanger than the ones more centrally located in the bridge where the load is more evenly distributed and transferred in a more gradual manner. In addition to these dynamic effects, there was also a small defect present in the threaded part of the rod where the crack had originated from. Most likely the difference in stiffness of the support plate “bearings” also contributed to the initiation of the crack, probably then starting from the stiffer side at the diaphragm plate (Fig. 20.12).
