# BUILDING SURVEYS & REPORTS

*4<sup>th</sup> Edition*

**James Douglas BSc, MRICS, MBEng, FHEA  
and Edward A. Noy FASI, ARSH**

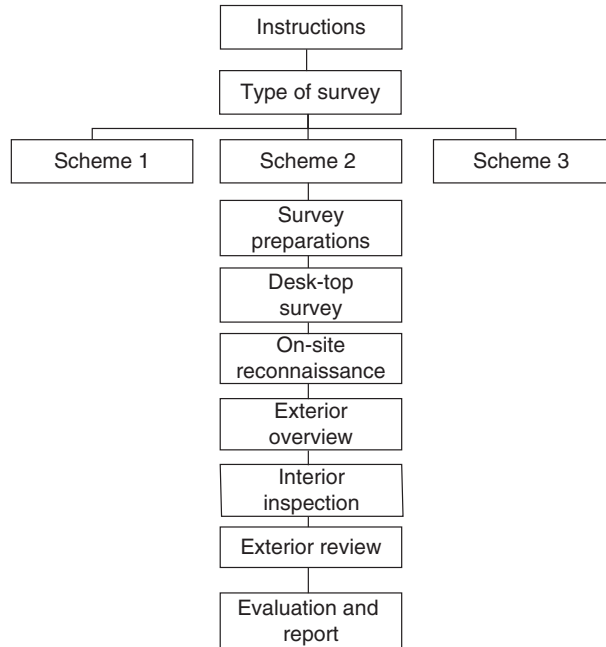
**Figure 2.1 The main stages in the building survey process**

In summary the main stages of the process of surveying a building are shown in Figure 2.1.

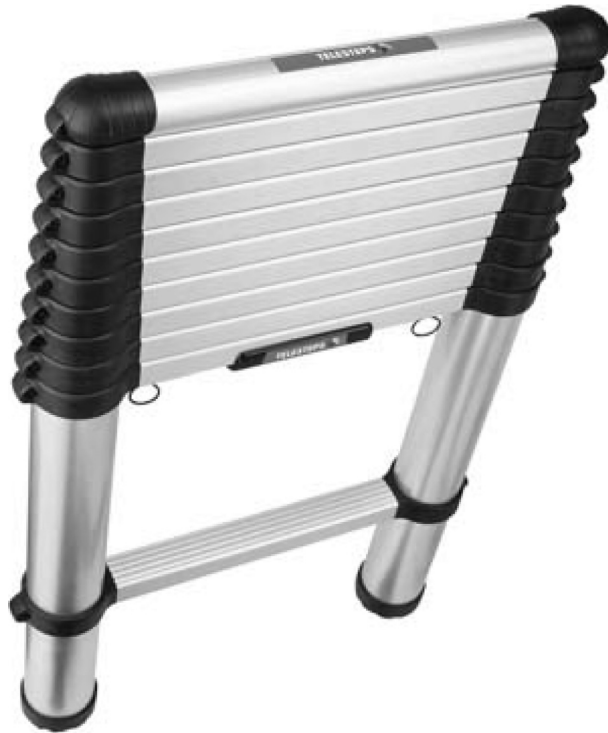
**Figure 2.2** Telesteps® telescopic ladder (courtesy of The Telescopic Ladder Company Ltd).

- When no builder is involved it is often necessary to gain access to high ceilings and roof spaces. A telescopic aluminium ladder capable of extending to about 3 m will meet this need, and will be found useful for most surveys. This type of ladder is usually about 1 m long when retracted and can easily fit into a car (see Figure 2.2).

- Telescopic ladder (around £200 at 2010 prices) (Figure 2.2). A fairly recent innovation is the use of a telescopic ladder for building inspection purposes. It is only about 0.75 m in height when closed but can stretch to 3.3 m when fully extended.
- Electronic moisture-reading meter (around £350 at 2010 prices) (Figure 2.3).
- 2 m folding rule and 5–8 m retractable steel tape.
- Laser distance measuring meter – 30 m range (accurate to  $\pm 1$  mm).
- Torch (5 million candle strength) for attic/sub-floor inspections.
- 20× magnification (minimum) binoculars to facilitate inspection of roofs and chimneys.
- Digital camera (5 million pixel minimum).
- Spirit level to check levels of floor.
- Plumb bob to check verticality of walls and columns.

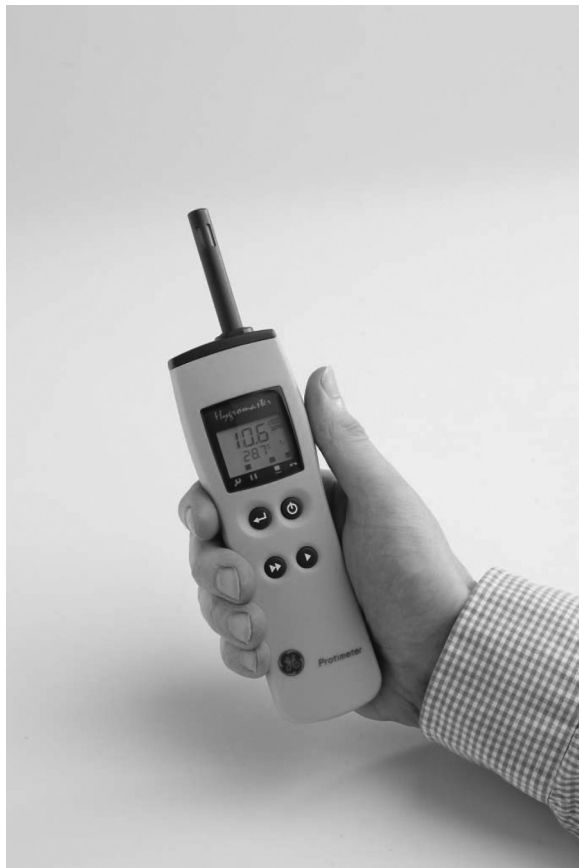
**Figure 2.5** 'Protimeter Hygromaster' hygrometer (courtesy GE Sensing Infrastructure, Inc)

- (1) Endoscopy: a fibre-optic borescope (Figure 2.4) is a useful tool for building surveyors to inspect hidden voids and cavities for problems such as bridging, wall-tie corrosion and fungal attack (Hollis, 2005) (around £1500–£4000 at 2010 prices).
- (2) Electric drill.
- (3) Electronic hygrometer (Figure 2.5): this instrument is essential for investigating condensation dampness (around £350 at 2010 prices).

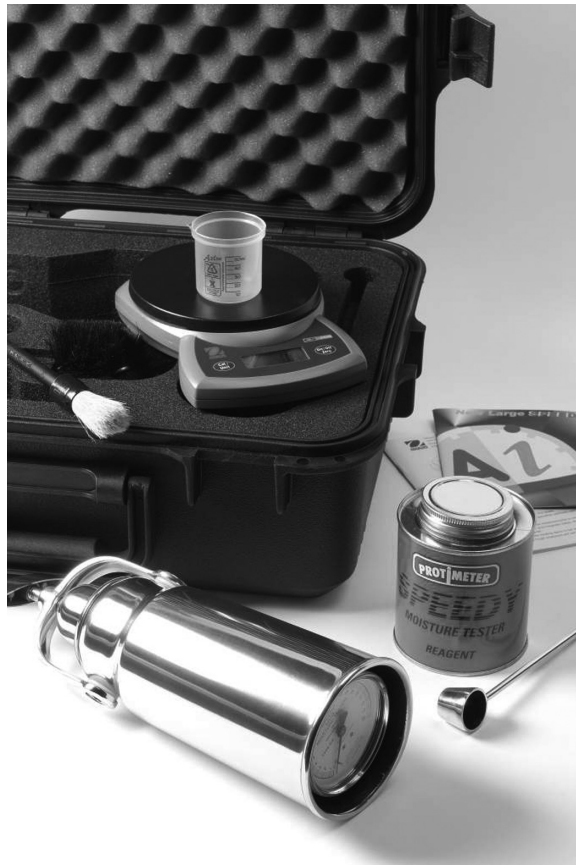
**Figure 2.7** 'Protimeter Speedy Moisture Tester' carbide meter (courtesy GE Sensing Infrastructure, Inc)

- (5) Calcium carbide ('Speedy') moisture meter (Figure 2.7): this instrument is used to ascertain on site the moisture content of particulate building materials such as mortar, brick, stone and concrete (around £700 at 2010 prices).

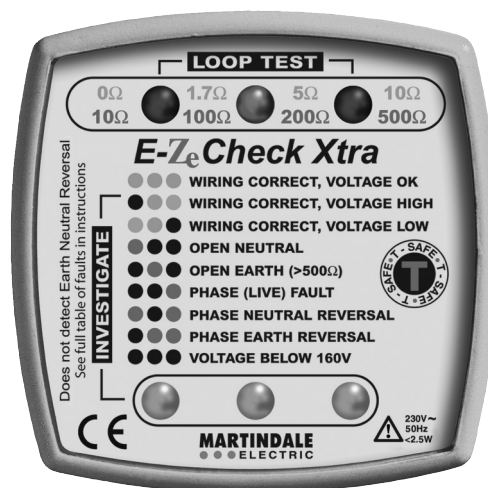
Figure 2.8 Earth loop impedance socket tester (courtesy of Martindale-Electric)

- (7) Socket tester (Figure 2.8): for use in undertaking earth safety test, voltage and wiring checks (around £50 at 2010 prices).
- (8) Micro-drilling: this is an expensive but very effective tool to determine the presence of decay in structural timbers using a special low-voltage hand-held drill that gives the result in the form of a resistograph (around £3500 at 2010 prices). Sorbus International Ltd can supply such a drill – IML-RESI F-series (<http://www.sorbus-intl.co.uk/resif-microdrill-kit.htm>).

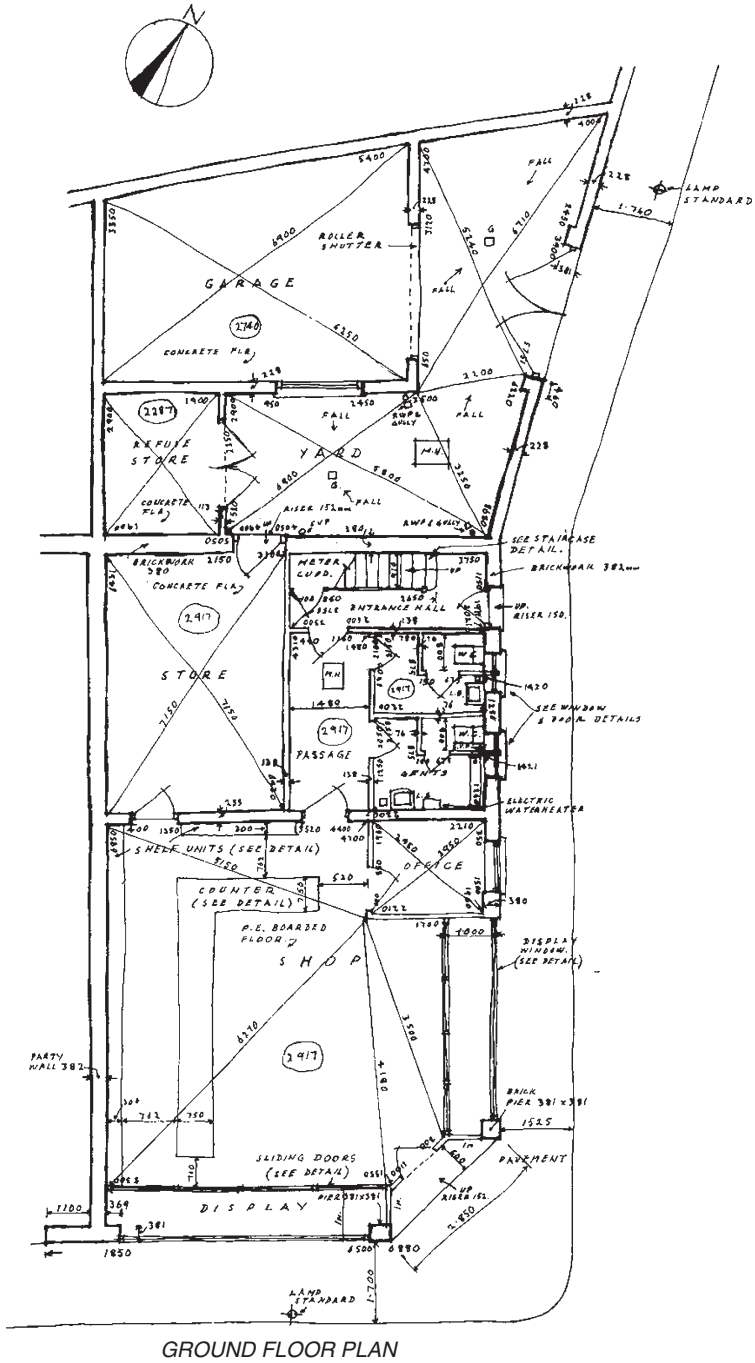
**Figure 3.1 Survey of ground floor shop premises**

*Internal finishes to rooms facing rear yard**Entrance hall**Floor* s.w./p.e. flooring in 152 mm widths. sound condition.*Skirting* 152 × 25. s.w. painted. F.G. condition.*Walls* plastered & painted. Minor cracks on outer wall. General condition F.G.*Staircase* All s.w. painted with polished hardwood handrail – solid panelled balustrade painted. Stair treads & nosing slightly worn. Decorative condition fairly good.*Ceiling* plastered & painted with 150-cove cornice. Minor plaster cracks around front entrance. General condition F.G.*Doors* Two flush s.w. doors to passage & meter cupboard and two panelled entrance door with glazed top panel & fanlight. All doors, frames & architraves are s.w. painted in good condition.*Store**Floor* Concrete screeded. F.G. condition. A few minor cracks in screed.*Skirting* 100 × 25. s.w. with rounded top edge painted. Timber sound paintwork in poor condition.*Walls* Plastered & painted. Plaster in F.G. condition paintwork poor.*Ceiling* Plastered & painted. Plaster sound paintwork poor.*Doors* Internal door s.w. flush. s.w. frame & architrave. Timber & paintwork in F.G. condition. External door s.w. two panelled & one glazed top panel. Timber & paintwork F.G. condition.*Refuse store**Floor* Concrete. F.G. condition.*Walls* Fair face brickwork. Pointing & brickwork in good condition.*Roof* Open timber joists (no ceiling) supporting boarded and felt roof. Joists 150 × 50 treated with preservative. All in good condition.*Double doors* s.w. framed doors lined with matchboarding. Evidence of movement in tenon joints & minor wet rot in bottom rails. Paintwork poor. Feet of s.w. frame shows evidence of wet rot.*Garage**Floor* Concrete. No serious defects apart from oil staining.*Walls* Fair face brickwork. Brickwork sound, pointing in poor condition.*Roof* R.c. slab. No defects.*Roller shutter* Laths & winding gear in F.G. condition. But requires overhaul.*Metal window* Metalwork sound. Paintwork poor.**Figure 3.1 (cont'd)**

Always take dimensions in a clockwise direction and the figures on the tape will be the right way up. It is better to measure the building to a set pattern in order to avoid omitting important dimensions. Measure along walls and partitions on the plaster face including door and window openings and piers etc. 'Running' dimensions should be taken; it is far more accurate and saves time. For example, a wall of a room 5 m long containing a 1 m wide door opening in the centre would not be measured in three separate dimensions 2 m, 1 m and 2 m. By using one length of tape the dimensions are booked 2 m, 3 m and 5 m. The dimension of the door opening should be in the actual door size. When booking running dimensions each figure should be booked near the end of the length to which it refers (see Figure 3.1).

In old buildings floor to ceiling heights are often found to vary. The heights can be booked in the centre of the room, and enclosed in a circle (see Figure 3.1). It is often difficult to take the height of a room against the wall where there is a large moulded cornice. In such cases it is easy to obtain the room height by measuring down from the ceiling to the top edge of an open door and adding this dimension to the height of the door. Industrial and warehouse buildings frequently have exposed steel roof trusses supported on stanchions. Measure from centre to centre of all stanchions and at the same time taking a note of their sizes. By using a ladder, details of the truss members and bearing connections etc. can be taken. At the same time the height from floor to the lowest horizontal truss member and the height to the apex can be obtained by using the steel tape.

If alterations or additions are contemplated a careful note should be made of the type and condition of the internal and external finishings adjoining the area of the proposed alterations. It is quite extraordinary how often this type of information is wanted. These details can be booked on a separate sheet or written at the side of the sketches as shown in Figure 3.1 which describes the internal finishes to the rear rooms of the ground floor plan.

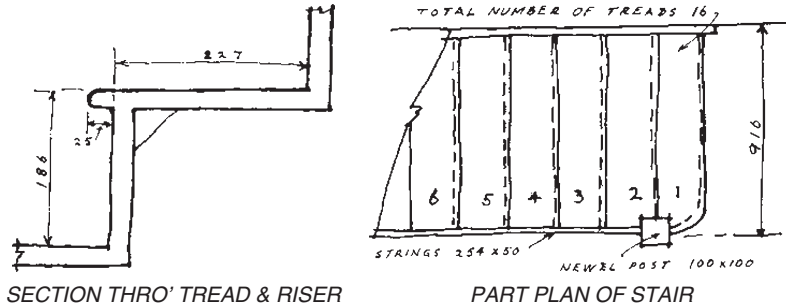
**Figure 3.3** Sketch of stair details

face of the lower riser to the face of the top riser. Enter this dimension with the number of treads on the survey sketch. The risers are similarly measured from tread to tread (see Figure 3.3). The plan and the section shown should be sufficient for a 1:50 or 1:100 scale, but details of newel posts and balustrade will probably require a larger scale.

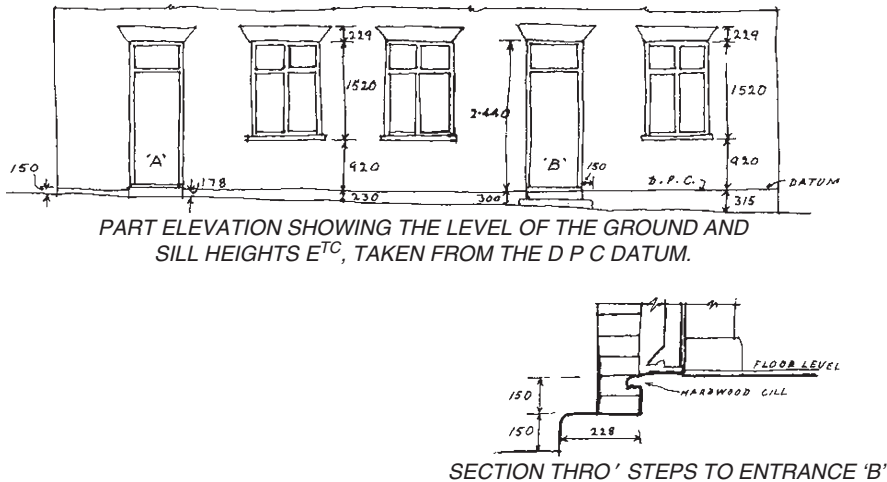
**Figure 3.5** Part elevation showing the level of the ground and sill heights etc. taken from the damp-proof course datum

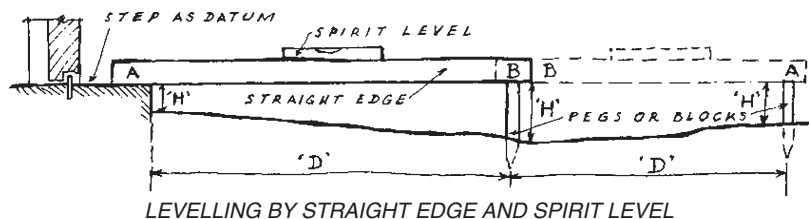
Figure 3.7 Levelling by straight edge and spirit level

as indicated by the letters 'A' and 'B' at each end of the board. By reversing the board and level any error will be minimised. The distance between the pegs or block and their height can then be measured, as indicated by the letters 'D' and 'H' on the sketch.

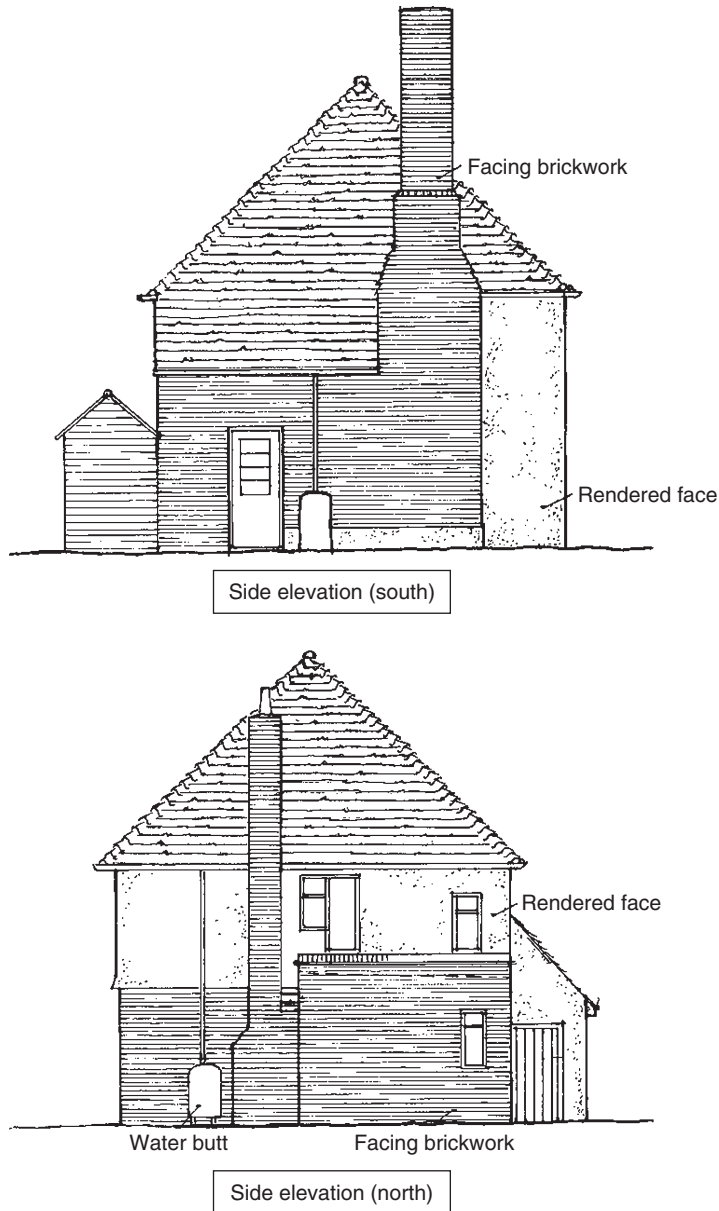
**Figure 4.2 Side elevations**

Figures 4.1, 4.2 and 4.3 show the elevations, plans and notes of an eighteenth century listed country farmhouse and cottage in Kent. This information is sufficient for a superficial layout as described above. Surveys of historic buildings for repair or restoration purposes will require more detailed information (Dallas, 2003). The primary object of this type of survey is to assist accurate diagnosis as a basis for a specification. All available evidence must be collected together and critically examined before conclusions are reached. Measured plans, elevations and sections will be required including all the items mentioned above.

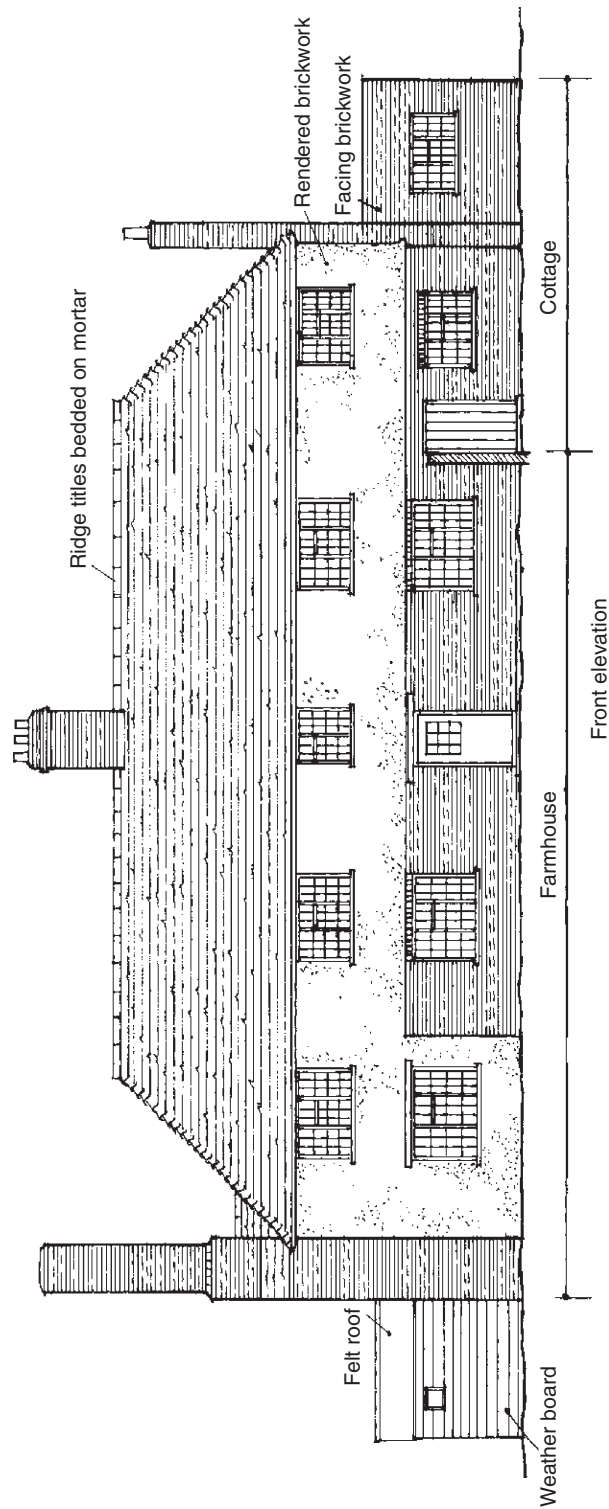
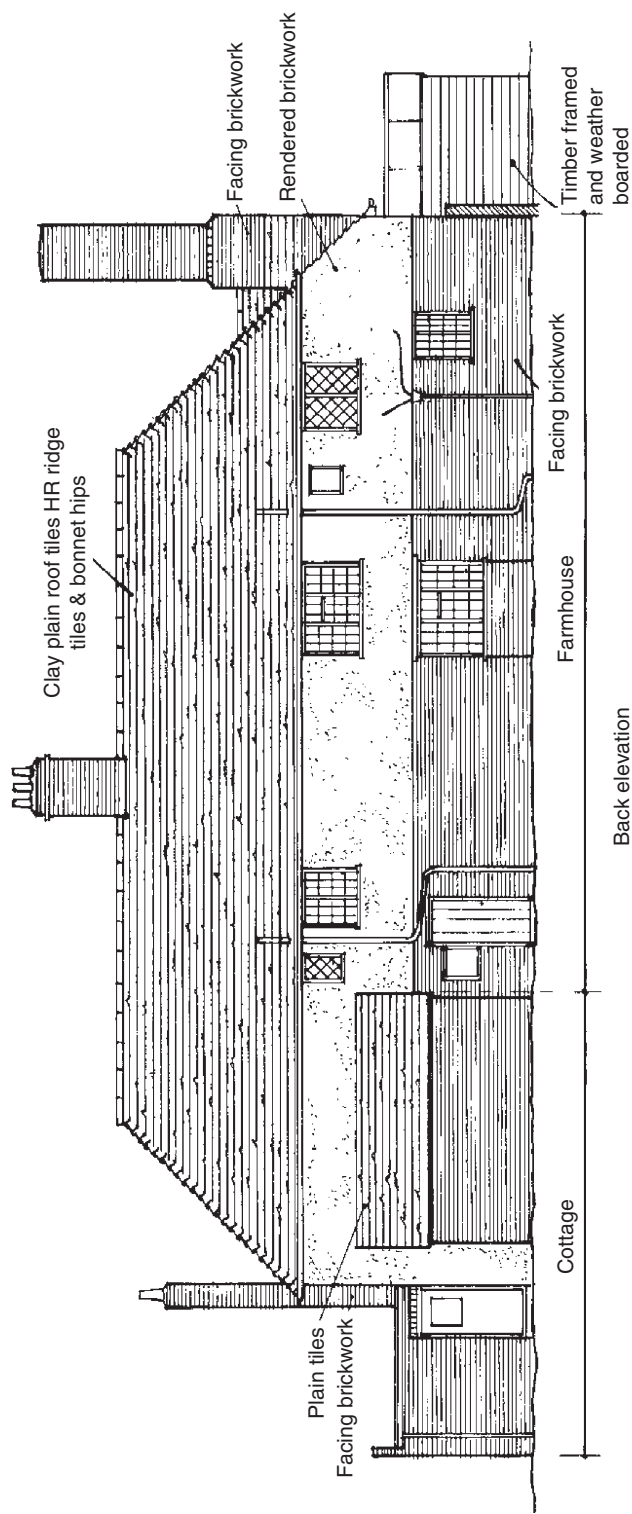
Figure 4.3 Front and back elevations

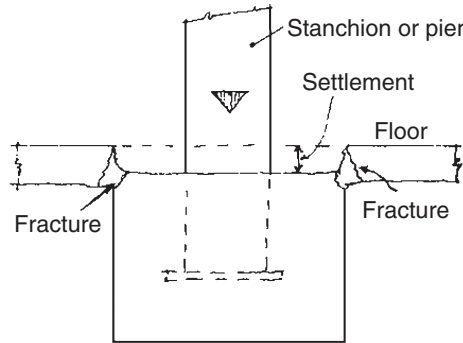
**Figure 5.3 Differential settlement under the point load of a stanchion**

Under concentrated loads such as an overloaded pier or stanchion on shallow foundations will often show movement cracks between floor and foundation where the foundation has been ‘punched’ downwards sometimes several centimetres (see Figure 5.3).

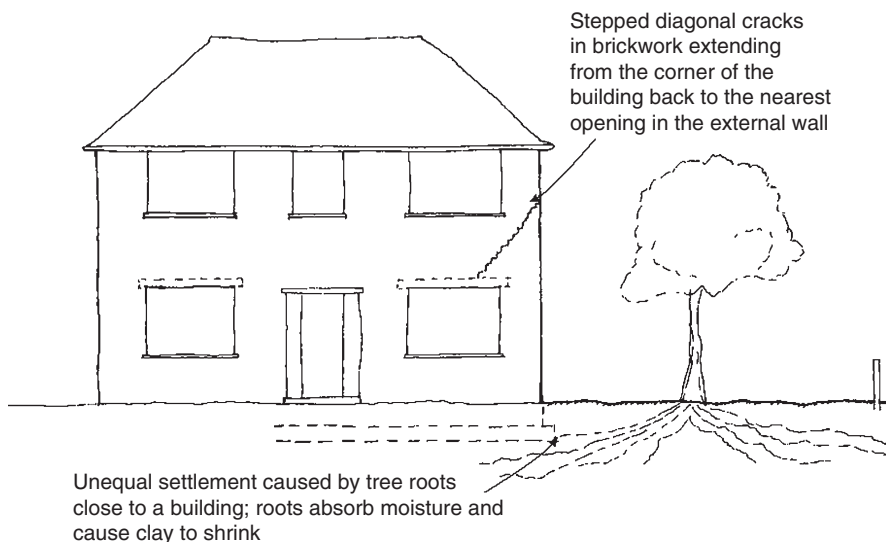
**Figure 5.4** Unequal settlement caused by tree roots

Fast growing trees close to buildings can cause unequal settlement when active tree roots dry out the soil causing differential soil shrinkage (BRE Digest 298, 1999). Shrinking clays affect the bearing capacity and lead to movement in the building, especially in shallow foundations. Tree roots can extend over a considerable distance and can extract moisture from as deep as 6 m below the surface. It is, therefore, necessary to make an accurate survey of their position and obtain details of the type of tree, and at the same time establish that the tree is the cause of the damage (see Figure 5.4). Poplars and elms with fast growing root systems can be expected to cause serious seasonal movements.

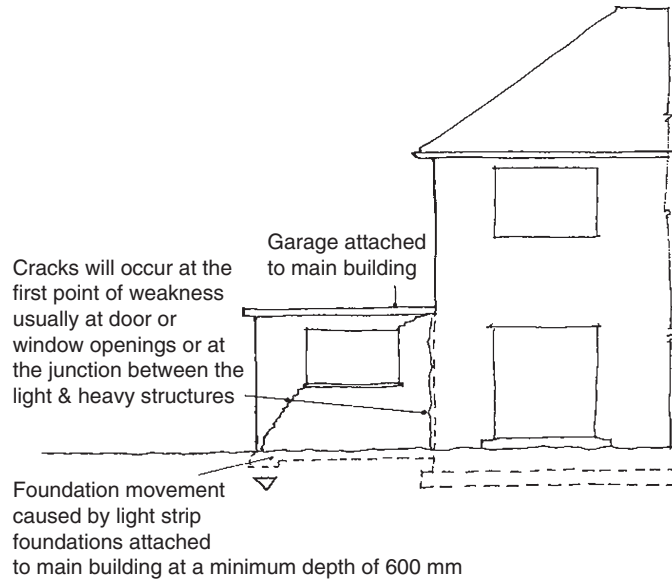
**Figure 5.5 Diagonal fracture between light and heavy structure**

The surveyor will often find that foundation movement in older domestic properties can be caused by light strip foundations attached to the main building supporting porches, bay windows and garages. There is a common misconception that these lightweight structures do not need deep foundations as does the main building. If this type of foundation is not carried down sufficiently deep to avoid movement by atmospheric action, the junction between the light and heavy parts of the structure will often show a diagonal crack running down from the lower corner of the rear window as shown in Figure 5.5.

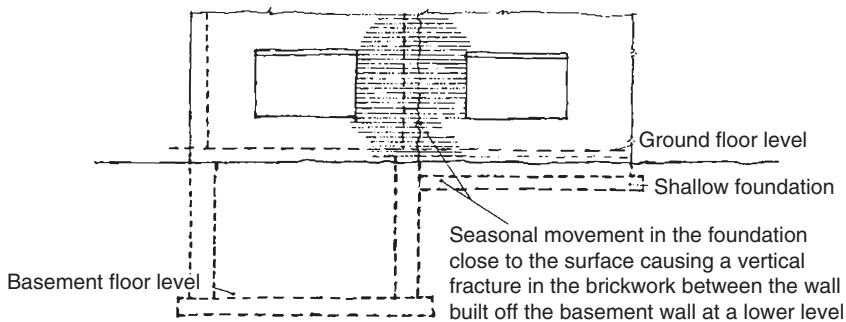
**Figure 5.6 Unequal settlement between basement and ground floor walls**

Another common example is when part of a building has a basement with foundations set in deep geological beds. Seasonal movement will often take place in the foundations close to the surface causing a vertical fracture at the junction between the walls built off the basement wall and the ground floor. The heavier walls to the basement area will settle relatively more causing movement cracks between the light and heavily loaded walls as shown in Figure 5.6. This is more noticeable when the ground floor structure is built on shallow foundations in a clay subsoil.

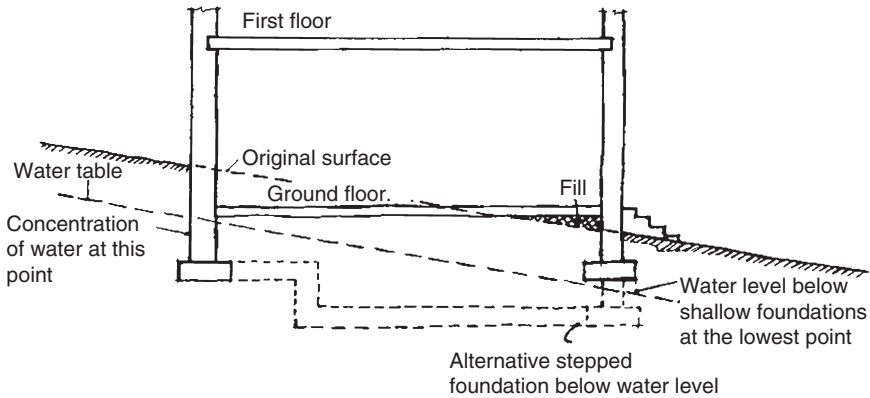
**Figure 5.7 Building on sloping clay site**

Buildings on sloping clay sites can often present difficulties (IstructE, 2000). The water table on sloping sites tends to follow the topography of the surface and if the natural contours of the site change it does not necessarily alter this line. Where the foundations have been set at a constant depth from the stepped level surface the concentrations of water may affect the foundations at the lowest point causing differential settlement. Figure 5.7 shows such a case where the water table is above the foundation at the highest point and beneath a shallow foundation at the lowest

point. In such cases it would have been advisable to form stepped foundations as shown in the sketch in order to be below the water level.

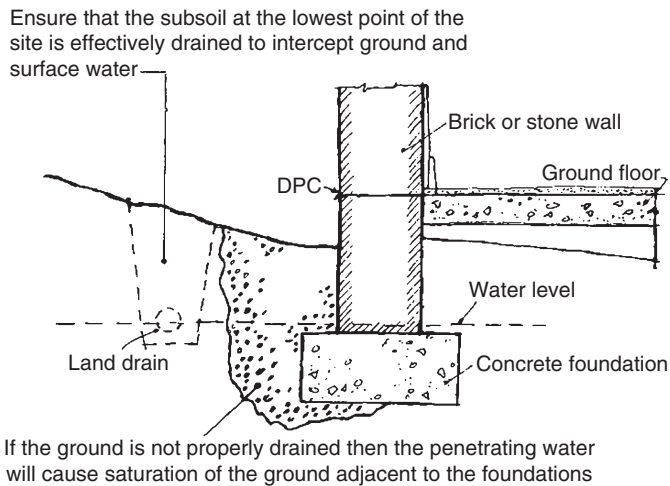
**Figure 5.8 Building at the lowest point of a sloping site**

If a building is erected at the lowest point of a sloping site, natural drainage of the water to the lower points can cause saturation of the ground around the base of the wall and foundations thus lowering the bearing capacity (see Figure 5.8). In both the above cases it is advisable to check that the subsoil is effectively drained at the highest level in order to protect the building against damage by water penetration. The surveyor will often find that surface water drainage has been omitted especially in ancient buildings.

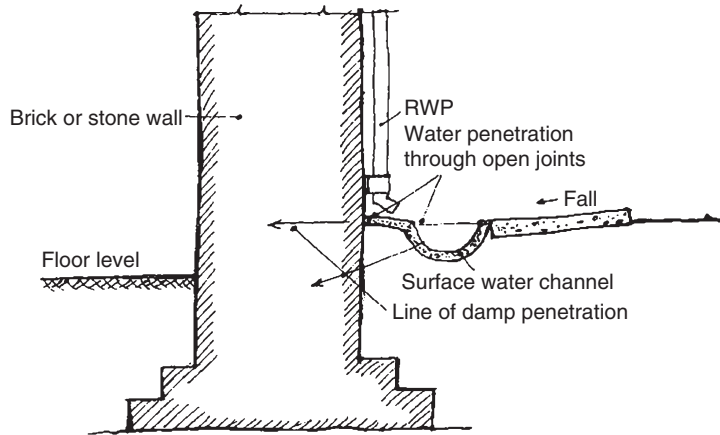
**Figure 5.9** Water penetration around base of external walls where the ground floor level is below the ground level

surveyor will probably notice that clayware or concrete channels have been inserted around the base of the wall to collect rainwater from the roofs and a certain amount of surface water from paved areas around the building. The channels tend to move with the seasonal changes in the subsoil causing the joints to open, thus allowing water to percolate through to the subsoil and the base of the wall. In such cases there is a risk of uneven movement in the subsoil leading to settlement cracks (see Figure 5.9).

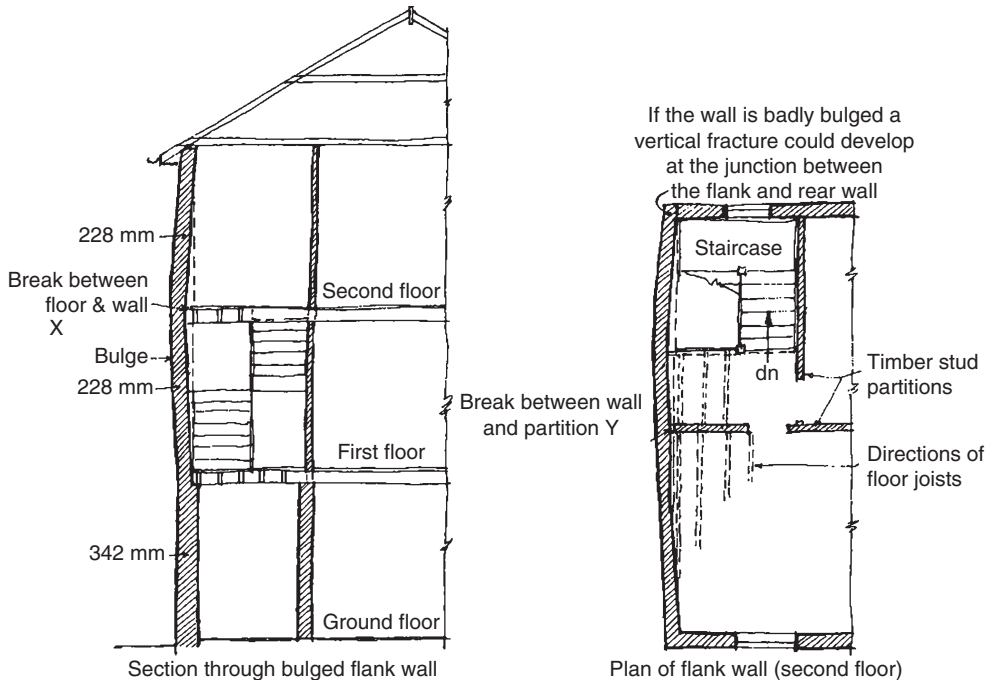
**Figure 6.1 Bulging due to inadequate thickness and lack of restraint in walls**

of brick walls that some form of restraint should be provided to prevent lateral movement. This is achieved by building in floor joists or by bonding in partitions at right angles to the wall. In Figure 6.1 the wall is only 228 mm thick at first and second floor levels, and the floor joists run parallel to the flank wall, and do not provide a tie to the external wall. Furthermore, the staircase is positioned against the flank wall so that there is minimal restraint between flank and rear walls. If the brickwork at the junction marked 'X' on the sketch is weak a vertical fracture could develop. The flank wall will also tend to pull away from the timber stud partition as shown on the plan view marked 'Y'. These defects are common in properties built pre-1914 end-of-terrace or semi-detached three-storey houses. Figure 6.2 shows an unrestrained flank gable wall where the shortest span for the first floor and ceiling joists is front to rear. The danger in such cases is the loss of bearing to the ridge.

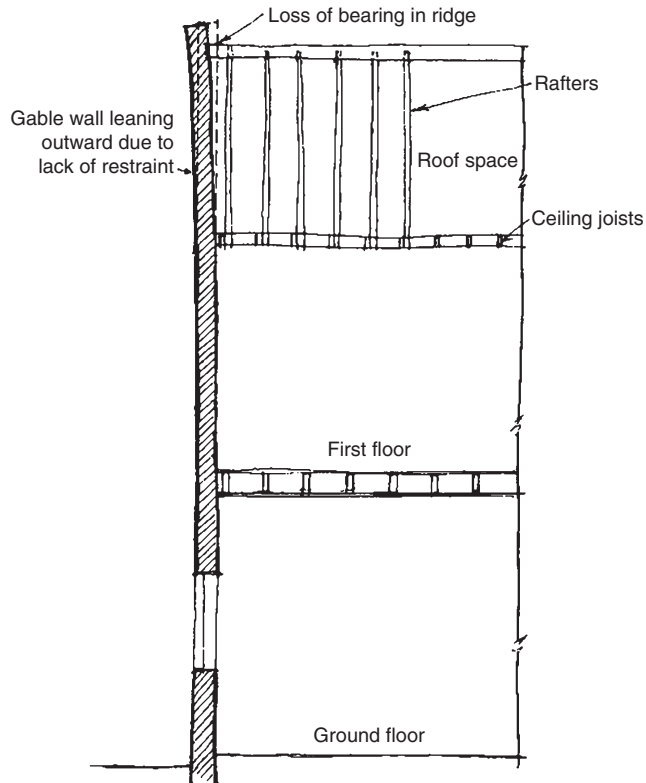
**Figure 6.2 Unrestrained flank gable wall**

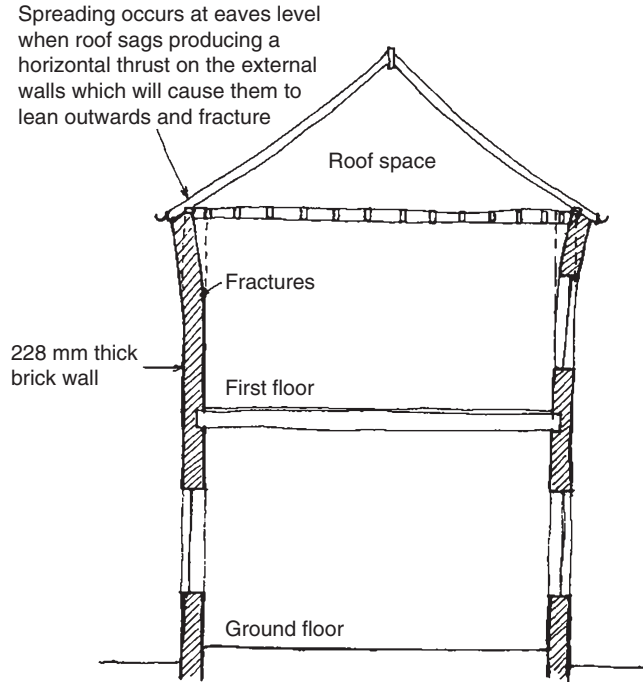
**Figure 6.3 Untied roof causing rafters to spread**

Figure 6.3 is an example of an untied roof causing the roof to sag. The sagging produces a horizontal thrust on the external walls which may cause them to lean and fracture. With all bulging and leaning defects evidence can also be seen internally by way of cracks in the ceilings, particularly at the junction of wall and ceiling, and where the partitions meet at right angles to the external wall.

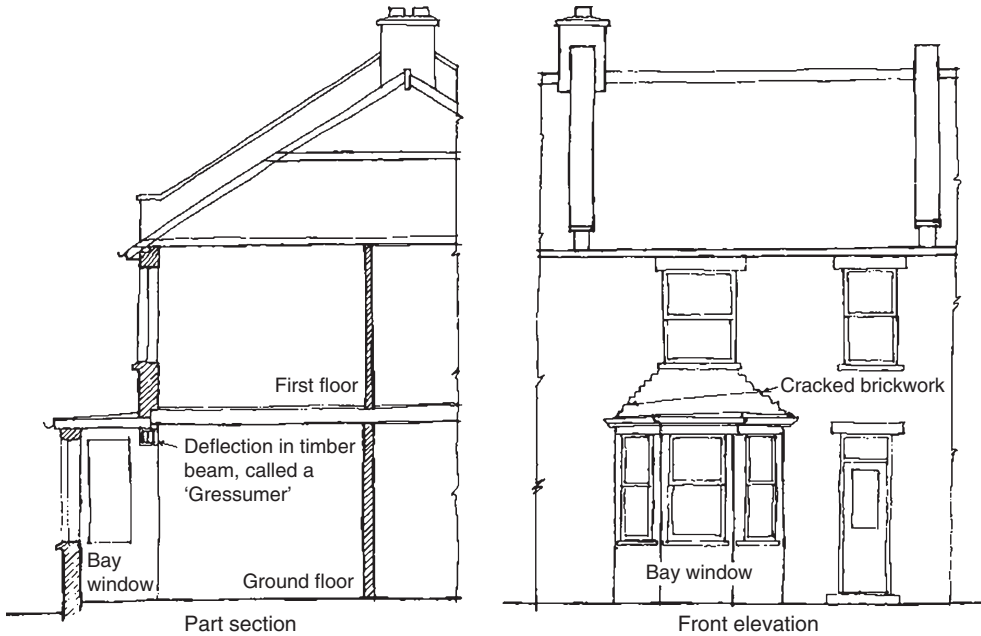
**Figure 6.4** Typical case of overloading in older domestic property where about a quarter of the total load above ground is carried on the timber beam over the bay window

Excess loads on roofs can also affect brickwork causing bowing or crushing. An example of overloading is shown in Figure 6.4 and is caused by faulty design; this is typical of many Victorian domestic properties where about a quarter of the total loading above ground level is carried on the timber beams over the bay window producing a deflection in the beam, and cracked brickwork as shown in the sketch.

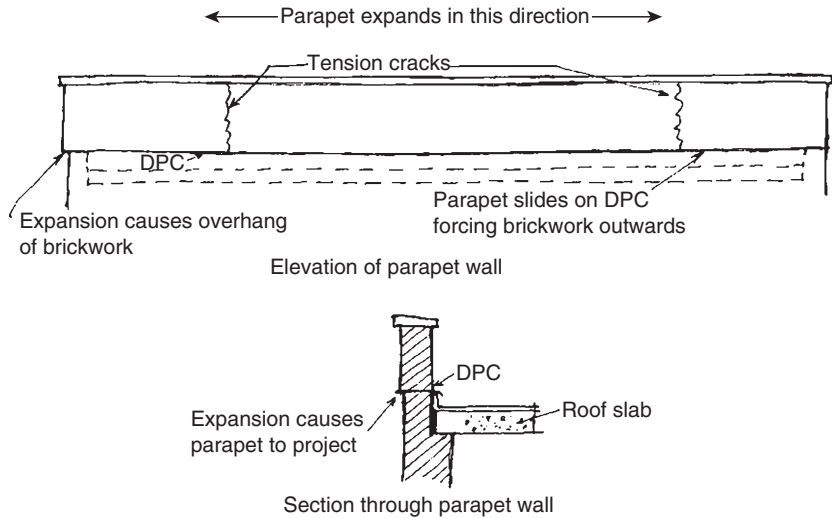
**Figure 6.5 Thermal movement of brickwork**

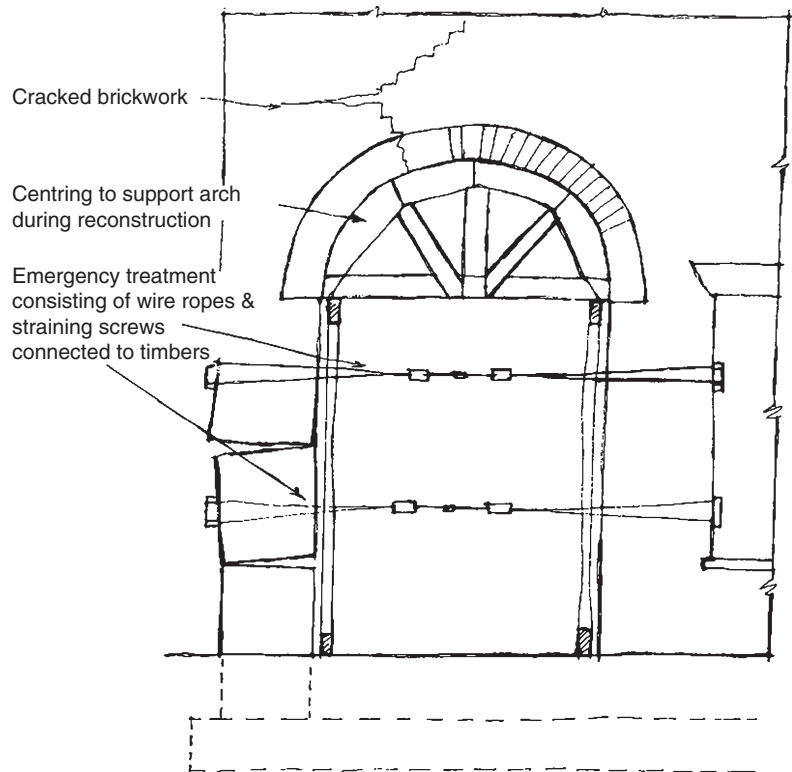
Figure 6.6 Damage to abutments due to inadequacy of the pier

Settlement cracks usually arise from the inadequacy in size of the abutments causing the brickwork to thrust outwards as shown in Figure 6.6 where the opening is too near the corner of the building. If the surveyor considers the fractures to be

serious and requiring emergency treatment, the first step is to tie the abutments together by using two or three wire ropes and straining screws connected to timbers through the nearest opening. The arch will also require support by erecting centring similar to that used in the construction of new arches. This will relieve the arch of its load and enable the necessary repairs to be carried out. Alternatively, a raking shore should be erected against the fractured abutment to resist any further movement. A similar problem can arise from the excessive deflection of a lintel, causing converging cracks to run upwards as shown in Figure 6.7.

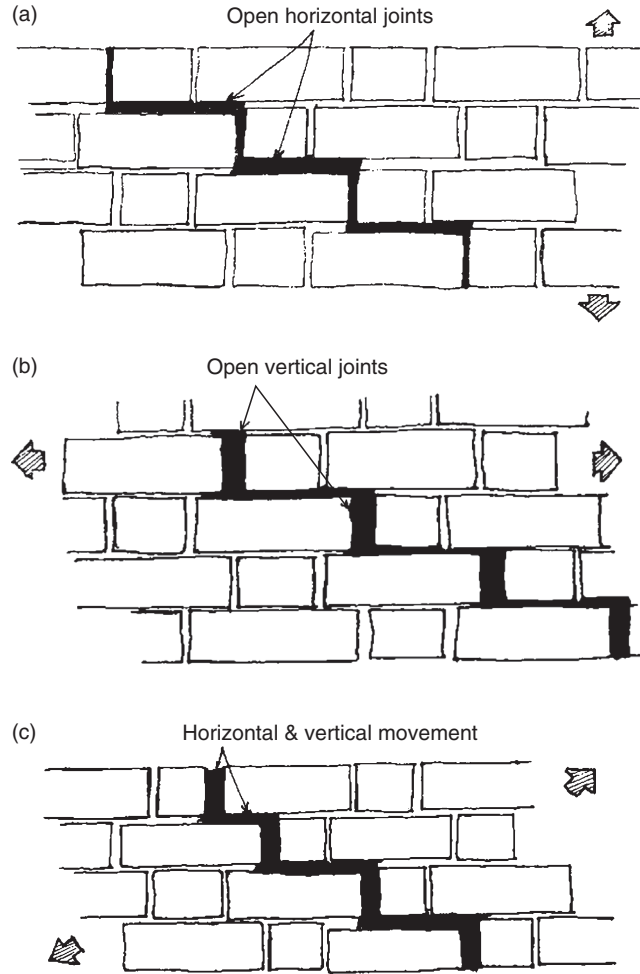
**Figure 6.12 Assessment of cracks. (a) Vertical settlement, (b) horizontal movement and (c) transverse failure**

- Open horizontal joints indicate vertical settlement (see Figure 6.12a).
- Open vertical joints indicate horizontal movement (see Figure 6.12b).
- Horizontal and vertical movement indicates transverse failure (see Figure 6.12c).
- In certain cases one side of a crack may be in advance of the other, which indicates a thrust at right angles to the wall.

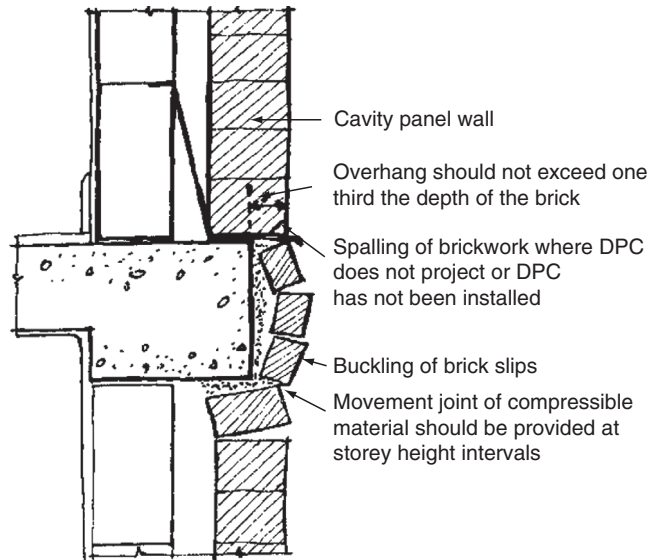
**Figure 7.3** Movement in concrete structure due to creep of concrete frame and expansion of brick panel walls

Where brickwork is supported on reinforced concrete beams or 'nibs', brick slips are often used to cover the edge of the beam. In recent years there have been a number of failures due to the brick slips buckling. It is usually attributed to the expansion of the brickwork or 'creep' of the concrete frame (see Figure 7.3). Conventional mortars and adhesive have proved inadequate for fixing the brick slips. A considerable amount of research has been carried out in this field by the Brick Development Association (BDA) and the use of special mortars such as polyester resin or styrene butadiene rubber (SBR) emulsion is now recommended. If the brick slips are to be replaced it is advisable to recommend that they should be isolated by compression joints from the brick panels. One of the important points that should be checked is the overhang of the outer skin of brickwork as shown in Figure 7.3. The overhang should not exceed one third the depth of the brick. The position of the DPC is also important and should project beyond the outer face of the brickwork to prevent spalling of the lower edge of the brick.

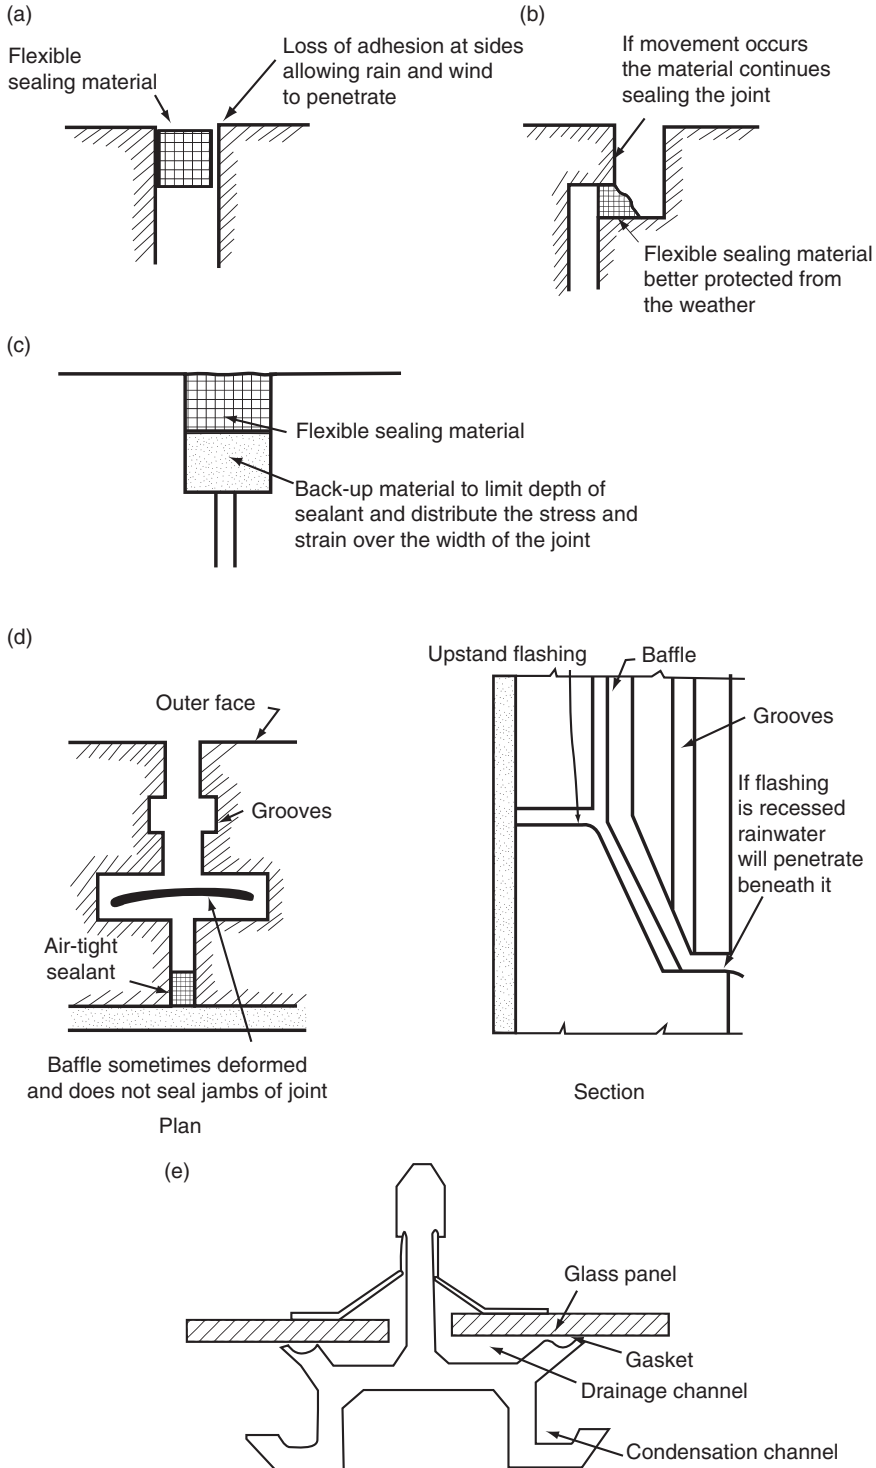
**Figure 7.4** Joint problems. (a) Butt joint, (b) lap joint, (c) back-up material, (d) drained joint and (e) vertical gasket joint in patent glazing

Accurate assembly of the cladding units is essential and the movement expected between the sides of the joint must be properly calculated. Unfortunately, there have been many failures of sealants, some of which are caused by butt joints which are too deep and too narrow causing loss of adhesion at the sides of the joint (see Figure 7.4a) or loss of cohesion in the sealant. If the sealant material is unduly

stressed it will tend to break down. The lap joint shown in Figure 7.4b is often preferred because it is better protected from the rain, snow and wind and therefore imposes less strain on the sealant. In order to limit the depth of the sealant and distribute the stress and strain over the width of the joint, a back-up material is often used. The back-up materials usually consist of expanded plastics or fibre building board, but if butyl mastics are used as a sealant then it is usual to use a polyurethane sponge (see Figure 7.4c).

One of the most successful concrete cladding joints is the open drained joint which reduces the risk of rainwater penetration. The vertical joints between the panels shown in Figure 7.4d usually consist of an outer groove to trap rainwater which discharges over an upstand flashing at the base of the panel. The centre portion consists of a baffle which if deformed does not form a satisfactory seal at the jambs of the recessed joint. If rainwater penetrates the grooves in the outer face and the defective baffle there is only the inner barrier consisting of a sealant to prevent damage to the inner face of the cladding. The inner sealant must be air- and weather-tight. Flashings at the lower edges direct any rainwater to the outside face which may have penetrated the baffle. One common failure is that the flashing may be recessed behind the panel face allowing rainwater to penetrate beneath it. Gaskets are preformed materials extruded from plastics or rubber, and widely used for securing glass panels and for waterproofing a joint (see Figure 7.4e). They do not depend on adhesion, but on pressure against the joint surfaces to provide a seal. Gaskets cannot adjust well to rough surfaces, and are, therefore, best used between smooth surfaces. One of the difficulties in forming a gasket joint on site is the mitre at the corners. This is a joint that should be carefully checked during the site investigation. Points of weakness are also likely to be found where there is a change in the construction of the cladding or where window or door openings occur. Sills should be carefully checked to ensure that they throw rainwater clear of the cladding below.

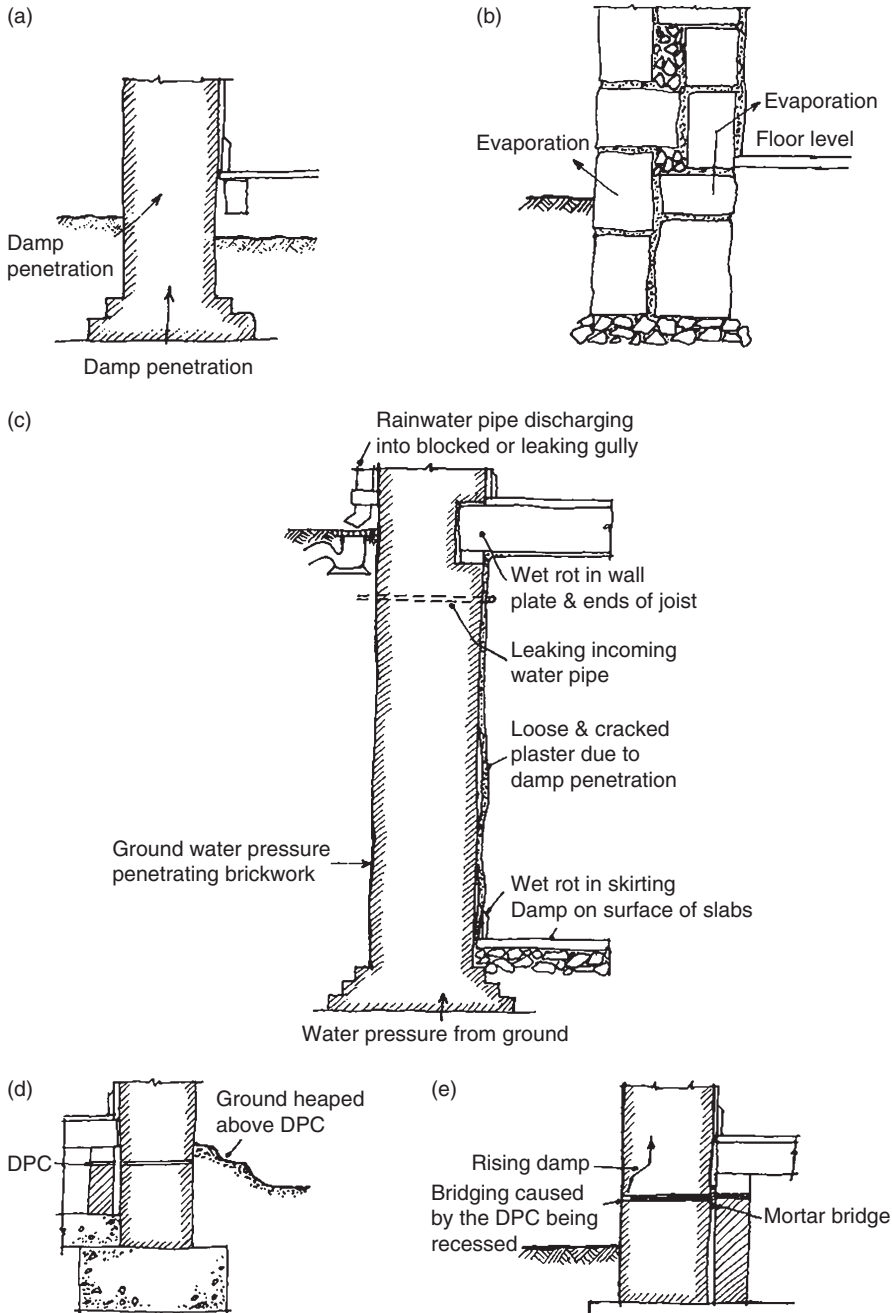
**Figure 8.1** (a) Typical early nineteenth century external wall construction with no DPC. (b) Traditional solid stone wall. No DPC. (c) Typical damp problems in old basement walls. (d) DPC covered by earth. (e) Defects caused by bridging DPC

As mentioned in Section 8.1 the ground around the foundations is often damp; moisture rises into the brick or stonework by capillary attraction and unless a DPC is provided above ground level the moisture can rise, causing considerable dampness to walls and floors. It is, therefore, important that the surveyor makes a careful examination of the base of the wall to ascertain the existence or absence of a DPC. If there is no damp course, dampness will show along the bottom of both external and internal faces causing discoloration, mildew and peeling decorations. The damp will rise in a wall or partition to a height at which there is a balance between the rate of evaporation and the rate which the damp can be drawn up by capillary attraction. The line of dampness due to the absence of DPC is usually continuous and fairly horizontal and in severe cases can reach a height in excess of 1 m (see BRE Digest 245). Figure 8.1a shows a typical early nineteenth century external wall construction with no DPC and no foundation concrete.

The important point for the surveyor to remember is that any treatment which prevents evaporation such as waterproof rendering internally or externally, will only cause the damp to rise higher before it can evaporate, causing more problems (Massari & Massari, 1993)! Any treatment recommended (Burkinshaw, 2009) is a matter requiring careful judgment (see Figure 8.1b).

Flag stones or brick floors were usually laid on the bare earth and moisture rising from the ground is common. The surveyor will often find an impervious finish has been laid over the solid floor which has become very wet underneath, and probably affected by rot. Figure 8.1c shows typical problems in an old basement wall.
