# BUILDING SURVEYS & REPORTS

*4<sup>th</sup> Edition*

**James Douglas BSc, MRICS, MBEng, FHEA  
and Edward A. Noy FASI, ARSH**

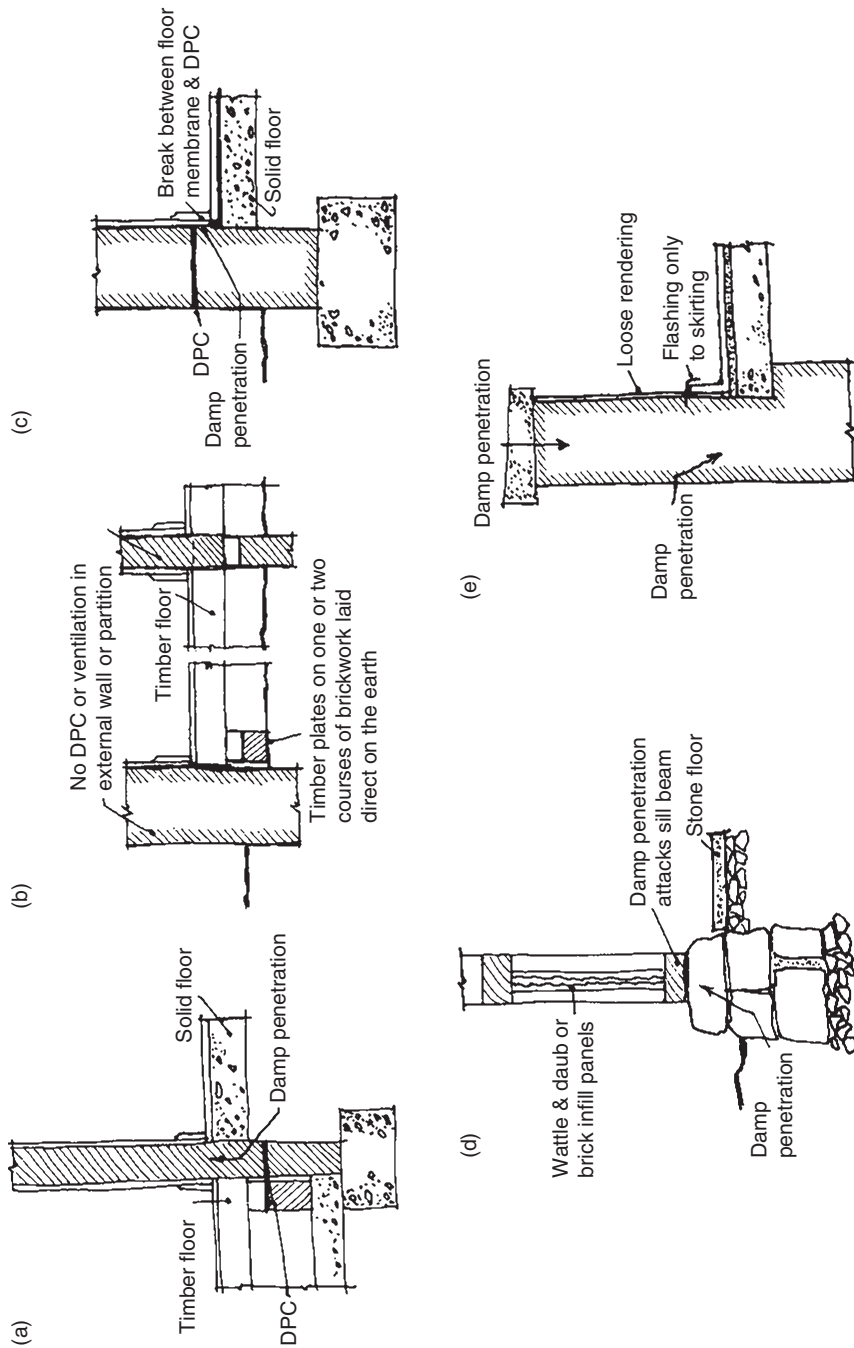
Figure 8.2 (a) Incorrect DPC insertion in partition wall. (b) Typical early nineteenth century timber floor construction. (c) Inadequate jointing between floor membrane and DPC. (d) Typical base detail of timber framed building. (e) Defects caused by the absence of DPCs in parapet wall

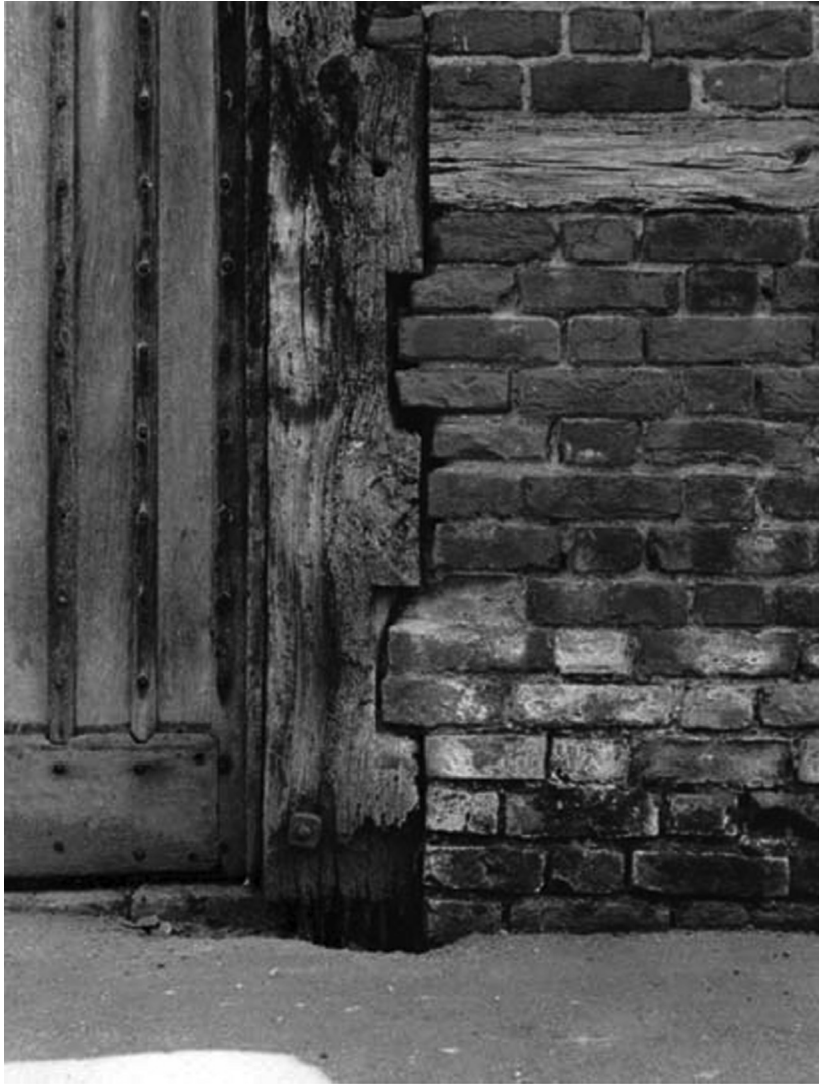
**Figure 8.3** Effects of rising damp and woodworm in a timber-framed building

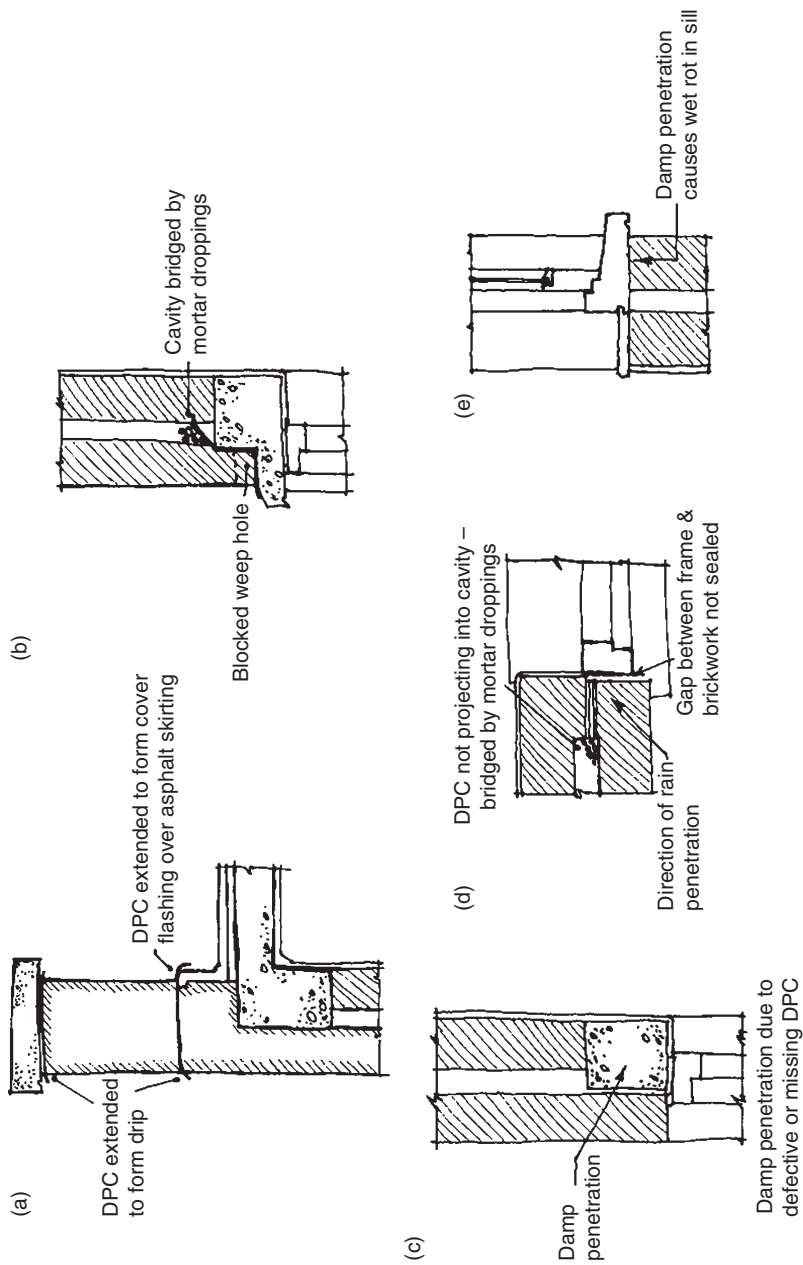
Figure 8.4 (a) Correct detail for DPCs in solid parapet wall. (b) Bridging of DPC over opening. (c) Damp penetration due to defective or missing DPC. (d) Damp penetration due to poor detailing of DPCs and jointing to reveal opening. (e) Damp penetration due to omission of DPC under sill

is also a common fault with DPCs over window and door openings as shown in Figures 8.4b and c where bridging of the cavity is caused by excessive mortar droppings building up off the DPC or due to a faulty or missing damp-proof tray. Damp patches on the plaster about 300 mm above the head of the window usually indicate mortar droppings collecting at the head of the damp-proof tray. The weep holes externally should also be examined to ensure that they are not blocked.

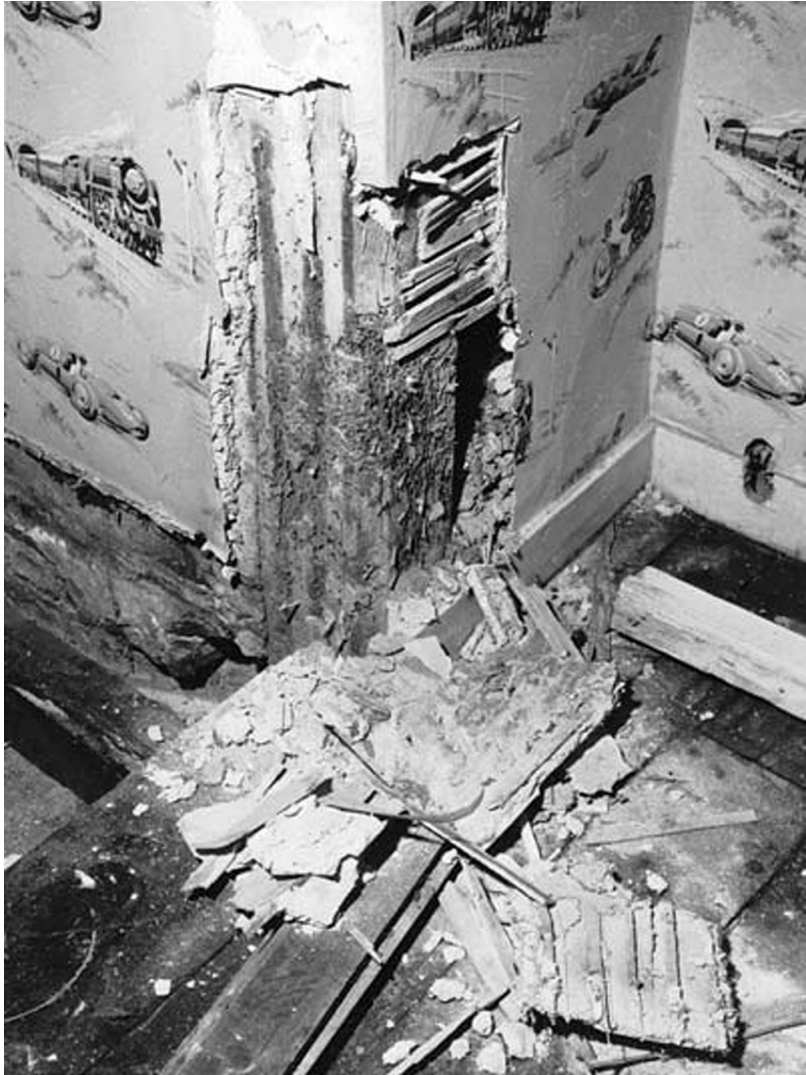
**Figure 9.2** Effects of death watch beetle. Reproduced by permission of Harsco Infrastructure

old hardwoods, usually oak and chestnut, and most damage occurs in built-in parts of a structure such as end beams, wall plates and poorly ventilated places (Figure 9.2).

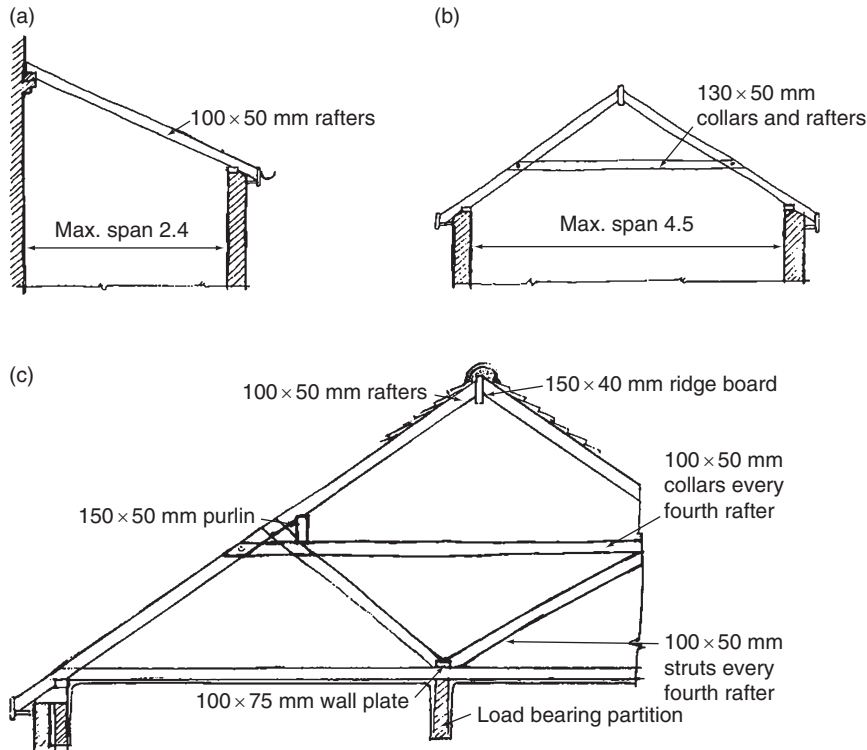
**Figure 10.1 (a) Lean-to roof. (b) Collar roof. (c) Double or purlin roof**

The timber lean-to and collar roofs are the simplest type of roofs for short spans and are often found on back additions or on outbuildings to older domestic properties (see Figures 10.1a and b).

Figure 10.1c shows a typical purlin roof found in many domestic properties erected during the first half of the twentieth century and consists of a ridge piece, rafters, purlins, collars and struts. The purlins are fixed under the rafters to provide intermediate support and are secured to struts which bear on an internal loadbearing partition. It was also common practice to stiffen the roof by providing collars at every fourth pair of rafters. The size of the various members is important as it is essential to use economical sizes governed by the span of the roof and the load it supports.

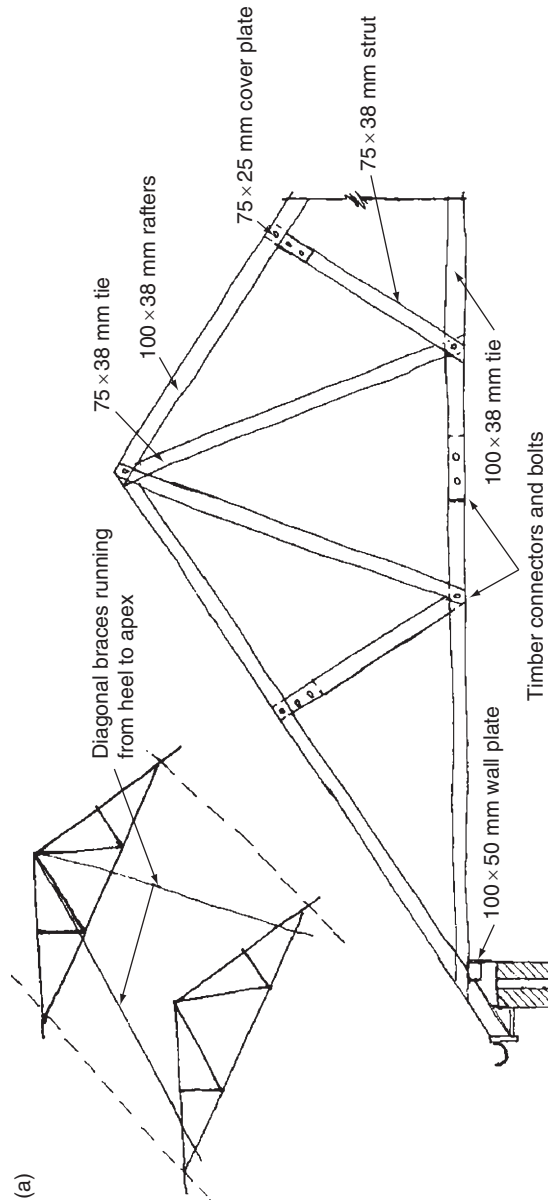
Figure 10.2 (a) Trussed rafters

During the past 30 years many experiments have been made in the construction of both flat and pitched roofs with the object of effecting economies in the use of material. A very economical system is the trussed rafter which is now used in over 90% of new domestic work. It consists of lightweight truss units formed into a number of strongly built triangles that span wide areas, generally spaced at about 600 mm centre to centre. The trusses are available for pitches of 40° for plain tiles and 35° for interlocking tiles or slates. No purlins or common rafters are used. The advantages are that there is no need for a loadbearing partition on the first floor and the trusses are suitable for prefabrication. The trusses are made from timbers of uniform thickness secured at the main joints with double-sided timber connectors and bolts (see Figure 10.2a).

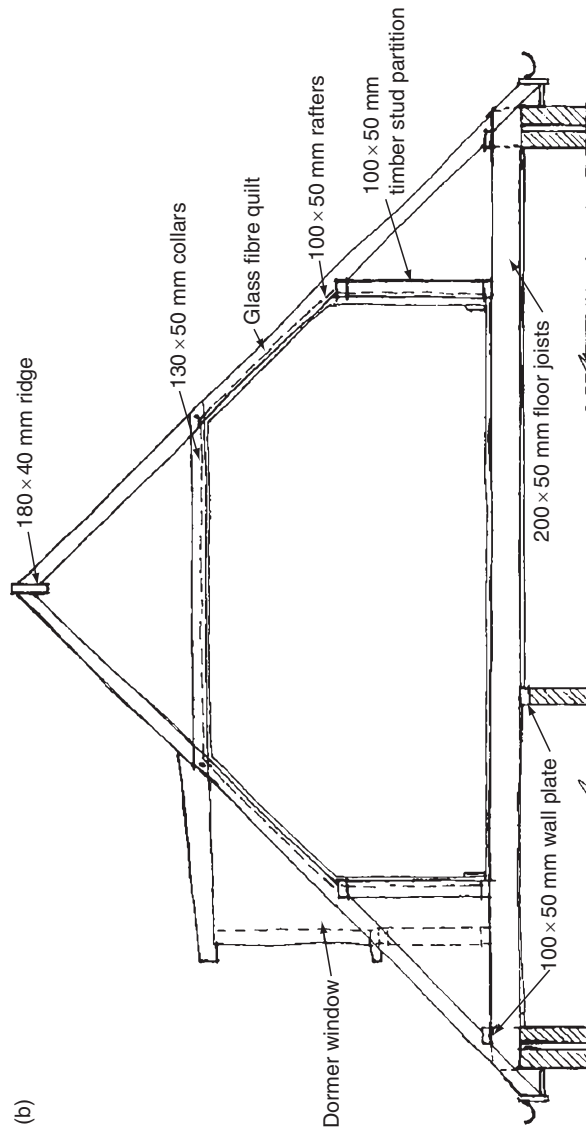
Figure 10.2 (b) Room in roof space

are also the ceiling joists and timber studs clad in plasterboard with skim coat plaster finish form the walls. Dormer windows and sloping ceilings make attractive but sometimes cold rooms, but in the more modern dwellings glass fibre quilt is often used to insulate the triangular space and ceiling (see Figure 10.2b). The mansard roof is of similar construction, but without the sloping ceilings.

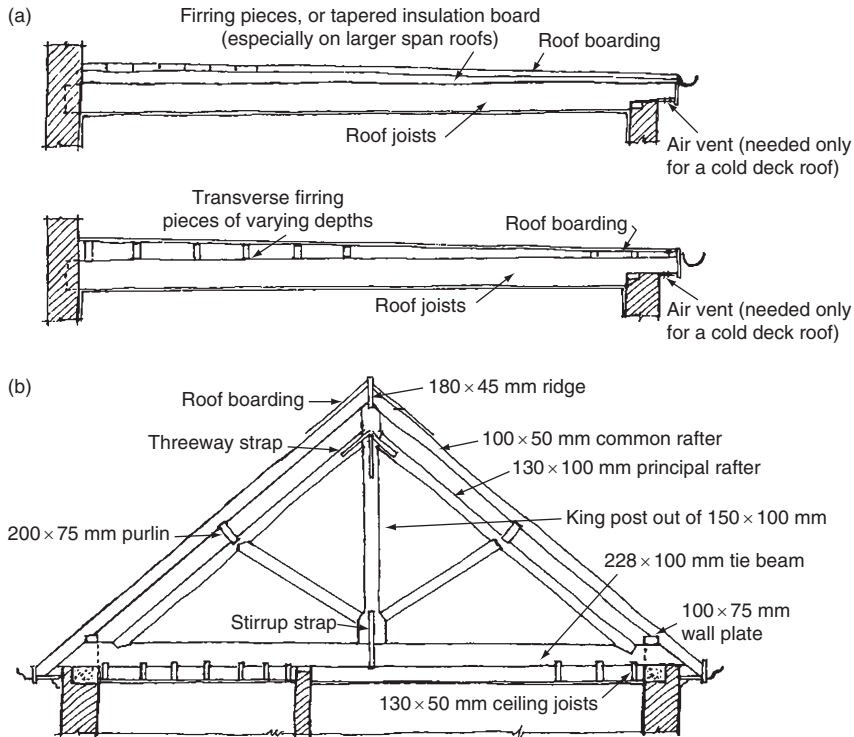
**Figure 10.3 (a) Flat roof construction. (b) King post roof**

Flat roofs for medium spans, say 6–7.5 m, are usually constructed of timber joists which are freely adaptable and are particularly suitable for domestic roofing (see Figure 10.3a).

During the eighteenth and nineteenth centuries larger span roof trusses followed the pattern shown in Figure 10.3b for the majority of the larger domestic dwellings, light industrial and commercial buildings. This type of roof has been included because surveyors are often called upon to examine an old building where this type of construction is met with. The example shown is a king post

truss, but there were many variations and this type together with the queen post reached their ultimate design during the mid-nineteenth century. The truss supports the purlins which in turn support the common rafters. The roofs were usually close boarded and covered with slates making a sound insulated loft. In all cases the joints were strengthened with iron straps and bolts.

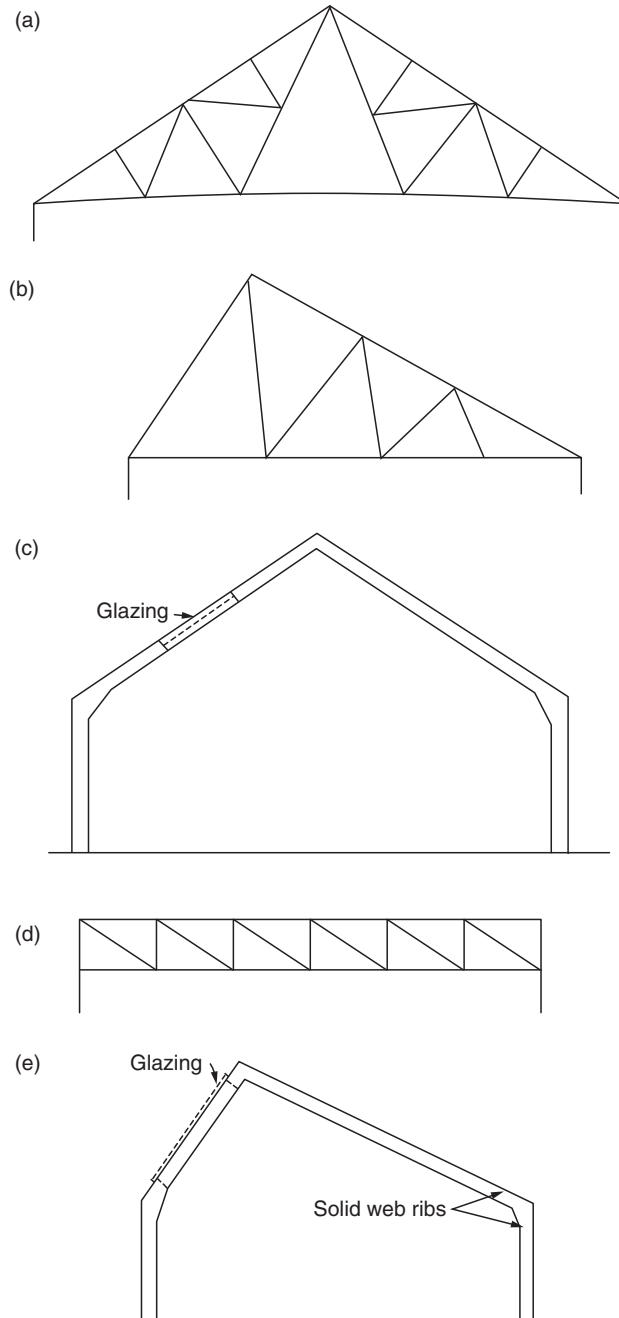
**Figure 10.4** (a) Typical steel truss arrangement for a 25m span. (b) Typical steel north light truss. (c) Solid web portal frame. (d) Lattice girder for flat roof. (e) North light frame

Medium and long span roofs cover a large variety of single and multi-storey buildings including industrial, commercial, warehouses and assembly halls. Many of these roofs are constructed of steel trusses, lattice girders or portal frames which are fabricated in structural steel sections and assembled by bolts or welding. The variations in design are unlimited. Figures 10.4a–e show the outlines of the various types in common use.

All exposed structural steelwork requires protective treatment either by painting or galvanising and special care should be taken to examine the steel sections for rust. The surveyor's report should include a description of the areas affected and method of preparation and treatment. Painting over rust is undesirable as the paint is likely to deteriorate (see Figures 10.4a–e).

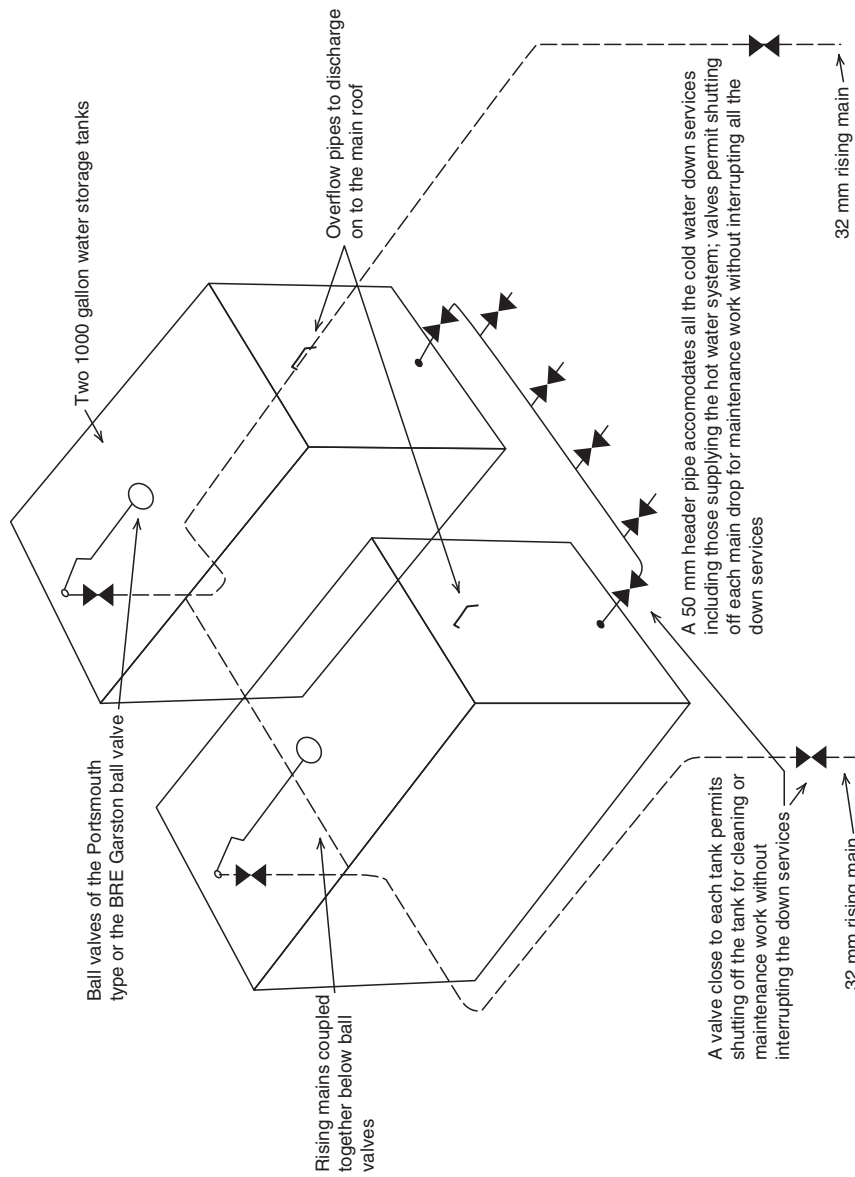
Figure 10.5 Cold water storage system in high buildings

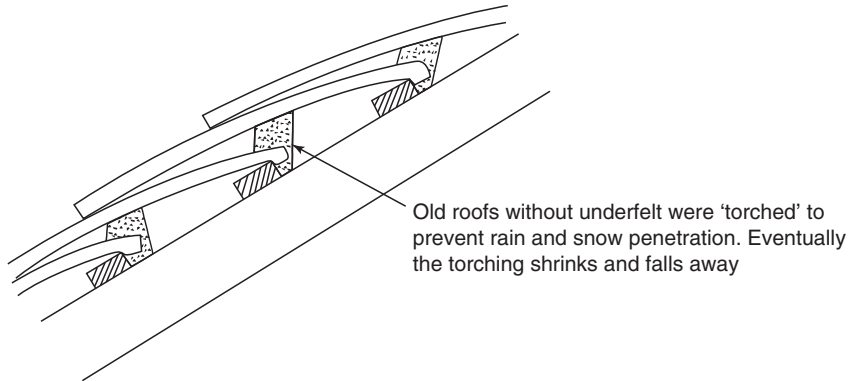
**Figure 10.6** Method of 'torching' to underside of roof tiling

- A great number of domestic buildings built before 1940 have roofs without either underfelt or boarding. To prevent rain or snow penetration 'torching' has been used on the underside of the tiles and consists of a mixture of lime mortar and cow hair. The mixture was spread behind each batten to fill the space between the tiles. The disadvantage with 'torching' is that it tends to shrink and fall away. The torching should be carefully examined and commented on (Figure 10.6).

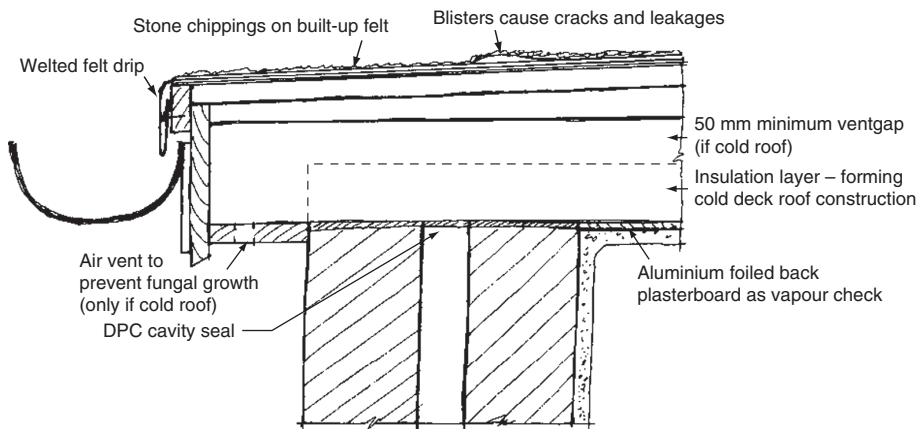
Figure 10.7 Built-up roofing – eaves detail

- (2) As mentioned in Chapter 8, condensation can present serious problems in roofs of this type. Moisture can be prevented from entering the roof by the provision of a vapour barrier such as plaster board and ventilation in the roof void to prevent fungal growth. The entrapped air or moisture between the layers of felt or between the felt and the substructure will cause the felt to lift in the form of 'blisters'. The blisters are not necessarily a sign of failure, but should be carefully examined to see whether any foot pressure has been applied to cause the blister to crack and form a passage for water penetration. One of the most common defects is to find that no provision has been made for ventilation and a vapour barrier. It is, therefore, important that the surveyor endeavours to ascertain the nature of the original construction (see Figure 10.7).

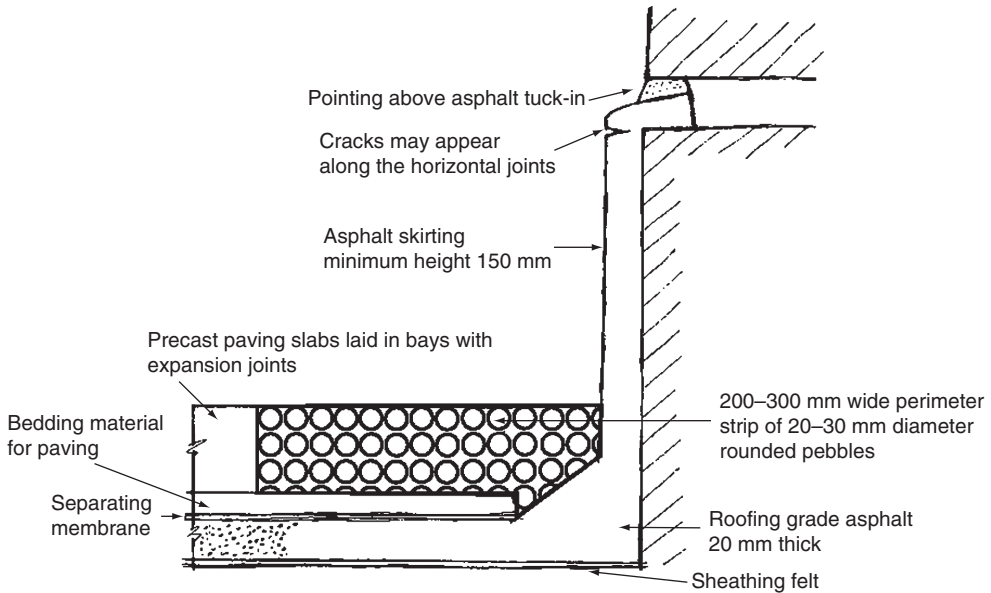
**Figure 10.8 Mastic asphalt to roof garden or car park roof**

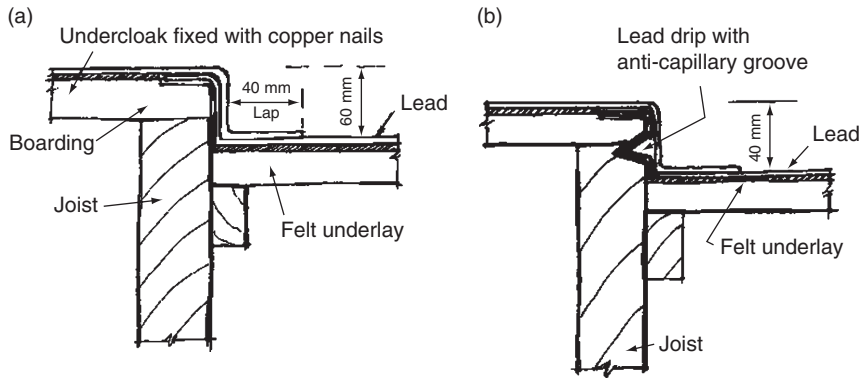
**Figure 10.9 (a) Lead drip. (b) Lead drip with anti-capillary groove**

- (3) One of the most common faults is due to inadequate drips. They are normally 60 mm deep as shown in Figure 10.9a but a minimum depth of 40 mm is permissible if an anti-capillary groove is provided in the vertical face of the drip. This groove prevents rainwater rising and penetrating through to the timber as shown in Figure 10.9b.

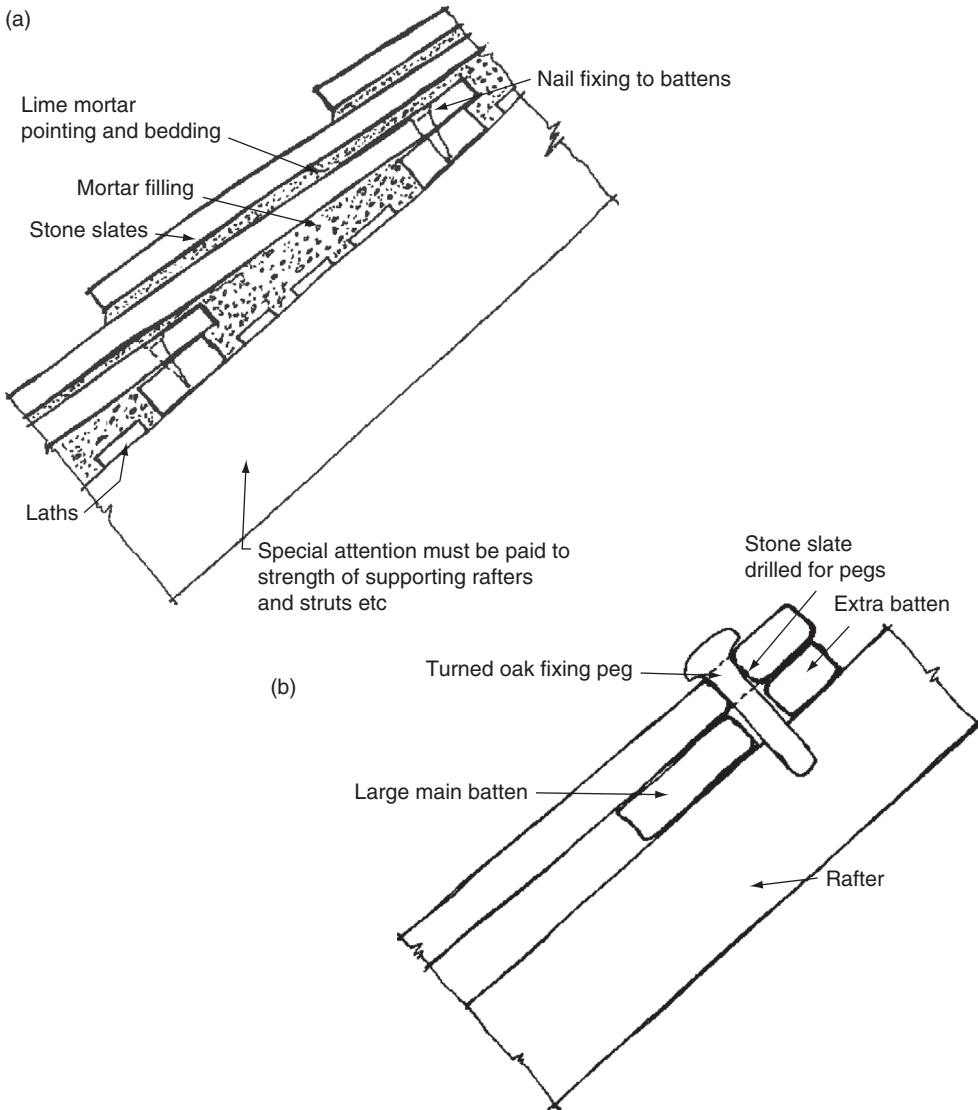
**Figure 10.10 (a) Stone slates sealed by bedding. (b) Tarred oak peg fixing**

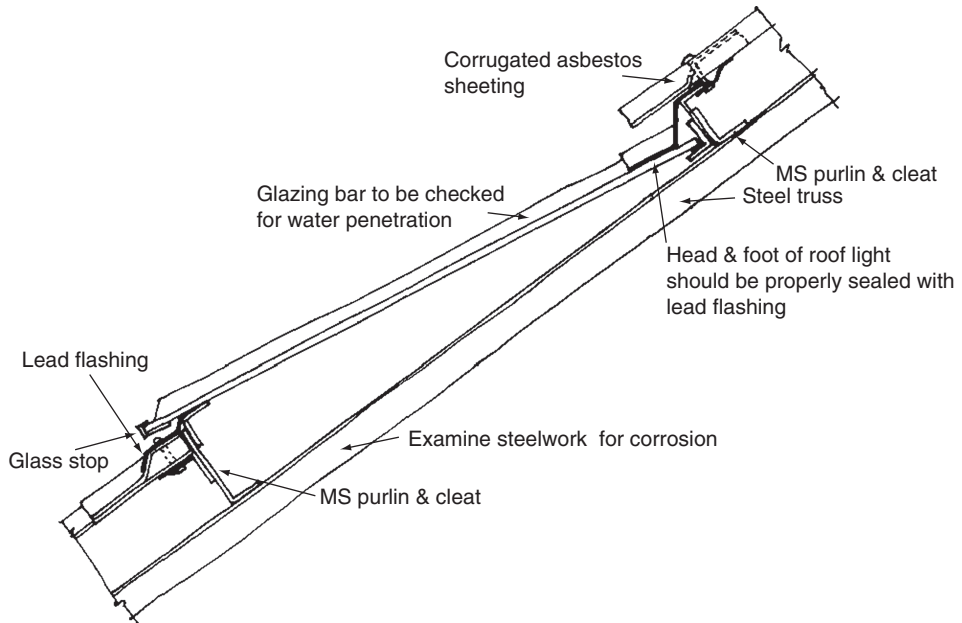
**Figure 10.12 Fixed roof glazing**

- Fixed roof glazing to pitched roofs is used in conjunction with asbestos sheeting or other types of covering and usually consists of patent glazing bars designed to accommodate single or double glazing secured to the roof purlins (Figure 10.12).

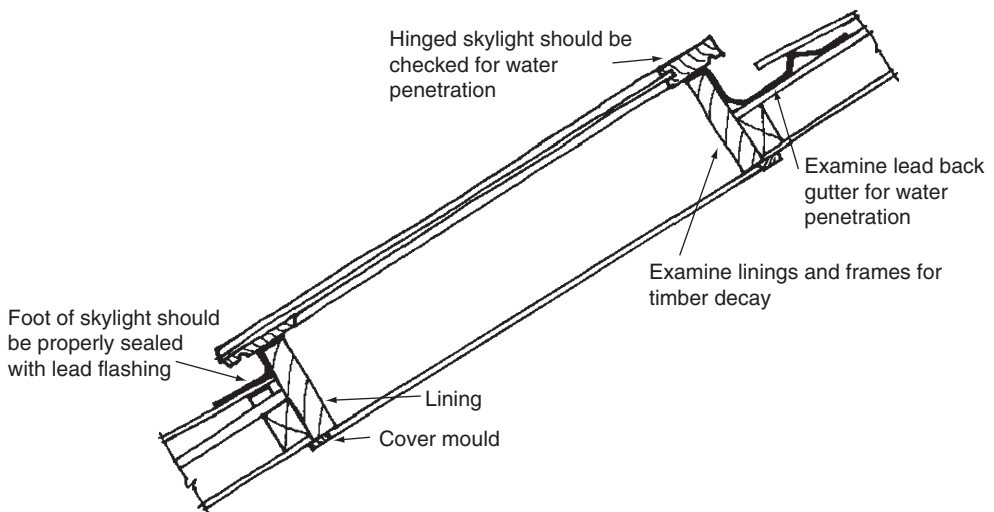
**Figure 10.13 Skylight detail**

- Skylights may be provided in pitched roofs to light a staircase, landing or attic. The skylight may be hinged or fixed (Figure 10.13).
- The traditional form of timber lantern light is still efficient and is found on the flat roofs of many old buildings (Figure 10.14). During the last 40 years they have largely been superseded by dome lights which are manufactured by

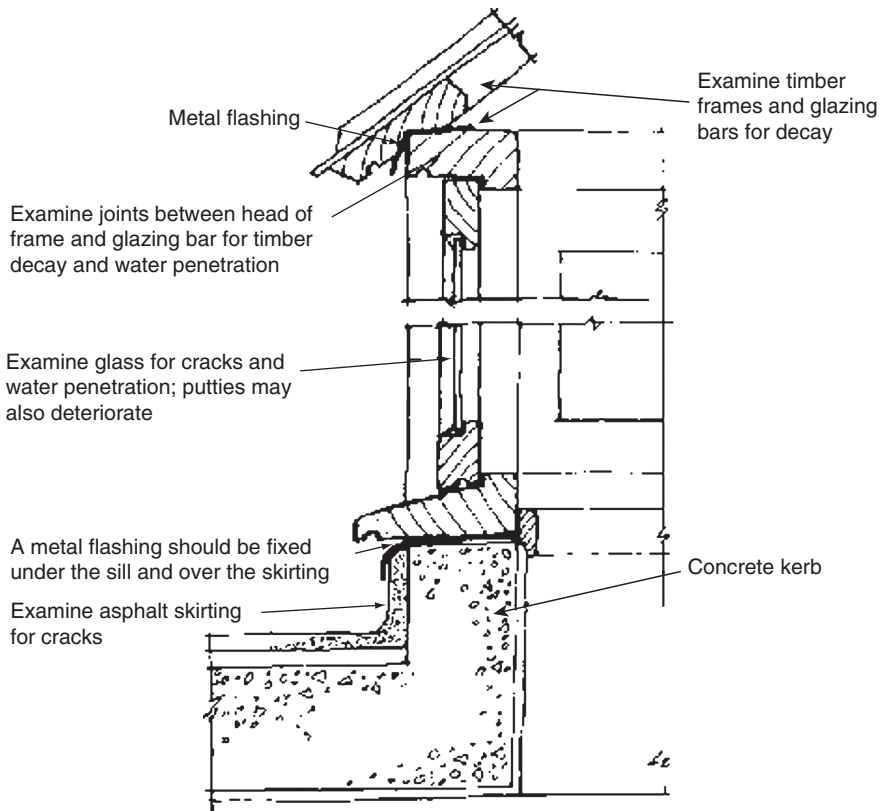
**Figure 10.14** Lantern light

- Skylights may be hinged or fixed, but if the light is hinged penetration of rain-water is likely.
- All forms of upstands to the lantern lights must be in sound condition and should have an angle fillet between roof and upstand. A metal flashing should be fixed under the sill and over the upstand covering as shown in Figure 10.14. Poor detailing in this area is a common cause of water penetration.

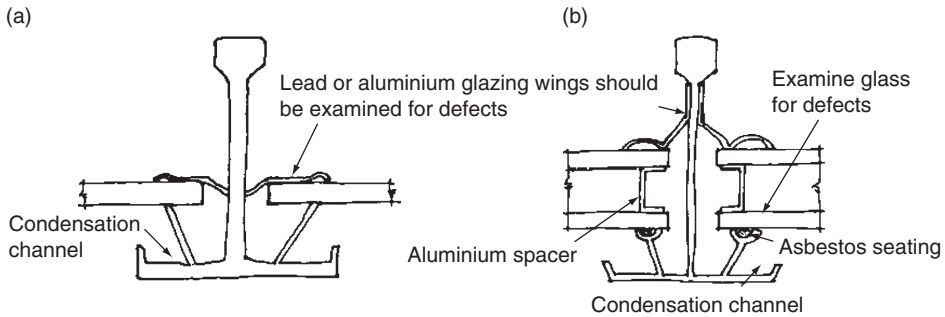
**Figure 10.15 (a) Aluminium glazing bar. (b) Aluminium double glazing bar**

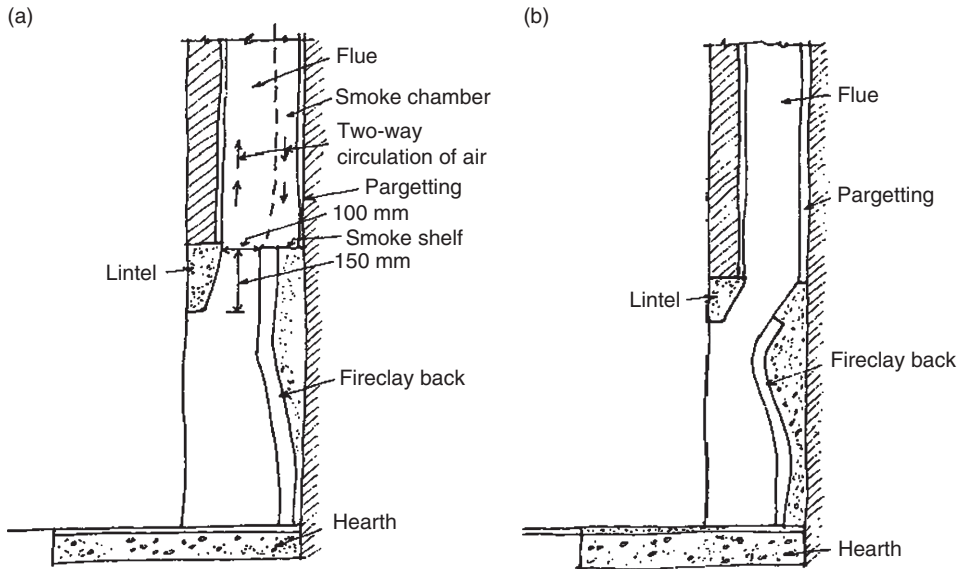
**Figure 11.1 (a) Section through fireplace designed on the principles of Count Rumford. (b) Fireplace design commonly adopted in modern work**

In practice of course, the surveyor will often find that these ideal conditions may not always occur. The fireplace and flue entry shown in Figure 11.1a has been designed on the Rumford principles (Billington & Roberts, 1982) and Figure 11.1b shows a section commonly adopted in modern work which is usually successful. The surveyor will often find that dwellings erected in the past 40 years have been fitted with precast throat units which ensure that the throat is formed to the correct dimensions.

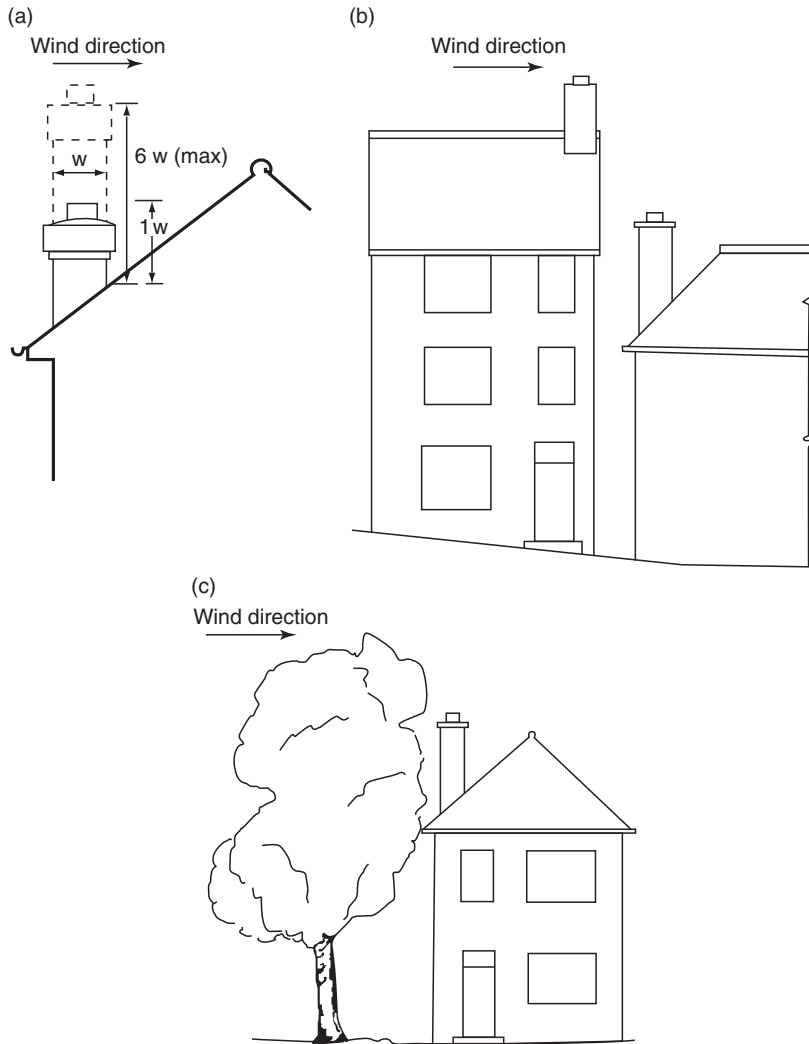
**Figure 11.2 (a) Chimney lower than ridge causing down-draught. (b) Chimney too low in relation to higher adjoining building. (c) Tree in too close proximity to chimney causing down-draught**

A steady blow back of smoke can also be due to unfavourable site conditions. As the wind strikes buildings and trees, areas of air pressure and suction are set up. The area of pressure is on the side which the wind strikes and the area of suction on the opposite side. These areas extend above the roof, whether the roof is flat or pitched. Where a badly placed chimney is in an area of high winds, the pressure may be greater than the upward pressure of the smoke rising up the flue, and therefore a down-draught will result. The main lesson to be learnt from this is that the chimney outlet should be high enough to avoid interference from pressure and suction. Where it is clear that the existing outlet is too low, the almost certain remedy is to raise it to bring the outlet above the disturbed area. If this is done by building up the chimney in the existing materials it is well to remember that no brick chimney should rise more than six times its width (see Figure 11.2a).

although above its own ridge. The lower chimney will probably suffer from down-draught. The remedy is to take the chimney up to a higher level which may make it necessary to install special bracing. A possible alternative is to recommend a change in the form of heating. Tall trees near a building may cause down-draught by creating areas of pressure and suction. A typical case is shown in Figure 11.2c. If it is impracticable to raise the chimney above the area of pressure, the tree should be lopped.

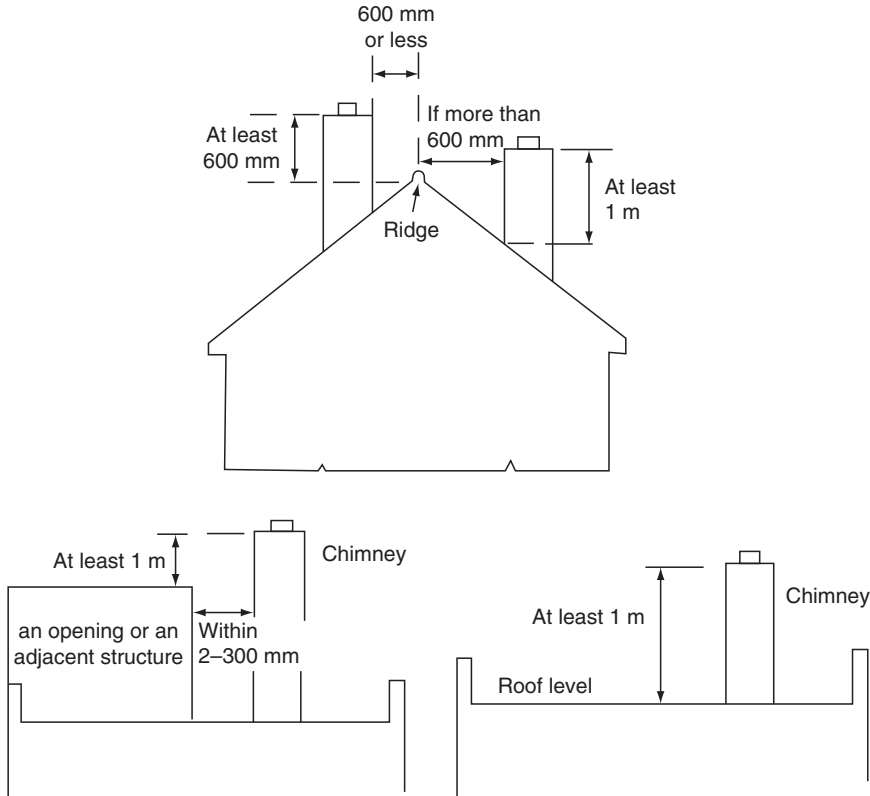
**Figure 11.3** Minimum chimney heights laid down in the Building Regulations for solid fuel and oil burning appliances

The building regulations require that the chimney outlet should be 1 m above the highest point of the intersection of the chimney stack and roof slope as shown in Figure 11.3. Adjacent buildings modify the areas of pressure and suction around the building. In some cases it is not sufficient to carry the chimney up 1 m above the ridge. A single storey building may have the ridge at a much lower level than that of the adjoining buildings. On steep hills one building may be lower than an adjoining building. In Figure 11.2b the building in the lower position has a chimney which is below the ridge level of the adjoining building

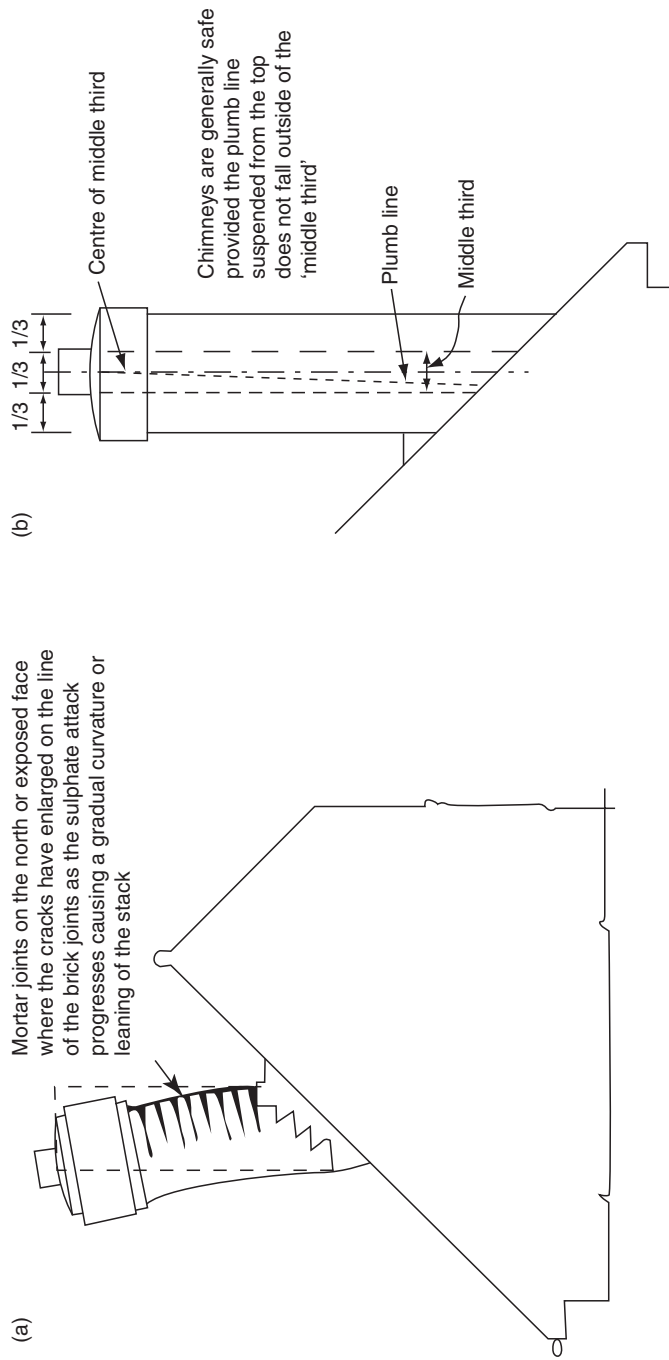
Figure 11.4 (a) Sulphate attack on a typical kitchen boiler flue. (b) Middle third rule

- (1) As already mentioned, sulphate attack causes the mortar to expand and this leads to a gradual curvature or leaning of the stack which can be extensive on rendered stacks. The lining or pargetting can also be attacked by the products of combustion as they rise up the flue. Sulphate attack on a typical kitchen boiler flue is shown in Figure 11.4a where the shrinkage cracks have enlarged on the horizontal brick joints as the sulphate attack progresses. A chimney stack which has begun to lean is generally safe provided a plumb line suspended from the top of the stack does not pass outside the 'middle third' of its area as shown in Figure 11.4b. If the rate of lean appears excessive the surveyor should recommend that the stack should be demolished to the level at which it appears reasonably perpendicular and rebuilt using a sulphate-resisting cement. If the chimney is old and is to be used in conjunction with a gas appliance and is not protected with a flue liner, the rebuilding of the stack will provide a good opportunity to install a flexible liner.

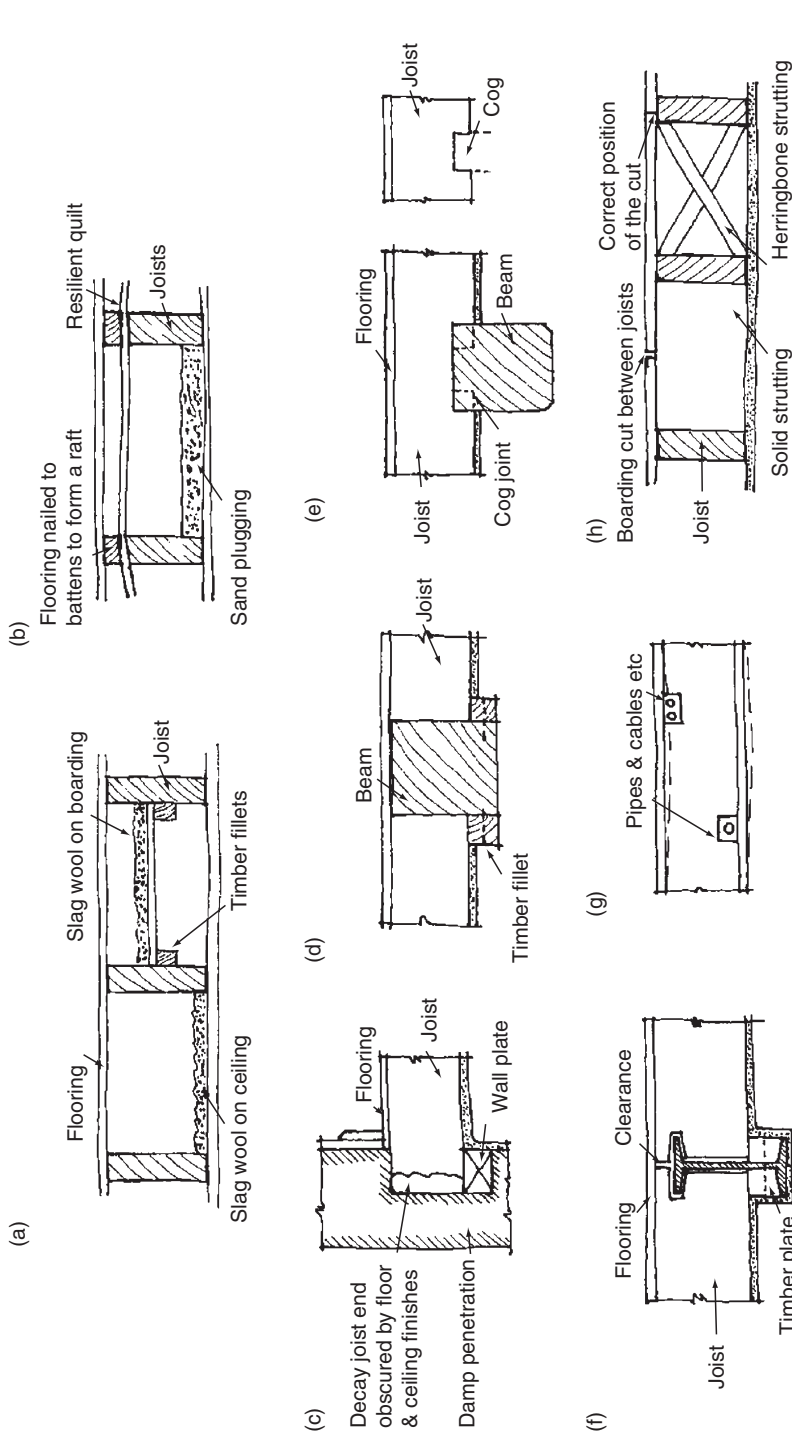
Figure 12.1 (a) Two methods of sound insulation between floors. (b) 'Floating floor' for sound insulation. (c) Joists built into solid wall without an air space. (d) Joist resting on fillets nailed to bottom edge of beam. (e) Method of cogging joists over timber beam. (f) Typical notching when RSJs are used. (g) Deflection due to excessive notching. (h) Floorboard jointing and strutting details

After removing some sections of the floor boarding it is fairly easy to recognise the various types of insulation to enable a report to be prepared. A simple method is a layer of slag wool about 75 mm thick resting on the ceiling below as shown on the left-hand side of Figure 12.1a. A better method which is often found in business premises is shown on the right-hand side of Figure 12.1a and consists of an air space above and below the wool. The wool is supported on boarding which is in turn secured to the joists by timber fillets. A third method is shown in Figure 12.1b and consists of a heavy plugging of sand on the ceiling with a resilient quilt draped over the joists known as a 'floating floor'. The principle underlying the design of a floating floor is its isolation from any other part of the structure. It is, therefore, important to ensure that the flooring is nailed to the battens to form a raft and not nailed through to the joists. The floor must also be isolated from the surrounding walls. These are points which require checking during the examination.

The surveyor will sometimes find that the ends of the boards meet between joists forming a cantilever as shown on the left-hand side of Figure 12.1h and will spring under weight. The cut should be made at the middle of the joists as shown on the right-hand side of Figure 12.1h.

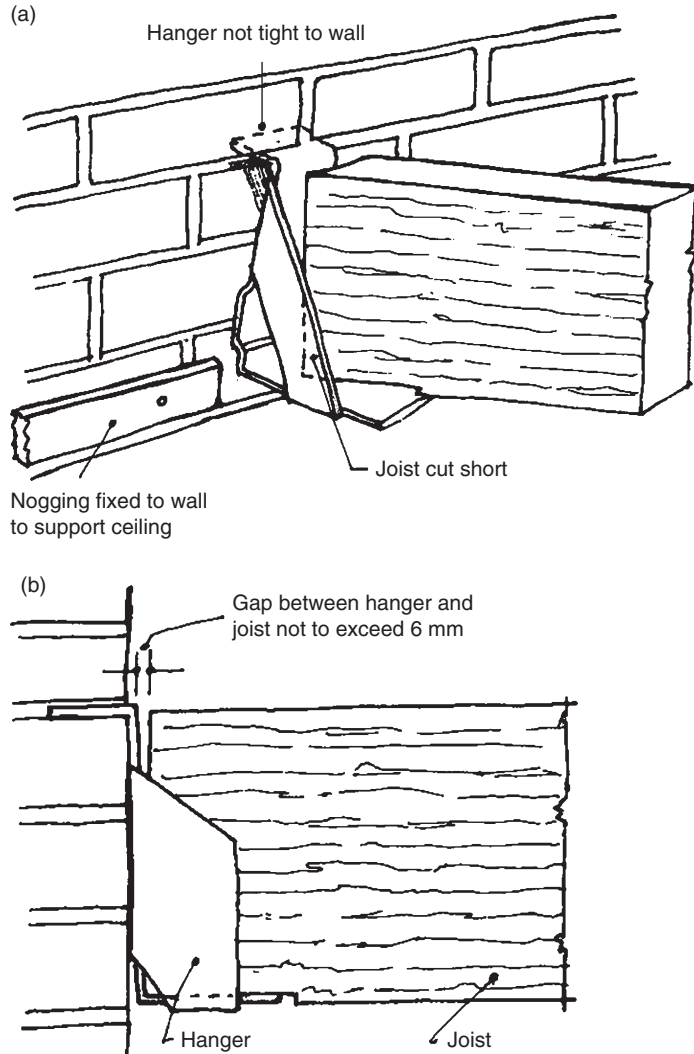
- (8) In modern properties metal joist hangers have been used extensively. Unfortunately, recent surveys have found instances where the hangers or joists have failed due to one or more of the following causes (see Figures 12.2a and b).

**Figure 12.2 Use of metal joist hangers: (a) incorrect positioning; (b) correct positioning**

- Hangers should be tight against the face of the masonry.
- Incorrect grade of hanger used. It is important that hangers are not used with masonry of lower strength than the hanger grade marking. Hangers should comply with BS 6178 Part 1 and are made for minimum masonry crushing strengths.
- Sometimes joists are cut short leaving a large gap between joists and back plate of hanger. This may cause hangers to move and the floor to settle.
- Check to ensure that no damaged or corroded hangers have been used.
- Check that the undersides of the joists are properly notched to accommodate the hanger flanges.
