# BUILDING SURVEYS & REPORTS

*4<sup>th</sup> Edition*

**James Douglas BSc, MRICS, MBEng, FHEA  
and Edward A. Noy FASI, ARSH**

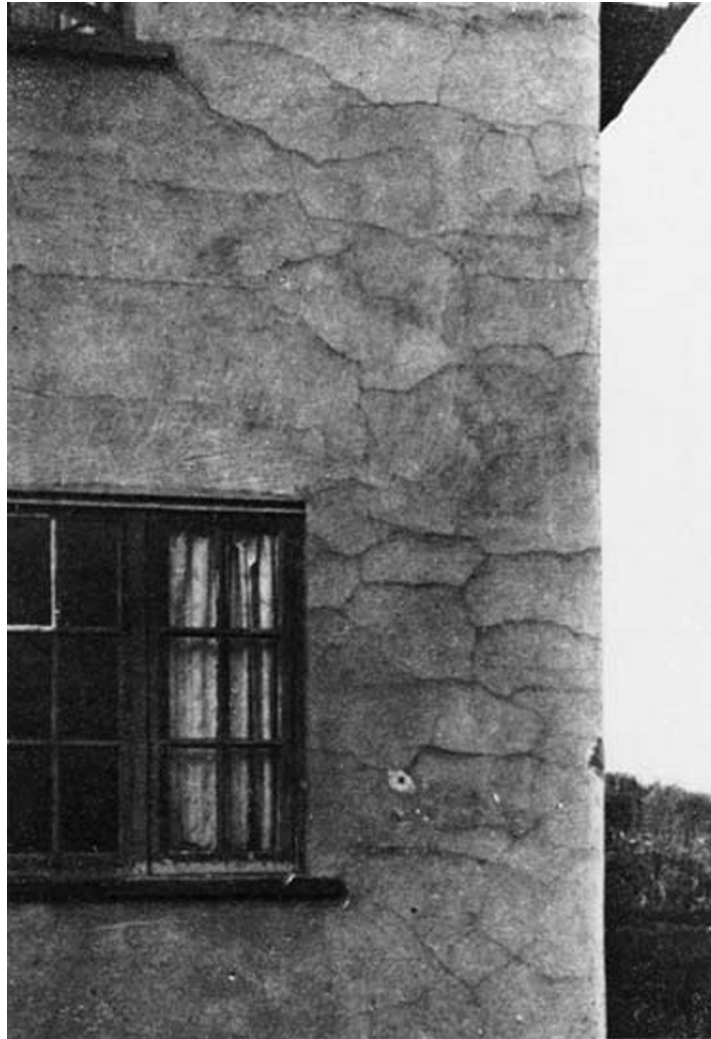
**Figure 13.1** Cracked rendering as a result of sulphate action

- Rendering consisting of cement and sand without the inclusion of lime and applied with a floated finish will often produce 'map' patterns. In exposed conditions this type of rendering will lead to loss of adhesion due to frost action and provide damp conditions necessary for sulphate attack. Figure 13.1 shows cracking of rendering as a result of sulphate action.

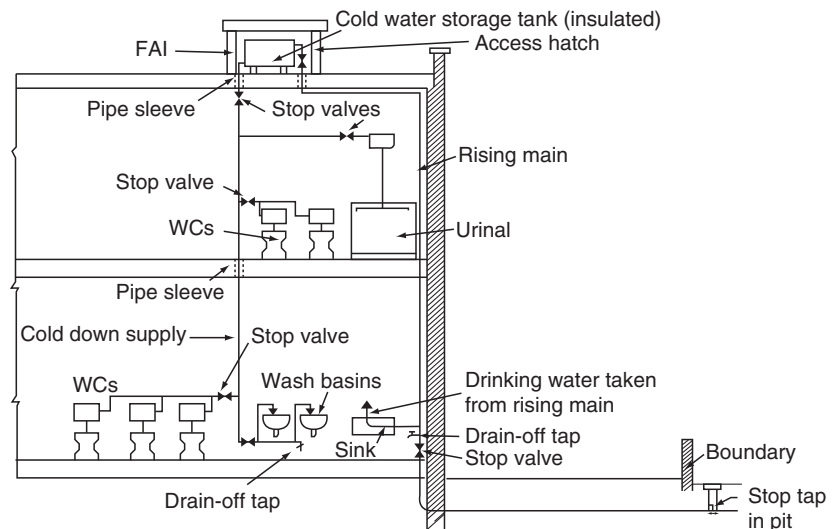
The distribution of cold water through a building so that draw-off points can be adequately served depends on the requirements of the local water authority and the available pressure on the mains (Figure 14.1).

**Figure 14.1** Layout of cold water supply to small office block

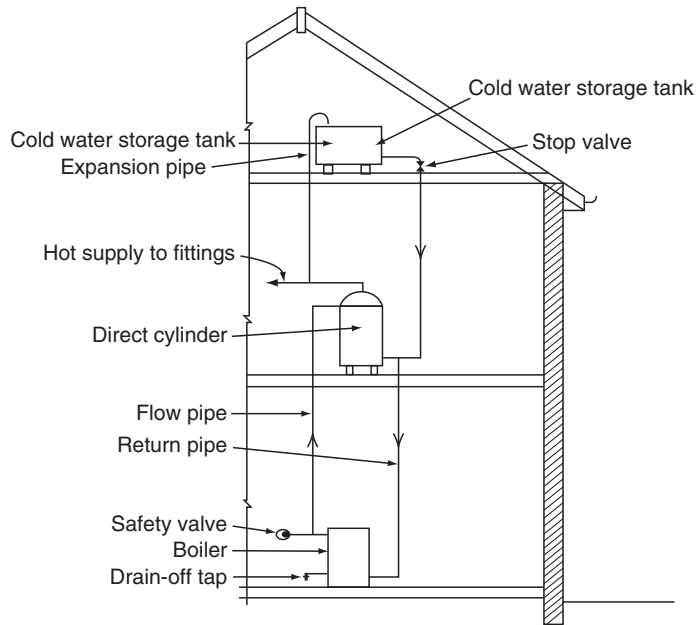
In direct heating systems the principal components are boiler; flow and return pipes; hot water storage cylinder; cold water supply pipe; expansion pipe and draw-offs (see Figure 14.2). Furring of pipes in this type of system is common in 'hard water' areas.

**Figure 14.2** Layout of direct heating system

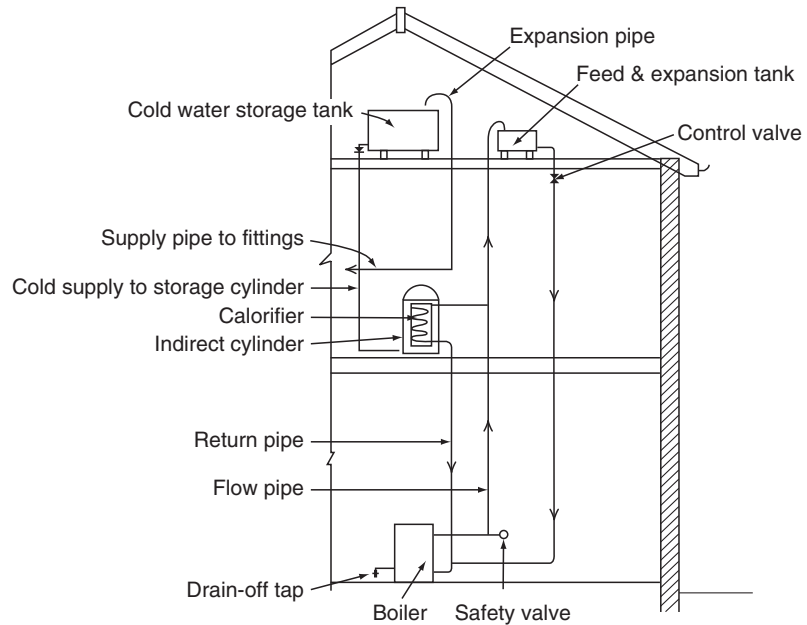
**Figure 14.3** Layout of indirect heating system

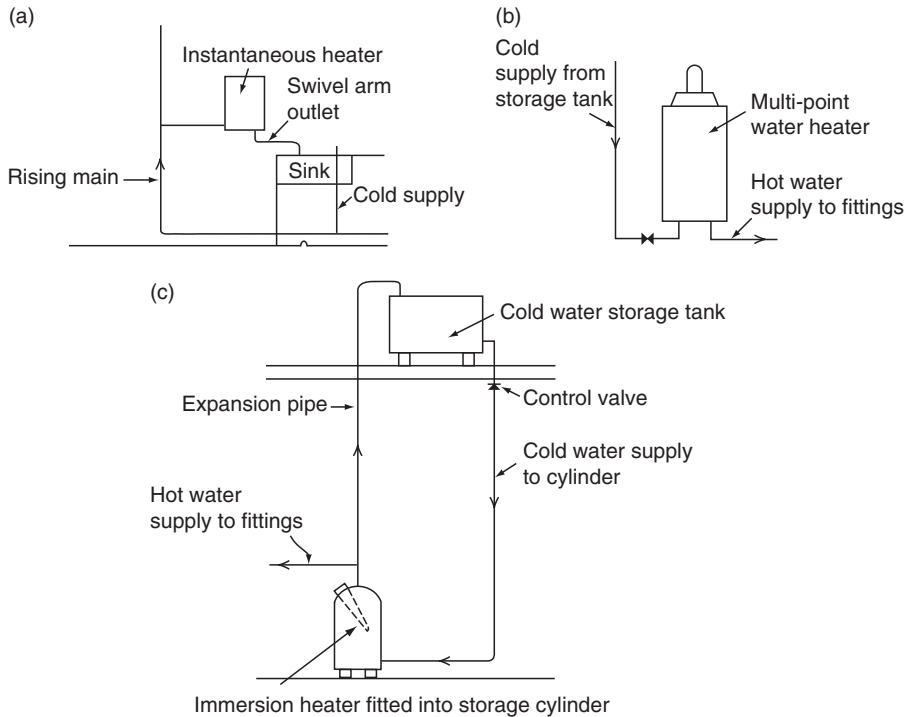
Wall mounted water heaters can be heated by gas or electricity. The instantaneous type is usually found above a sink unit in domestic properties and does not take up valuable floor space (Figure 14.4a). The water is heated at a single point and is supplied through a swivel arm outlet. The multi-point heaters can be heated by

**Figure 14.4** (a) Wall mounted instantaneous heater. (b) Wall mounted multi-point heater. (c) Heating water by electric immersion heater

gas or electricity. They receive the cold supply from a cold water storage tank which then supplies hot water to several fittings (Figure 14.4b).

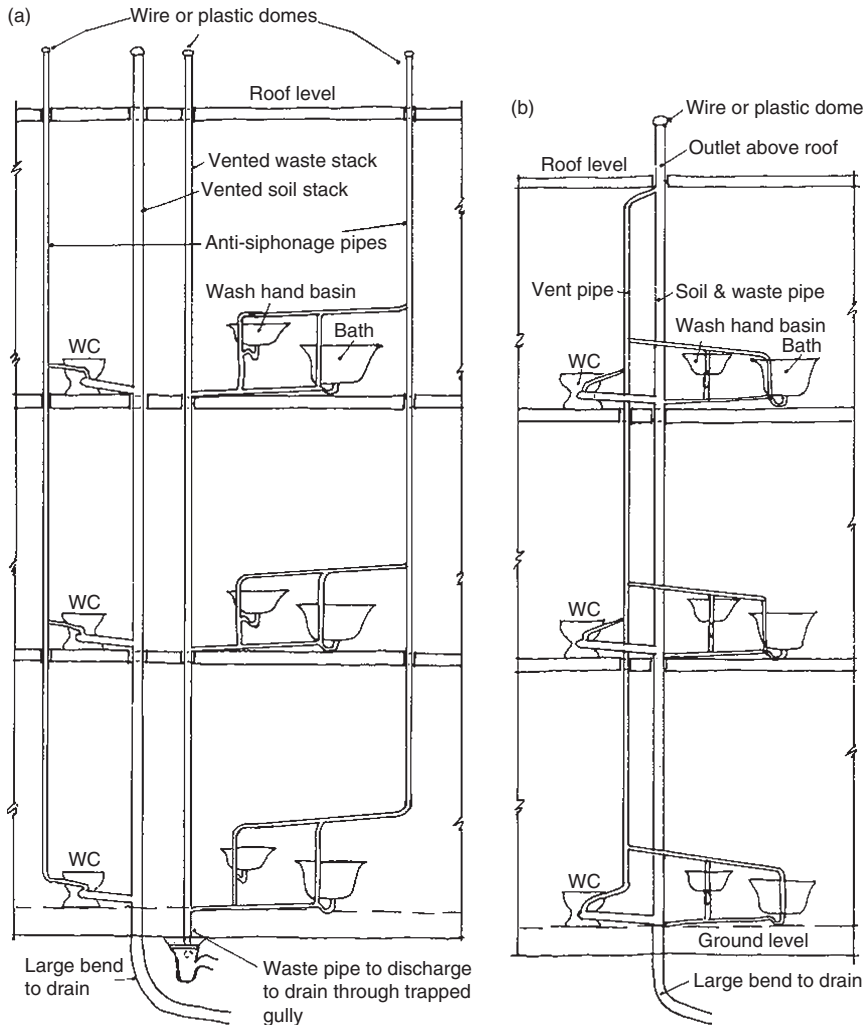
Figure 14.5 (a) Two pipe system for block of flats. (b) One pipe system

drain through a trapped back inlet gully, and the discharge from the water closets is direct to the drain. This system has a disadvantage in regard to the present day use of detergents and is now seldom used (see Figure 14.5a).

In this system the soil and waste are conveyed together in one pipe with ventilating pipes connected to each fitting and sized according to the loading of the installation. The main stack is connected directly to the drain (see Figure 14.5b).

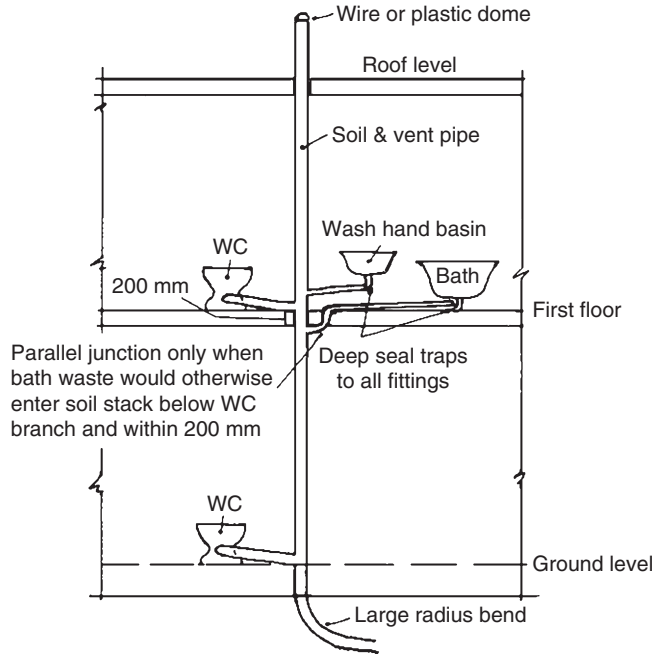
**Figure 14.6 Single stack system**

This is a much simpler system, does not employ separate ventilating pipes and is commonly used although it is based on strict rules which must be observed, e.g. deep seal traps must be used on all fittings (see Figure 14.6).

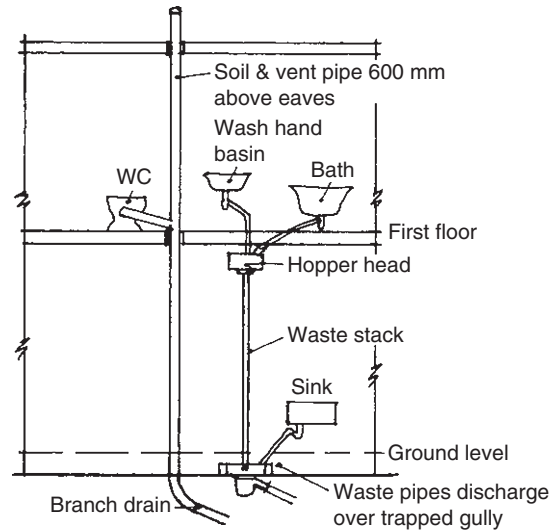
**Figure 14.7 Disposal of soil and waste water in older domestic properties**

In many domestic properties built before World War II the surveyor will find that the waste pipes from fittings above ground level, such as baths, basins and showers, discharge into hopper heads and the sinks at ground level discharge over a trapped gully. The WC is usually connected to a ventilated soil pipe. The waste pipe and hopper are not a satisfactory method and will often be found to be partially blocked with slimy soap and hair etc., and in very cold weather the waste water will freeze and possibly fracture the pipes (see Figure 14.7).

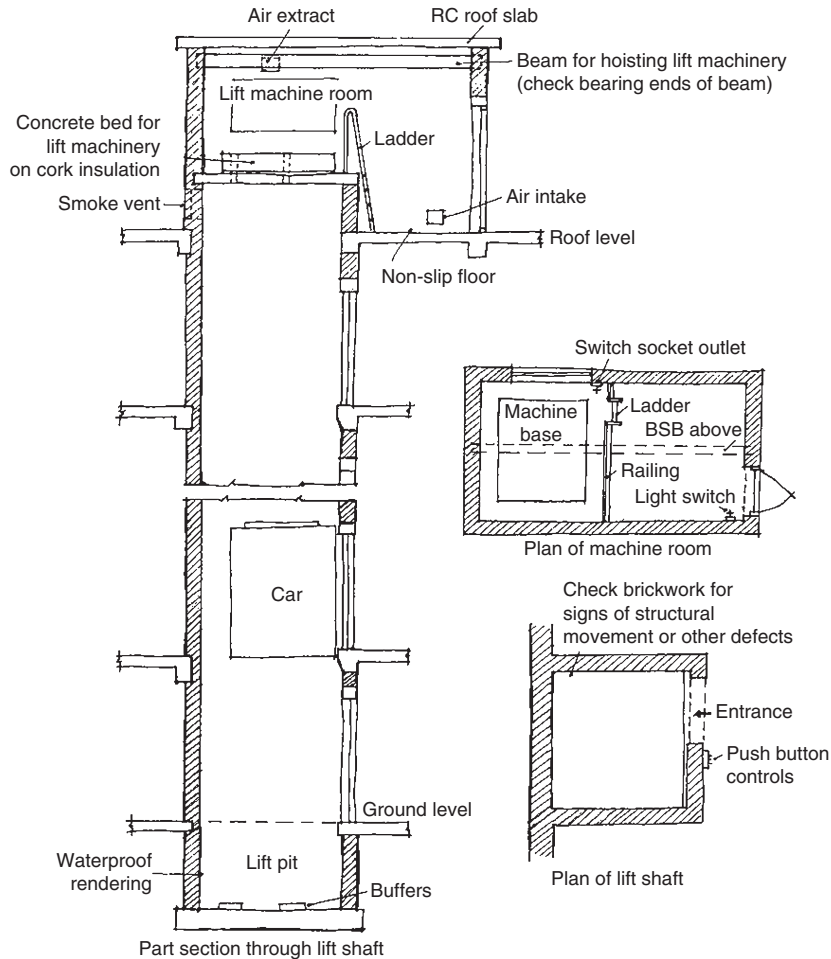
**Figure 14.8** Typical lift shaft and machine room showing 'builders' work'

There are three main areas requiring the surveyor's attention: the lift pit, shaft and machine room. The first operation on site will involve the lift engineer who will shut off all push button controls at all levels so that the surveyor and engineer can use the lift without interference from the landing call points (see Figure 14.8).

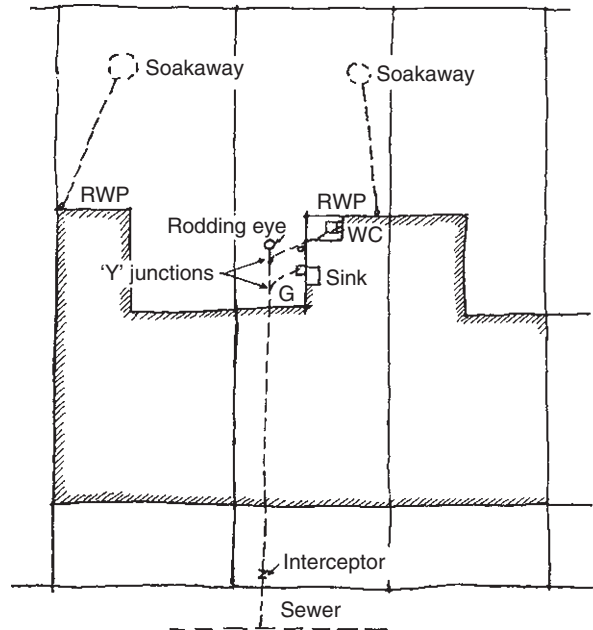
**Figure 15.1** Soil drainage system to terraced housing erected before 1900

If inspection chambers are not visible on site, the possibility that they may have been covered up by raised flower beds, pavings or rubbish should not be ruled out. If, however, inspection chambers cannot be located, there is a strong possibility that the building is still equipped with the original system which was probably installed some time between 1850 and 1880. Such a system was usually laid in 4" or 6" salt glazed pipes with clay joints and without any form of concrete bed. In the case of terraced houses, the most common layout was a straight run under the house from the outside WC to the sewer. This meant that the soil branch drain connected to the WC outlet and vented to the open air and went directly to the main drain while a second pipe took the waste water from the kitchen sink to an outside trapped gulley. Sometimes the WC connection entered the main run with a 'Y' junction, the main run then being extended via an easy-bend up to yard level where it was capped off with a rodding eye. However, it was fairly common practice to form a junction by cementing the end of a 4" branch pipe into a hole cut into a 6" main drain (see Figure 15.1).

Drainage systems of the kind shown in Figure 15.1 are seldom found today. They do not satisfy any of the requirements of the current Building Regulations in that they are unlikely to be watertight and not laid to a self-cleansing fall. The surveyor can safely assume that, if no inspection chambers can be found, a new drainage system must be provided as the system will certainly be condemned by the Environmental Health Officer. Where inspection chambers are found on nineteenth century properties similar to that shown in Figure 15.2 it is usually an indication that the drains have been relaid at a more recent date. An examination of the type and condition of the brickwork and channels can give an indication of the age of the system.

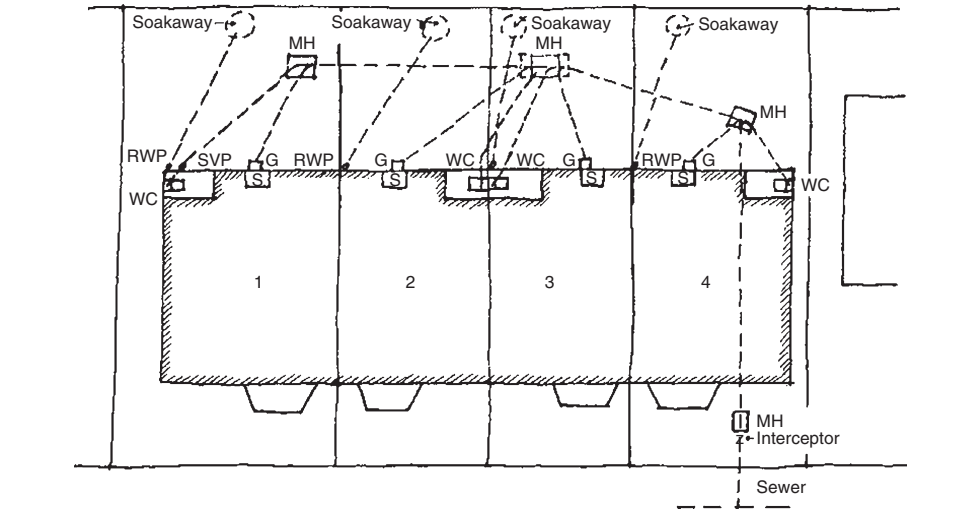
**Figure 15.2 Soil and surface water system to terraced housing erected after 1900**

Alternatively, where several houses were in one ownership, the drains were collected into a main run at the rear of the terrace before being discharged under the last house in the terrace and thence to the sewer (see Figure 15.2). Towards the end of the century the local authorities usually insisted on inspection chambers at every change of direction, but this was not always adopted and pipes were often laid in curves. The Public Health Act 1875 was the first Act to regulate the construction and ventilation of sewers. It was, therefore, considered necessary to disconnect the house drain from the sewer by means of an intercepting trap. Some of the early types of trapped gulleys and interceptors introduced were inefficient and simply consisted of a shallow bend with an unreliable water seal. These fittings often became blocked and were difficult to rod. Joints between pipes were often badly formed and in surface water drains they were almost non-existent.

In some cases it will be found that, although there is no inspection chamber on the property, the drains are in fact connected into an inspection chamber in an adjoining property, as shown in houses 2 and 3 in Figure 15.2. No particular problems should arise from this unless the properties belong to different owners. Should this be the case a 'drainage agreement' will have to be entered into by the various owners, whereby joint responsibility is accepted for the repair of common

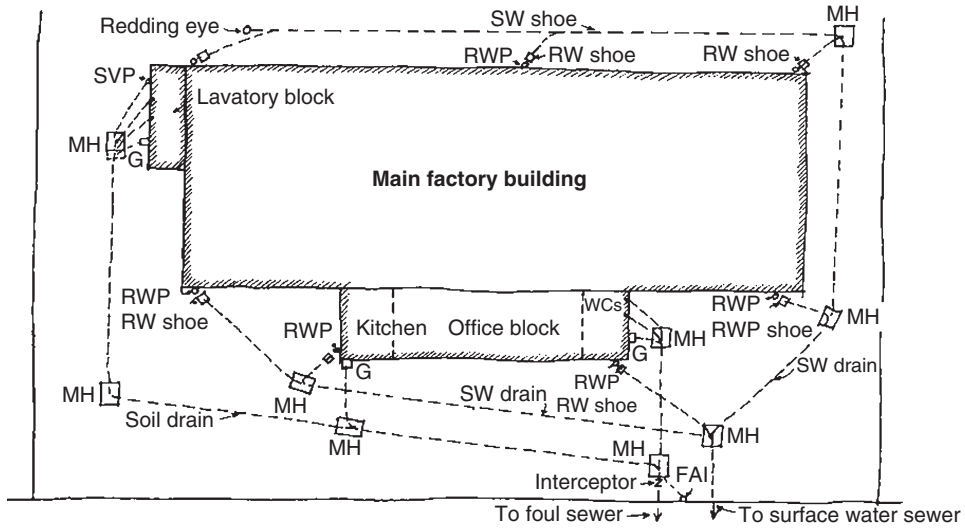
Figure 15.3 Typical separate system layout for a small factory

It may well be found that the surface water drainage is on a ‘separate system’ either to a surface water sewer or to a soakaway within the curtilage of the site as shown in Figures 15.1, 15.2 and 15.3. Care must be taken not to get the systems inadvertently interconnected. ‘Separate systems’ were adopted by many local authorities in large towns in order to avoid overloading the sewage treatment plant. They will not allow rainwater pipes or yard drainage to be connected to the foul sewer. However, some local authorities allow the soil and surface water to discharge into the same sewer as shown in Figure 15.4.

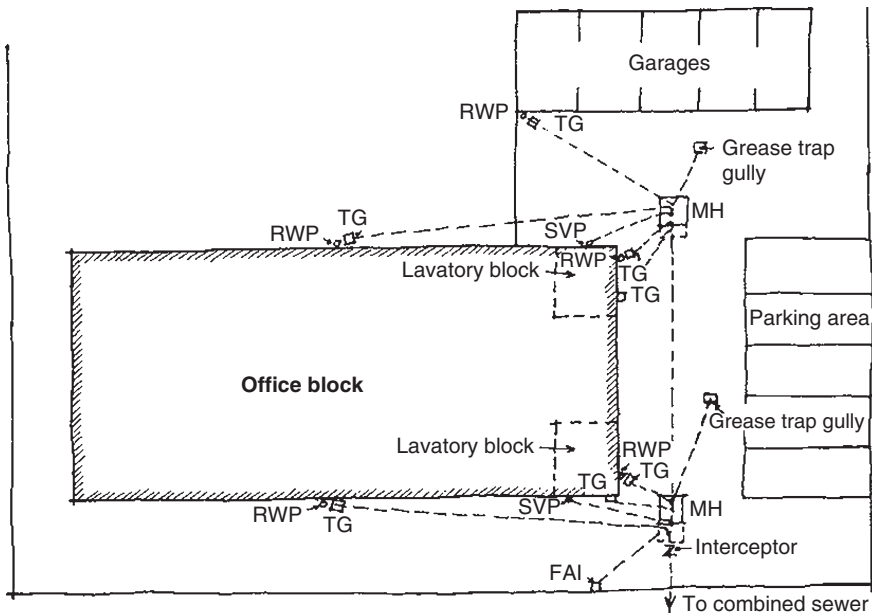
Figure 15.4 Typical combined system for small commercial building

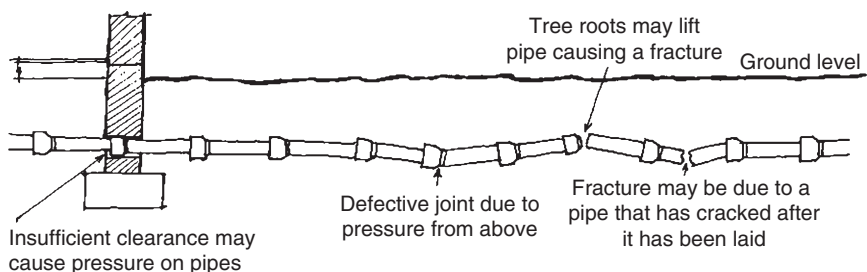
**Figure 15.5** Defects due to movement of ground through settlement, shrinkage or tree roots

- Leaky pipe joints which may require rejoining. Old drains are almost certain to have leaky joints. Cement joints often shrink and crack.
- Movement of the ground through settlement or shrinkage may disturb the pipes and often the joints. This type of defect is illustrated in Figure 15.5.
- Cement and debris left in pipes causing obstruction.
- Obstruction due to solid matter being washed down the drains.
- Lack of proper ventilation causing bad smells in the system.
- Bad smells through leaks, faulty fittings or blocked traps.

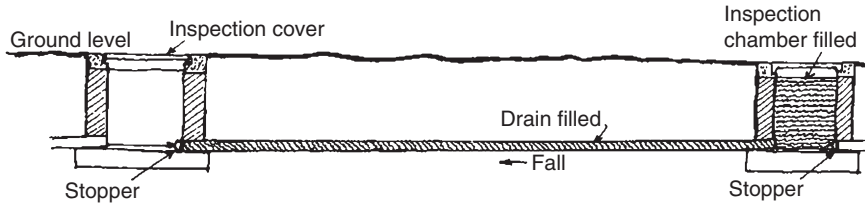
**Figure 15.6** Water test applied to section of drain between two inspection chambers

The only certain method of demonstrating that a drain will hold water is to fill it with water and note if the level drops. This can usually be done by gaining access to the drain at the lowest inspection chamber and stopping the inlet with an expanding stopper. Another stopper should be fitted to the inlet (or to each inlet if there are more than one) at the next inspection chamber higher up. These positions are shown in Figure 15.6 which is a section through a drain being tested. The higher inspection chamber is then filled with water and the distance from the top of the cover frame to the top of the water carefully measured and then left for about 1.5–2 hours. If the water level in the chamber goes down by any appreciable extent a leakage is indicated. There will be a slight lowering of the water level even

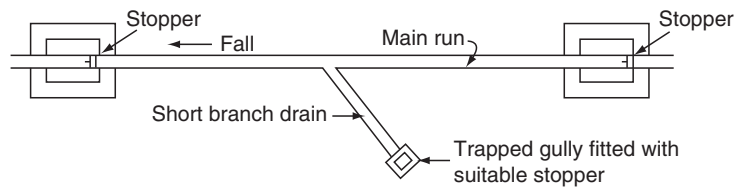
**Figure 15.7** Water test applied to main and branch drain

Short branches connected to a main drain between inspection chambers as shown in Figure 15.7 should be tested with the main drain. The gully should be fitted with a suitable stopper and any confined air in the gully should be drawn off as the pipe fills with water, using a rubber tube passed through the seal of the gully. The shorter the lengths tested at one time the better, as the job of opening the ground and searching for defects can be confined to those sections in which defects are indicated by test.

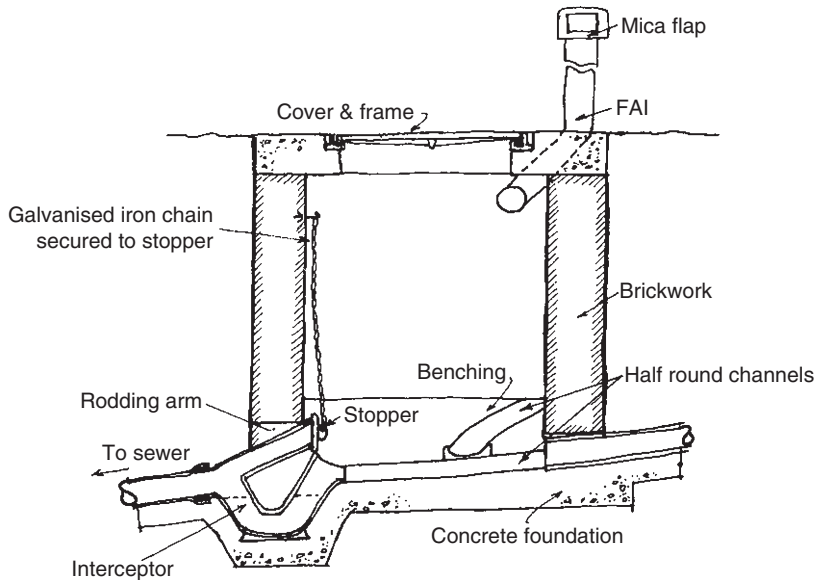
**Figure 15.8** Section through interceptor and inspection chamber

The interior of each inspection chamber should be carefully examined and the construction and condition of the following parts noted (see Figure 15.8):

It is advisable to recommend that a galvanised iron chain is provided and secured to the chamber wall as shown in Figure 15.8. Where an interceptor is provided, a fresh air inlet with a mica-flap is theoretically necessary as shown in Figure 15.8. It should be located away from windows and doors and sited where the front will not be accidentally damaged. The mica-flaps should be closely examined. They may cause a nuisance by acting as a foul air outlet if the flaps are damaged.

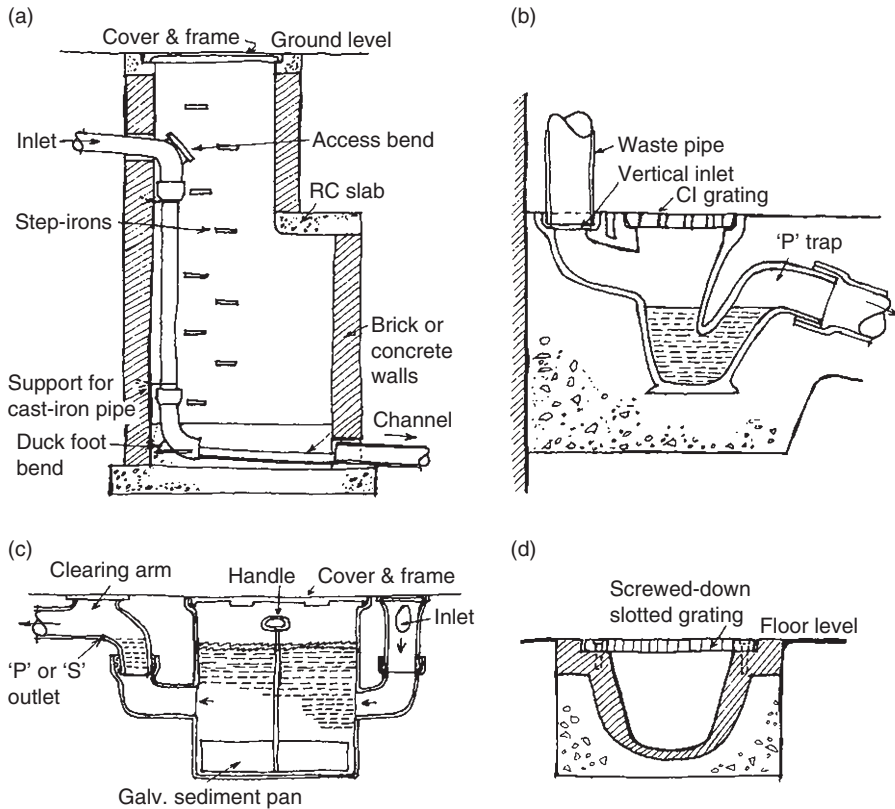
An inspection chamber incorporating a vertical drop for the purpose of connecting to a sewer or drain at high level to one at a lower level is known as a back-drop inspection chamber, or tumbling bay. The vertical drop is usually constructed outside the chamber, but may be constructed inside provided there is sufficient space in the chamber as shown in Figure 15.9a. If the vertical drop is constructed

**Figure 15.9** (a) Section through back-drop inspection chamber. (b) Back inlet gully. (c) Grease trap. (d) Drainage channel

This type of gully is used outside a building and is fitted with a vertical or horizontal inlet as shown in Figure 15.9b. For use within a building this type of gully must be fitted with a sealing cover and frame secured with screws and washers. The inlet should be connected below the grating, but above the water seal; be self-cleansing; have a seal of at least 50 mm and a flat base for bedding in concrete. During the examination the surveyor will find that many of the older type gulleys will not comply with these requirements and are often fitted with insanitary connecting channels to receive the discharge from waste pipes or, alternatively, the waste pipes discharge over the top of the gully grating.

In normal domestic drainage grease traps need not be provided, but where substantial quantities of grease are discharged into a drainage system from large kitchens and wash-up rooms a grease trap should be provided. The intention is that the cooling effect of the water in the trap solidifies the grease which rises to the surface and collects in a solid mass. The heavier matter collects in a galvanised sediment pan situated at the base of the grease trap. The grease trap consists of a cast iron or galvanised steel tank fitted with a single seal cover at ground level. A vent grating at ground level is fitted close to the inlet and the connection to the main drain is fitted with a 'P' or 'S' outlet. The disadvantages of these traps are that they are rarely cleaned and the removal of grease is usually an offensive operation. However, the surveyor will often find that the increased use of detergents has lessened the need for providing grease traps or gulleys (see Figure 15.9c).

The type of floor channel shown in Figure 15.9d is usually found in industrial buildings. It consists of a cast-iron or precast concrete half-round channel fitted with a light, medium or heavy duty slotted grating. Some channels have a built-in fall with an outlet at one end connected to the drainage system.

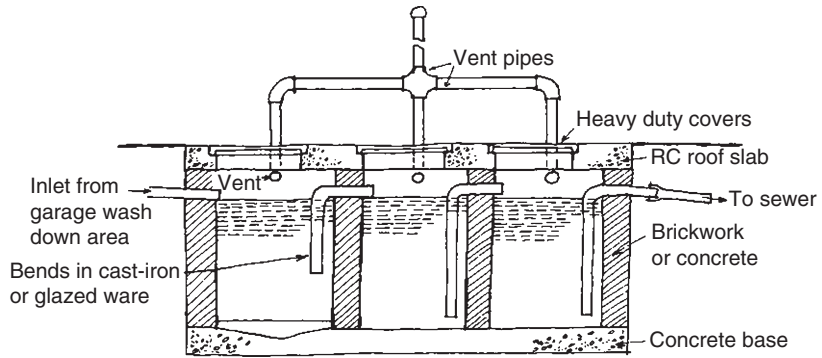
**Figure 15.10 Petrol interceptor**

Where there is a risk of pollution from petrol or oil spillage from garage wash downs entering a drain communicating with a sewer, a suitable interceptor should be incorporated in the system. For a single domestic garage a deep gulley trap fitted with a perforated lifting tray is usually sufficient. For a large number of garages or a filling station, a brick or concrete structure consisting of three chambers is necessary, as shown in Figure 15.10. The chambers allow for any petrol that may be present to rise to the surface and evaporate into the atmosphere through the vent pipes. The construction details are similar to brick inspection chambers, but many petrol interceptors in modern buildings are constructed of precast concrete or prefabricated in glass reinforced polyester (GRP). GRP interceptors are factory manufactured, rot proof, impact resistant and are usually installed in a concrete surround. The condition and construction of the following parts of the interceptor should be noted:

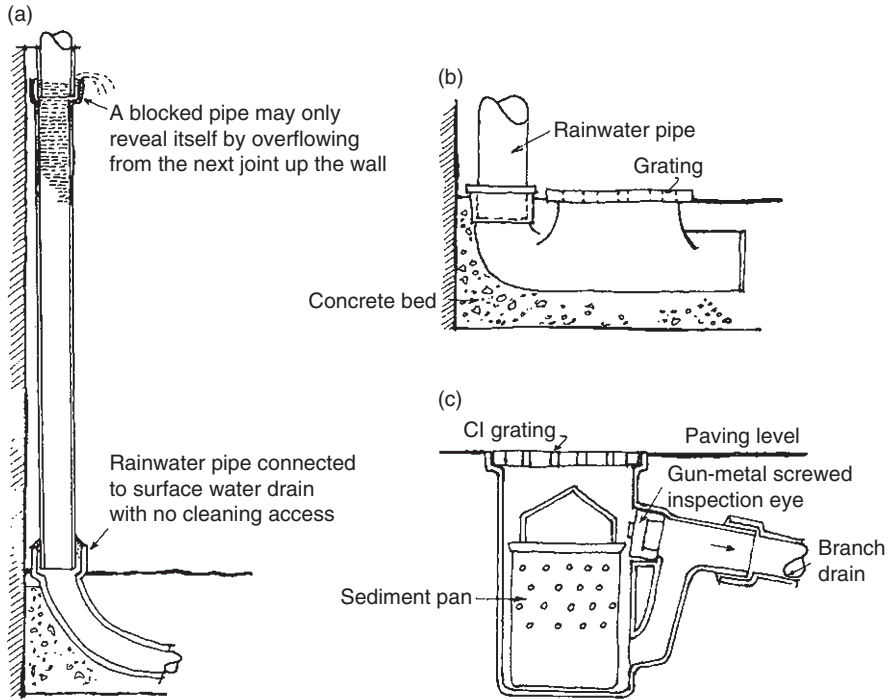
**Figure 15.11** (a) Rainwater pipe connected direct to surface water drain. (b) Rainwater shoe. (c) Yard gully

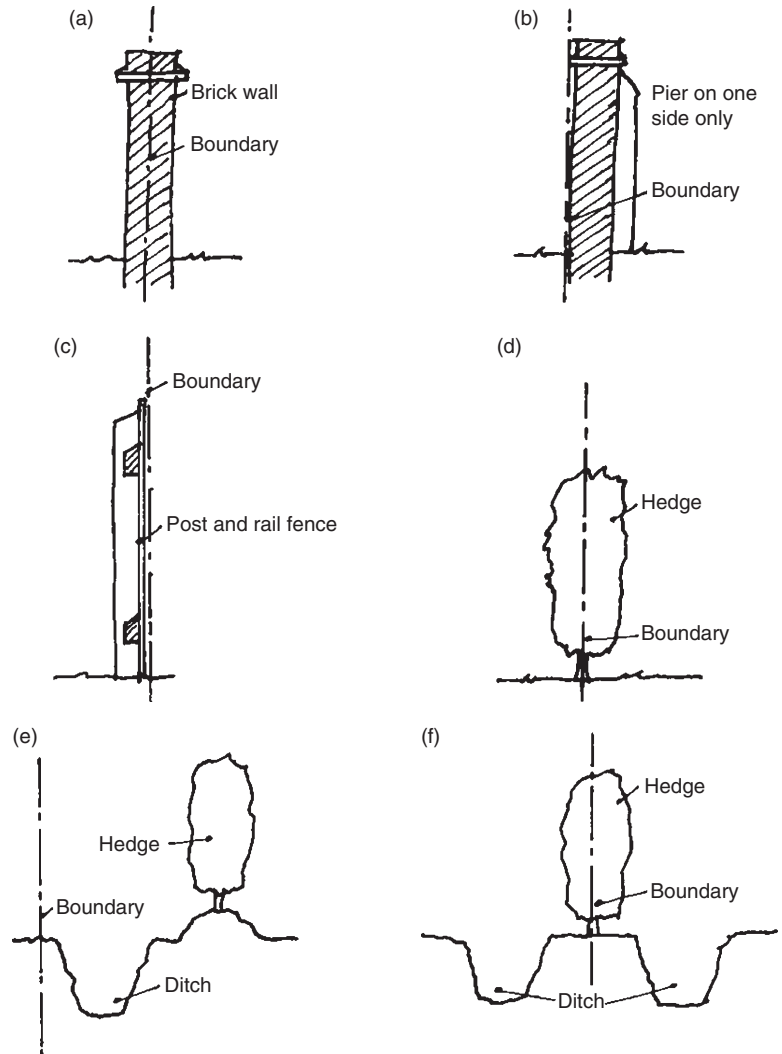
**Figure 15.12 Presumed ownership of boundary features**

Brick, stone or concrete block walls separating the properties of different owners, when built on the line of junction of two properties are usually deemed to be shared by the respective owners and are known as 'party fence walls'. A considerable number of terraced houses built before 1900 were provided with this type of boundary wall which is usually 1.5–2 m high. Section 38 of the Law of Property Act 1925 provides that party fence walls shall be treated as being severed vertically, but that each owner shall have a right to have his part of the wall supported by the other (Figure 15.12a). This means that neither can remove his part of the wall if this would mean that the other part collapses. Occasionally, projecting piers indicate ownership since they are invariably built on the land of the owner of the wall. In such cases the actual boundary line may be the far face of the wall (Figure 15.12b).

Unlike walls, fences generally belong wholly to one owner. The facts that have a distinct bearing on the ownership of fencing are still valid. An owner must erect a fence entirely on his land and therefore places the posts and rails on his ground with the boarding fixed on the outside (Figure 15.12c). Thus, the face of the fence defines the boundary line even though the owner of the fence must sometimes enter upon the neighbouring ground to drive the nails into the woodwork.

- Where two properties or fields are separated by a hedge or ditch there is a presumption that the boundary is the centre of the hedge or ditch (Figure 15.12d).
- If the properties are separated by an artificial ditch alongside a bank with a hedge on it there is a presumption that the boundary is along the edge of the ditch furthest from the hedge (Figure 15.12e).
- If there is a ditch on either side of the hedge the ownership of the hedge must be proved by acts of ownership. No presumption operates, because the original landowner's actions in digging the ditch or planting the hedge cannot be logically deduced. However, Ordnance Survey practice is to take the centre line of the hedge as the boundary feature (Figure 15.12f).

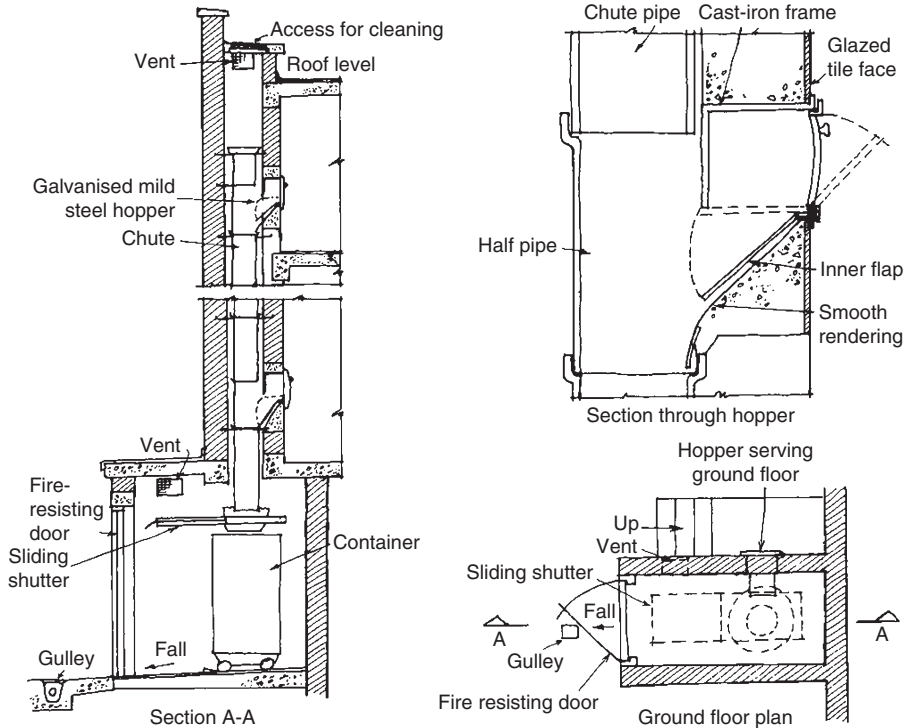
**Figure 15.13 Typical refuse chute**

The problem of refuse disposal in large blocks of flats and in some commercial buildings is usually overcome by refuse chutes. Figure 15.13 shows many of the standard features of a refuse chute and storage chamber which are required by the Building Regulations. The chute consists of a vertical pipe with a minimum diameter of 457 mm although some older types will be approximately 375 mm. The pipes must be constructed of non-combustible impervious materials such as salt glazed ware or vitreous enamelled iron, though in modern buildings spun concrete is used. The chute runs from top to bottom of the building and has an inlet hopper on each floor. At ground floor level the chutes discharge into a wheeled container in a specially constructed chamber consisting of a brick structure with a concrete roof slab and floor fitted with a fire-resisting door. Adequate ventilation is a necessity and both chamber and chute must be ventilated as shown in Figure 15.13.

- Hoppers for access to the chute at each floor level are usually galvanised mild steel. When open, an inner flap closes thus shutting off the main chute. When the hopper is in the closed position the inner flap drops allowing the contents to fall into the chute. Hinges and fastenings should be checked for ease of working. The hopper should have a surround at least 300 mm wide on the external face consisting of glazed tiling or other impervious material.
- The chute must be ventilated at the top and so positioned as not to transmit foul air in such a manner as to become prejudicial to health.

- A hinged cover for access at the top of the chute for cleaning is desirable, as shown in Figure 15.13.
- The chamber containing the wheeled container must have a fire resistance of 1 hour and be impervious to moisture. The floor of the chamber should be laid to a fall towards a trapped gulley situated immediately outside the chamber to enable the floor to be washed down. The construction of the walls, floor and roof should be checked as described in Chapters 5, 6 and 7.

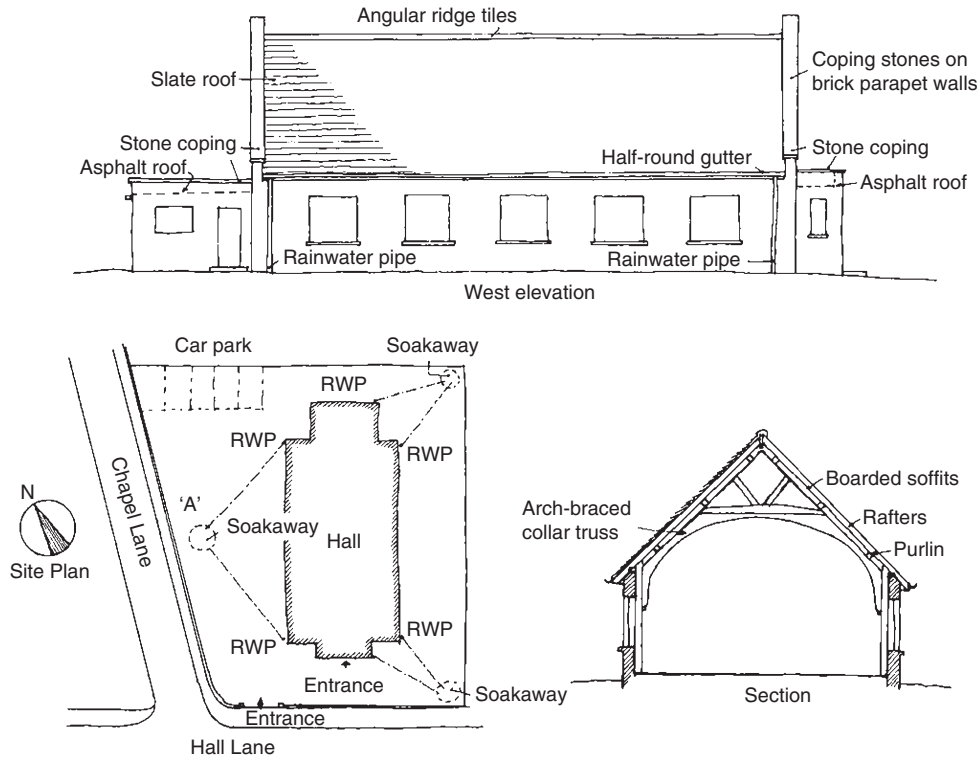
**Figure AVI** Details of roof and surface water drainage system referred to in Appendix VI

- (a) That all rainwater gutters are replaced with 125 mm half round PVC system. All gutter outlets to be fitted with plastic balloons to prevent possible blocking by leaves and other debris.
- (b) That all rainwater pipes are replaced with 76 mm diameter PVC pipes with all necessary offsets and fixing clips.
- (c) The softwood fascia board to both sides of the main roof to be replaced and treated with a preservative before fixing.

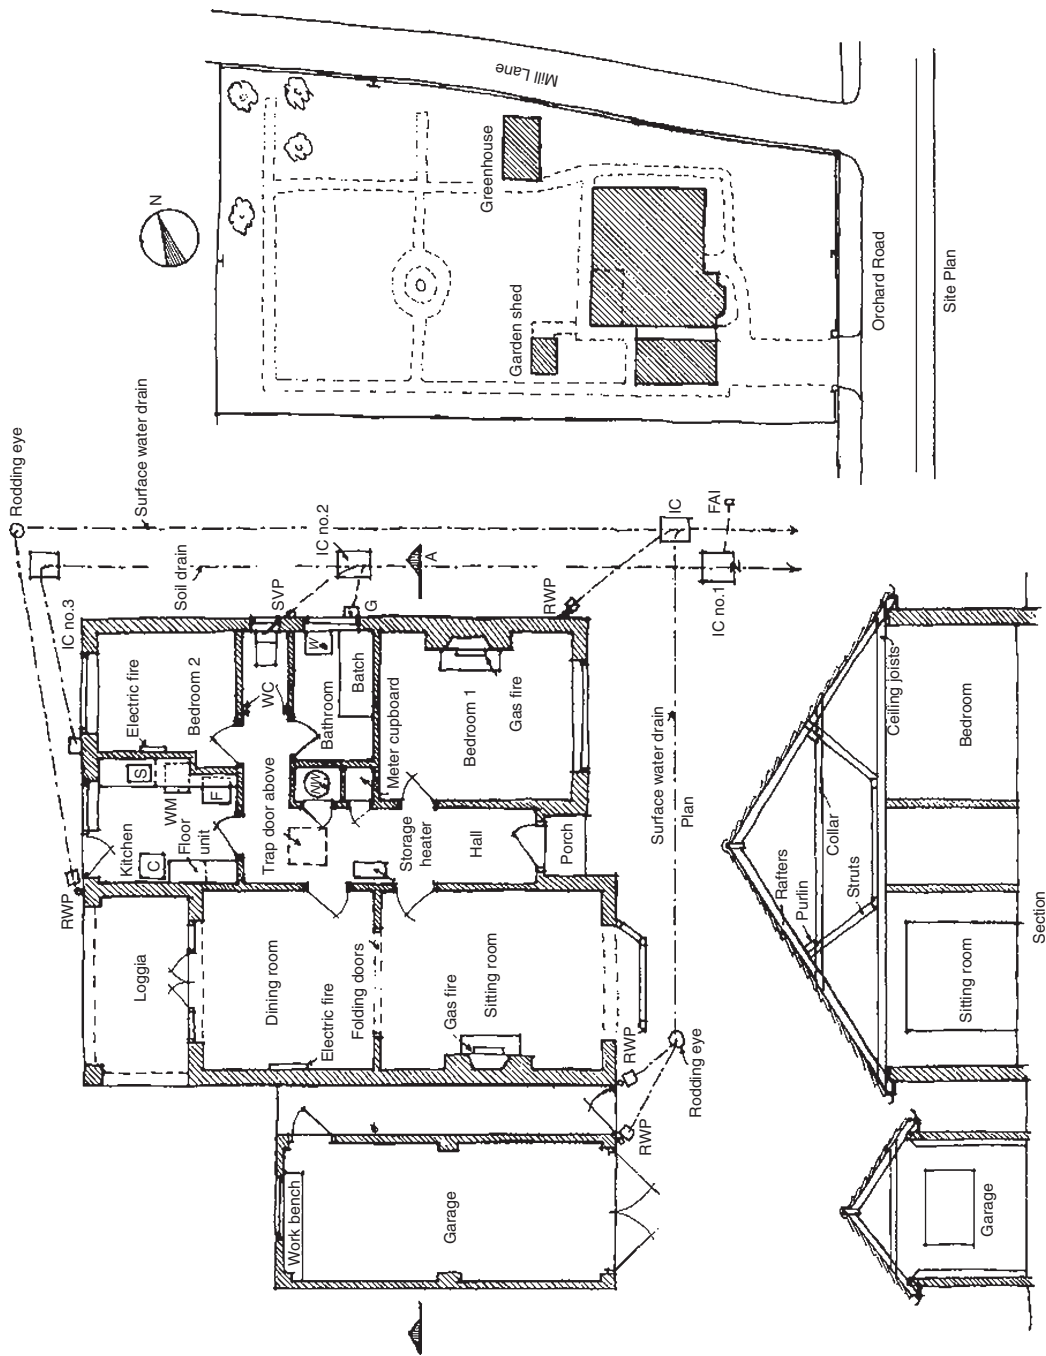
Figure AVII Plan of detached bungalow referred to in the report (Appendix VII)
