Corrosion protection of reinforcing steels

Technical report prepared by
Task Group 9.7

February 2009

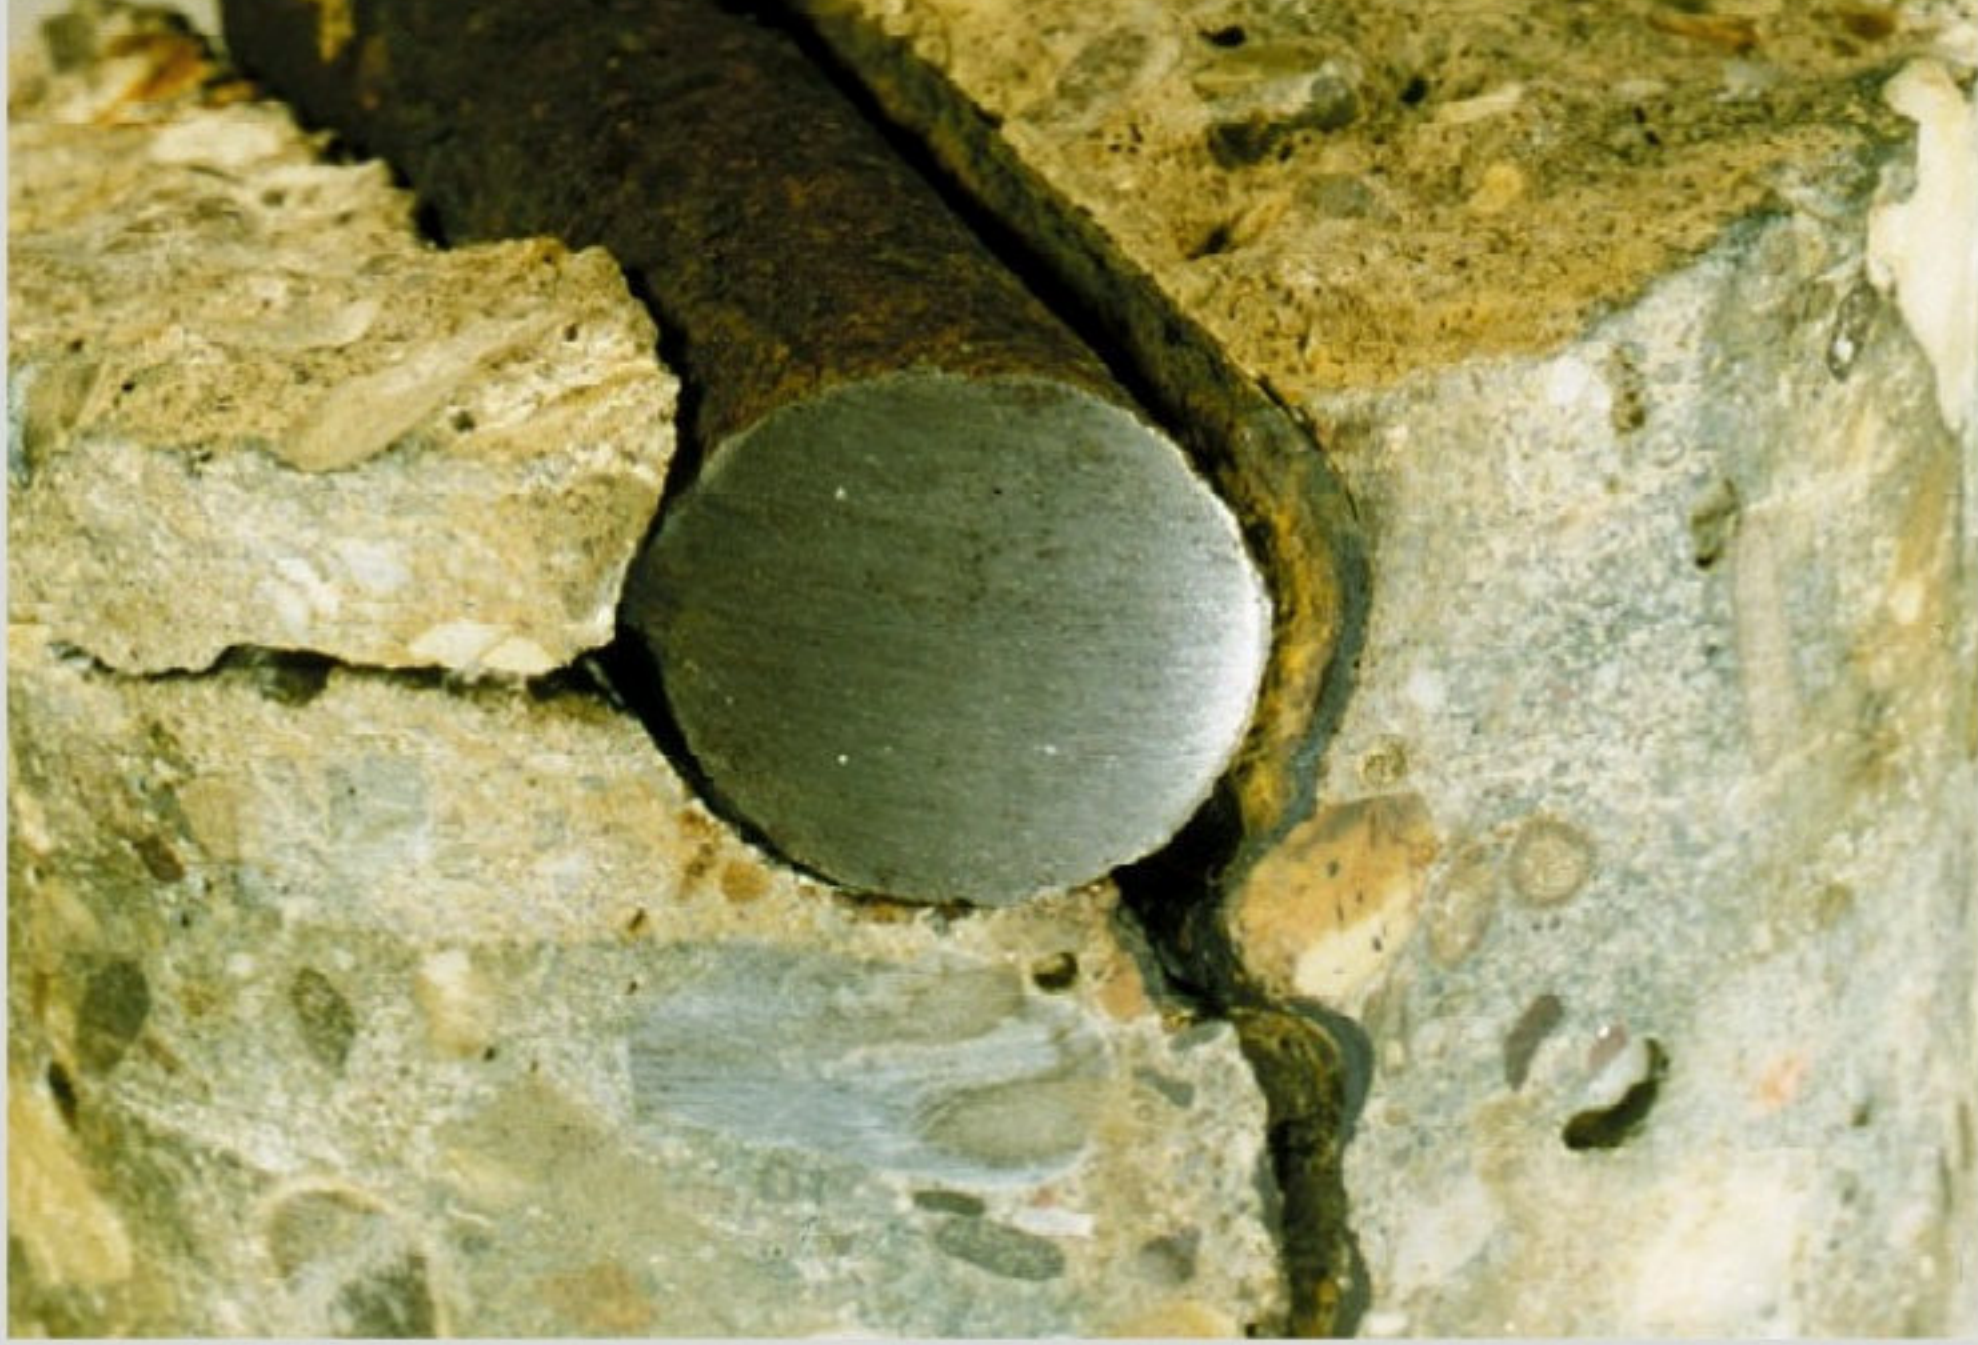
Cover image: Cracking of concrete due to reinforcement corrosion.

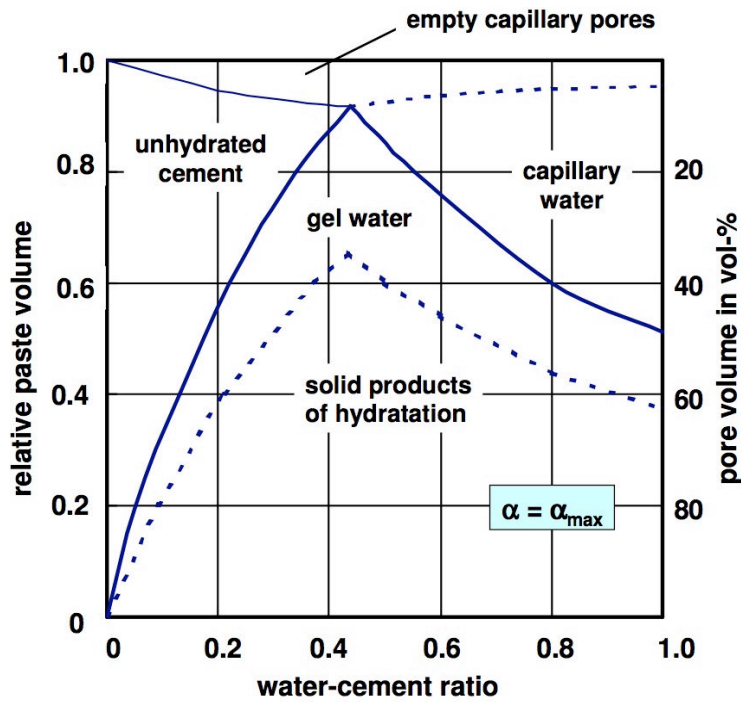
Fig. 2.1: Composition of hydrated cement paste and the final stage of hydration [6]
 α = degree of hydration

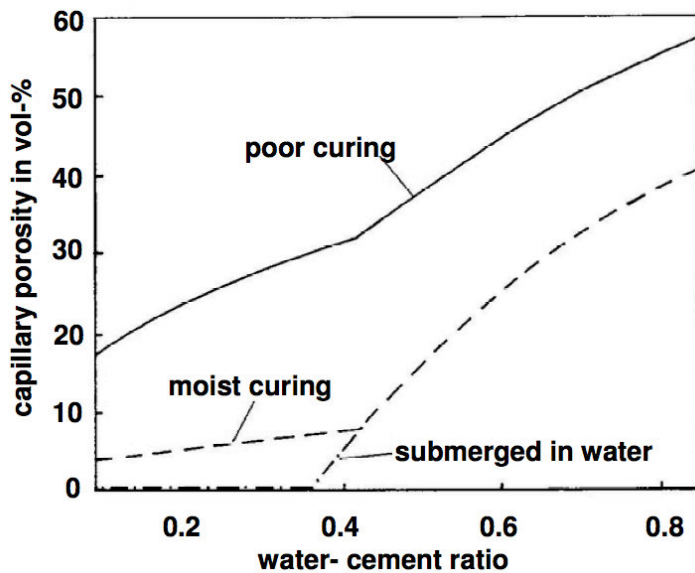
Fig. 2.2: Composition of hydrated cement paste at partial hydration

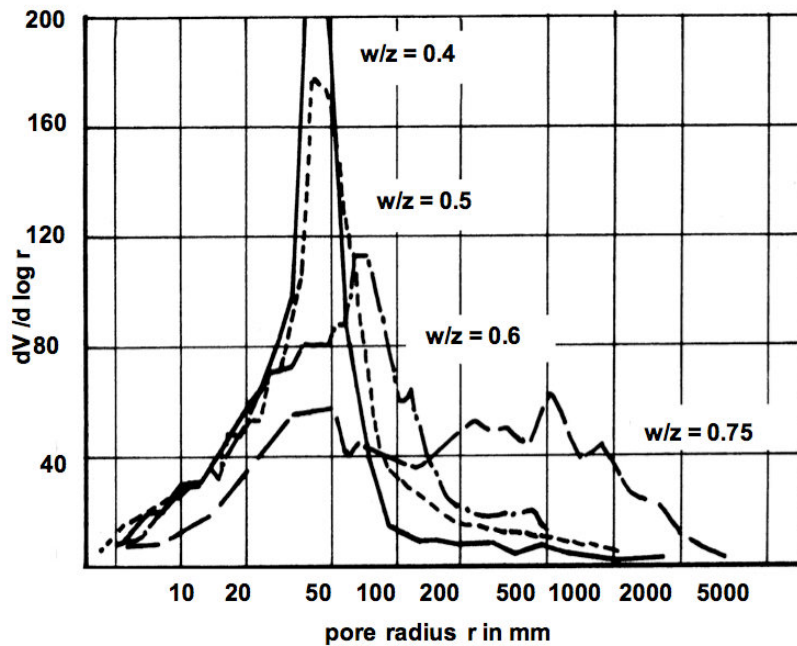
Fig. 2.3: Pore size distribution as a function of water/cement ratio [8]

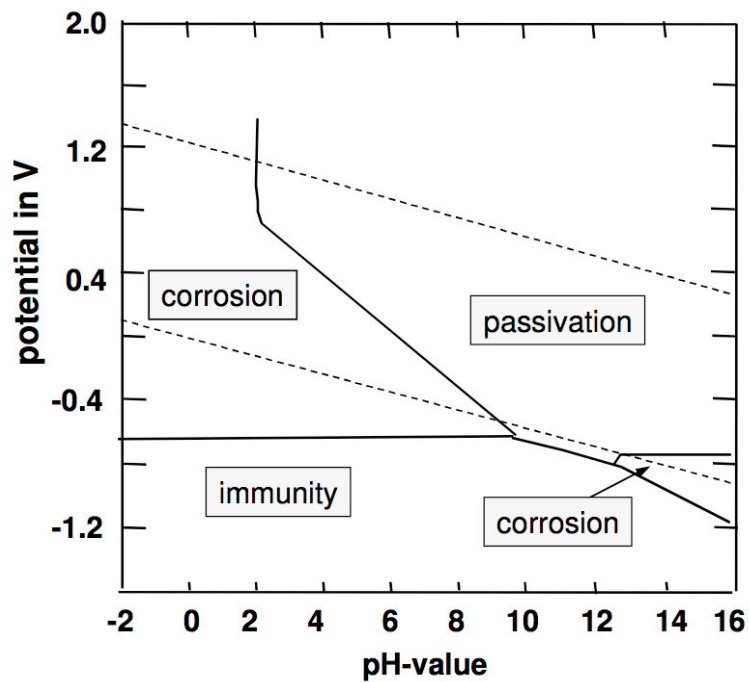
Fig. 2.4: Pourbaix diagram of iron in aqueous solution [9]

Due to the solution of calcium hydroxide and alkali oxides, the pore water of fresh concrete has a pH of 13.0 to 13.8. This high alkalinity protects the steel from corrosion as has been illustrated by Pourbaix [9]. The diagram distinguishes from areas where corrosion takes place, when the metal is stable (immune) and when it is passivated.

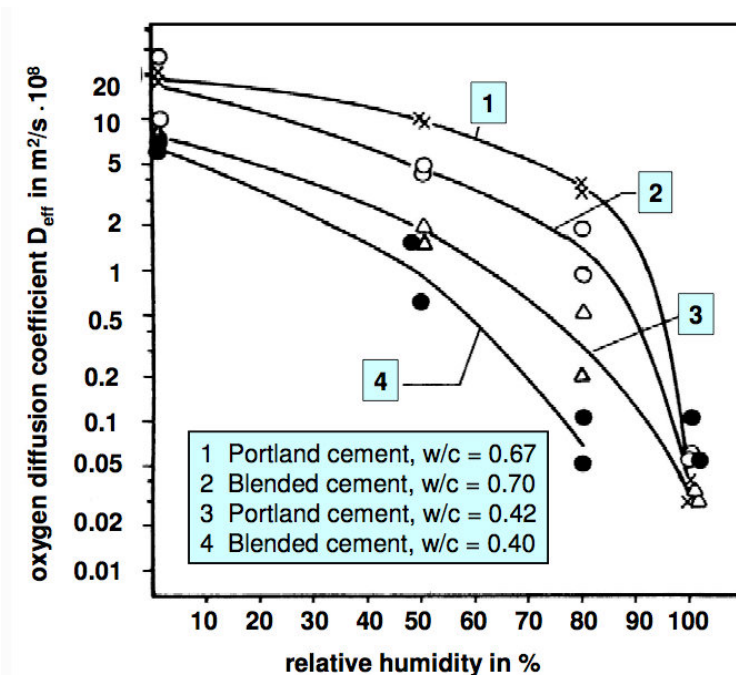
Fig. 2.5: Effective oxygen diffusion coefficient of Portland cement and slag cement concrete [10]

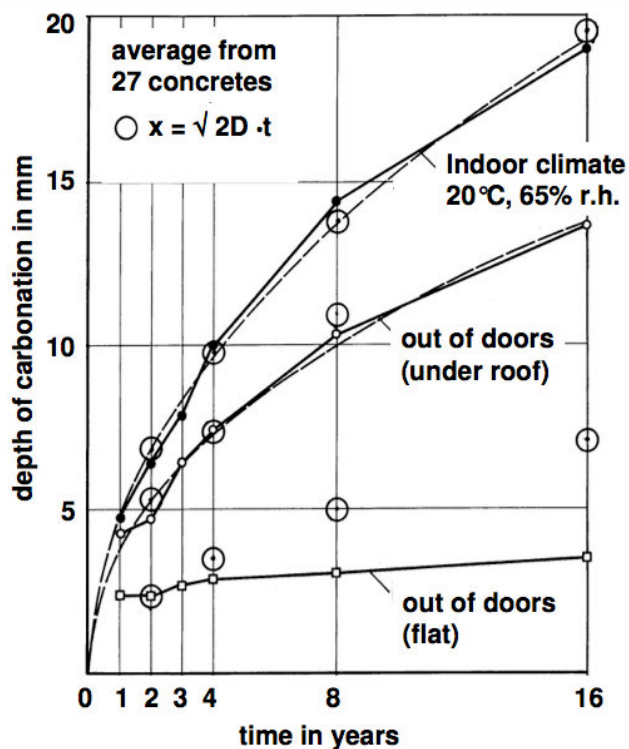
Fig. 2.6: Carbonation depth as function of time and environment [12]

with D = effective diffusion coefficient, c_0 = CO_2 -content in the ambient air, m_0 = mass of CO_2 which can be combined with cement and t = time. The CO_2 content of the air can be taken as a constant as 0.03 mass-% or 0.6 g/m^3 air in normal environment. The other two quantities depend strongly on the concrete. The quantity of c_0 is influenced by the type of cement. It is at its greatest with Portland cement and its smallest with slag cement. The carbonation depth increases in the following order when the same curing time is considered: Portland cement, Portland slag cement, portland puzzolan cement, slag cement. The carbonation depth of slag cement is about 60% more than Portland cement, with the same water/cement ratio. However, when slag cement is moist cured for a long period the carbonation depth is in the same order of magnitude. When the carbonation depth of a concrete with water/cement ratio of 0.42 is one, it is three for a water/cement ratio of 0.80. When concrete is not cured properly the skin of a concrete structure remains very porous and the diffusion coefficient is high. The carbonation depth is also strongly dependant on the moisture content. The diffusion coefficient is about $1.5 \times 10^{-8} \text{ m}^2/\text{s}$ in air and 0.8 to $5 \cdot 10^{-12} \text{ m}^2/\text{s}$ in water [11]. If a concrete gets wet and dry there is no carbonation during the period of water saturation. Fig. 2.6 shows the result of carbonation experiments, with clear distinction between dry and moist environments. In a dry climate, e.g. Spain, the carbonation proceeds quicker than in a rainy environment, e.g. Ireland.

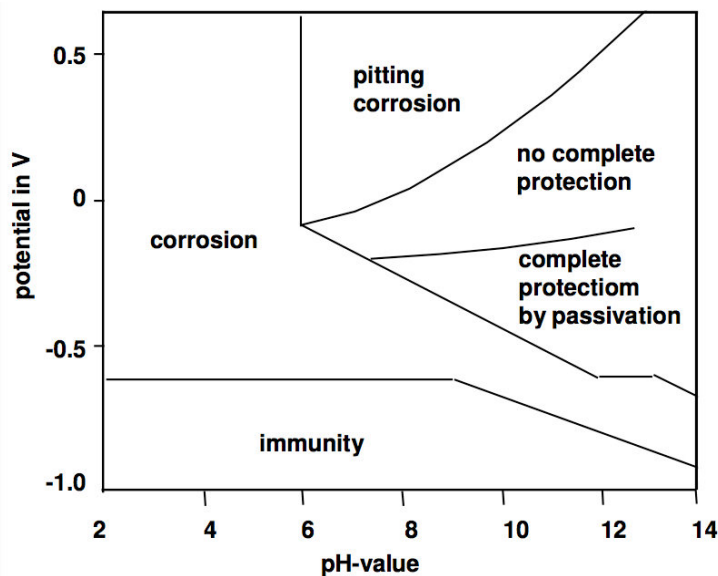
Fig. 2.7: Pourbaix diagram for iron in chloride solution [9]

Chlorides are either chemically bound in the hydrated cement paste or free. The bound chloride amounts to about 0.4% of the mass of cement. However, in carbonated concrete this number drops to almost zero. The free chlorides in the pore solution can penetrate the passivation layer and cause corrosion. This can be explained by Fig. 2.7.

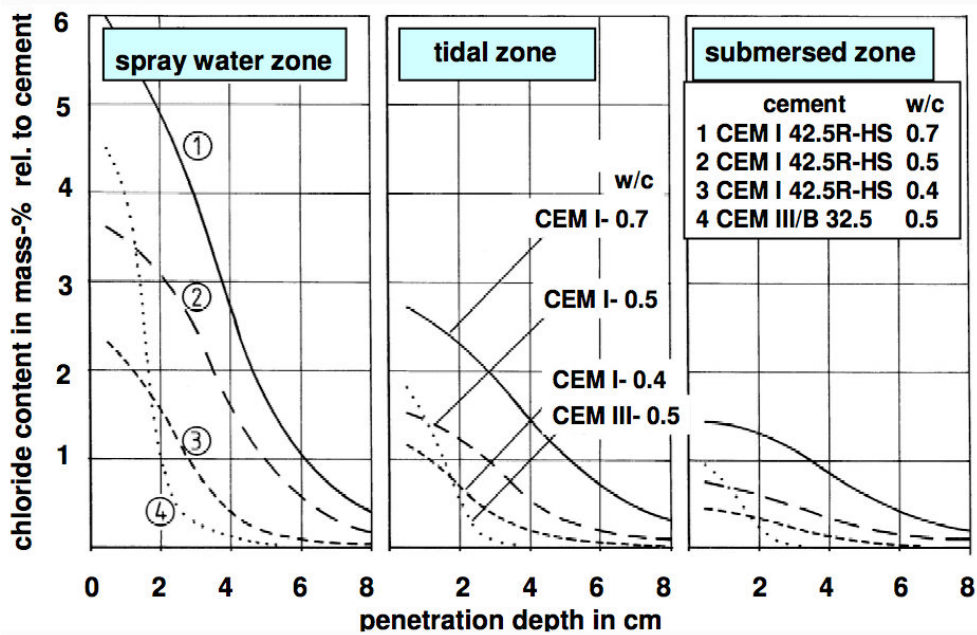
Fig. 2.8: Chloride concentration in various concretes [16]

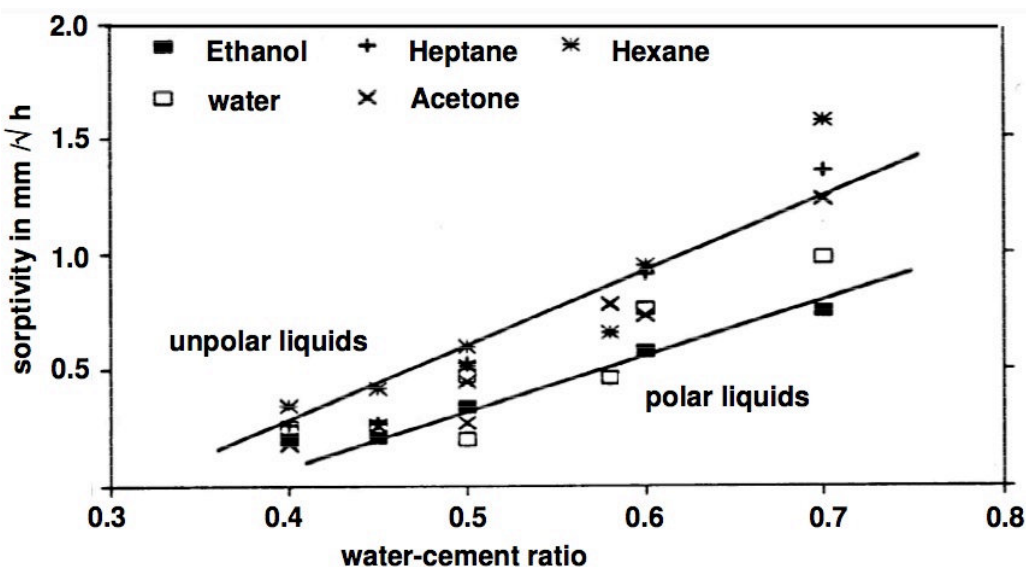
Fig. 2.9: Sorptivity vs. water/cement ratio for five fluids [15]

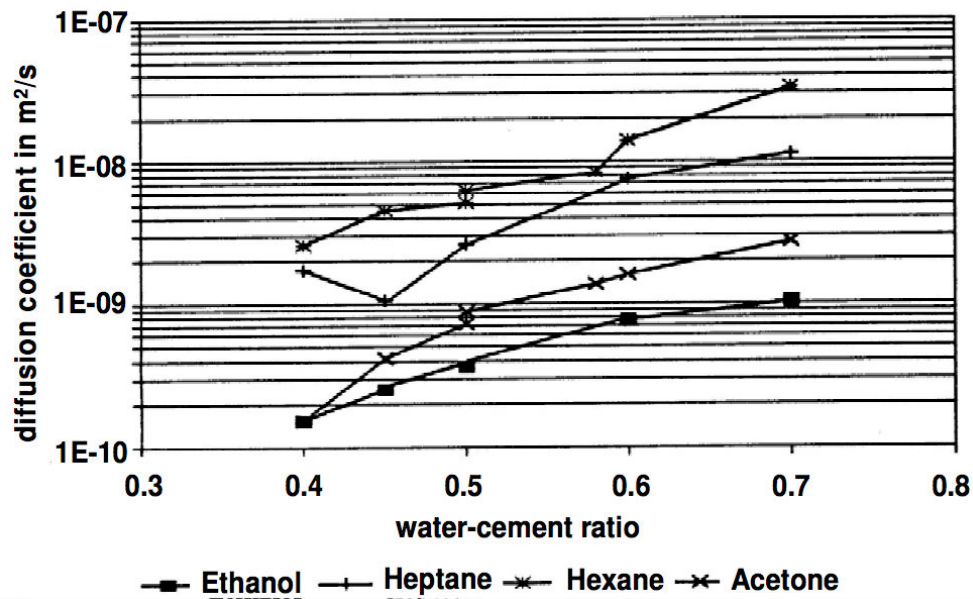
Fig. 2.10: Diffusion coefficient vs. water/cement ratio for four vapours [19]

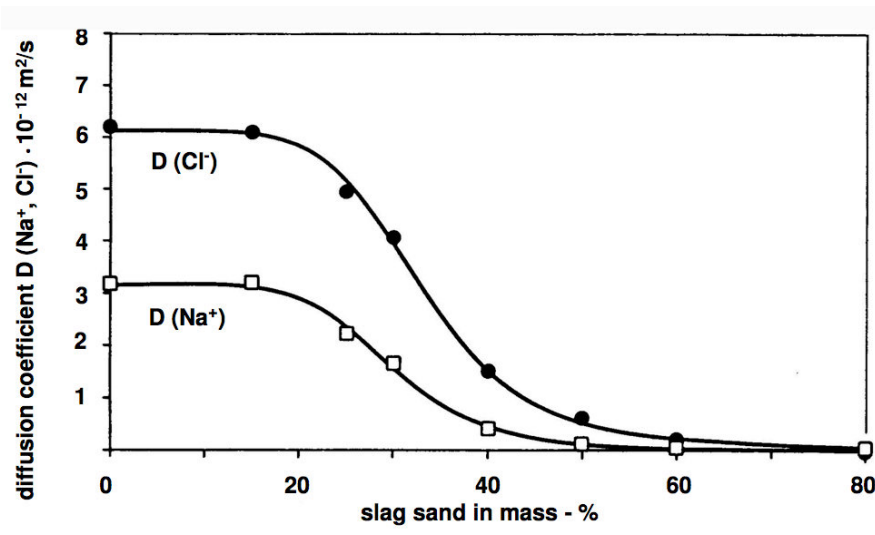
Fig. 2.11: Influence of ground granulated blast furnace slag on diffusion coefficient of sodium- and chloride-ions [20]

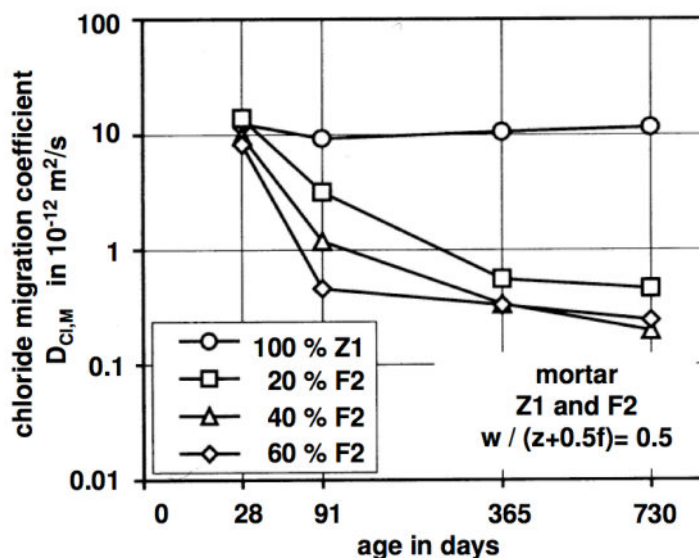
Fig. 2.12: Chloride migration coefficient as function of age and fly ash content [23]

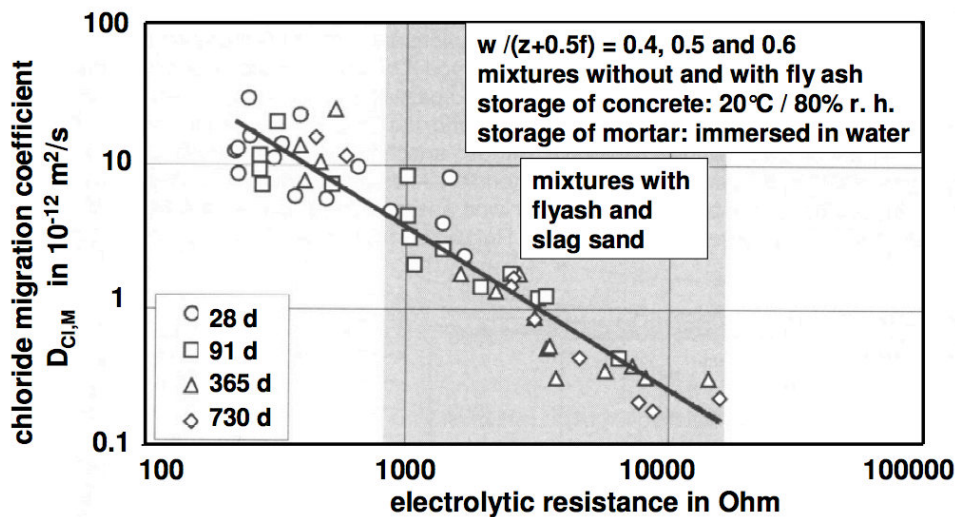
Fig. 2.13: Chloride migration coefficient vs. electrolytic resistance [23]

If the migration coefficient drops, the electrolytic resistance increases as described in Fig. 2.13 shows. This holds for mixtures with fly ash or ground granulated blast furnace slag, as indicated by the shaded area. The addition of silica fume has a positive effect on the tightness of concrete by reducing the porosity and the size of the pores. Since silica fume is mainly used in high-performance concrete, the effect is discussed in the next chapter.

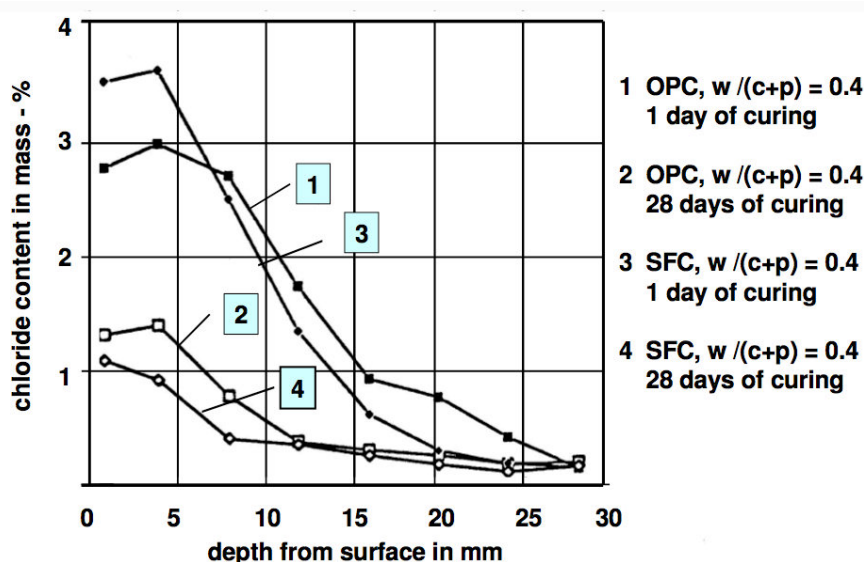
Fig. 2.14: Chloride distribution in concrete with and without silica fume [27]

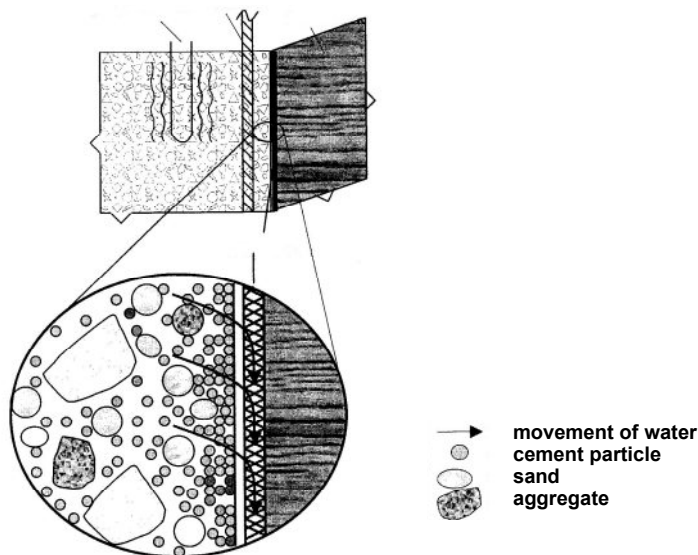
Fig. 2.15: Schematic of CFP effect [30]

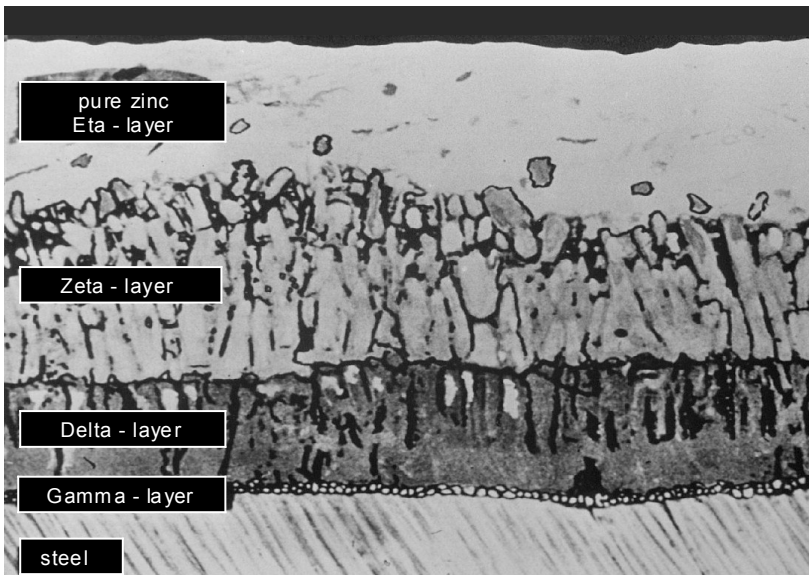
Fig. 3.1: Structure of the coating of a hot dip galvanized steel

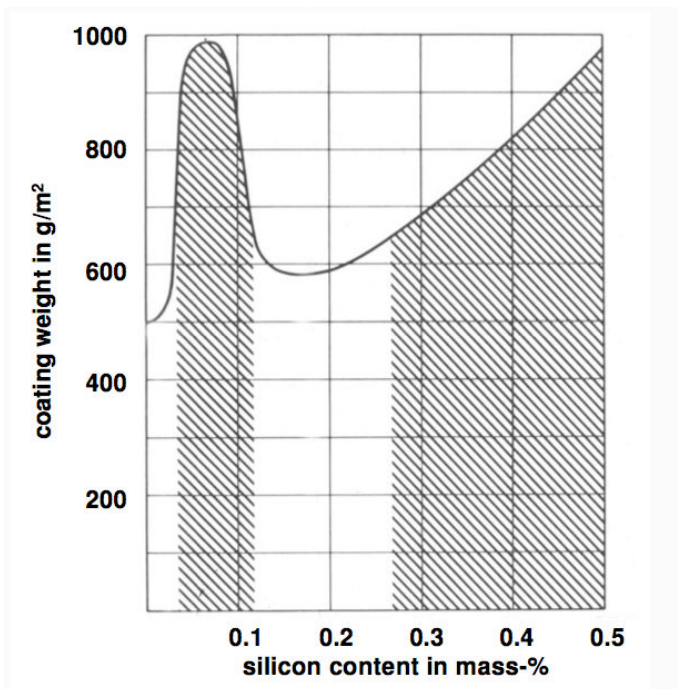
Fig. 3.2: Influence of silicon content in steels on zinc deposition

As to the steel composition, the silicon content is of the greatest influence. If this is either between 0.02 and 0.15 % (Sandelin effect) or greater than 0.25 %, the reactivity between steel and zinc is higher and the alloy layers may become considerably thicker (Fig. 3.2). Furthermore, coatings with a too high thickness and especially too high thickness of Zn-Fe intermetallic compounds are brittle and tend to crack and flake during bending of the bars. Since the steel of reinforcing bars often comes from the recycling of scrap-steel, it is practically impossible to find steel bars on the market with a silicon content less than 0.03 %. Therefore the best choice, with respect to the chemical analysis and not too thick coating, is to have a silicon percentage in the range 0.15 - 0.25.

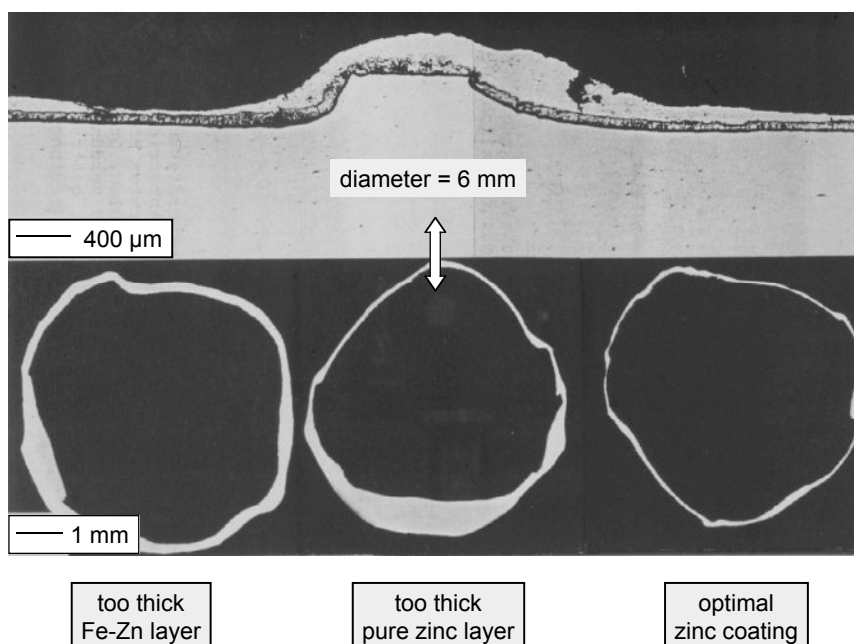
Fig. 3.3: Thick coating in the rib area of a small diameter reinforcing steel (DPN = Diamond Pyramid Number)

layer:	hardness:
base steel	159 DPN
delta layer	244 DPN
zeta layer	179 DPN
eta layer	70 DPN

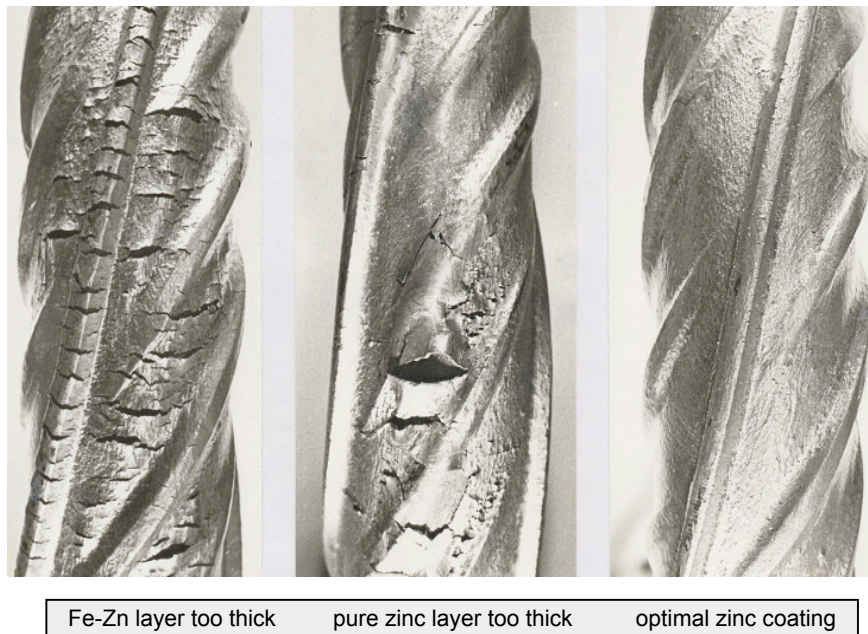
Fig. 3.4: Behaviour of coatings during bending around a smaller mandrel [8]

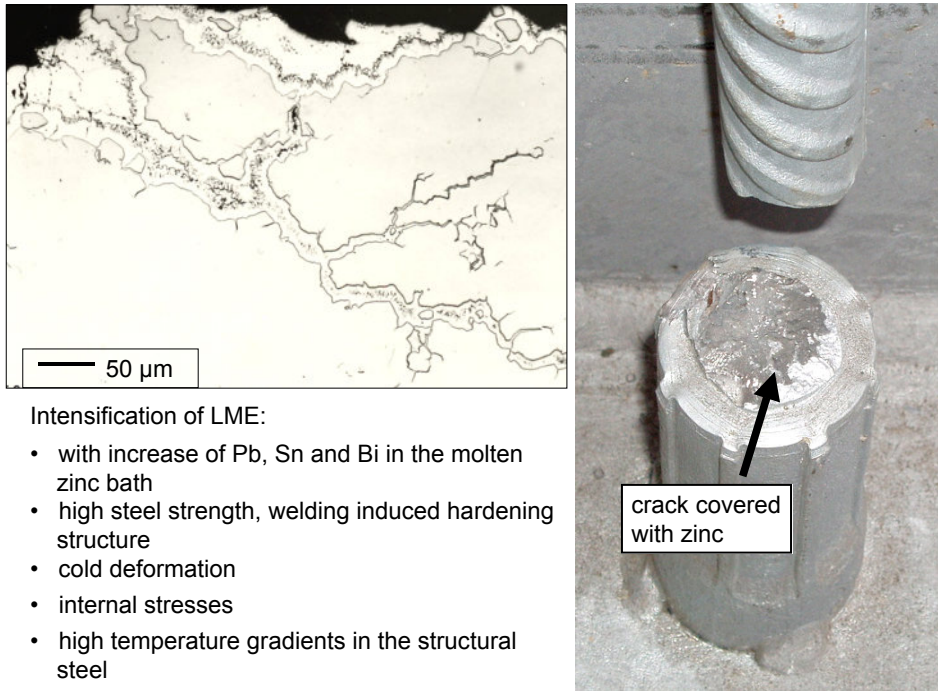
Fig. 3.5: Clamp joint between steel plate and galvanized reinforcement; steel fracture because of liquid metal induced embrittlement (LME) of galvanized steel. Cracks: zinc enriched with tin (Sn) and lead (Pb)

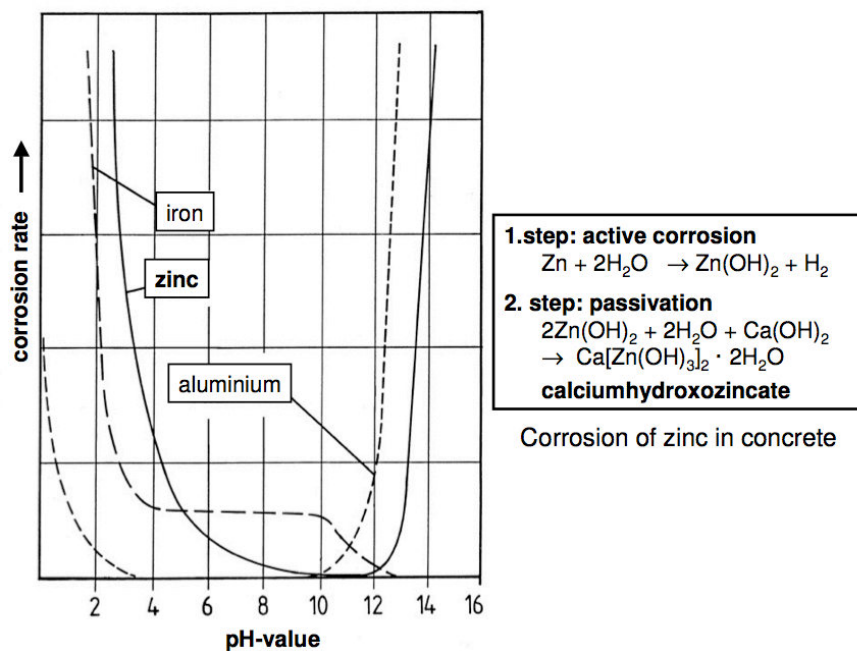
Fig. 3.6: Corrosion rate of metals in aqueous solutions as function of the pH value and corrosion of steel in fresh concrete

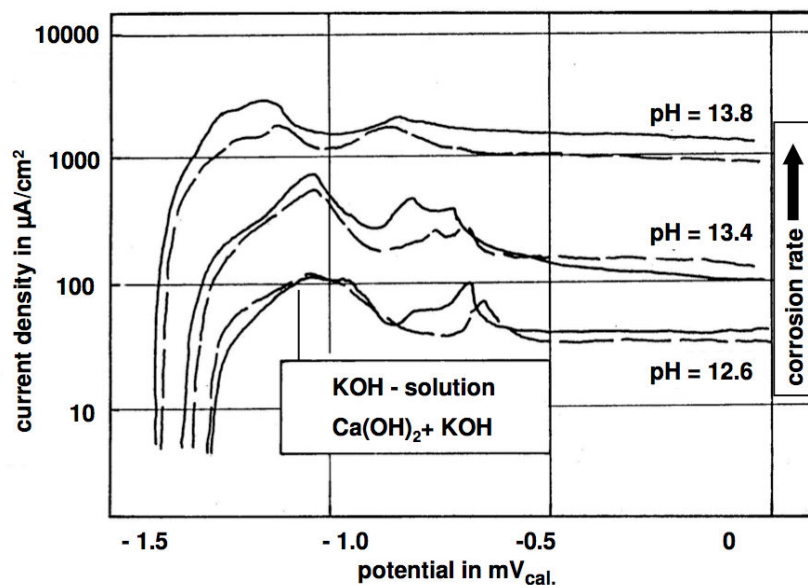
Fig. 3.7: Zinc corrosion in high alkaline aqueous solutions [24]

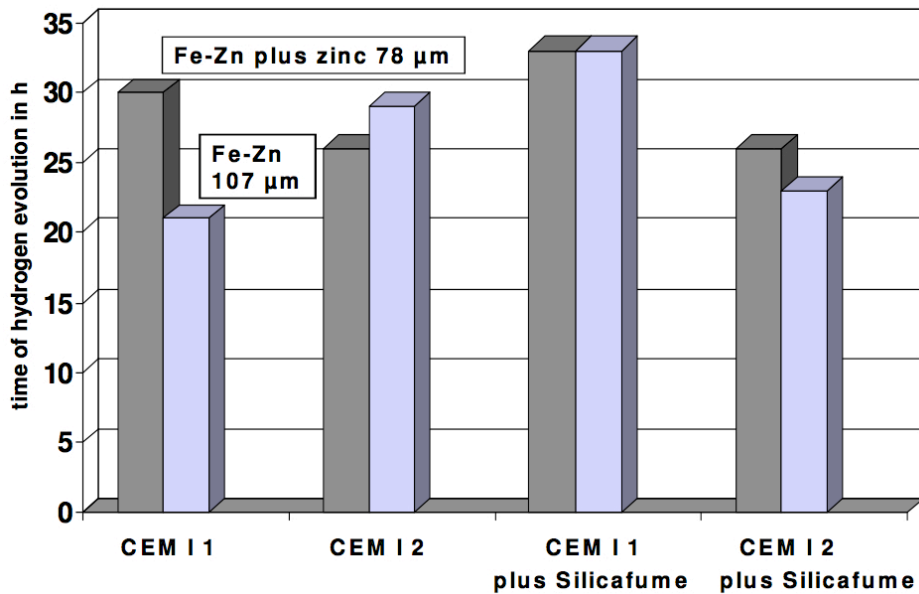
Fig. 3.8: Time of hydrogen evolution of galvanized steel embedded in concrete made of chromate reduced cement [28]

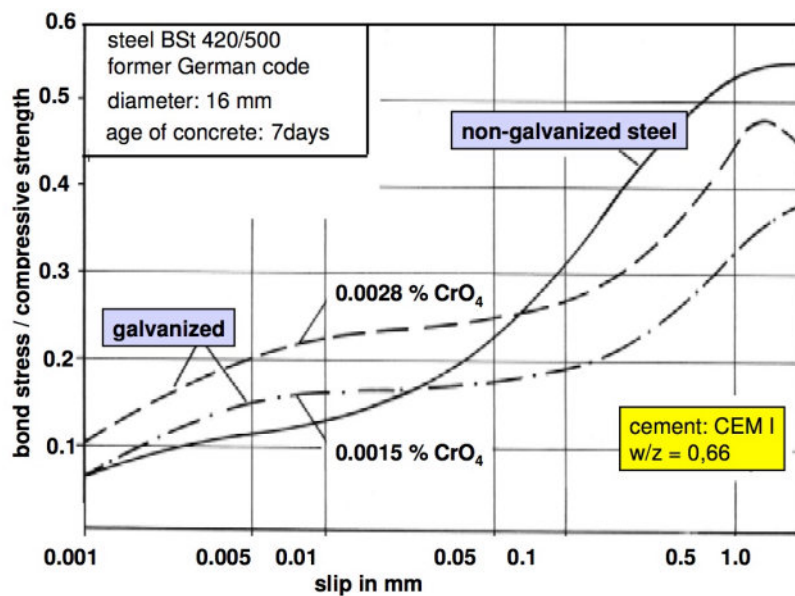
Fig. 3.9: Bond of non-galvanized and galvanized ribbed reinforcing steel after 7 days [13]

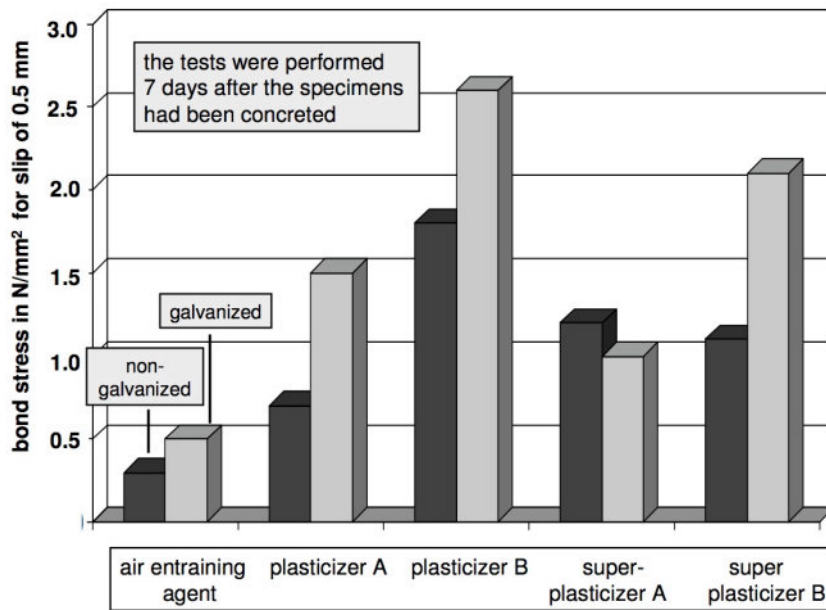
Fig. 3.10: Results of pull-out tests of smooth non-galvanized and galvanized bars, $d=20$ mm, specimens concreted with different admixtures, cement with low chromate content of 3 ppm [33]

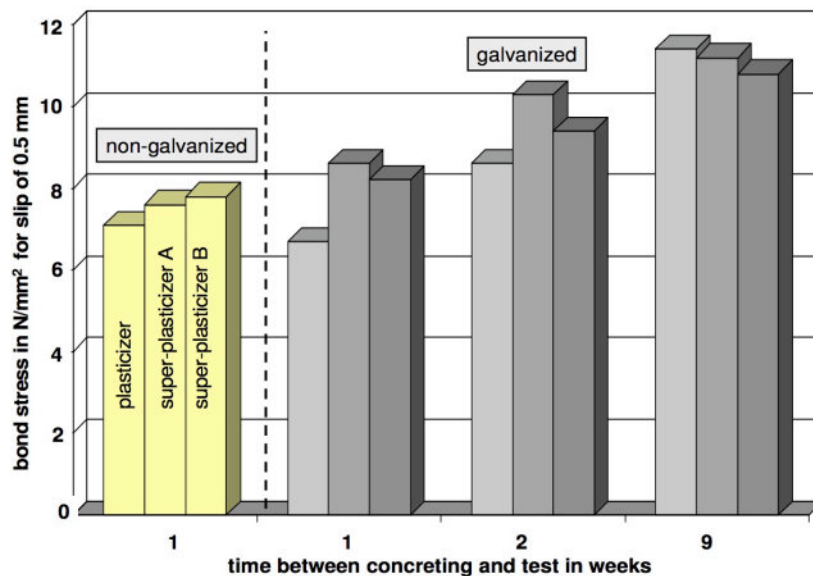
Fig. 3.11: Results of pull-out tests of smooth non-galvanized and galvanized bars, $d = 20$ mm, specimens concreted with different admixtures, cement with low chromate content of 3 ppm [33]

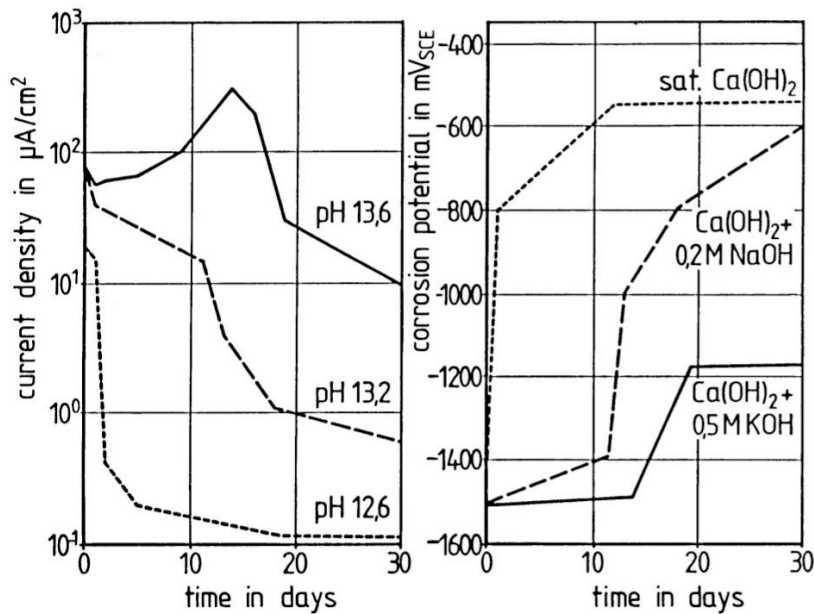
Fig. 3.12: Corrosion current density and -potential of galvanized reinforcing steel in alkaline solutions with pH 12.6, 13.2 and 13.6 [41]

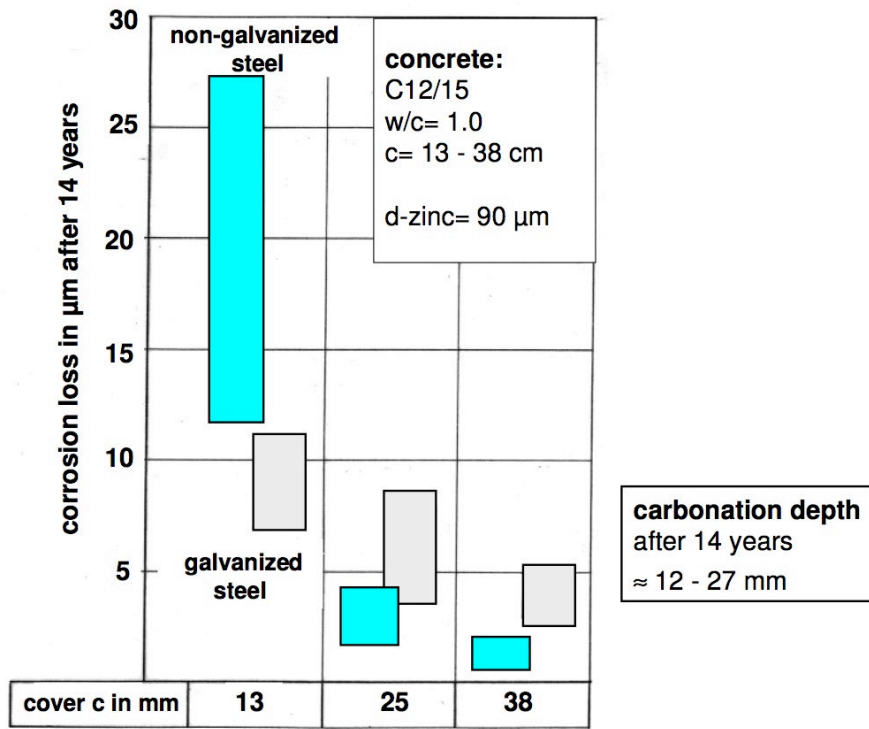
Fig. 3.13: Metal wastage of non-galvanized and galvanized reinforcing steel in lightweight concrete after exposure [44]

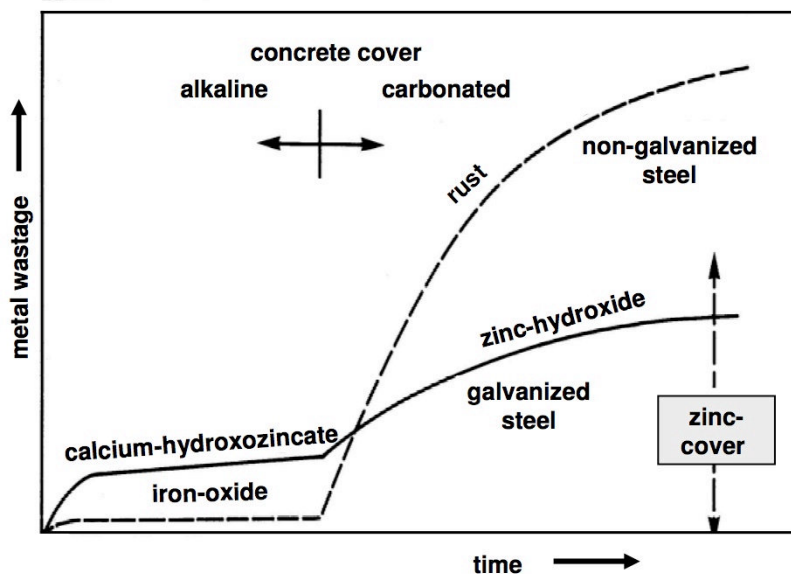
Fig. 3.14: Corrosion performance of non-galvanized and galvanized steel in concrete [3]

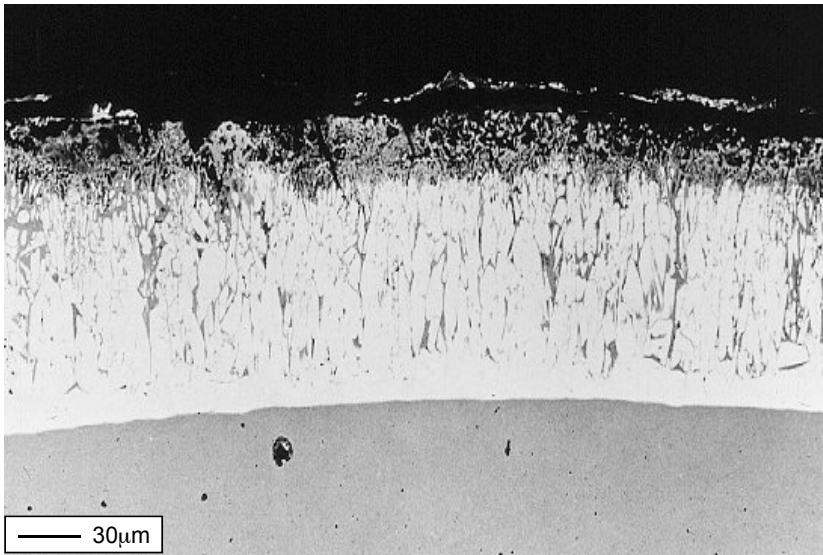
Fig. 3.15: Uniform corrosion of galvanized steel in carbonated concrete [3]

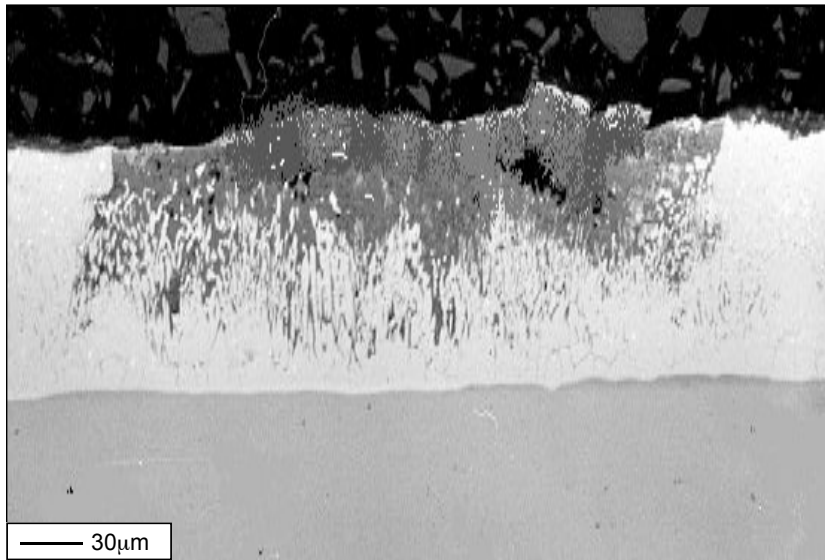
Fig.3.16: Pitting corrosion of galvanized steel in chloride containing concrete [3]

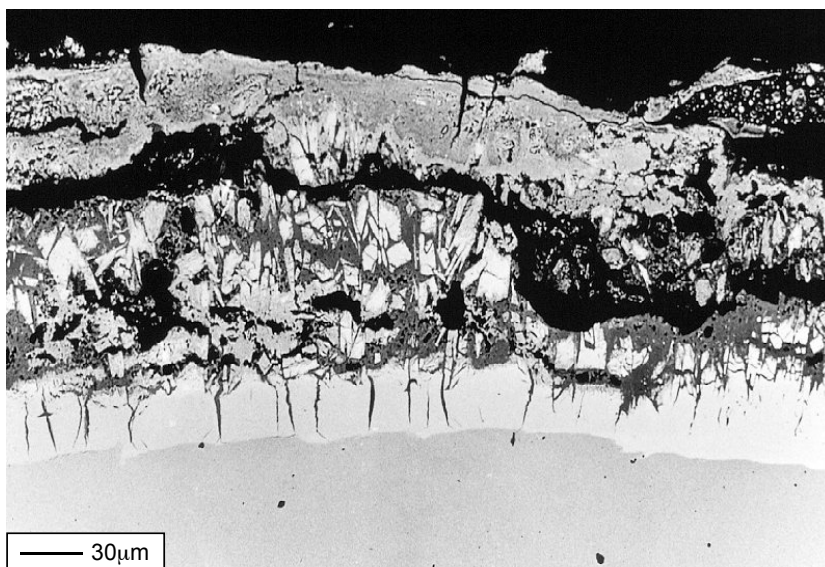
Fig. 3.17: Zinc-corrosion in heavily chloride-contaminated concrete [3]

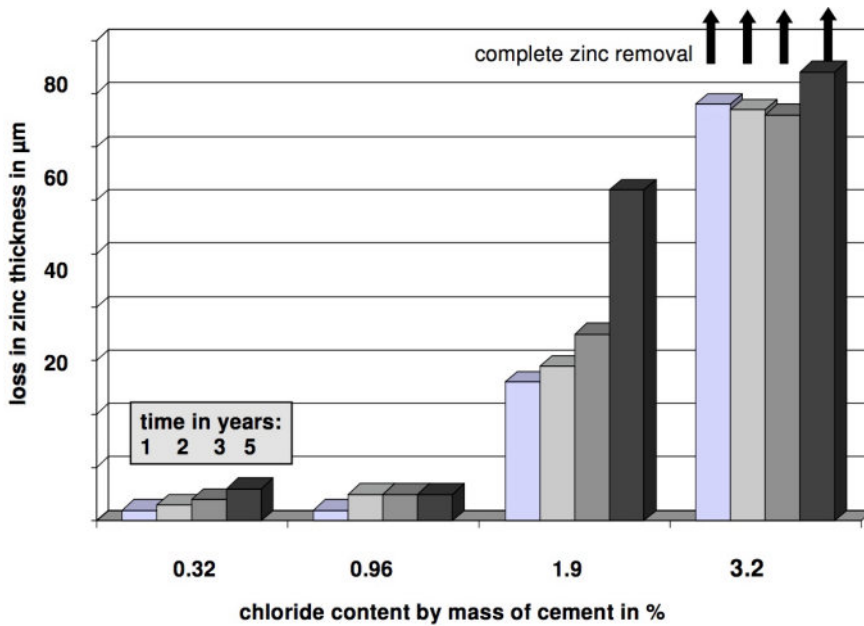
Fig. 3.18: Influence of the chloride content on the corrosion of galvanized reinforcing steel stored in concrete in the open air [44]

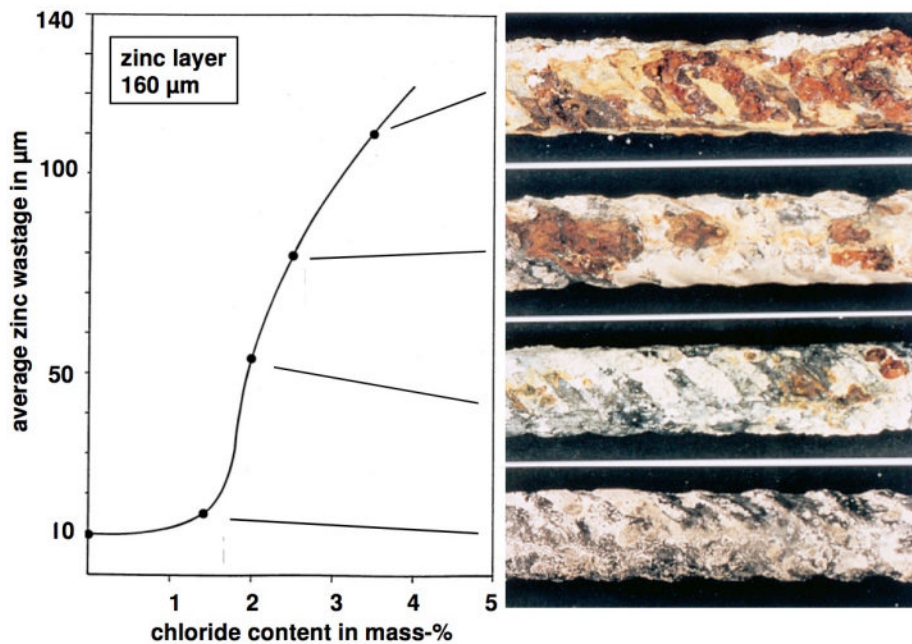
Fig. 3.19: Zinc wastage of galvanized reinforcing steels after 2.5 years embedded normal-weight concrete as a function of chloride content after seawater exposure (concrete cover 15 and 25 mm) [47]

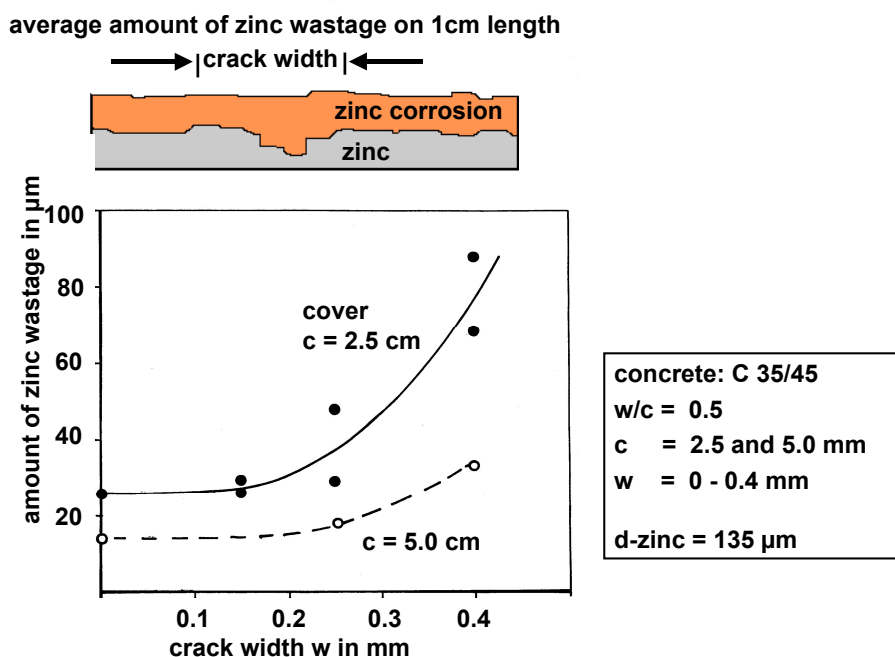
Fig. 3.20: Corrosion of galvanized reinforcing steels in cracks of concrete under condition of seawater splash zone [47]

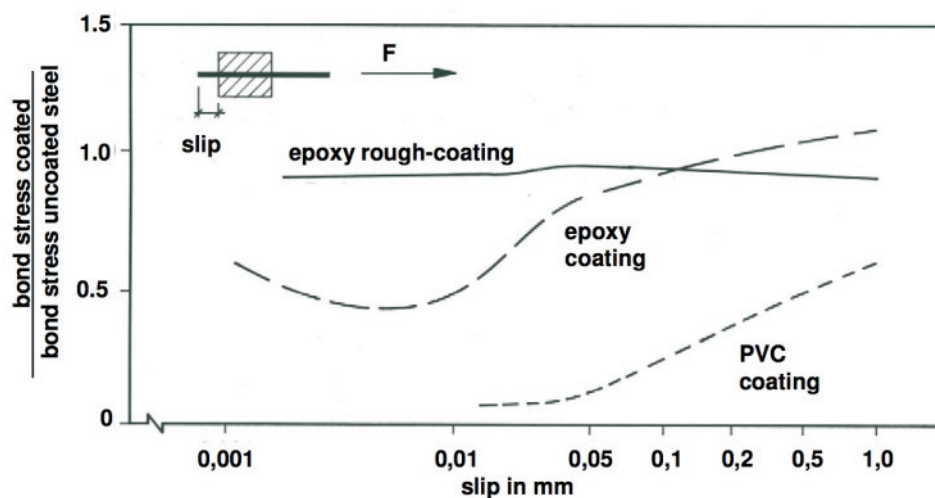
Fig. 4.1: Comparison of the bond behaviour of coated and non-coated bars [13]
