Corrosion protection of reinforcing steels

Technical report prepared by
Task Group 9.7

February 2009

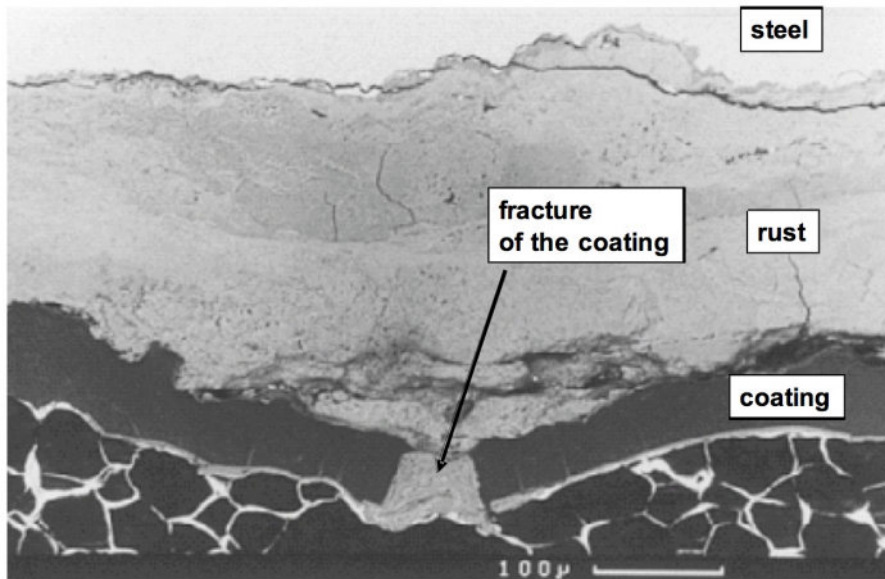
Fig 4.2: Under-rusting of a PVC-coating starting from local defects

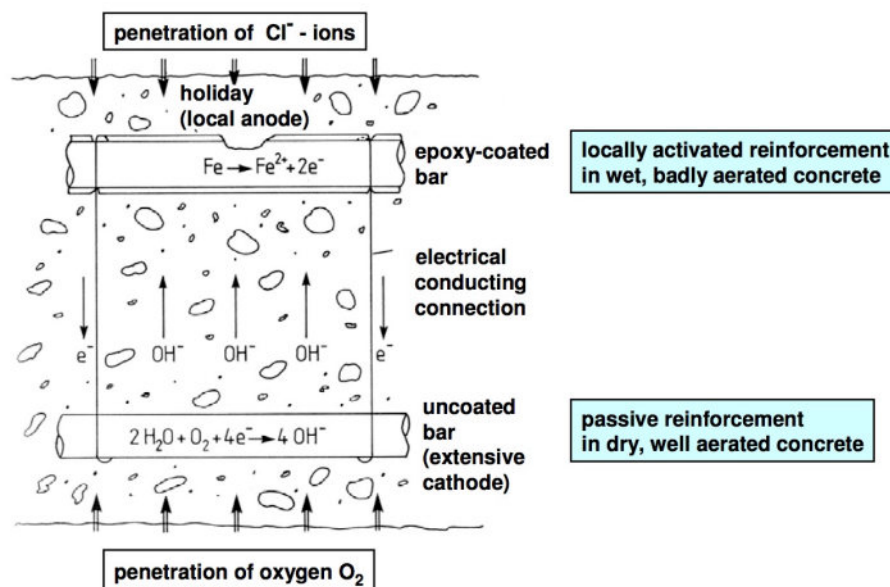
Fig. 4.3: Corrosion cell between epoxy-coated bar and uncoated reinforcement (e.g. parking decks) [1]

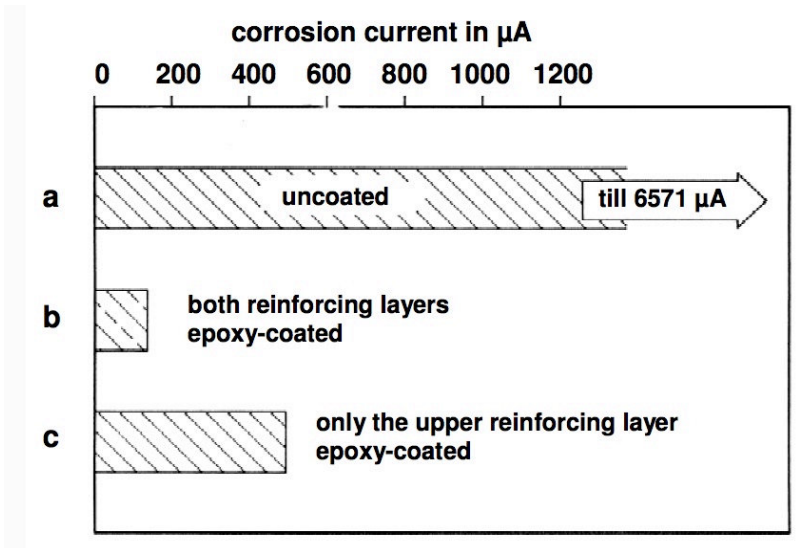
Fig. 4.4: Corrosion currents depending on the state of coating (FHWA)

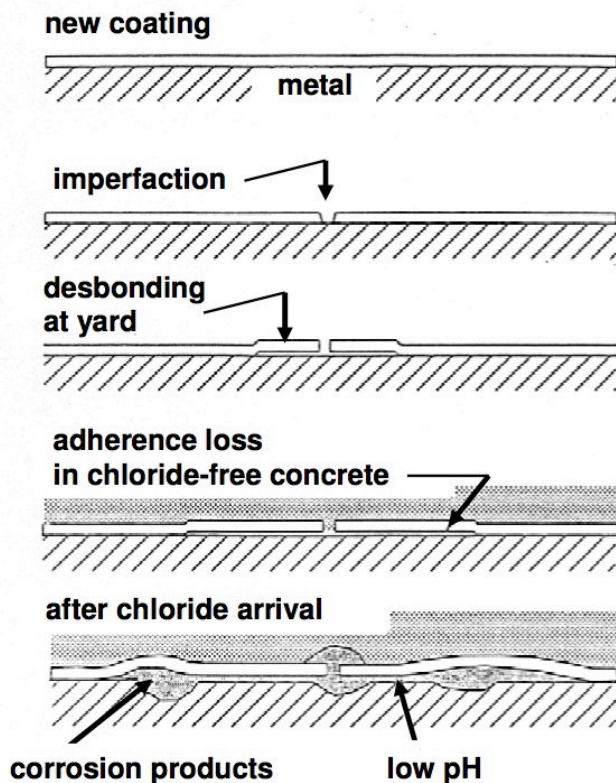
Fig. 4.5: Stages in the development of corrosion of epoxy-coated rebar in concrete [35]

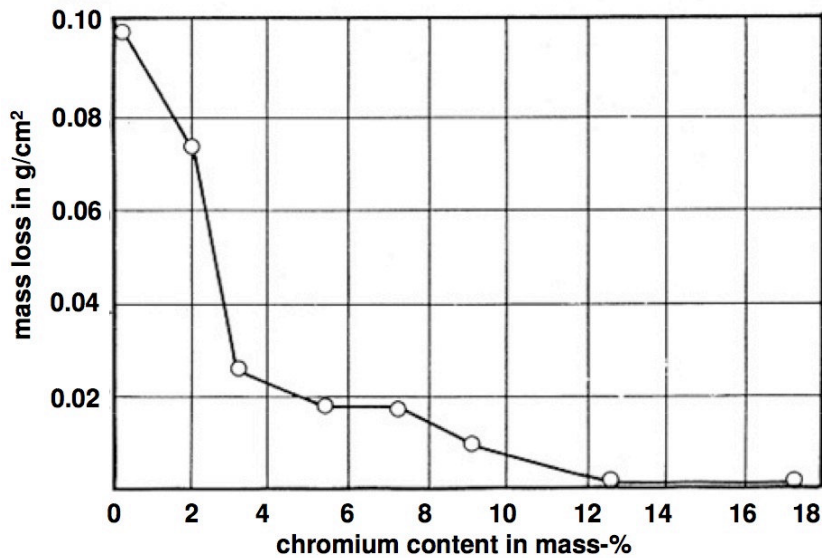
Fig. 5.1: Corrosion of chromium steels in industrial air (Binder and Brown in [3])

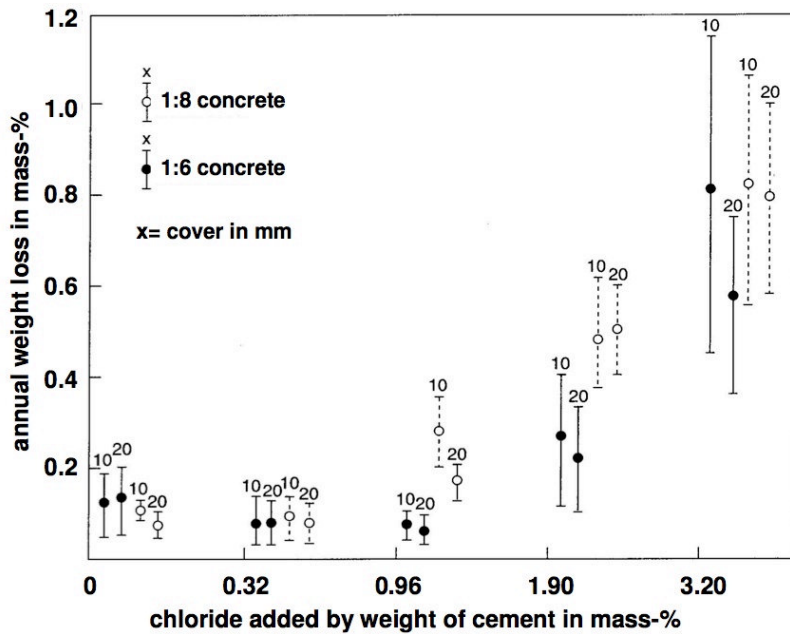
Fig. 5.2.a: Weight loss of shot-blasted unalloyed steel with respect to chloride content of concrete

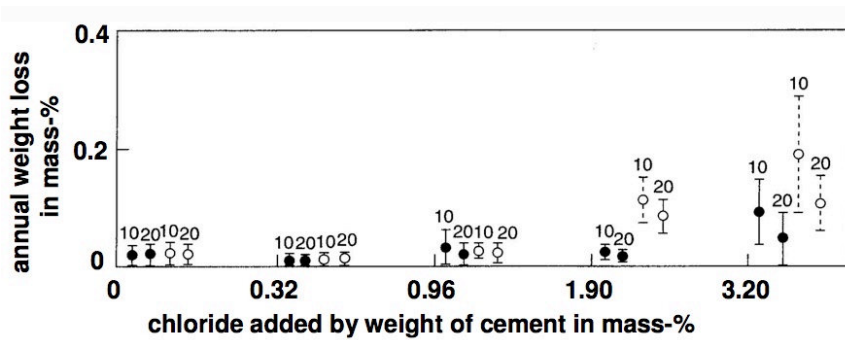
Fig. 5.2.b: Weight loss of type 430 ferritic steel with respect to chloride content concrete

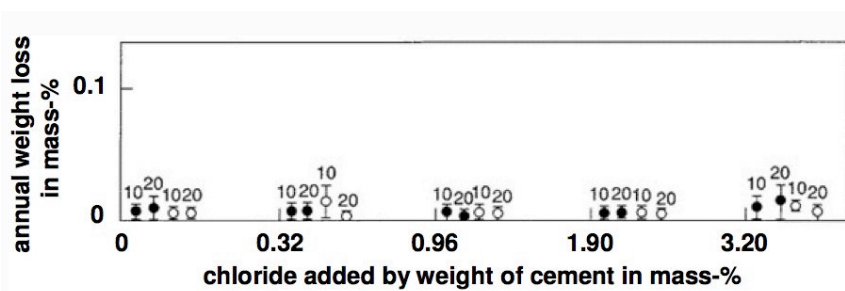
Fig. 5.2.c: Weight loss of type 316 austenitic steel with respect to chloride content of concrete

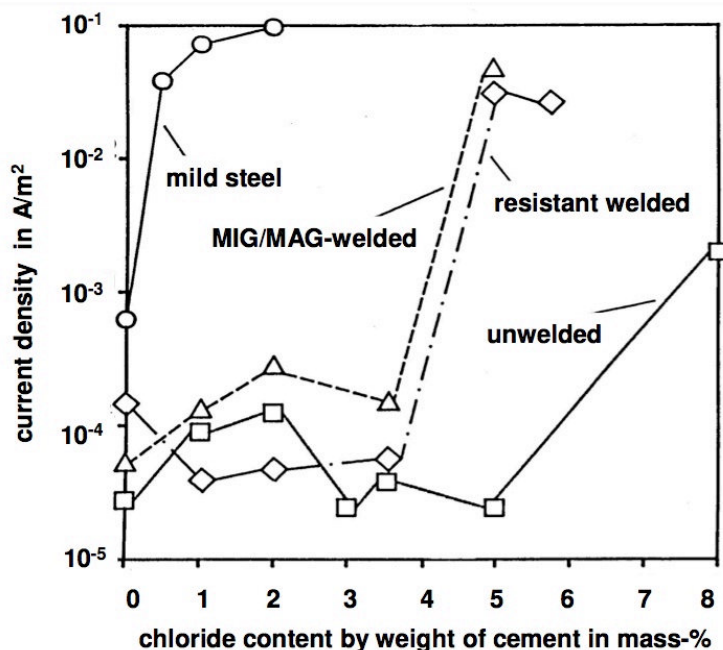
Fig. 5.3: Corrosion current density of steel type 1.4301 versus content of mixed-in chloride 0 mV

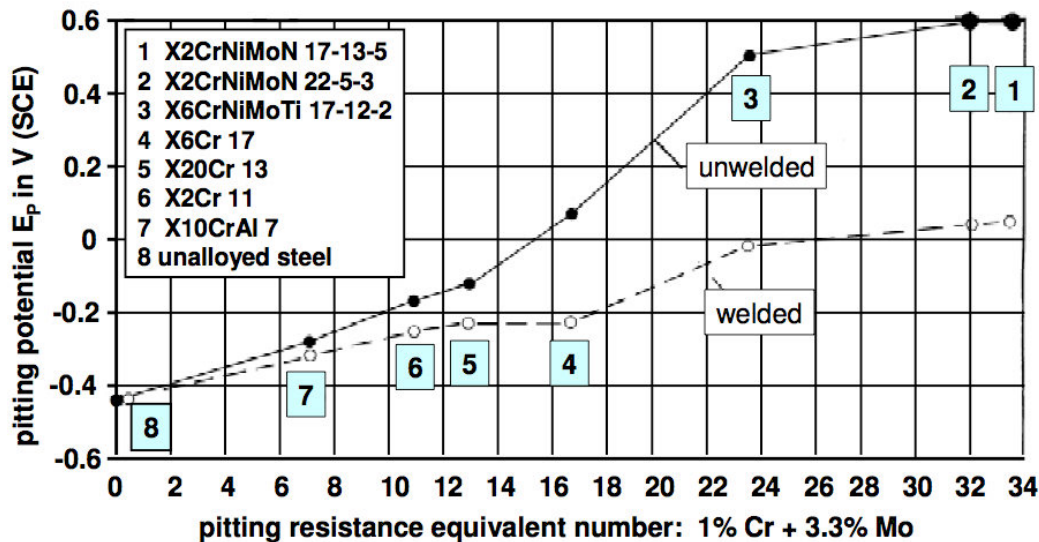
Fig. 5.4: Pitting potential of steel specimens with plain surface in saturated $Ca(OH)_2$ - solution with 5 M.-% chloride (potentiokinetic tests)

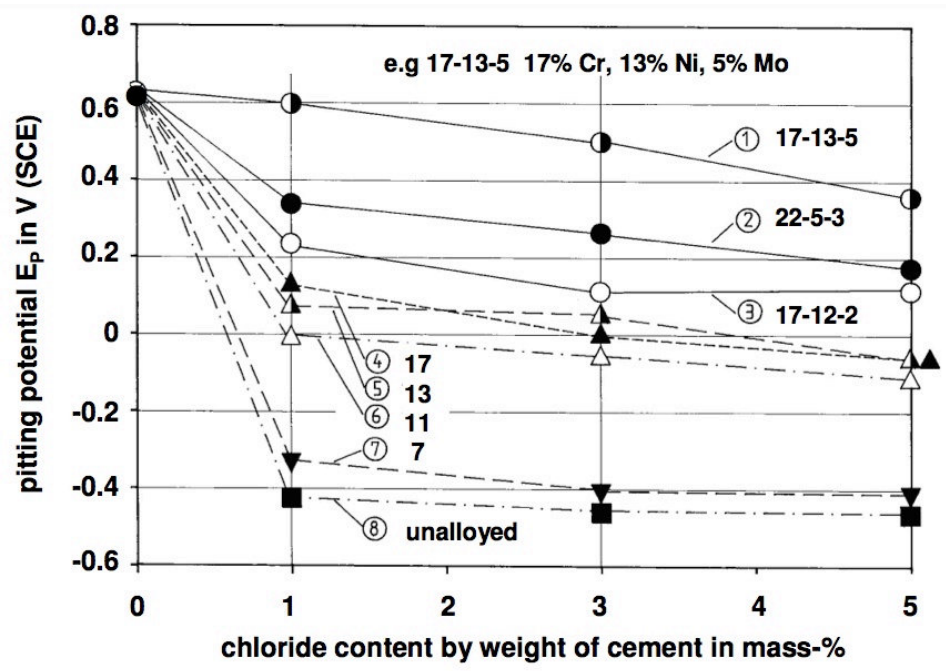
Fig. 5.5: Pitting potential E_p of plain welded steel specimens in PC-mortar-electrodes depending on the steel type and chloride content; potentiostatic test (oxygen evolution potential $E = +600 \text{ mV}_{SCE}$)

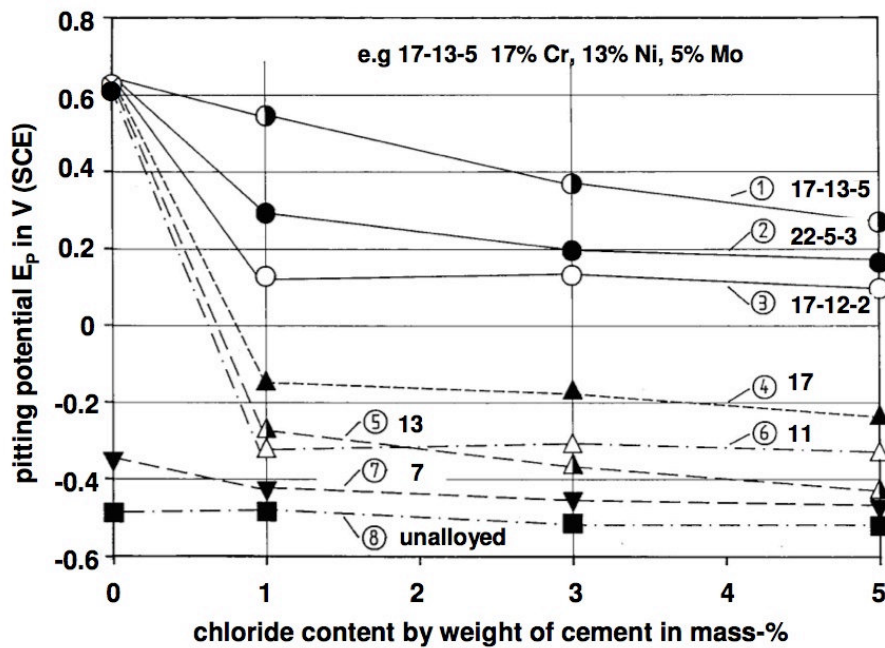
Fig. 5.6: Pitting potential E_P of plain welded steel specimens in carbonates PC-mortar- electrodes depending on the steel type and chloride content; potentiostatic test ($t = 24$ h), oxygen evolution potential $E = +600\text{mV}_{SCE}$

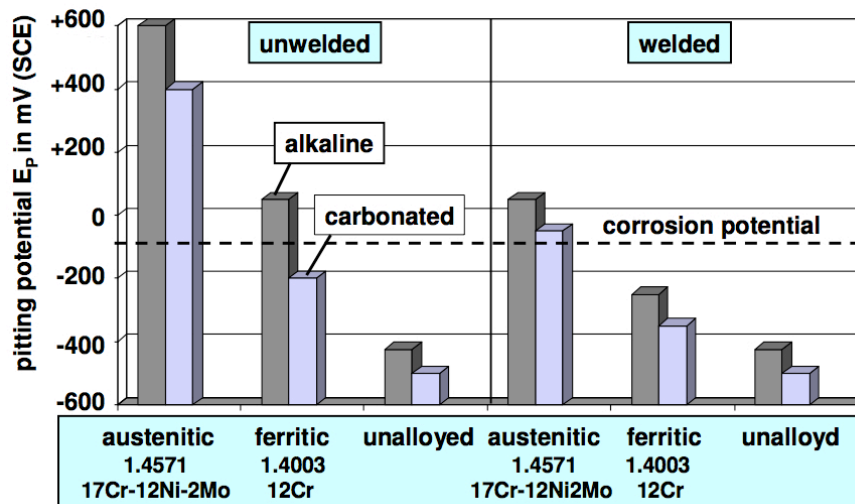
Fig. 5.7: Pitting potential E_p of deformed steel specimens in mortar-electrodes with 3 mass-% chloride depending on the steel type, the presence of welds and carbonation; potentiostatic test (oxygen evolution potential $E = +600$ mV_{SCE})

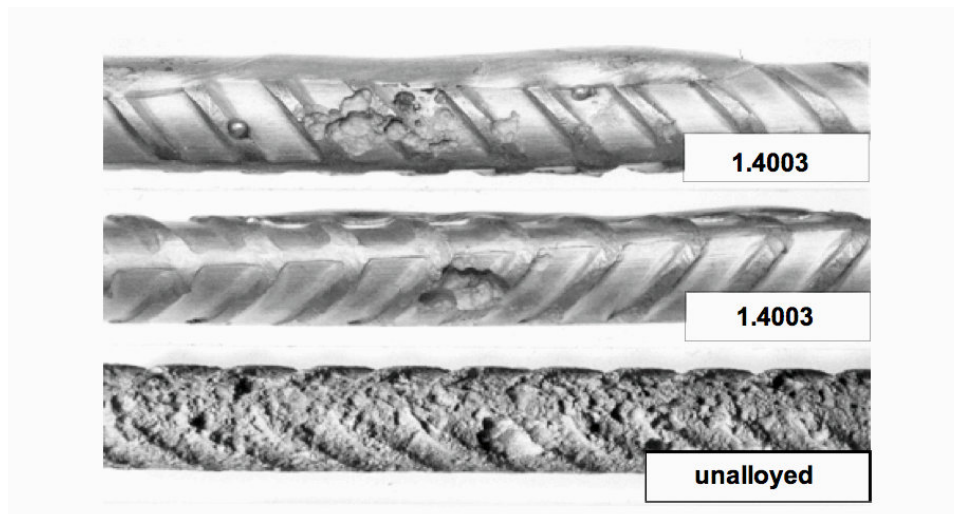
Fig. 5.9: Corrosion of deformed reinforcing bars in concrete (2 years; 2.5 mass-% Cl⁻)

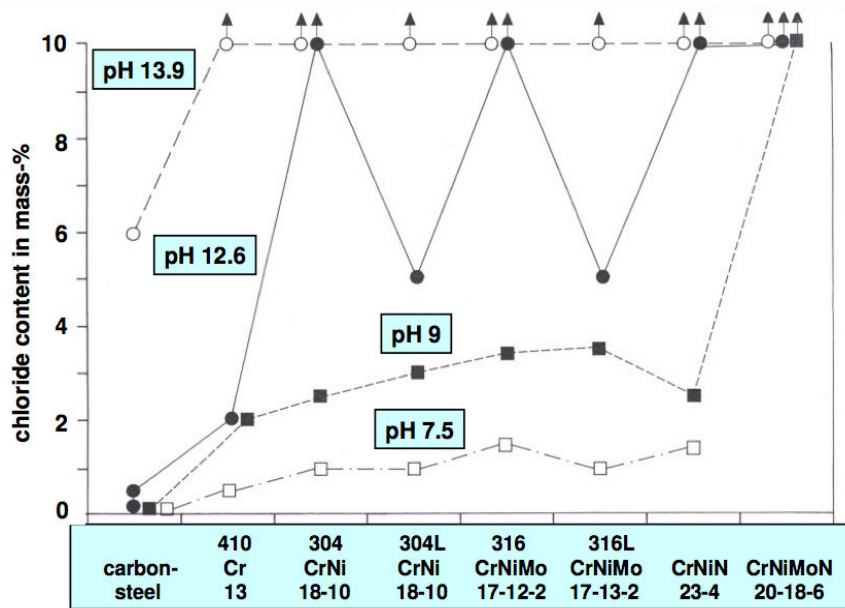
Fig. 5.10 Critical chloride content in pH 7.5 - 13.9 solutions at 20 °C during potentiostatic tests at +200 mV vs SCE

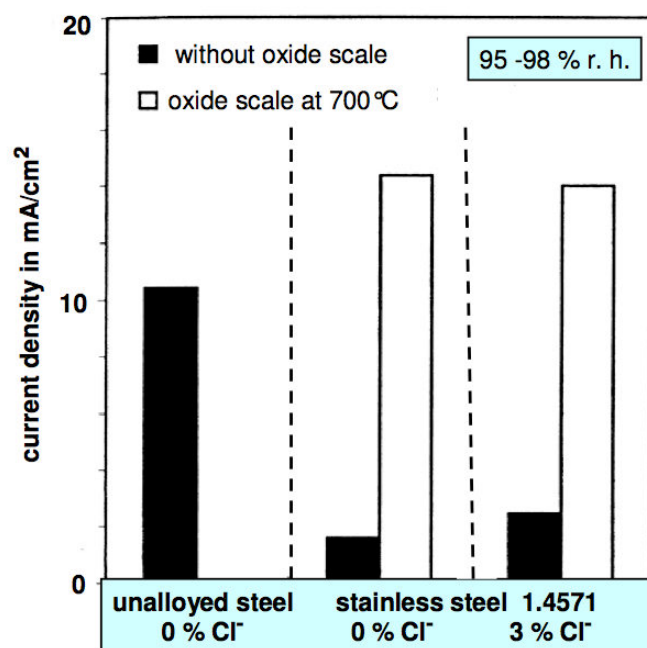
Fig. 5.12: Macrocouple current density in a corroding bar of carbon steel in 3 % chloride contaminated concrete when it was coupled with
 - a passive bar of unalloyed steel in chloride free concrete,
 - bars of 1.4571 stainless steel in chloride free concrete,
 - bars of 1.4571 stainless steel in 3 % chloride contaminated concrete.
 Results on stainless steel bars also with the surface covered with oxide scale produced by heating at 700 °C in order to simulate a welding scale [11].
