# Electrical Insulation for Rotating Machines

Design, Evaluation, Aging, Testing, and Repair

SECOND EDITION

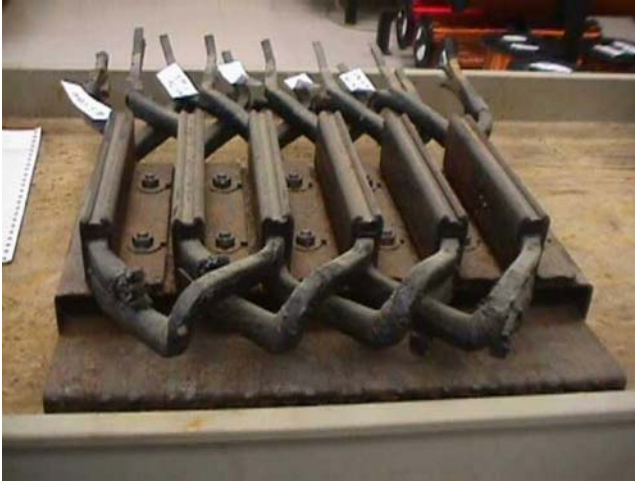
Figure 2.2 Photograph of a formette containing four multi-turn coils after a thermal endurance test (Source: Eltek Laboratories).

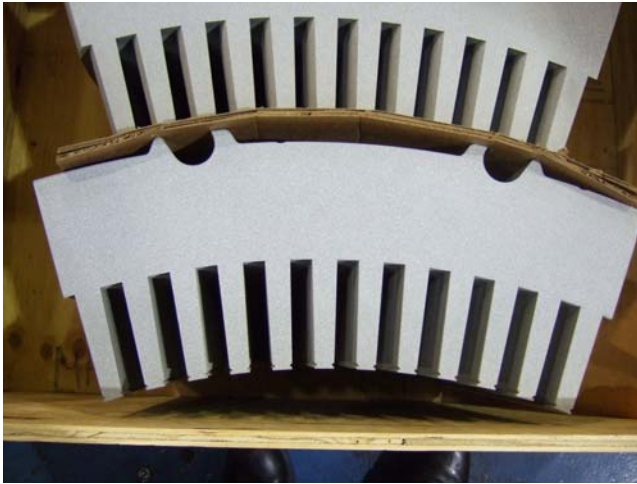
Figure 6.3 Segmented stator core laminations used in large diameter stator cores.

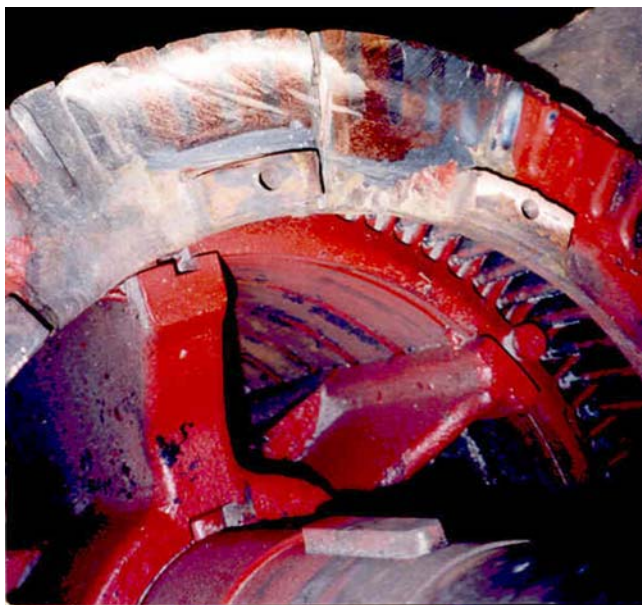
Figure 6.5 Core supported by spider arms mounted on a hub.

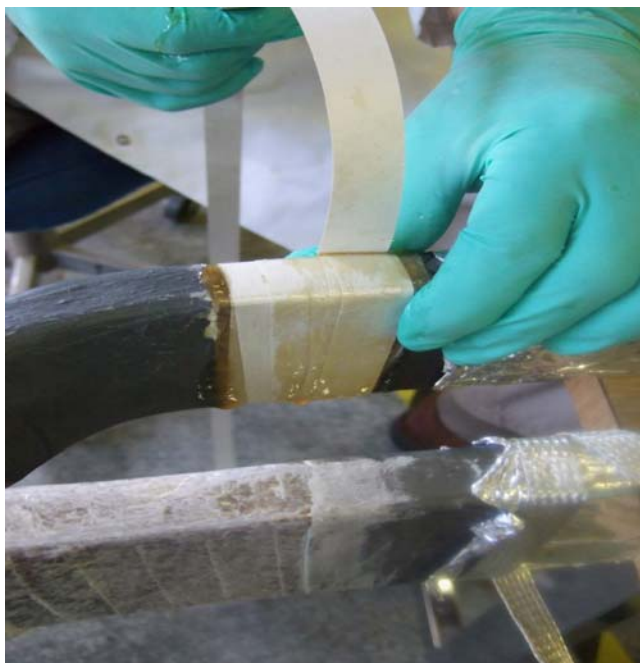
Figure 7.1 A coil that is in the process of being repaired after the coil insulation was accidentally crushed by a hammer blow just outside of the stator slot (Source: Courtesy Iris Power-Qualitrol).

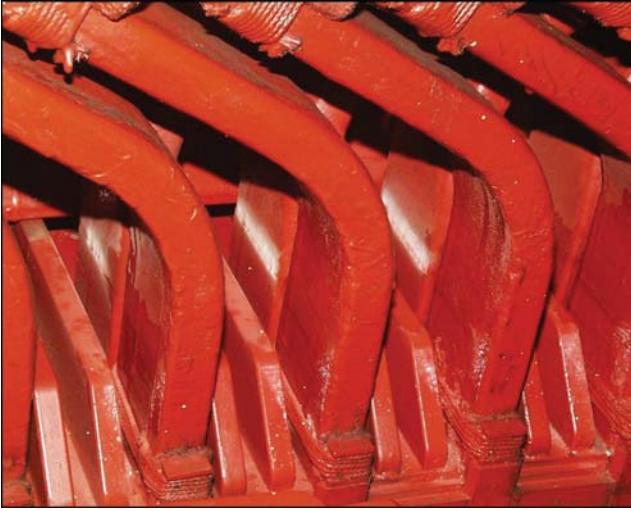
Figure 8.10 Photograph of the end winding area from a hydrogenerator. The white band around some of the coils just outside the slot indicates where the coating overlap area has degraded. Note that the entire stator has been painted with an abrasion resistant coating that makes repair of the overlap problem very difficult.

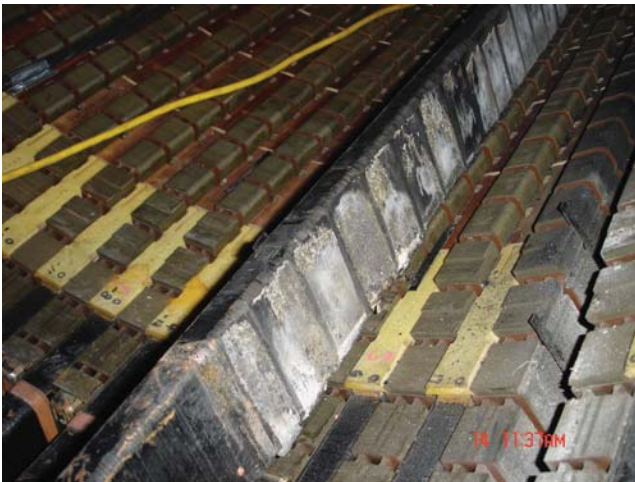
Figure 8.12 A stator bar being removed from an air-cooled turbine generator affected by VS.

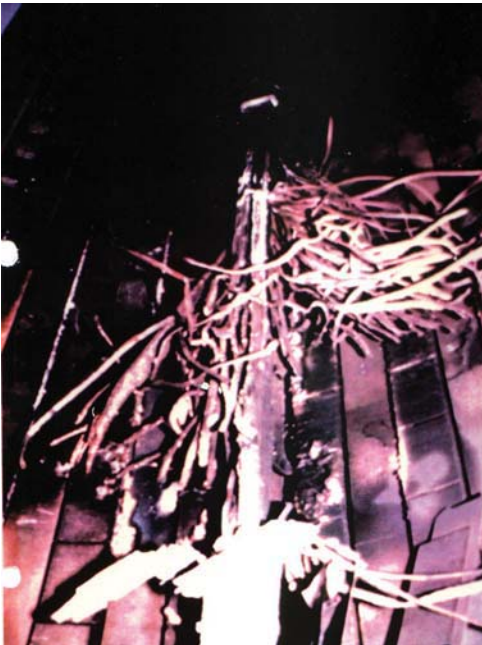
Figure 8.13 View of the stator bore (after rotor removal) of an 800 MVA turbogenerator that experienced a phase-to-phase fault in the stator slot. The white “spaghetti” are the copper conductors that came out of the stator slot under the tremendous magnetic forces that accompany a phase-to-phase fault.

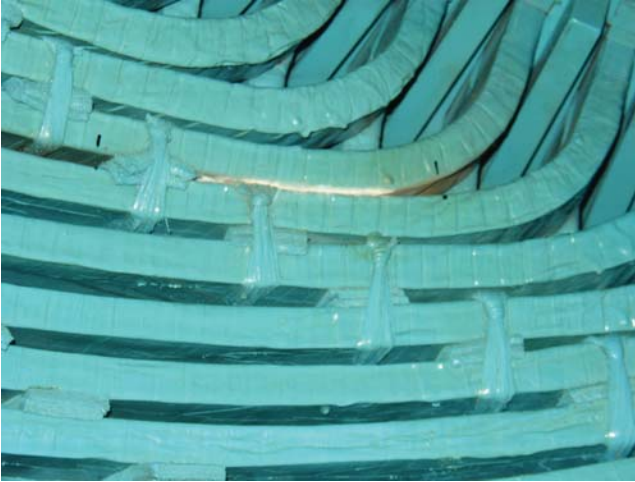
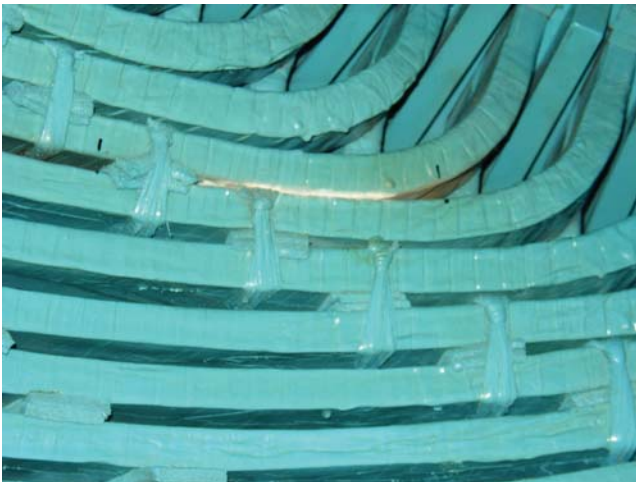
Figure 8.20 PD between adjacent coils in different phases results in white powder on the stator bar surfaces. (See color plate section).

Figure 8.20 PD between adjacent coils in different phases results in white powder on the stator bar surfaces.

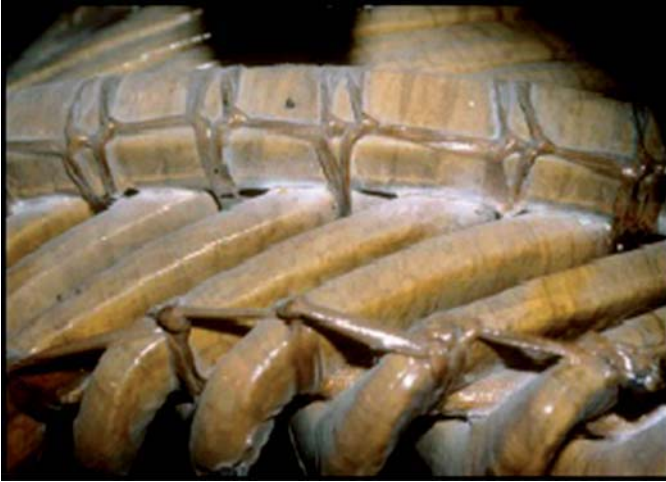
Figure 8.21 The white areas indicate fretting due to end winding vibration where the coils are lashed to a support ring in a motor stator.

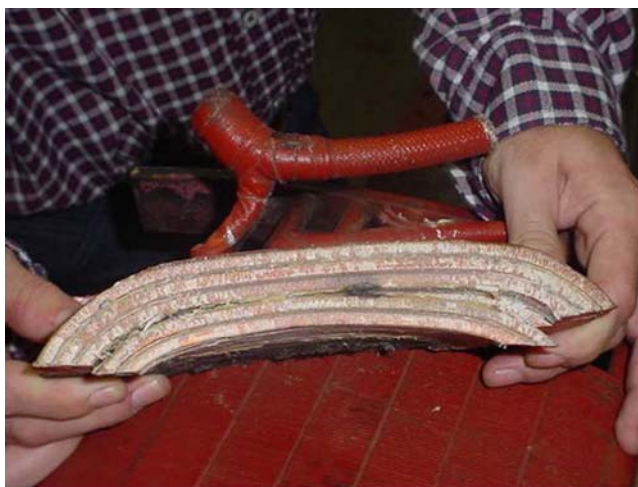
Figure 10.2 Turn insulation in wire wound coil resulting from cracking of the bonding resin as a consequence of thermal cycling.

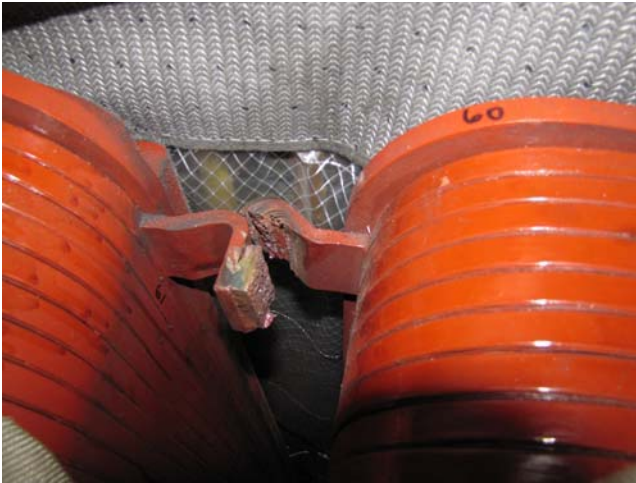
Figure 10.3 Failure of inter-pole connection from thermal cycling.

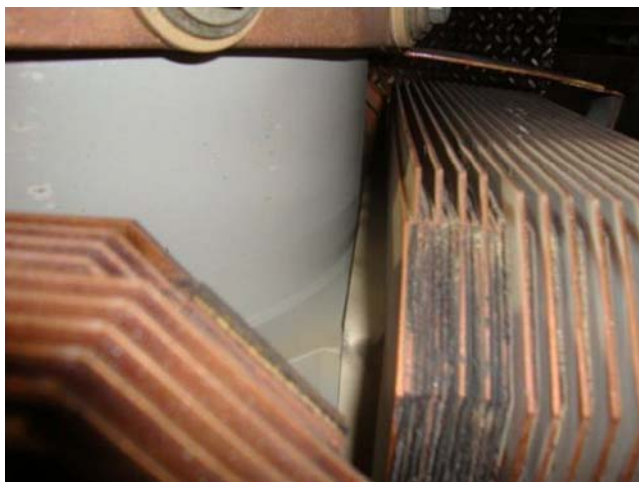
Figure 10.4 Contamination of a strip-on-edge field winding pole.

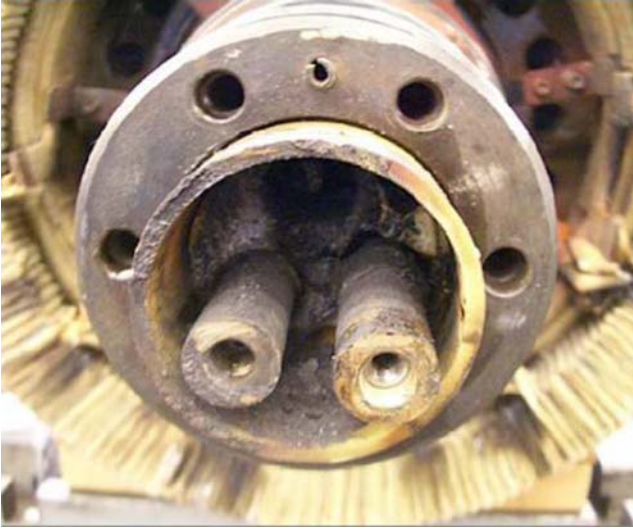
Figure 11.2 Rotor winding lead insulation failure from interphasal partial discharges.

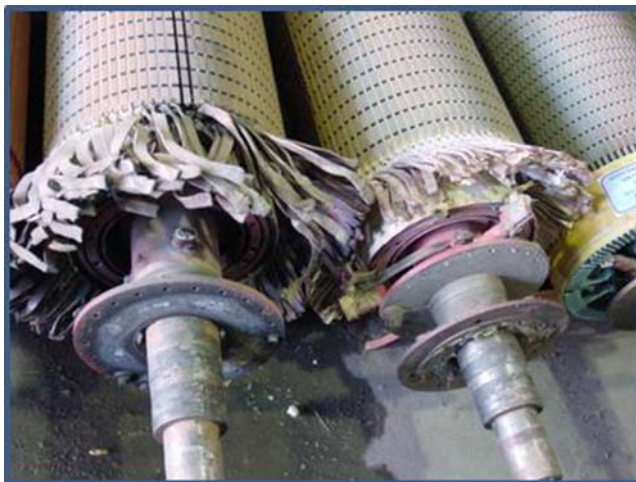
Figure 11.3 Two wound rotors in which the end winding banding has failed.

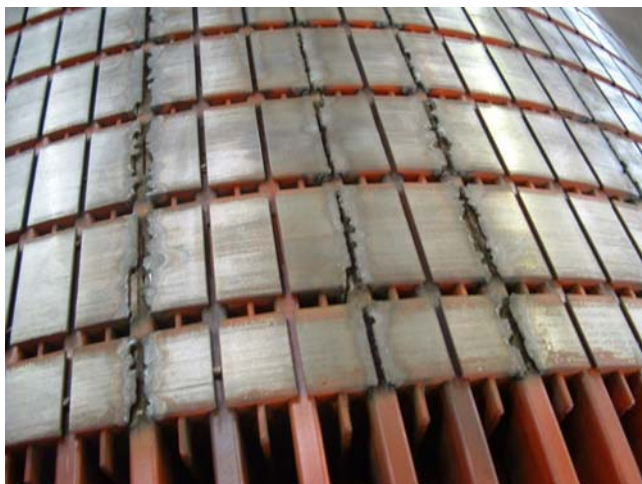
Figure 12.8 Core bridge burning due to loose bars in slots (Source: Courtesy of EASA).

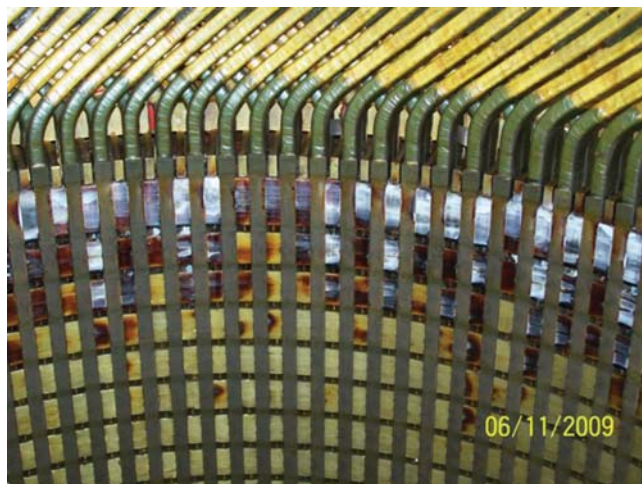
Figure 13.2 Stator core burning that resulted from excessive oven temperatures during stator winding burnout prior to rewind.

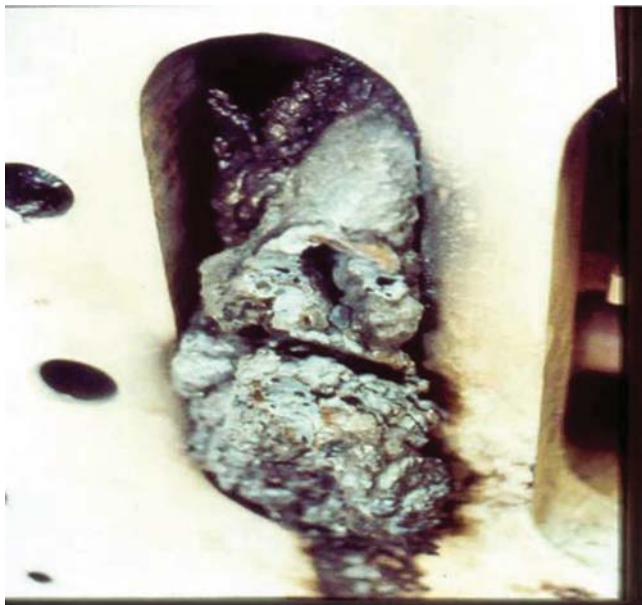
Figure 13.8 Massive core melting with molten steel coming out of the axial vent ducts in a large turbo generator.

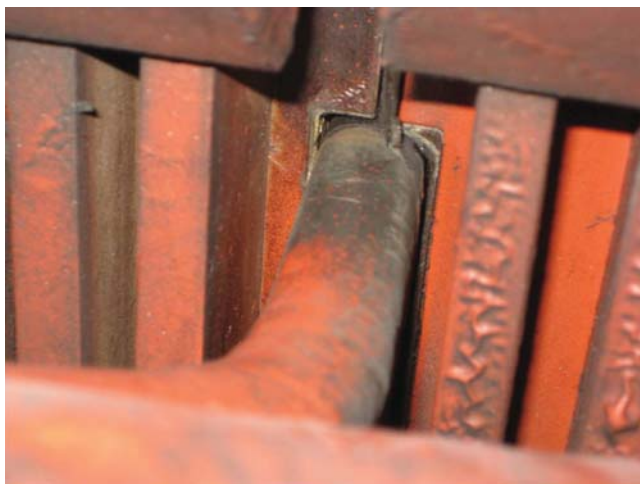
Figure 13.9 Split core packing movement.

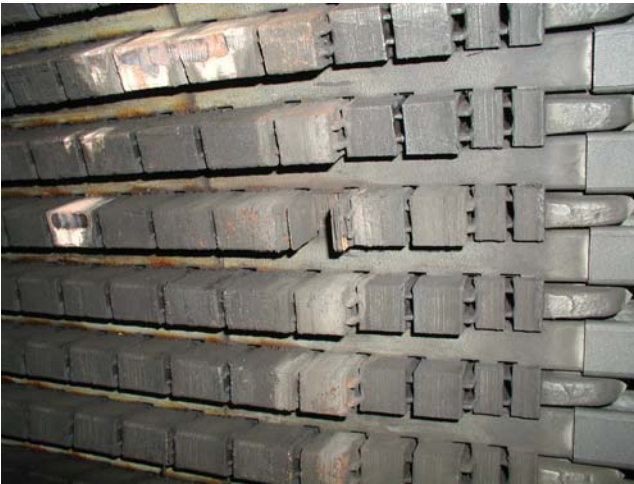
Figure 13.11 Core damage from a loose bolt.

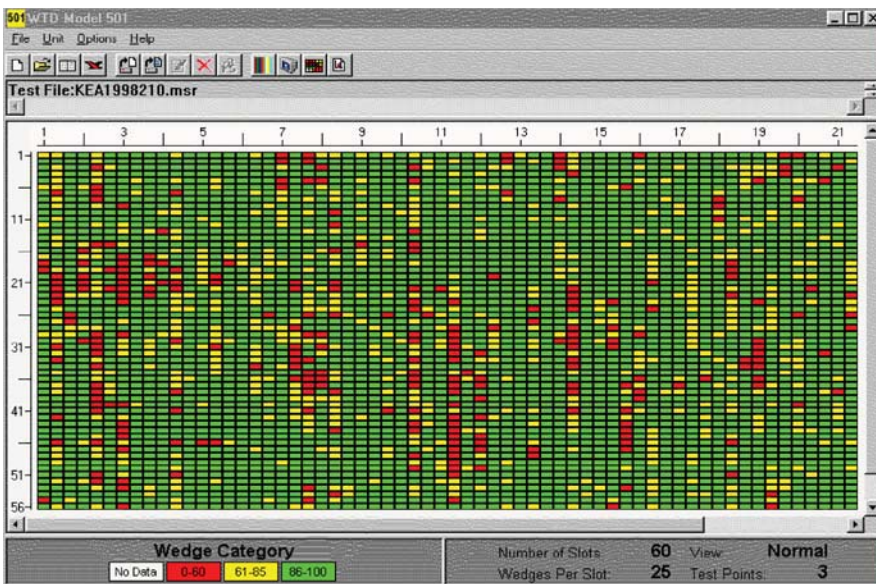
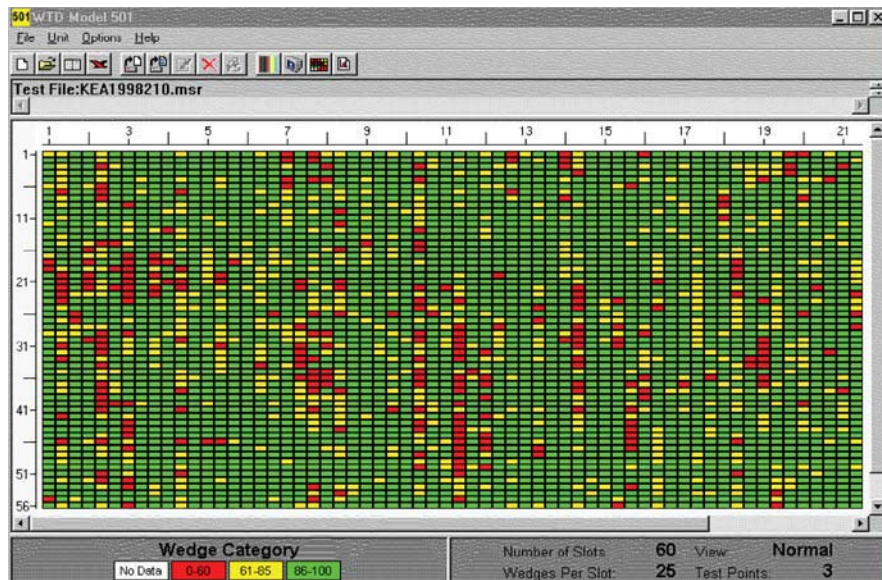
Figure 15.9 Map of wedge tightness versus slot number (vertical scale) and axial wedge number (horizontal scale). Green is tight, red is loose, and yellow is indeterminate. (Source: Iris Power-Qualitrol). See color plate section.

Figure 15.9 Map of wedge tightness versus slot number (vertical scale) and axial wedge number (horizontal scale). Green is tight, red is loose, and yellow is indeterminate. (Source: Iris Power-Qualitrol).

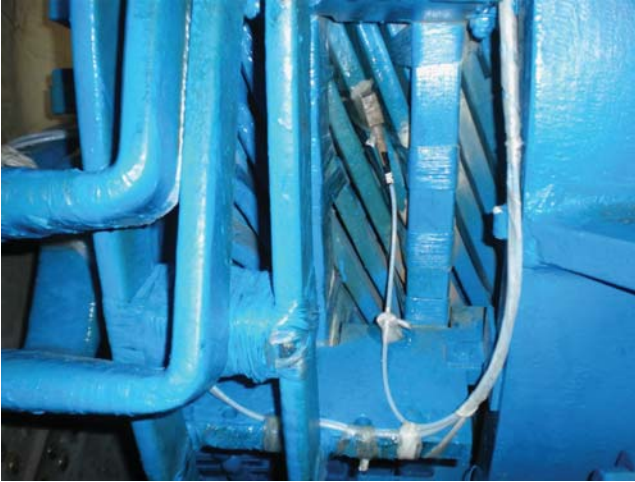
Figure 16.10 Photo of the installation of fiber-optic accelerometers on stator bars in an endwinding. (Source: Iris Power-Qualitrol.)

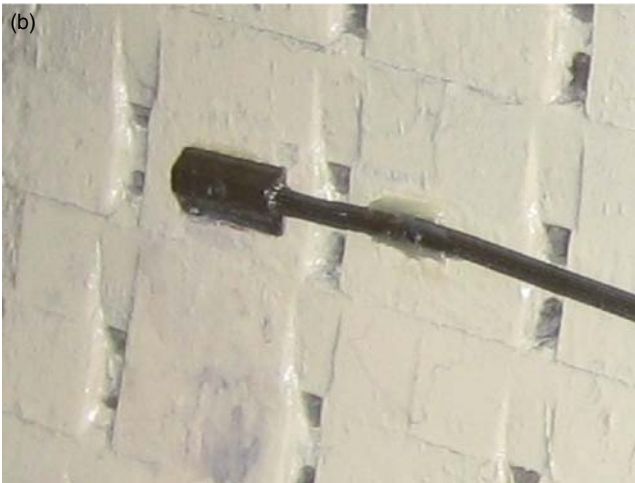
Figure 16.13 (a) A photo of a conventional wedge-mounted foldable flux probe that projects into the air gap. (b) A photo of an installed flat flux probe glued to a stator tooth. (Source: Iris Power-Qualitrol.)

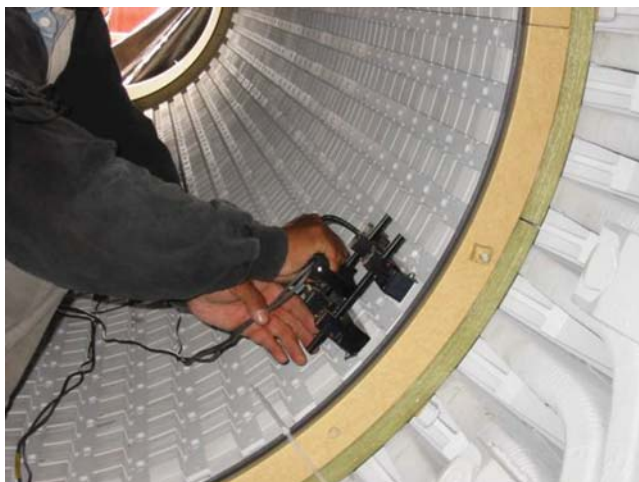
Figure 17.15 El-CID trolley with Chattock coil mounted.

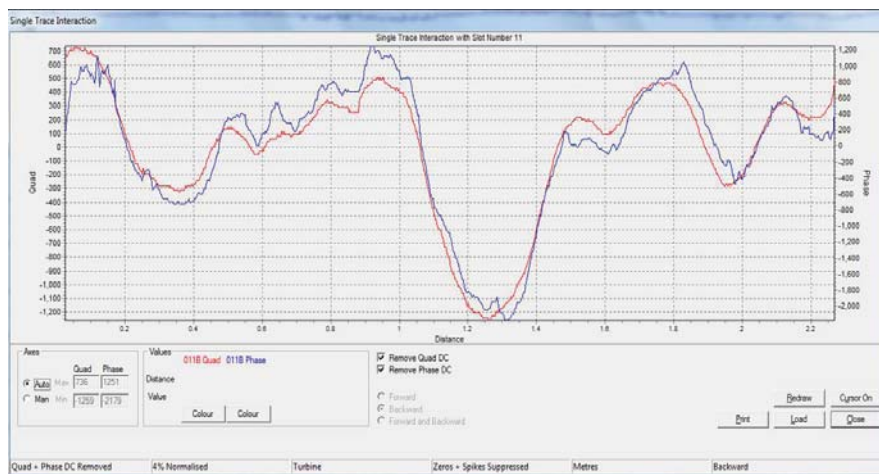
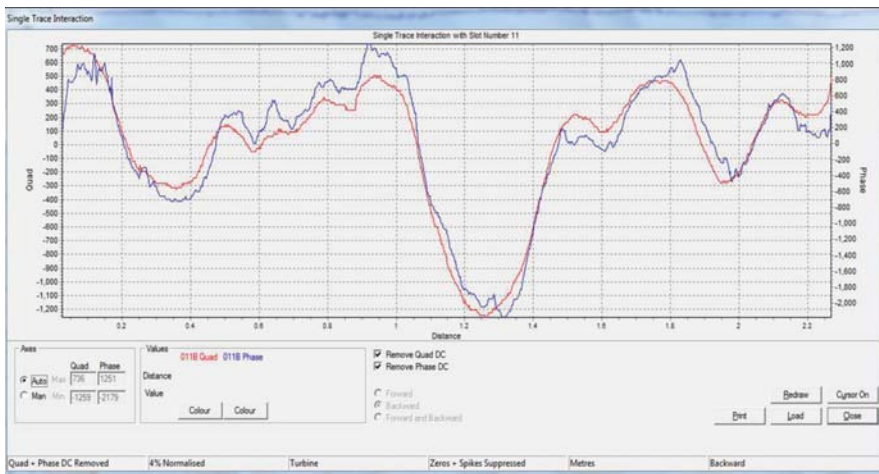
Figure 17.20 El-CID QUAD and PHASE current comparisons along a stator slot at a core split—same shape and constant PHASE/QUAD current ratio confirms that there is no core insulation damage. (Source: Courtesy Iris Power-Qualitrol.) *See color plate section.*

Figure 17.20 El-CID QUAD and PHASE current comparisons along a stator slot at a core split—same shape and constant PHASE/QUAD current ratio confirms that there is no core insulation damage. (Source: Courtesy Iris Power-Qualitrol.)

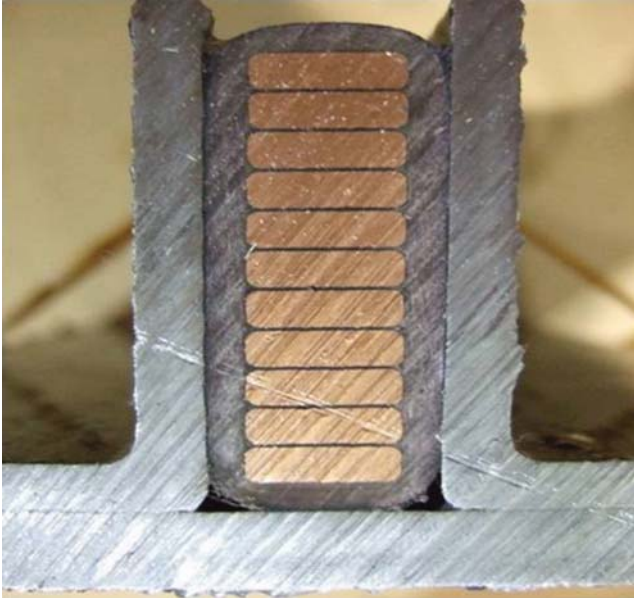
Figure 18.5 Section of sample global VPI'd coil in simulated slot.
