Durability of composites for civil structural applications

Edited by Vistasp M. Karbhari

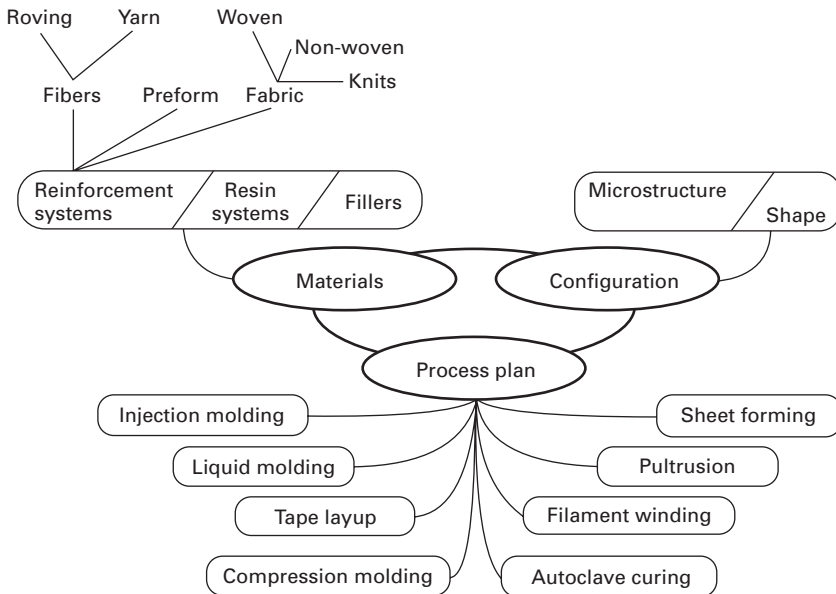
2.3 Interacting decision areas.

Each of the elements in Fig. 2.3 presents a spectrum of choices. The configuration of a composite is unique in that it includes both shape and microstructure, either or both of which could be varied to attain a specific attribute. Unlike manufacturing methods for metals the processes related to the fabrication of composites have limitations based on shape, microstructure and materials. Theoretically, any combination of the three aspects should be

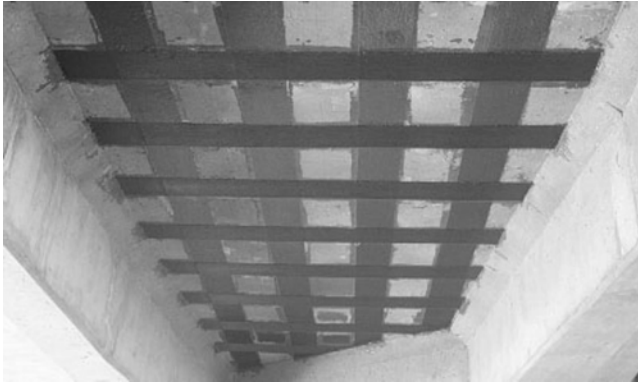
2.5 External bonding of fabric onto deck soffits for strengthening using wet layup.

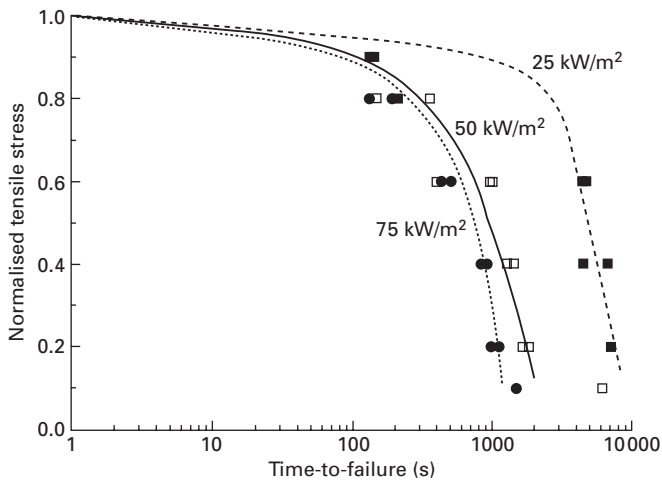
6.11 Effect of applied tensile stress on the time-to-failure of a glass/vinyl ester composite exposed to different heat fluxes.

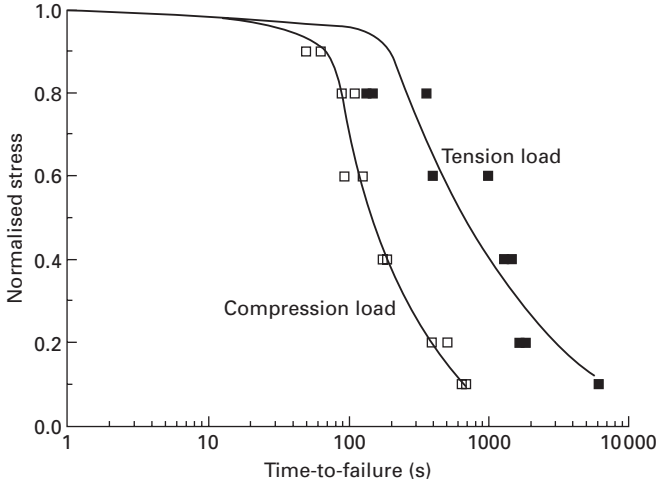
6.12 Comparison of the time-to-failure of a glass/vinyl ester composite under tension or compression loading. The loaded composite was exposed to a heat flux of 50 kW/m².

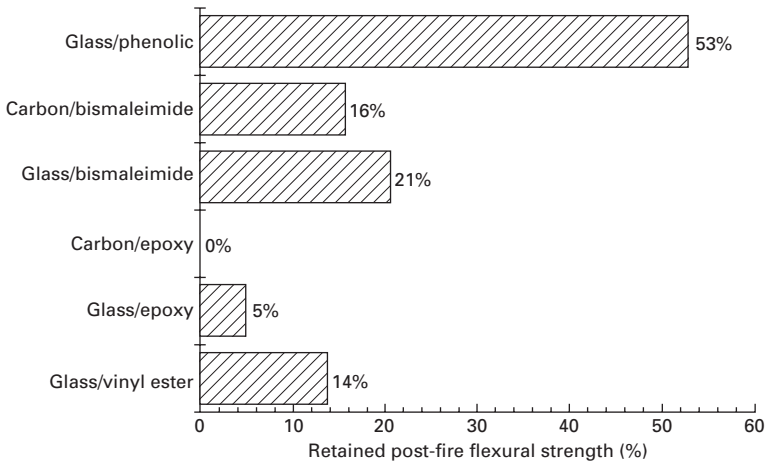
6.13 Retained flexural strengths of various thermoset laminates following fire testing at the heat flux of 25 kW/m² for 20 min. Data from Sorathia.¹²

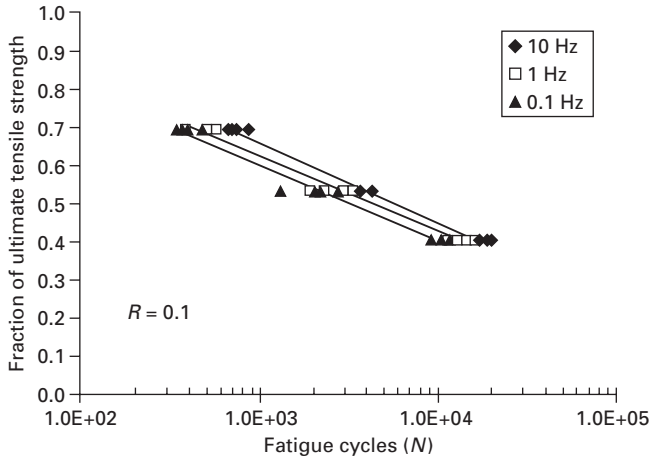
7.3 *S-N* curves for an E-glass/vinyl ester composite tested at different loading frequencies (same laminates as in Fig. 7.2).

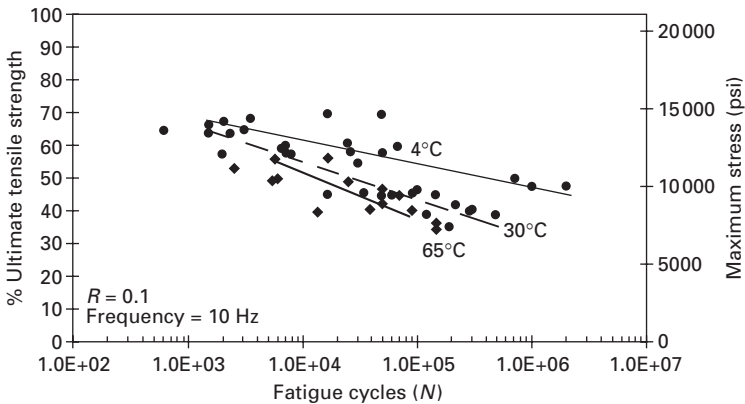
7.4 Thermal-mechanical effects on the fatigue of a pultruded E-glass/vinyl ester composite.

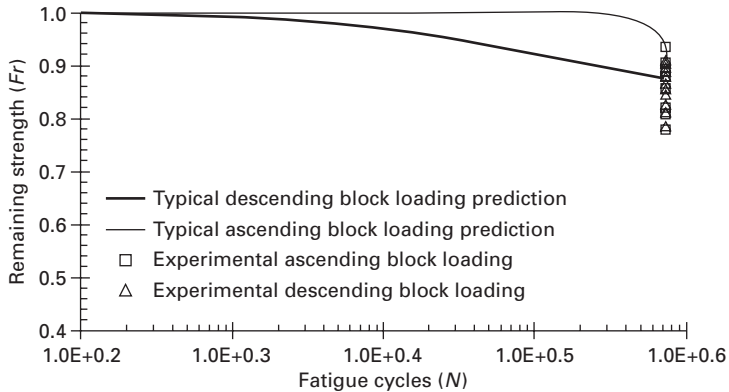
7.6 Predicted residual strength curves compared with experimental data (E-glass/vinyl ester laminates made through the VARTM process).

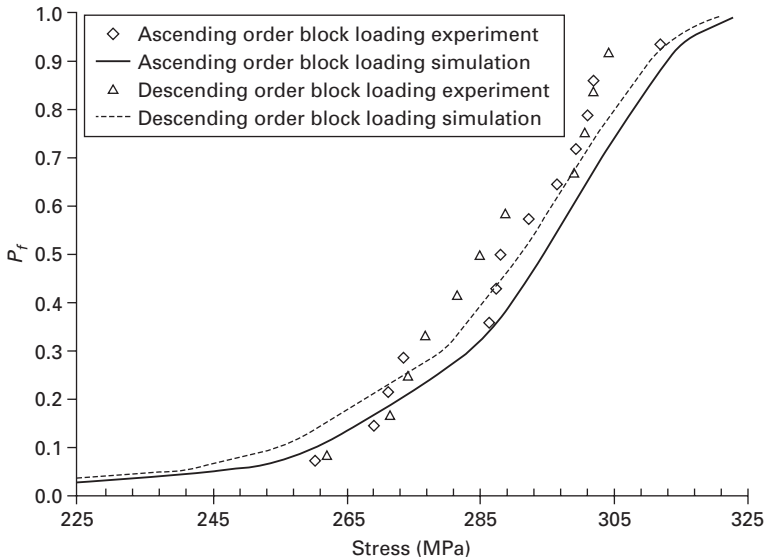
7.7 Residual strength cumulative probability distribution function comparison for block ordered spectrum experimental and model results.

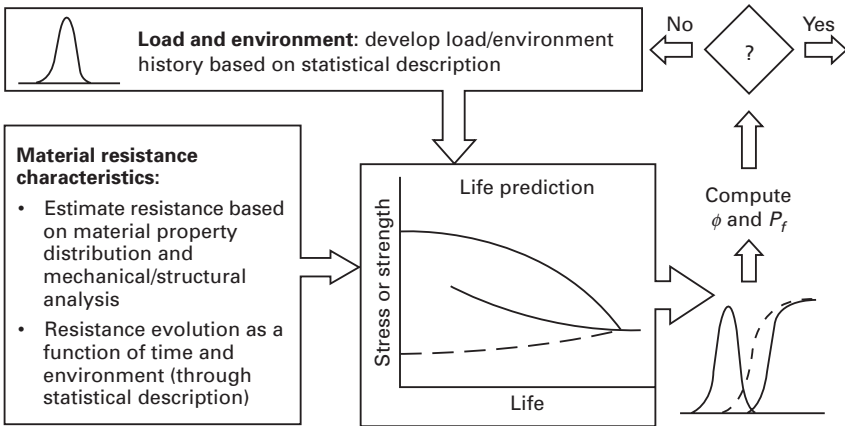
7.8 Schematic of a design approach considering fatigue and durability within a reliability-based approach.

The framework is illustrated schematically in Fig. 7.8. The core of the methodology is the life prediction, i.e. residual material resistance (stiffness or strength) as a function of time or fatigue cycles (life). The life prediction uses a statistical approach considering the statistical characteristics of the load and environment history, and the material resistance, simultaneously. Limited data from laboratory testing and field histories are used in conjunction with statistical simulation and this will help us to build the confidence level and reduce uncertainty. The outputs of the life prediction and statistical simulation are resistance and its knockdown factor, as well as the possibility of failure. The obtained resistance and the knockdown factor are then used in equation [7.10] to compare to its right-hand side. The main advantage of this methodology is to use the limited data to their maximum potential for designing polymer matrix composites with consideration of fatigue and durability issues. The implementation of this framework is demonstrated in equations [7.7] to [7.10] and the results are shown in Figs 7.6 and 7.7. Efforts are under way to incorporate random block loading and synergistic effects into this framework. Using this framework, structural health monitoring

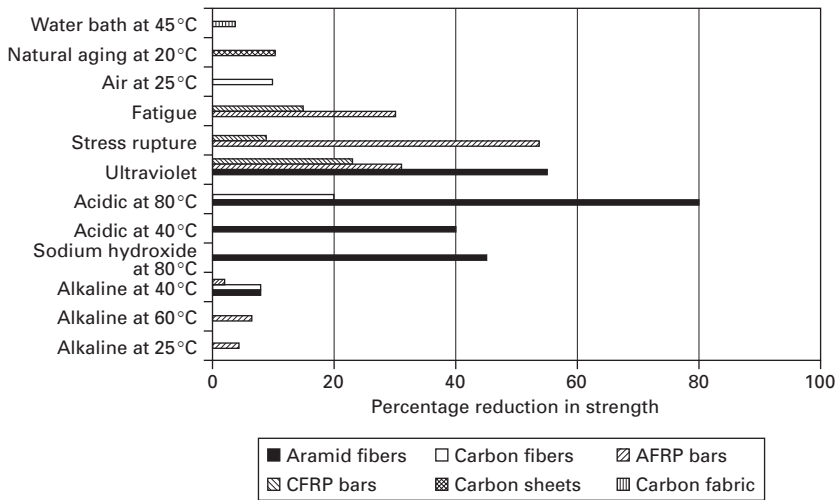
12.2 Strength degradation of fiber-reinforced polymer material alone.

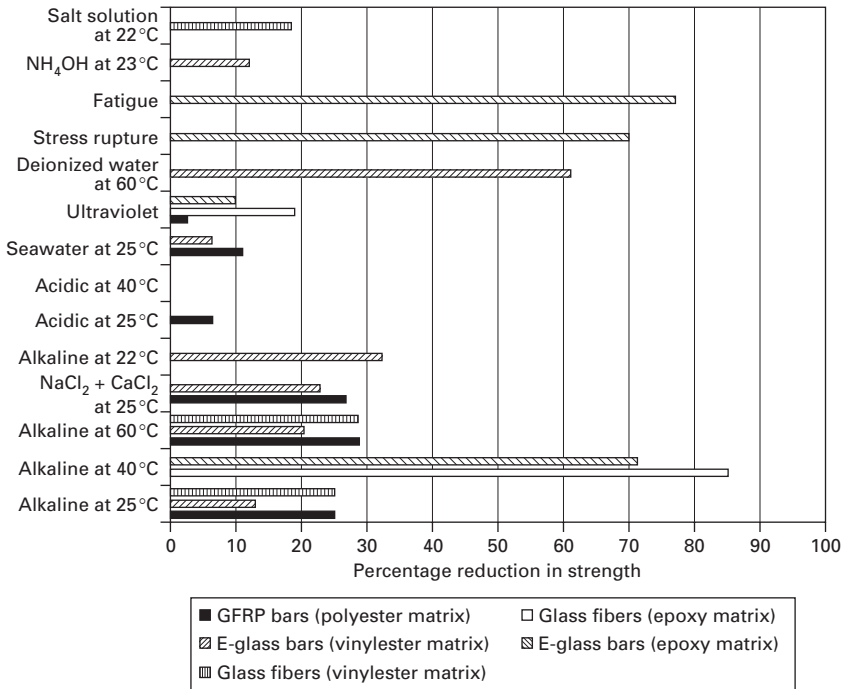
12.3 Strength degradation in glass fiber-reinforced polymers alone.

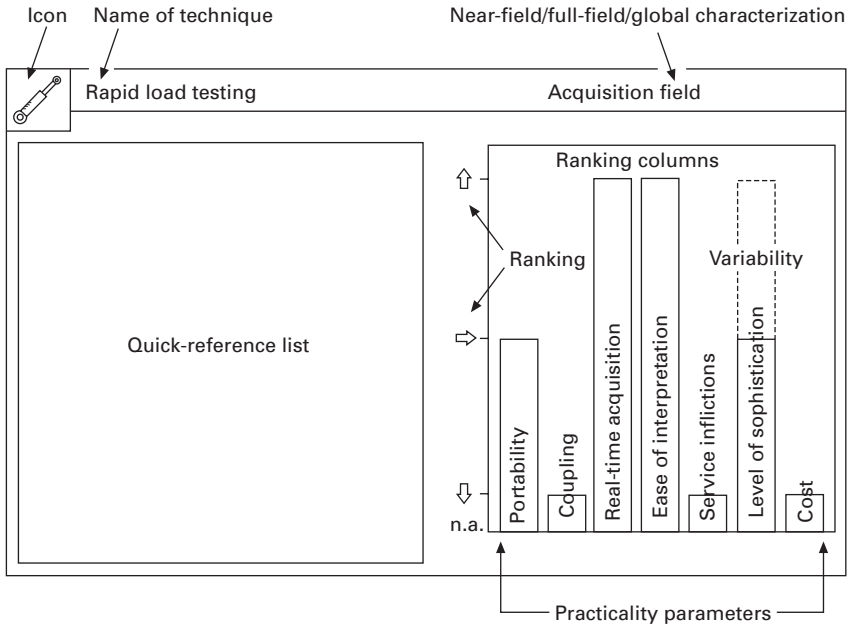
13.3 Schema used in the practicality matrix.

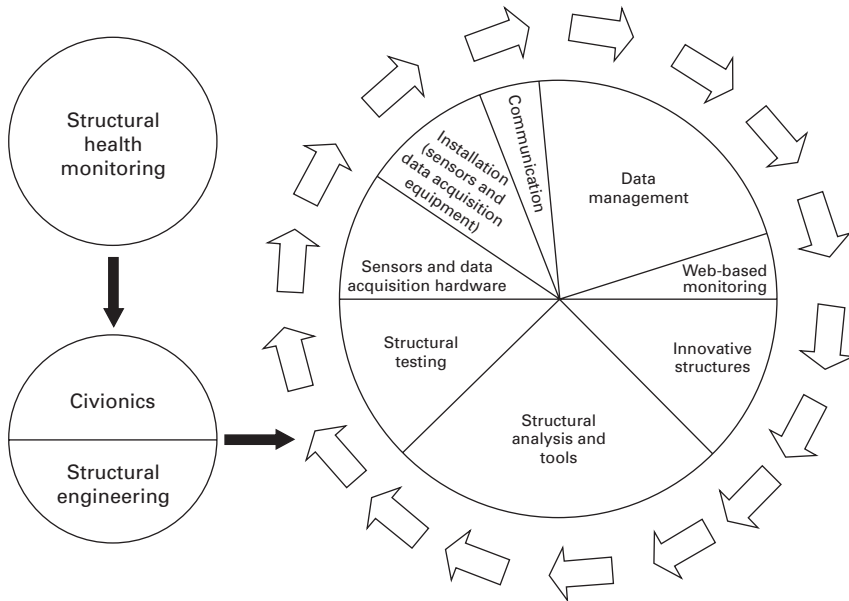
14.2 Various components of structural engineering and civionics.

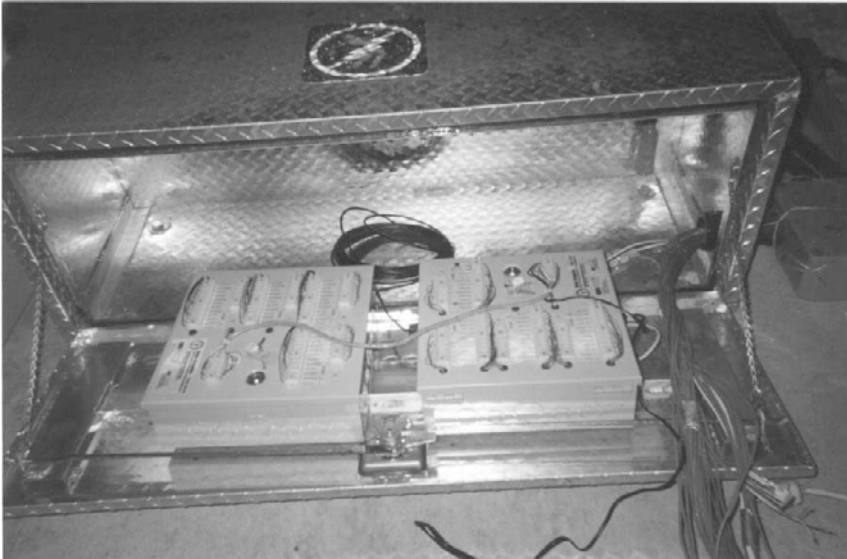
14.13 Datalogger installed on Portage Creek Bridge.
